YEAR 2 MONITORING REPORT Bay Wood Interim Action Cleanup and Shoreline Restoration Project CITY OF EVERETT, WASHINGTON

January 26, 2024 Shannon & Wilson No: 102336-022 Submitted To: Port of Everett 1205 Craftsman Way, Suite 200 Everett, WA 98201 Attn: Mr. Erik Gerking

Subject: YEAR 2 MONITORING REPORT, BAY WOOD INTERIM ACTION CLEANUP AND SHORELINE RESTORATION PROJECT, CITY OF EVERETT, WASHINGTON

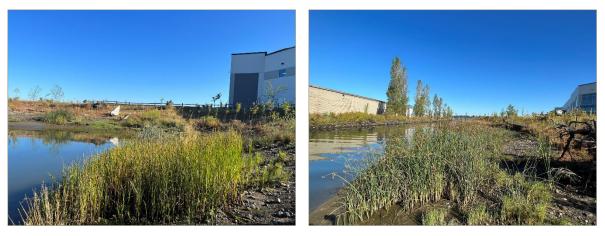
Exhibit 7-5: Example Planted Emergent Areas on the South Shore (Photos Taken August 4, 2023)

All the emergent and herbaceous species in the low- and mid-shore planting zones plant schedule were observed, and the dominants included baltic rush (*Juncus balticus*), hardstem bulrush (*Schoenoplectus acutus*), saltgrass (*Distichlis spicata*), common spikerush (*Eleocharis palustris*), coast gumweed (*Grindelia integrifolia*), Pacific silverweed (*Argentina pacifica*), and Douglas aster (*Symphyotrichum subspicatum*) (Exhibit 7-5).

- 4. Areas of emergent vegetation gaps along the southern shoreline, where wind and wave erosion do not prevent plant establishment, will also continue to be monitored and assessed for potential emergent plant replacement in future years.

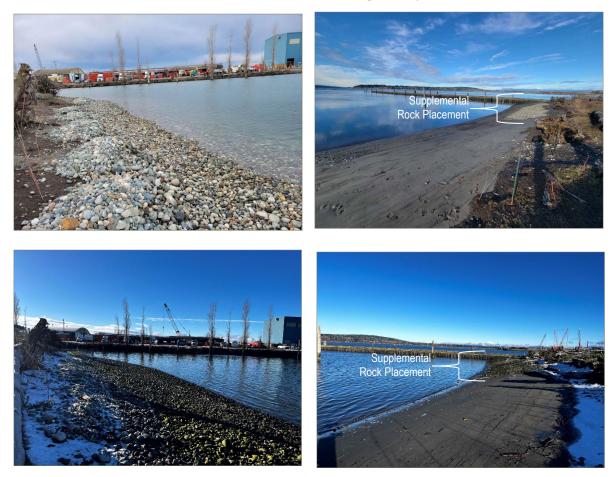
Exhibit 7-6: Photos of the Southern (Left) and Northern (Right) Supplemental Rock Placement Areas on the West Shore (Top Photos Taken by Port on January 5 and 11, 2023; Bottom Photos Taken by Port on January 12, 2024)

As documented in the Year 1 report, the Port installed rounded rock on two areas of the west shore that experienced substantial erosion and loss of the installed emergent vegetation and willow stakes. Exhibit 7-6 shows those two areas at the time of installation in 2023 and one year later in 2024. The placed material appears to be stable and the sand beach section between the two areas has been preserved. The supplemental substrate areas have not recruited sufficient fines to accommodate a replanting effort.

- 3. The supplemental substrate areas will continue to be monitored to assess whether the new material has trapped any fines or may have developed conditions suitable for future plantings. Depending on the findings, recommendations for supplemental emergent or other plantings may be made.

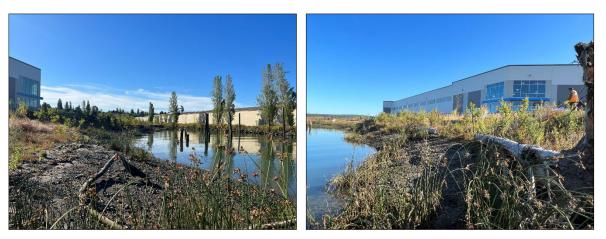
Exhibit 7-7: Photos of Beach Areas on the South Shore (Photos Taken August 4, 2023)

The south shore has shown little signs of being adversely impacted by wind or wave energy. The shoreline remains generally a shallow-sloped sandy, silty beach with some variablesized bands of gravels (for examples, see Exhibit 7-7 below and Exhibits C-3 and C-6 in Appendix C).
