Periodic Review Orchard Middle School

**1024 Orchard Avenue, Wenatchee, Chelan County
Facility Site ID: 771247, Cleanup Site ID: 447**

Toxics Cleanup Program, Central Region

July 2022

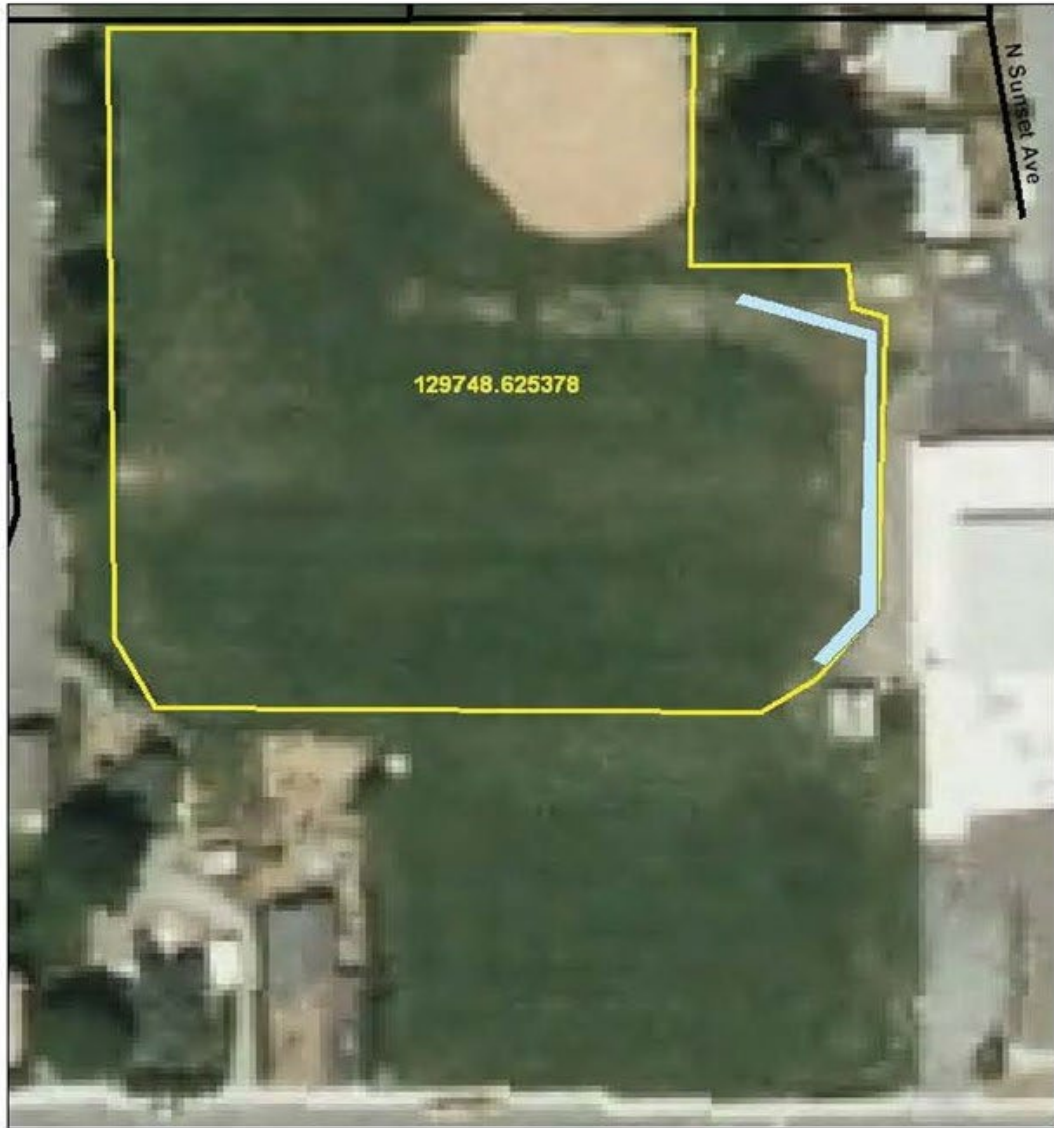
Orchard Remediation Area

To prevent exposure to contaminated soil, a geotextile barrier and 6-inch cap of clean soil were installed over the existing sports fields. Turf replacement was accomplished with sod on the football field and hydro-seed on the softball field. Because contamination was not removed from the Site, an environmental covenant was recorded to restrict future development or improvements on the Site which could expose contaminated soil.

Details of the installed cap are provided as follows: The existing grass turf was tilled to a depth of approximately six inches. A permeable geotextile fabric was then installed over the existing soil surface. The geotextile was placed in rolls that were 15 feet wide and they were overlapped a minimum of 12 inches. The fabric was secured with 6-inch long landscaping staples and then covered with clean topsoil.

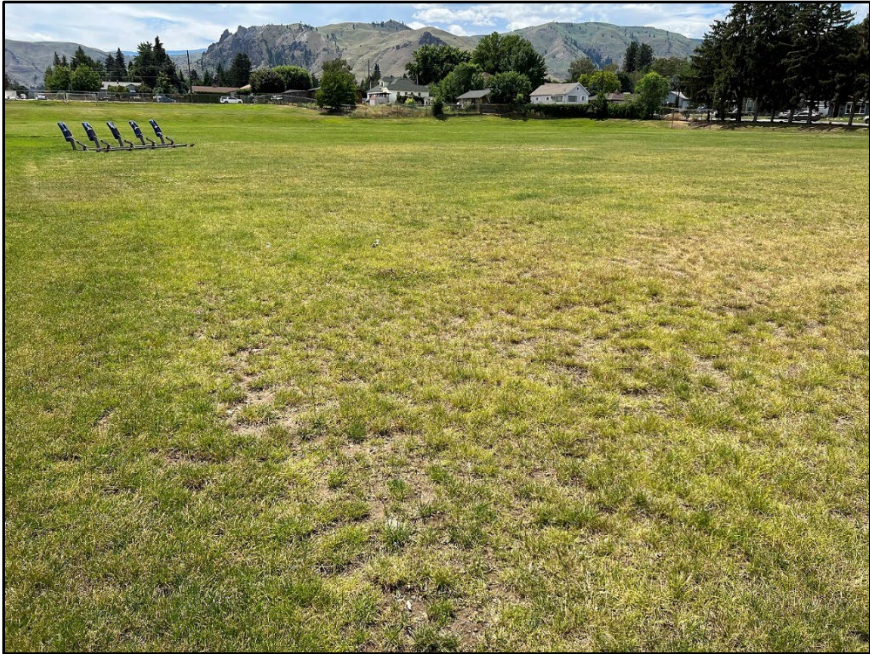
Photo 3: Field to northwest of the school (view to southwest)

- Some distressed turf in the northeast part of the field located northwest of the school (Photo 3).

Note distressed turf in foreground.

Maintenance activities are warranted to prevent erosion in areas of uncovered soil that could lead to potential future exposures to contaminated soils.

Based on this periodic review, Ecology has determined the requirements of the Covenant are being followed. Some surface maintenance activities are recommended as discussed herein. No additional cleanup actions are required by the property owner at this time. The property owner is responsible for continuing to inspect the Site to ensure the integrity of the cap is maintained.
