**APPENDIX E**  
**Open Space Restoration**

**Anchor QEA Memorandum  
“Response to U.S. Army Corp of Engineers’ Request  
for Additional Information”**

**To:** Erin Legge, U.S. Army Corps of Engineers      **Date:** March 28, 2013  
**From:** Heather Griffin, City of Everett  
Heather Page, Anchor QEA, LLC  
**Re:** Kimberly Clark DWO Project (NWS-2000-34)  
Response to U.S. Army Corps of Engineers' Request for Additional Information

## FIGURES OF ORIGINAL BEACH RESTORATION, PHASE 1, AND PHASE 2

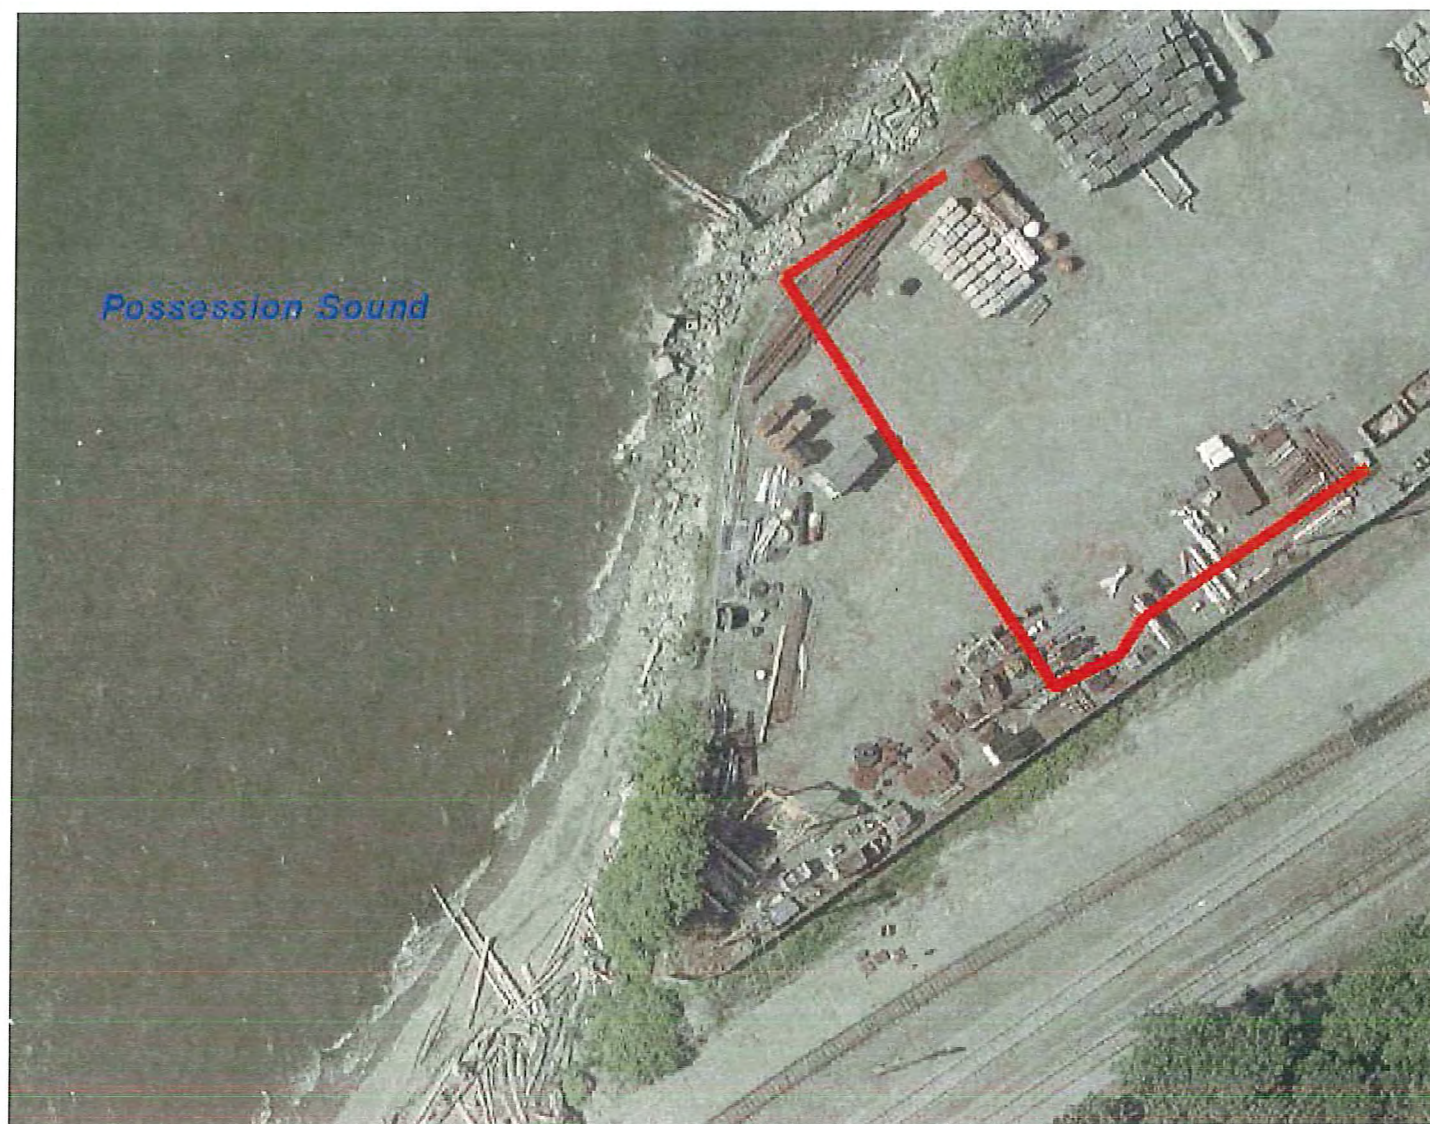
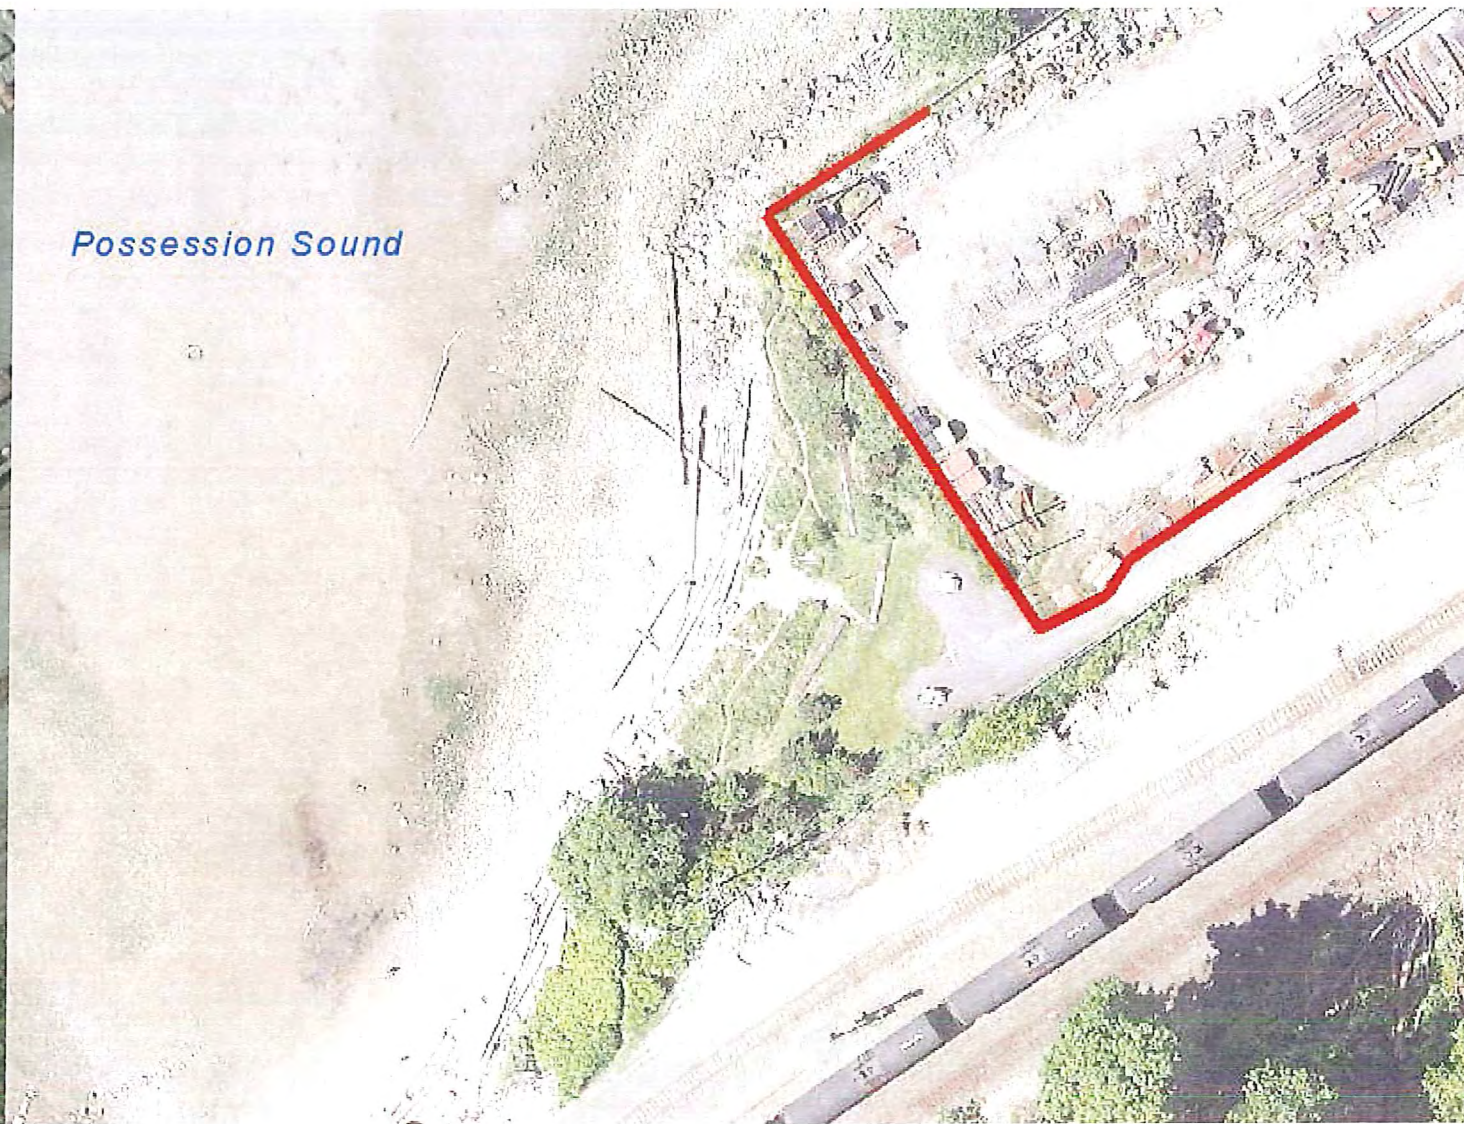
Note: Red line is the fence line digitized in from the 2011 aerial photograph

Figure 1: Pre-Construction (left) 2001 and Post-Construction (right) 2011 Aerial Photography of Project Site  
Depp Water Outfall Beach Repair Project

The site was originally uplands and was part of the Port of Everett (Port) as a laydown yard. It extended from the current northwest corner of the Port's laydown area to the southern portion of the project extent (see Figure 1 in Attachment 1).

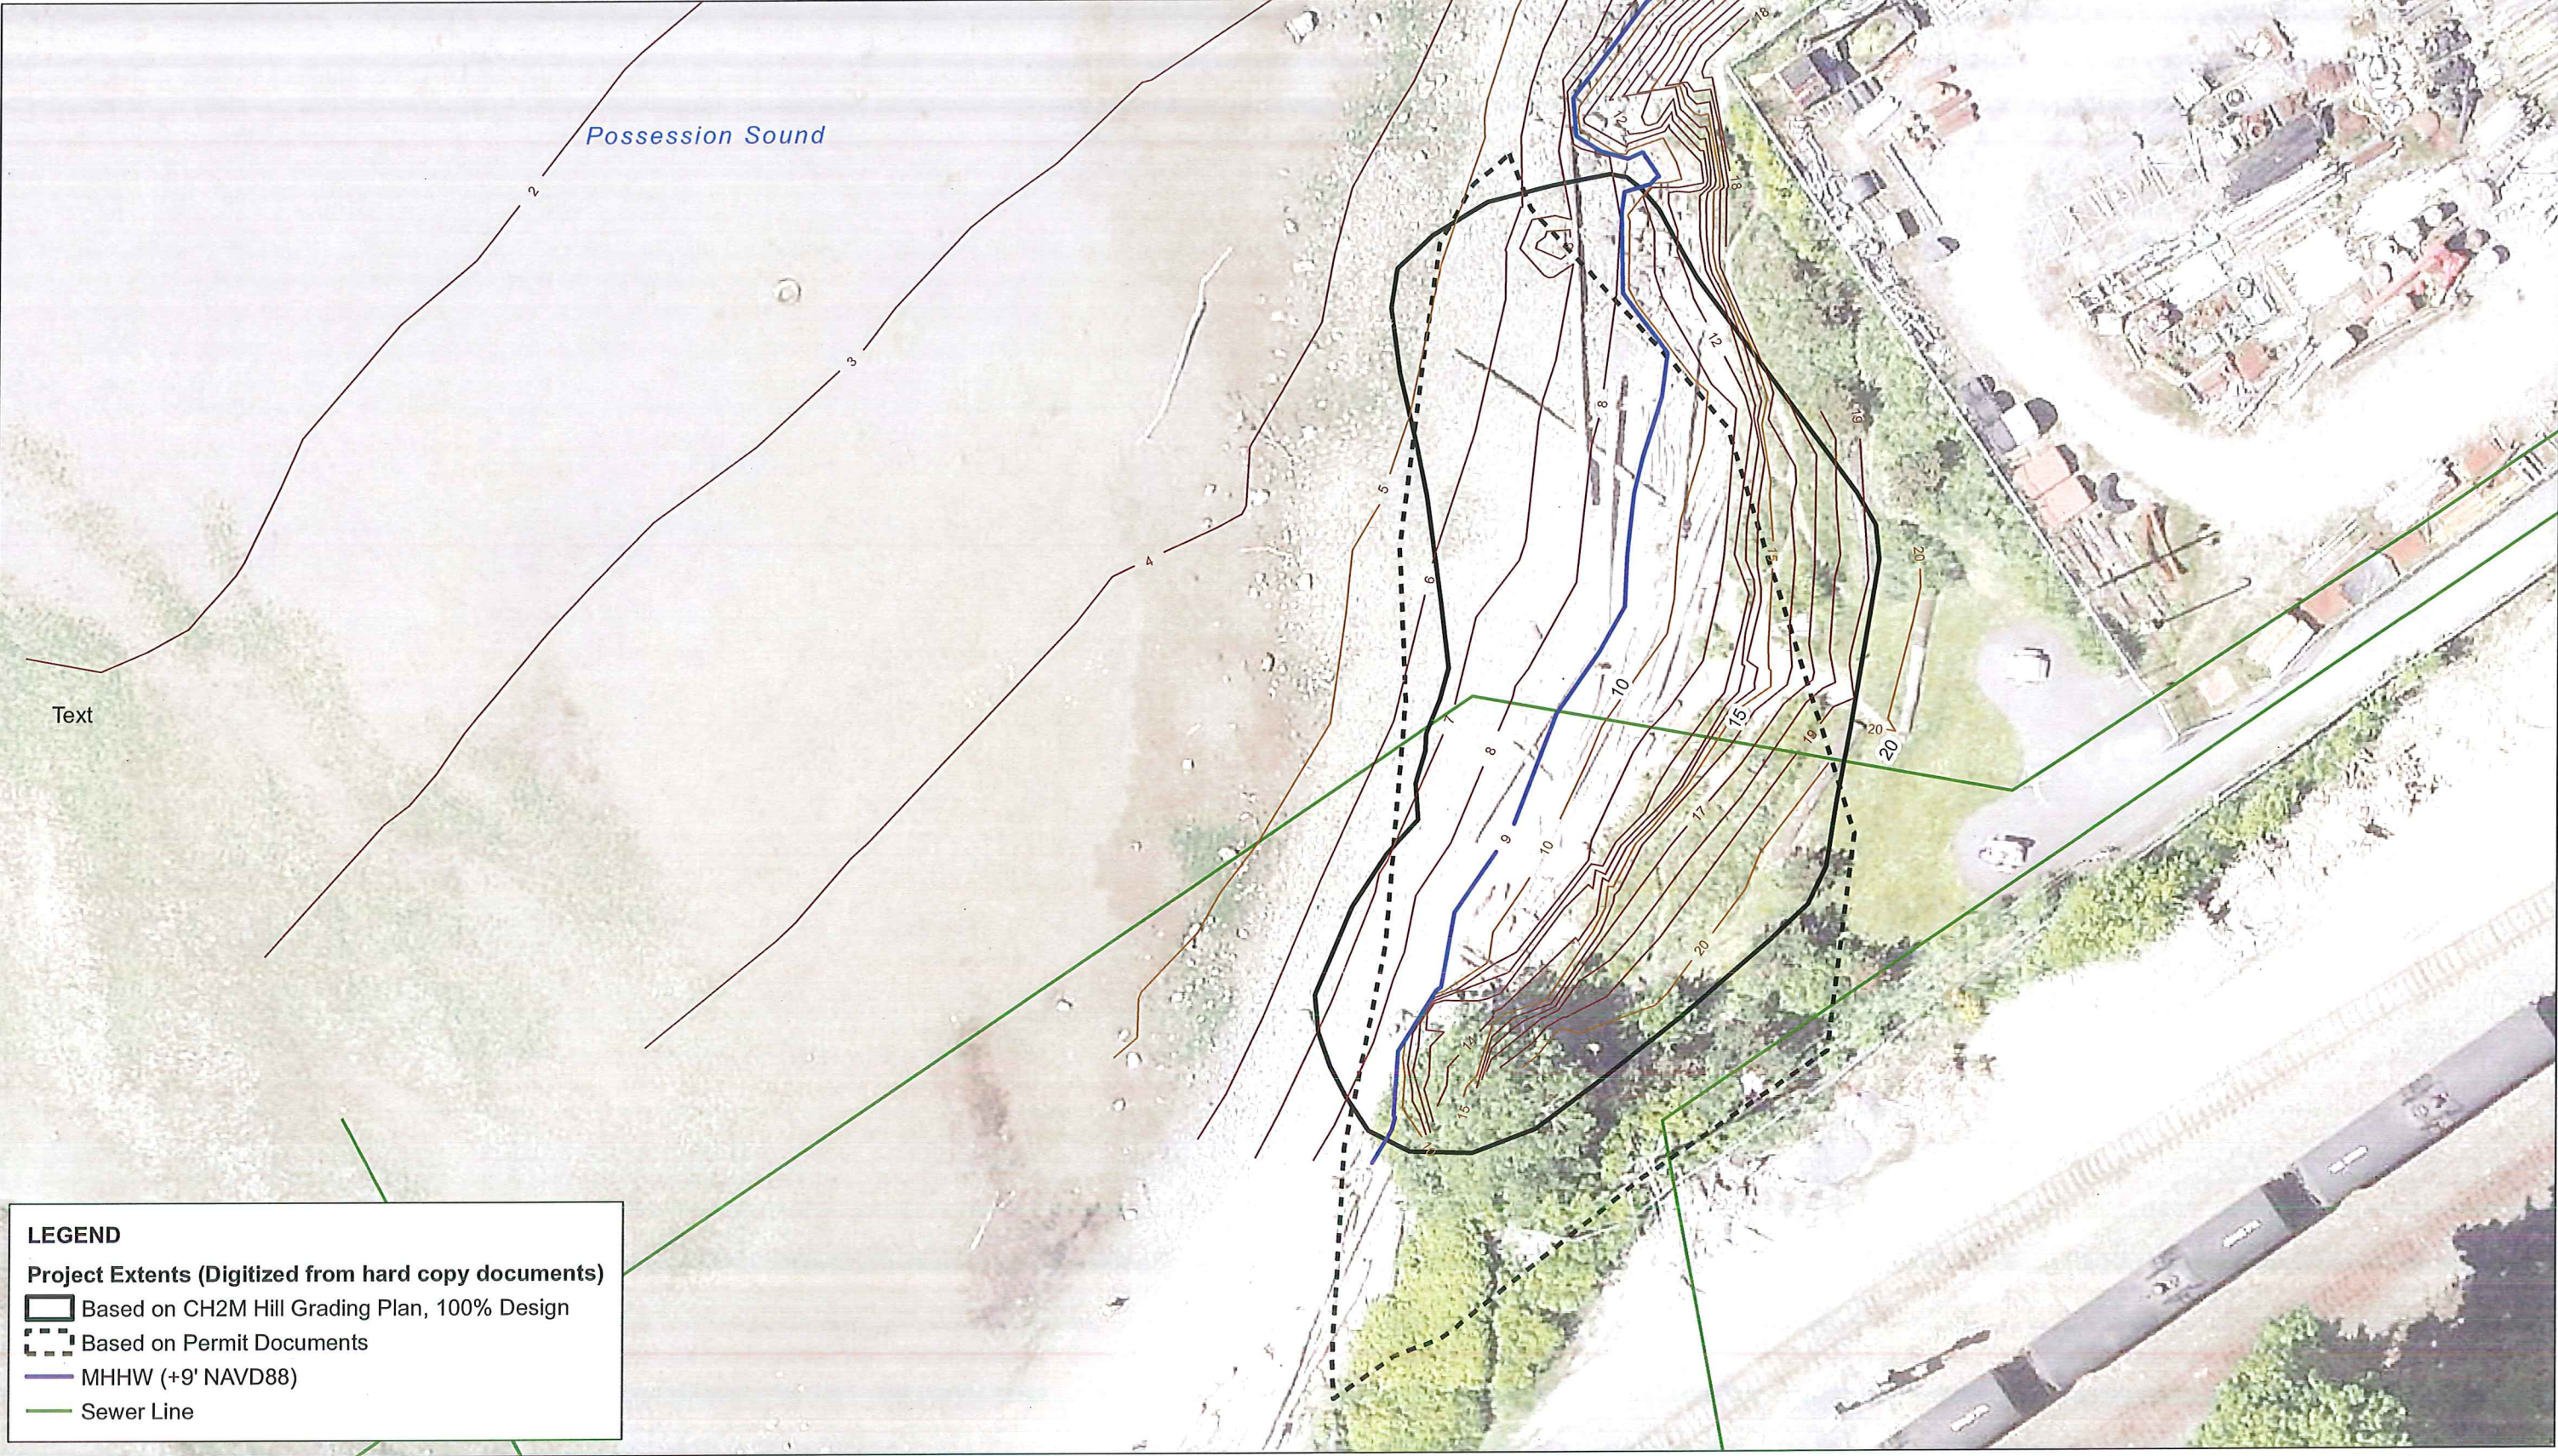
**Figure 2: Site Map and Approximate Limits of Grading of Original Beach Enhancement Work**  
 Deep Water Outfall Beach Repair Project

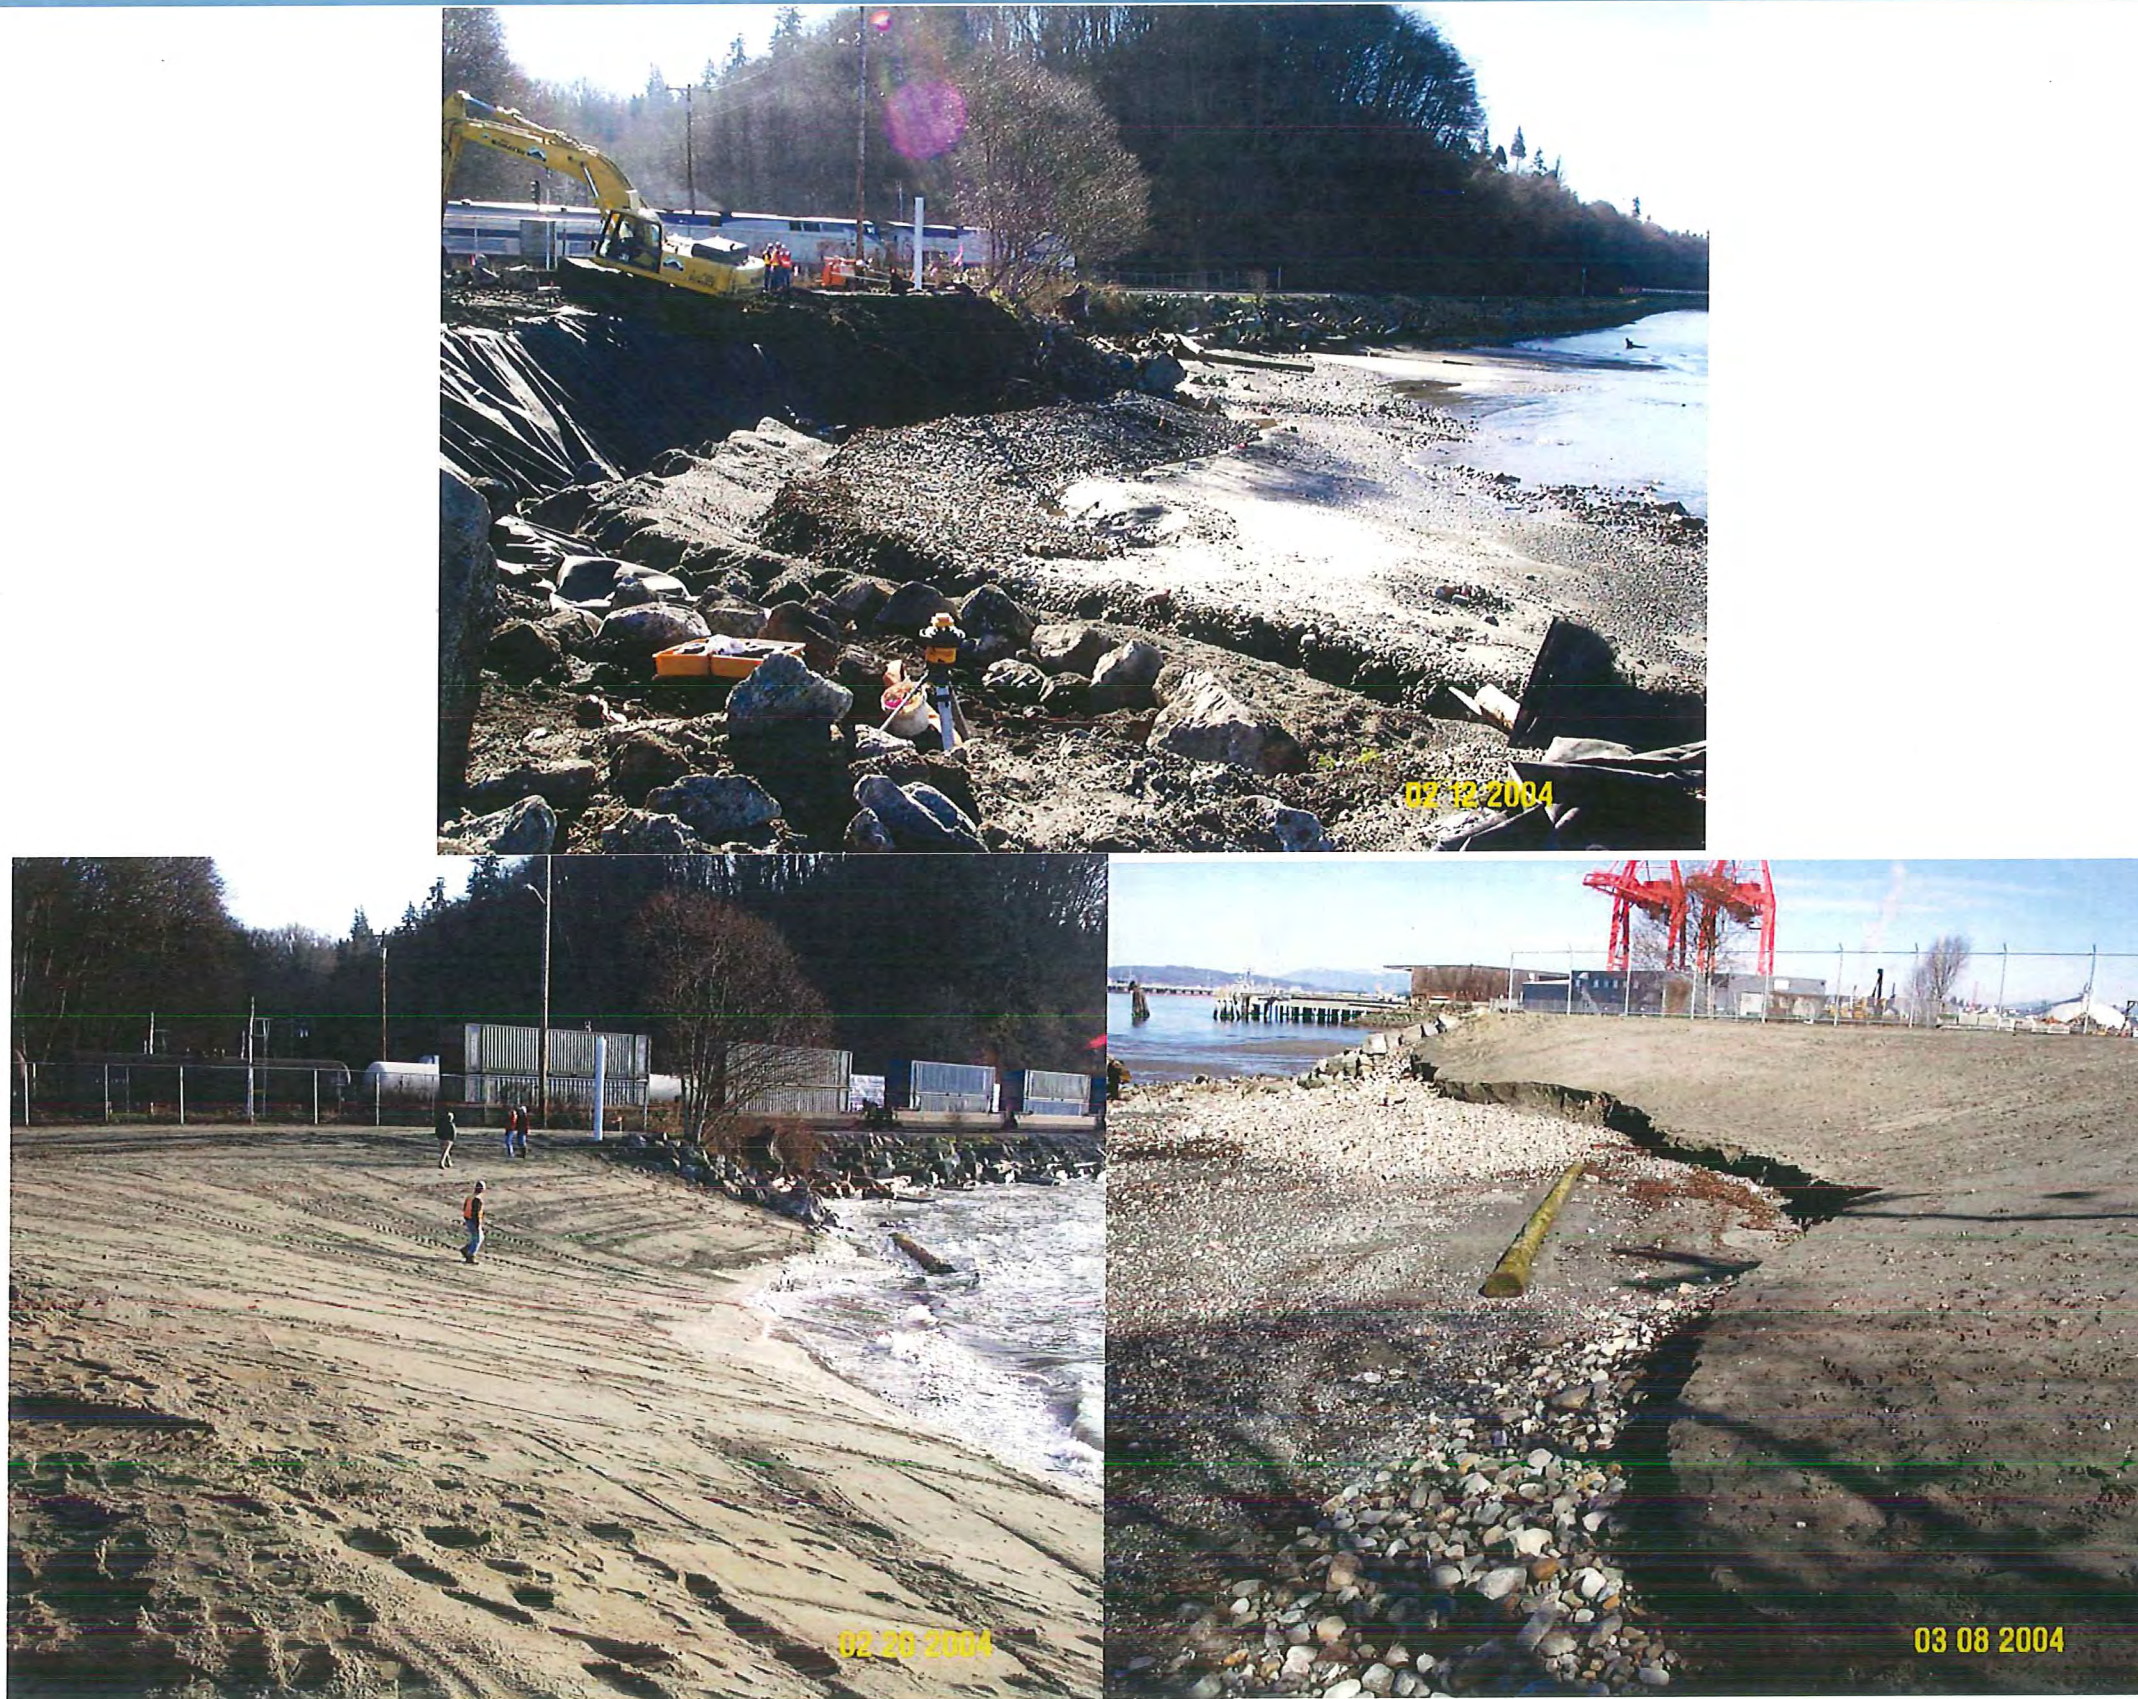
Figure 3: During Construction (top), Post-Construction (bottom left) February 20, 2004 and Beginning of Erosion (bottom right) March 8, 2004  
Deep Water Outfall Beach Repair Project

Beach nourishment (placement of beach gravels) is proposed as part of Phase 2 to provide additional shoreline protection to upland areas and provide additional beach area at upper intertidal elevations at the site. The original beach nourishment at the site, constructed in 2004, used sandy sediments as the primary fill material. Due to relatively steep slopes in the fill area (greater than 8H:1V) and high wave energy at the project site, the majority of the sand placed on the site at or below MHHW was significantly eroded within 1 month of placement (see Figure 3 in Attachment 1).

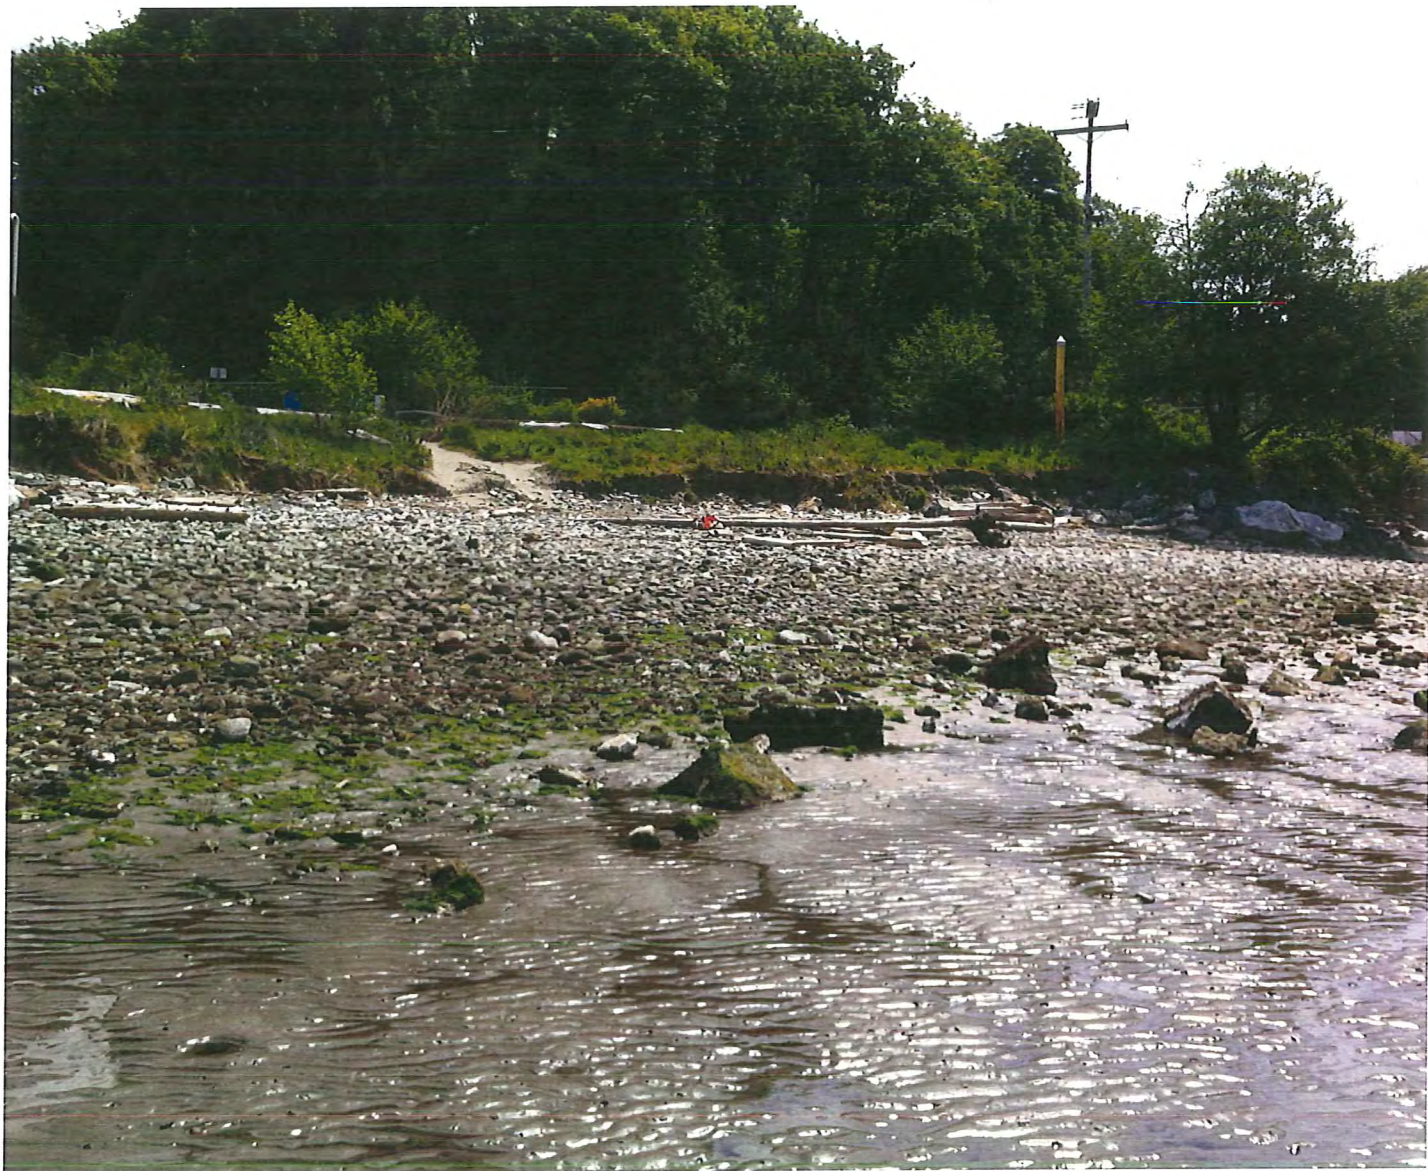
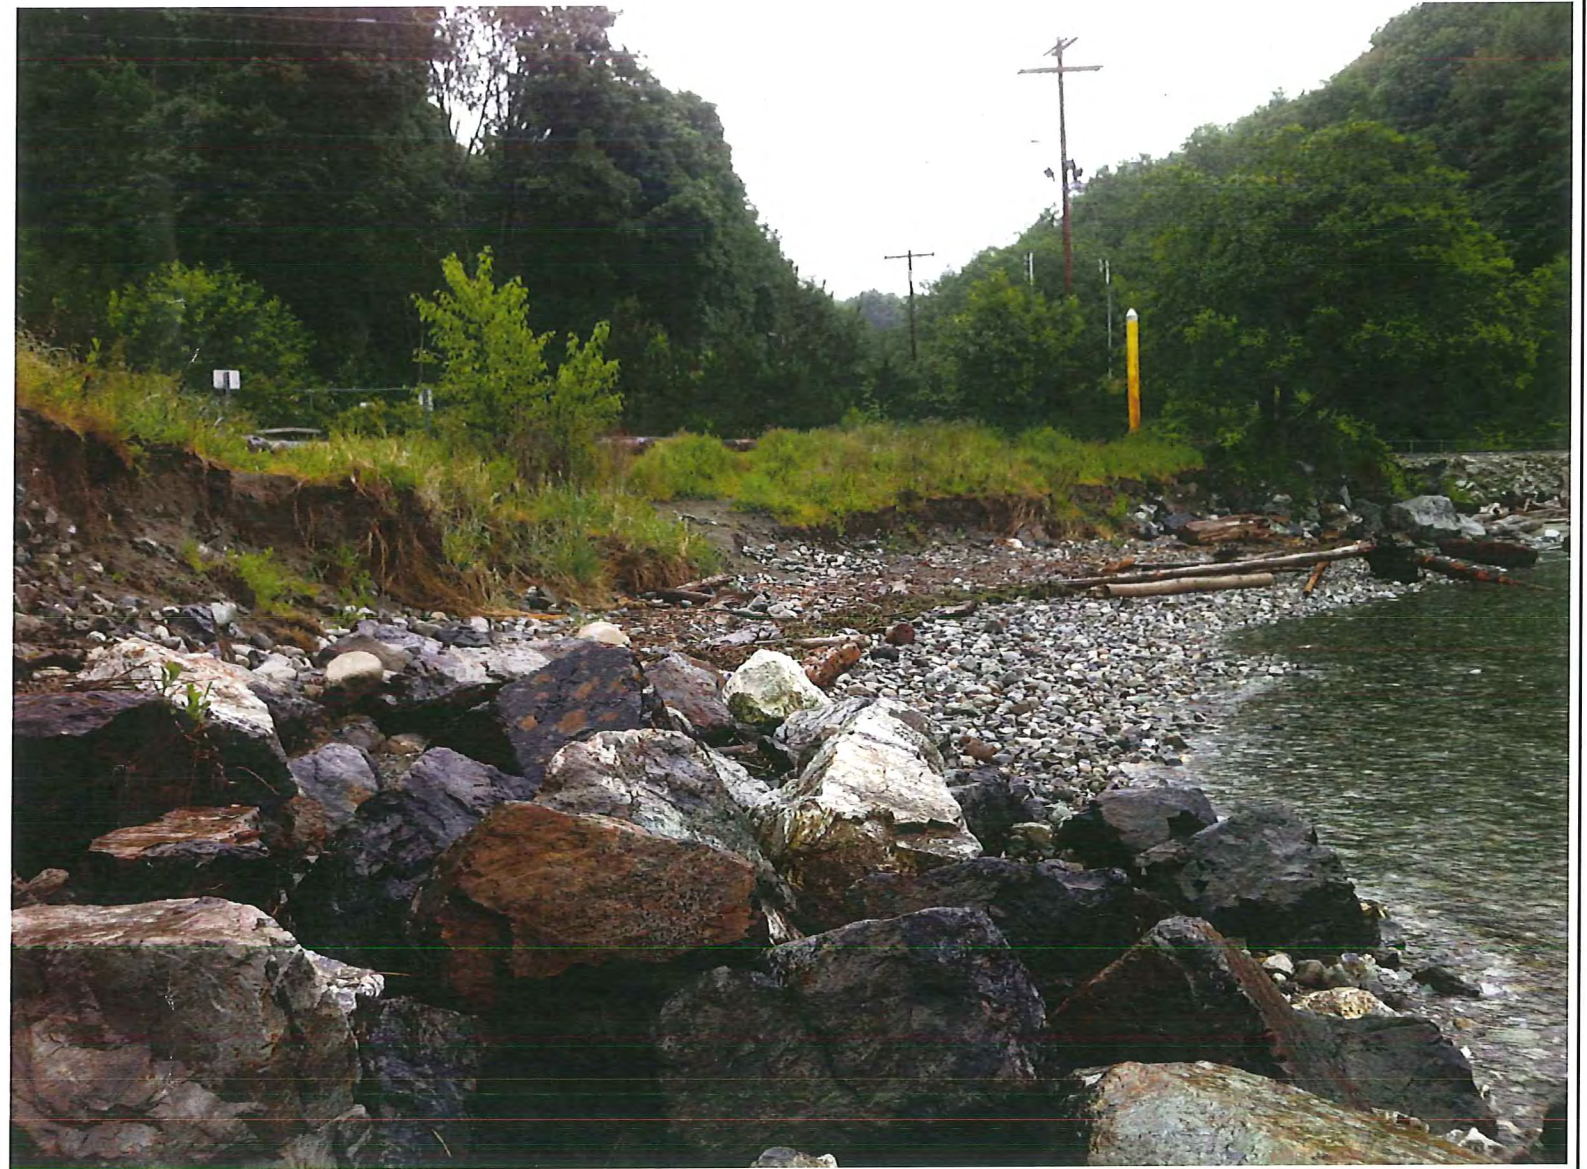
Figure 4: Site Visit May 18, 2012, Low Tide (Left) and Site Visit June 7, 2012, High Tide (Right)  
Deep Water Outfall Beach Repair Project

The project area and vicinity were excavated in late 2003 to place an offshore outfall for Kimberly Clark (KC) and the City. A temporary trestle was built to aid in the placement of the offshore outfall, which extended from its land connection at the project site to the southwest. In February 2004, following construction of the outfall, the site was re-graded and filled to create a pocket beach. The temporary pier was removed and the shoreline was cut back from a straight shoreline to the curved shoreline shown in Figure 2 in Attachment 1. Immediately after construction, the beach sand began eroding due to impacts from wave action (likely between mean high water [MHW] and MHHW), forming a vertical scarp along the shoreline. A month following construction, the beach sand had eroded to the point that the underlying cobble and larger armor rocks became visible (see Figure 3 in Attachment 1). At present, the majority of the placed sand has eroded from the upper intertidal area and the underlying cobble has spread over the area (see Figure 4 in Attachment 1).

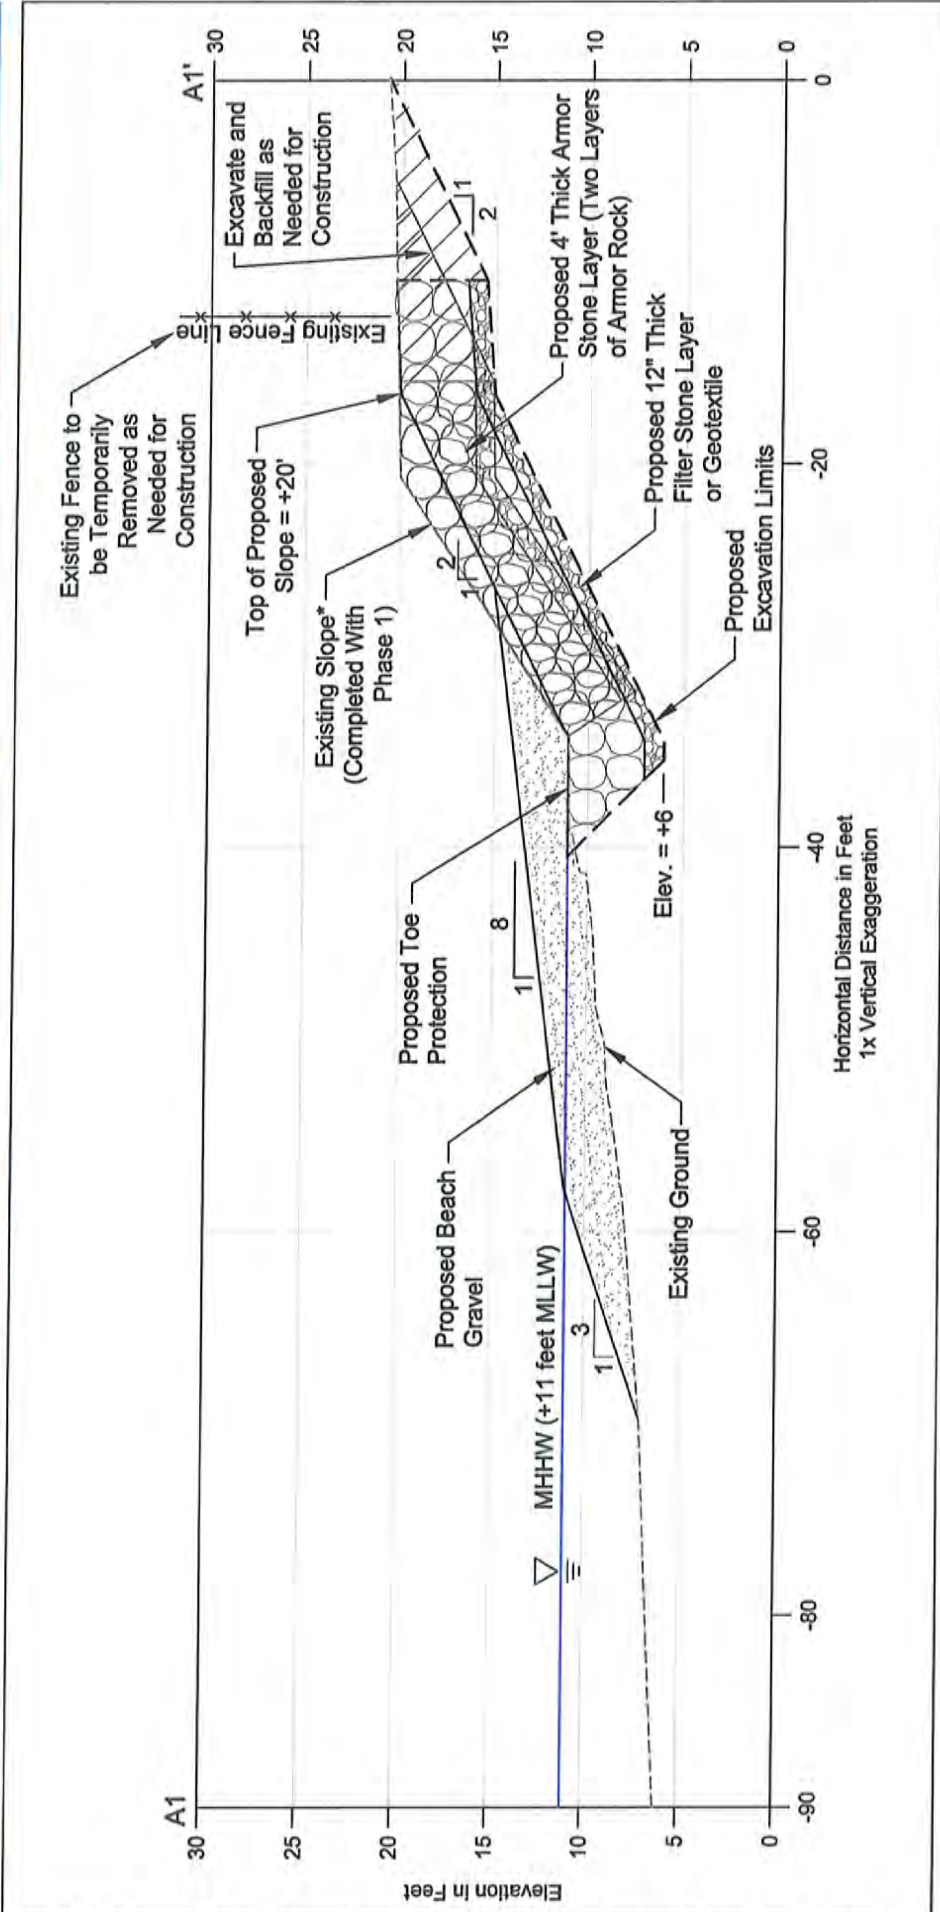
- \* Deconstruct 1.5H:1V rock armor slope and rebuild as shown. Located above Mean Higher High Water (MHHW).

**Figure 6**  
 Cross Section of Phase 1 / Phase 2 Overlap  
 Deep Water Outfall Beach Repair Project

Phase 2 consists of adding additional toe protection to portions of the Phase 1 slope above and below MHHW (see revised Sheet 2 of the Joint Aquatic Resource Permit Application [JARPA] Drawings in Attachment 2). See Figure 6 in Attachment 1 for a cross-section of the overlap between Phase 1 and Phase 2. The toe of the slope from Phase 1 will be extended 50 square feet beyond MHHW to the extent required to build a stable rock revetment to stabilize that area. The revetment would also be modified from the 1.5H:1V slope for the Phase 1 construction, to achieve a 2H:1V slope for the final Phase 2 construction. Please see the JARPA submitted to USACE for a complete description of Phase 2 (City of Everett 2012).

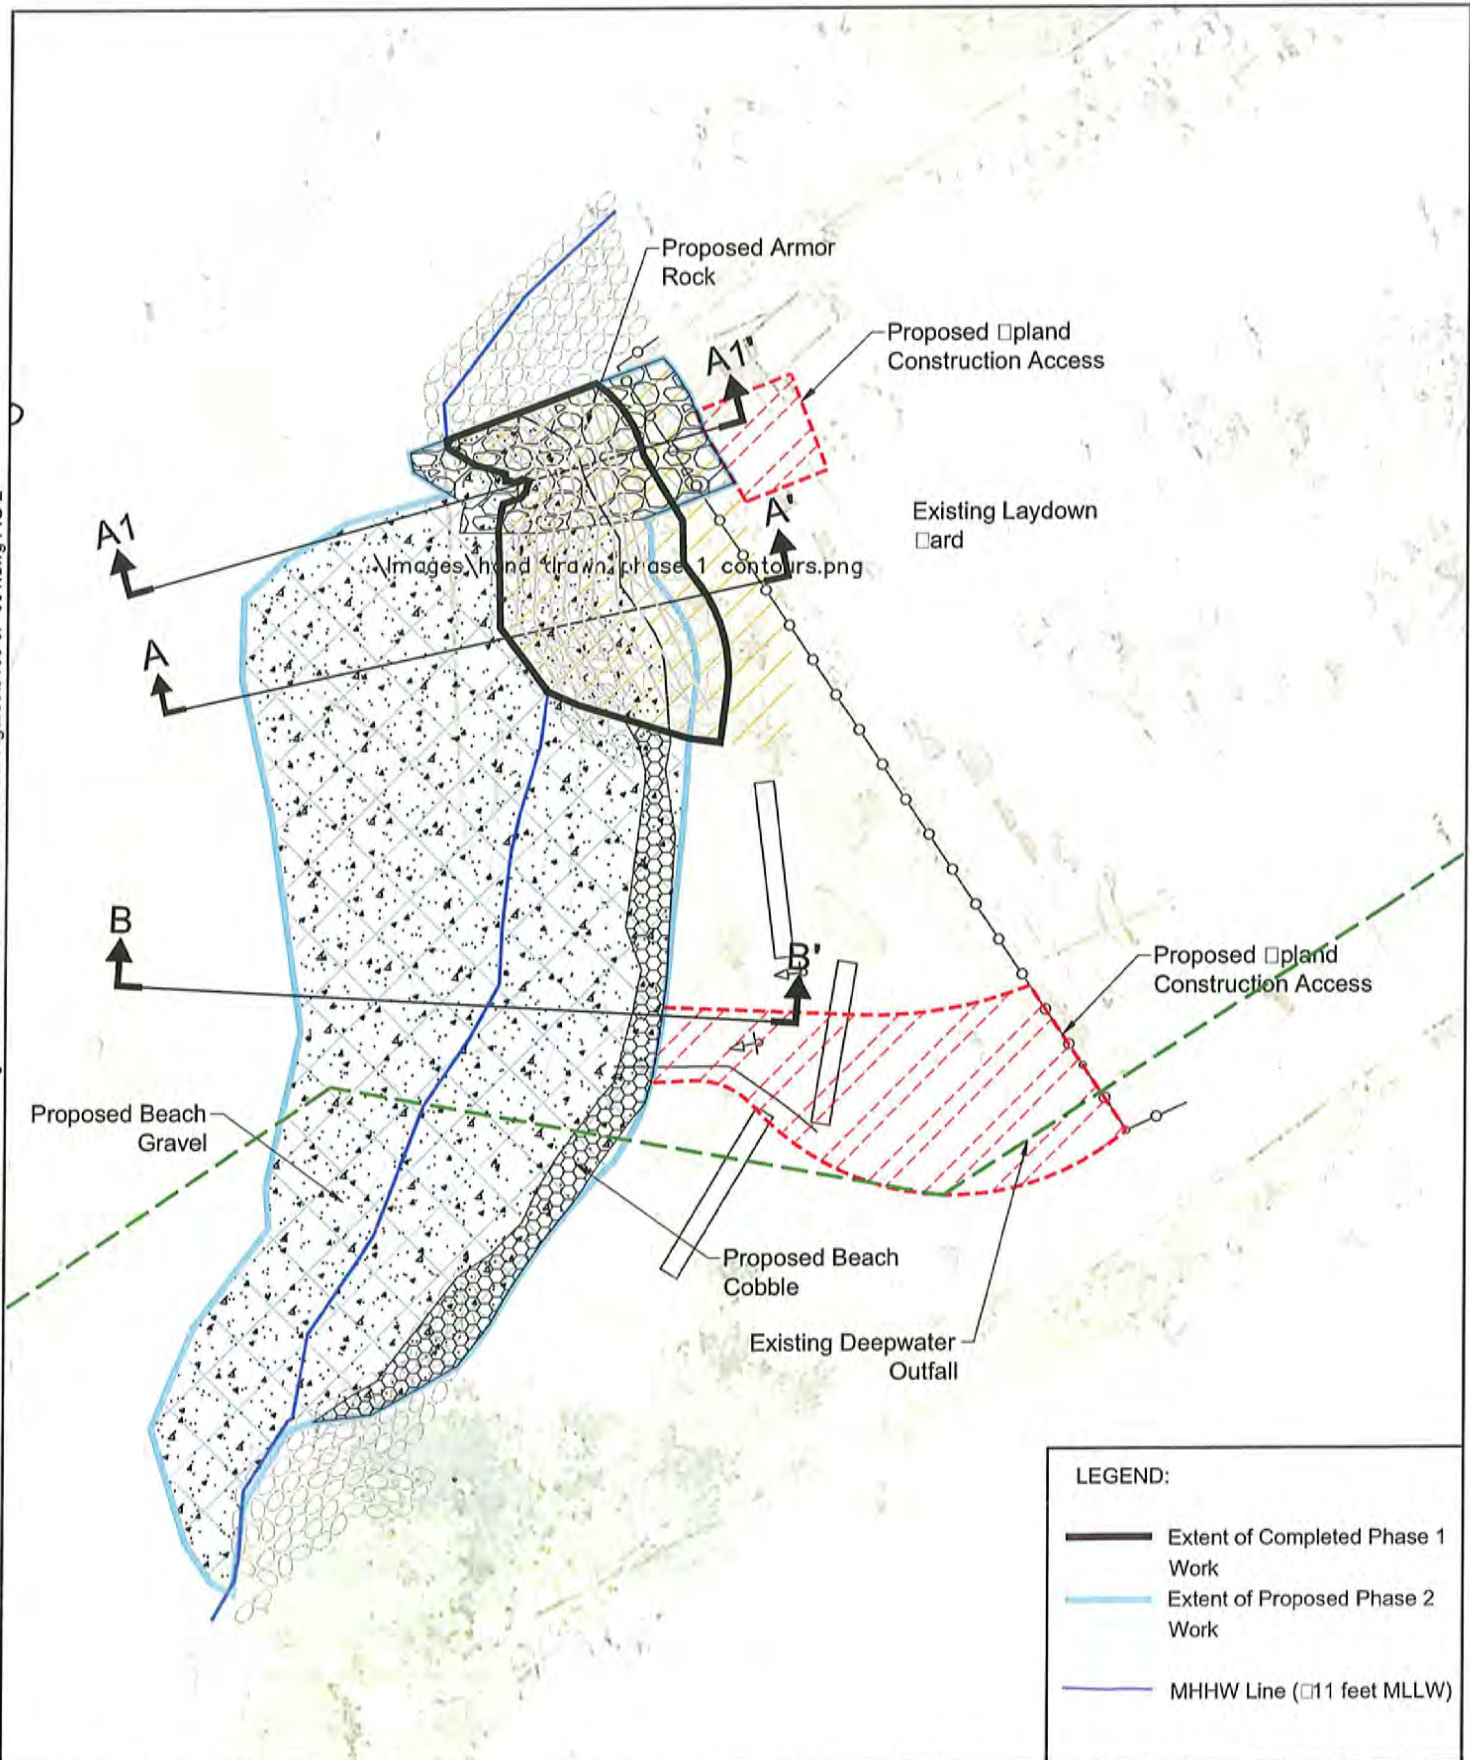
**SHEET: 2 OF 6**

**PURPOSE:** REPAIRING BEACH TO PREVENT EROSION AND SLOPE DESTABILIZATION

**PROPOSED:** SLOPE STABILIZATION REPAIR AND REHABILITATION

The project area and vicinity were excavated in late 2003 to place an offshore outfall for KC and the City (outfall shown on revised Sheet 2 of the JARPA Drawings in Attachment 2). A temporary trestle was built to aid in the placement of the offshore outfall, which extended from its land connection at the project site to the southwest. In February 2004, following construction of the outfall, the site was re-graded and filled to create a pocket beach. The temporary pier was removed and the shoreline was cut back from a straight shoreline to a curved shoreline. Immediately after construction, the beach sand began eroding due to impacts from storm wave action (as described above in "Original Beach Restoration"), forming a vertical scarp along the shoreline. A month following construction, the beach
