**APPENDIX E**  
**Open Space Restoration**

**Anchor QEA Memorandum  
“Response to U.S. Army Corp of Engineers’ Request  
for Additional Information”**

**To:** Erin Legge, U.S. Army Corps of Engineers      **Date:** March 28, 2013  
**From:** Heather Griffin, City of Everett  
Heather Page, Anchor QEA, LLC  
**Re:** Kimberly Clark DWO Project (NWS-2000-34)  
Response to U.S. Army Corps of Engineers' Request for Additional Information

## FIGURES OF ORIGINAL BEACH RESTORATION, PHASE 1, AND PHASE 2

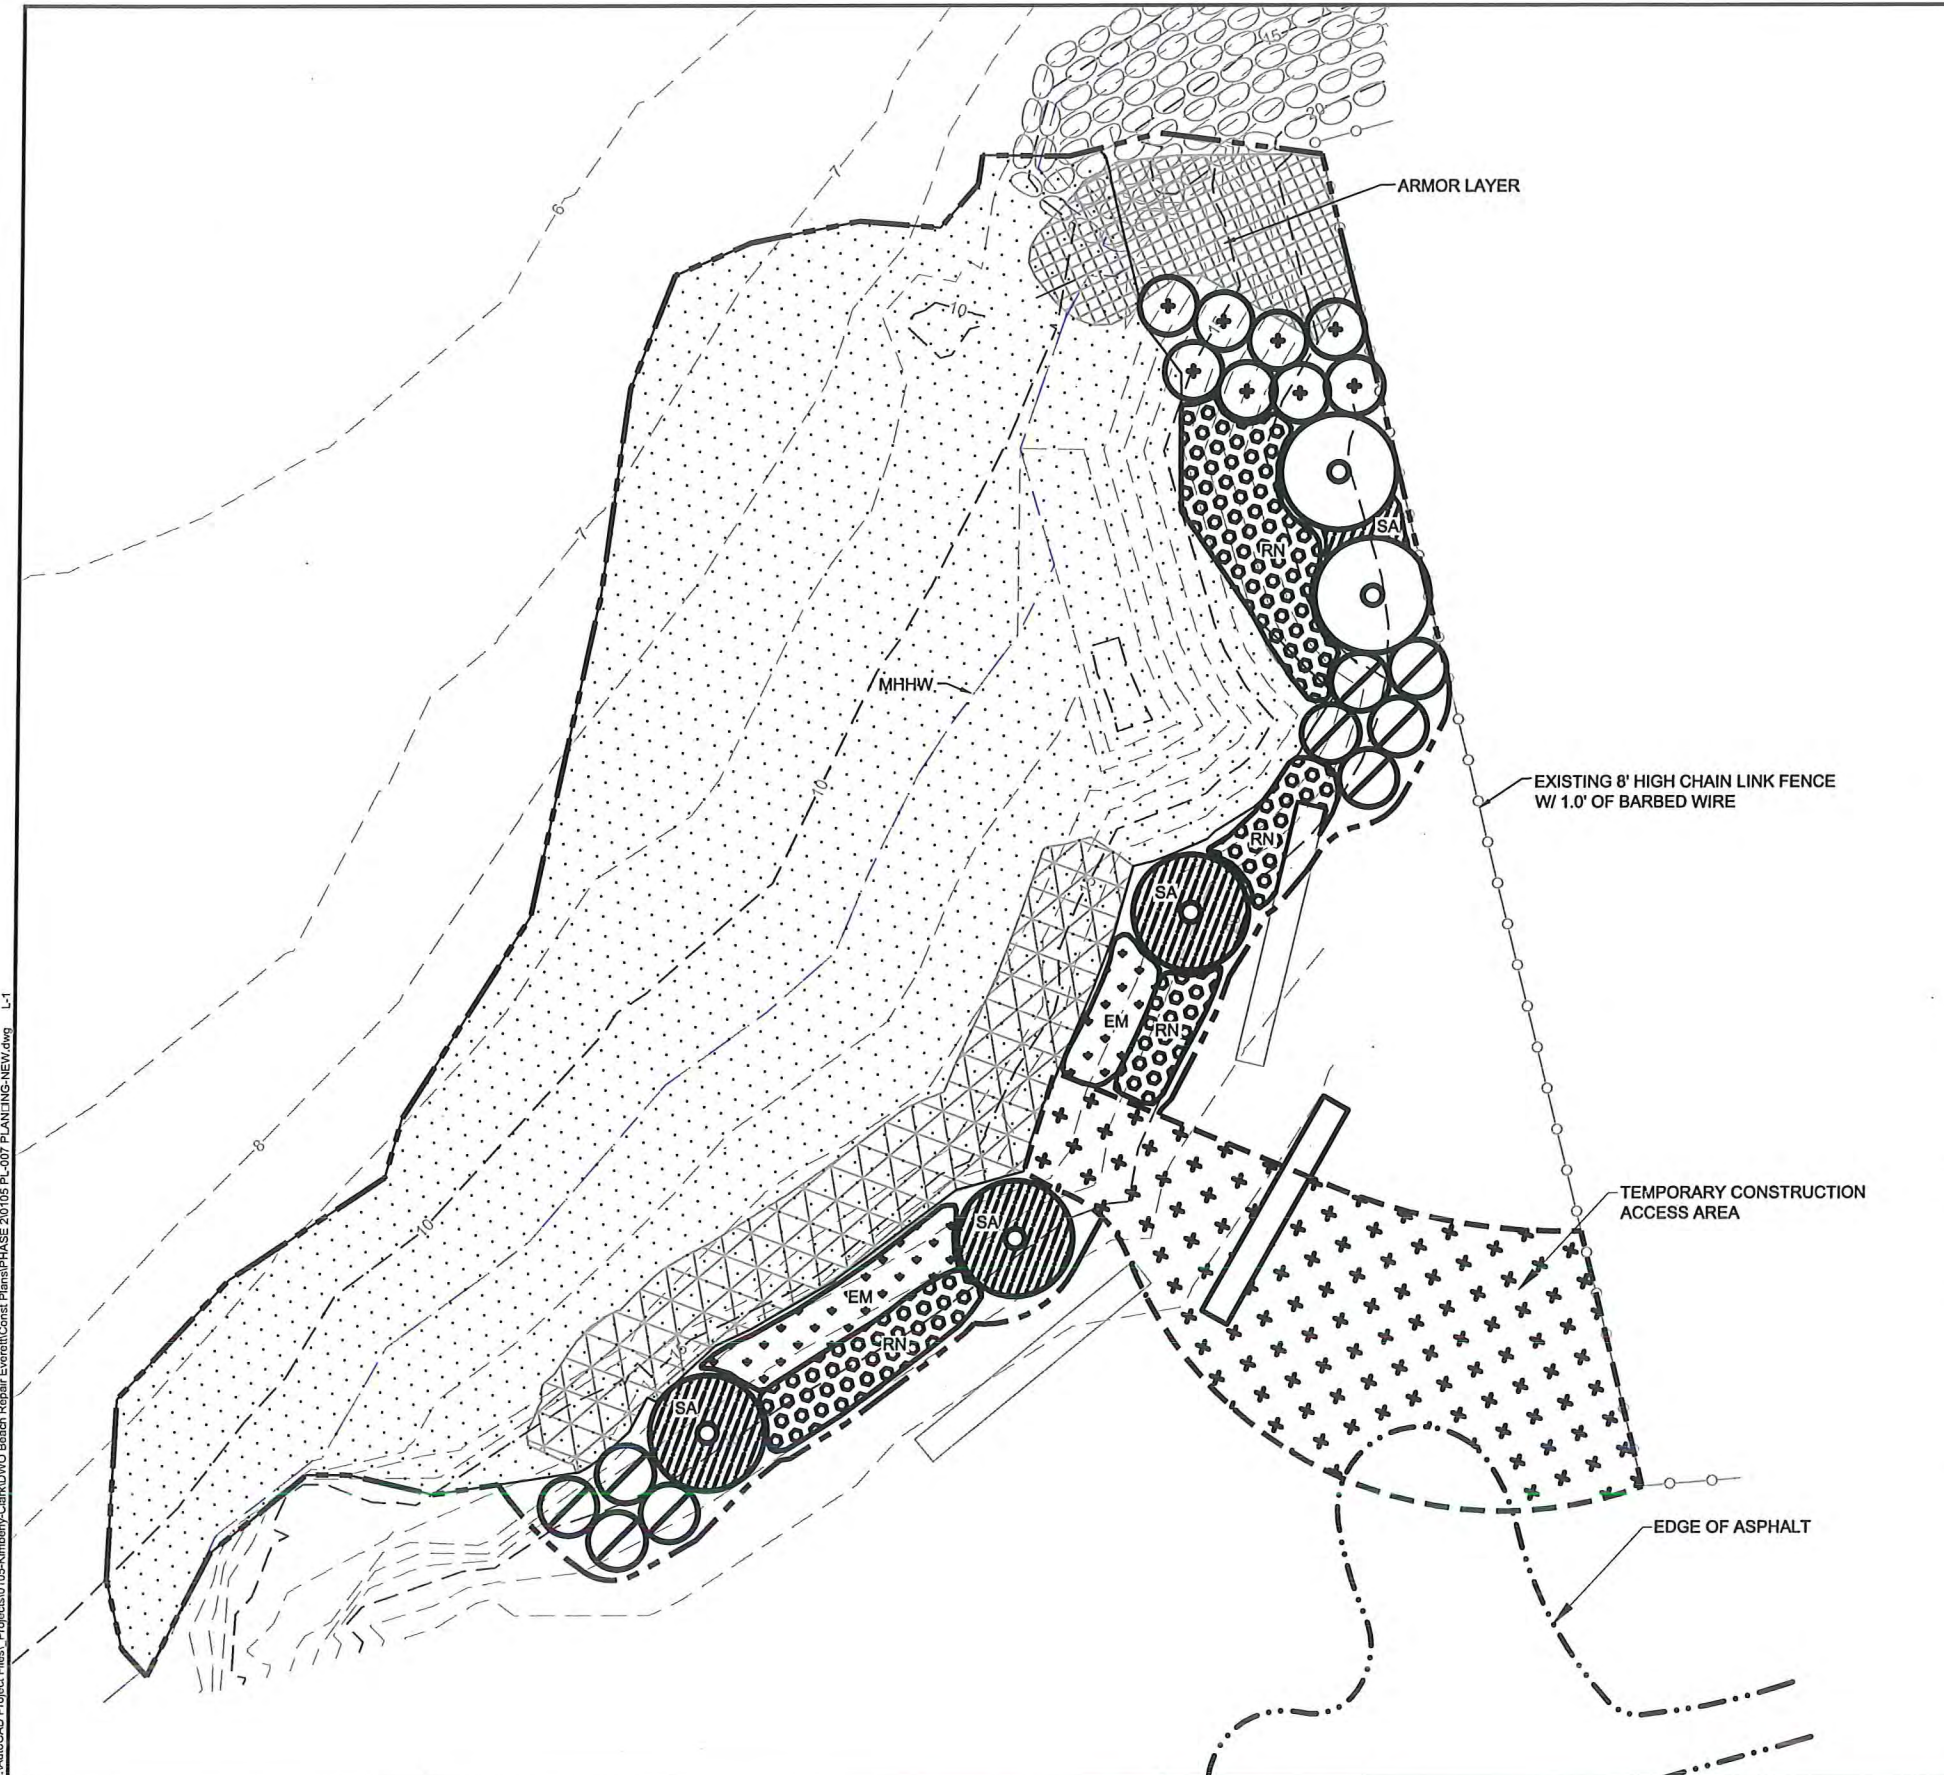
**L-1**

1. SEE PLAN SCHEDULE SHEET L-2 FOR SPECIES DEFINITION
2. EVENLY SPREAD TOPSOIL (SALVAGED AND IMPORTED) IN ALL PLANTING AREAS; SEE SPECIFICATIONS
3. FOR PLANTING BED PREPARATION AND PLANT INSTALLATION SEE SPECIFICATIONS
4. RESTORE ALL DISORBED LAWN AREAS WITH HYDROSEED, AND FILL AND SMOOTH HOLES AND ROES CAUSED BY CONSTRUCTION ACTIVITIES

**PLANTING PLAN**

Please see Attachment 3 the planting plan proposed for the project.

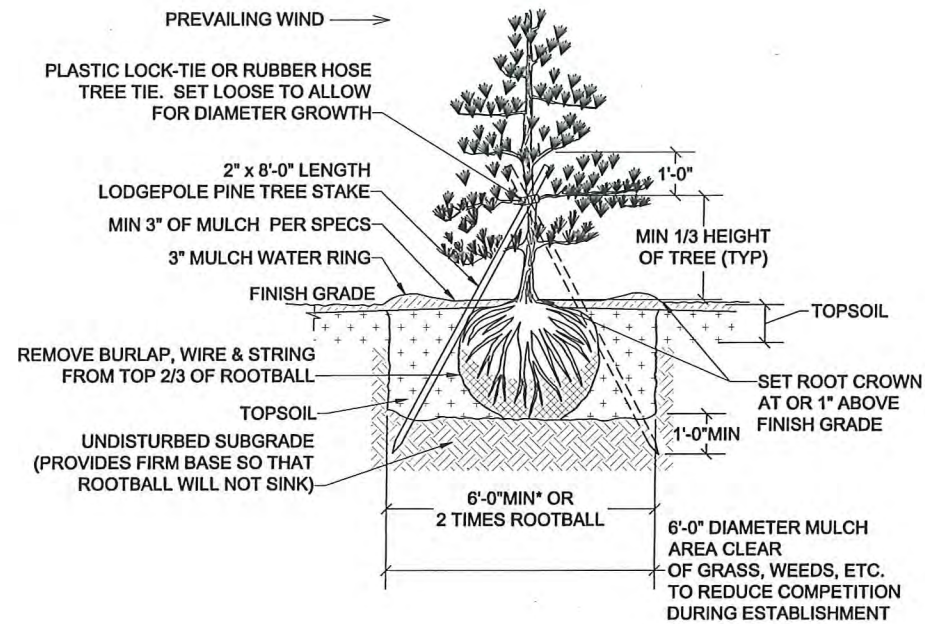
2 CONIFEROUS TREE PLANTING & STAKING  
SCALE: NTS

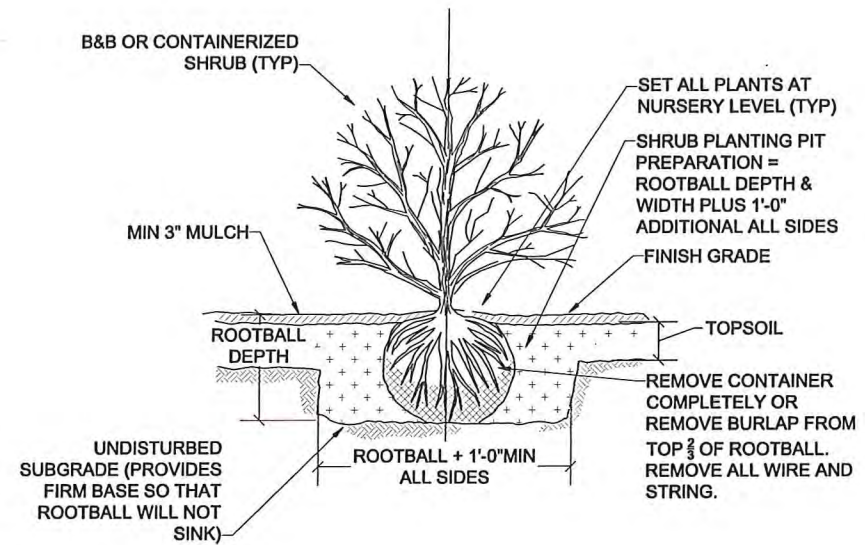
3 SMALL TREE AND SHRUB PLANTING  
SCALE: NTS

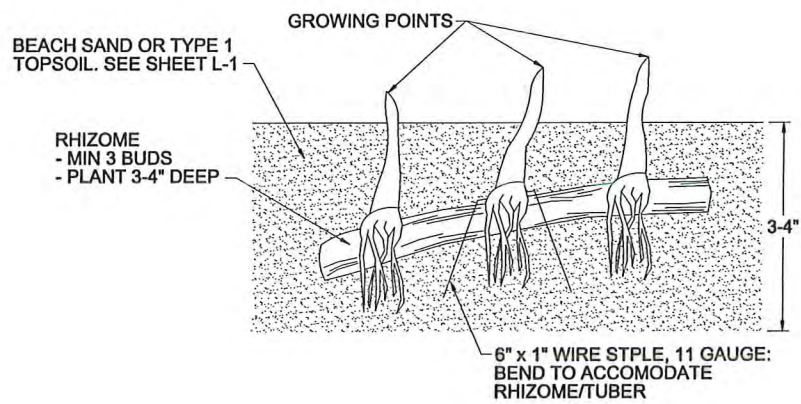
4 BEACHGRASS PLANTING DETAIL  
SCALE: NTS
