Construction Completion (As-Built) Report

Weyerhaeuser Mill A Former Cleanup Site
Interim Action
Everett, Washington

January 16, 2018

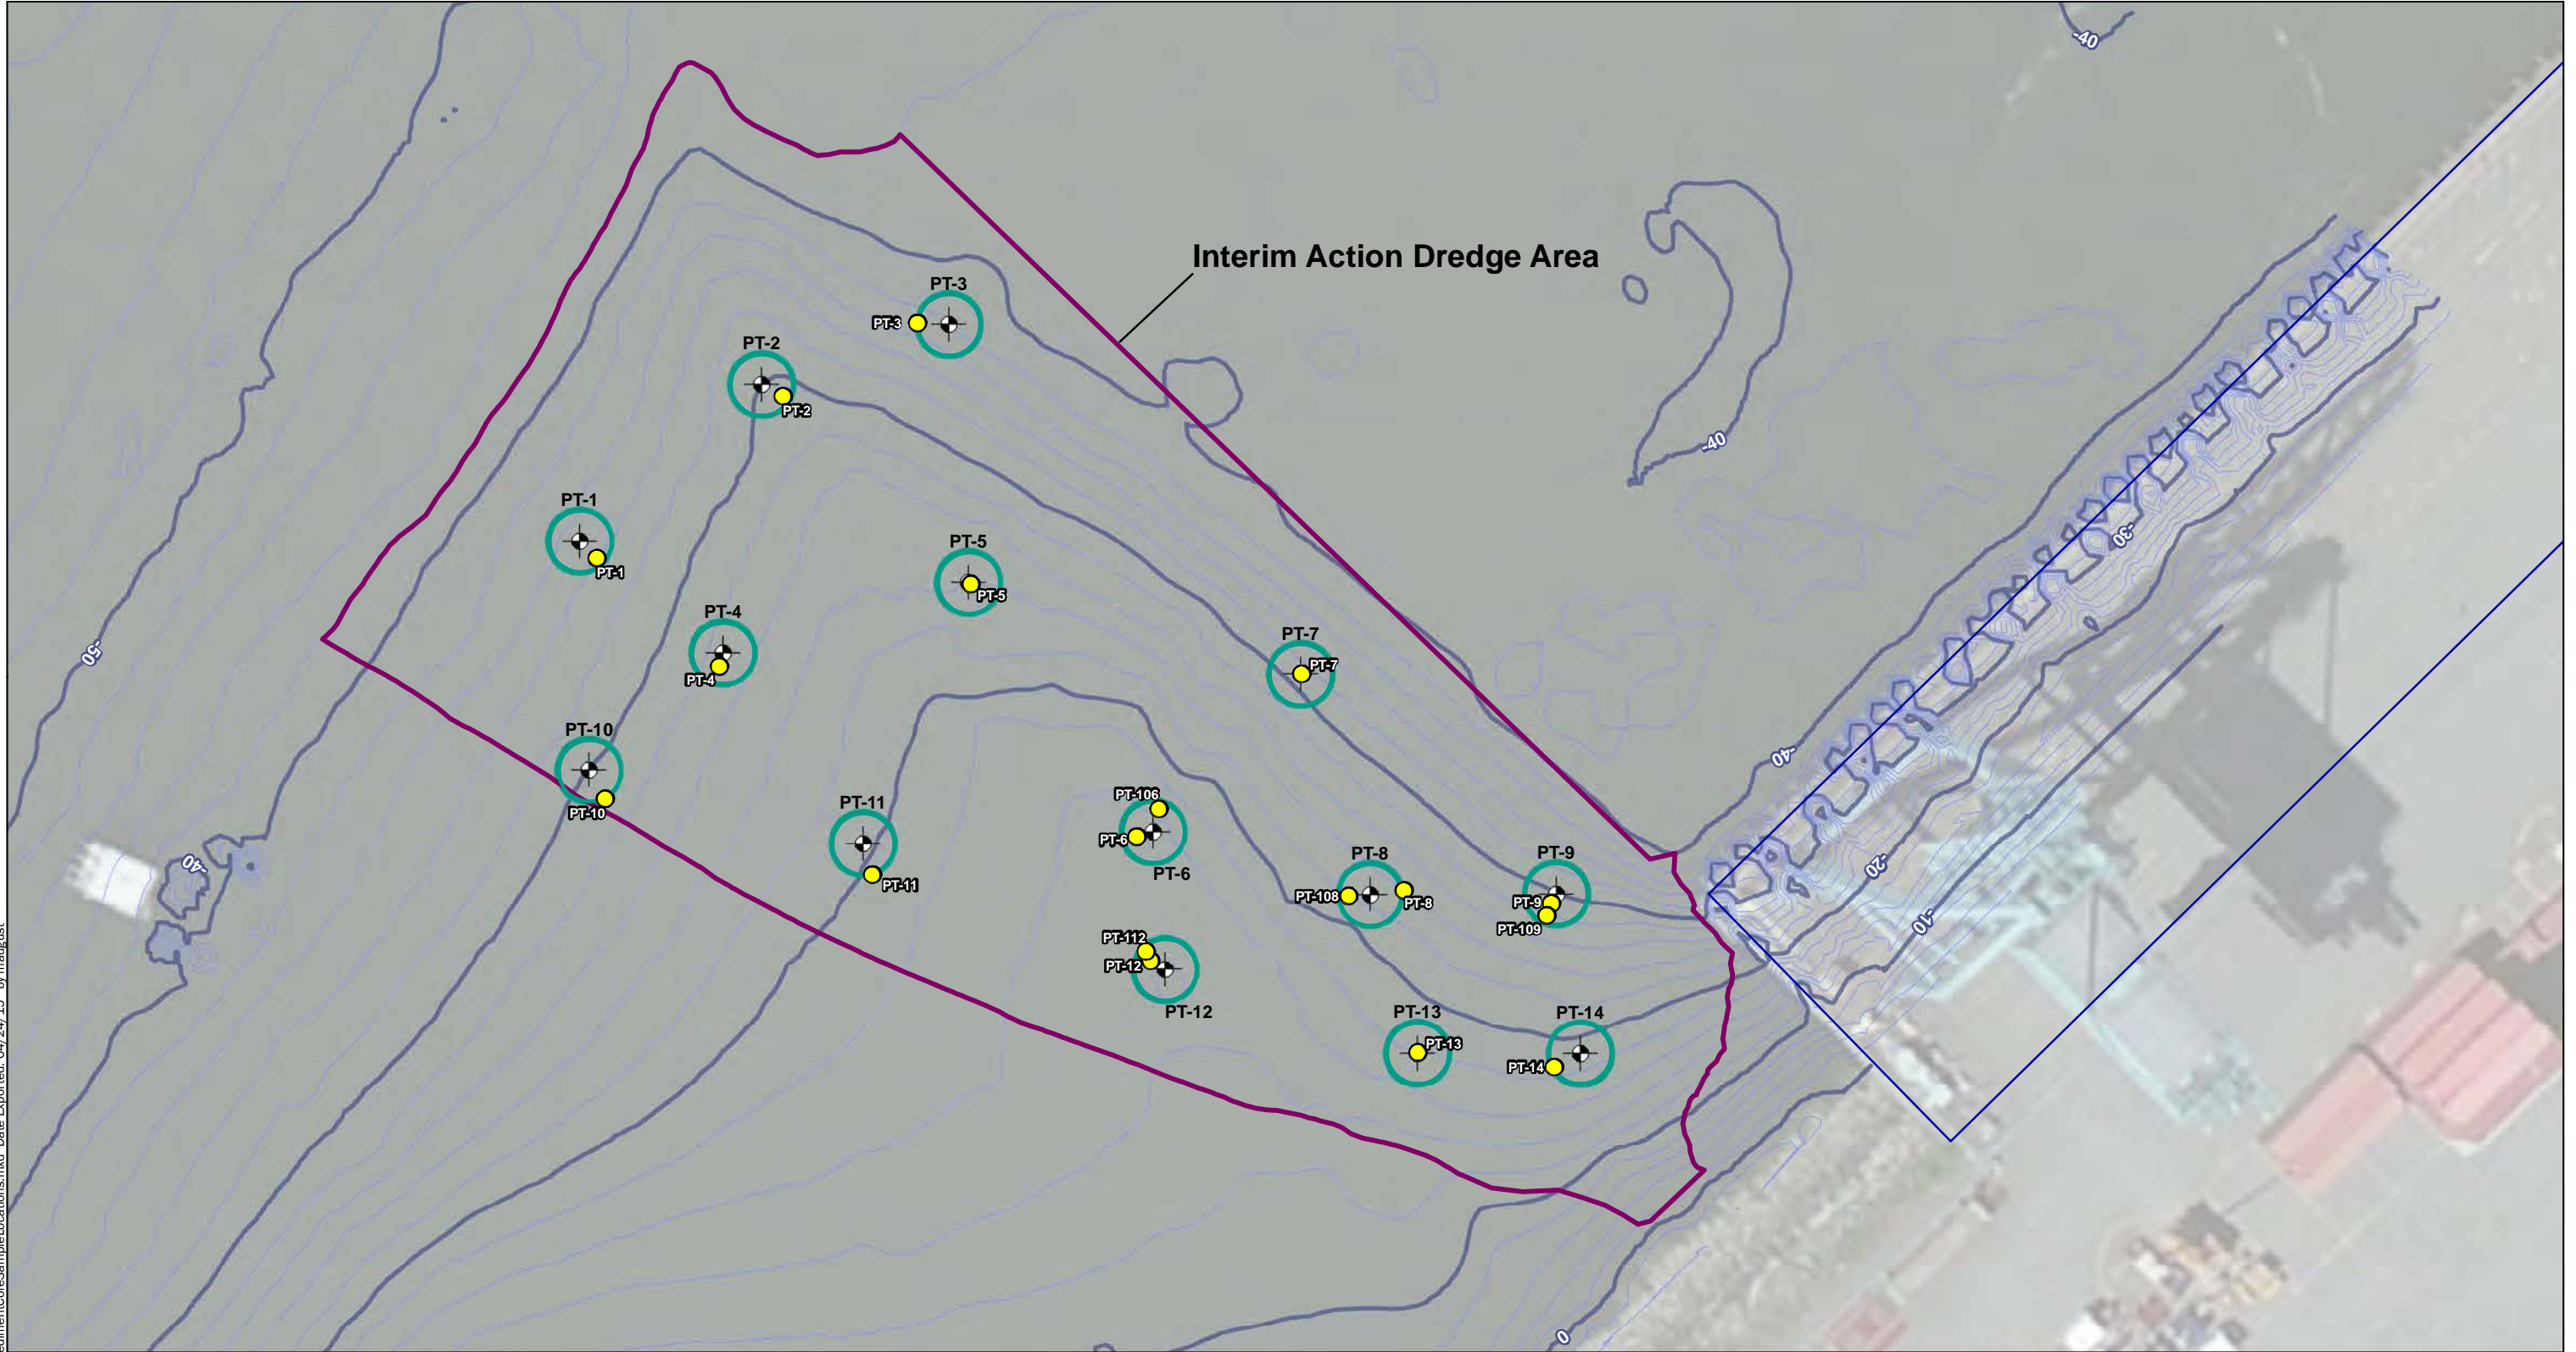
Sediment Core Sampling and Compositing Plan	
Weyerhaeuser Mill A Former Site Everett, Washington	
	Figure 8

- Dredge Limit (including overdredge allowance)
- Anticipated Native Horizon (assumed at -42 ft MLLW)
- 1-ft sample interval to be collected and used as composite material for corresponding color DMMU and individually archived for possible followup analysis
- 1-ft sample interval to be collected and archived
- 1-ft sample interval to be collected and analyzed for characterization of exposed surface
- Sample to be collected and analyzed for total sulfides

Interim Action Dredge Area

The total project volume at the time the sampling and analysis plan (SAP) was submitted was 35,140 cubic yards, including a one-foot overdredge allowance and an uncertainty factor of 10%. The project was divided into eleven dredged material management units (DMMUs) in six layers. Figures 4 to 7 show the layers, DMMUs and sampling locations. Figure 8 shows the compositing scheme. A total of 48 individual core sections were to be composited to represent the 11 DMMUs. However, the DMMP agencies agreed to review the core logs prior to compositing in order to take into account the stratigraphy encountered during sampling.

Figures 10, 11 and 12 show the stratigraphy encountered during sampling and the revised DMMU configurations. Figure 13 includes the revised compositing plan. In addition to the DMMU modifications, the z-layer sample at PT-3 was substituted for PT-2 because wood debris was observed closer to the dredging limit at this location. This change is evident in Figure 13.
