January 3, 2023  
Project No. M1945.01.002

Re: Phase II Environmental Site Assessment for Riverfront Park  
North Worthen Street, Wenatchee, Washington

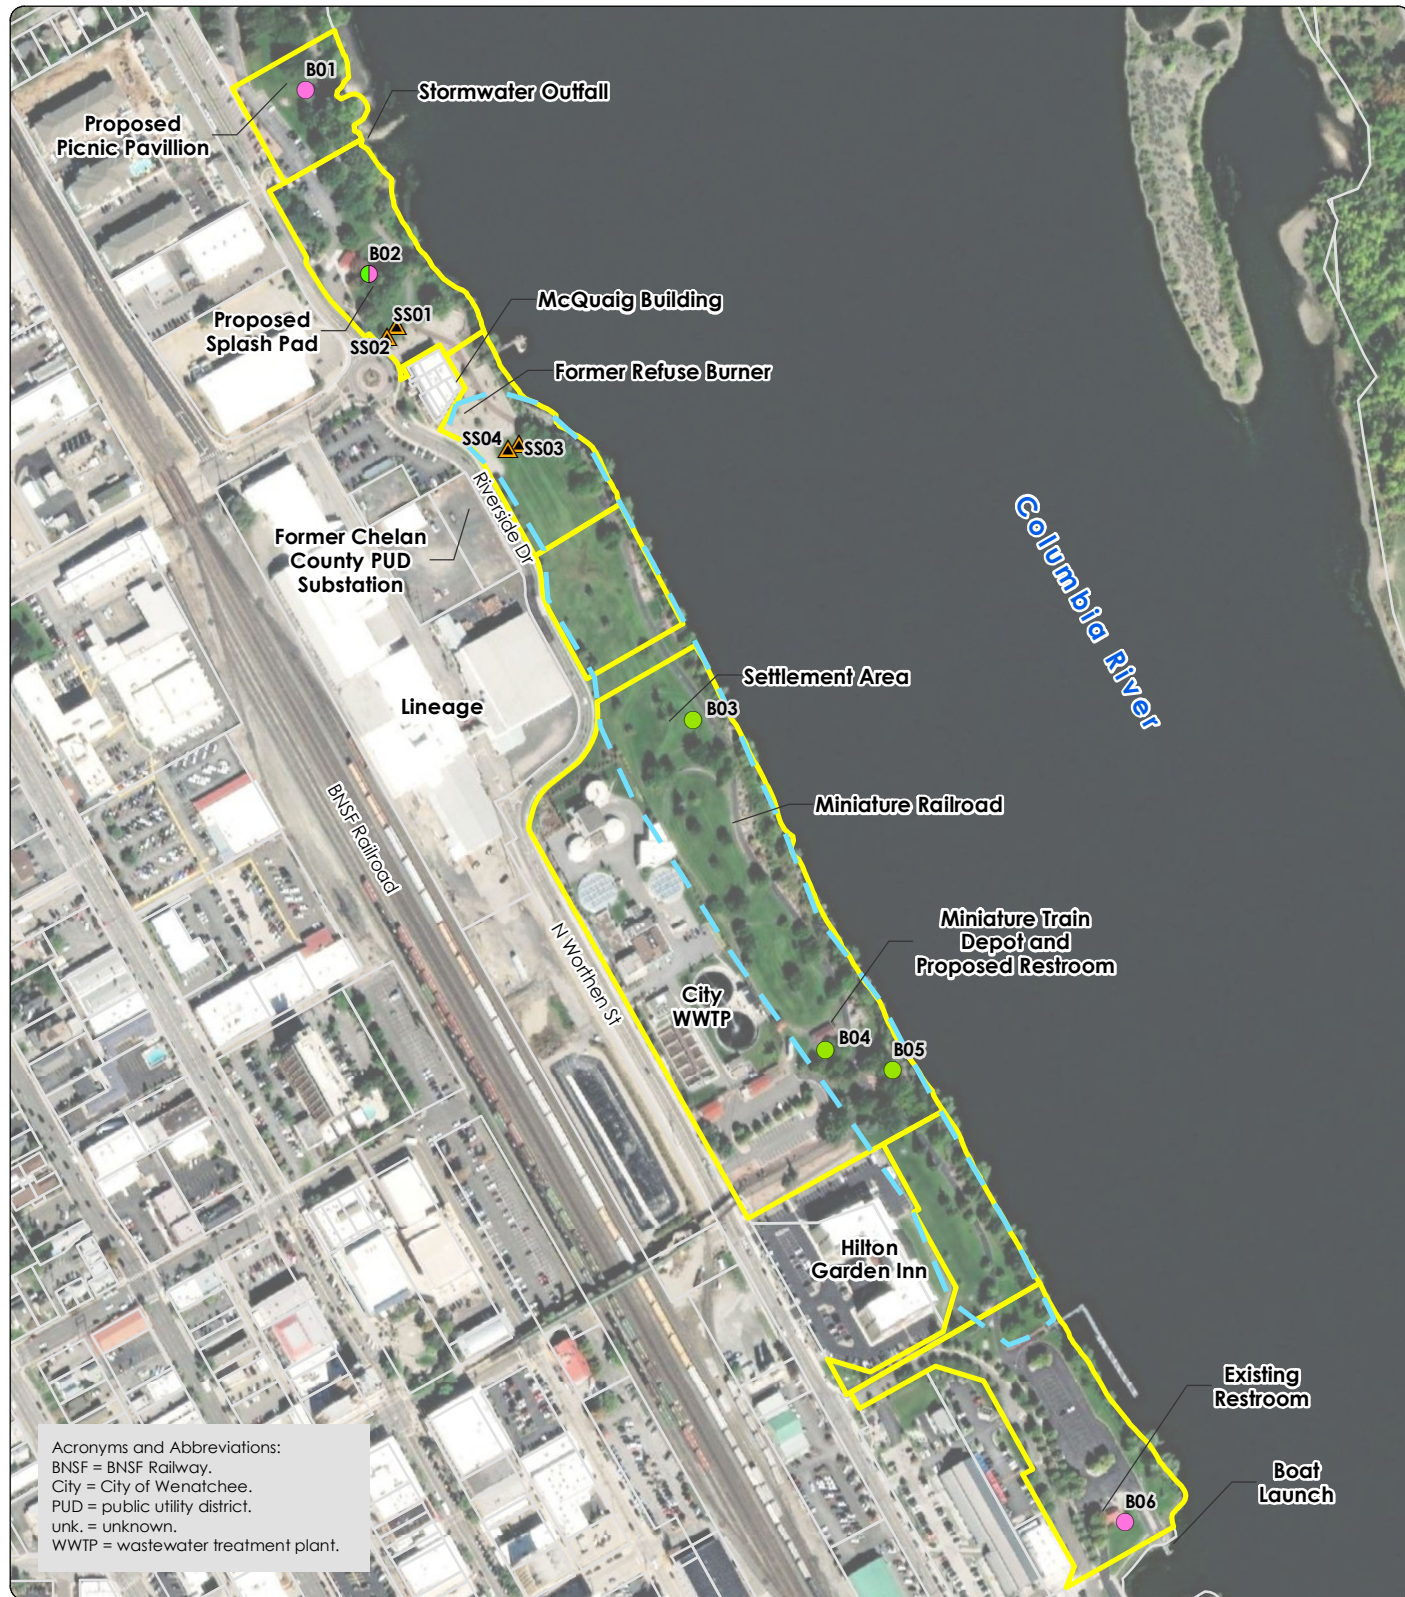
MFA collected surface soil samples from four locations (SS01 through SS04) near the former refuse burner at the Property (see Figure 2). Each surface soil sample was collected from approximately 3 inches bgs. One surface soil sample was collected at each location and a field duplicate was collected at location SS01. Surface soil samples were analyzed for polycyclic aromatic hydrocarbons (PAHs) and metals (arsenic, cadmium, chromium, lead, mercury, and zinc), which have been identified as contaminants of potential concern from municipal solid waste incineration (Zhong et al. 2020).

Notes:  
 All feature locations are approximate.  
 Sample locations were recorded with a handheld global positioning system with sub-meter accuracy.  
 Soil conditions did not allow for soil gas sample collection at location B04.

PAHs and metals in surface soil samples collected from locations SS01 through SS04, near the former refuse burner (see Figure 2) were either non-detect or were detected below screening levels (MTCA Method A CULs for unrestricted land use, or Washington State background concentrations when MTCA Method A CULs were unavailable; see Table 1).

At B04, indoor air sampling for methane and VOCs is recommended given the elevated methane concentrations in soil gas at 5 feet bgs at B04 (10.3 percent by volume) and the unsuccessful soil gas sample collection attempt for VOCs. Indoor air sampling will inform current inhalation risks in the miniature train depot building and construction considerations for the proposed restroom (see Figure 2).

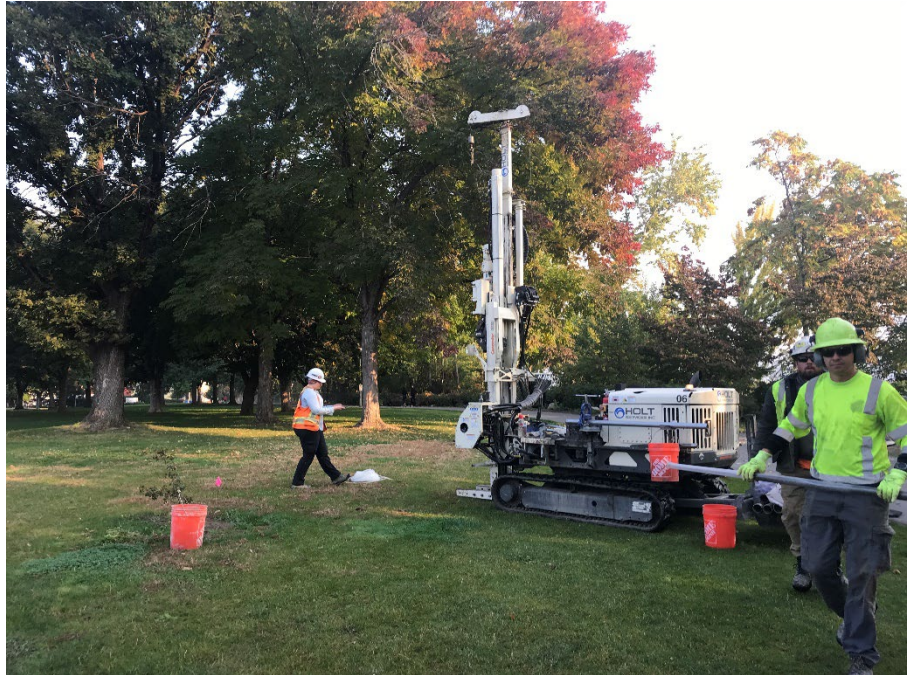
Drill rig at location B01,  
near the proposed  
picnic pavilion.  
Photograph taken on  
October 18, 2022.

At location B01, only one VOC (acrolein) exceeds MTCA Method B VI CULs. Given the limited VOC exceedances and that future use in this area includes an open-air picnic pavilion (i.e., no enclosed structures), no additional investigation is recommended at or near B01.

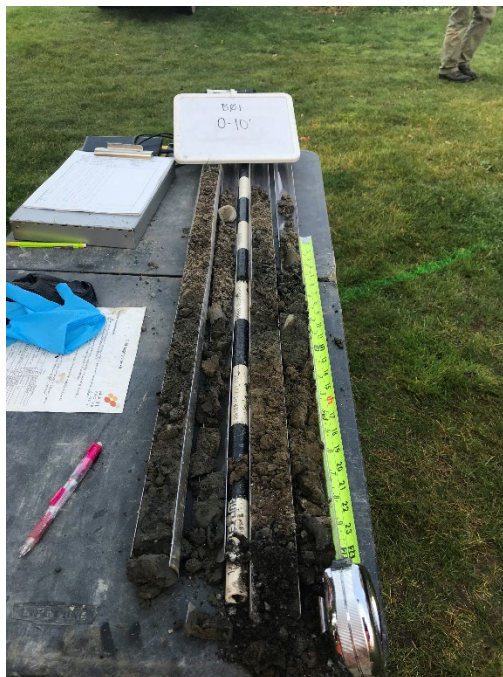
### **Photo No. 1.**

Soil core from 0 to 10  
feet below ground  
surface (bgs) at B01.  
Photograph taken on  
October 18, 2022.

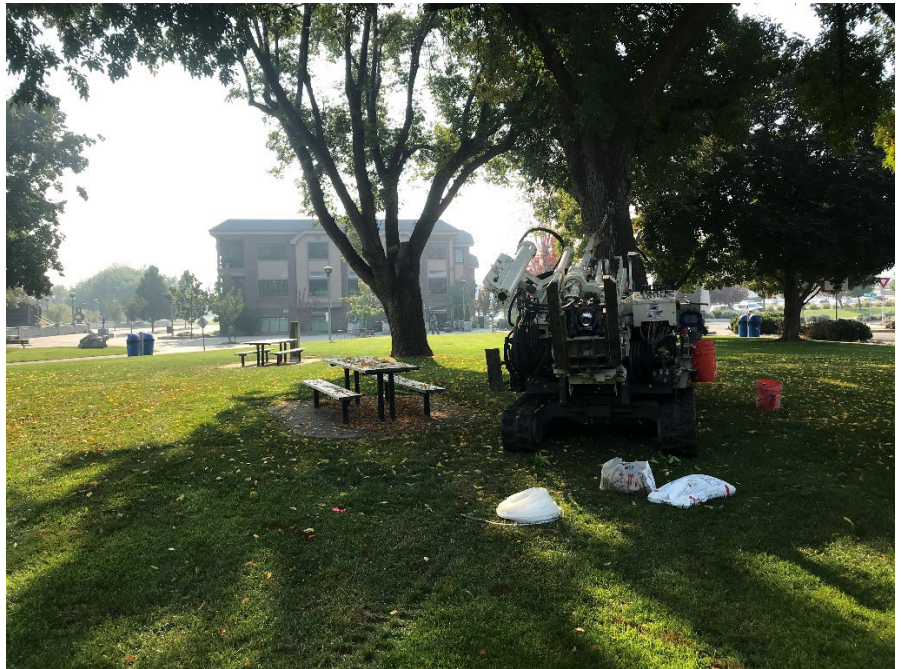
Drill rig at location B02, near the proposed splash pad. Photograph taken on October 18, 2022.

At B02, three VOCs (acrolein, bromodichloromethane, and chloroform) exceed MTCA Method B VI CULs. The intended future use of this area (a splash pad) will include a pad drain system where methane and VOCs could accumulate and pose a potential explosion risk. However, this risk can be effectively mitigated by designing and constructing the pad drain system with bentonite utility dams. Given the recommendation that risk mitigation measures be incorporated into the splash pad design, no additional environmental investigation is recommended at or near B02.

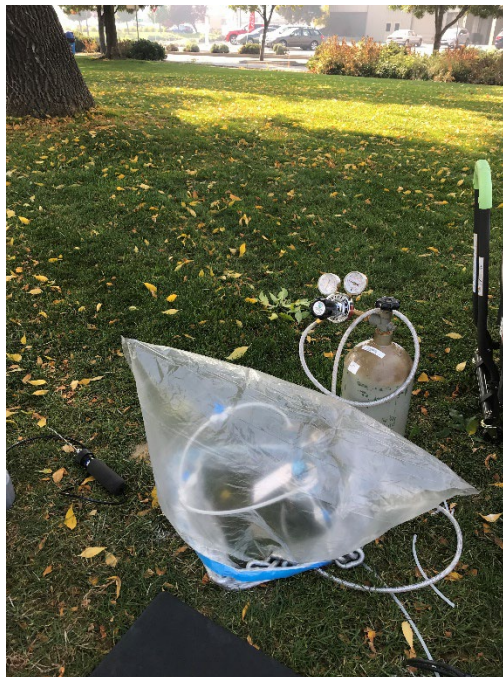
### **Photo No. 4.**

Helium shroud around soil vapor sampling apparatus at location B02 near the proposed splash pad. Photograph taken on October 18, 2022.

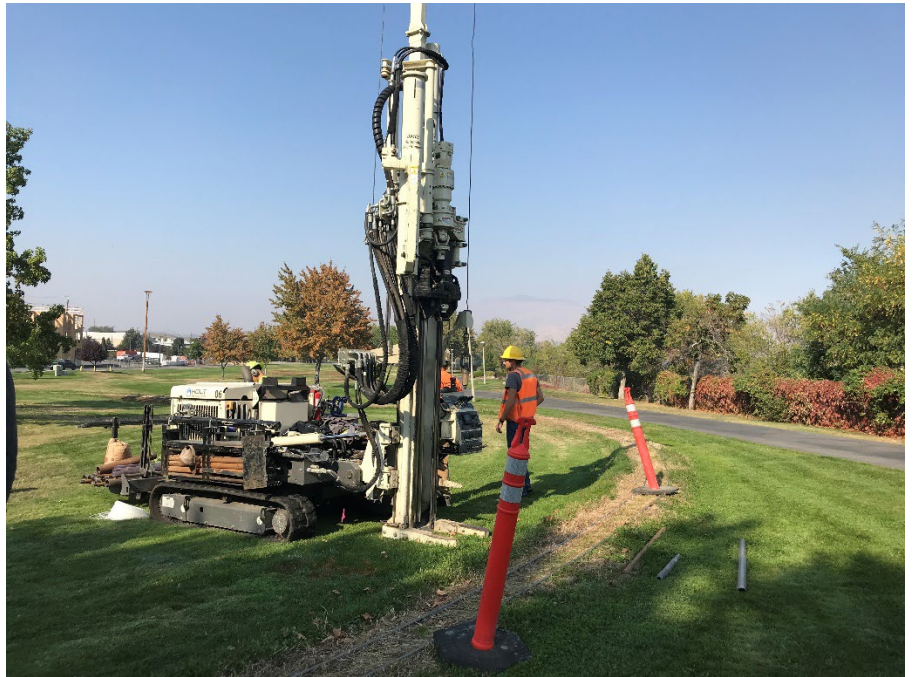
Sludge and strong odors were observed in borings B03 and B05, likely consistent with landfilled material in these areas.

Drill rig at location B03, near the miniature railroad and settlement area. Photograph taken on October 18, 2022.

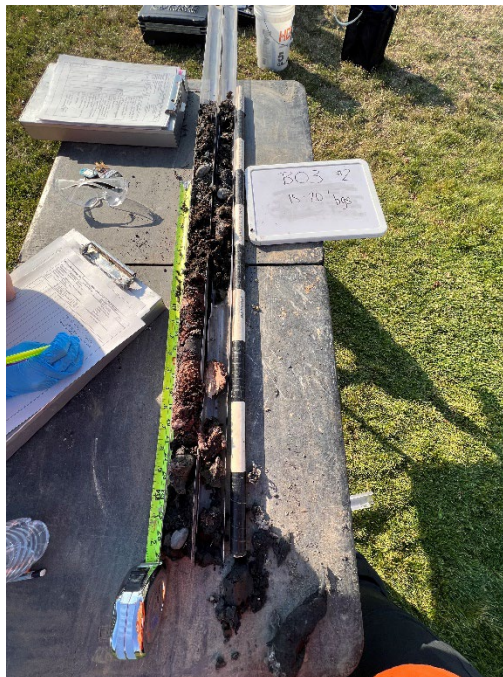
### Photo No. 6.

Refuse in soil core at B03 from 15 to 20 feet bgs. Photograph taken on October 18, 2022.

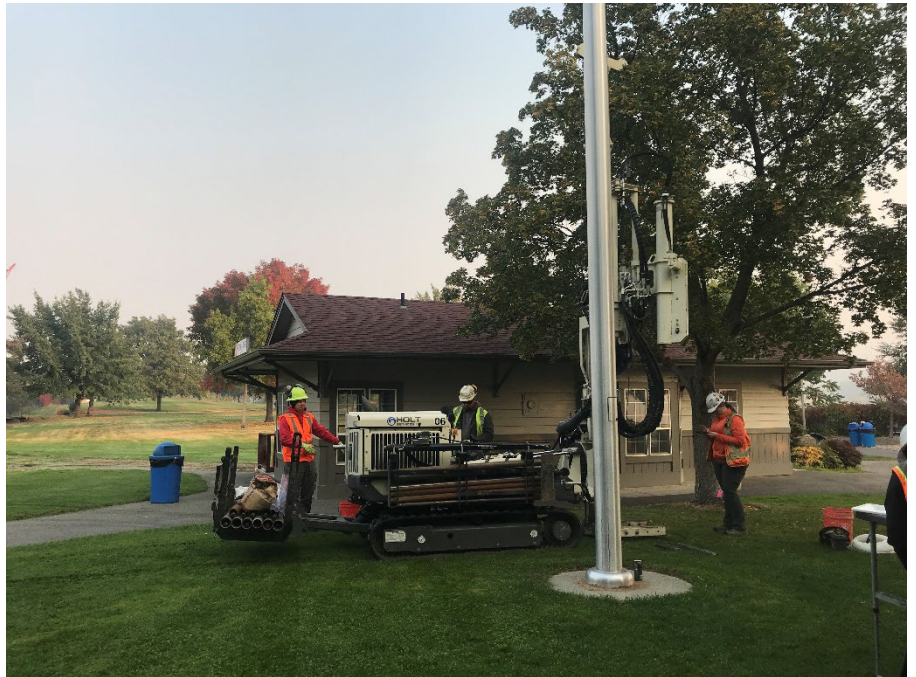
Drill rig at location B04, near the miniature railroad depot building and the proposed restroom location. Photograph taken on October 19, 2022.

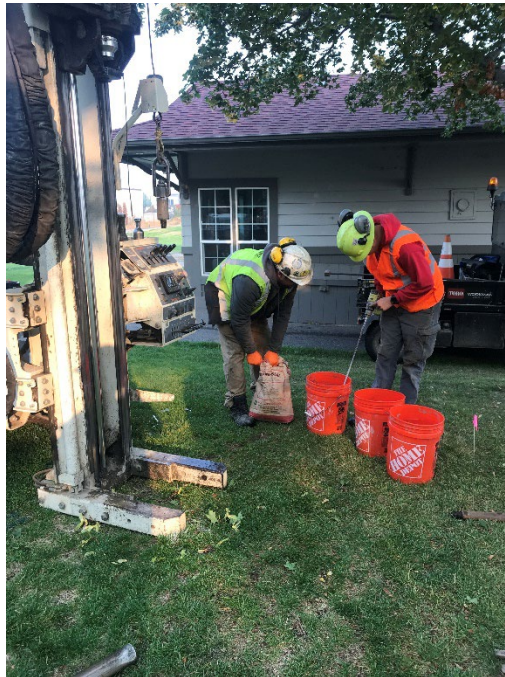
Borehole  
decommissioning with  
bentonite slurry at B04  
near the miniature train  
depot and proposed  
restroom location.  
Photograph taken on  
October 19, 2022.

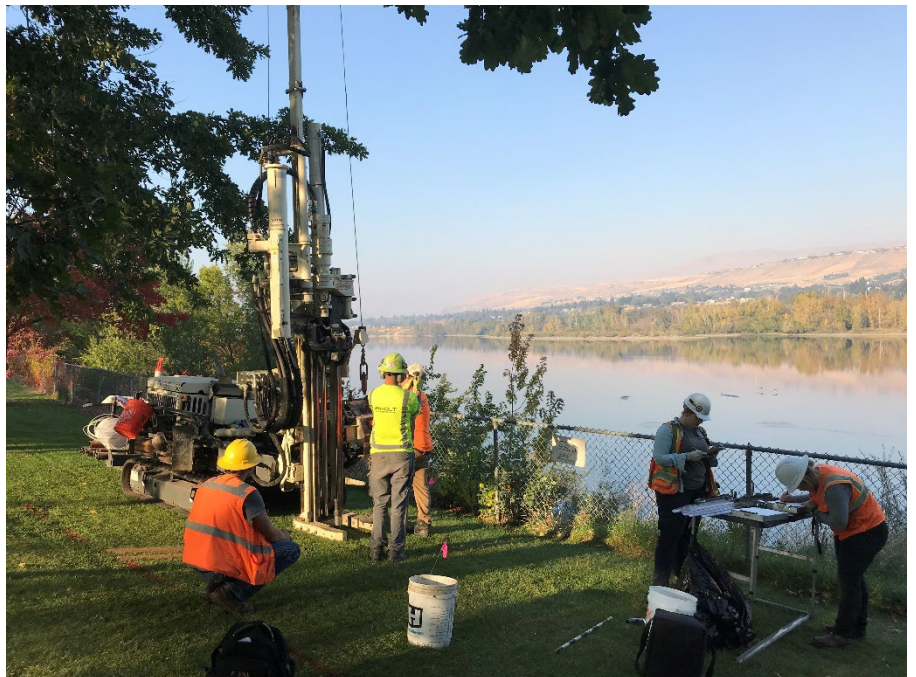
Drill rig at location B05  
near the proposed  
retaining wall associated  
with the river overlook.  
Photograph taken on  
October 18, 2022.

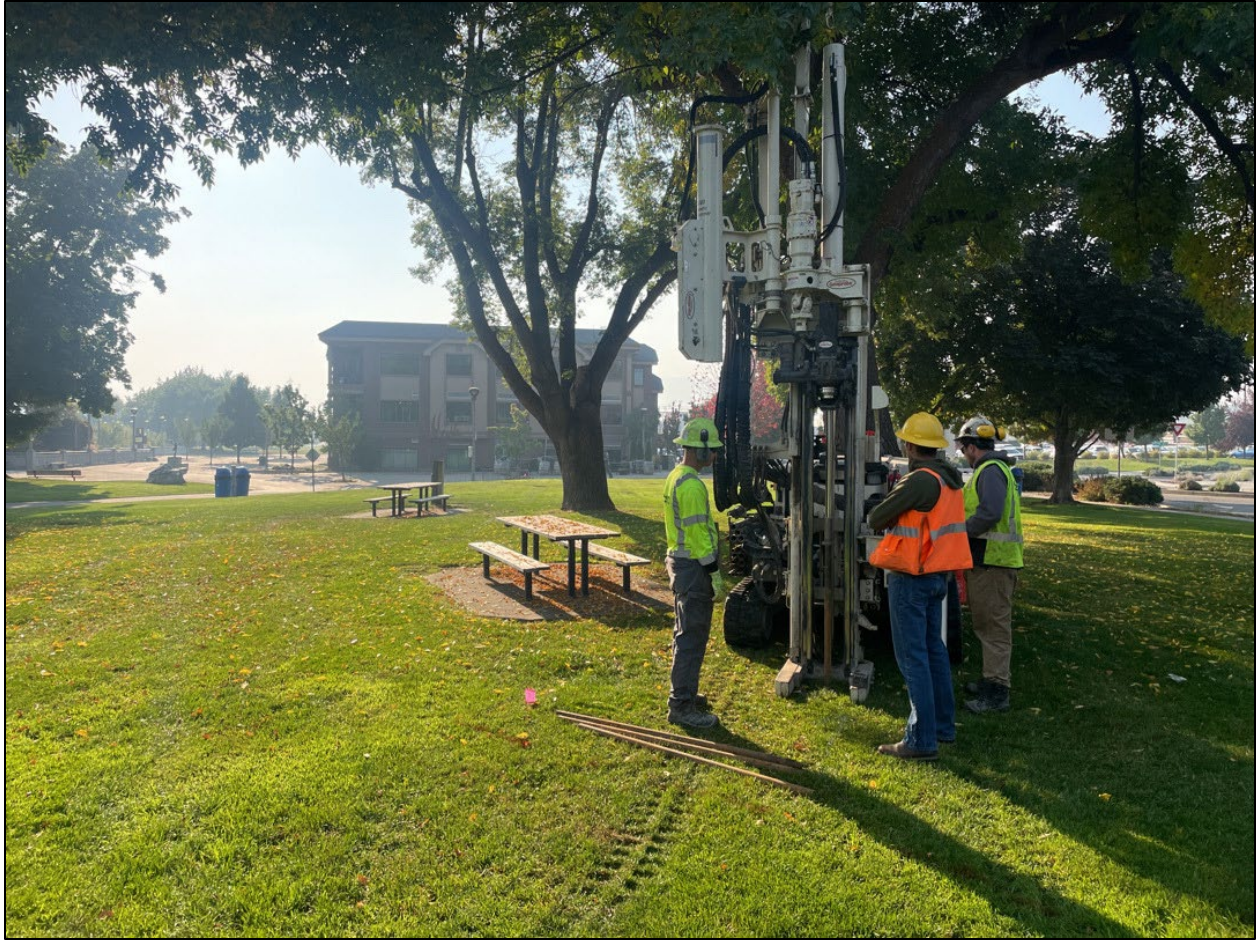
**Figure 2**  
Wenatchee Riverfront Park Phase II Environmental Site  
Assessment Sampling and Geotechnical Locations.

The boring research design planned a total of six direct-push borings (B-01 through B-06) to be advanced across the site by Holt Services, Inc. (Figure 2). After B-03 encountered an unexpected obstruction, the boring was moved slightly and readvanced. The borings were advanced using a Geoprobe direct-push drill rig collecting continuous 2.25-inch diameter cores in 5-foot intervals (Figure 3), with 1.5-foot-long split spoon samples generally collected every 5 feet. Split spoon samples were not collected at some locations due to high methane concentrations. Boring depths ranged from 10 to 21.5 feet below surface (bs).

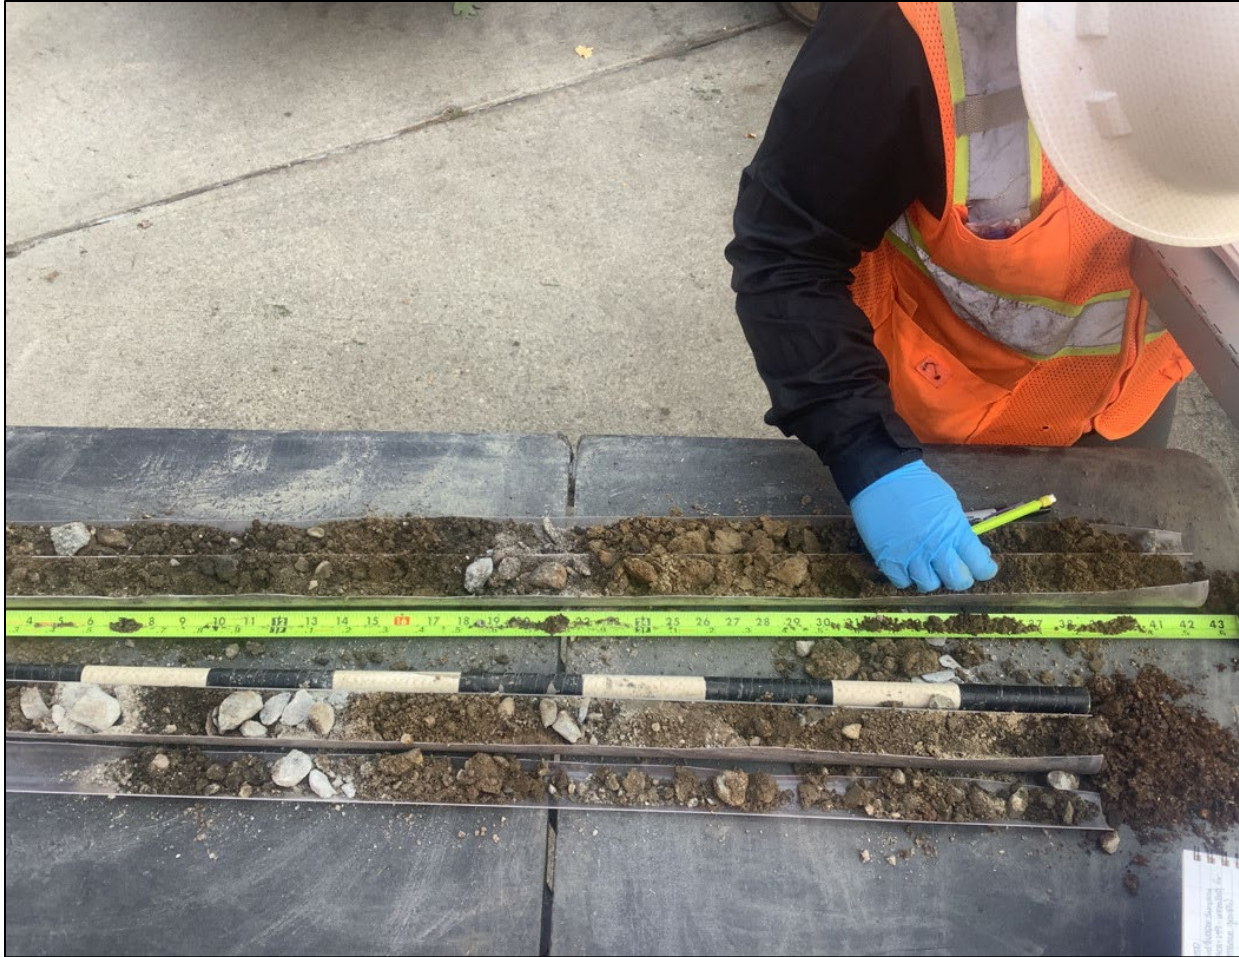
**Figure 4**  
View of typical boring sample recovery as observed within B-06.

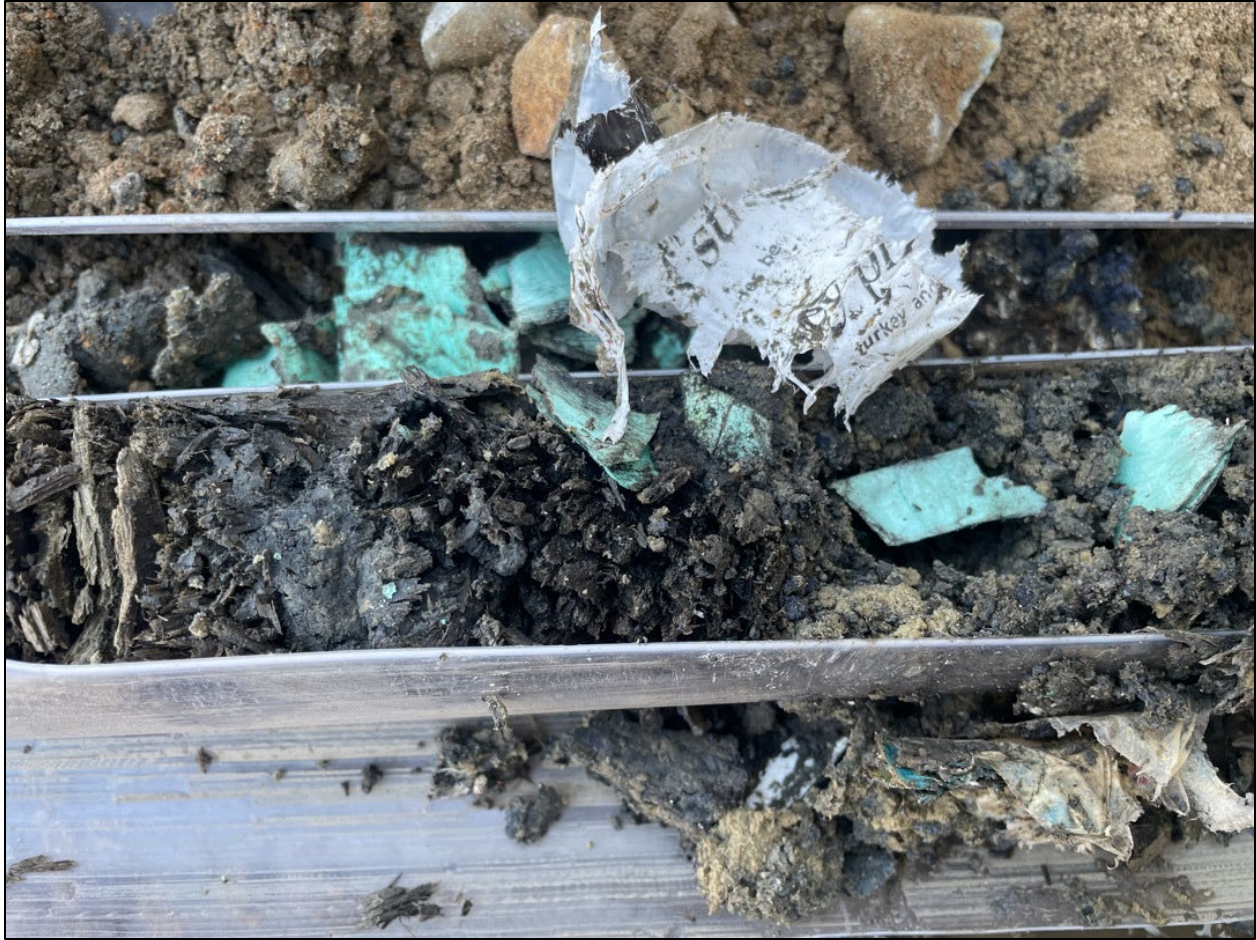
Observed stratigraphy across the APE generally consisted of sod and topsoil overlying landfill cap (i.e., imported sandy gravel and clay layers) then landfill deposits. The landfill deposits consisted of a mixture of organics, fragmented bottle glass, fragmented brick, plastic, metal, and Styrofoam. No diagnostic debris was encountered, and all observed debris appeared modern in age (Figure 5).

**Figure 5**  
Typical landfill material (including plastic and Styrofoam)  
as observed within B-05.

Landfill was observed between 58 and 240 inches (4.8 to 20 feet) bs. Top elevation of landfill varied between 58 and 84 inches (4.8 to 7 feet) bs. Borings did not reach the bottom of the landfill. No landfill material was observed within boring B-01, B-02, or B-06. B-01 and B-02 are located north of the estimated landfill footprint, and B-06 is located south of the estimated landfill footprint.

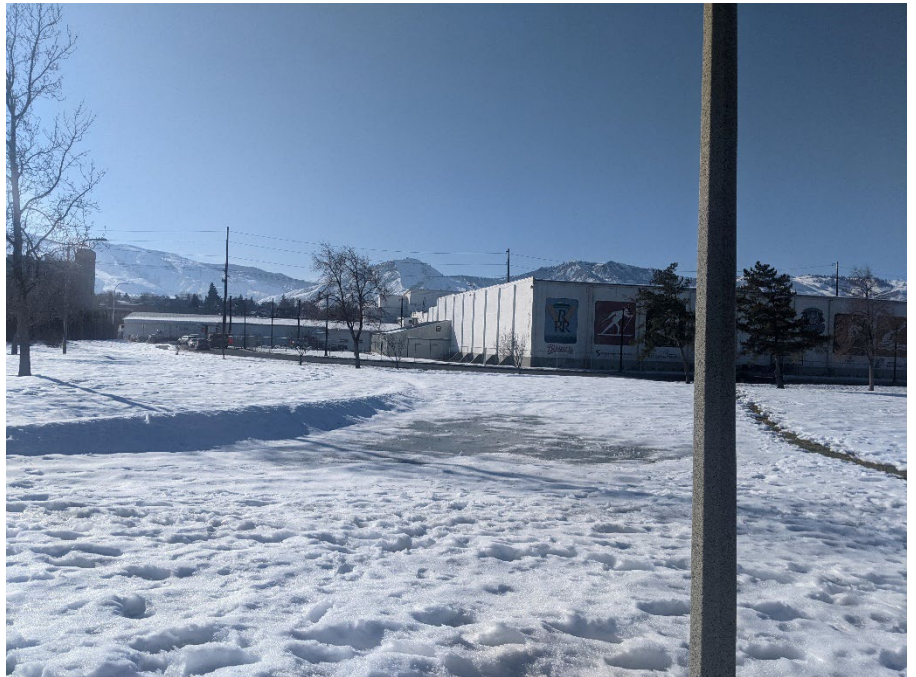
### **Photo No. 3.**

Settlement area east of the Simplot site, looking west. Photograph taken February 7, 2022.

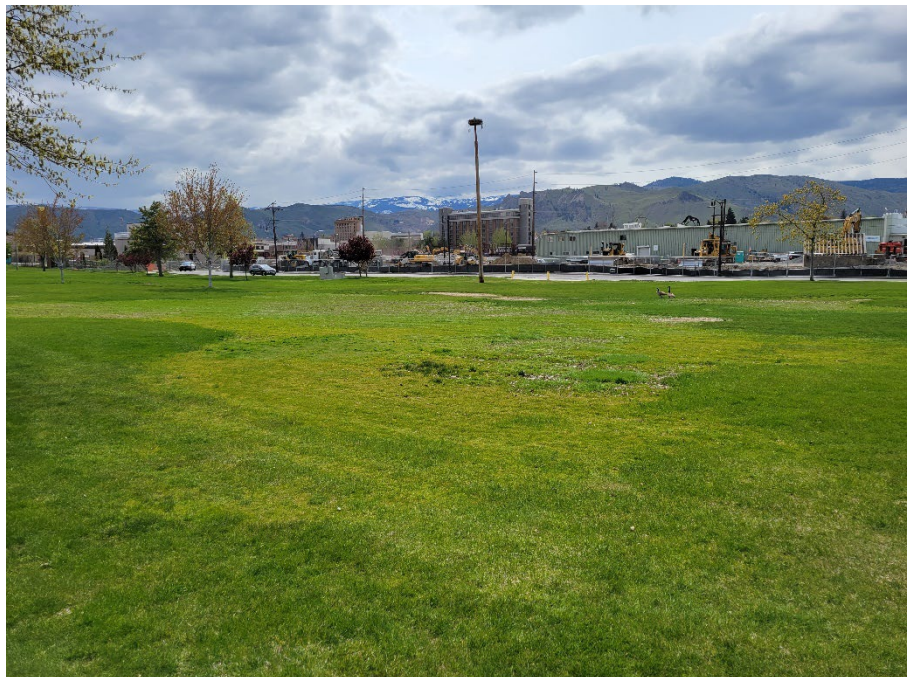
### **Photo No. 4.**

Settlement area east of the Simplot site, looking southwest. Photograph taken April 28, 2022.

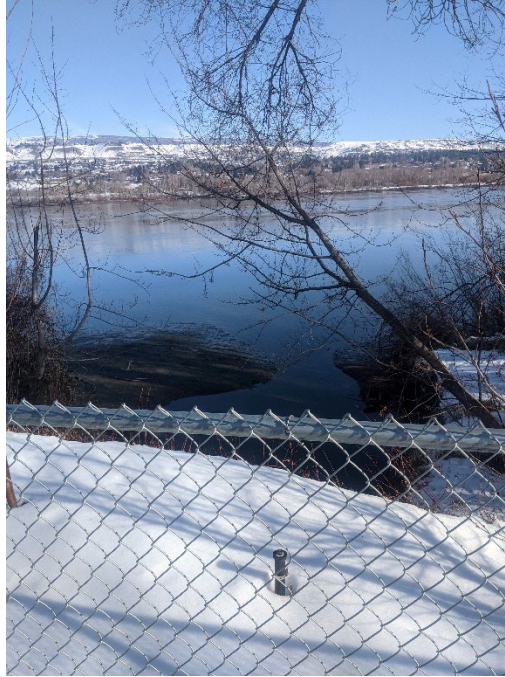
Replacement  
stormwater outfall  
location in north  
portion of property,  
looking east.  
Photograph taken  
February 7, 2022.

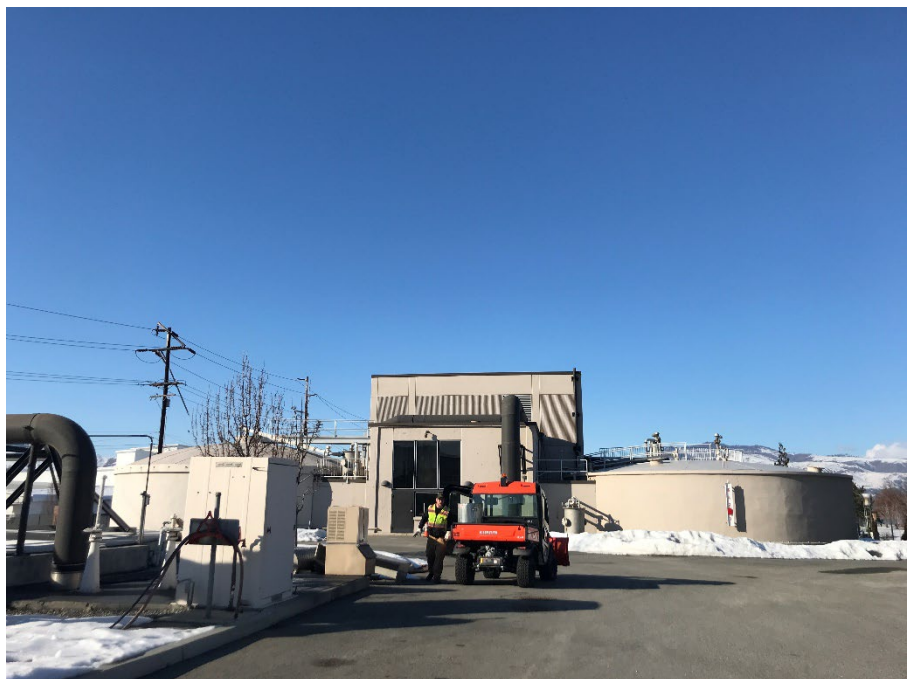
### **Photo No. 16.**

Digestors (round structures) at the City WWTP, looking north. Photograph taken February 7, 2022.

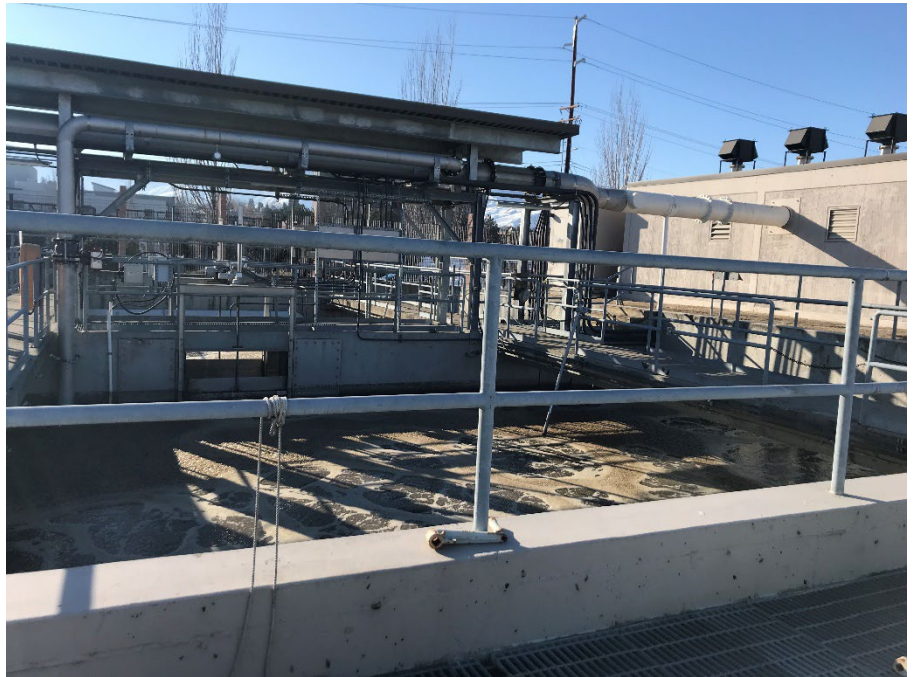
Aerators at the City WWTP, looking west.  
Photograph taken February 7, 2022.

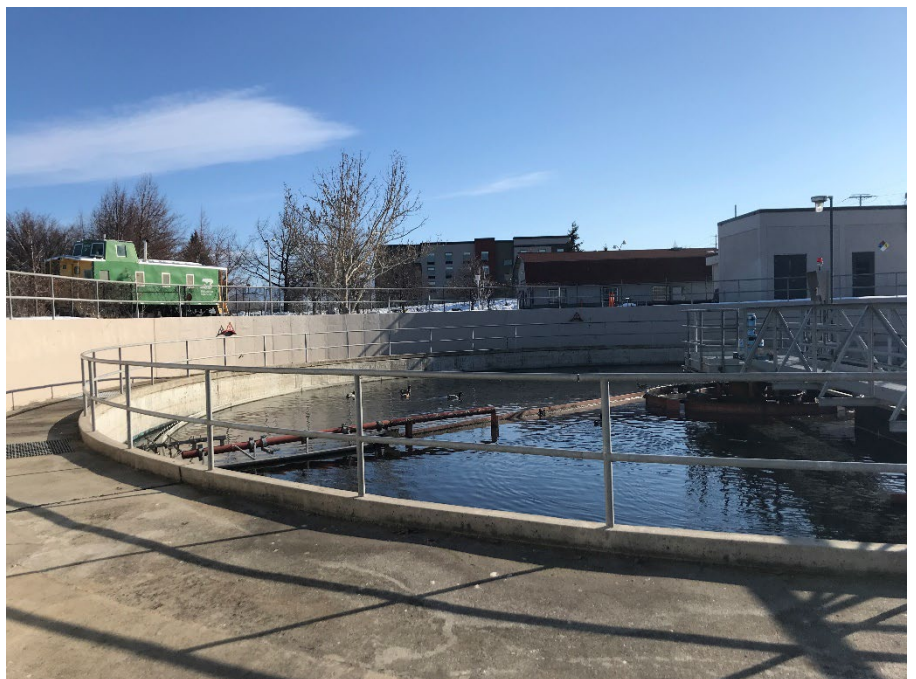
### **Photo No. 18.**

Skimming pond post-aeration at the City WWTP, looking north.  
Photograph taken February 7, 2022.

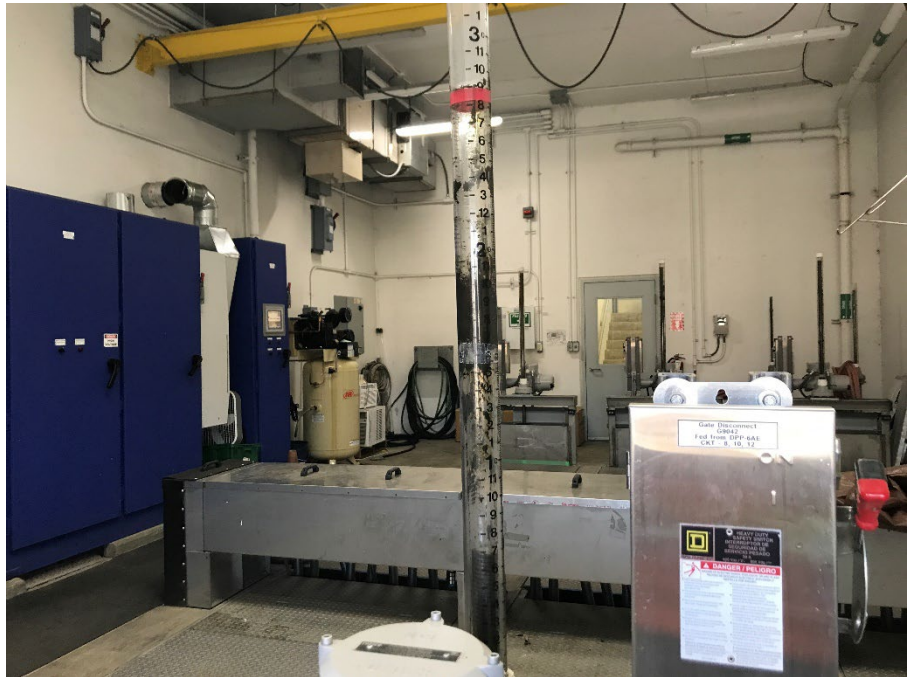
Ultraviolet wastewater treatment area at the City WWTP prior to discharge to the Columbia River. Photograph taken February 7, 2022.

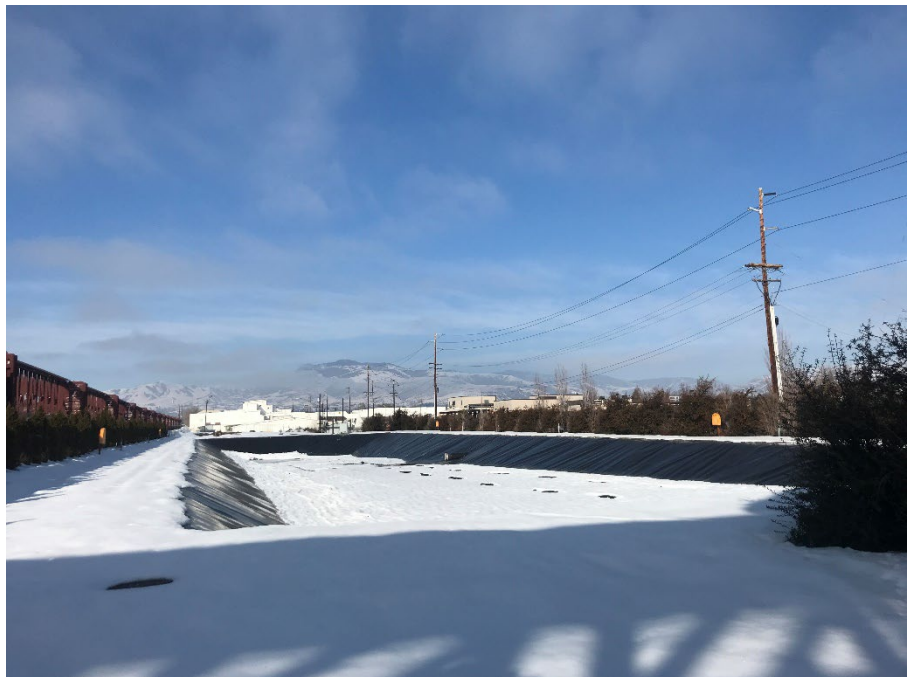
### **Photo No. 20.**

Lined wastewater overflow retention area on west side of N Worthen Street, looking north. Photograph taken February 7, 2022.

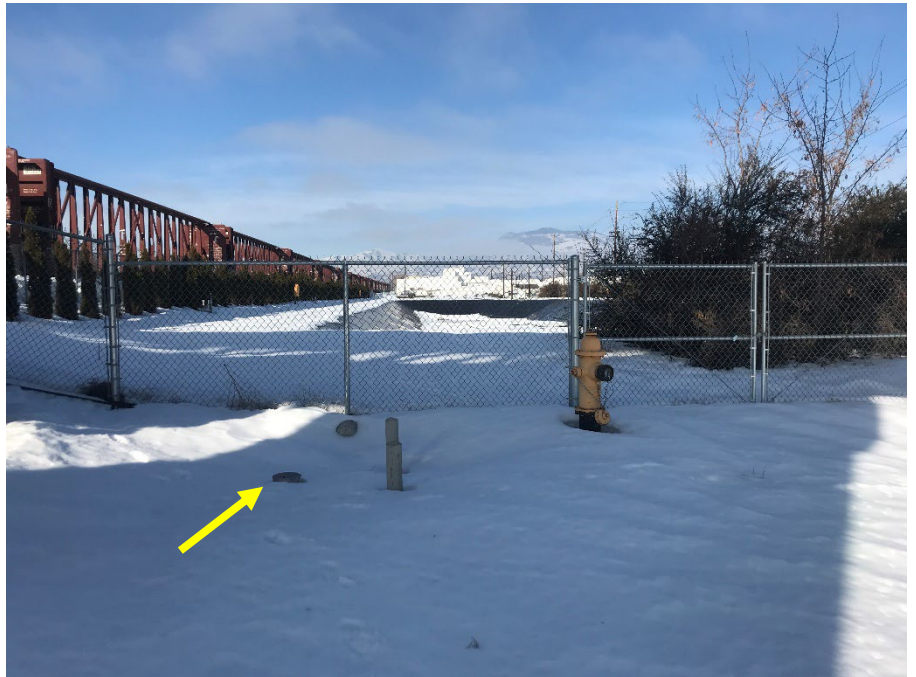
Monitoring well on south side of wastewater overflow retention area, looking north.  
Photograph taken February 7, 2022.

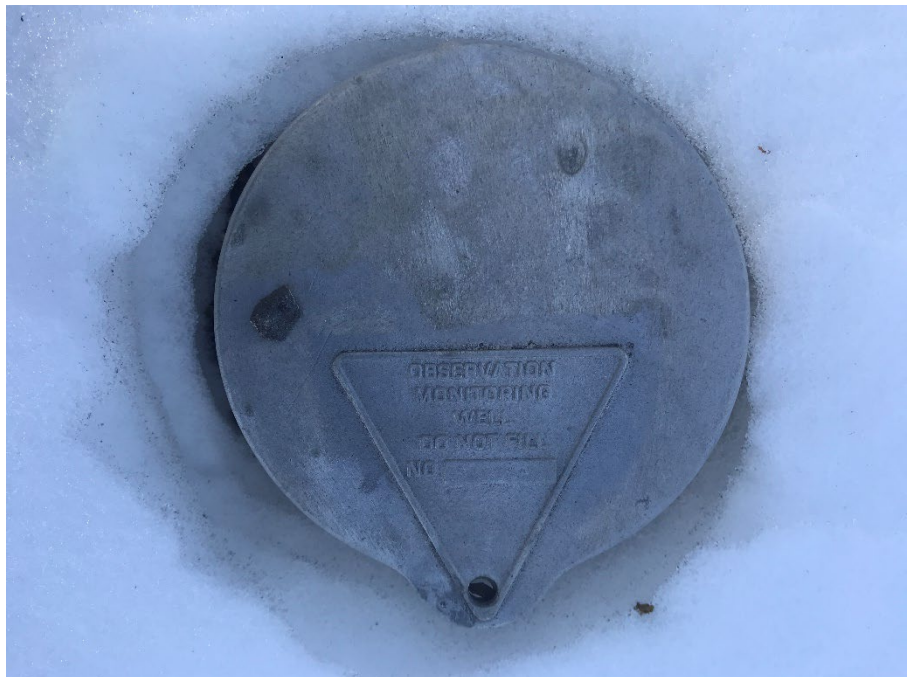
### Photo No. 22.

Close-up of monitoring well on south side of wastewater overflow retention area.  
Photograph taken February 7, 2022.

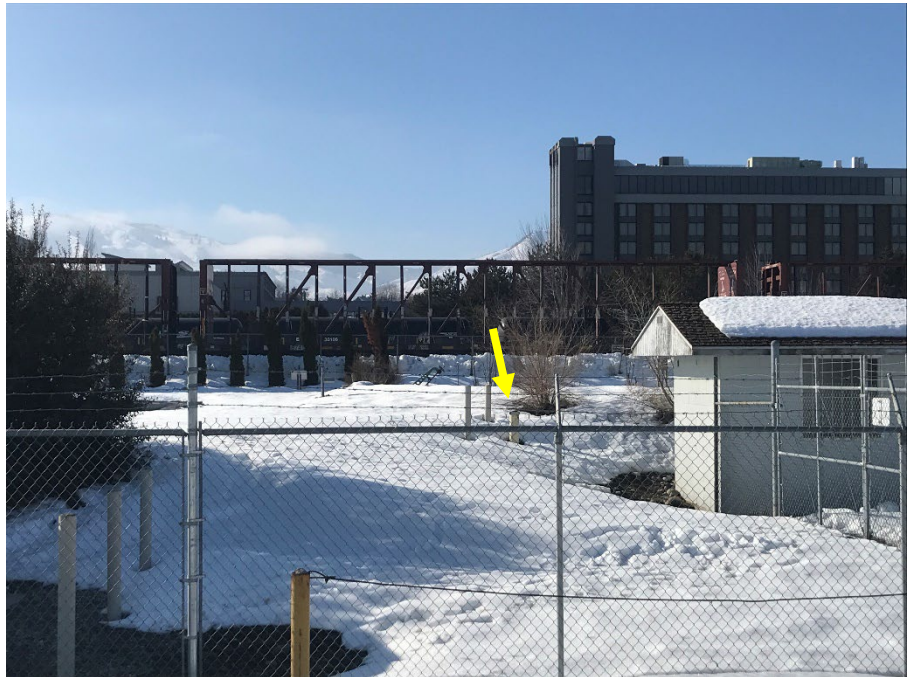
Monitoring well on  
north side of wastewater  
overflow retention area,  
looking west.  
Photograph taken  
February 7, 2022.

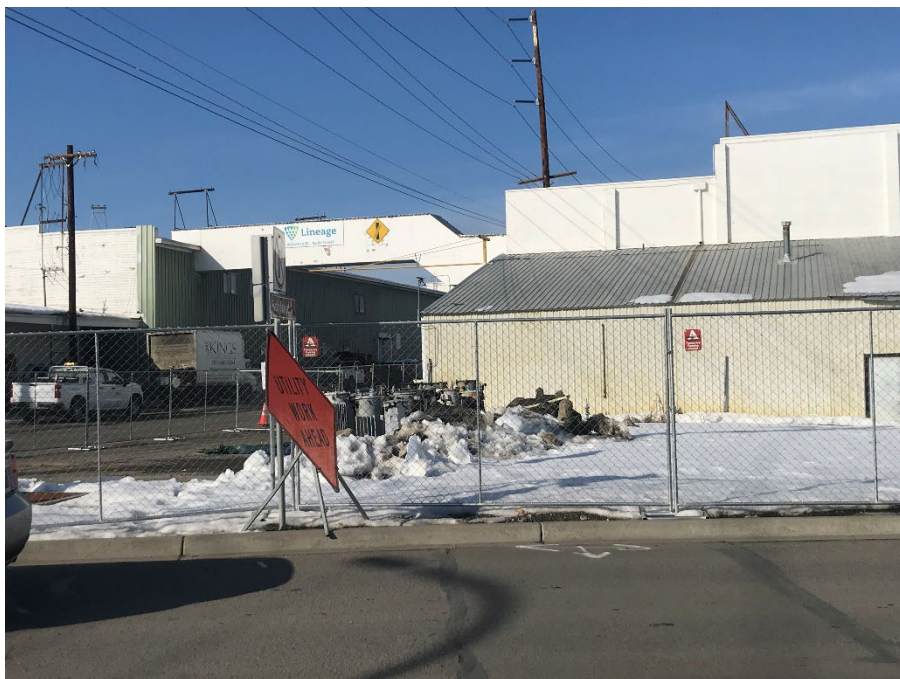
Potentially polychlorinated-biphenyl-containing transformers stored on the Lineage property. Photograph taken February 7, 2022.

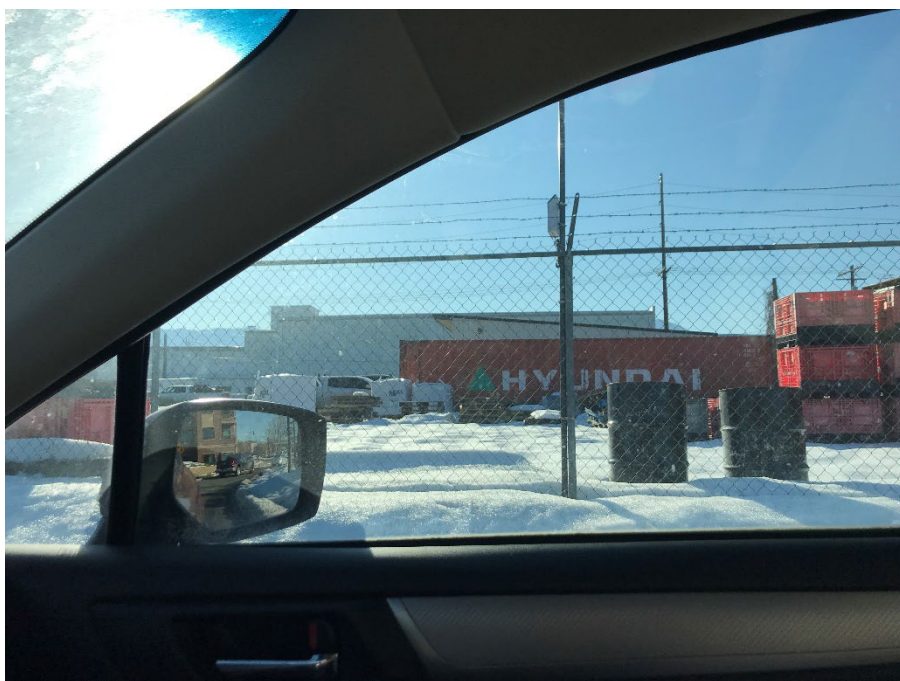
55-gallon drums on an adjacent west property (former Chelan County Public Utility District substation) near the north portion of the property. Photograph taken February 7, 2022.

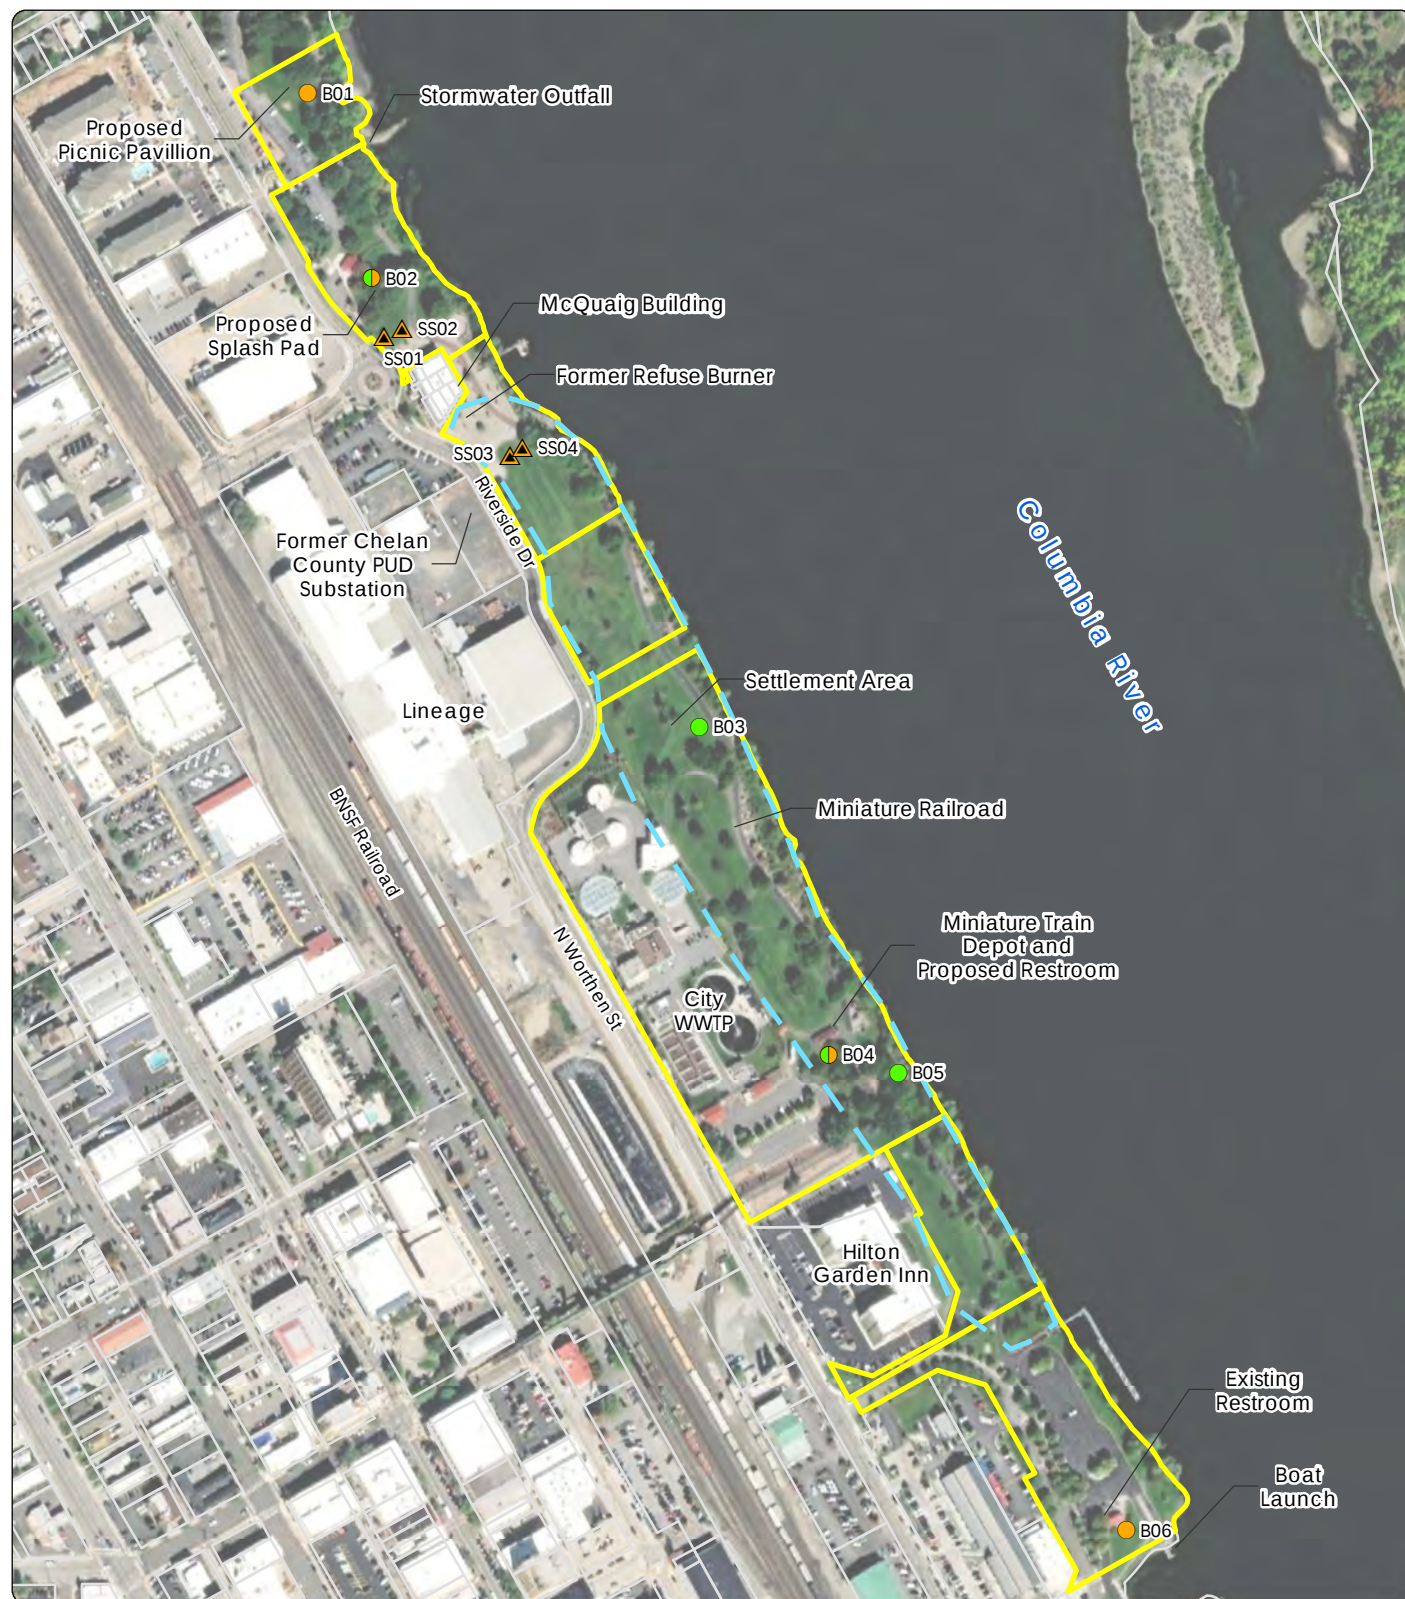
Figure 2 – Site Map

Based on the results of this investigation, the scope of the proposed improvements span across both native alluvium and historic landfill deposits (**Figure 2**). Therefore, the conclusions will be broken into two separate sections: one addressing construction on the landfill, and one addressing the native alluvium.
