# VCP Application Standard and Expedited Processes

Washington State Department of Ecology  
Toxics Cleanup Program

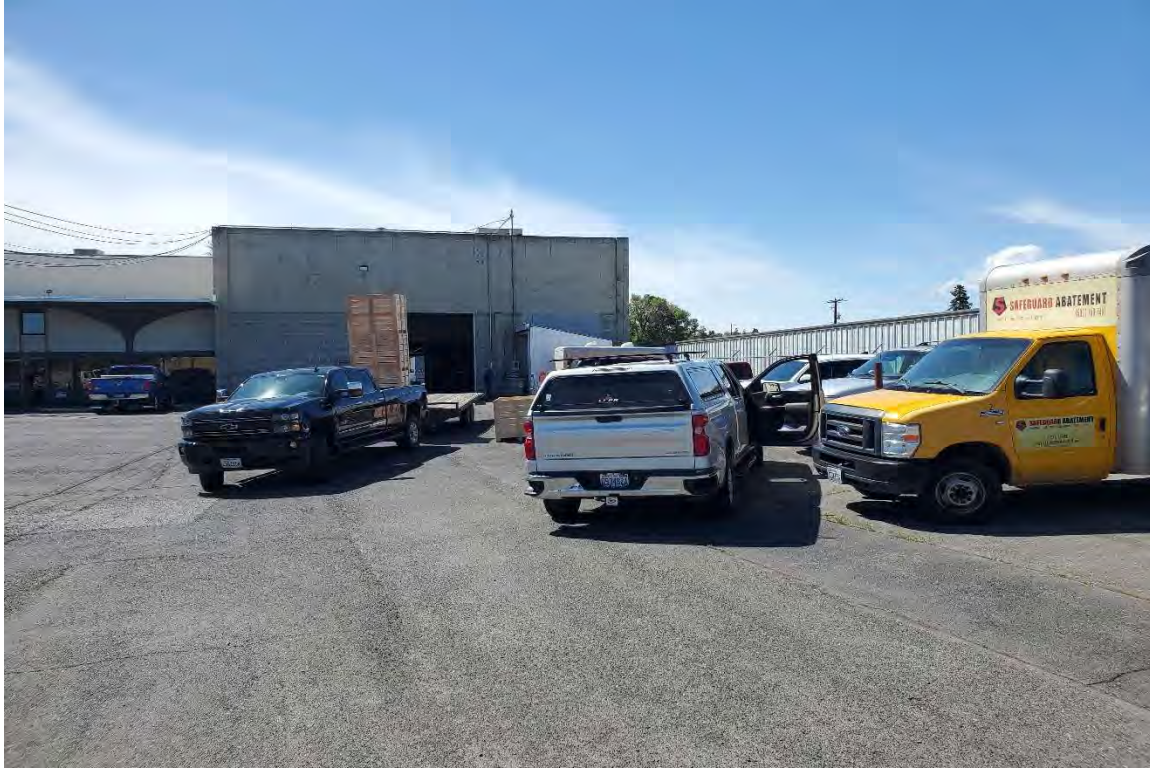
SITE LOOKING SOUTHWEST

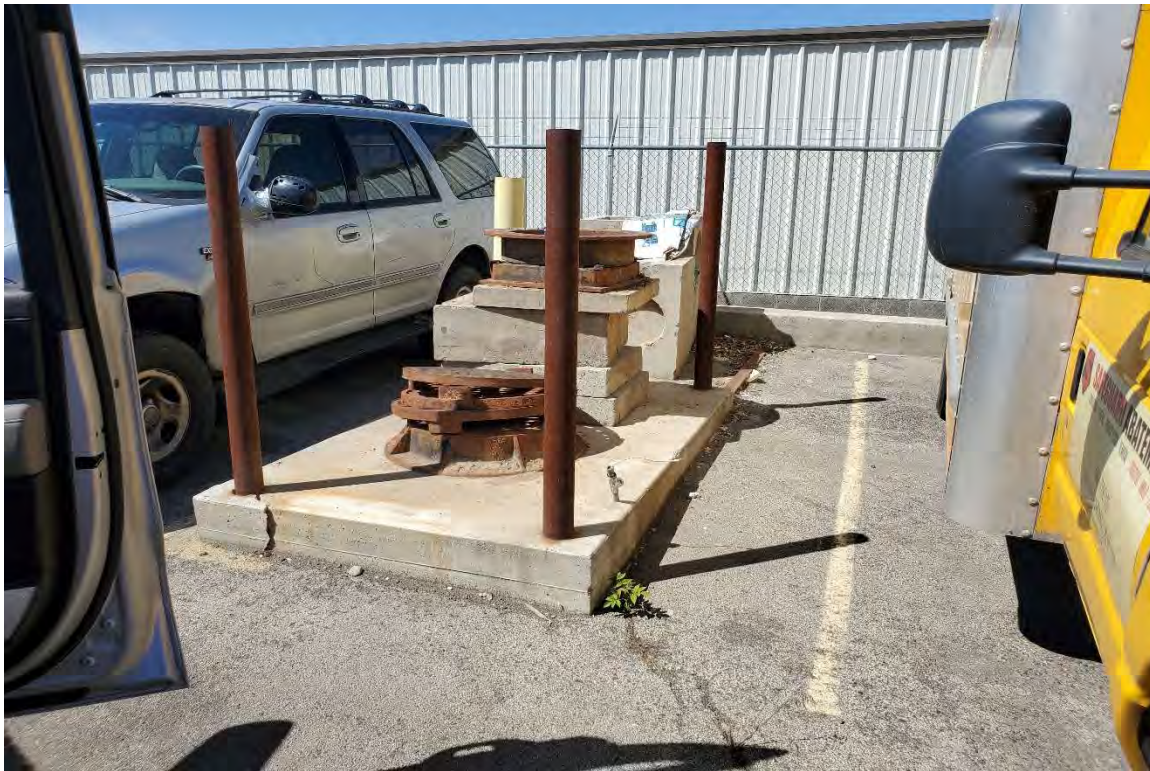
WELL LOCATED BEHIND CONCRETE FOOTING

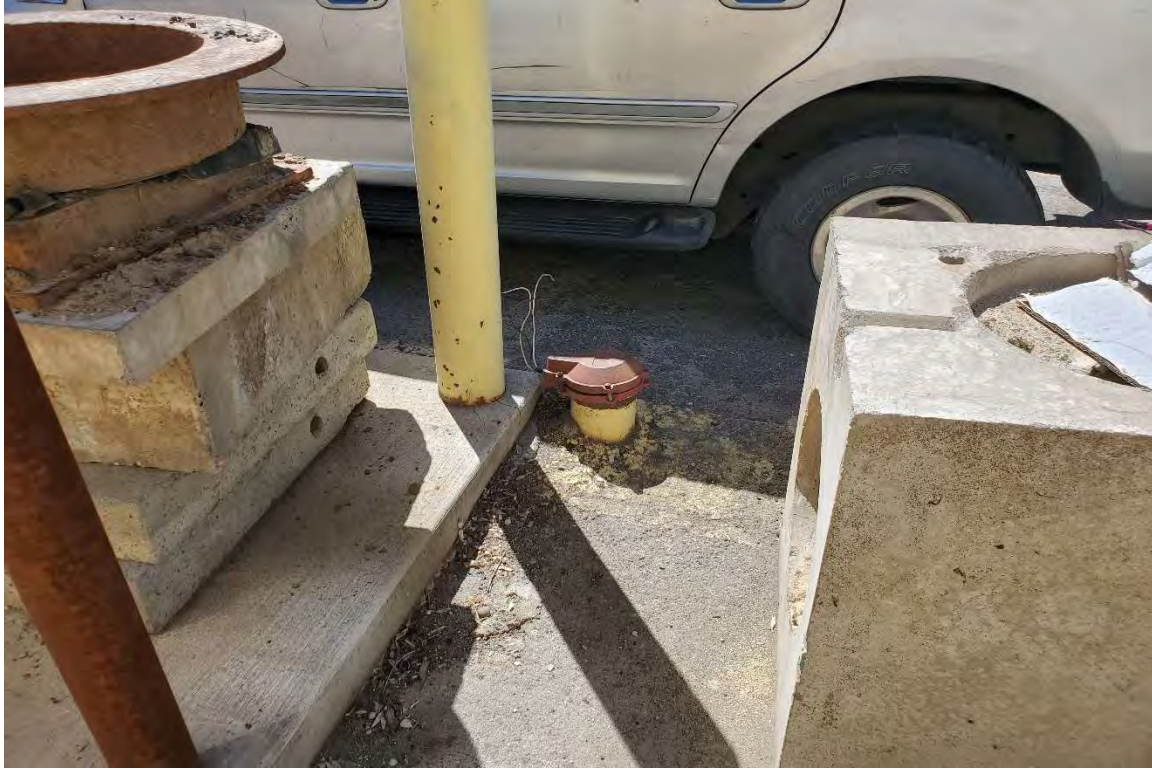
LOCATION OF WW1

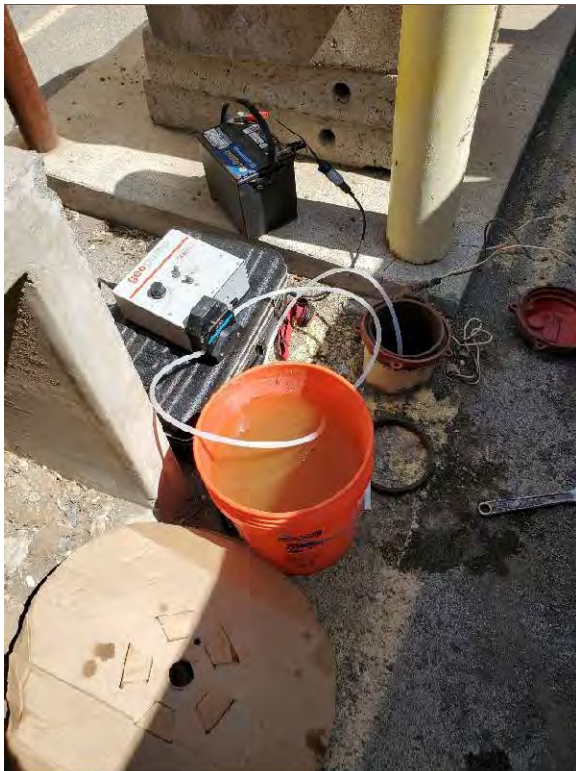
PURGING WW1
