**Four Star  
Petroleum Contaminated Soil  
Vapor Intrusion Investigation**

**Pullman Marketing Building  
325 NW State Street  
Pullman, Washington**

Project Number: 233516.01

Date: June 3, 2024

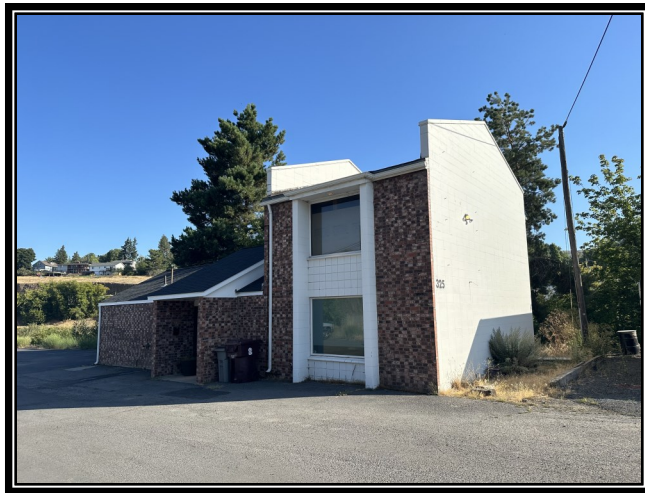
**Photograph #1: 07/18/2023:**

View of the Pullman Marketing building located adjacent to the Four Star Fuel Supply January 2022 fuel spill site.

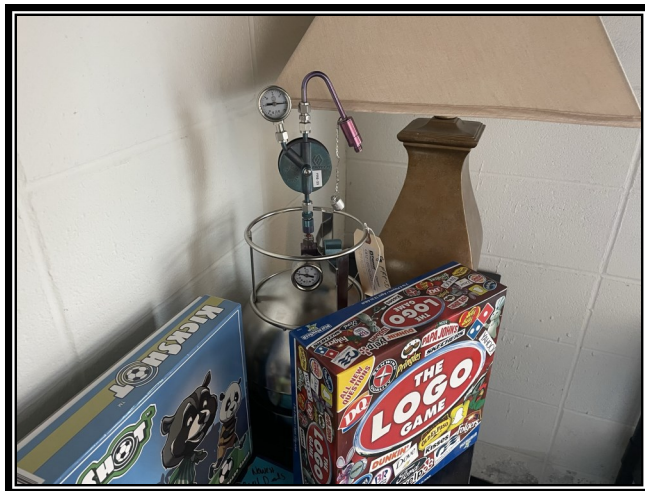
**Photograph #2: 07/18/2023:**

View of initial ambient air sample collected from the east corner of the Pullman Marketing building.

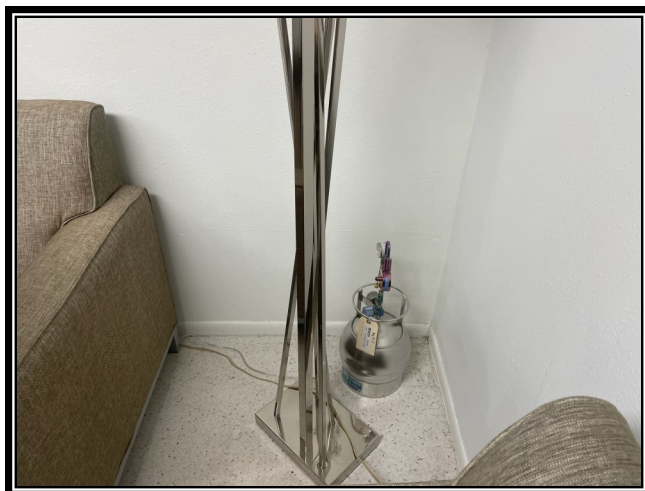
**Photograph #3: 07/18/2023:**

View of initial ambient air sample collected from the north central area of the Pullman Marketing building.

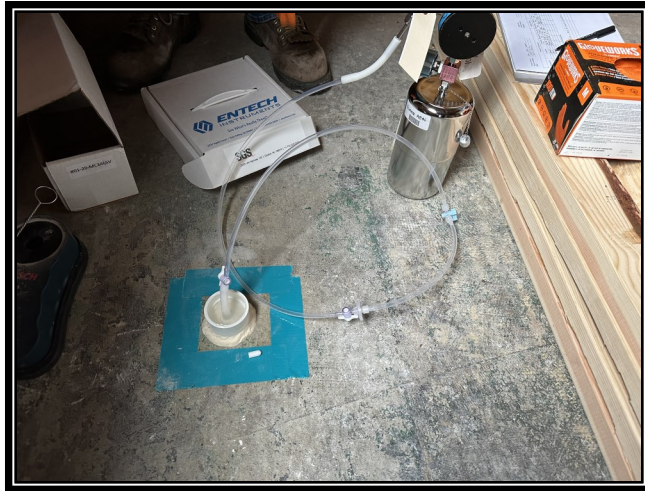
**Photograph #4: 10/11/2023:**

View of initial sub-slab soil vapor sample collected from the northwest area of the Pullman Marketing building.

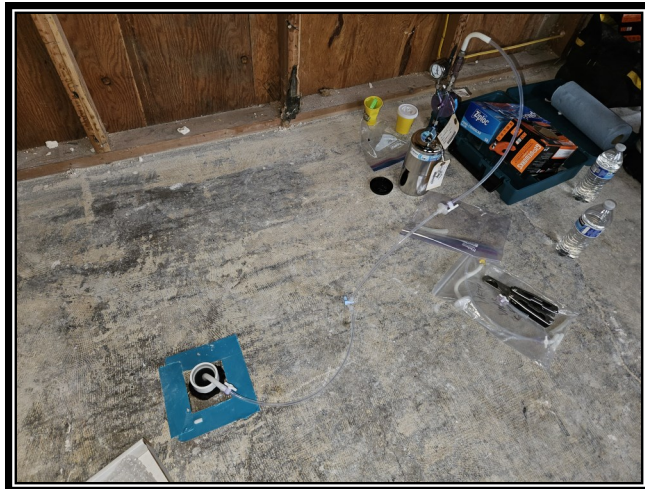
**Photograph #5: 10/11/2023:**

View of initial sub-slab soil vapor sample collected from the central area of the Pullman Marketing building.

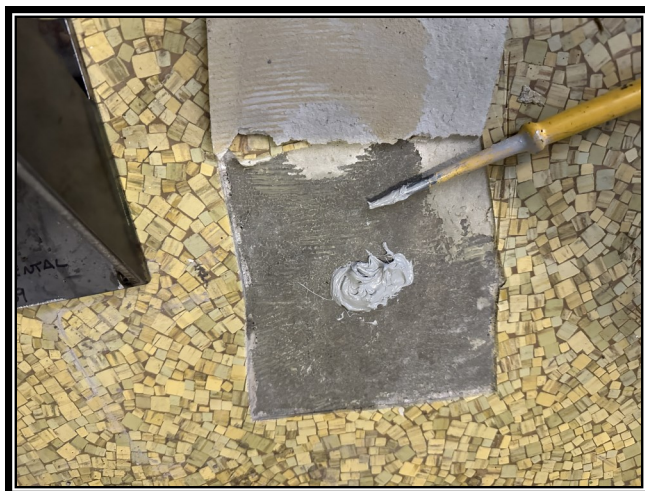
**Photograph #6: 10/11/2023:**

View of sealed sample port following initial sub-slab soil vapor sampling from the east area of the Pullman Marketing building.

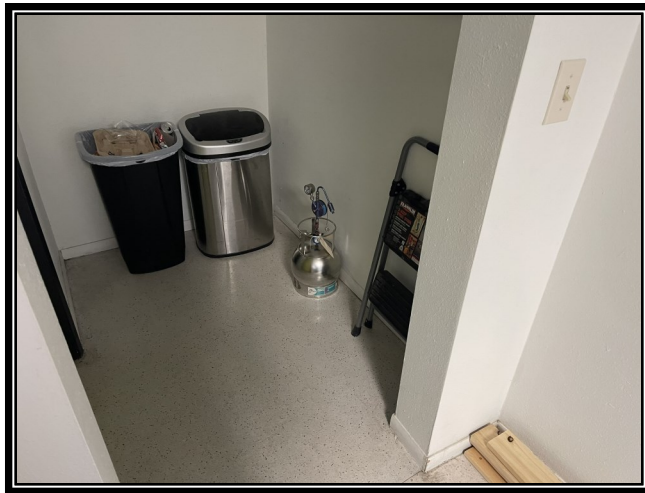
**Photograph #7: 01/18/2024:**

View of interior passive ambient air sample collected from the south central portion of the Pullman Marketing building.

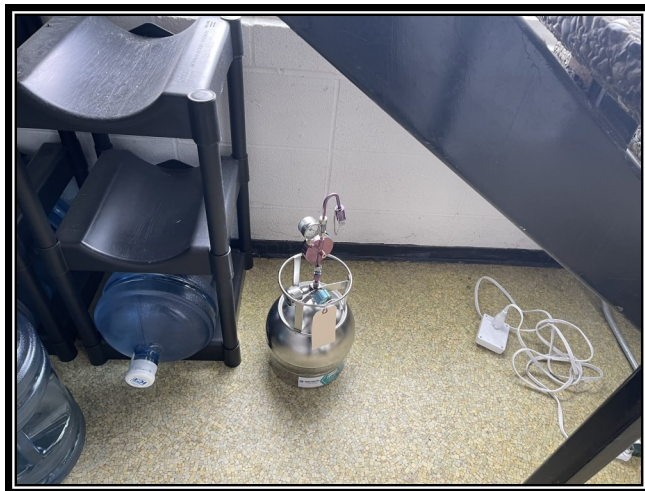
**Photograph #8: 01/18/2024:**

View of interior passive ambient air sample collected from the east portion of the Pullman Marketing building.

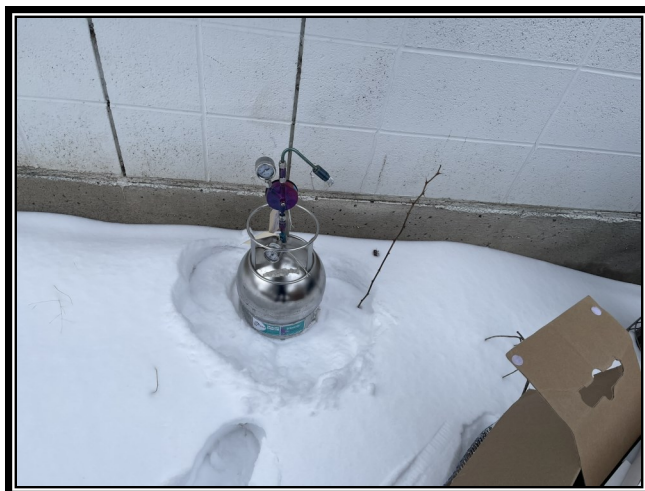
**Photograph #9: 01/18/2024:**

View of exterior passive air sample collected from the north exterior of the Pullman Marketing building.

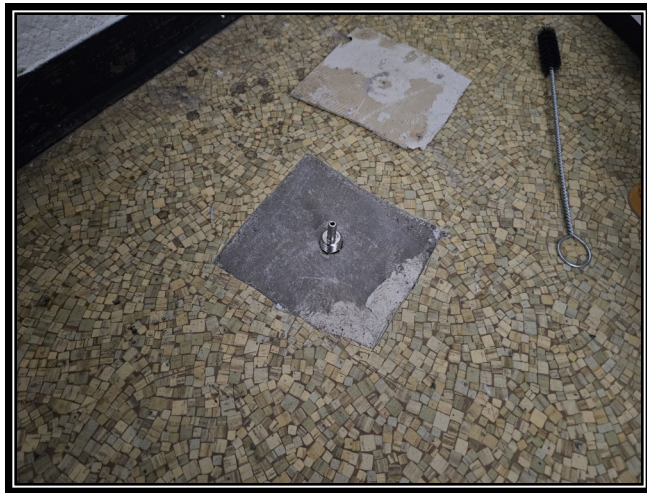
**Photograph #10: 01/30/2024:**

View of the sample port for the follow-up indoor sub-slab soil gas sample located in the east portion of the Pullman Marketing building.

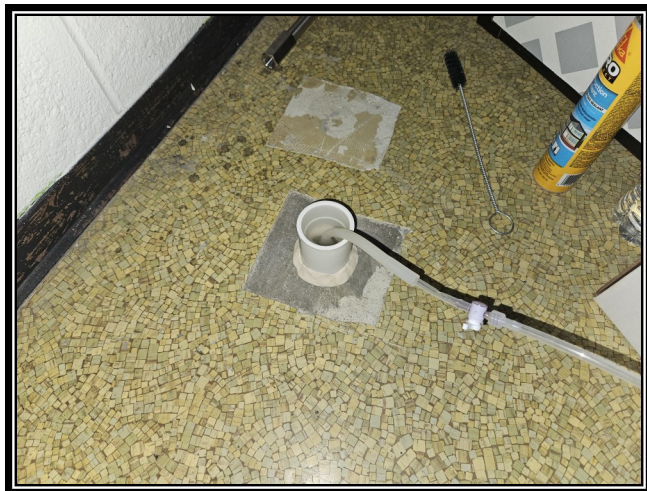
**Photograph #11: 01/30/2024:**

On January 30, 2024, Fulcrum completed sub-slab sampling from the east central stairwell. Exterior temperatures were documented to be at 42° F as compared to interior temperatures at 72° F. Prior to completing the sub-slab sampling, a water dam seal was completed and the sample collection train was connected to the Teflon tubing and verified to be leak free after maintaining a constant 0.25-inch of mercury vacuum pressure for a 5-minute period during the pre-sample shut-in verification test.

View of the water dam seal test being conducted prior to sub-slab soil gas sampling.
