### **Cleanup Action Plan Block 38 West**

**500 through 536 Westlake Avenue North  
Seattle, Washington**

Washington State Department of Ecology  
Shoreline, Washington

October 2024

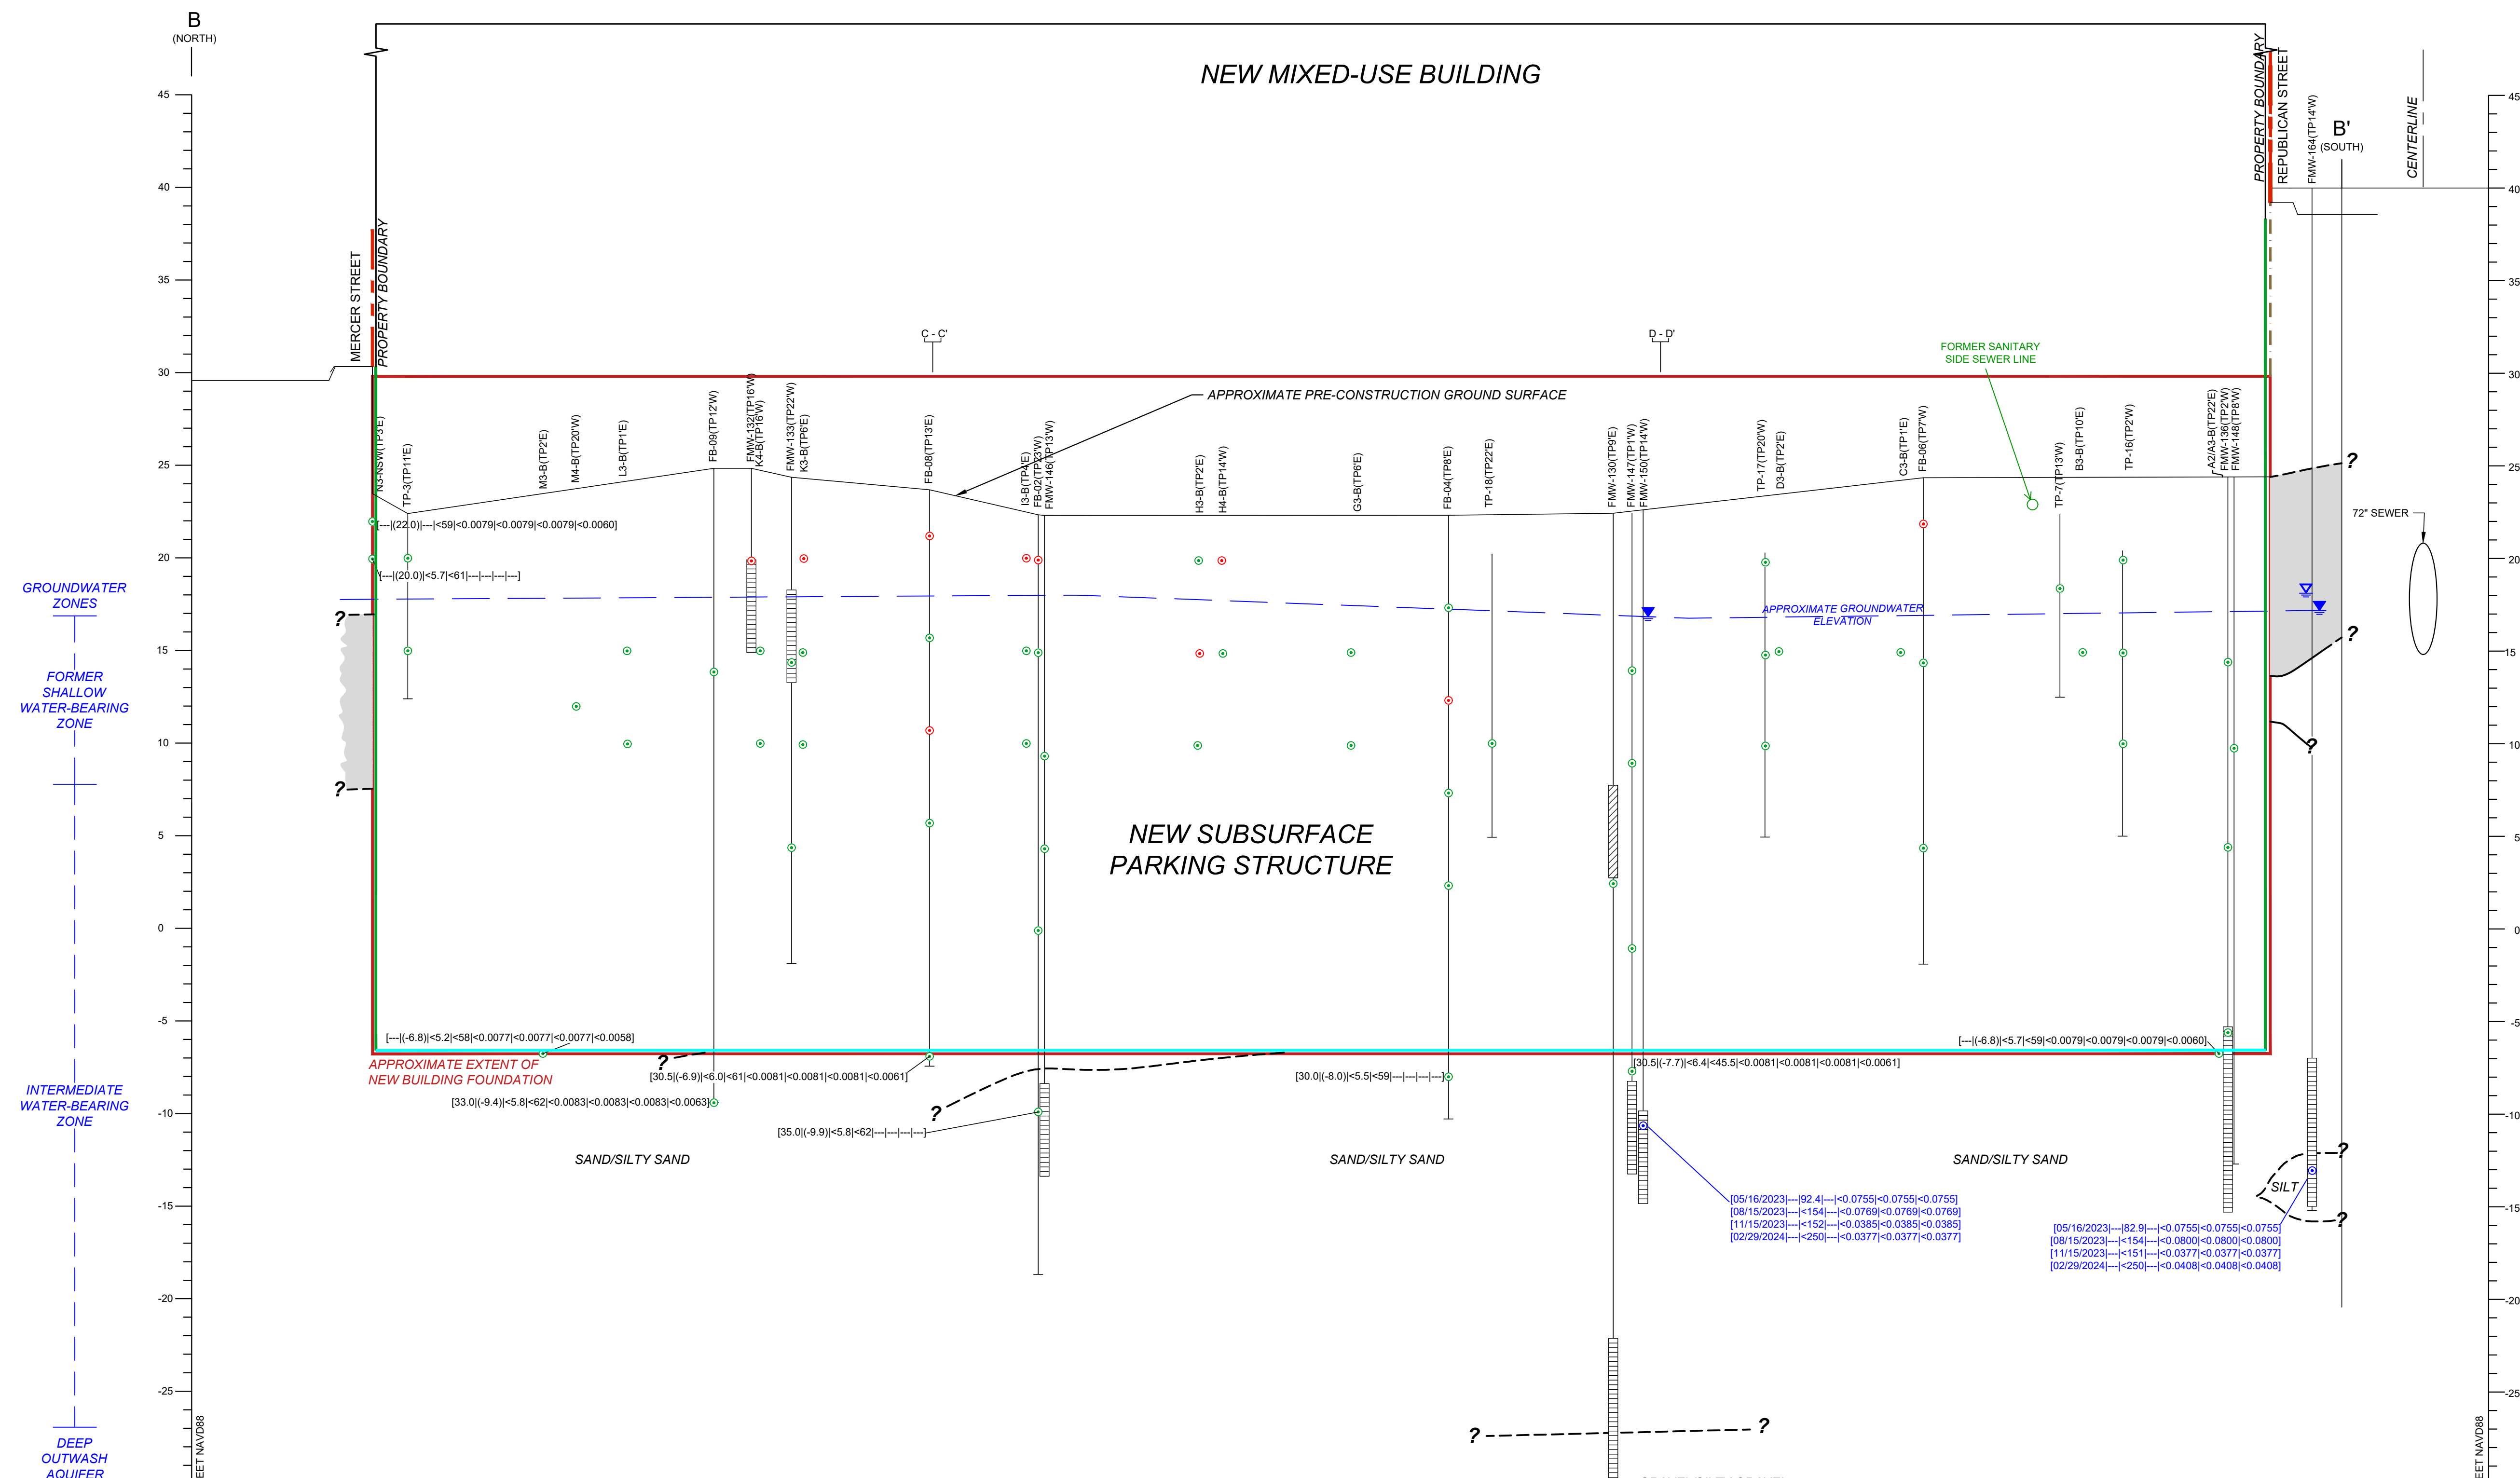
**FIGURE 5**  
 POST INTERIM ACTION CROSS SECTION B-B'  
 BLOCK 38 WEST SITE  
 SEATTLE, WASHINGTON  
 FARALLON PN:397-019

TP-3 (TP-11E) BORING OR MONITORING WELL LOCATION TRANSPROSED (TP) IN FEET, EAST (E) OR WEST (W), TO CROSS-SECTION LINE  
 INDICATES CONCENTRATIONS OF ONE OR MORE HAZARDOUS SUBSTANCES EXCEEDED THE APPLICABLE MTCA CLEANUP LEVELS  
 INDICATES CONCENTRATIONS OF HAZARDOUS SUBSTANCES ANALYZED DID NOT EXCEED THE APPLICABLE MTCA CLEANUP LEVELS  
 APPROXIMATE GROUNDWATER ELEVATION  
 STRATIGRAPHIC CONTACT  
 BLANK CASING OR BORING  
 STATIC GROUNDWATER ELEVATION (MOST RECENT)  
 GROUNDWATER ELEVATION AT TIME OF DRILLING  
 TEMPORARY SCREEN INTERVAL  
 GROUNDWATER SAMPLE LOCATION  
 WELL SCREEN INTERVAL

Mass excavation removed the entirety of the fill and the recent deposits from within the boundaries of the Block 38 West Property. The bottom of the mass excavation at elevation -7 feet NAVD88 was in glacially consolidated soils. Cross-sections depicting the post-excavation conditions of the Block 38 West Property are presented on Figures 4 through 6. The locations of

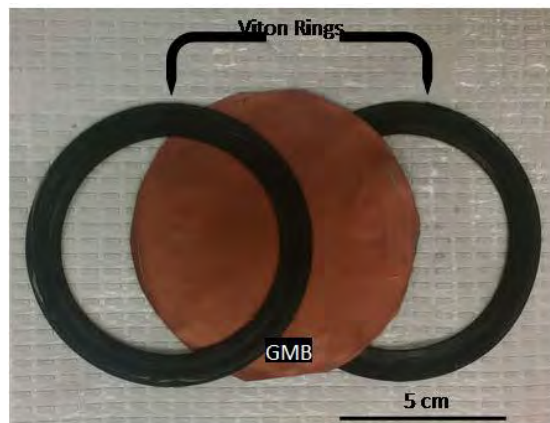
Figure 2: Membrane and Viton Rings

Sorption testing was also performed to directly measure the partitioning coefficients for each chemical. The sorption testing was conducted using 20-ml vials where a specimen was placed in double deionized water. The mass of the specimen was recorded beforehand. The vials were filled with double deionized water so that there was no airspace in the vial. Known masses of contaminants were added and 50  $\mu$ l samples were taken daily from the vials for analysis and replaced with double deionized water until equilibrium was reached. The chemical analysis of these specimens was performed in the same manner as chemical analysis of the diffusion tests. This analysis is described in Appendix B.

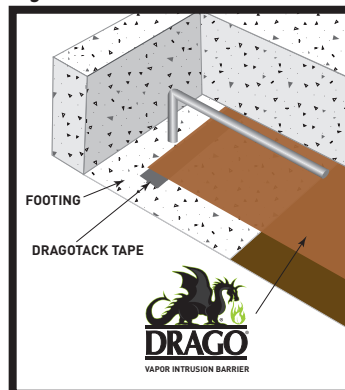
Fig. 2b: SEAL TO FOOTING

- a. Make sure area of adhesion is free of dust, dirt, debris, moisture, and frost to allow maximum adhesion.
- b. Remove release liner on one side and stick to desired surface.
- c. When ready to apply Drago Wrap, remove the exposed release liner and press firmly against DragoTack Tape to secure.
- d. If a mechanical seal is needed, fasten a termination bar over the top of the Drago Wrap inline with the DragoTack Tape.

**NOTE: If sealing to the footing, the footing should receive a hand float finish to allow for maximum adhesion.**

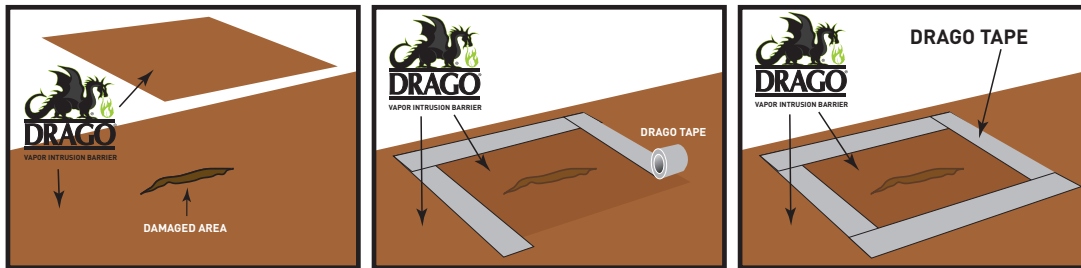
Fig. 3: SEALING DAMAGED AREAS

4. In the event that Drago Wrap is damaged during or after installation, repairs must be made. Cut a piece of Drago Wrap to a size and shape that covers any damage by a minimum of 6 inches in all directions. Clean all adhesion areas of dust, dirt, moisture, and frost. Tape down all edges using Drago Tape. (Fig. 3)

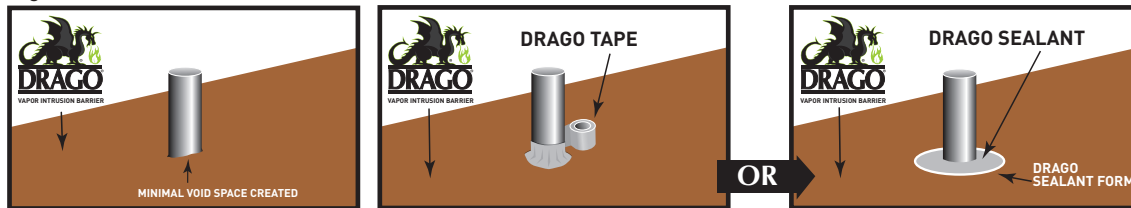
Fig. 4a: PIPE PENETRATION SEALING

5. **IMPORTANT: ALL PENETRATIONS MUST BE SEALED.** All pipe, ducting, rebar, and block outs should be sealed using Drago Wrap, Drago Tape, and/or Drago® Sealant and Drago® Sealant Form. (Fig. 4a). Drago accessories should be sealed directly to the penetrations.

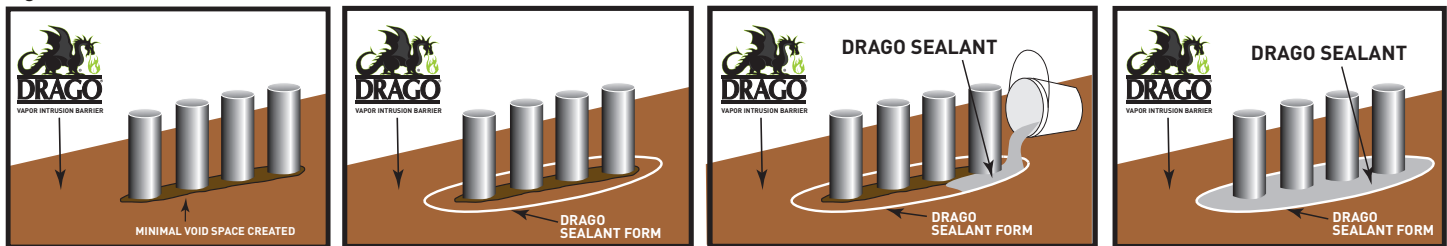
Fig. 5: MULTIPLE PIPE PENETRATION SEALING

- a. Cut a hole in Drago Wrap such that the membrane fits over and around the base of the pipes as closely as possible, ensuring that it is flush with the base of the penetrations.
- b. Install Drago Sealant Form continuously around the entire perimeter of the group of penetrations and at least 1 inch beyond the terminating edge of Drago Wrap.
- c. Pour Drago Sealant inside of Drago Sealant Form to create a seal around the penetrations.
- d. If the void space between Drago Wrap and the penetrations is not minimized and/or the base course allows for too much drainage of sealant, a second coat of Drago Sealant may need to be poured after the first application has cured.
