Phase II Environmental Site Assessment

4 Corners Cleaners

23886 SE Kent-Kangley Road

AEG Project #: 17-126

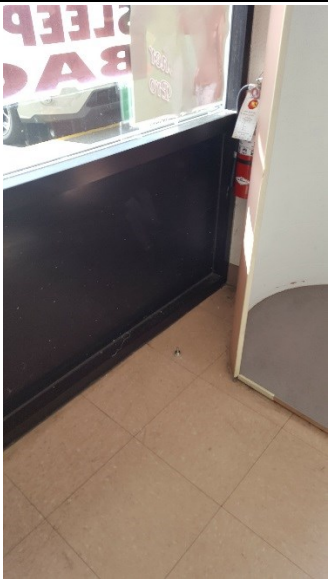
Photo #1: Sample location of SV-1.	Photo #2: Vapor sample collection equipment at sample location SV-2.

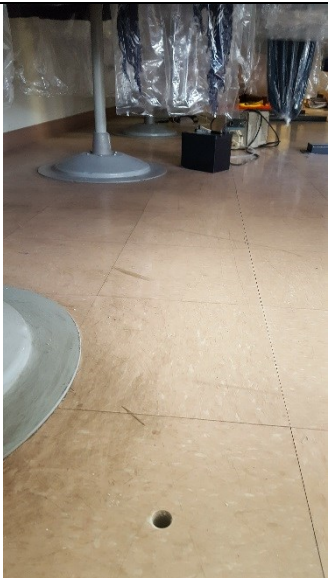
Photo #3: Sample location of SV-3.	Photo #4: Sample location of SV-7 and SV-14.

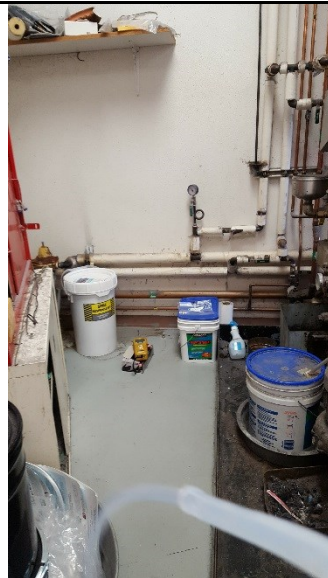
Analytical results of the sub-slab vapor samples indicated the presence of PCE **above** the MTCA Method B sub-slab screening level of 321 micrograms per cubic meter ($\mu\text{g}/\text{m}^3$) in all samples, except SV-13. Concentrations of PCE ranged from 850 $\mu\text{g}/\text{m}^3$ in SV-6 to 6,300 $\mu\text{g}/\text{m}^3$ in SV-11.

Photo #7: Vapor sample collection from sample location SV-11, behind the current dry cleaning machine.	Photo #8: Vapor sample SV-12 collected in front of the cleaning machine.

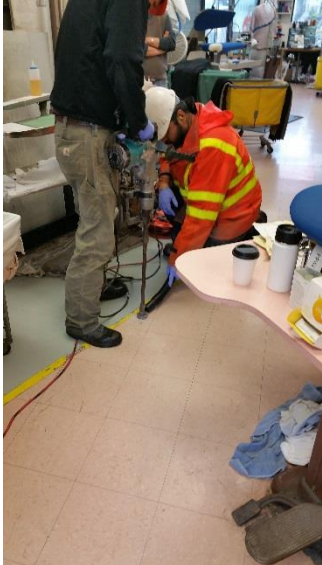
Photo #9: Coring through concrete at sample location B-1.	Photo #10: Coring through concrete at sample location B-2.

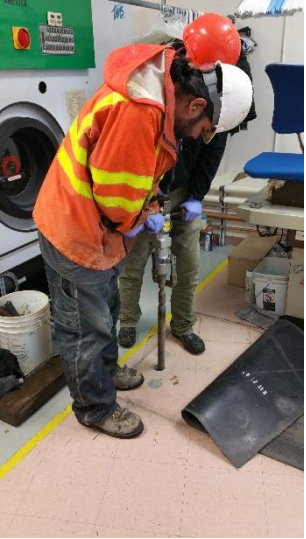
Photo #11: Core barrel advance at sample location B-3.	Photo #12: Soil sample material from B-1 refusal at 22 inches bsg.

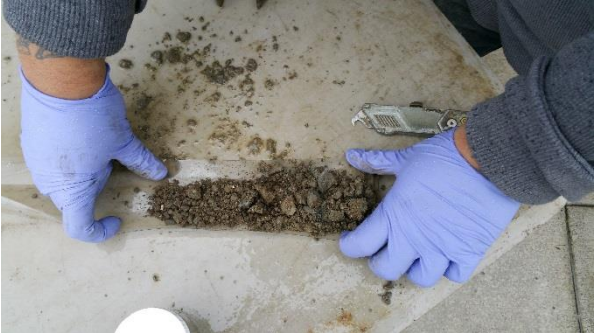
Soil samples results indicated PCE was detected **above** the MTCA Method A cleanup level of 0.05 milligrams per kilogram (mg/kg) in sample B1-22 (0.058 mg/kg) and B3-23 (0.067 mg/kg). PCE was detected **below** the MTCA Method A cleanup level in B2-20 (0.044 mg/kg).

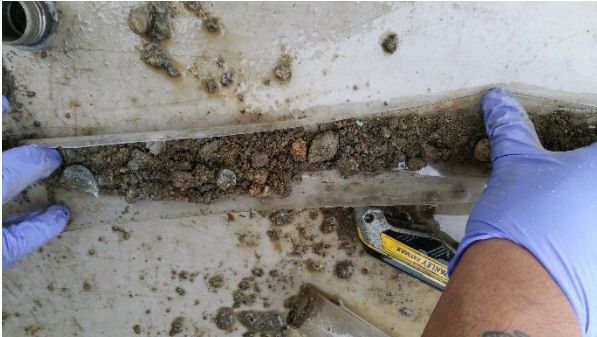
Photo #13:	Soil sample material B-2 refusal at 20 inches bsg.	Photo #14:	Soil sample material B-3 refusal at 23 inches bsg.
<p>INTENTIONALLY LEFT BLANK</p>
