**WORK PLAN FOR  
ADDITIONAL SITE  
CHARACTERIZATION**

Cascade Laundry  
205 Prospect Street  
Bellingham, Washington 98225  
Facility Site ID #21786898  
VCP Project No# NW3076

November 1, 2024

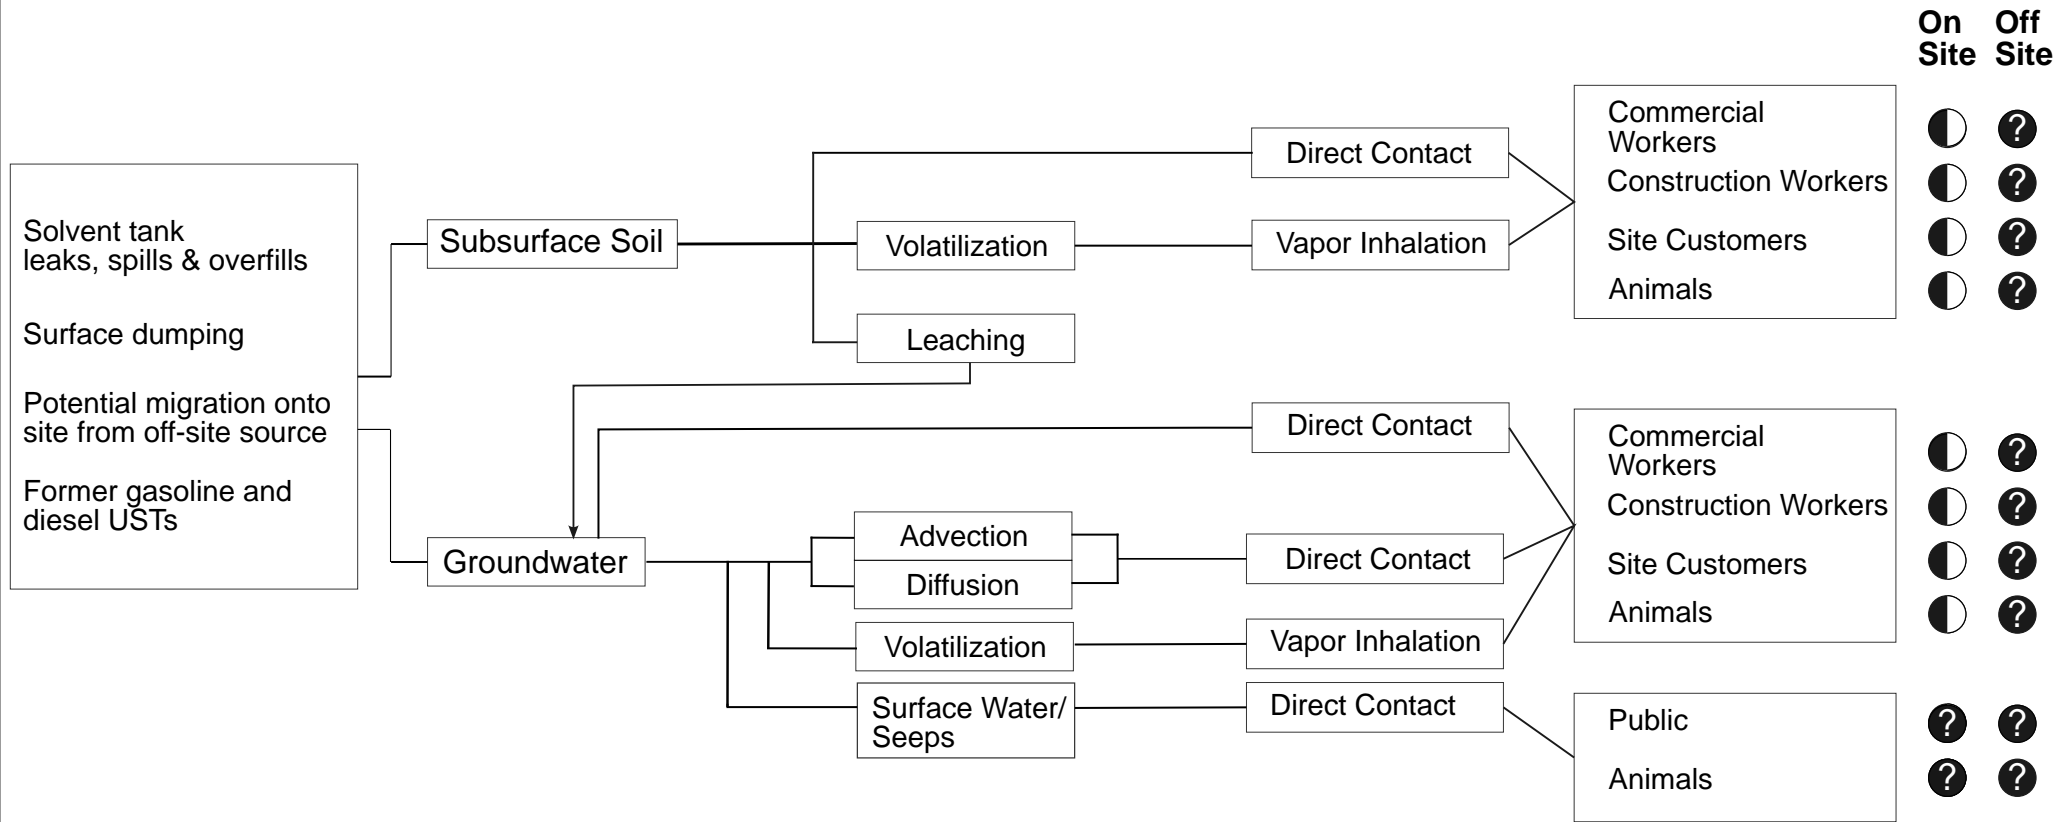
**Figure 3-1**

Primary Sources → Secondary Sources → Transport Mechanisms → Exposure Pathways → Potential Receptors → Exposure Potential

Schematic Conceptual Site Model

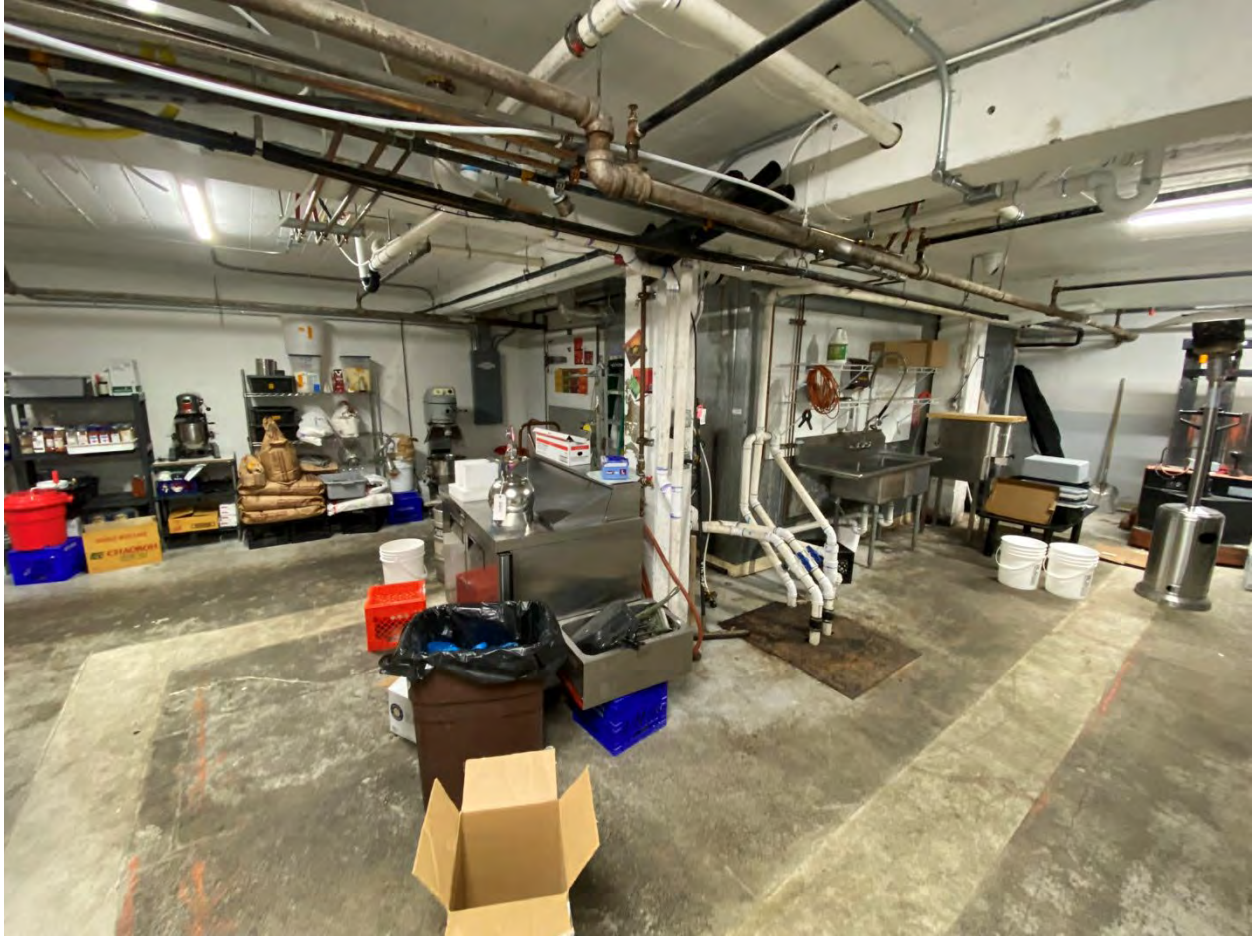
Photograph of Cascade Laundry basement (December 2022). Lighter color pavement indicates the location of the buried vapor mitigation piping locations.
