Re: Additional Remedial Investigation Report

NWMS Puyallup 400 River Road Puyallup, Washington

WADE Cleanup ID 17046 H&H Job No. SAI-413

ADDITIONAL REMEDIAL INVESTIGATION REPORT

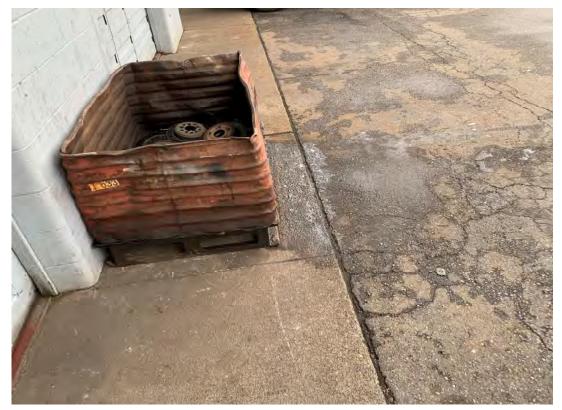
Photograph 9: Scrap metal car parts bin with observed staining, located at the southern extent of the North Shop, facing east.

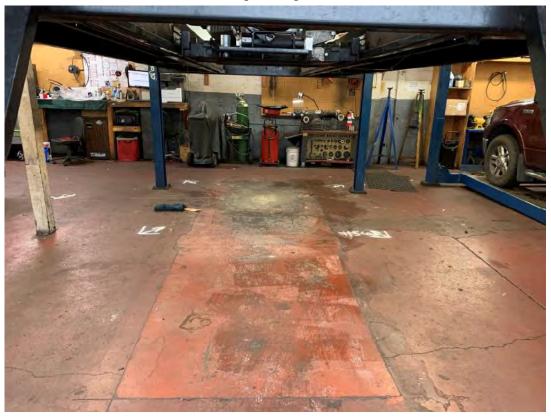
Photograph 10: Patched floor in North Shop with some observed staining in lift area, location of SB-5, facing north.

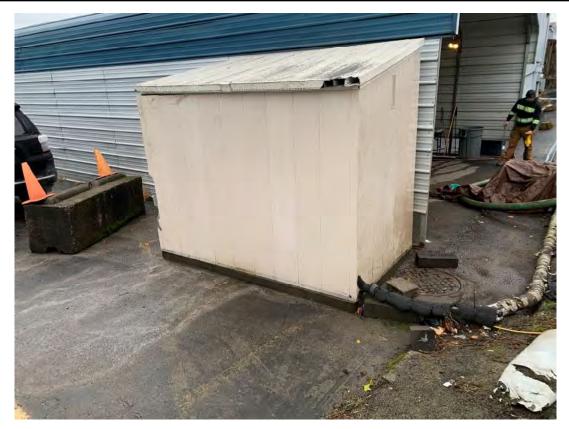
Photograph 11: View of OWS and skimmer shed at southern edge of wash bay, facing northeast.

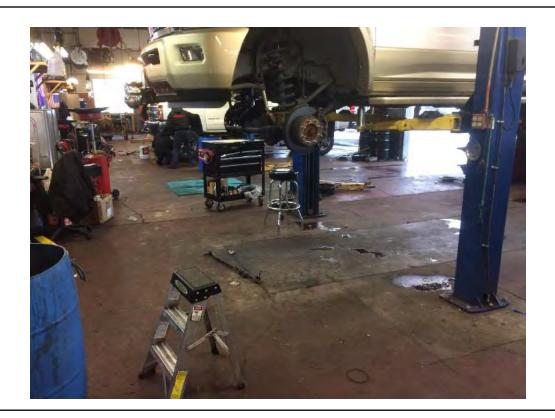
South Shop, includes 8 services bays, currently with above ground hoists, and two ASTs containing engine oil. Services include general vehicle maintenance and repair. Patches on floor represent former in ground hydraulic hoist locations.

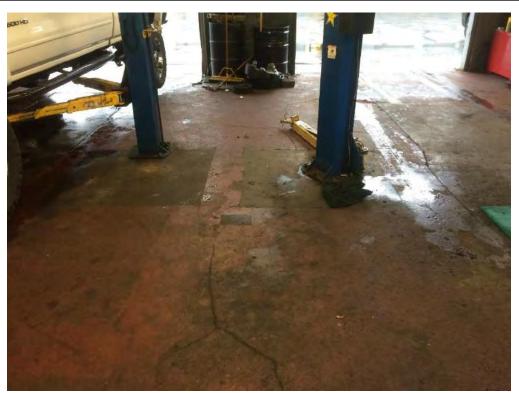
South Shop, in-between bay 5 and bay 6 has patched floors where hoist systems presumably were located in the past. Interview with employee noted this shop historically had in-ground hoist systems for vehicle maintenance.

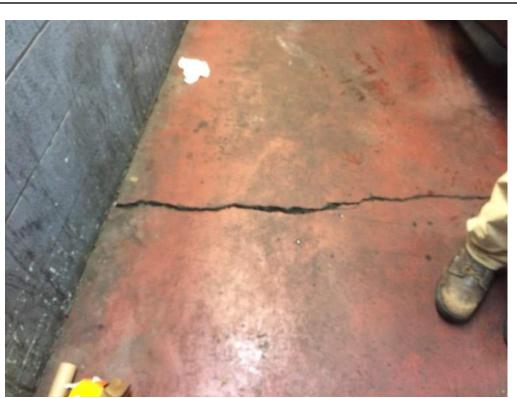
South Shop, near bay 1 which has the widest floor crack noted in shops.
Multiple cracks this size near bay 1.

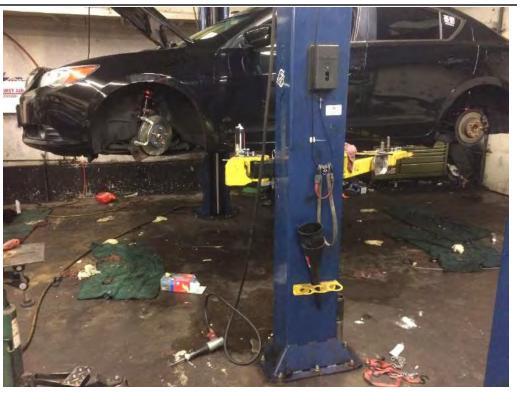
Lower shop furthest south service bay. Noteably stained and cluttered. Unable to discern whether heavily stained or just wet from vehicle recently moved indoors and dripping from rain.

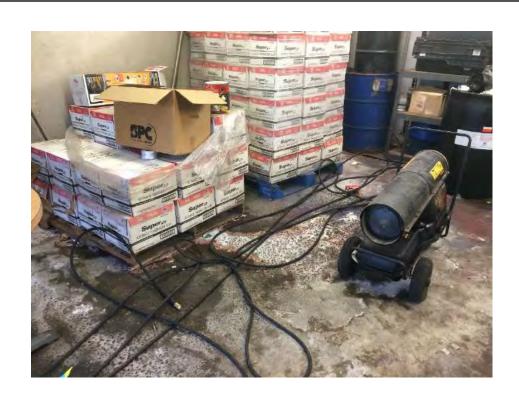
Vehicle wash chemical storage area, heavily stained concrete floor.

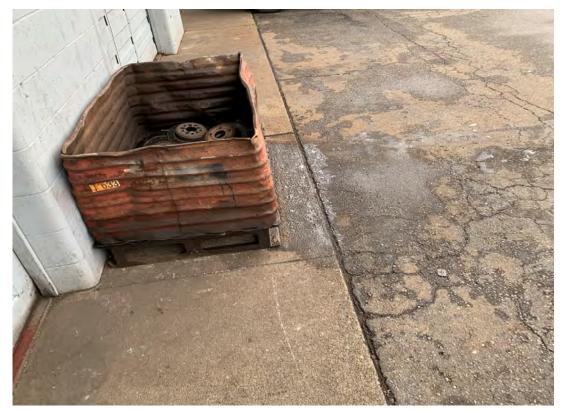
Photograph 9: Scrap metal car parts bin with observed staining, located at the southern extent of the North Shop, facing east.

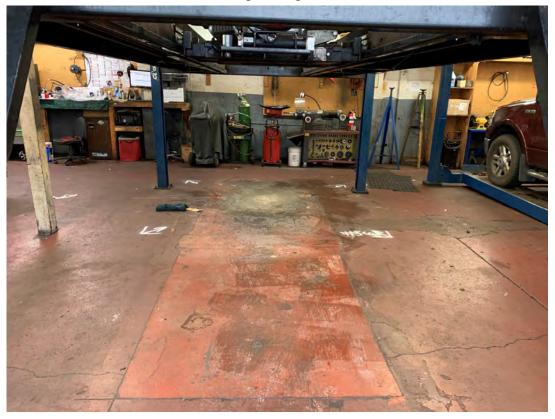
Photograph 10: Patched floor in North Shop with some observed staining in lift area, location of SB-5, facing north.

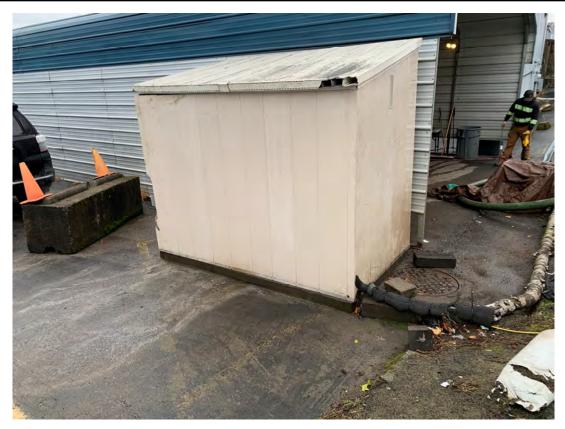
Photograph 11: View of OWS and skimmer shed at southern edge of wash bay, facing northeast.

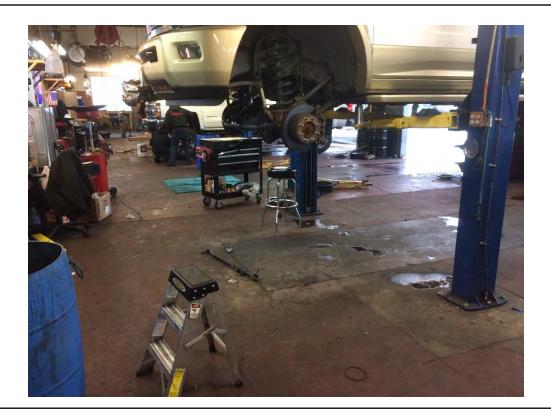
South Shop, includes 8 services bays, currently with above ground hoists, and two ASTs containing engine oil. Services include general vehicle maintenance and repair. Patches on floor represent former in ground hydraulic hoist locations.

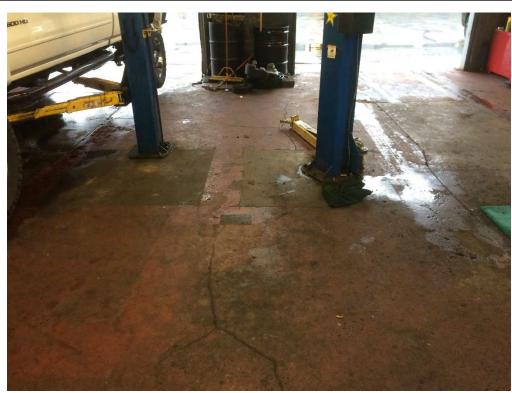
South Shop, in-between bay 5 and bay 6 has patched floors where hoist systems presumably were located in the past. Interview with employee noted this shop historically had in-ground hoist systems for vehicle maintenance.

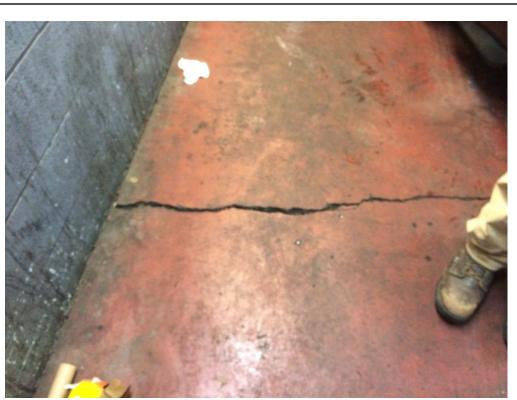
South Shop, near bay 1 which has the widest floor crack noted in shops.
Multiple cracks this size near bay 1.

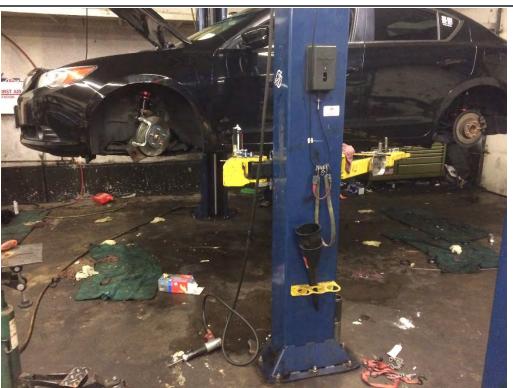
Lower shop furthest south service bay. Noteably stained and cluttered. Unable to discern whether heavily stained or just wet from vehicle recently moved indoors and dripping from rain.

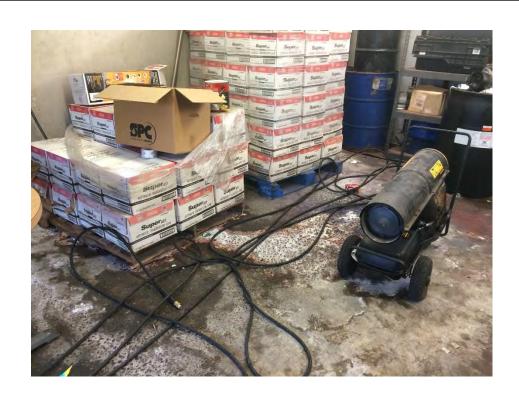
Vehicle wash chemical storage area, heavily stained concrete floor.
