REMEDIAL INVESTIGATION REPORT

Industrial Container Services, WA, LLC [Former NW Cooperage Site]
Seattle, Washington

Public Review Draft: February 2020 (revised June 2024)

Volume 1: Text, Tables and Figures

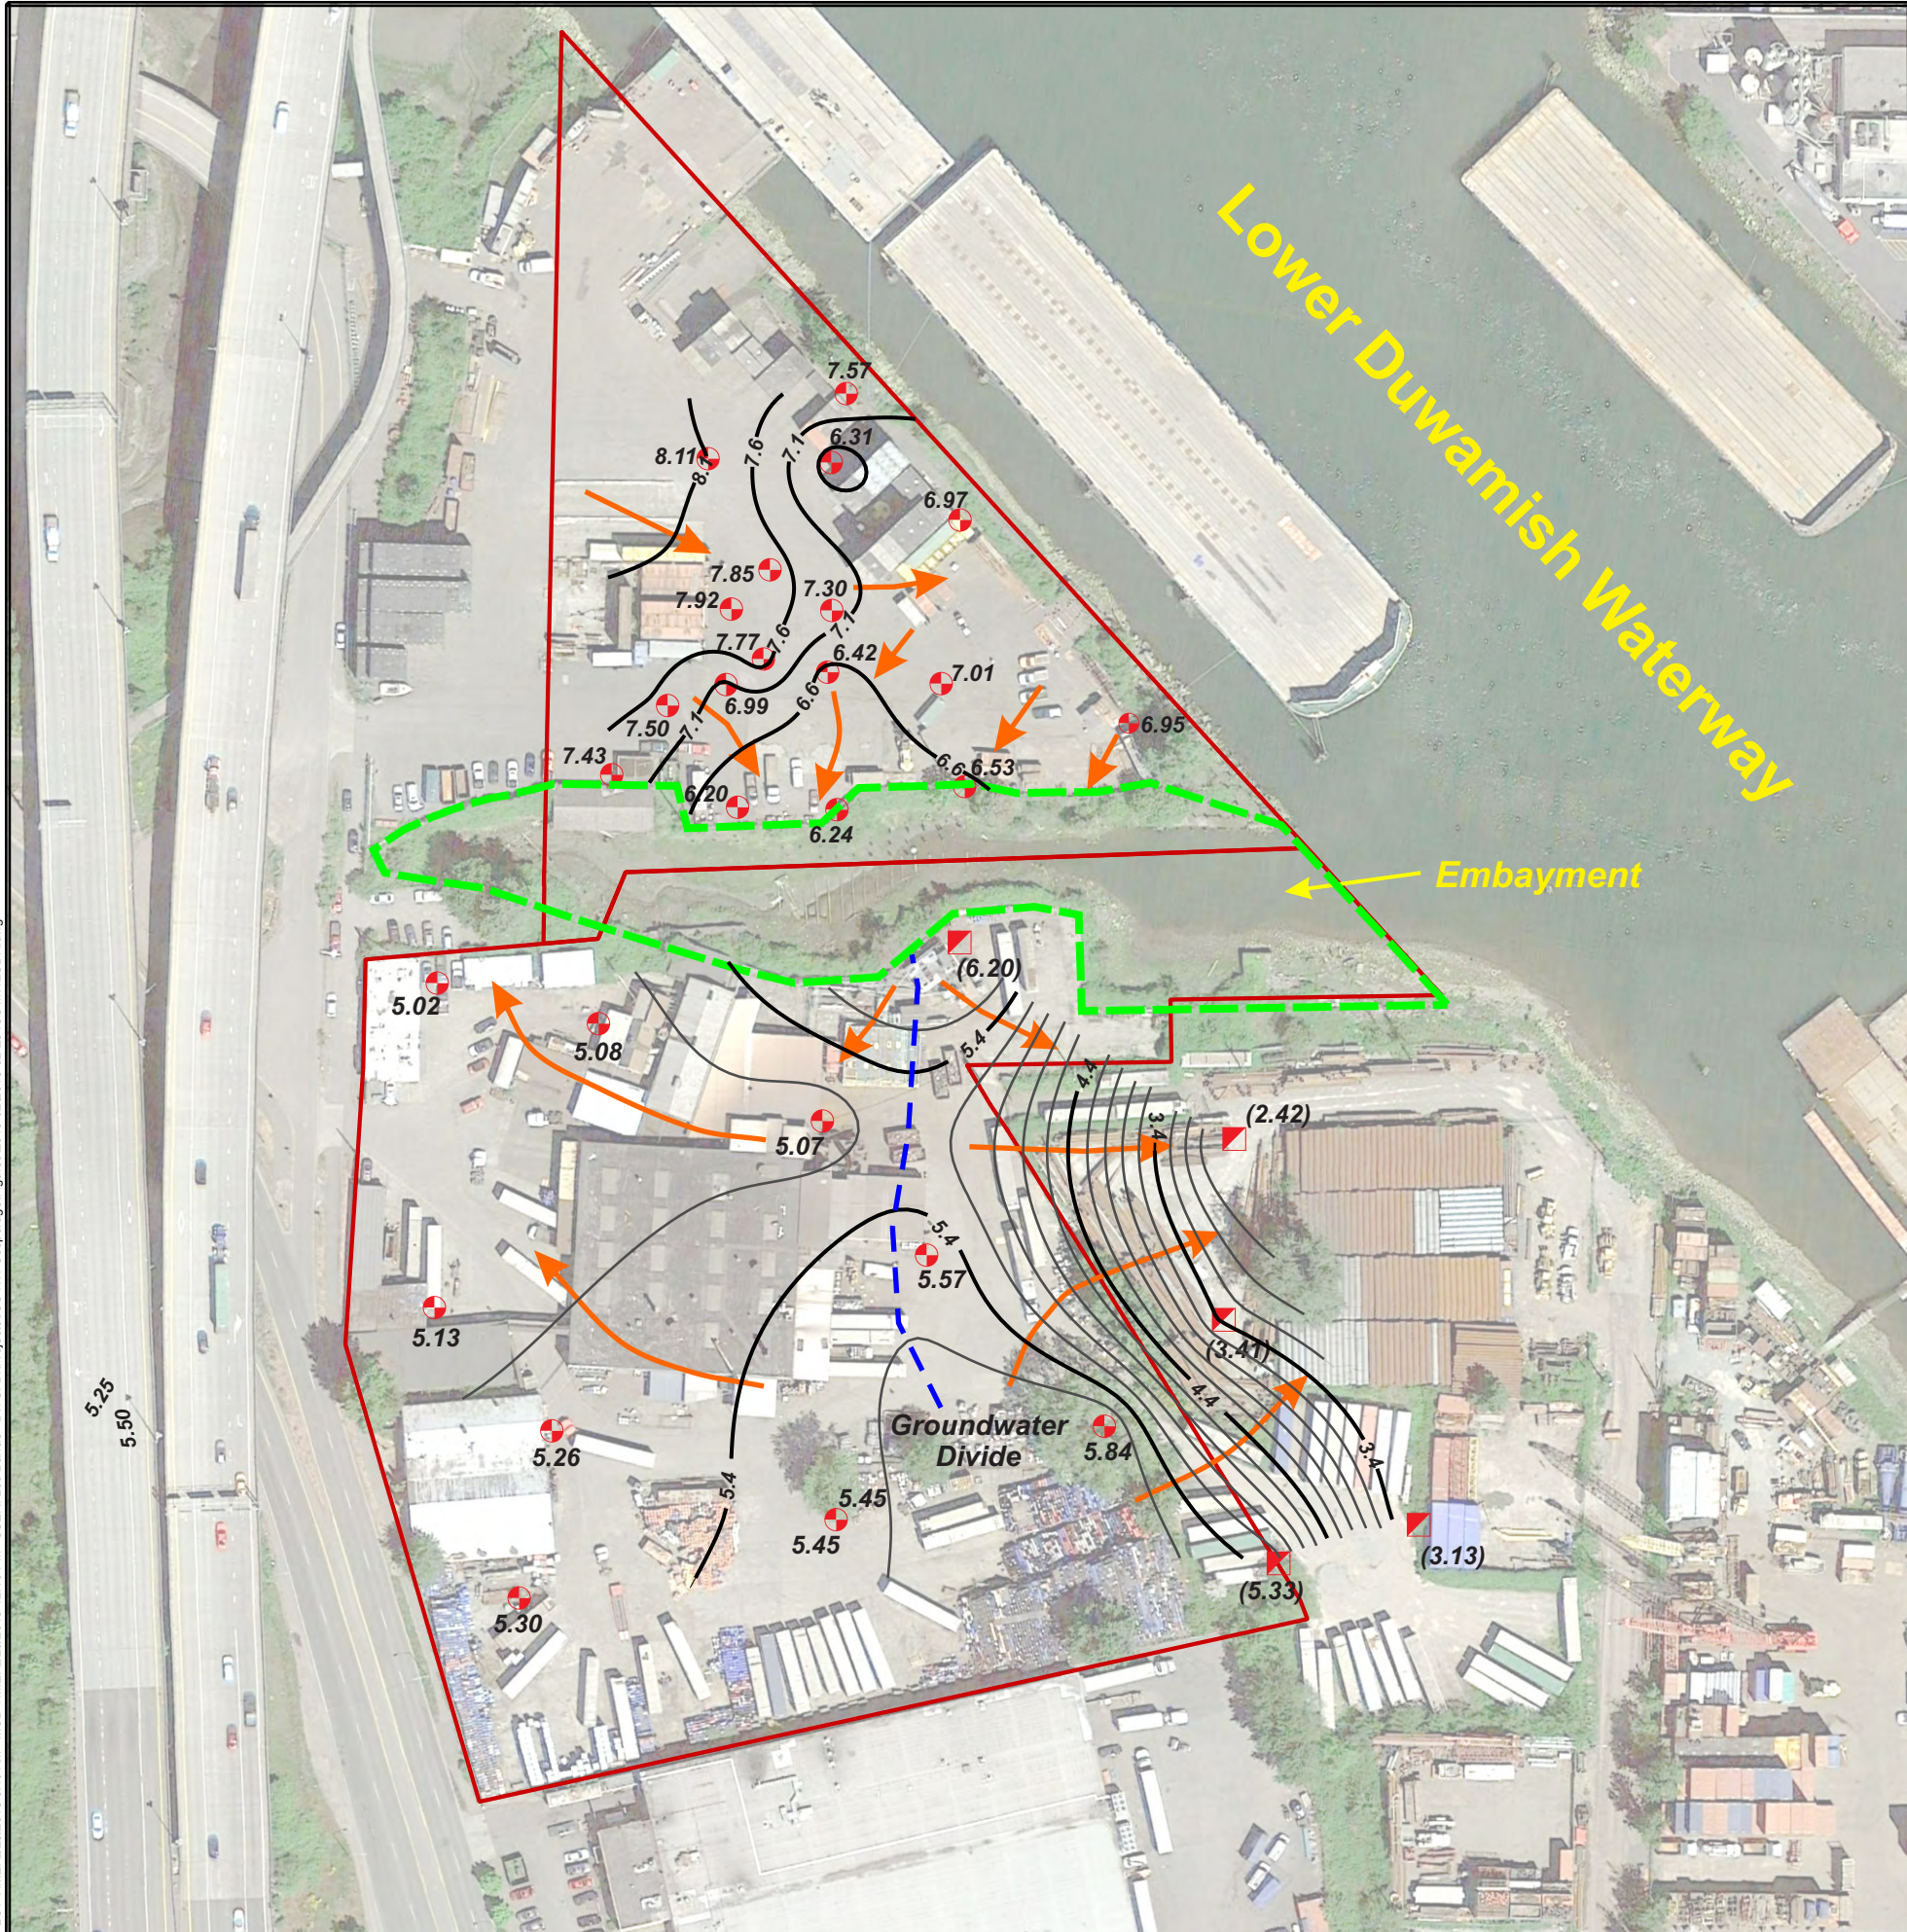
FIGURE
4-19a
March 2018

- Monitoring Well (Upper Zone)
- 7.33** Water Level Elevation (ft. NAVD88)
- Monitoring Location w/ Water Table and Lower Zone Wells
- (7.33)** Interpolated Water Level Elevation (ft. NAVD88)
- ⤵ 8.0 Groundwater Contour (ft. NAVD88)
- ➔ Estimated Low Tide Flow Gradient Direction
- Property Boundary

1) Water level measurements were made on February 6, 2018 during a predicted high tide of +0.1 feet NAVD88 (+2.5 feet MLLW) at 1609 hours between 1541 hours and 1632 hours.

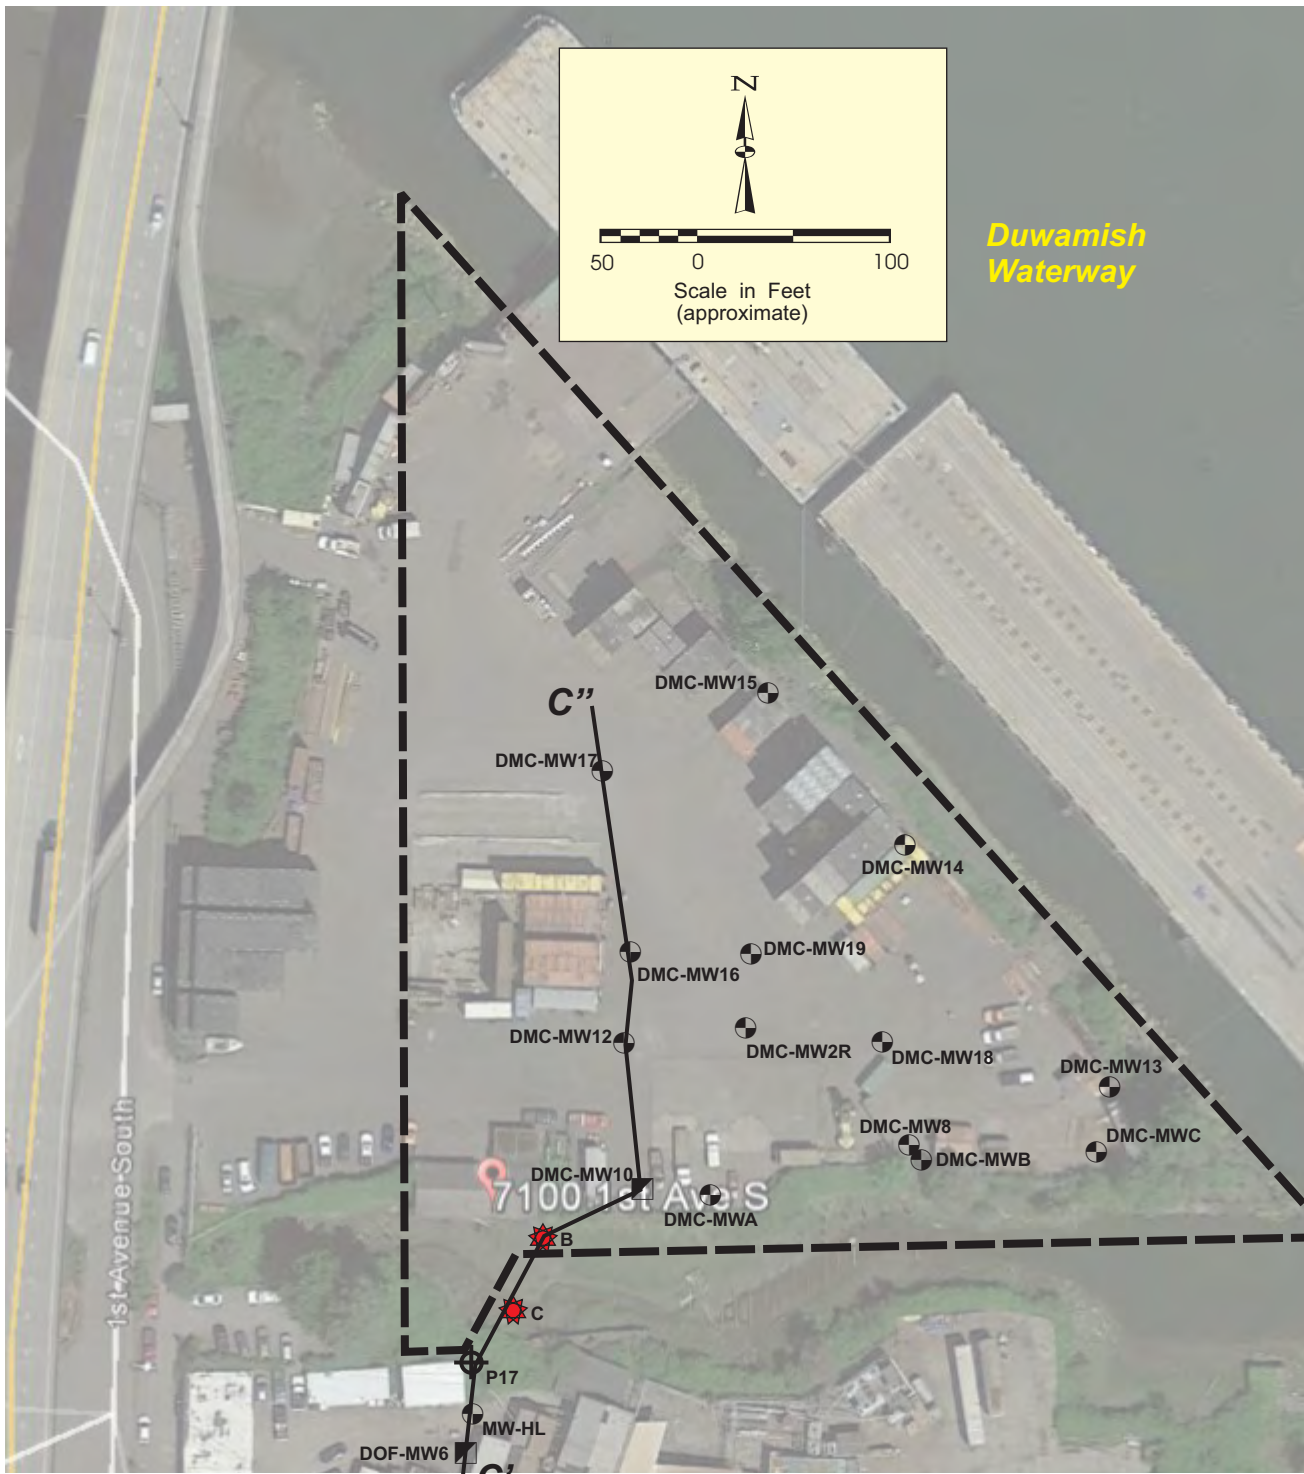
**FIGURE
6-18c**

- DMC-MW11 Deeper Monitoring Well with Soil Samples Below 0' MLLW
- DOF-MW6 Upper Zone Monitoring Well
- B Sediment Core
- P17 Push-Probe
- C' — C'' Section Trend

Douglas soil observations and analytical data were evaluated to estimate the depth (elevation) interval potentially affected by releases from the ICS/NWC property. Field data documented on the geologic logs and analytical data were compiled for wells drilled deep enough (significantly below zero feet MLLW) to provide pertinent information. The well depths and elevations are summarized in attached Table A6.1. Thirteen wells were drilled and sampled to adequate depths for use in this analysis; their locations are shown on Figure 6-18.

Data for the deeper well sample locations are summarized in attached Table A6.2. As highlighted on the table, sheens, elevated organic vapor (PID) measurements, and relatively elevated concentrations of DRO, RRO, PCB, lead and mercury were found in samples collected between approximately (-)4 to (-)11 feet MLLW. These samples appear to likely have been near the bottom of the turning basin and the observations/analytical data are consistent with materials present along the north ICS/NWC shoreline and in embayment sediment. The vertical extent of the subsurface layer where these observations/data were collected is shown on Section C'-C'' (Figure 6-19). The trend of the section is shown on Figure 6-18.
