Technical Memorandum

September 26, 2024

RE: **Cleanup Action Plan**
Interbay Property Redevelopment – Pickleball at the Palms
3435 15th Avenue West, Seattle, WA
Interbay Rising North LLC

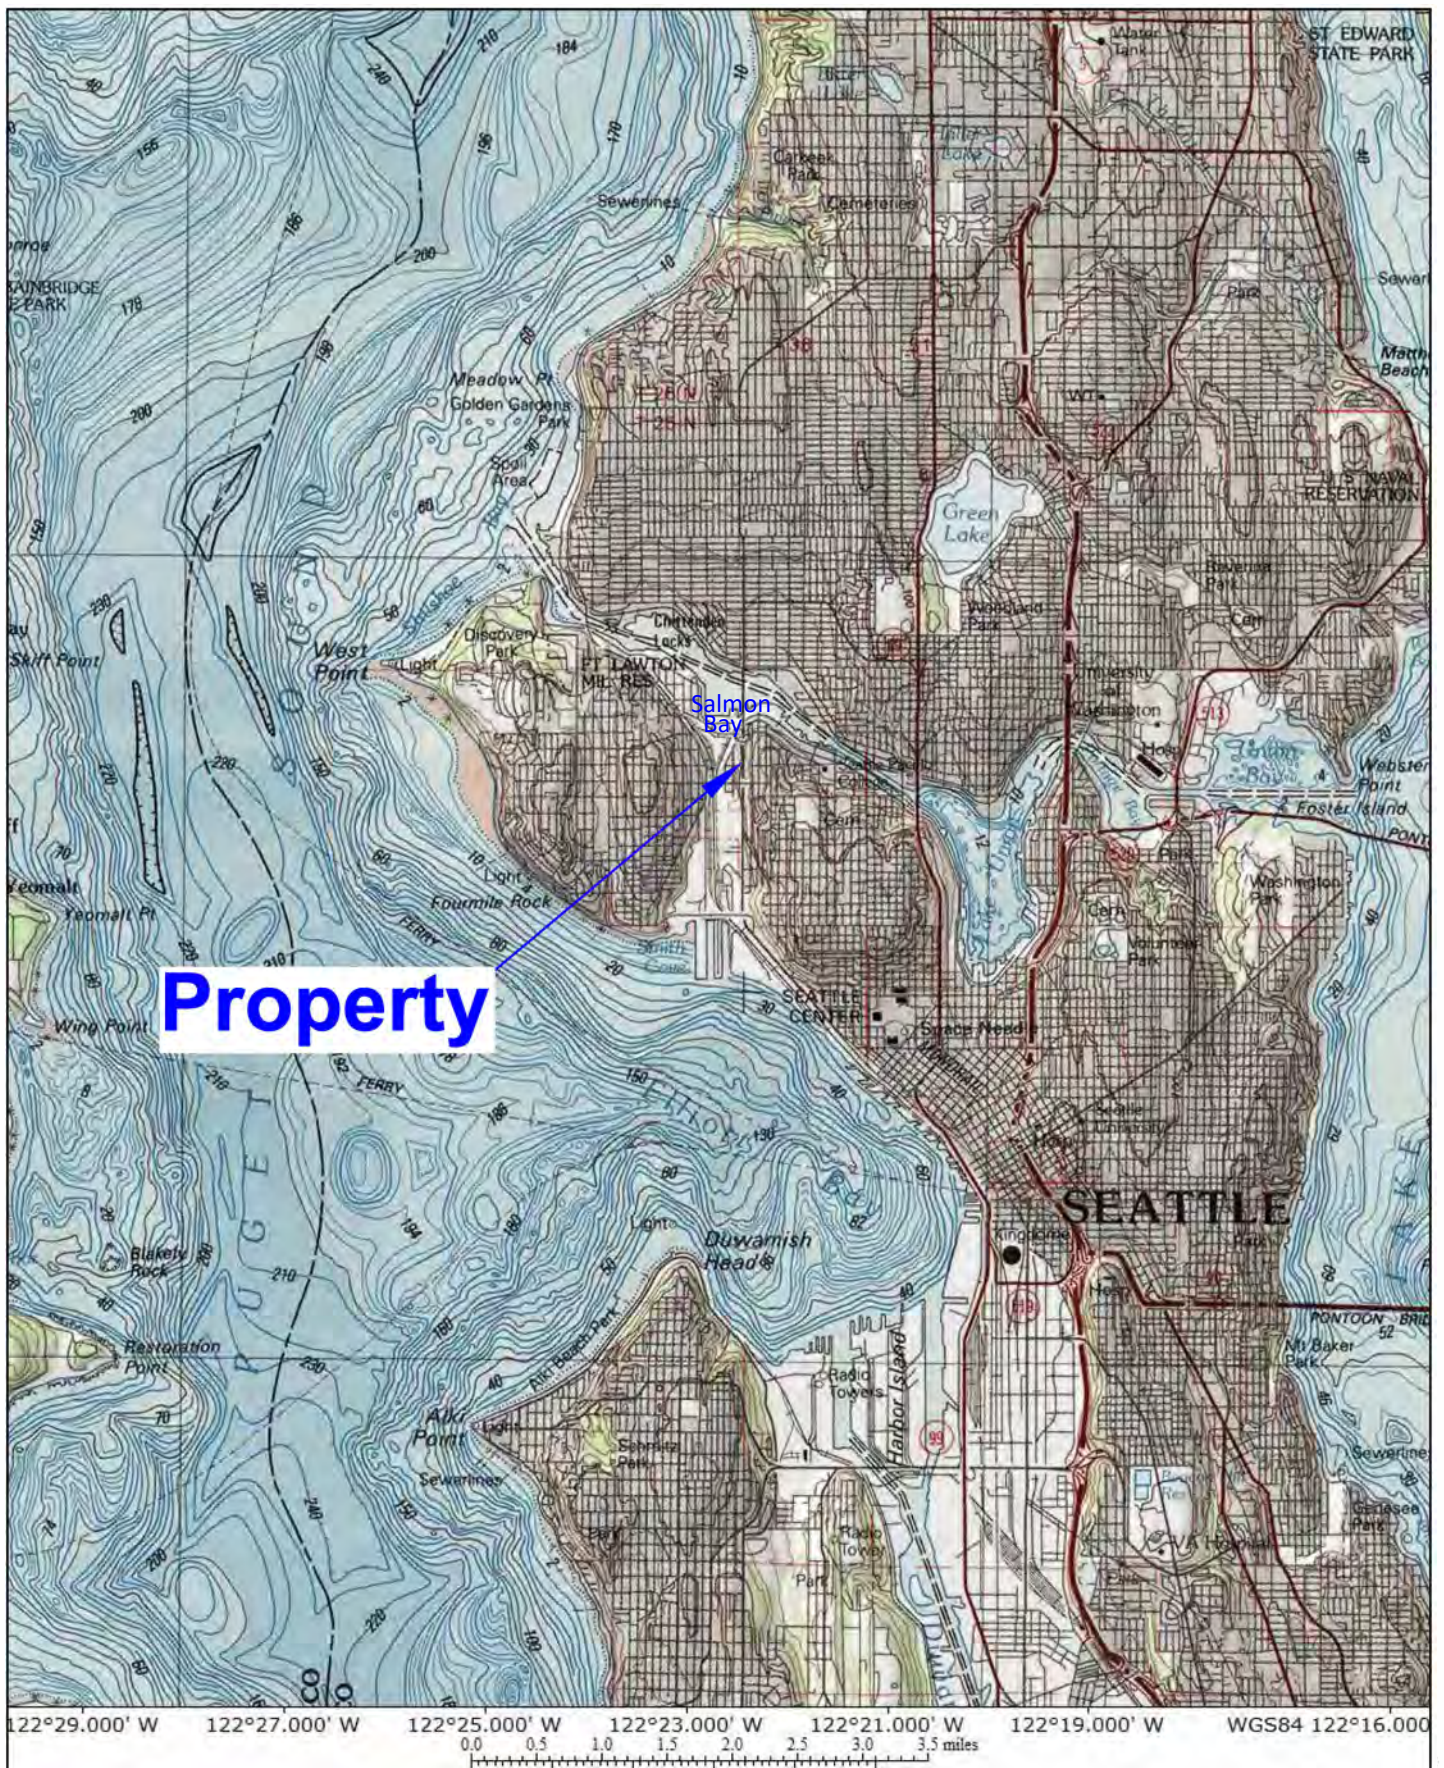
Figure 1
Vicinity Map

From Phase I
Environmental Site Assessment
3435 15th Avenue West
Seattle, Washington

As shown on Figure 1 and Figure 1B, the Property originally existed on the south shore of an intertidal bay (Interbay) between the southern reach of Salmon Bay and Smith Cove. Consequently, the Property contains significant fill soil zones ranging between about 7 and 24 feet in depth. As shown on the 1950 and 1966 Sanborn Maps, and repeated on UEP Figure 2, the historic locations of at least three gasoline service stations with USTS and fueling islands are shown on the north, central and south areas of Property in the time frames between the 1930s through the 1970s. These gas station and car wash operations have resulted in isolated areas of petroleum impacted soil and impacted deep groundwater on the Property. The Property location and previous layout with past structures and businesses circa 2014 are shown on UEP Figure 2. The locations of the past removal of three USTS in the Property North end are shown on Shannon and Wilson Figure 2 (S&W, 1994) and on Geotech Consultants Plate 2 Figure (Geotech, 1990).

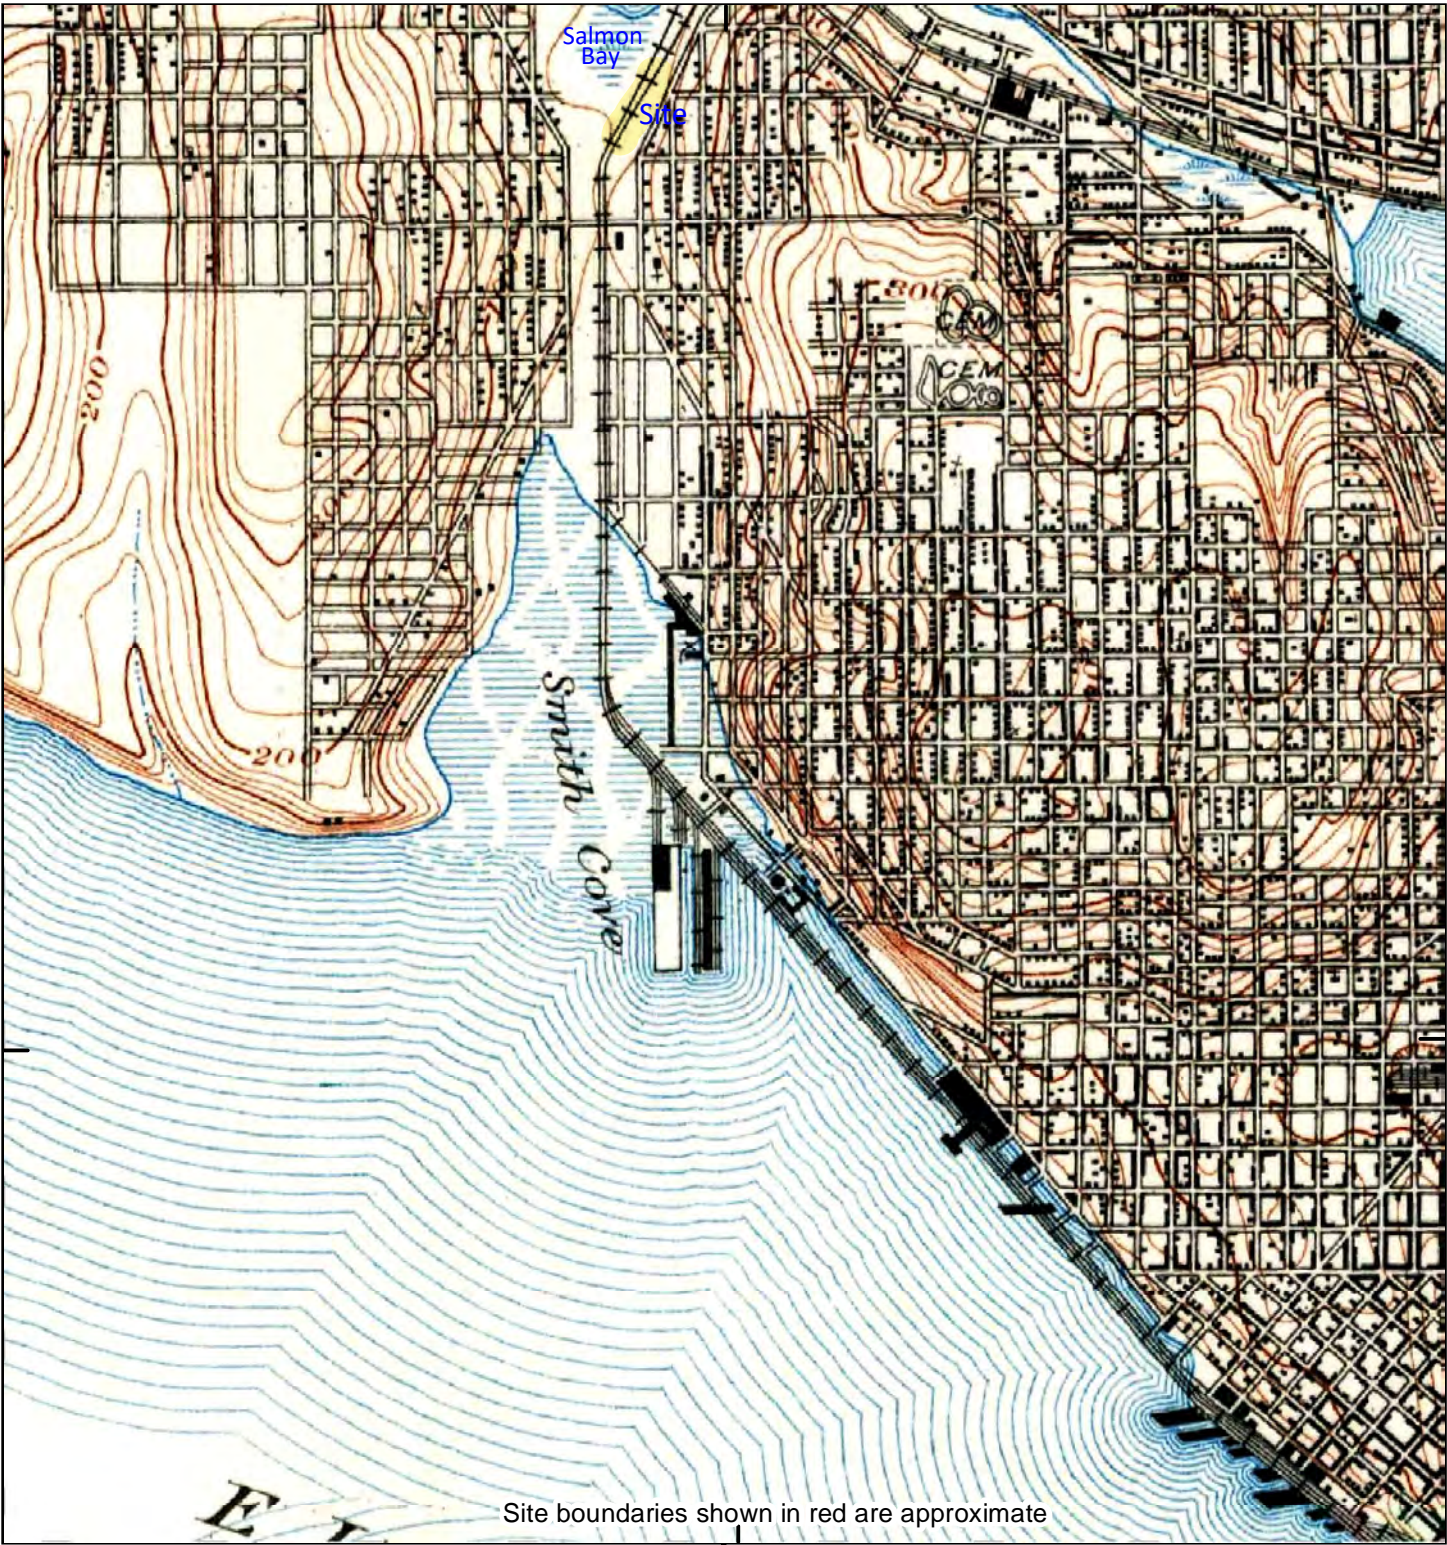
Figure 1B - Site in 1908

1908		<div><div>0</div><div>Distance in Miles</div><div>1</div></div> <div>1: 24,000 (1"=2,000') NAD 1983 UTM Zone 10N</div>		Site information: 1502 15th Ave W Seattle, WA 98119

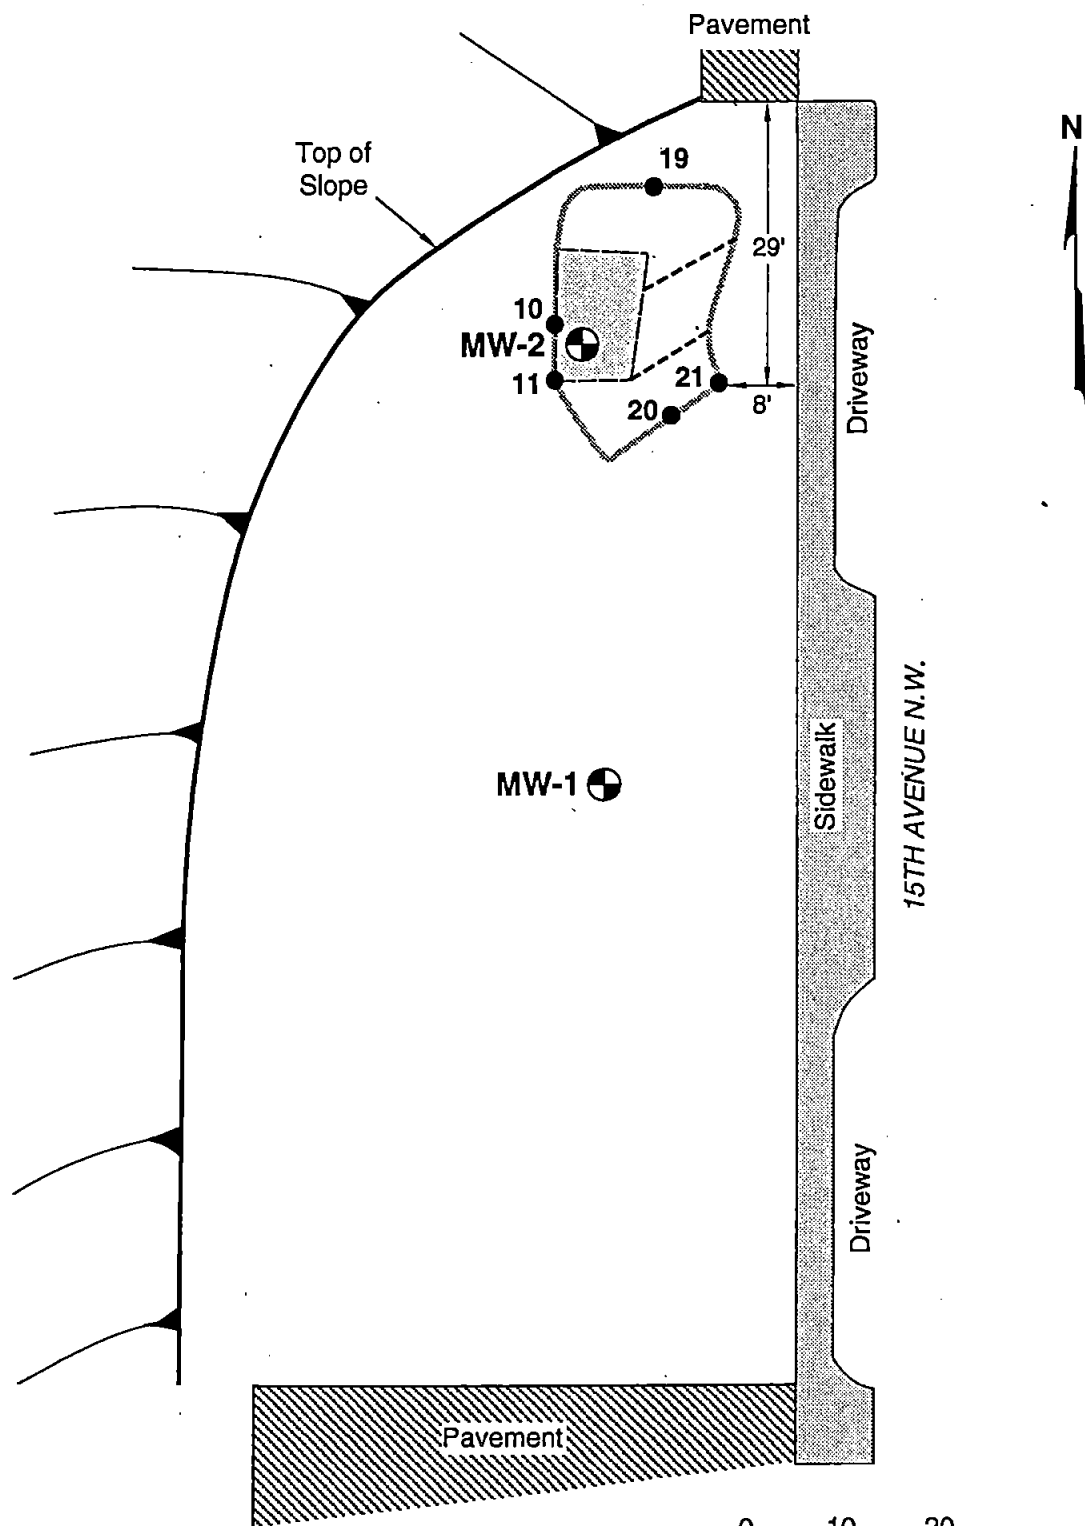
FIG. 2

MW-1 Monitoring Well Designation and Approximate Location

- In 1994, Shannon and Wilson initiated groundwater quality sampling with the installation of monitoring wells MW-1 and MW-2, both located on the north end of the property as shown on UEP Figure 4. Lab results were non-detect (ND) for both wells, providing an upgradient extent to the gasoline impacted groundwater zone (defined by wells GLB-2 and MW-3A/B).

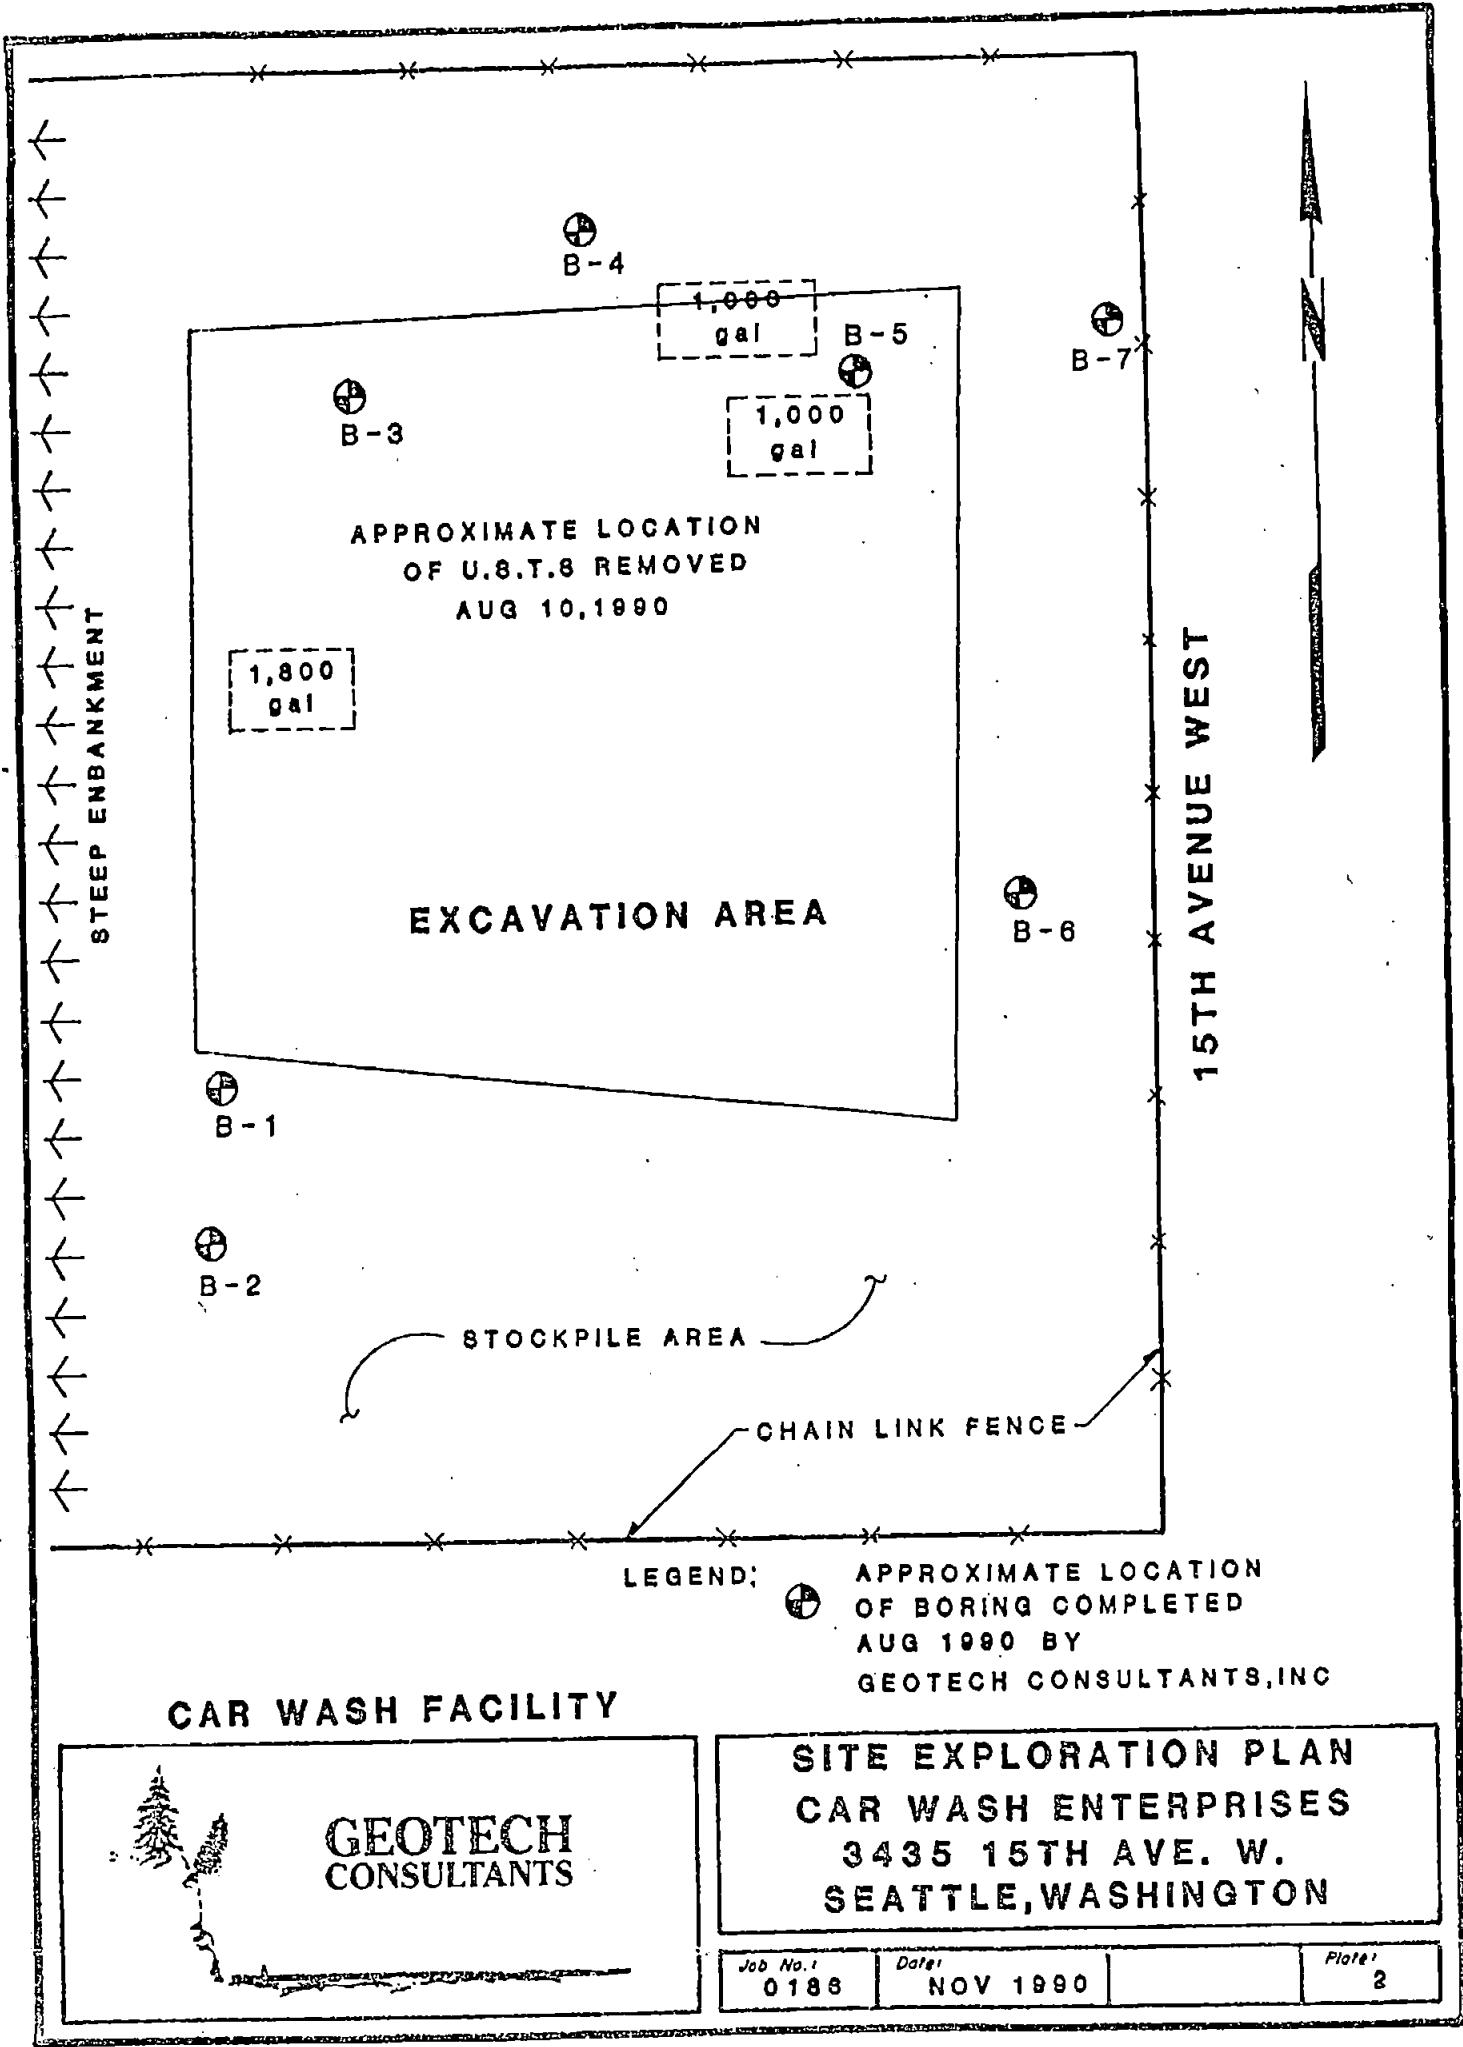
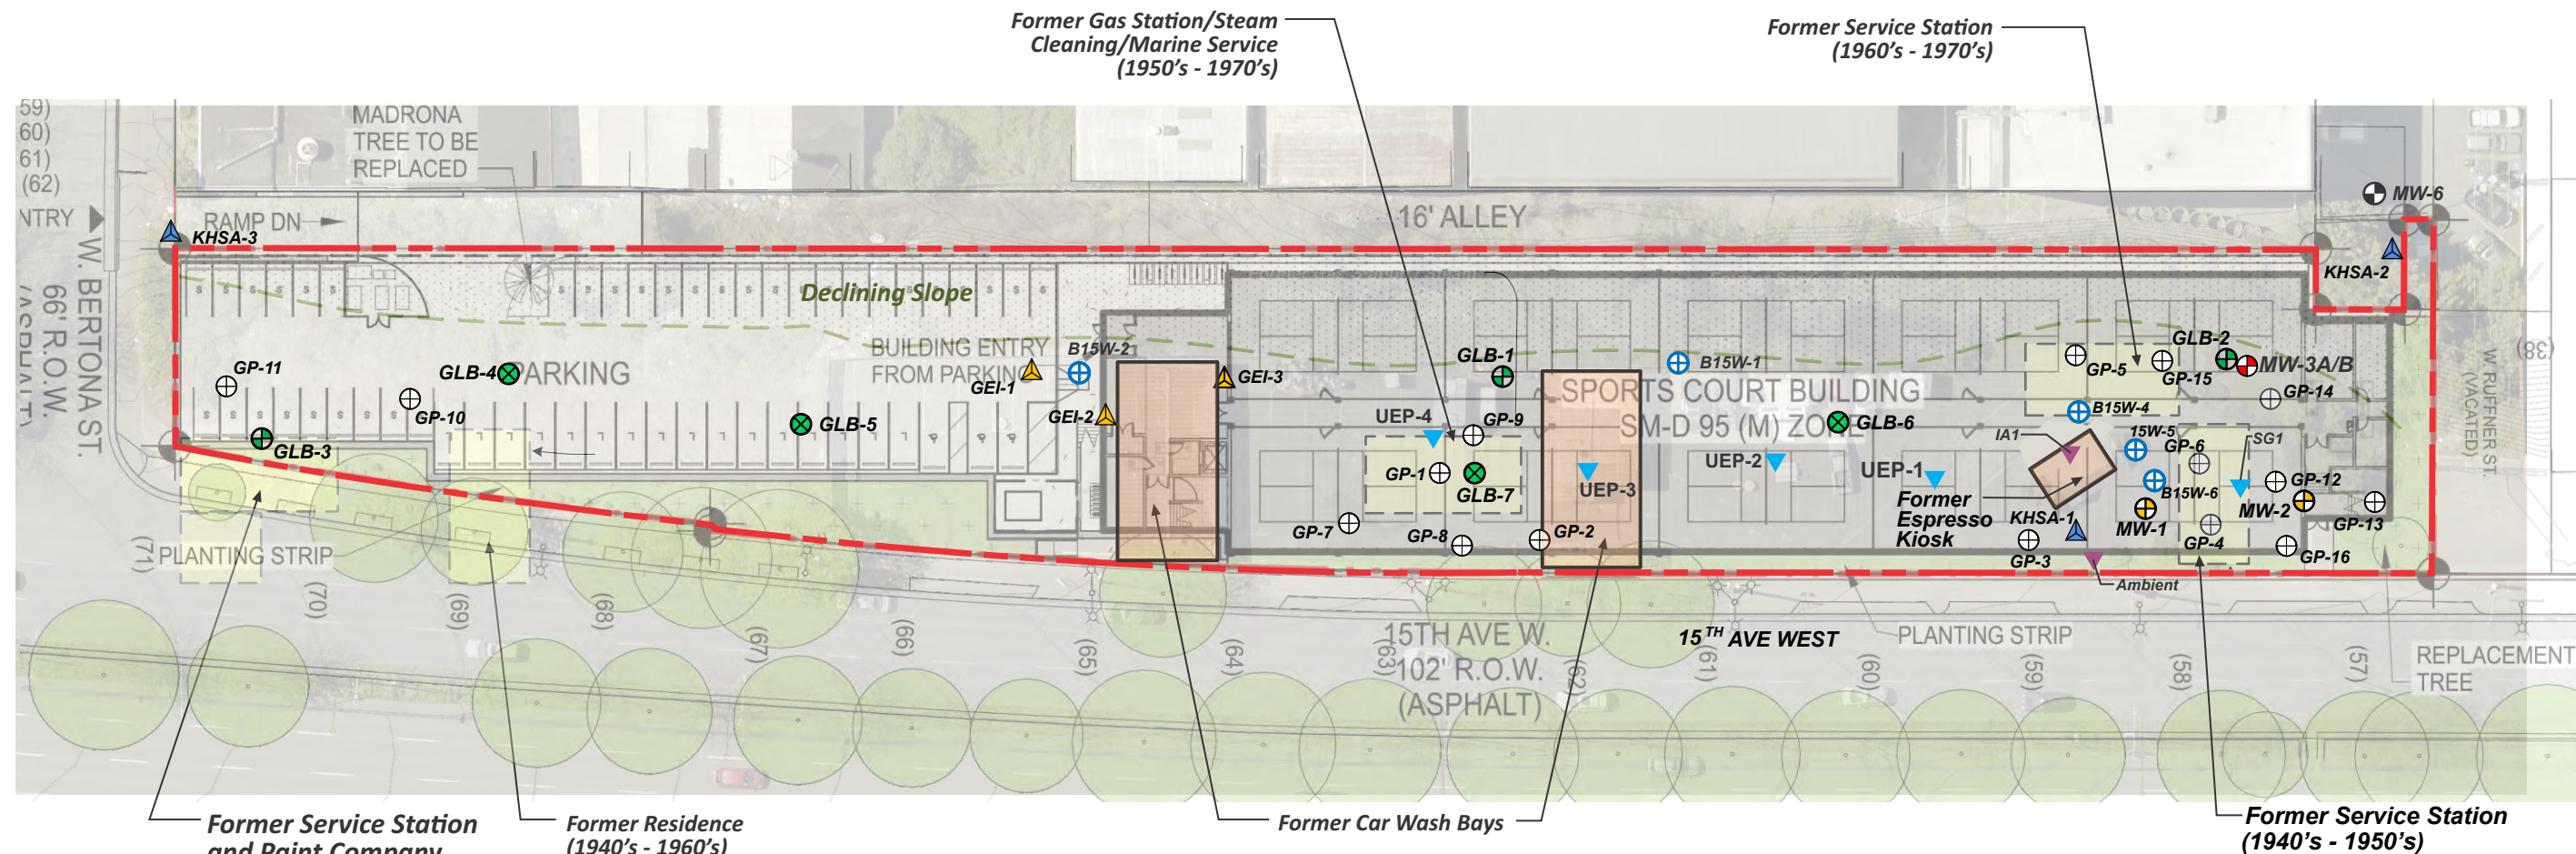
- MW-1 Monitoring Well (Shannon & Wilson, 1994)
- B15W-2 Geoprobe Boring (Environmental Partners, 2003)
- GP-10 Geoprobe Boring (Adapt Engineering, 2007)
- MW-3A/B Monitoring Well (GeoEngineers, 2011)
- MW-6 Monitoring Well (Adapt, 2011)
- Former Building
- Existing Structure

Figure 2 and also on G-Logics Figure 7 (UEP Figure 3) from the attached G-Logics RI report.

- As presented in the G-Logics RI, the groundwater occurrence is first encountered approximately 20-feet below ground surface (bgs). Several rounds of well installation and sampling data is assembled on UEP Figure 2 and G-Logics Figure 7(UEP Figure 3) and in UEP Table 1, and discussed below to provide an understanding of groundwater quality conditions.

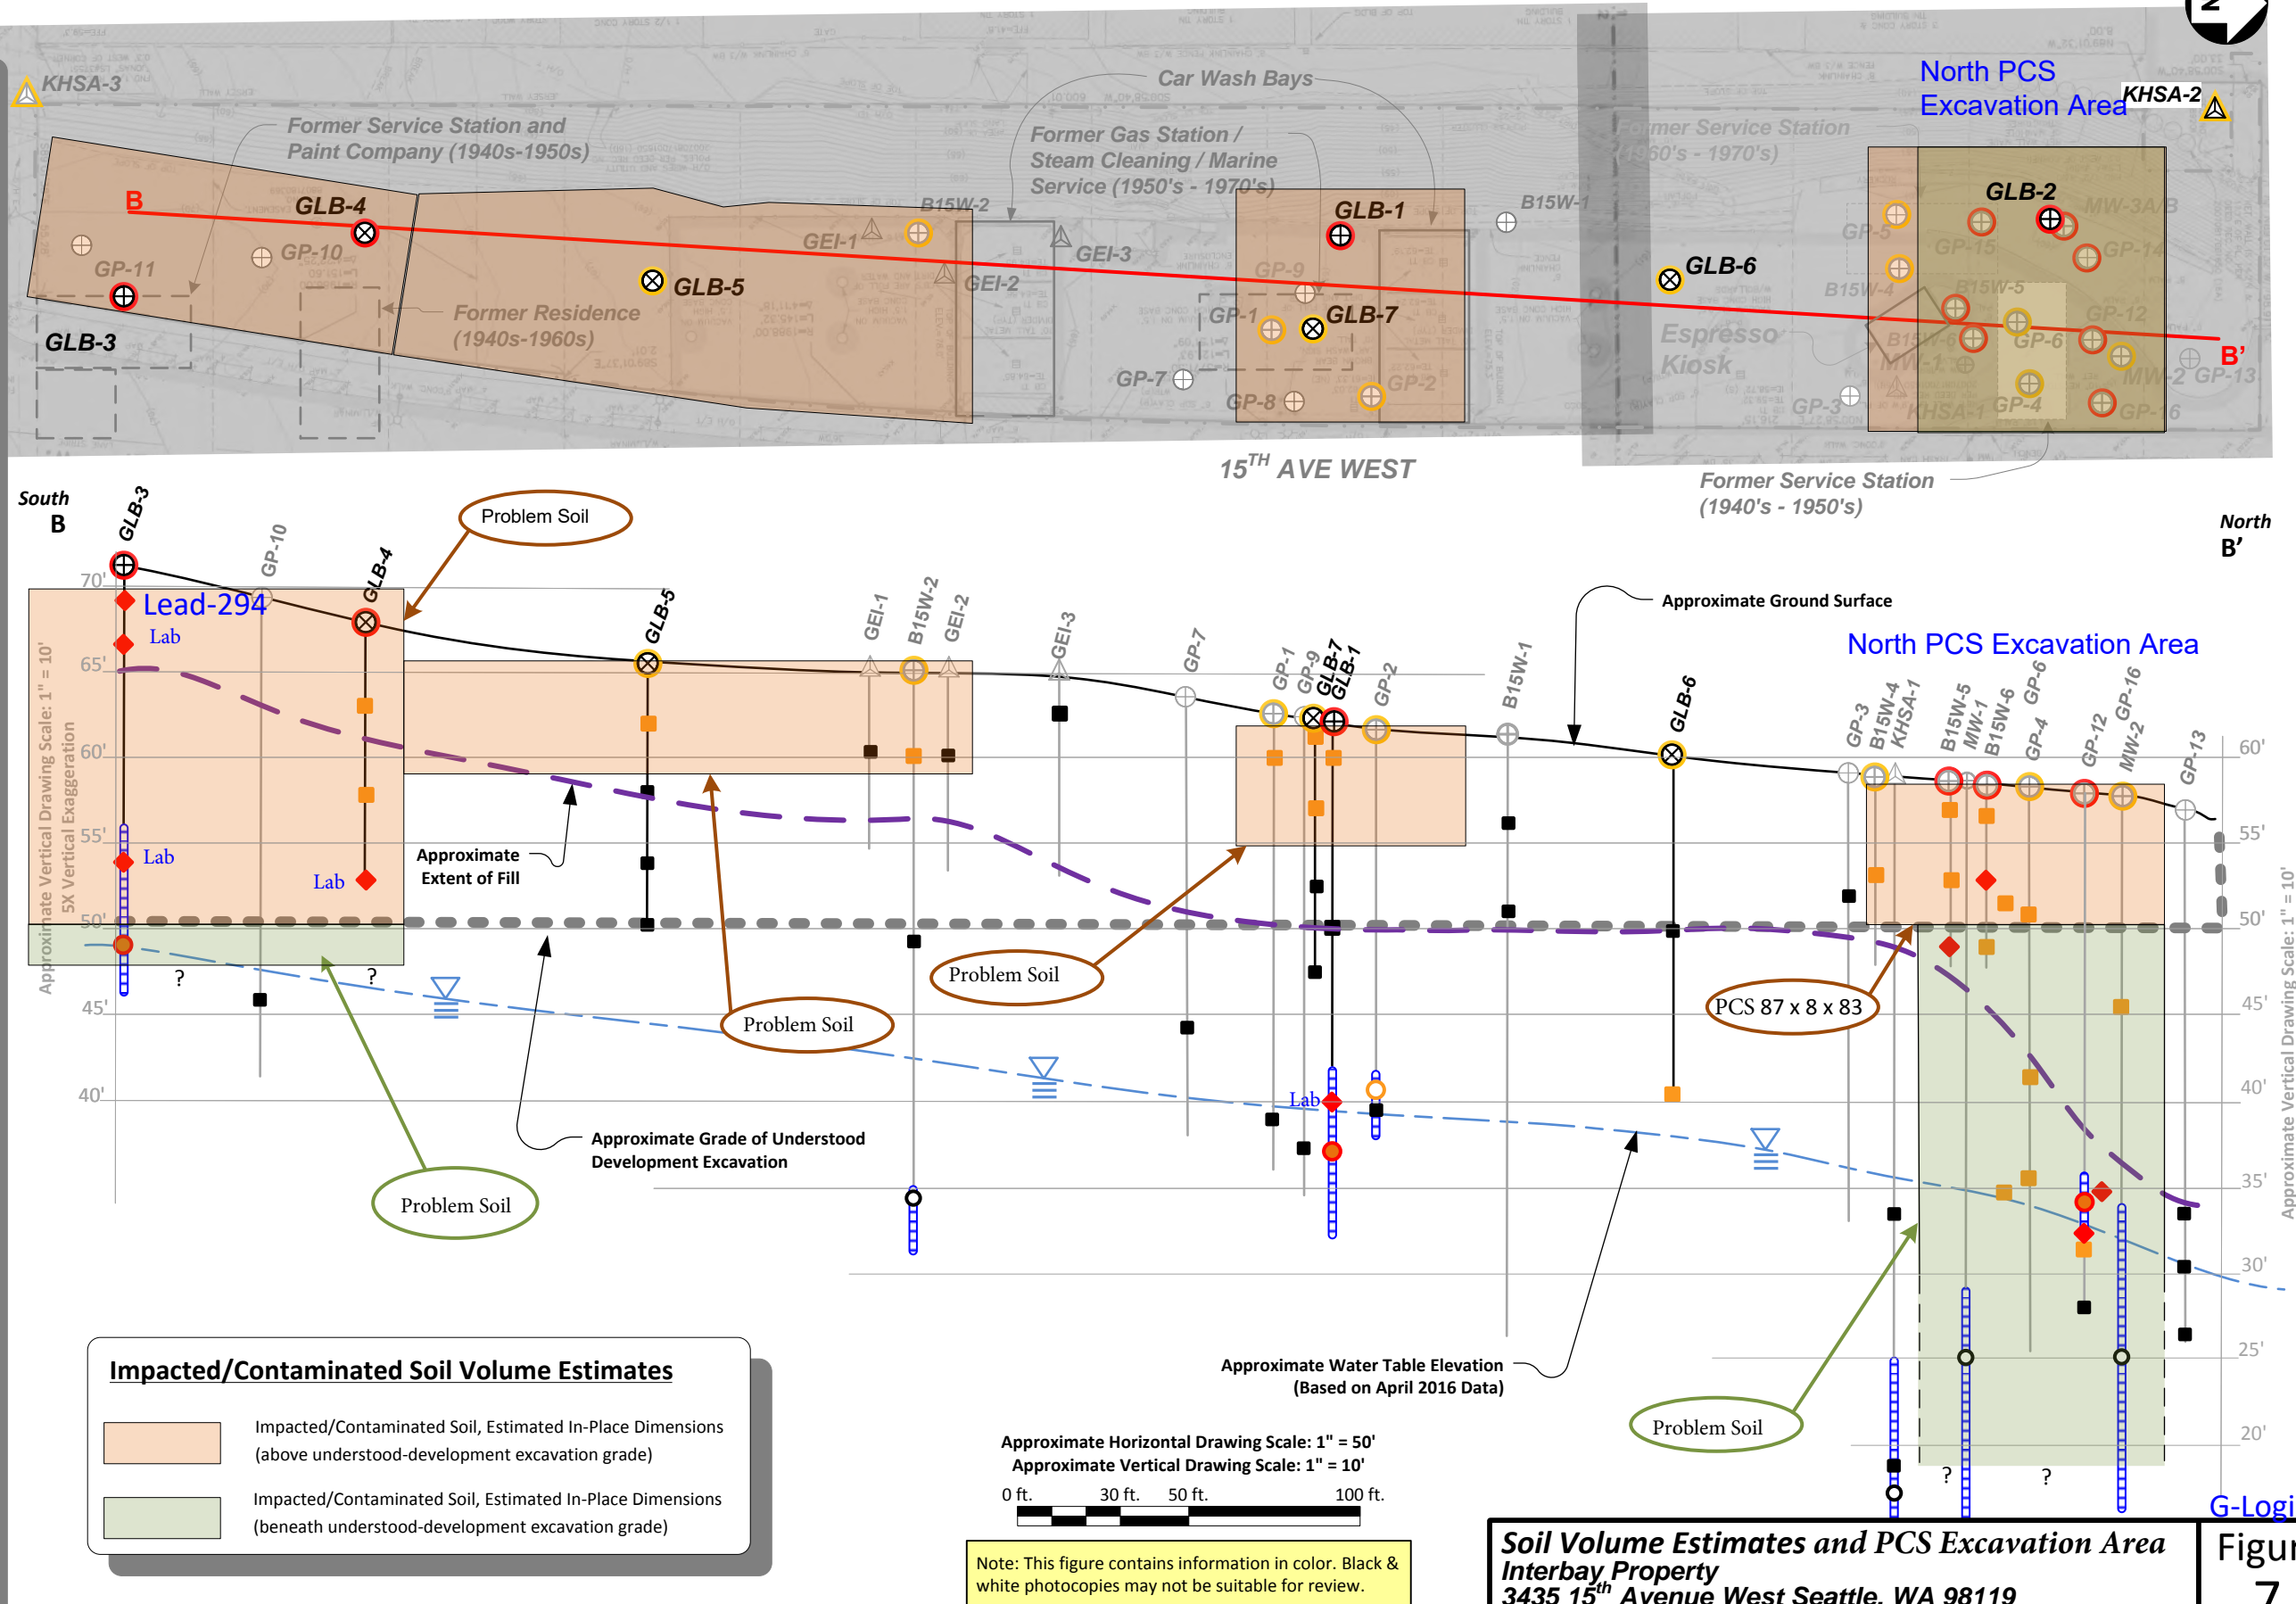
- GLB-3**
⊕ Monitoring Well (G-Logics, 2016)
- GLB-4**
⊗ Geoprobe Boring (G-Logics, 2016)
- MW-1**
⊕ Monitoring Well (SWI, 1994)
- B15W-2**
⊕ Geoprobe Boring (EPI, 2003)
- GP-10**
⊕ Geoprobe Boring (Adapt, 2007)
- MW**
⊕ Monitoring Well (GEI, 2011)
- GEI-1**
△ Hollow-stem Auger Boring (GEI, 2011)
- KHSA-1**
△ Hollow-stem Auger Boring (Kane, 2014)
- ⊗ **Contaminated, > MTCA**
- ⊕ **Impacted, < MTCA**
- Soil Sample, contaminants not detected
- Soil Sample, contaminant concentrations less than MTCA cleanup levels
- Soil Sample, contaminant concentrations above MTCA cleanup levels
- "Lab" - Data is Lab Artifact for Methylene Chloride Groundwater Sample, no contaminants detected
- Groundwater Sample, contaminant concentrations less than MTCA cleanup levels
- Groundwater Sample, contaminant concentrations above MTCA cleanup levels
- Well Screen Interval

Shallow and deep soil environmental quality conditions are best summarized in the G-Logics RI Report Figure 7 (UEP Figure 3) which provides a plan and cross-section profile view of the location of soil borings and soil data results. As shown on the figure, soil with petroleum impacts above and below Ecology's MTCA Method A cleanup levels (CULs) are present on the north, central and southern ends of the property and shaded with a beige color. Please note that several soil results (4) on the Figure are indicated in red diamonds (♦) with a blue annotation (Lab). These soil samples were above the CUL for methylene chloride, which is a typical lab contaminant. Consequently, these data for these samples can be discarded and ignored. The beige shaded areas on the figure show petroleum detections and match the historic locations of the three auto service and gas dispensing stations on the property. Please also note that only on the north end of the Property (the North PCS Excavation Area), there is an isolated area with two samples (B-15W-6:6 at 6 feet bgs, and B15W-5:10 at 10 feet bgs with isolated small areas of petroleum contaminated soil (PCS) above MTCA CULs both in the shallow zones of the property, planned for mass excavation during development.

Given the site history with several gas stations, the confirmed TPH-impacted soil areas, and planned excavation depths for development, deep soil gas samples UEP-1 through UEP-4 were collected from the central and north end of the property (Figure 2) to match the elevation just below the planned occupied areas of the future play court facility. Figure 2 also depicts an overlay showing a plan view of the planned development, which includes an enclosed Sports Court Building on the north half and unenclosed, surface Parking on the south half of the property. Deep soil gas samples all located on the north half of the Property ranged from 10- to 15-feet bgs, which matches the range of depths for TPH-impacted soil (UEP Figure 3 - G-Logics Figure 7).
