Re: DTG Yakima – Agreed Order No. DE 21624 – Monthly Progress Letter – October

### **Re: Monthly Data Assessment Report DTG Yakima Landfill Fire Incident – October 2024**

# DTG LPL LANDFILL FIRE INVESTIGATIONS AND MITIGATION

Monthly Monitoring Data Review

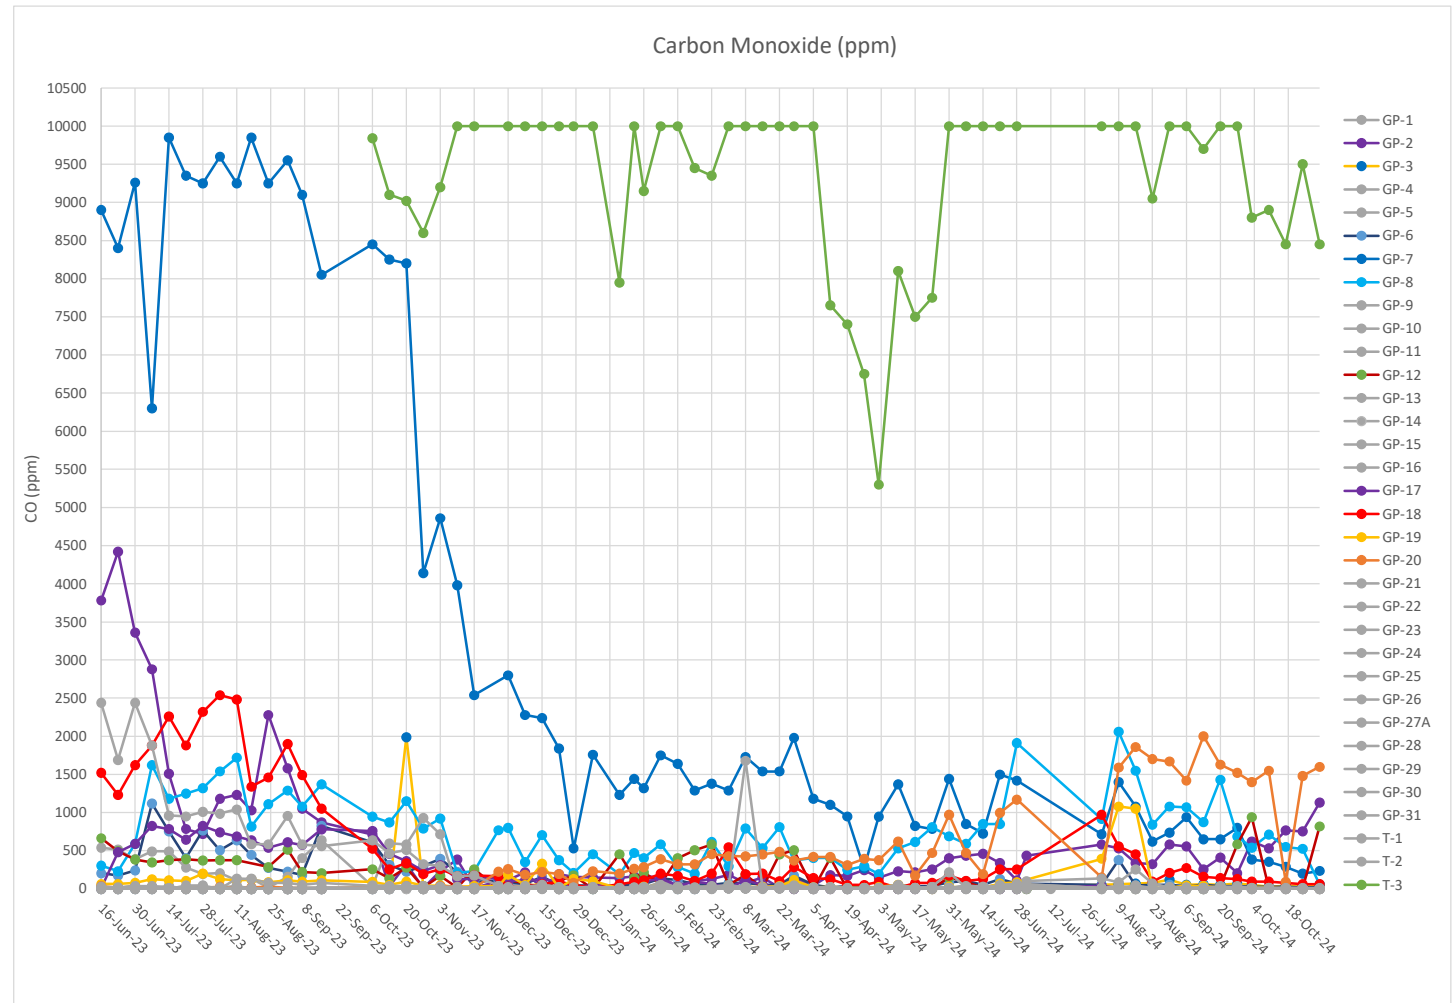
# Carbon Monoxide

October continued to show high CO concentrations at T-3, but levels were readable (below 10,000ppm) for the entire month.

GP-20 remains somewhat elevated at 1,500 ppm

All other wells that have been measured above 1500ppm have now dropped below 1,000 ppm.

As mentioned previously, additional instrumentation around the southern smolder zone is recommended.

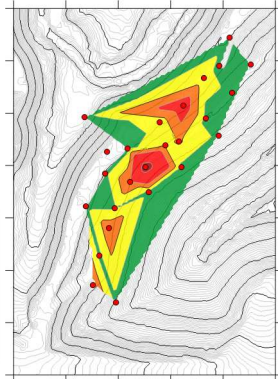
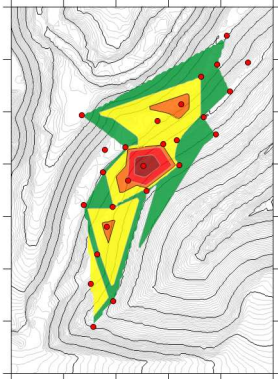
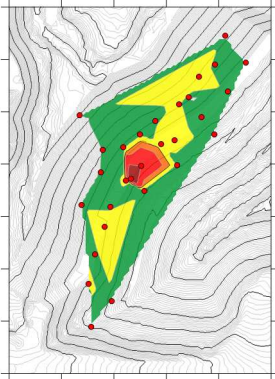
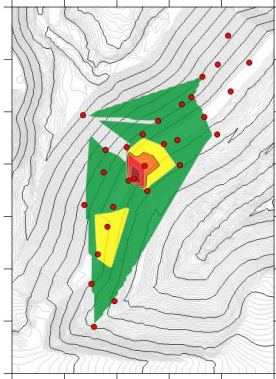
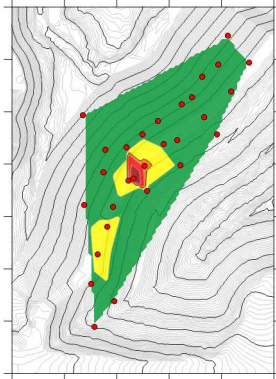
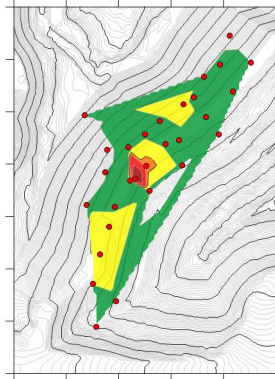
DTG RECYCLE LANDFILL FIRE		
<b>MONTHLY MONITORING SUMMARY</b>		
<b>SPATIAL MAPS - CO</b>		
DRAWING NO.	REV	SHEET
LFCI-2023-001-10-CO	1	1

- Data taken from first monitoring event of each month unless noted otherwise
- Data was linearly interpolated between data points
- Datapoints (probe locations) represented in red
- CO levels are measured in ppm
- Ground contours are of existing ground at beginning of project, with design contours added for after addition of fill

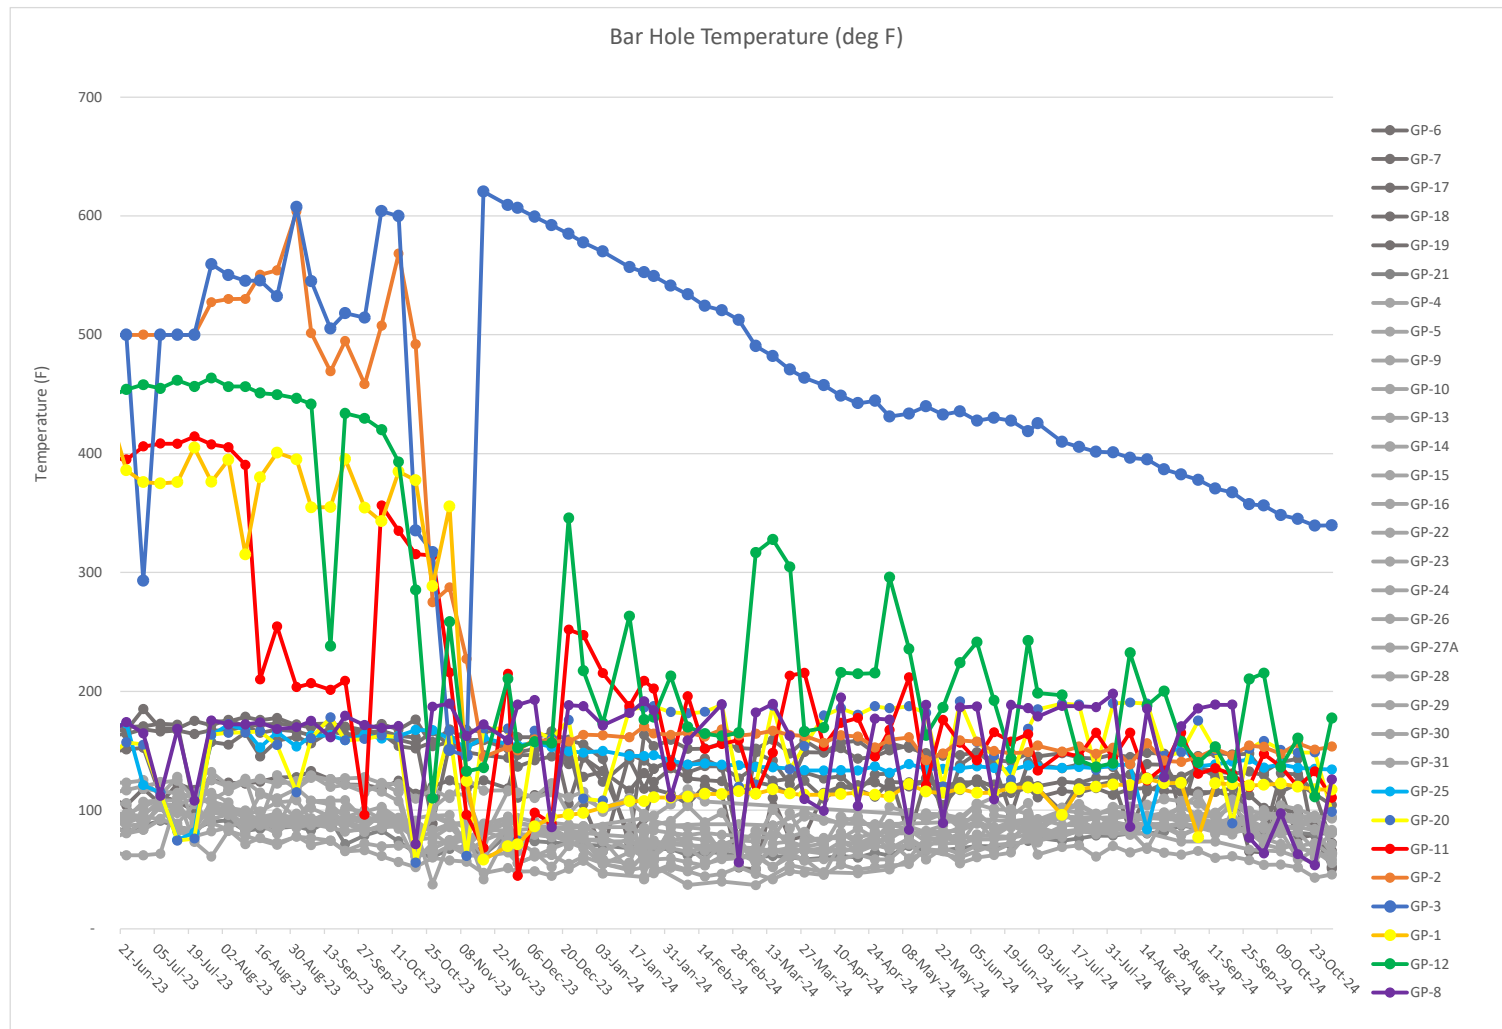
## Temperature (F)

Temperature has continued to decrease in GP-3, down 15F through October to 340F. The linear cooling trend continues.

This matches with higher temperatures in T-1 at 30' below ground, currently around 285F.

All other wells have remained low, with some variability possibly caused by atmospheric pressure swings.

GP-12 (green) seems to be especially susceptible to atmospheric pressure.

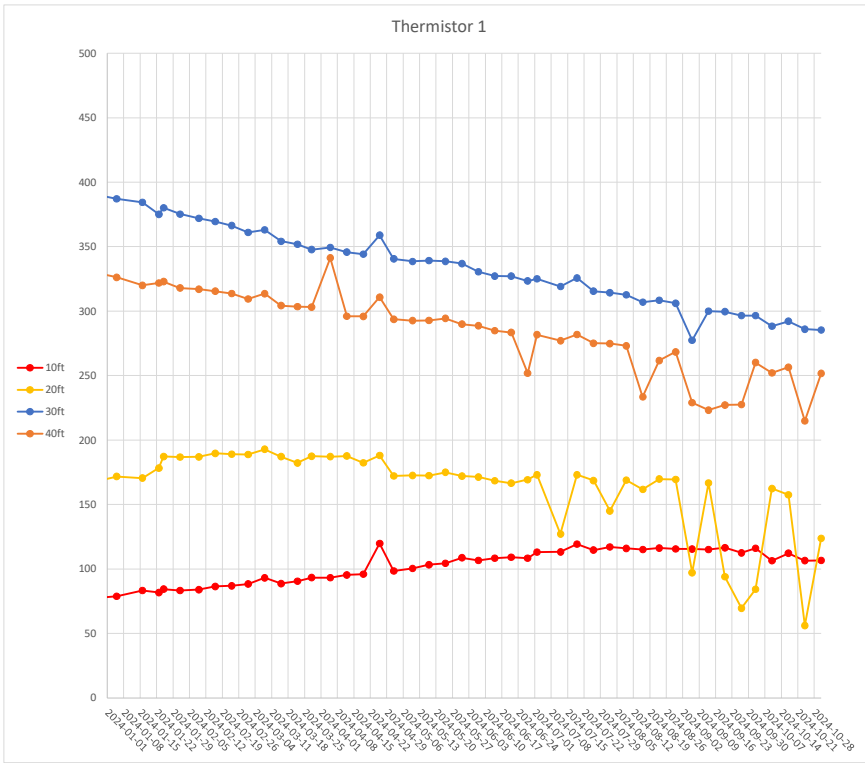
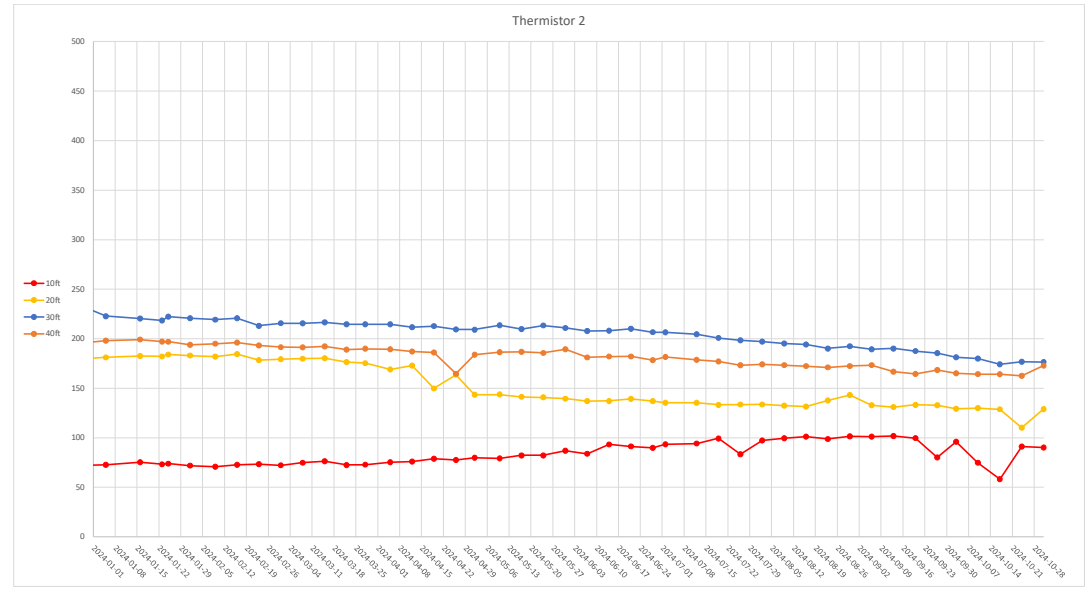
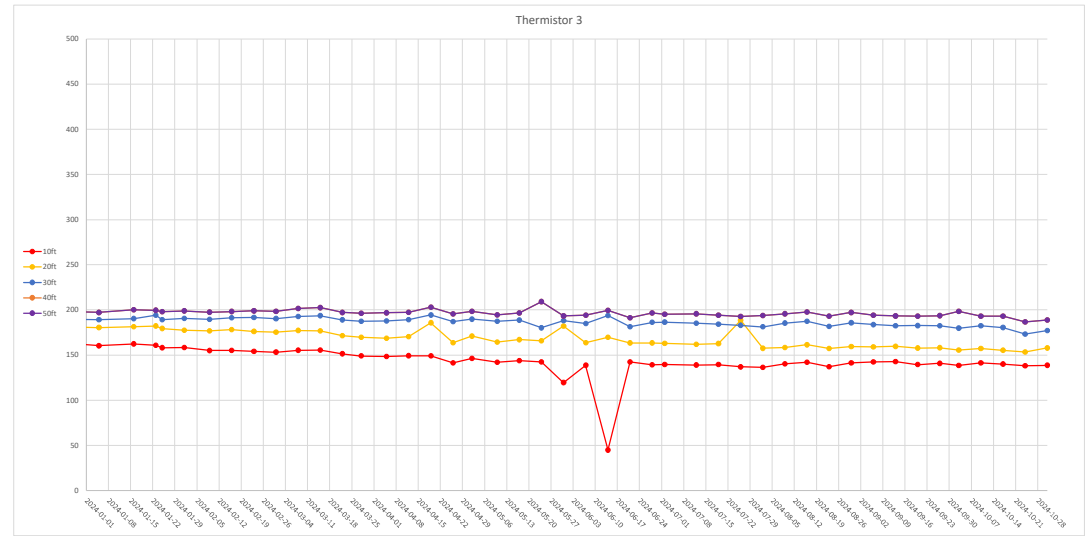
# Thermistor Temperatures

Thermistor temperatures mostly stable, with downward trend in T-1 and general levelling trend in T-2 and T-3 continuing. Monitoring of T-1 recommended to ensure no major changes. Noted that the deeper measurement of 20ft below surface is cooler than measurements at 10ft depth.

Rate of thermal decrease is very slow, 50 degrees every 4 months. We project about 2 years will be needed to get to desired baseline levels around 122F without additional cooling effort.

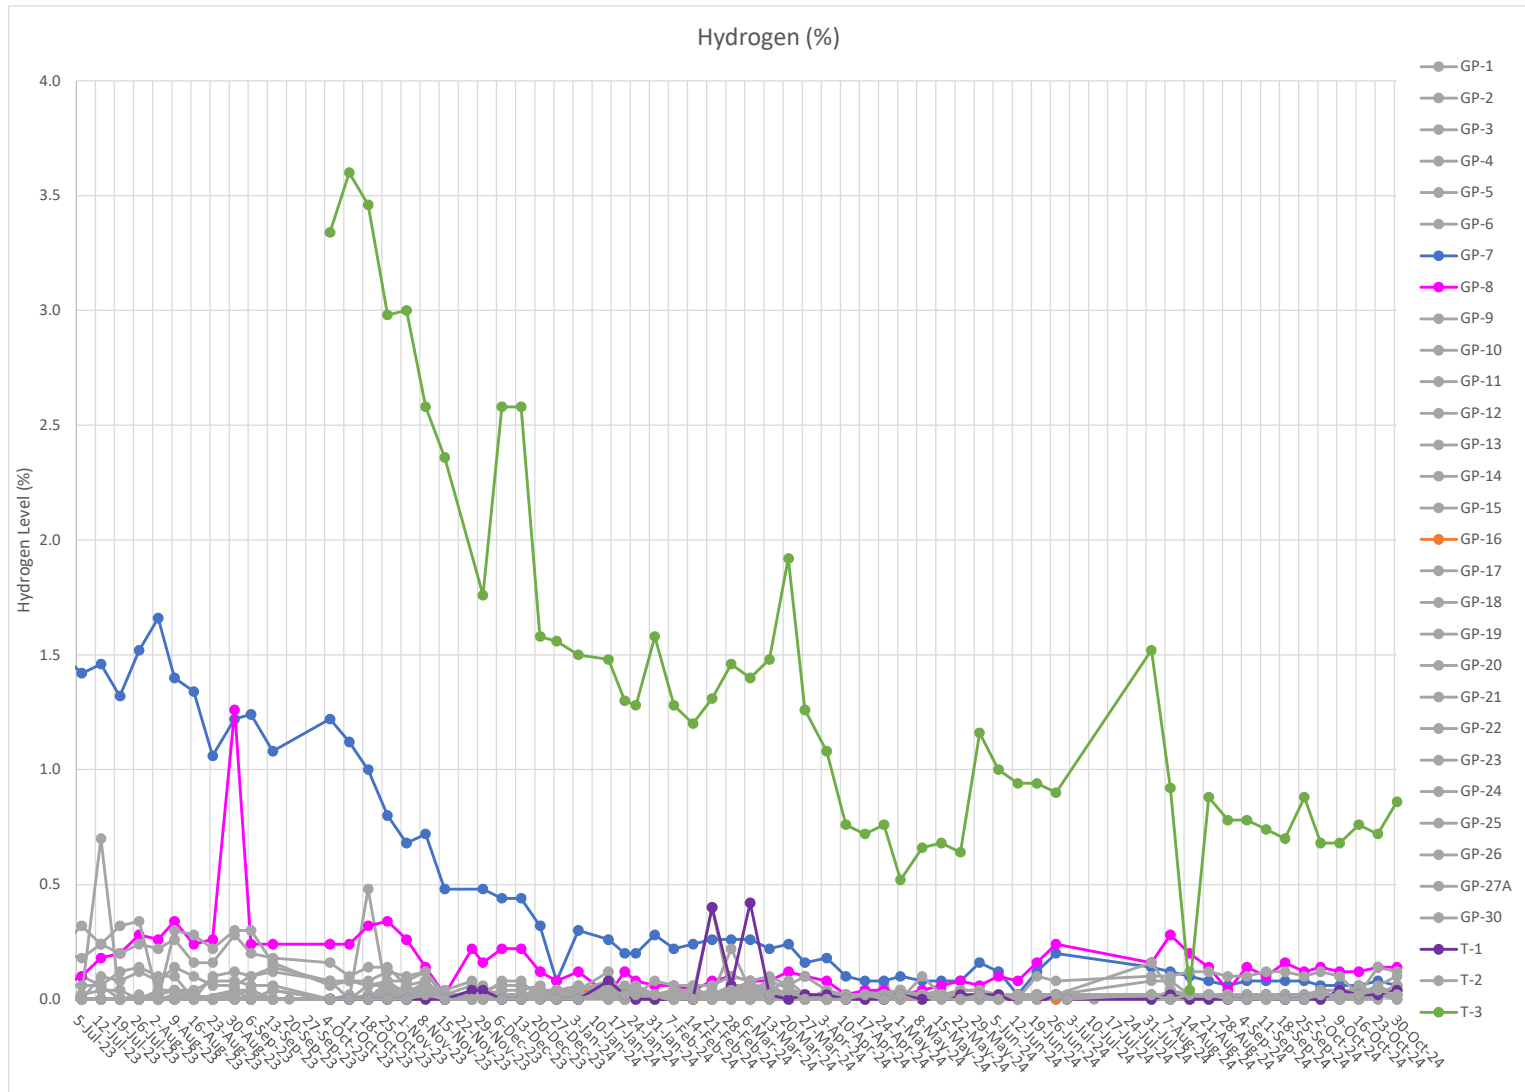
# Hydrogen

Hydrogen has remained stable around 0.8% in T-3 since mid August.

Hydrogen remains very low in all other wells. Production of H<sub>2</sub> is often observed with smoldering waste. LFCI believes that the level of H<sub>2</sub> dropping indicates that the fire is less active.

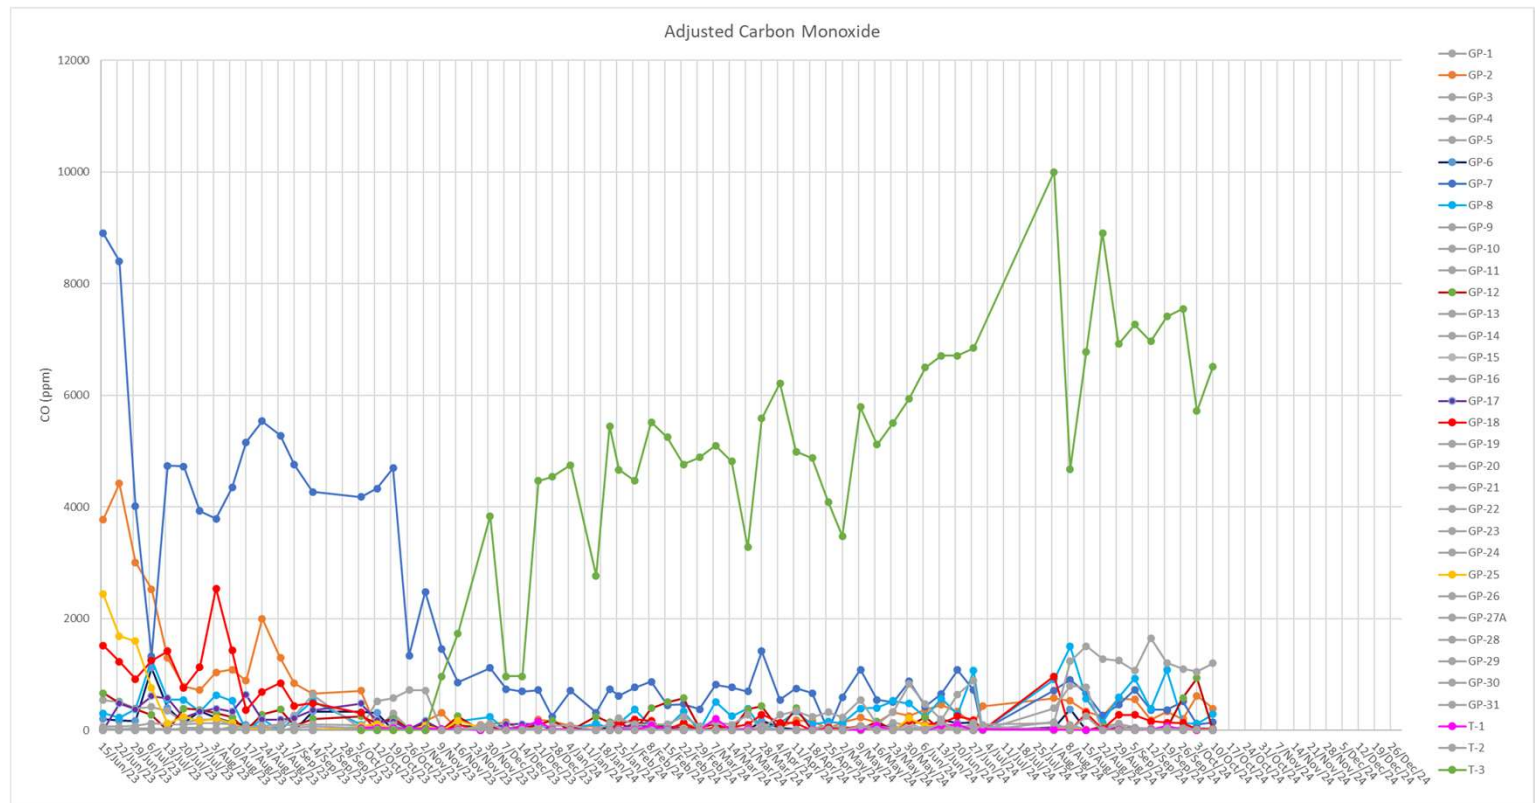
## H2 adjusted CO

A review of H2 adjusted CO readings indicate that CO levels corrected for H2 gas cross contamination of the sensor indicate that at T-3 CO is having a significant impact on readings. About 2,800 ppm of the measured CO value is due to H2 cross contamination.

H2 cross contamination must be considered as we move to full suppression.

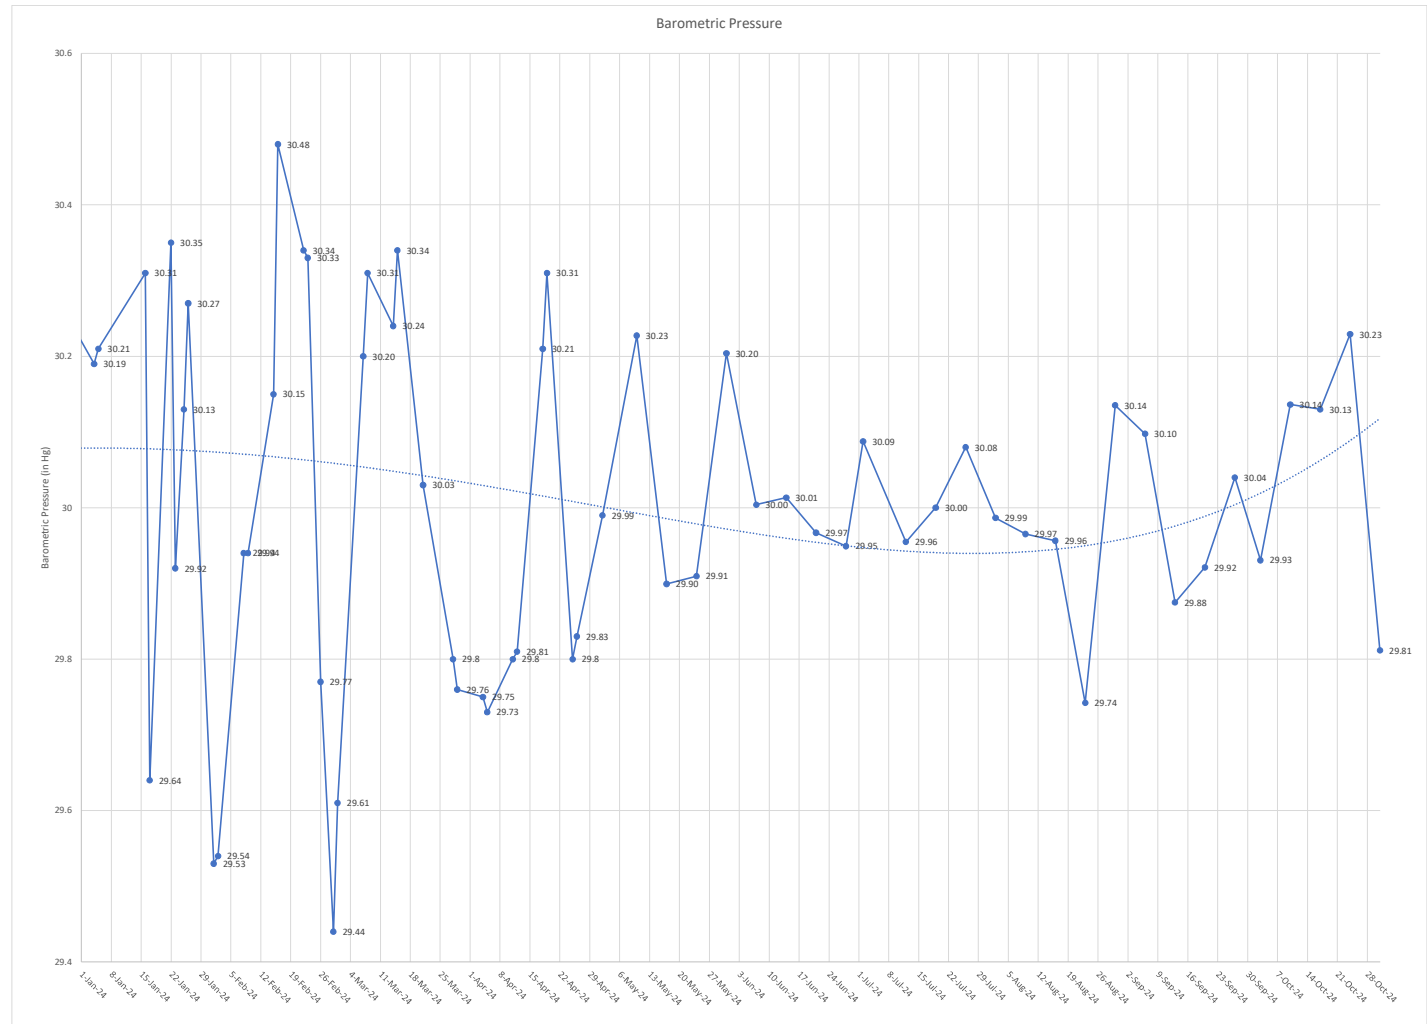
# Barometric Pressure

The site observed large swings in the barometric pressure over the last week. This has caused spikes in some datasets.

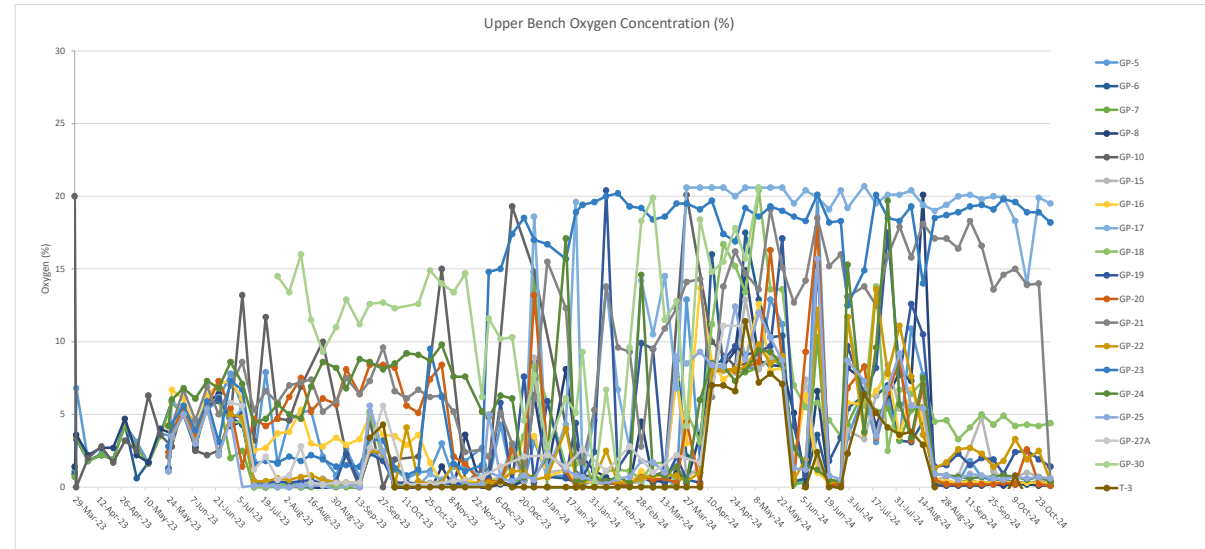
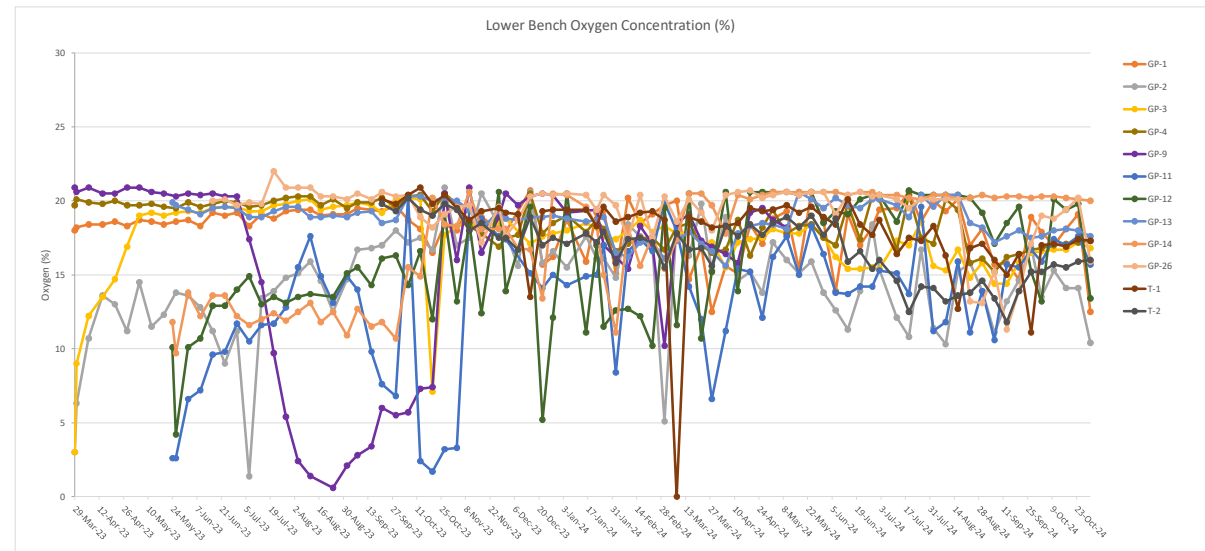
# Oxygen

The oldest portion of the landfill is likely relatively inert and biologically inactive, producing very little methane. As a result, the pore space is full of atmospheric air.

Some GPs likely susceptible to swings in pressure – LFCI believes this is causing the spikes. This theory fits with the large pressure swings over the last data points in October

Noted that higher levels of oxygen in GP-9 (>20%) are causing the spatial maps to be somewhat skewed.

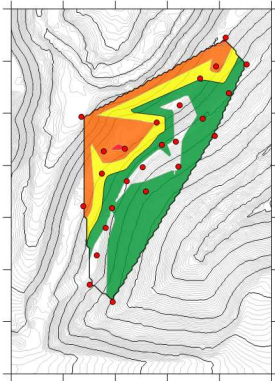
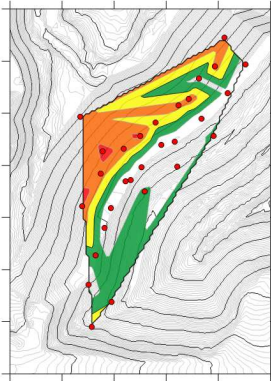
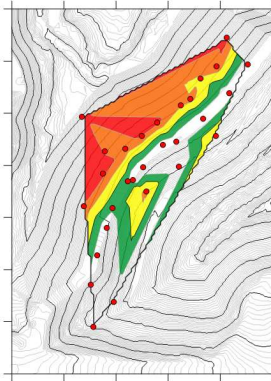
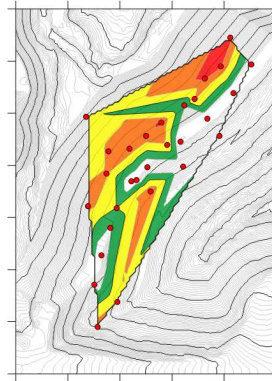
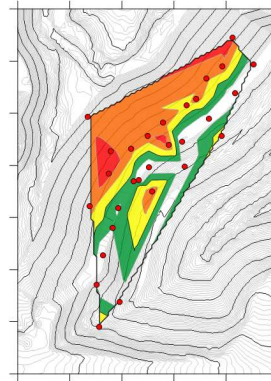
DTG RECYCLE LANDFILL FIRE		
MONTHLY MONITORING SUMMARY		
SPATIAL MAPS - O2		
DRAWING NO.	REV	SHEET
LFCI-2023-001-10-O2	1	1

- Data taken from first monitoring event of each month
- Data was linearly interpolated between data points
- Datapoints (probe locations) represented in red
- O2 levels are measured in % composition
- Ground contours are of existing ground at beginning of project, with design contours added for after addition of fill

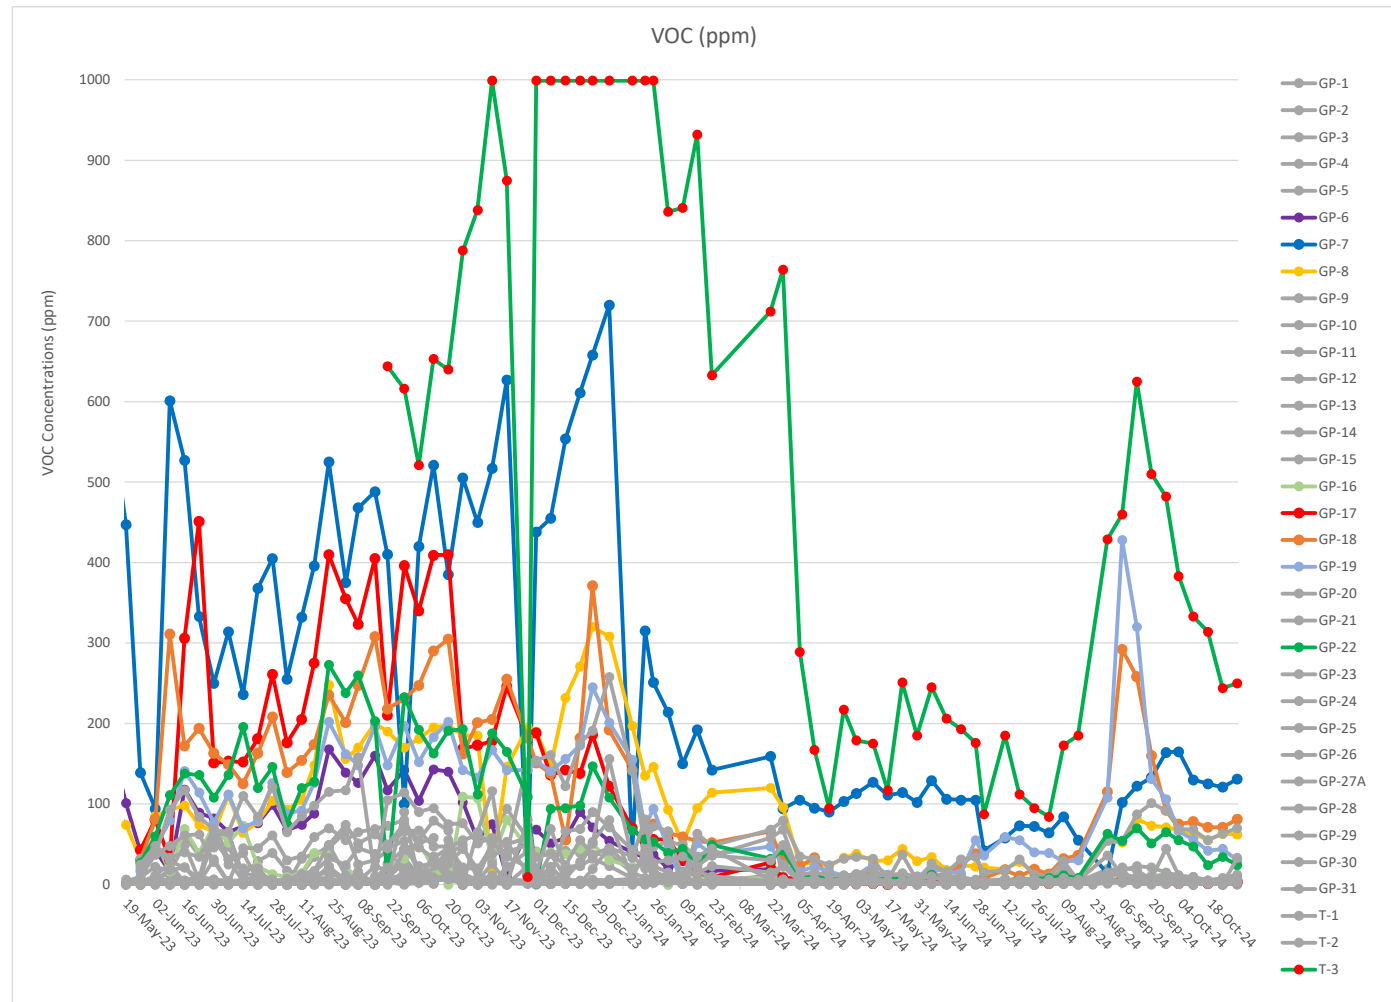
# Volatile Organic Compounds

Increase seen in August has been decreasing since early September. T-3 is only well that remains somewhat elevated.

Low VOC levels indicate reduced smolder activity.

LFCl is monitoring closely to ensure any negative trends are caught early.

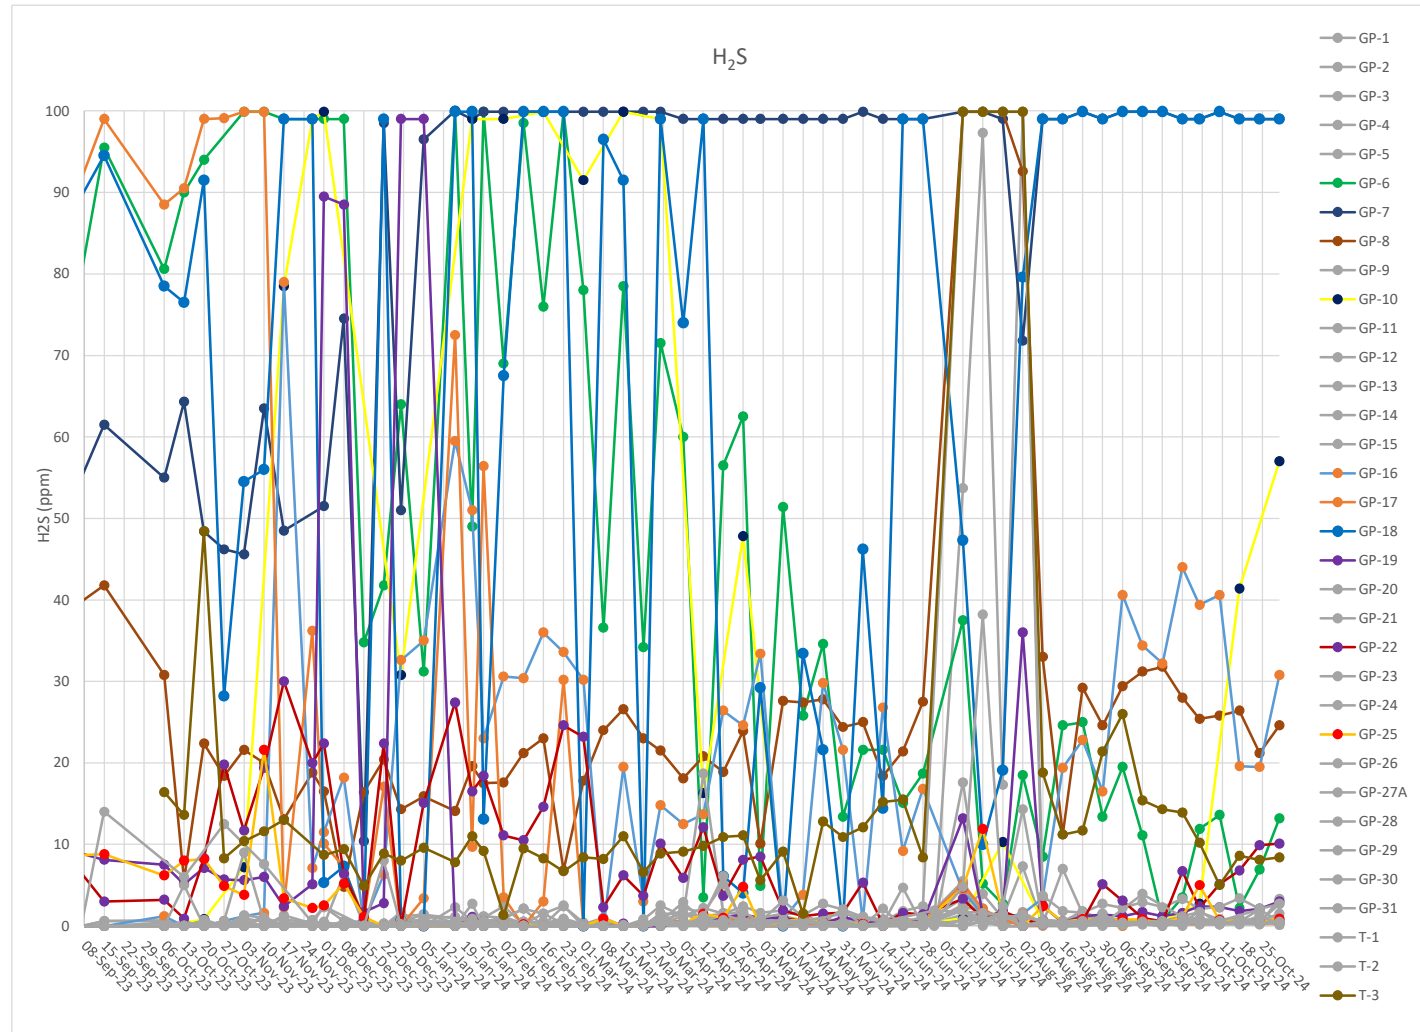
# Hydrogen Sulfide

H<sub>2</sub>S data continues to be noisy, likely affected by atmospheric pressure fluctuation. GP-18 remains high, and GP-10 has once again climbed.

GP-18 is in the area that LFCI believes gases are venting.

As mentioned previously, it is possible that the H<sub>2</sub>S sensor is being impacted by CO cross interference.

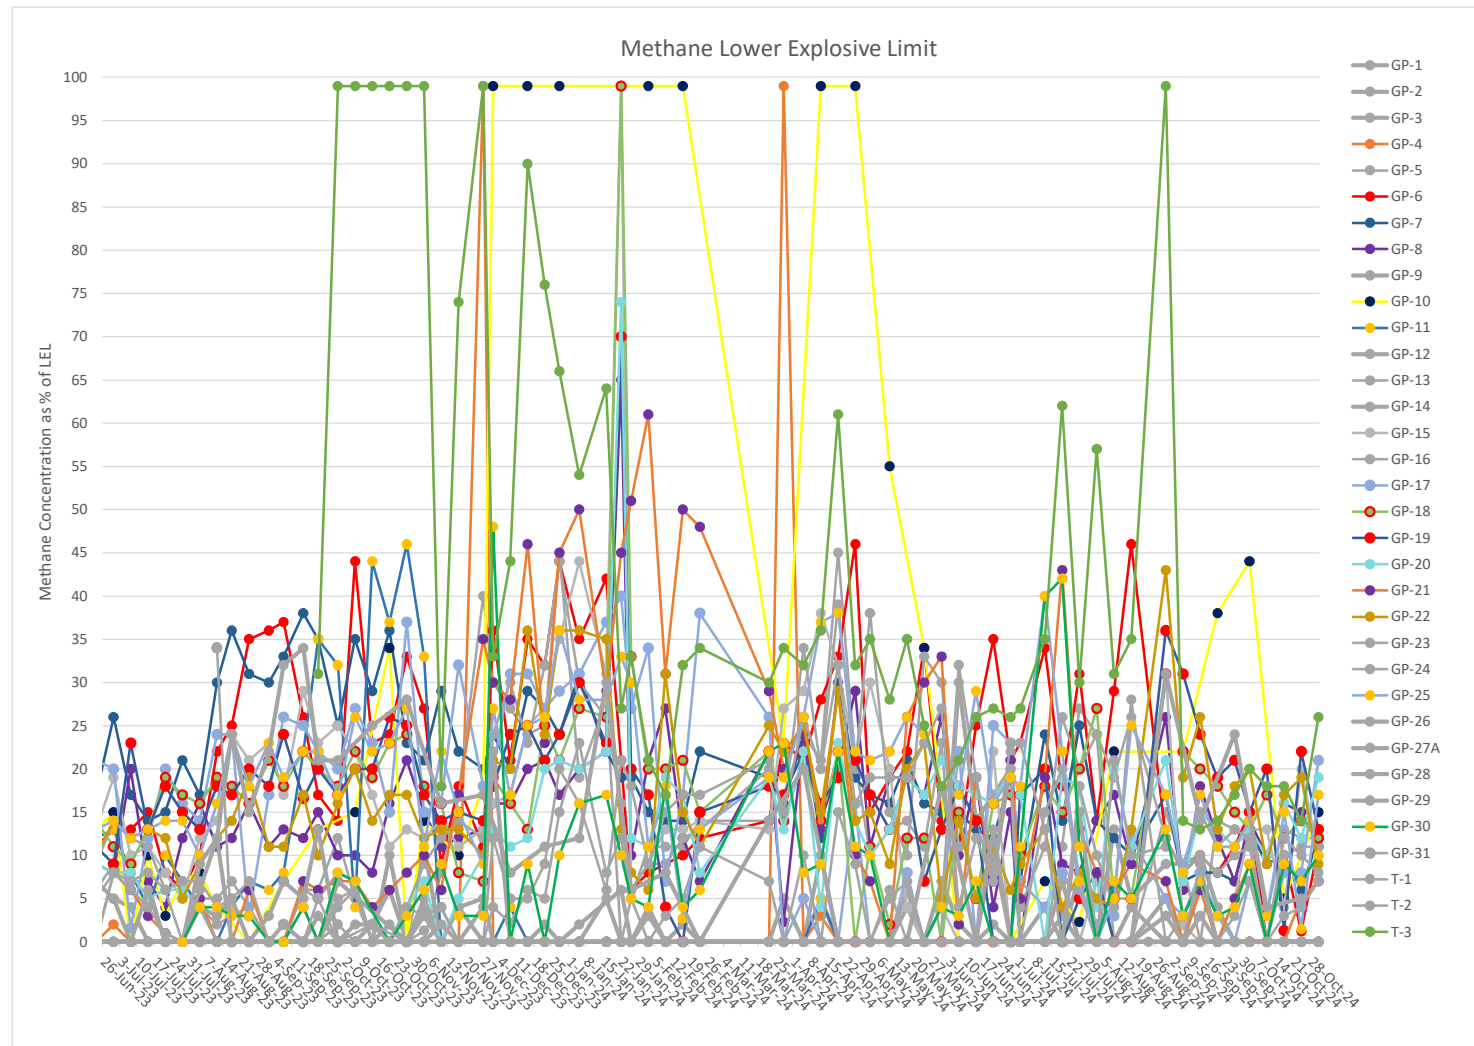
## Lower Explosive Limit

Many data points fluctuating wildly – methane composition is a better indicator of levels within the landfill.

Overall decrease in LEL over last month. LFCI suspects that this may be linked to the large pressure swings, which is somewhat confirmed by the higher pressure and slightly higher levels this past week.

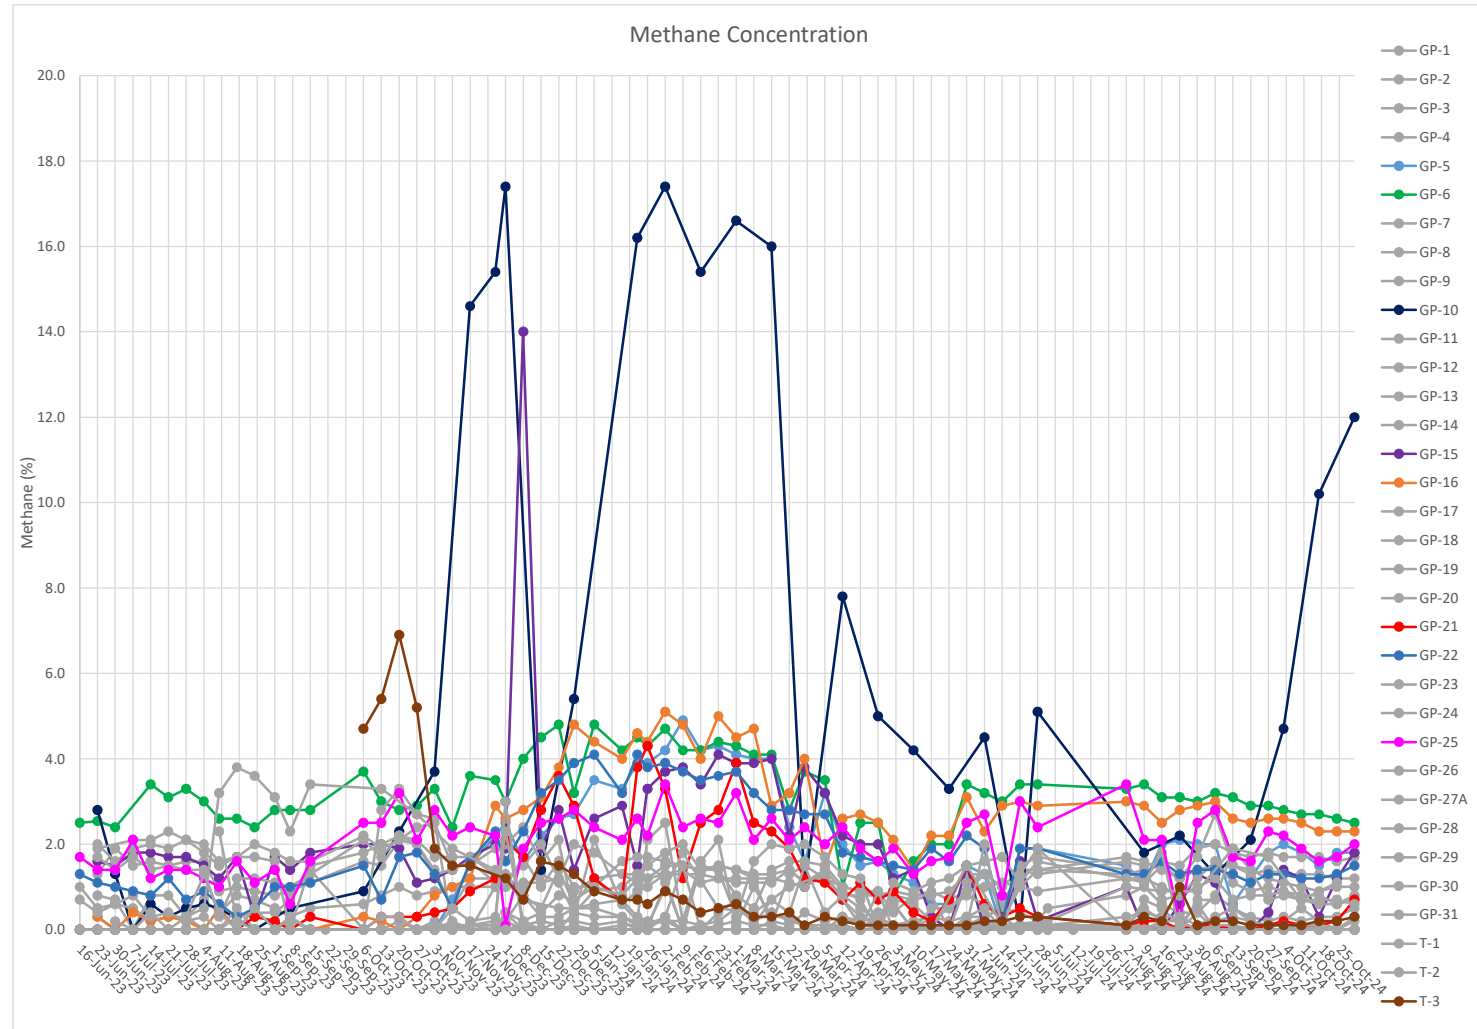
# Methane

Methane levels for most wells are converging between 0 and 3% indicating that landfill is not biologically active.

Only well GP-10 is indicating higher methane, now climbing to 12% methane. This well is as crest of landfill. Highest methane concentrations are typically observed at this well as it is affected by younger garbage that is still in process of decomposition.

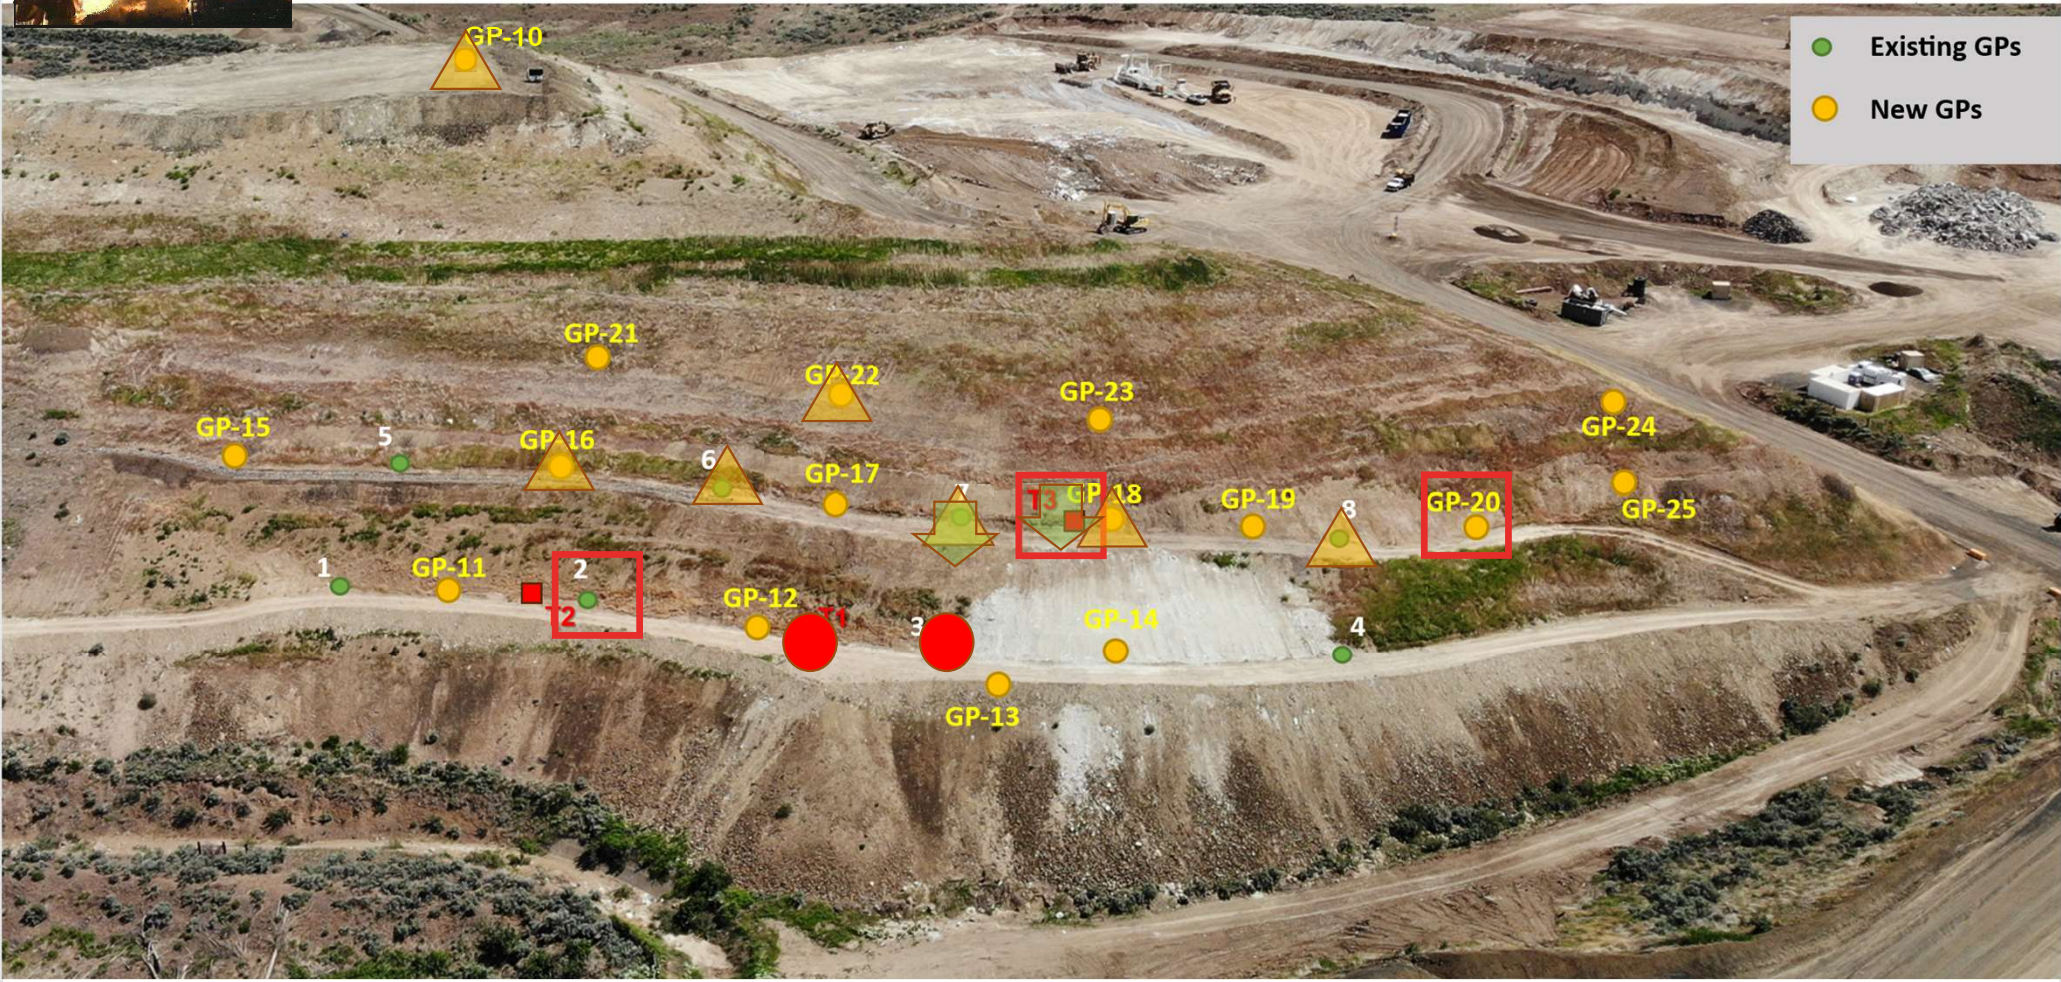
# Fire Path

▼ High VOC

● Existing GPs  
● New GPs

LFCI believes that the waste is still smoldering underneath GP-3 and T-1 (elevated temperature) and a 'chimney' effect is occurring, causing higher CO and VOC's in T-3 and GP-7. The large atmospheric pressure swing this week has likely caused some of the irregularities in the data, but LFCI will continue to monitor closely.
