Re: DTG Yakima – Agreed Order No. DE 21624 – Monthly Progress Letter – October

### **Re: Monthly Data Assessment Report DTG Yakima Landfill Fire Incident – October 2024**

# DTG LPL LANDFILL FIRE INVESTIGATIONS AND MITIGATION

Monthly Monitoring Data Review

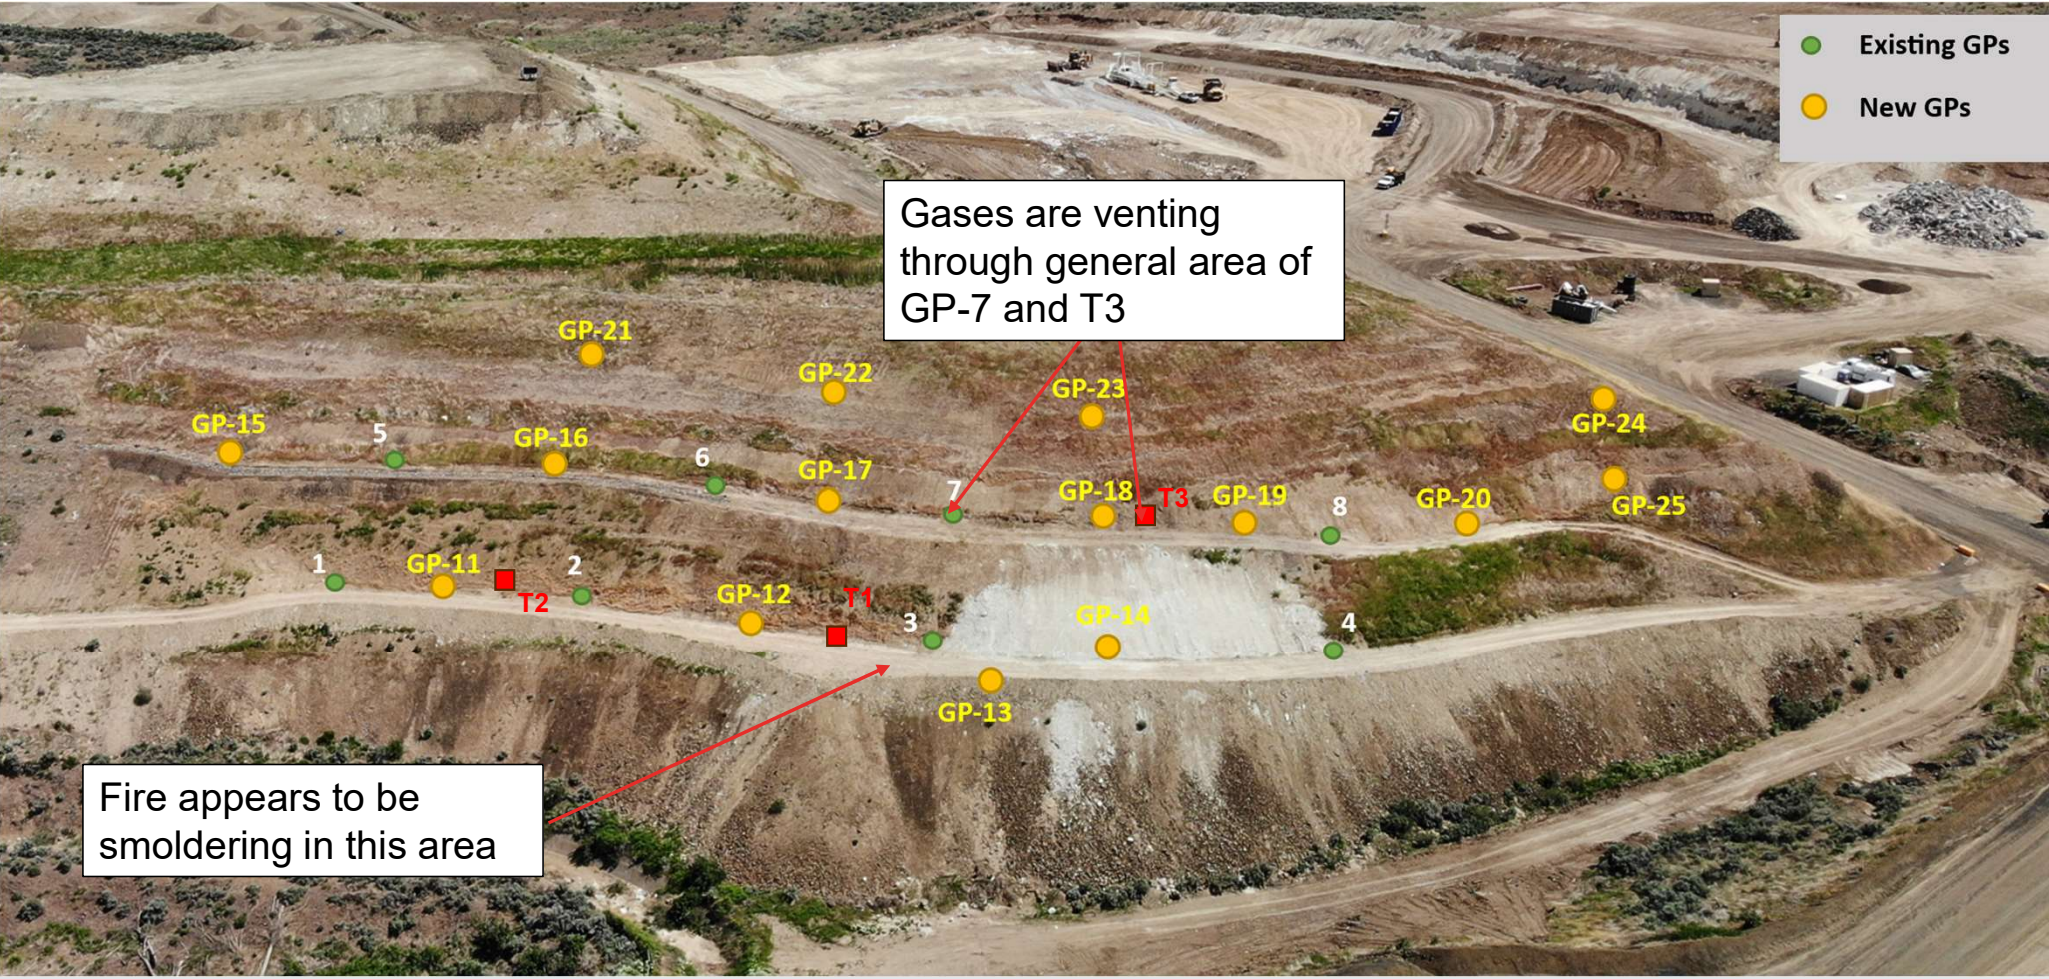
# Fire Path

LFCI believes that the waste is still smoldering underneath GP-3 and T-1 (elevated temperature) and a 'chimney' effect is occurring, causing higher CO and VOC's in T-3 and GP-7. The large atmospheric pressure swing this week has likely caused some of the irregularities in the data, but LFCI will continue to monitor closely.

Other than slightly elevated CO in GP-20, there is no other evidence of fire or smolder in the north zone, north of T-1. It is possible that with the placement of the soil wedge gas flow southward has become the preferred migration path for combustion gases from the smolder at T-1.

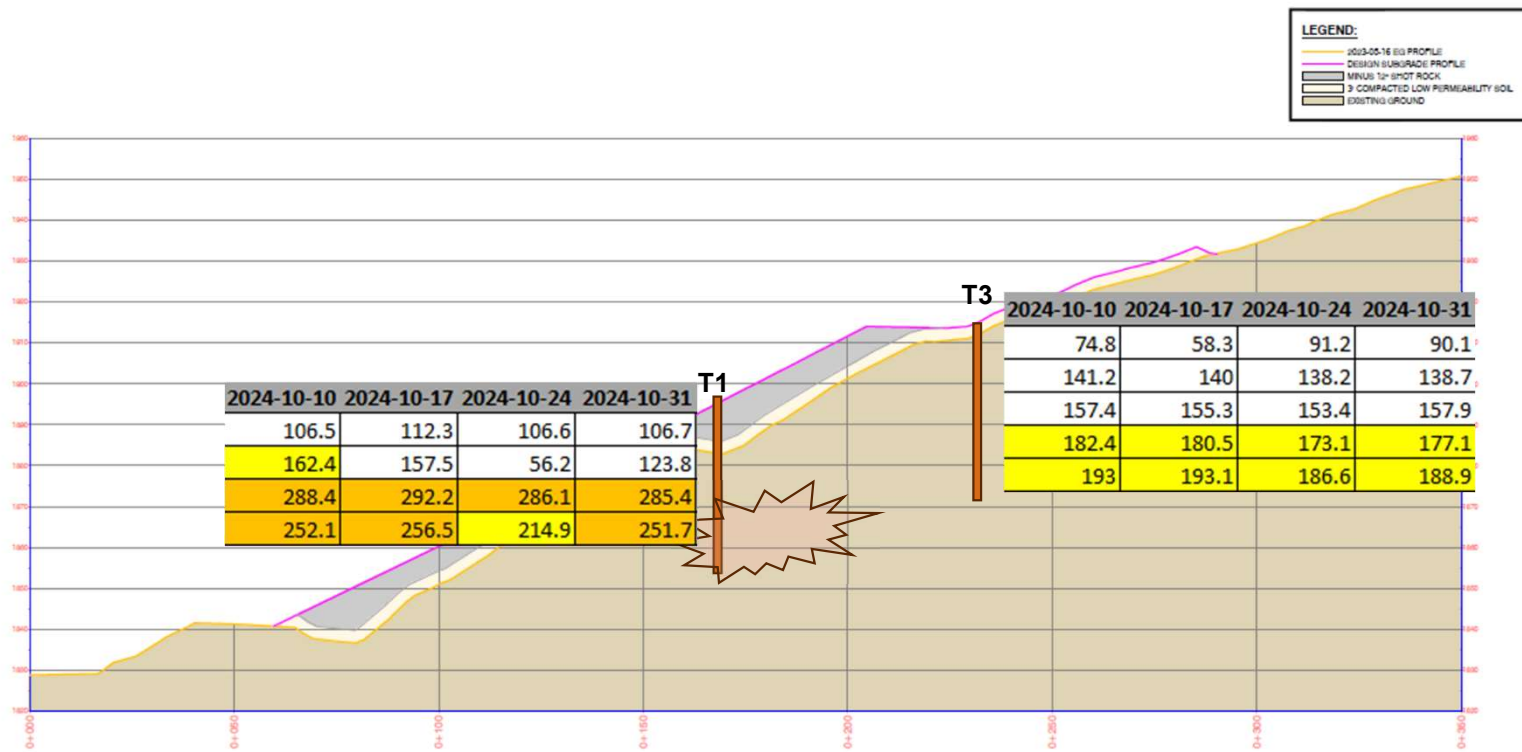
**SECTION B - B'**  
 H - 1" = 25'  
 V - 1" = 25'

2024-10-10	2024-10-17	2024-10-24	2024-10-31
106.5	112.3	106.6	106.7
162.4	157.5	56.2	123.8
288.4	292.2	286.1	285.4
252.1	256.5	214.9	251.7

2024-10-10	2024-10-17	2024-10-24	2024-10-31
74.8	58.3	91.2	90.1
141.2	140	138.2	138.7
157.4	155.3	153.4	157.9
182.4	180.5	173.1	177.1
193	193.1	186.6	188.9
