November 8, 2024
ZGA Job No. 2577.20

Subject: Submittal of Subsurface Investigation and Request for No Further Action Opinion

Site Name: G&W Oil & Wood Inc.
Site Address: 903 West 1st Street, Cle Elum, Washington 98922
Facility/Site ID (FSID): 4658443
Cleanup Site ID (CSID): 7045

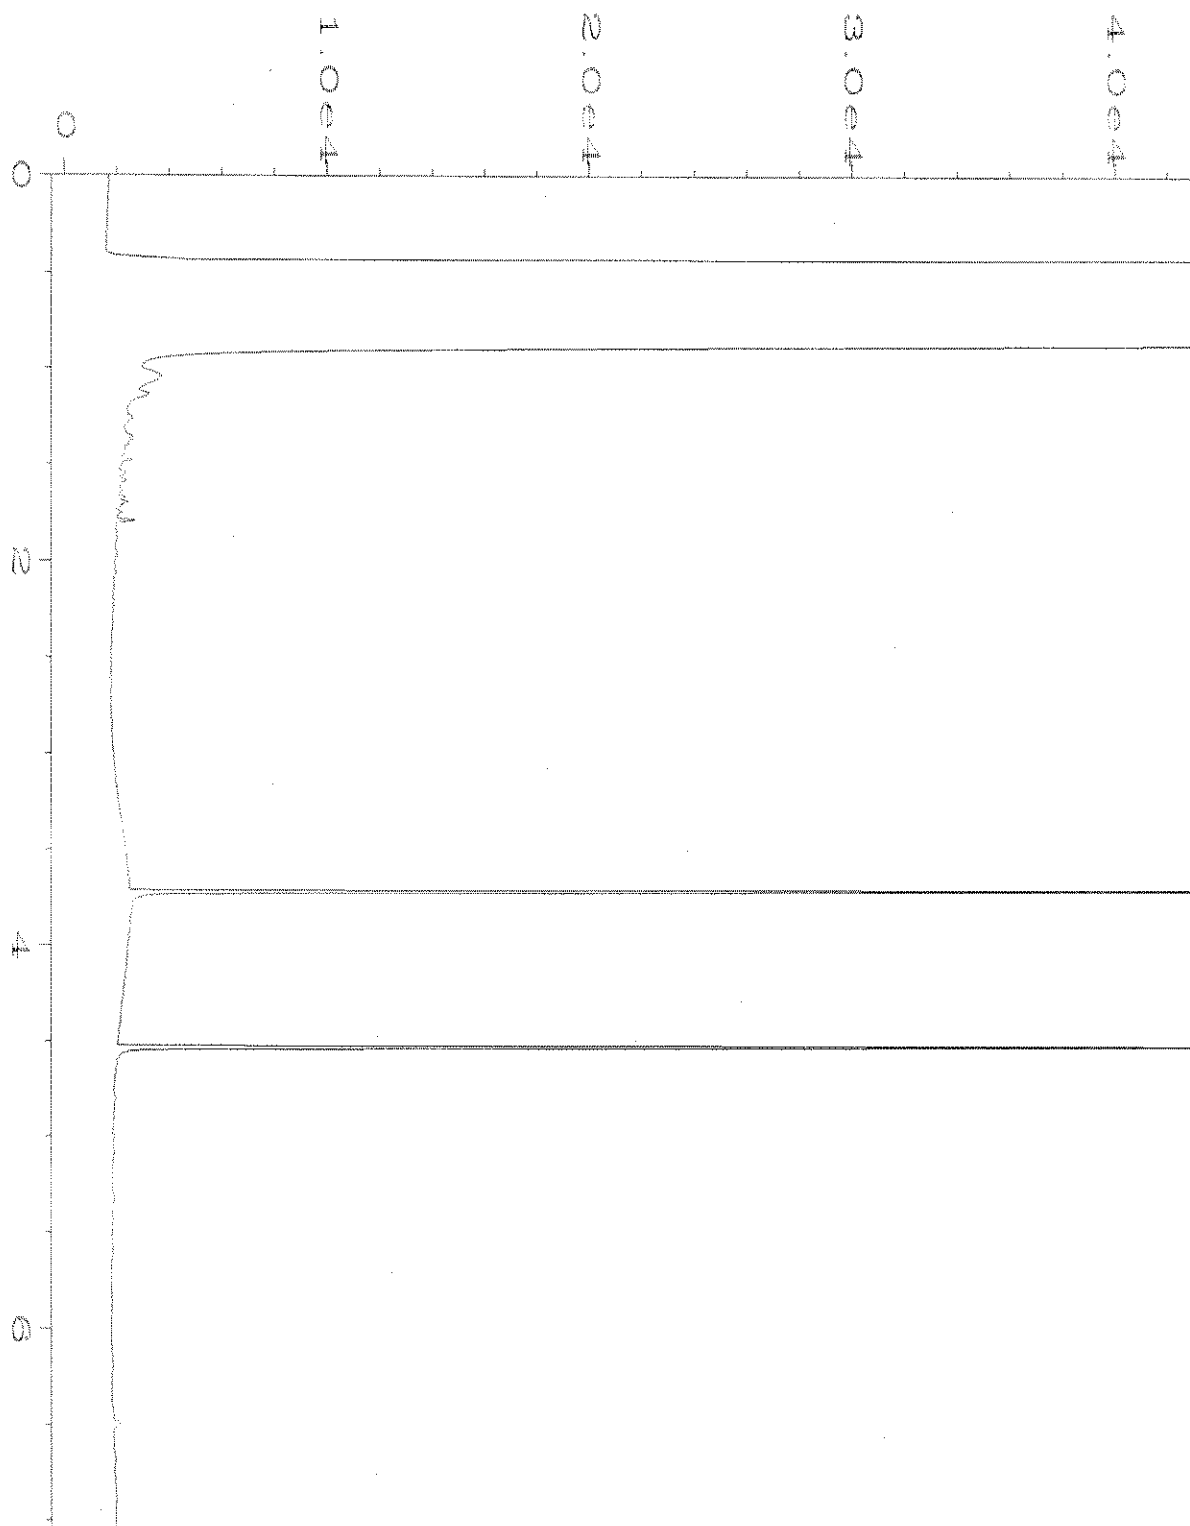
Data File Name	: C:\HPCHEM\4\DATA\04-11-22\025F0501.D	Page Number	: 1
Operator	: TL	Vial Number	: 25
Instrument	: GC#4	Injection Number	: 1
Sample Name	: 204132-01	Sequence Line	: 5
Run Time Bar Code:		Instrument Method:	DX.MTH
Acquired on	: 11 Apr 22 12:52 PM	Analysis Method	: DEFAULT.MTH
Report Created on:	12 Apr 22 08:21 AM

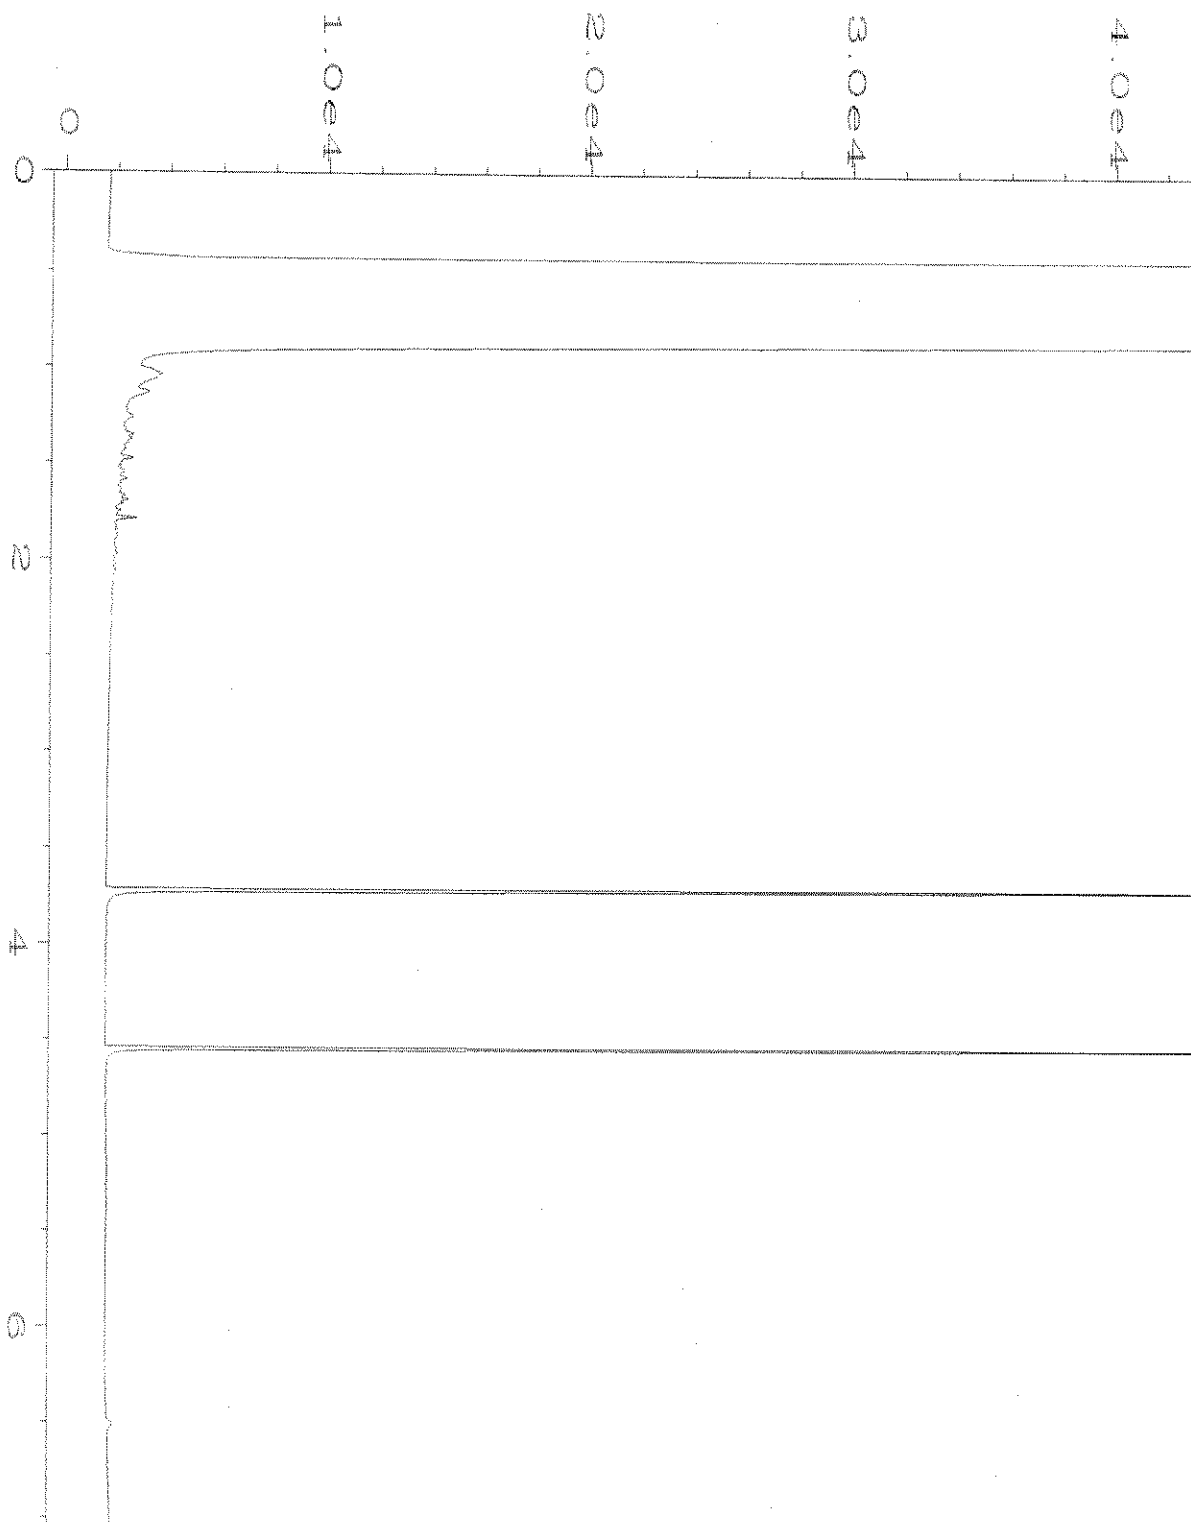
Data File Name	: C:\HPCHEM\4\DATA\04-11-22\026F0701.D	Page Number	: 1
Operator	: TL	Vial Number	: 26
Instrument	: GC#4	Injection Number	: 1
Sample Name	: 204132-02	Sequence Line	: 7
Run Time Bar Code:		Instrument Method:	DX.MTH
Acquired on	: 11 Apr 22 01:28 PM	Analysis Method	: DEFAULT.MTH
Report Created on:	12 Apr 22 08:21 AM

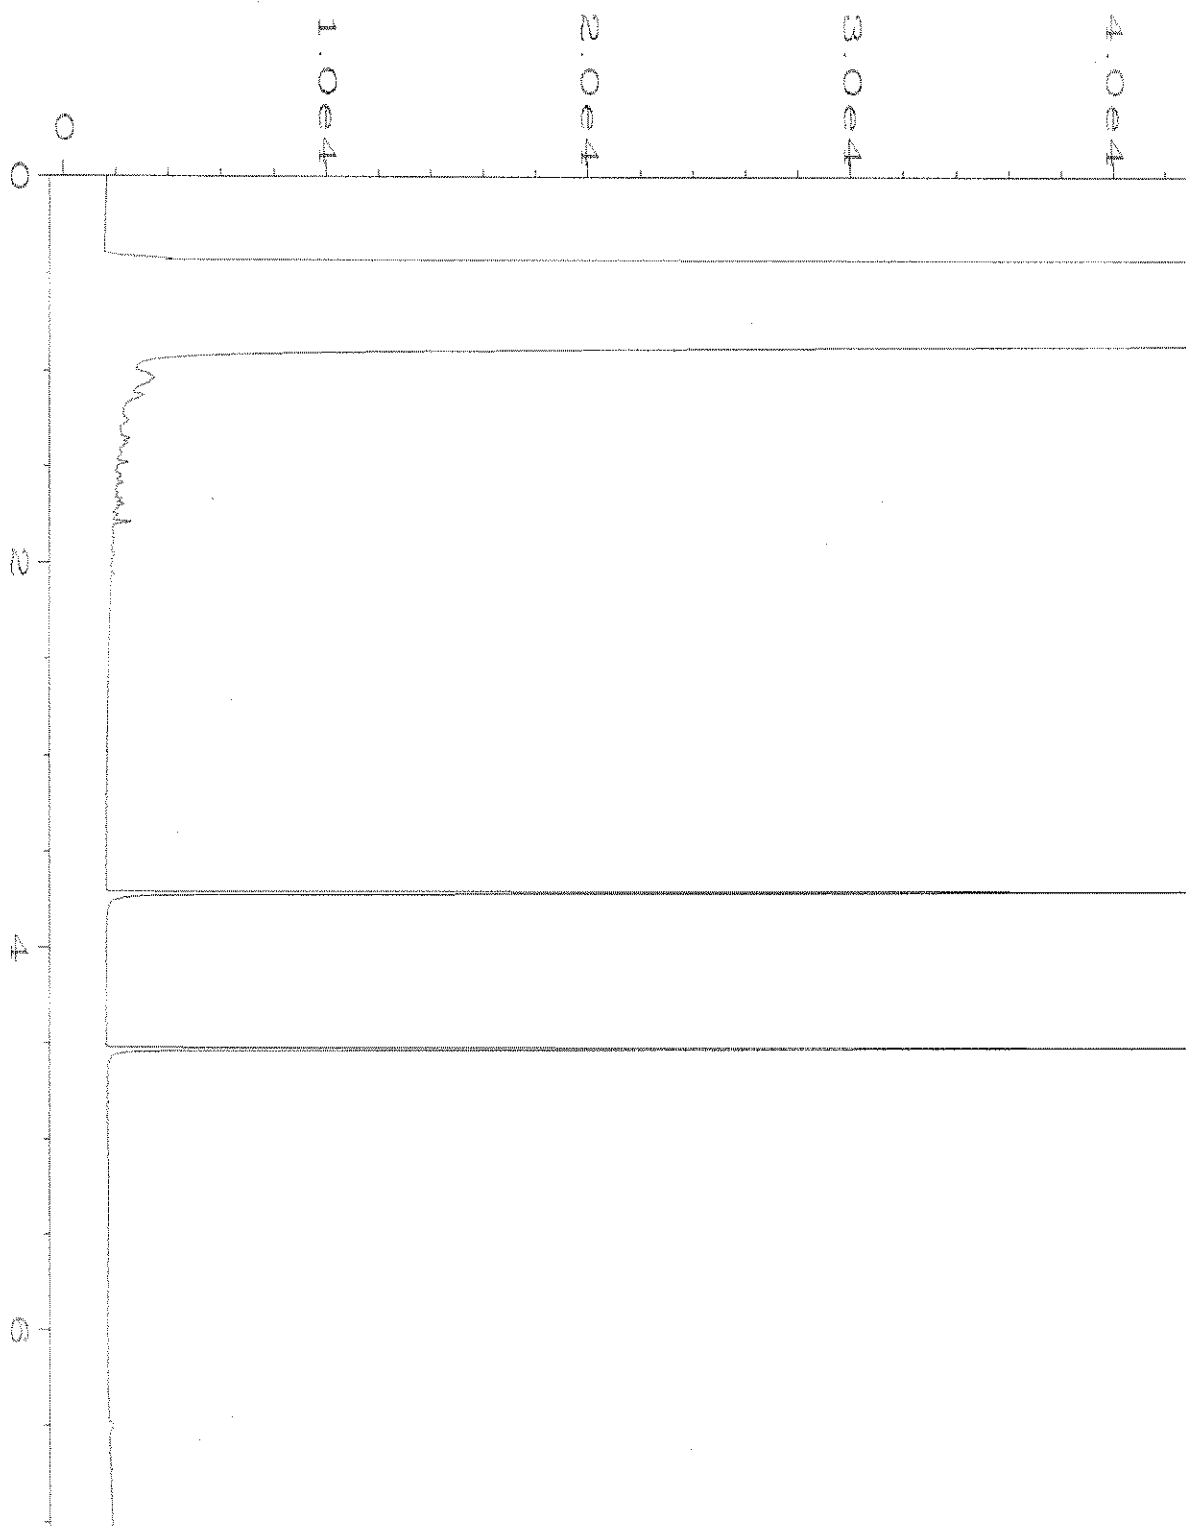
Data File Name	: C:\HPCHEM\4\DATA\04-11-22\027F0701.D	Page Number	: 1
Operator	: TL	Vial Number	: 27
Instrument	: GC#4	Injection Number	: 1
Sample Name	: 204132-03	Sequence Line	: 7
Run Time Bar Code:		Instrument Method	: DX.MTH
Acquired on	: 11 Apr 22 01:40 PM	Analysis Method	: DEFAULT.MTH
Report Created on:	: 12 Apr 22 08:21 AM

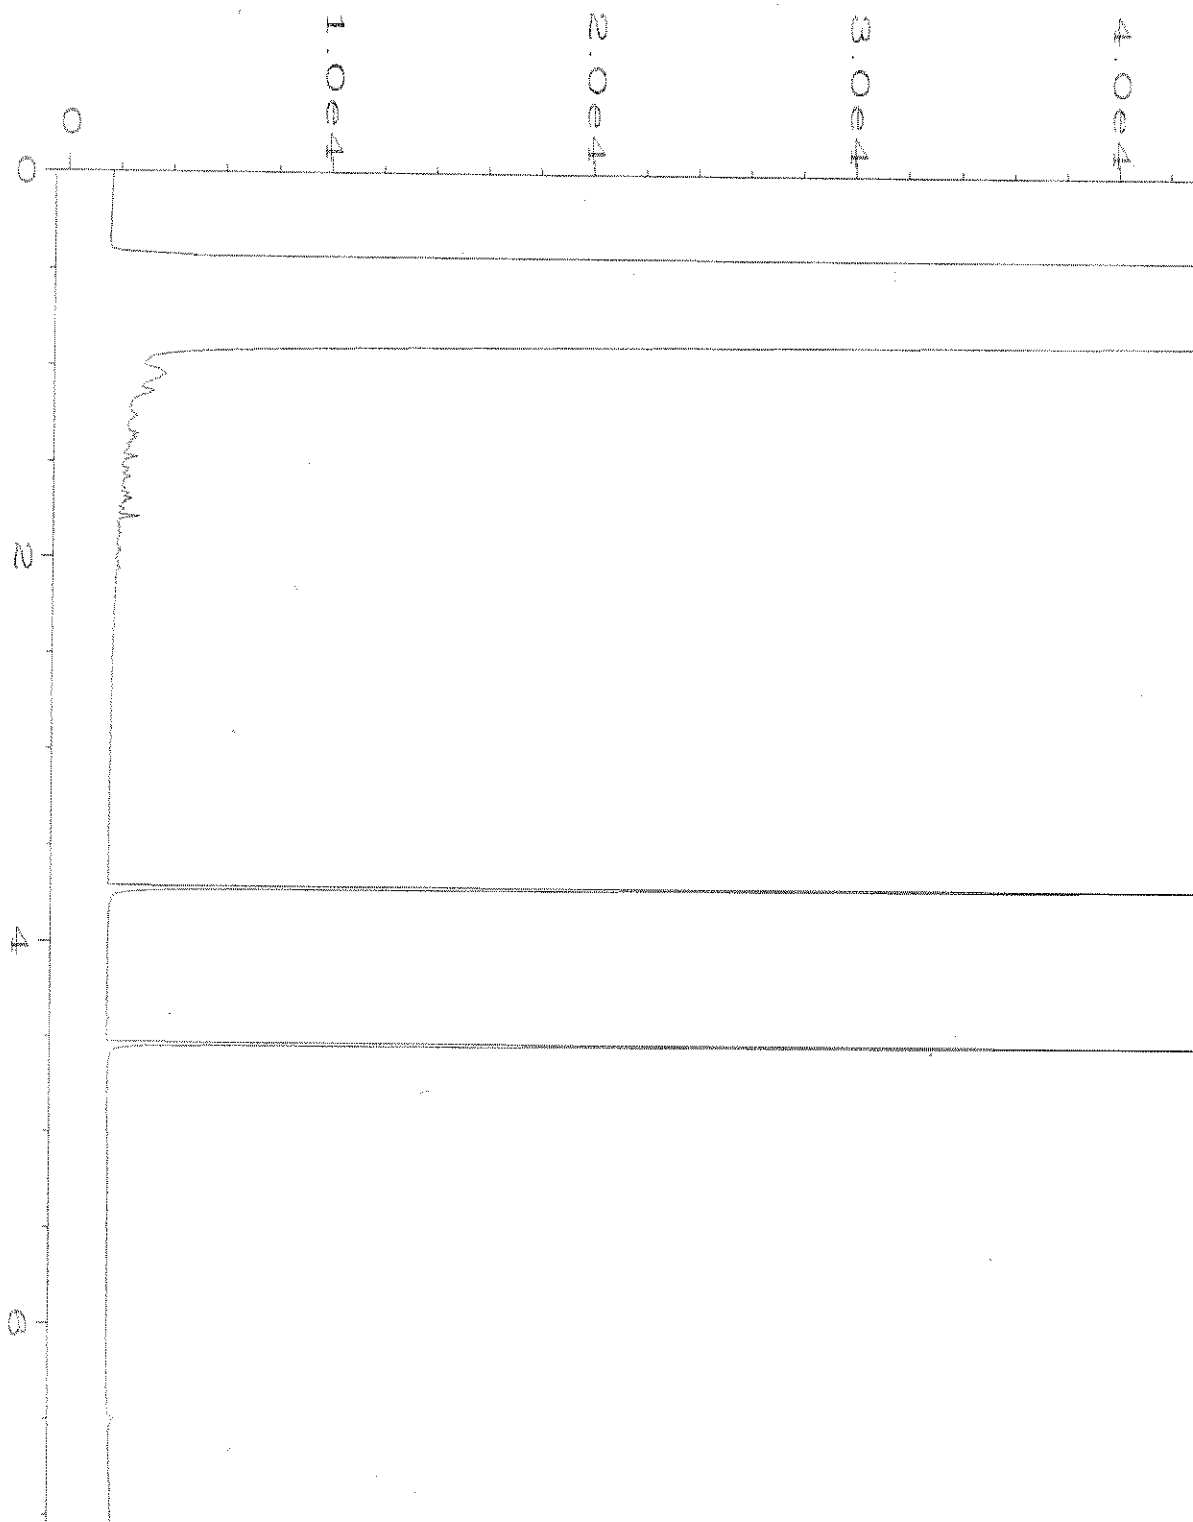
Data File Name	: C:\HPCHEM\4\DATA\04-11-22\028F0701.D	Page Number	: 1
Operator	: TL	Vial Number	: 28
Instrument	: GC#4	Injection Number	: 1
Sample Name	: 204132-04	Sequence Line	: 7
Run Time Bar Code:		Instrument Method:	DX.MTH
Acquired on	: 11 Apr 22 01:52 PM	Analysis Method	: DEFAULT.MTH
Report Created on:	12 Apr 22 08:21 AM
