INACTIVE AND ABANDONED MINE LANDS— Deer Trail Mine, Cedar Canyon Mining District, Stevens County, Washington

by Fritz E. Wolff,
Donald T. McKay, Jr.,
and David K. Norman

WASHINGTON
DIVISION OF GEOLOGY
AND EARTH RESOURCES
Information Circular 102
May 2006

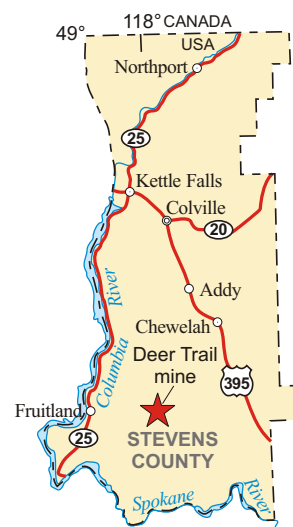
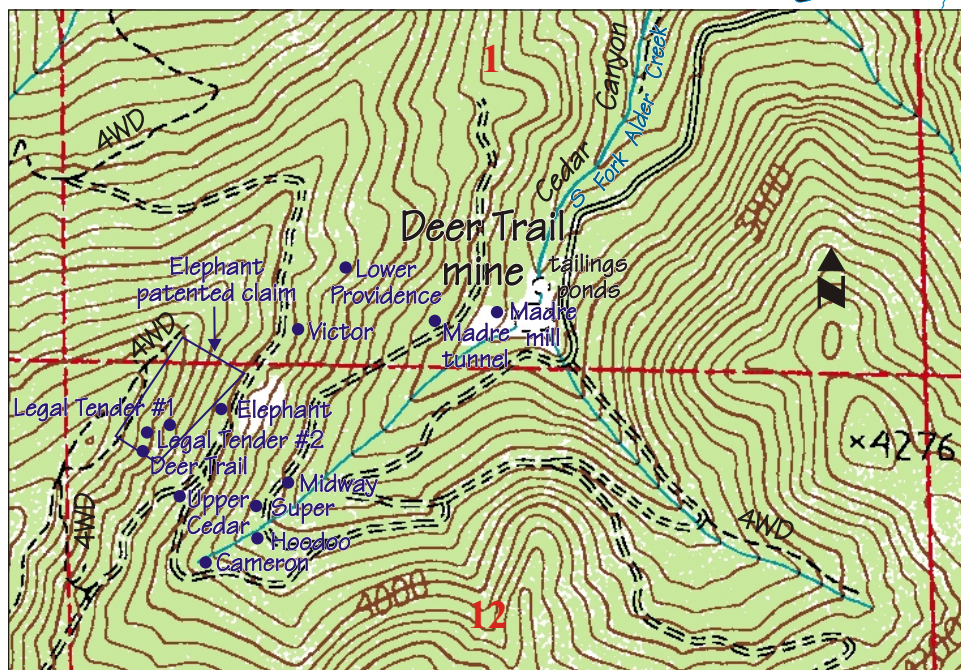
Figure 1. Map showing the location of the Deer Trail mine in Stevens County (top) and a more detailed map of the mine site (bottom). Section lines (red) are 1 mile apart.

The Deer Trail mine is located 6 miles east of Fruitland, Wash., in Stevens County. The original property consisted of 19 unpatented claims, one patented claim, and some deeded land occupying most of secs. 1 and 12, T29N R37E (Fig. 1). At present, the patented claim has reverted to the Bureau of Land Management (BLM). Two unpatented claims and 80 acres of deeded land are held privately by possessory title (BLM, written commun., 2005). DGER personnel performed field work at the site in September 2001 and May 2002. A partial overview of the property is shown in Figure 2. The property has produced some of the state's most concentrated silver mineralization. The total dollar value of all production to date, at historic metal prices, is approximately \$5 million.

M. Inman of Hunters, Wash., owns $E\frac{1}{2}SE\frac{1}{4}SW\frac{1}{4}$ and $W\frac{1}{2}SW\frac{1}{4}SE\frac{1}{4}$ sec. 1, T29N R37E, in fee simple, which includes the former mill sites, tailings ponds, Madre tunnel site, and most of the Providence mine area (Stevens Co. Assessor, written commun., 2006). Mr. Inman also holds possessory title to two unpatented lode claims, Elephant 1 and 2, which include portions of the Legal Tender, Deer Trail, and Hoodoo mine adits and waste dumps in sec. 12 (BLM, land records database, 2006). The Elephant patented claim shown in Figure 1 has reverted to BLM ownership, as has most of the property surrounding the mine area.

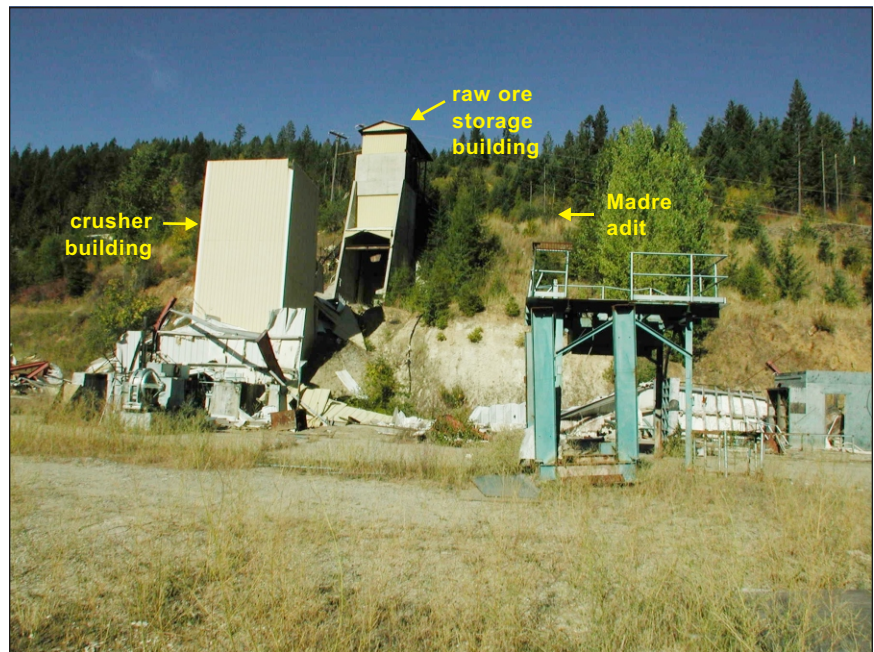
Figure 2. Partial overview of the mine site. The demolished mill with footings is in the center foreground. Legal Tender, Providence, Elephant, and Deer Trail openings are out of sight on the ridge line. View to the west.

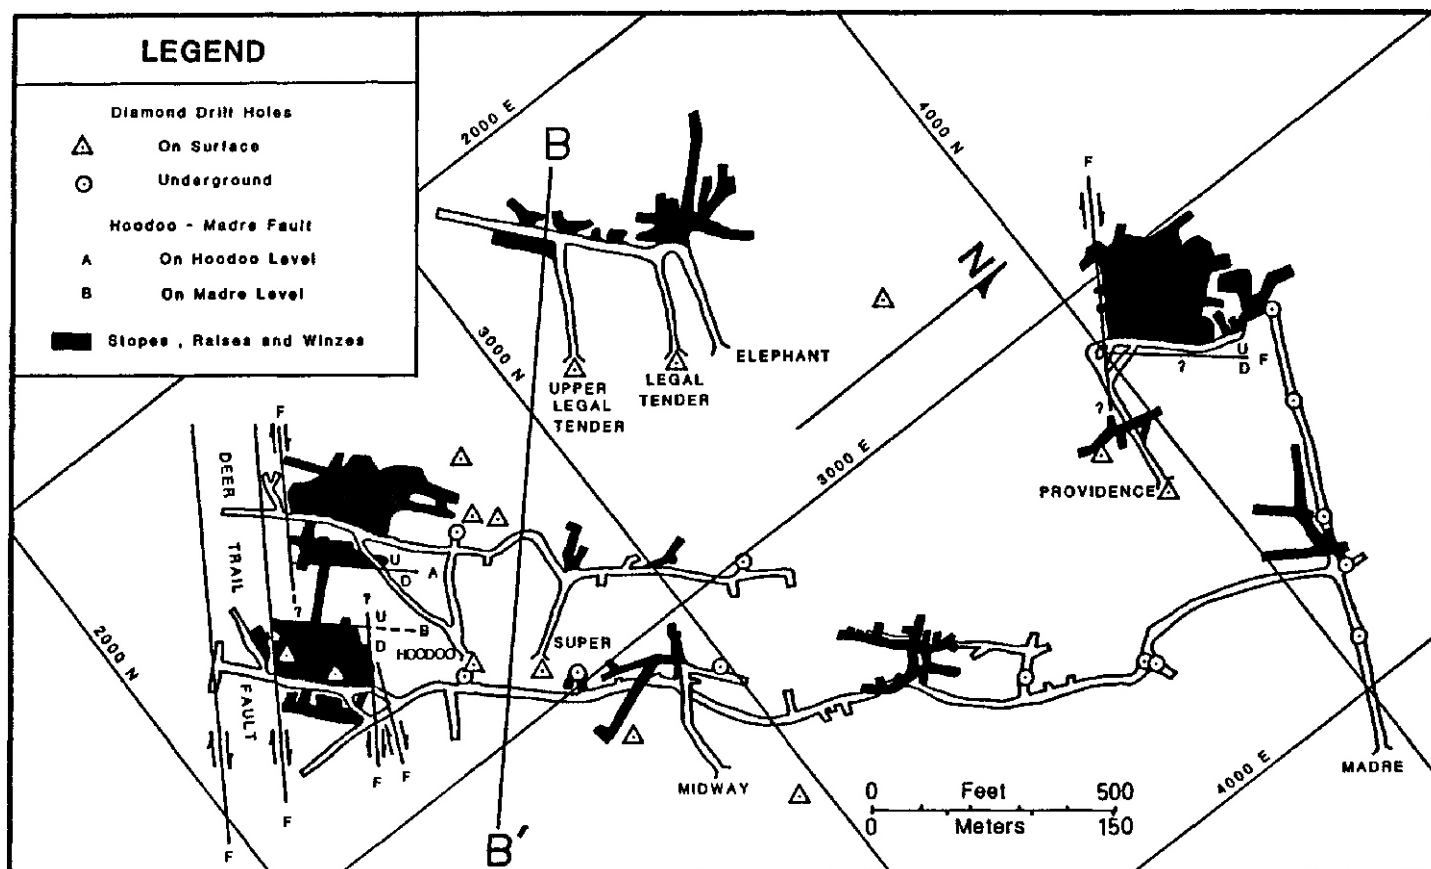
Figure 3. Plan view of principal mines in the Deer Trail group, showing connecting haulage way from the Madre tunnel to Hoodoo workings (after Fluet, 1986).

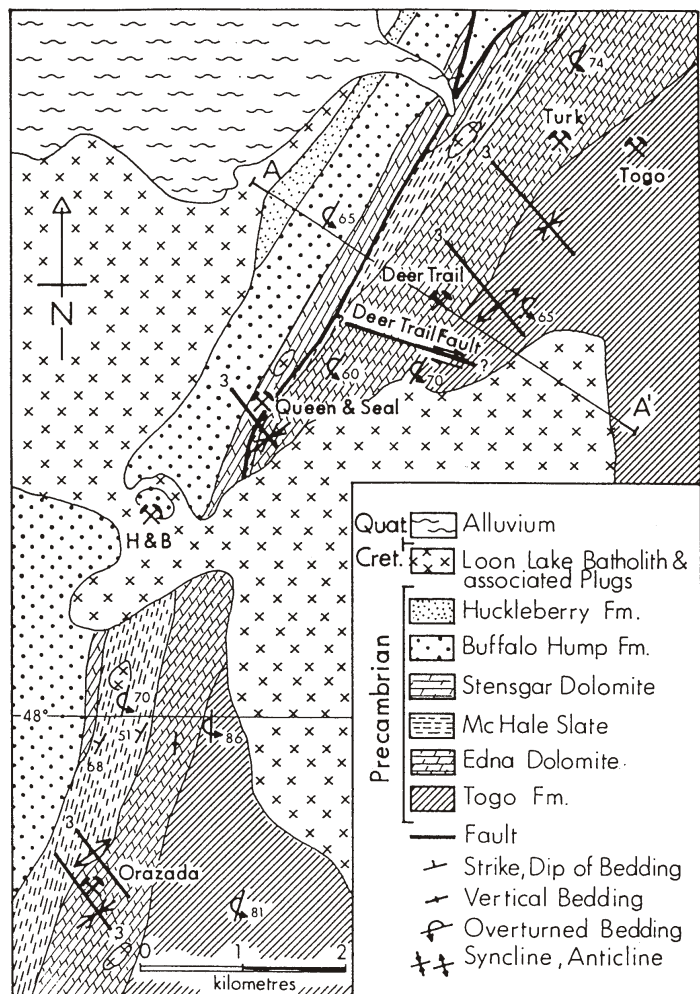
Figure 4. General geology of the Deer Trail mine area (after Fluet, 1987).

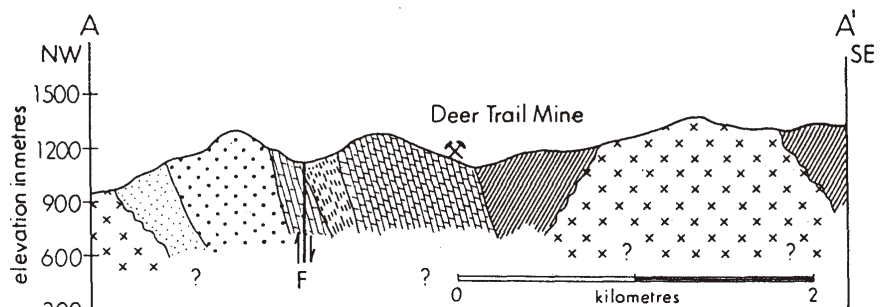
Figure 5. Geological cross section through the Deer Trail mine area (after Fluet, 1987).

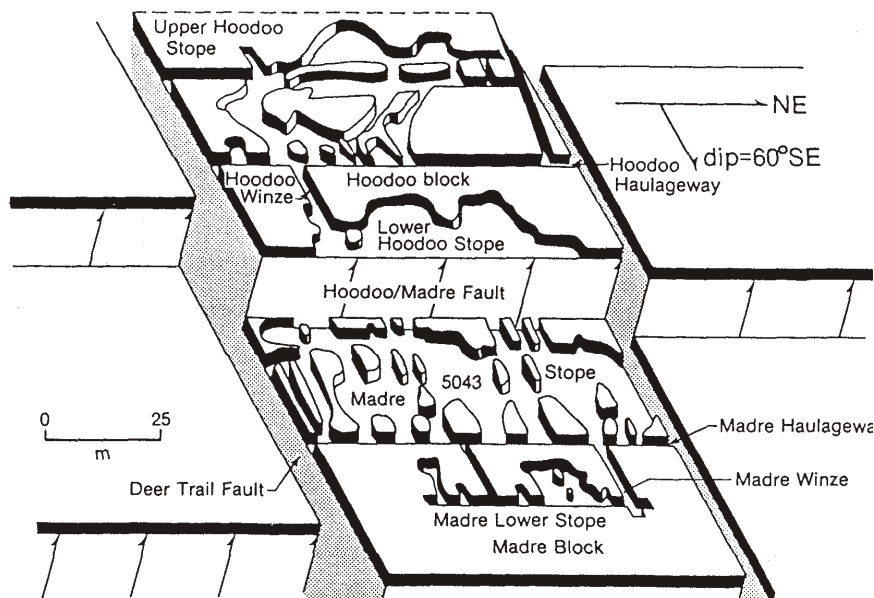
Figure 6. Fault displacement of the Madre-Hoodoo vein (after Fluet, 1987).

bedding at N40°E identified by Fluet as the Hoodoo-Madre fault. It displaced the Madre vein 60 feet vertically (Fig. 6). This fault is offset at right angles in at least two places by vertical strike-slip faults with right lateral displacement, one of which was recognized early on and named the Deer Trail fault (Figs. 3 and 6). Fluet mapped it as a shear zone approximately 130 feet wide extending across Cedar Canyon to the east and into the Togo Formation. The displacement along strike was not determined, but it may be considerable as the Queen Seal mine 1 mile west of the Deer Trail contained identical mineralization and high-grade silver values up to 240 ounces silver per ton (Moen, 1976).

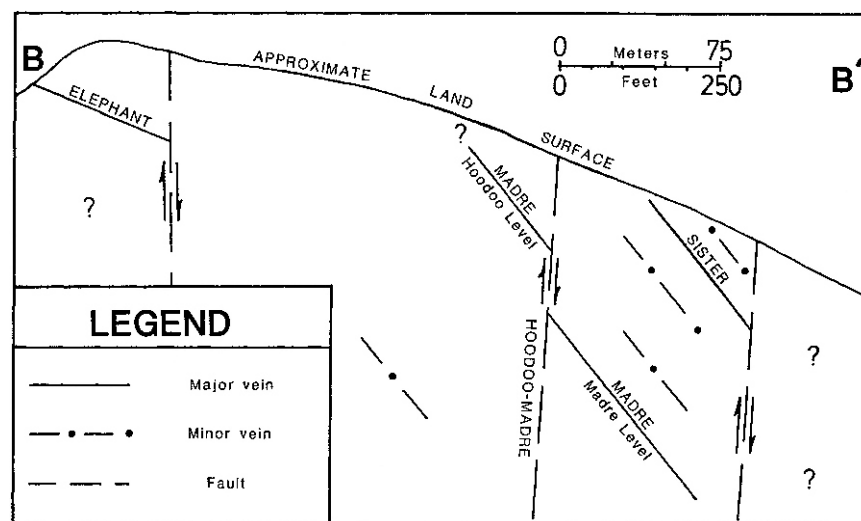
Figure 7. Cross section along line B-B' in Figure 3 showing major faults and veins (after Fluet, 1986).

- The Sister vein was discovered by Madre in the last stages of mine exploration. It may be an altogether separate fissure, or it may be a segment of the Madre vein displaced upward by a near-vertical normal fault (Fig. 7). It was intersected by two diamond drill holes, where “grades of 36.7 ounces/ton and 4.2 ounces/ton over one foot were recorded by Madre Mining records” (Fluet, 1987).

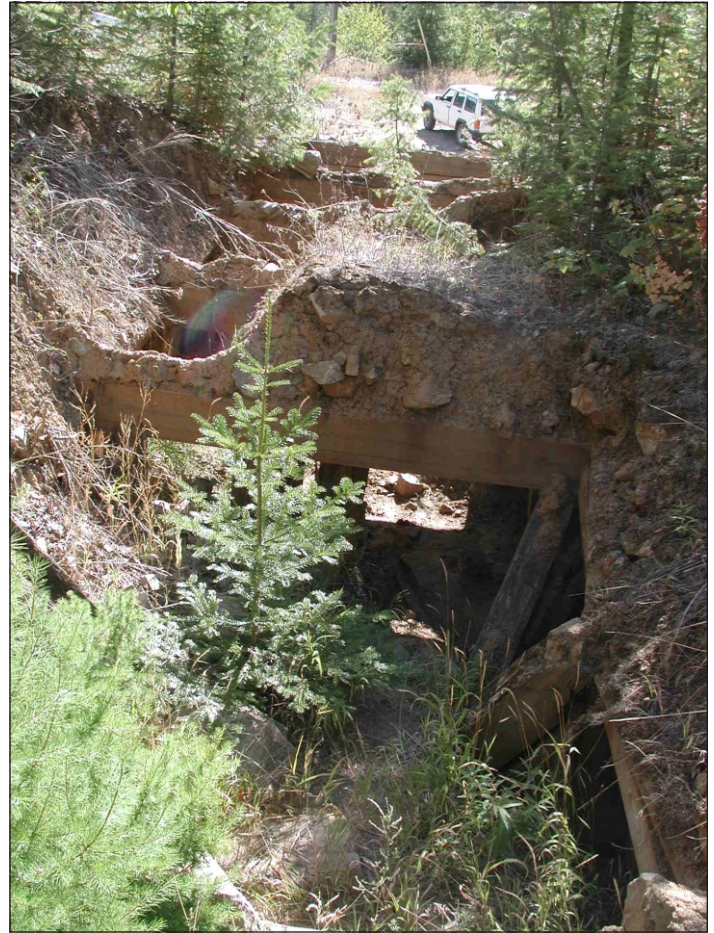
Figure 9. Deer Trail #2 adit showing typical condition of pre-1920 openings.

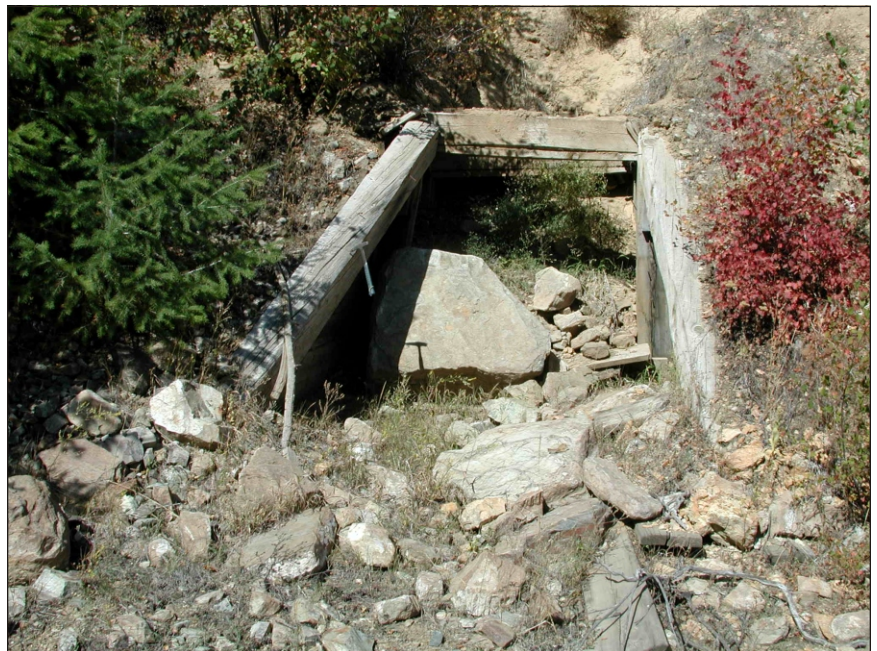
Figure 8. Exposed drift sets of the Madre tunnel. View to the east away from the adit.

All the openings found by DGER personnel in 2003 were caved at the portal, including the Madre tunnel located just above the mill site. Top lagging on the drift sets penetrating the surface alluvium have fallen through, leaving a hazardous condition (Fig. 8). Figure 9 is typical of the condition of pre-1980 adits. BLM installed steel culverts with bat gates in some of these openings in 2005 (M. Sweeney, BLM, oral commun., 2006).

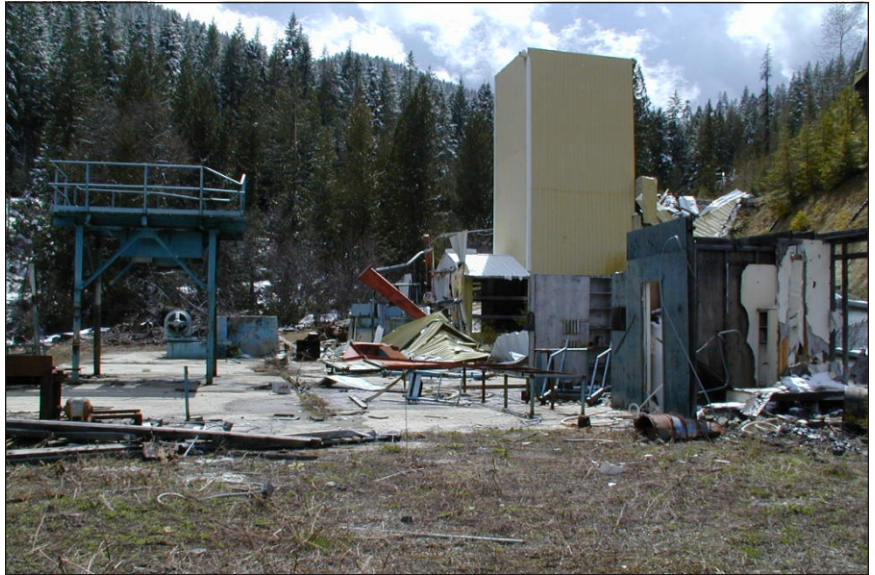
No hazardous materials or containers were found at the site. The mill erected by Madre was dismantled during the 1988 foreclosure action (Fig. 10). The reinforced concrete crusher building is still intact, but the jaw and cone crushers have been removed. The dry house/office has been vandalized, resulting in structural collapse. It is unsafe (Fig. 11). There are two large-diameter recycled tanks on the property, one of which is a 15,000-gallon rail car that supplied water to the mill (Fig. 12).

Figure 10. Remains of Madre mill site after 1988 salvage operation.

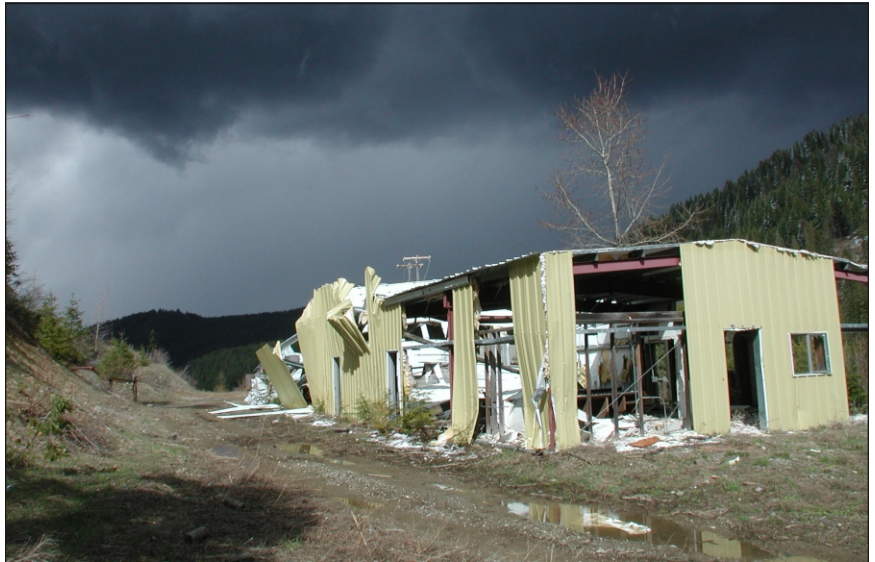
Physical hazards include collapsing sheet metal and concrete block buildings constructed by Madre, and all the former tunnel portals, some of which are partly accessible.

Figure 11. Madre's circa-1981 dry house/office building. View to the north.

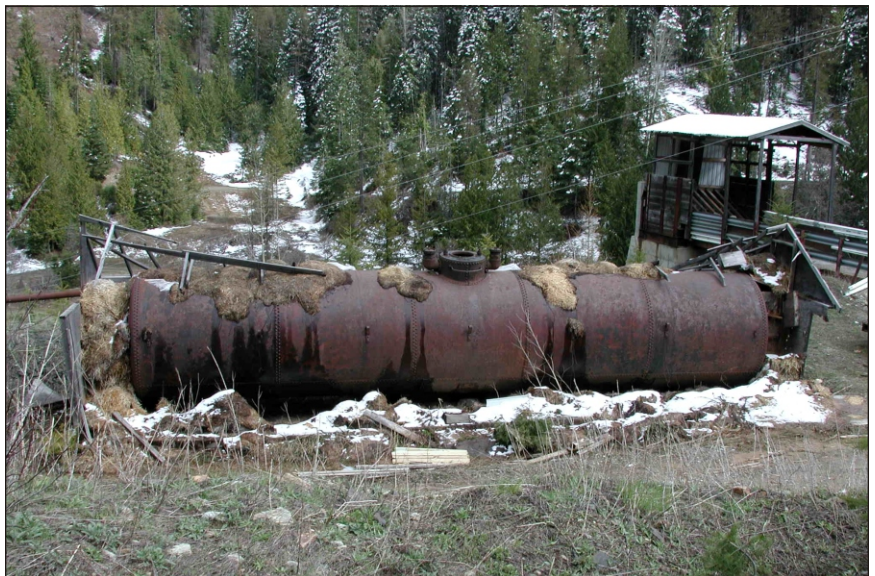
Figure 12. 15,000 gallon water storage tank. Rock tipple at far right. View to the east.

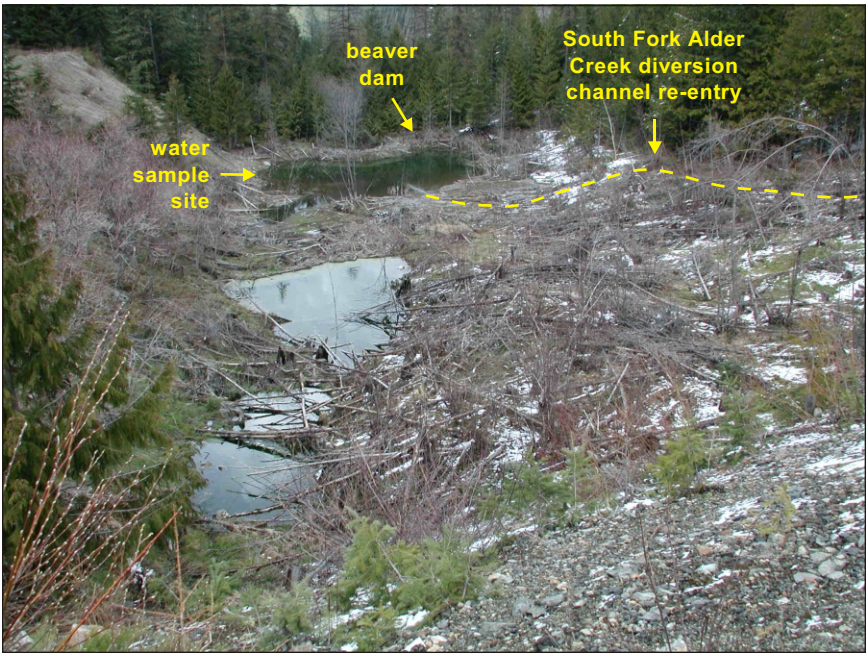
enters the canyon floor (Fig. 13). Meltwater and rain collects temporarily on the surface of the tailings before evaporating or infiltrating (Fig. 14). DGER sampled South Fork Alder Creek ¼-mile above and below the mine-affected area. Both samples exceeded the hardness-based standard for chronic effects of

Metasediment waste rock, predominantly dolomite generated by Madre’s development work, is located in an 80-foot-high embankment adjacent to and north of the Madre tunnel (Fig. 17). Its volume is in excess of 40,000 cubic yards. The tailings impoundments are shown in Figure 18. The combined volume is estimated to be in the range of 20,000 to 30,000 cubic yards, depending on pre-milling topography. A soil sample taken 6 inches beneath the surface of the upper impoundment was analyzed for arsenic, cadmium, copper, lead, and zinc and compared to the Model Toxics Control Act (MTCA) levels for priority contaminants of concern. The zinc analysis exceeded the standard for unrestricted land use, but did not exceed the standard for industrial or commercial use (see Tables 3 and 4). The impoundment berms contain rock aggregate in addition to tailing sand and appear stable (Figs. 13 and 14).

Figure 13. Downstream view of South Fork Alder Creek from crest of lower tailings impoundment. Diversion channel enters lower pond above beaver dam. Note rock aggregate on surface of berm, lower right corner. View to the north.

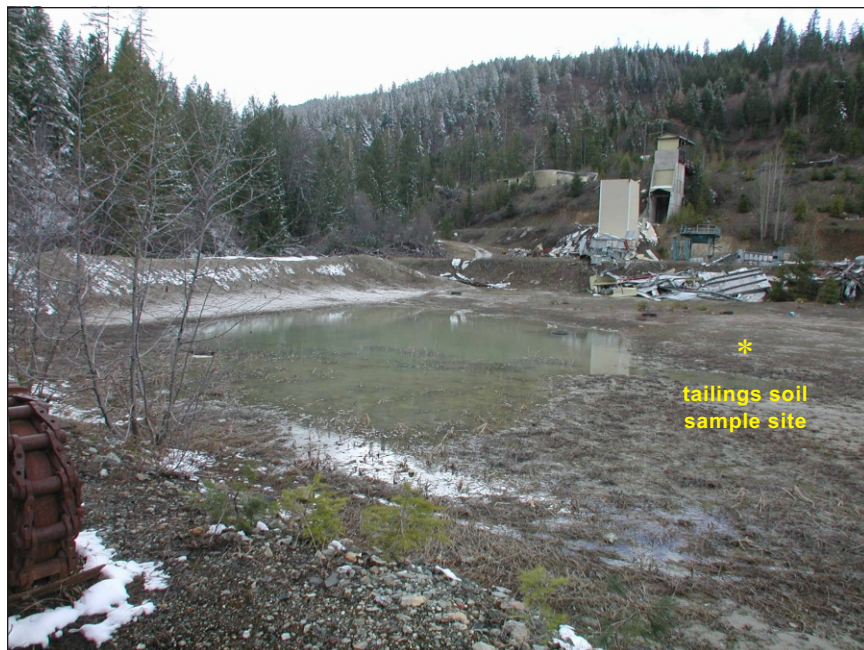
Figure 14. Upper tailings impoundment. Snowmelt water on surface. View to the southwest.

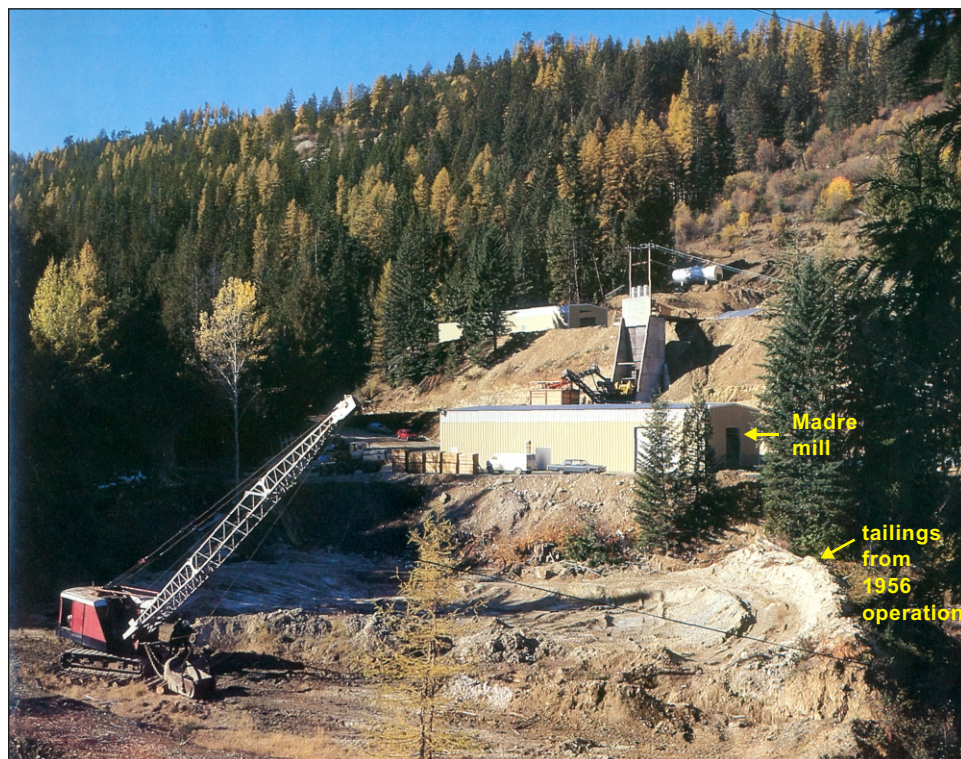
Figure 15. Madre mill site during construction circa-1981. Note dragline constructing berms for new tailings impoundment from surface alluvium and Venus Silver mill tailings. View to the southwest. (After Madre Mining Ltd., 1981.)

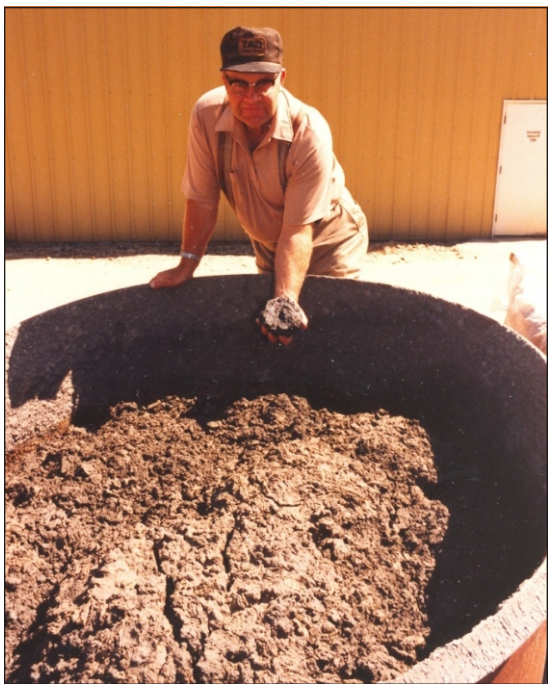
Figure 16. Madre silver-lead-zinc concentrate ready for shipment to the Cominco smelter at Trail, B.C., October 1983. Brownish cast of concentrate is due to high sphalerite content. (Photo courtesy of Mack M. Slate.)

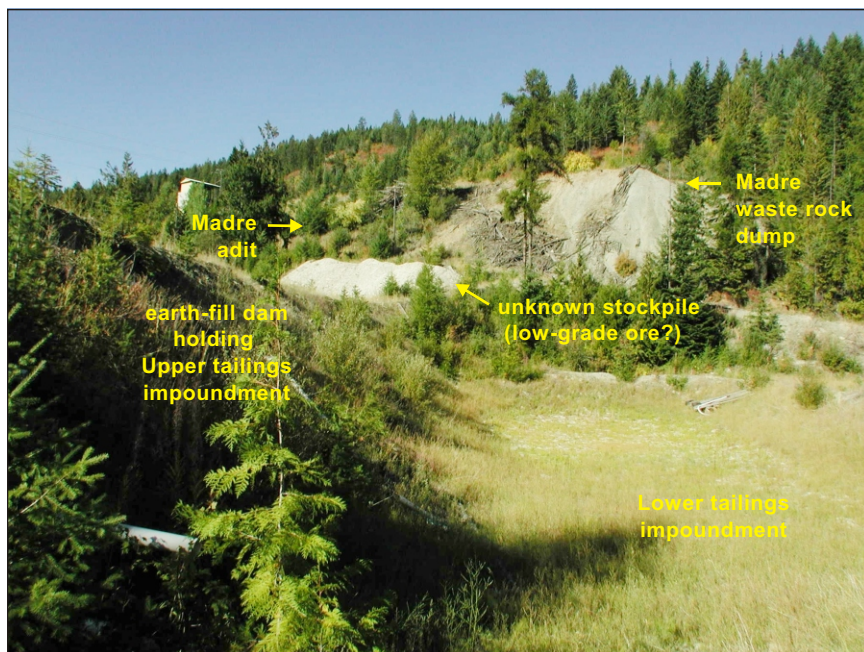
Figure 17. Overall view of Madre waste rock dump. View to the southwest.

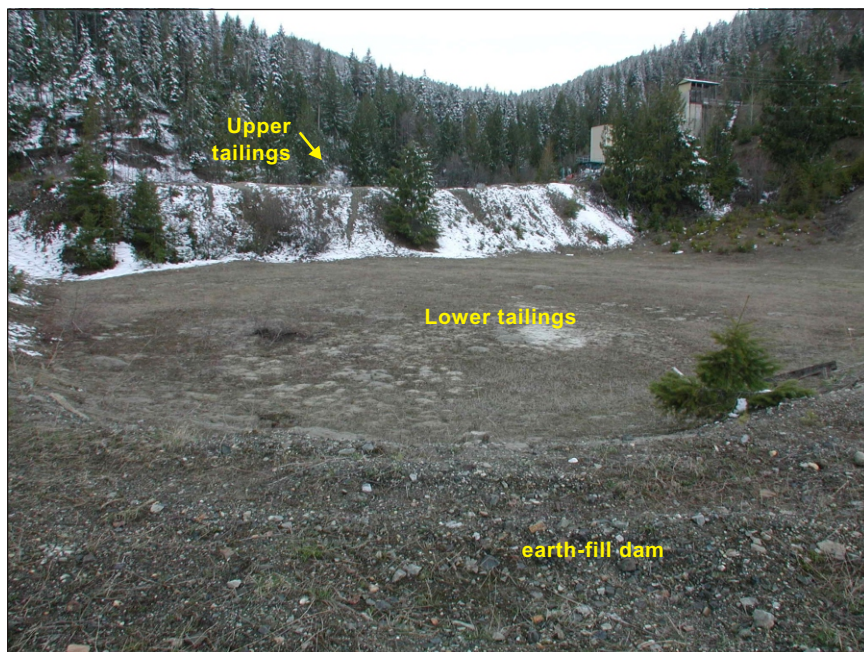
Figure 18. Upper and Lower tailings impoundments. View to the south.
