First Periodic Review Bruce Titus Chevrolet

**633 Division Avenue, Tacoma, Pierce County, 98403
Facility Site ID: 3427832, Cleanup Site ID: 5318**

Toxics Cleanup Program, Southwest Region

December 2024

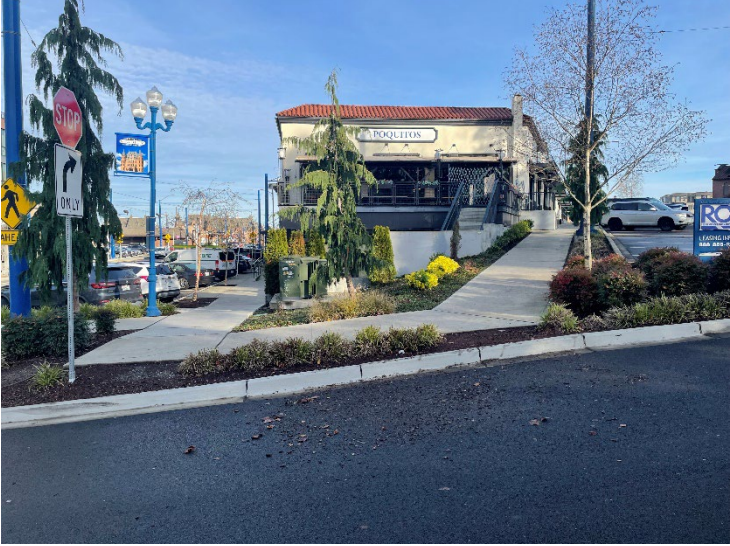
A wide-angle photograph showing a two-story building with a red-tiled roof and a sign that reads "BUCE TITUS". The building is situated on a street corner. In the foreground, there is a paved sidewalk, a landscaped area with trees and shrubs, and a street with a stop sign and a "ONE WAY" sign. The sky is clear and blue.	<p>1. View of property from the south, looking northeast.</p>

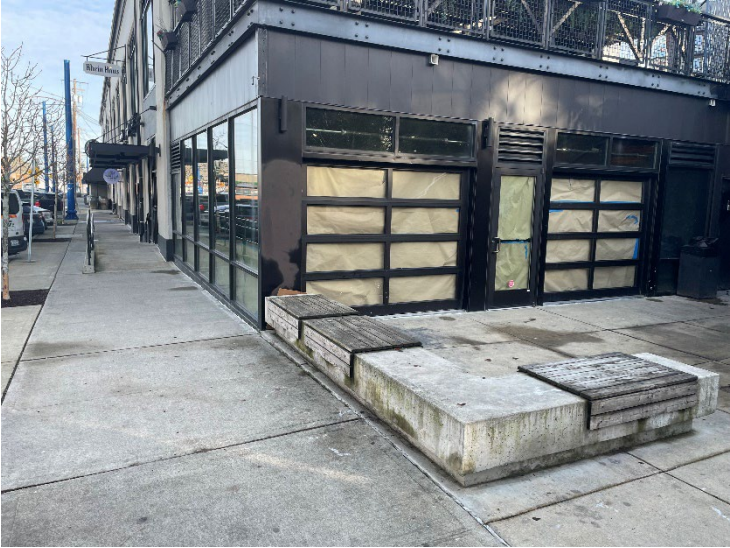
As noted in the monitoring reports, the Covenant area includes landscaped areas maintained by the City of Tacoma. These areas are located south of the main building and paved patio area (see photographs in Appendix C) and were reportedly installed prior to the Covenant. The monitoring reports conclude that the landscaped areas do not compromise the integrity of the remedy based on the depth to contaminated soil (>15 feet; i.e., protective of the direct contact pathway) and lack of TPH and related impacts to groundwater at well MW-11 (i.e., protective of the leaching pathway). This interpretation is consistent with the historical sampling data provided in the previous reports and with the long-term groundwater monitoring results. In addition, most of former south gas station area, including the former UST locations, is under the fully paved sections.

A photograph showing a close-up view of a concrete sidewalk and a courtyard area. The sidewalk is made of large concrete slabs. In the background, there is a building with large glass windows and a dark metal frame. The courtyard area is paved and has some concrete blocks or steps. The sky is clear and blue.	<p>2. View of sidewalk west of building and courtyard south of building, looking northeast.</p>

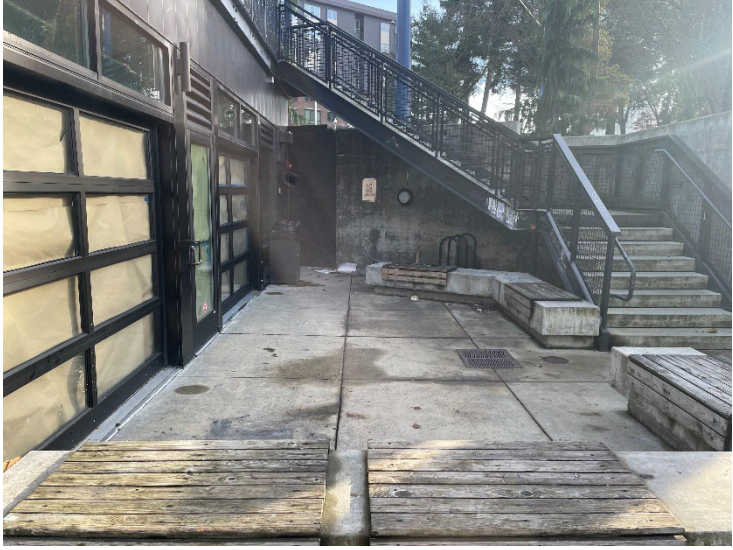
Ecology generally concurs with these conclusions regarding the landscaped areas within the Covenant boundaries, but cautions that the landscaped areas present a greater potential for infiltration and leaching from the former Gas Station Area. If any Site contaminants are detected in future groundwater samples at MW-11, Ecology may request additional investigation to evaluate the leaching pathway.

<p>3. Paved courtyard area south of building, approximate former serviced station location, view to the east.</p>

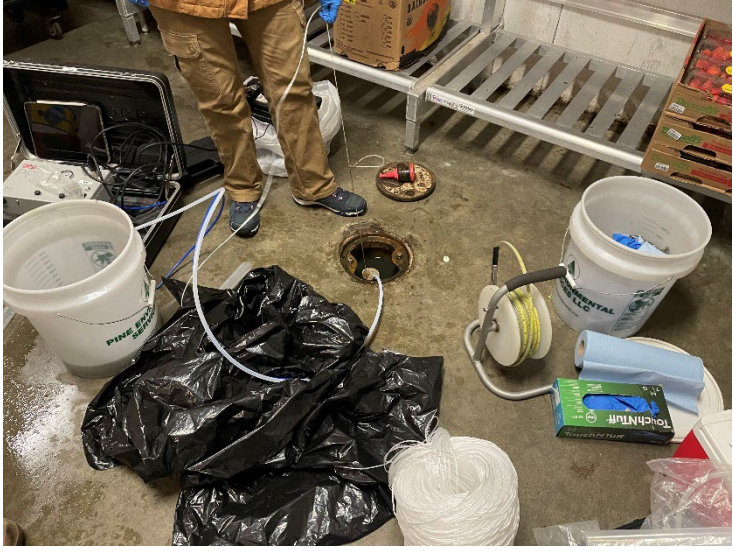
<p>4. Well MW-11, located inside grocery store storage room.</p>

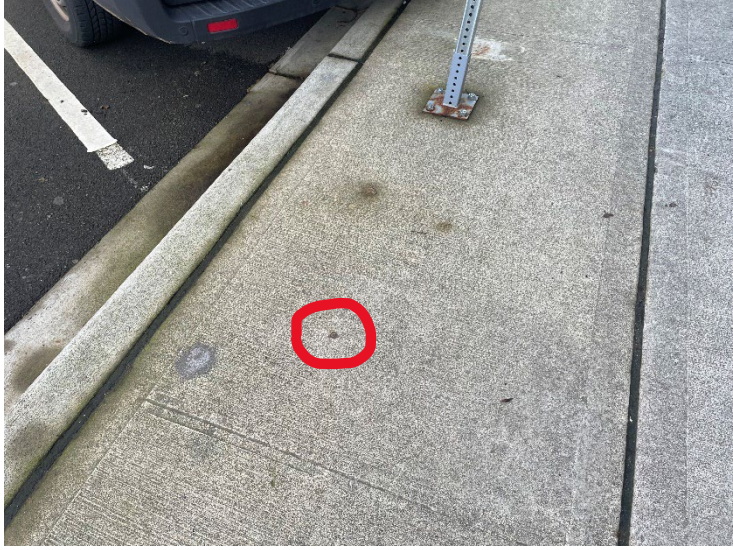
<p>5. Marker A, located in sidewalk near southwest building corner (circled).</p>

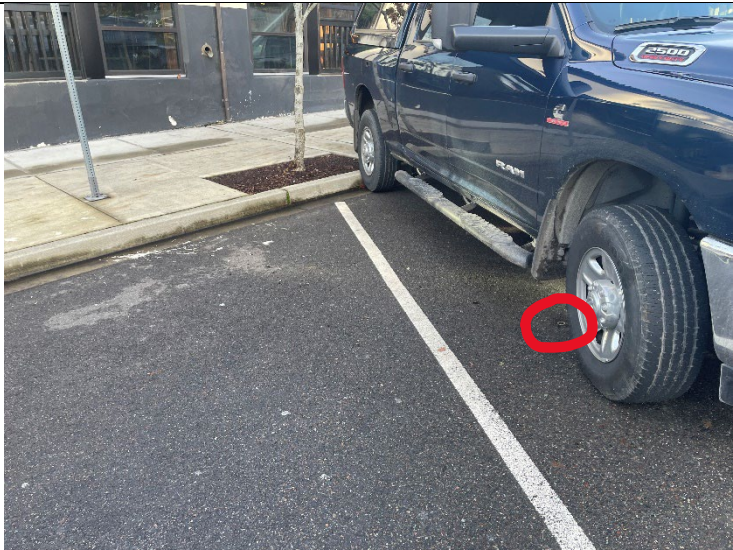
<p>6. Marker B, located in roadway near southwest corner of building (left of front truck tire, circled).</p>

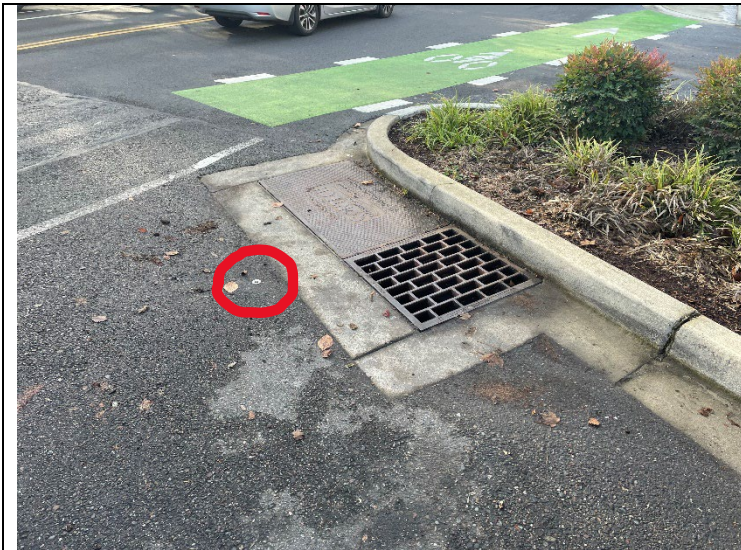
7. Marker C, in asphalt to the left of the catch basin, southeast corner of covenant area (circled), marker is offset 4 feet east from the EC area corner.

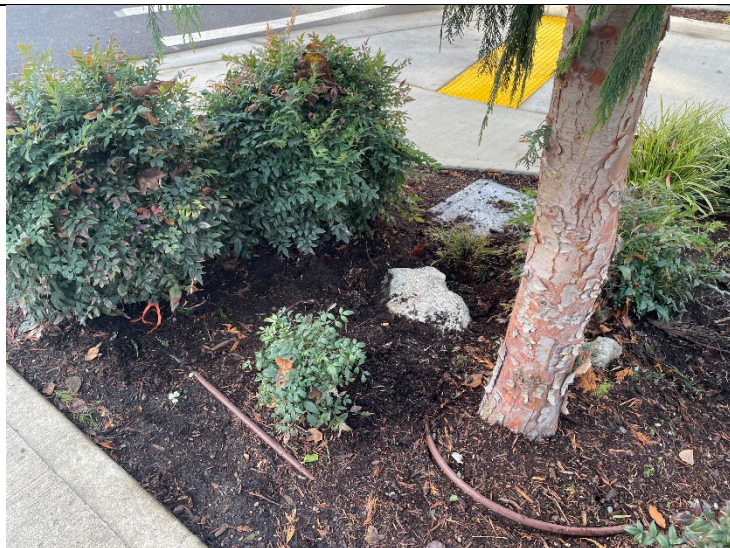
The inspection and sampling reports indicate that the building and pavement caps are intact and unchanged. This conclusion is consistent with Ecology's observations during the December 2023 site inspection. Markers at each corner of the Covenant area (see Appendix B maps) were located and are intact, except for Marker D which was not found. Based on maps and photographs provided in previous reports, the approximate location of Marker D was identified in the field. It appears that the marker (described as a rebar cap) may have been buried under landscaping bark and topsoil. The previous maps and photographs were sufficient to identify

8. Marker D location, presumed buried under bark near rock in center of photo, marker not located but location identified from photos and maps provided in reports, southwest corner of covenant area.

the corner of the Covenant area for the purposes of inspection. **Ecology recommends reinstalling the marker if it is not found during the next inspection event.**
