Re: DTG Yakima – Agreed Order No. DE 21624 – Monthly Progress Letter – December

Re: Monthly Data Assessment Report DTG Yakima Landfill Fire Incident – December 2024

DTG LPL LANDFILL FIRE INVESTIGATIONS AND MITIGATION

Monthly Monitoring Data Review
December 2024

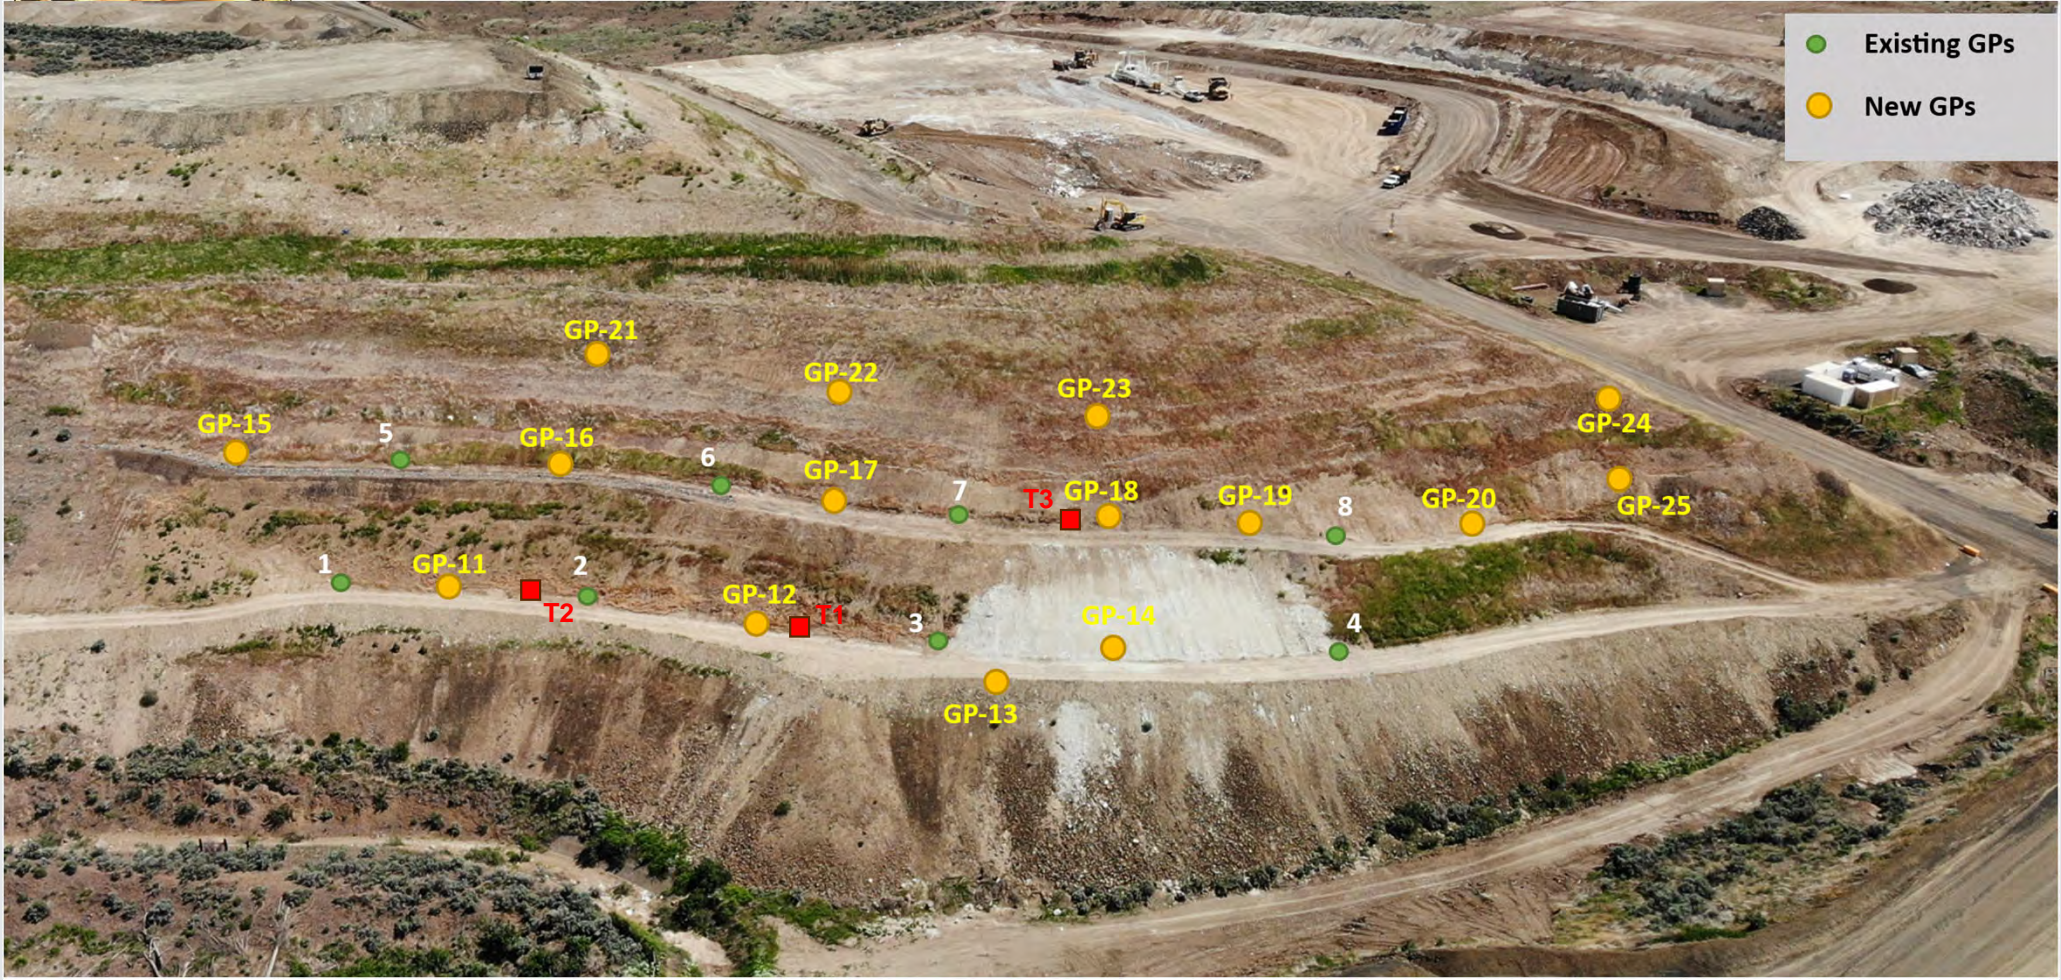
- Existing GPs
- New GPs
