Pre-Engineering Design Investigation Data Report

Riverside HVOC Site

Prepared for City of Bothell

December 2024 DRAFT

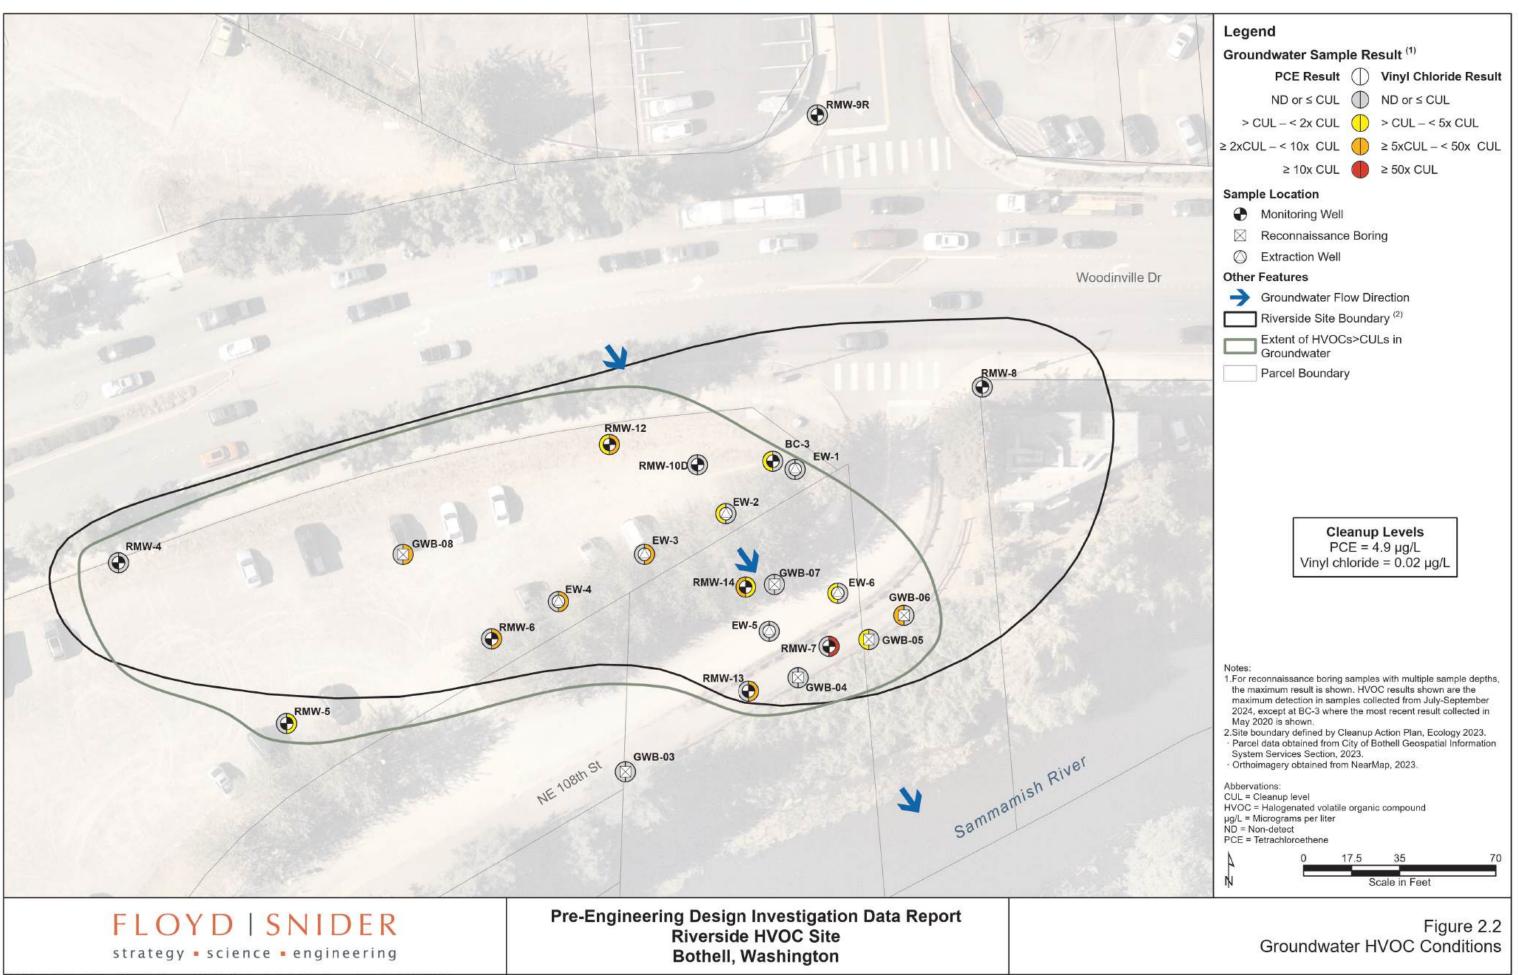
Groundwater samples were analyzed for PCE, TCE, *cis*- and *trans*-1,2-DCE, and vinyl chloride. Groundwater monitoring results for the PDI and all available historical sampling events are shown in Table 2.2. Key groundwater results for PCE and vinyl chloride (the final toxic degradation product of PCE) are also shown in Figure 2.2.

For consideration of nature and extent of HVOCs, as well as migration and degradation mechanisms, the Site HVOC plume can be subdivided into four subareas (refer to HVOC results presented in Figure 2.2):

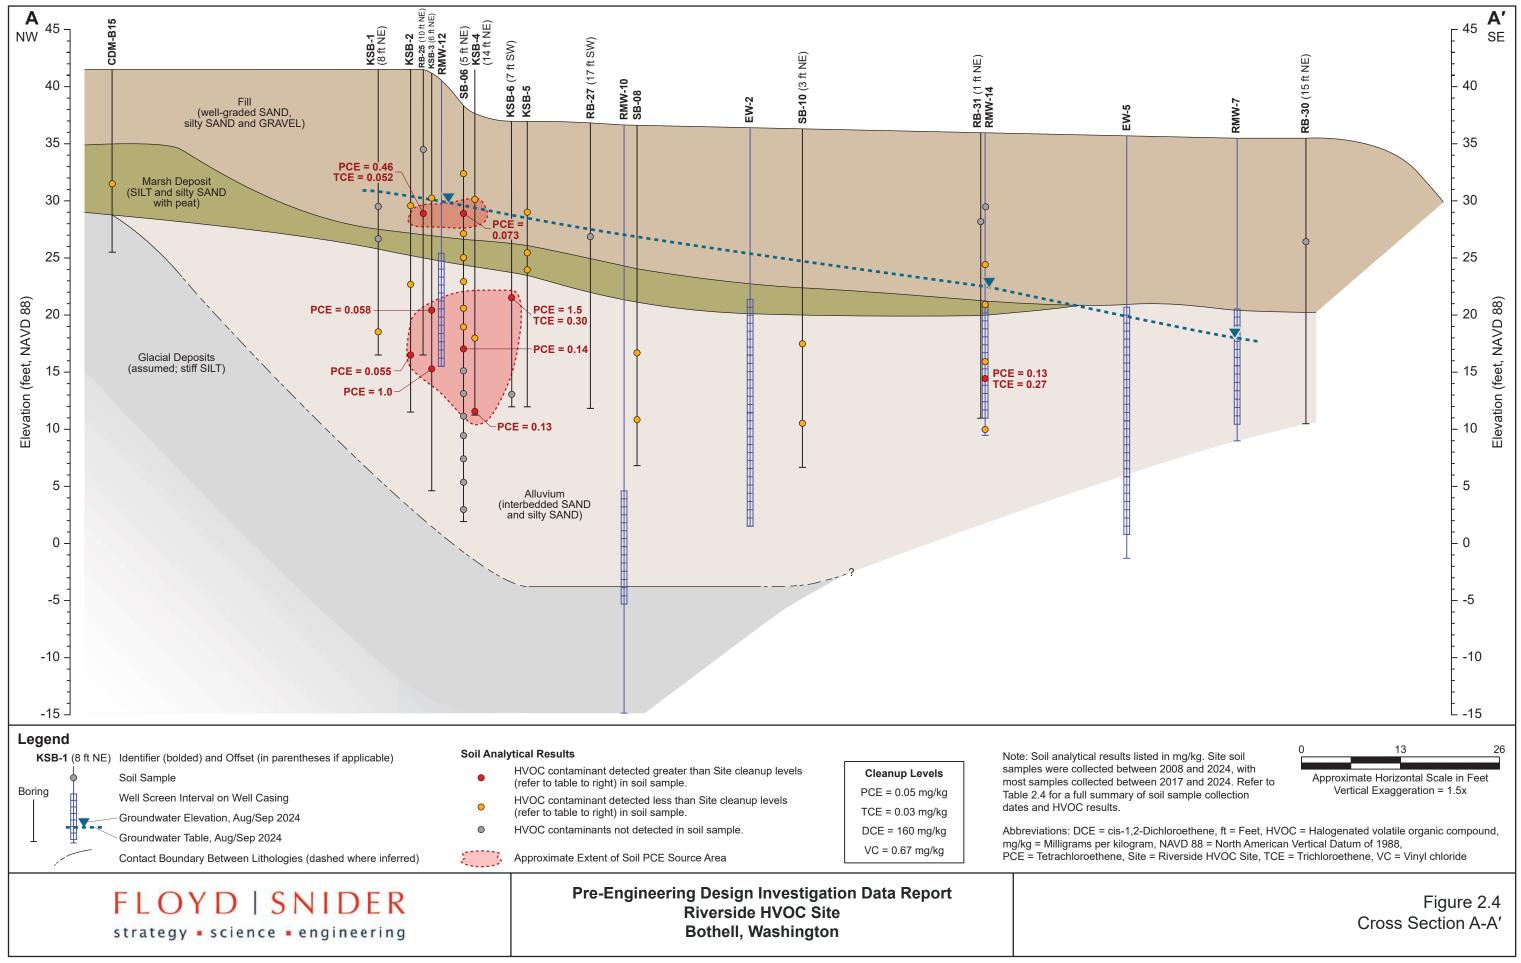
I:\GIS\Projects\COBothell-Riverside\00-AI\PDI Data Report\Figure 2.4 Cross Section A-A'.ai

Soils encountered at the Site consisted of an uppermost fill unit underlain by alluvium deposits. The fill was composed of varying amounts of well-graded sand, silty sand, and gravel and contained occasional anthropogenic debris. The contact between the fill and native alluvium was characterized by a peaty silt consistent with marsh deposits approximately 2 feet thick. Below the peaty deposit, soils consisted of interbedded fine sand and silty sand. Alluvium was observed to the deepest depth of 40 feet bgs explored during the PDI. Historical boring logs noted deeper occurrences of a stiff silt (for example, beginning at 40 feet bgs at RMW-10), which was interpreted to be a glacially deposited unit in prior reports.

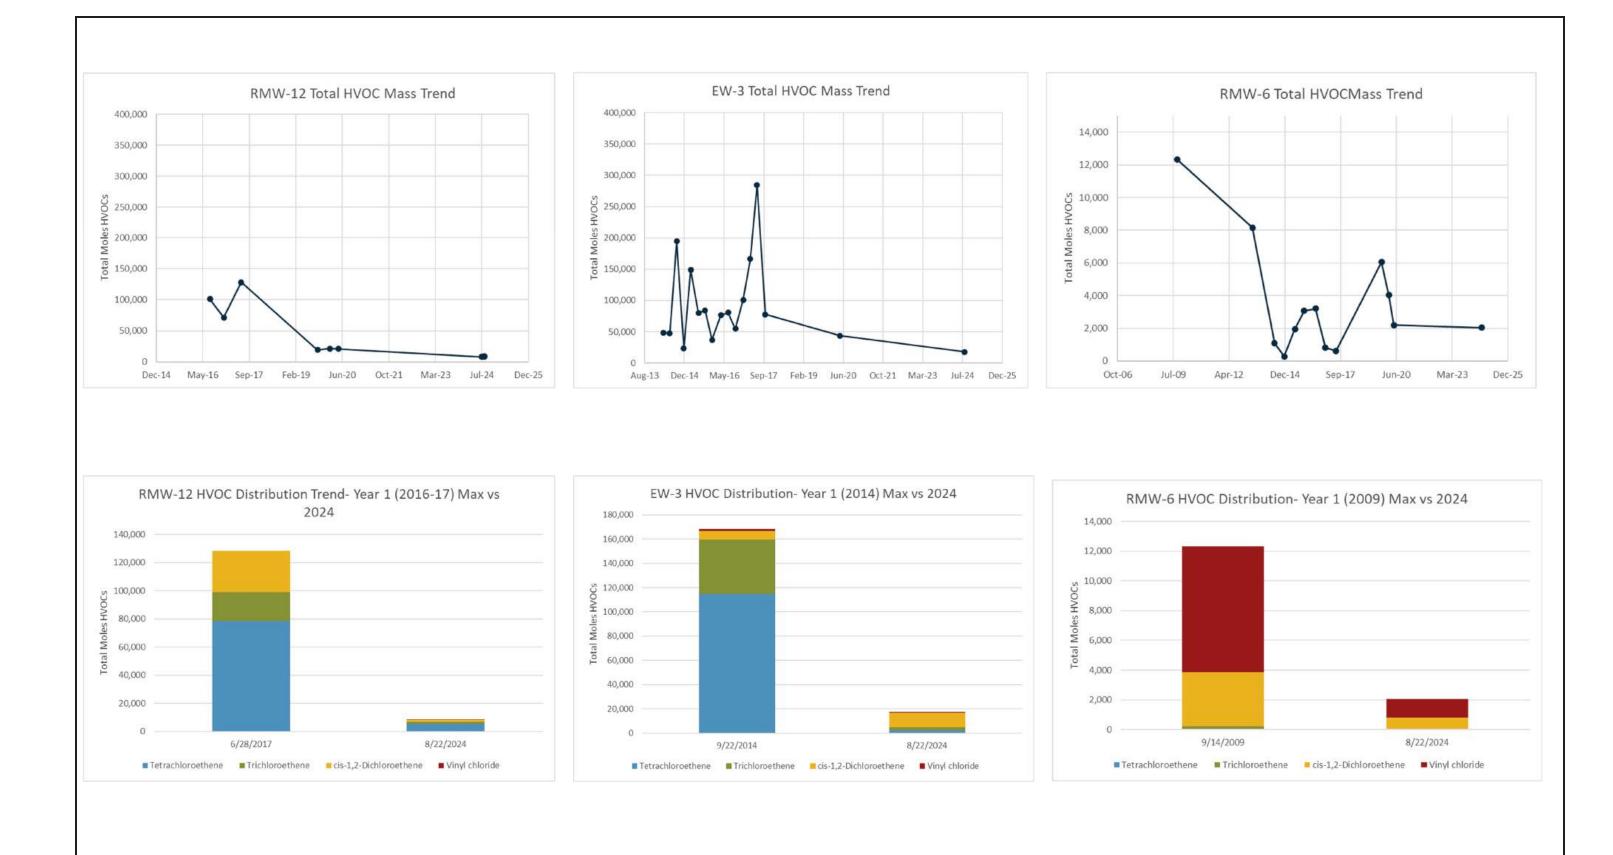
Figure 3.1 HVOC Molar Concentrations: Source Area and Upgradient Plume (Sheet 1 of 3)

For the permanent monitoring and extraction wells, the progress of mass removal and contaminant degradation within each subarea of the HVOC plume discussed above are further illustrated by analyzing changes in total HVOC molar concentrations and molar fractions of individual HVOCs over time. A molar concentration is a measure of the number of molecules of a given contaminant in a sample, which is obtained by normalizing the bulk concentration reported by the laboratory (in micrograms per liter) with the molecular weight of the compound

(in grams per mole [g/mol]). Molar weights are useful for compounds such as HVOCs that undergo a degradation process (dechlorination) that produces toxic daughter products with lesser molecular weights than the source contaminant. Molar concentrations of HVOCs in a sample, therefore, provide more precise information versus bulk concentrations to determine whether dechlorination is occurring, as well as the relative contributions of dechlorination versus physical extraction to the removal of HVOC molecules from Site groundwater.

The HVOC contamination within the source area (i.e., at RMW-12, BC-2, and EW-1 through EW-4) prior to groundwater extraction was composed primarily of PCE, with lesser fractions of TCE and *cis*-1,2-DCE and small amounts of vinyl chloride, as shown on the HVOC distribution trend plots in Figure 3.1. At the nearby wells on the plume edges (i.e., RMW-6 and RMW-8), the more mobile degradation products TCE, *cis*-1,2-DCE, and vinyl chloride made up most of the HVOC mixture. The distribution of HVOCs in the source plume has remained largely consistent over the duration of groundwater extraction while the overall concentrations have decreased, indicating that removal by pumping has caused most of the reduction of HVOC molar mass is now primarily *cis*-1,2-DCE; however, this appears to be a lesser contribution to overall mass reduction. There is some observed fluctuation of total HVOC molar mass between wet and dry seasons at RMW-8 during more recent sampling events; however, these potential fluctuations are within the context of overall low and relatively stable HVOC mass.

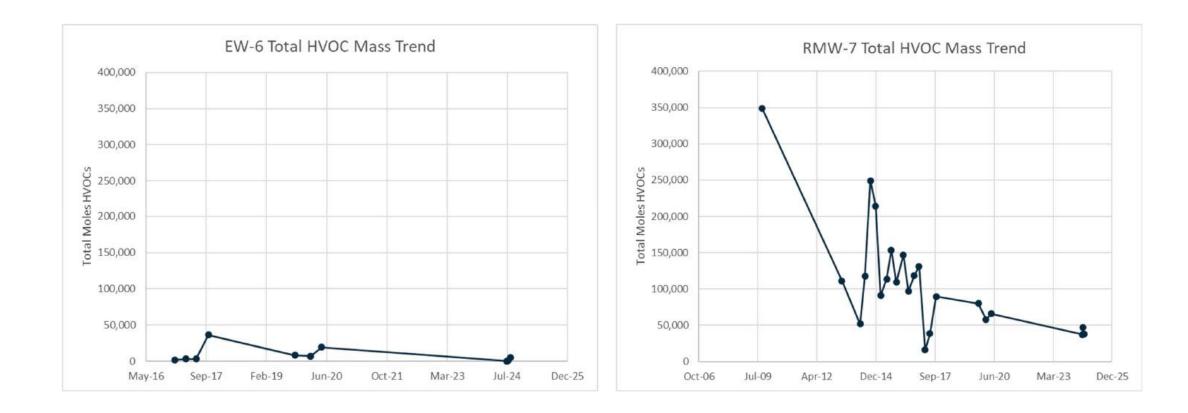
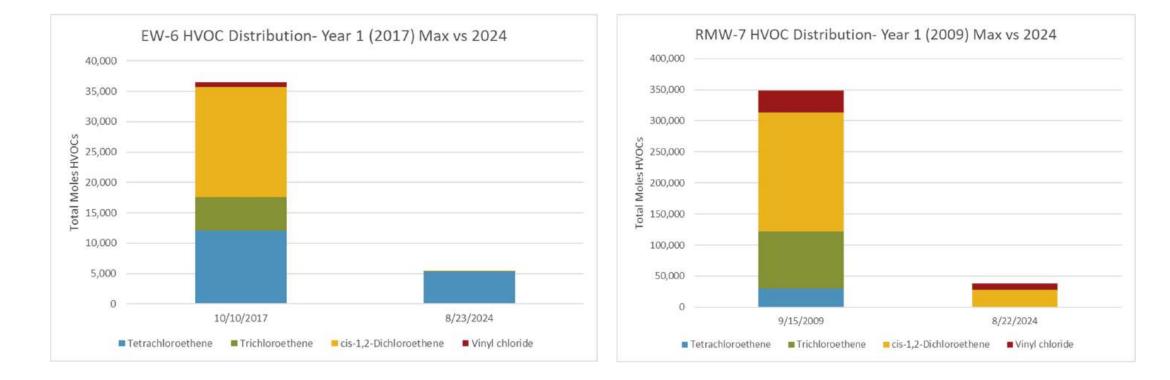
Figure 3.2 HVOC Molar Concentrations: Downgradient Plume (Sheet 2 of 2)

The initial distribution of HVOCs in the downgradient plume was more variable prior to pumping, with fractions of more highly mobile degradation products (i.e., *cis*-1,2-DCE and vinyl chloride) increasing with distance downgradient from the source area as shown on the distribution trend plots on Figure 3.2.

Similar to the source area and upgradient portions of the plume, the distribution of HVOCs has remained relatively consistent while overall concentrations have decreased, indicating that pumping has caused most of the mass reductions. However, farthest downgradient at RMW-7, remaining HVOCs are primarily *cis*-1,2-DCE and vinyl chloride, suggesting that dechlorination has also occurred.

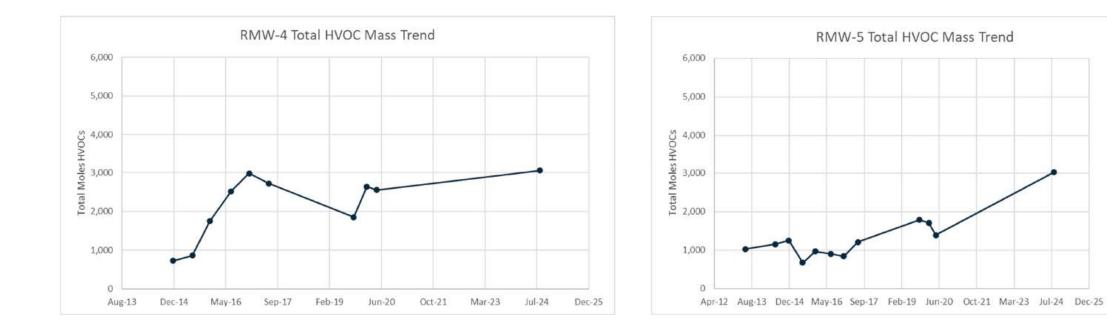
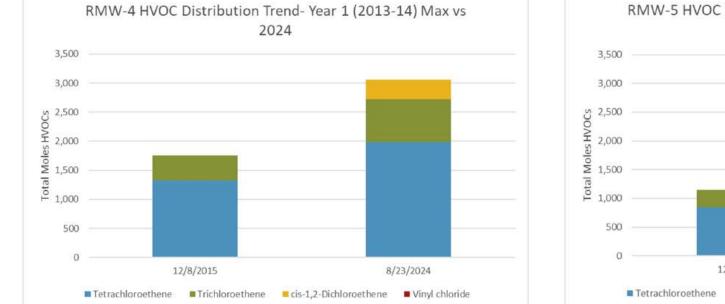
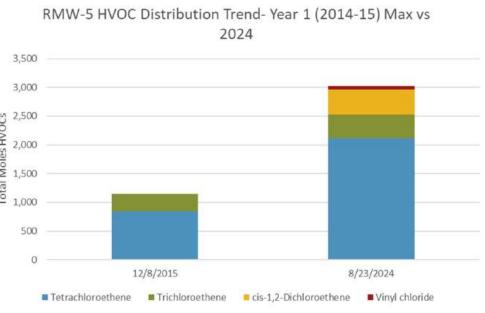
Figure 3.3 HVOC Molar Concentrations: Western Plume

Overall HVOC mass has been stable to slightly increasing at the permanent wells in this area as shown on the mass trend plots in Figure 3.3. The HVOC distribution trend suggests that dechlorination has occurred, as illustrated by increases in *cis*-1,2-DCE fractions at both wells and vinyl chloride fraction at EW-5; however, degradation appears to be slow and incomplete based on the relatively flat trends in HVOC concentrations during recent sampling events.

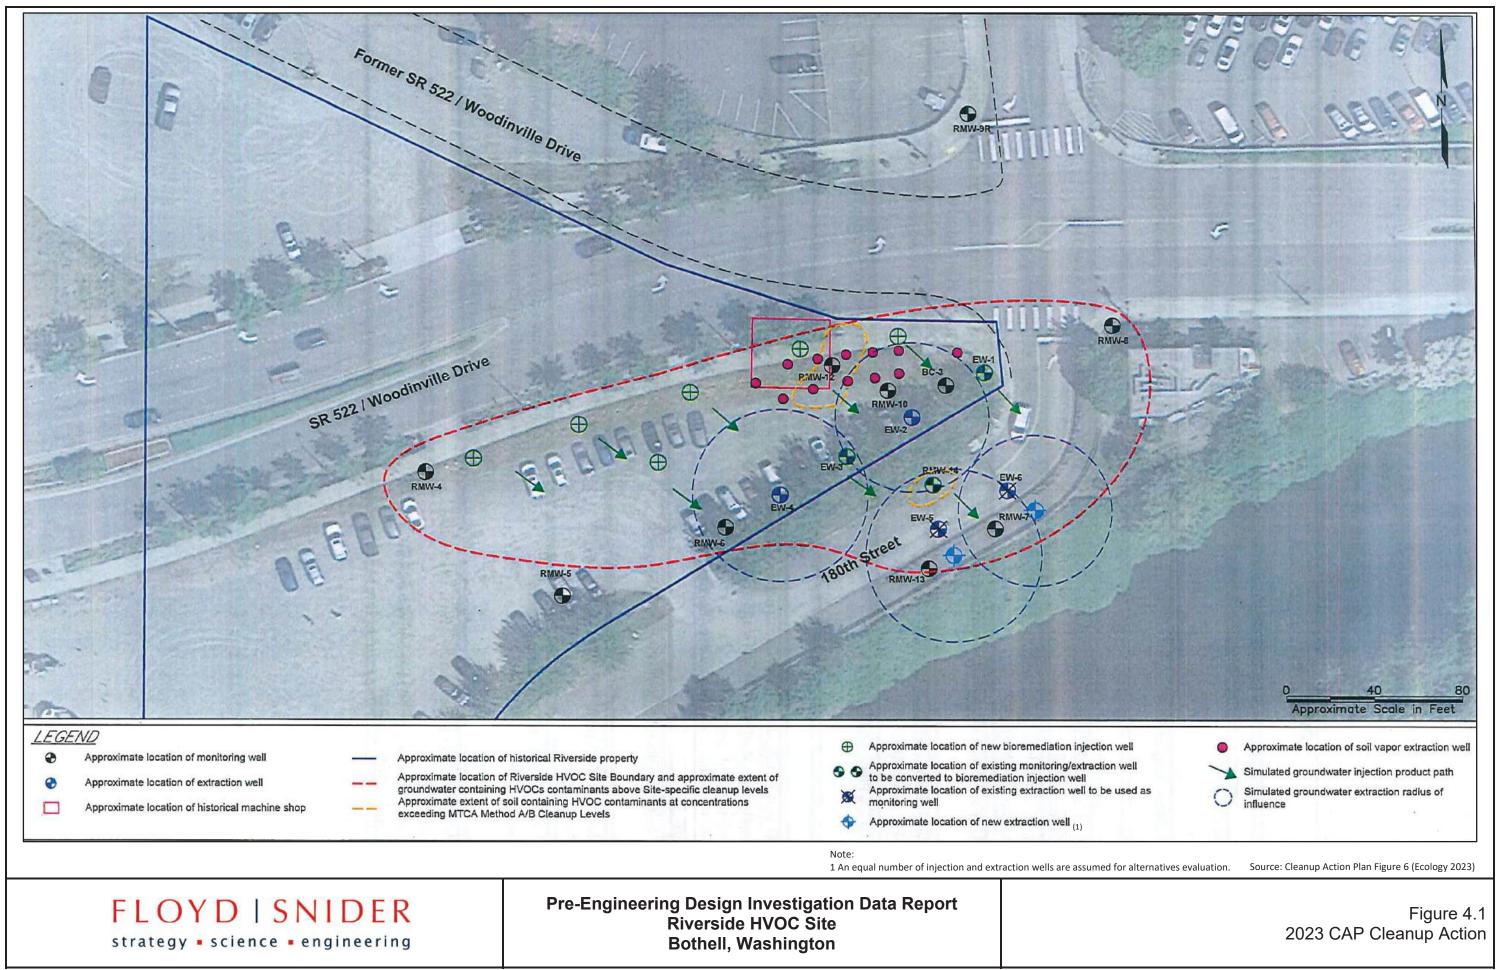
The 2023 CAP cleanup action includes soil vapor extraction and Site-wide recirculation of groundwater amended with a soluble organic carbon substrate electron donor (CarBstrate) to enhance biodegradation of HVOCs (Ecology 2023). The elements of the 2023 CAP cleanup action are shown on Figure 4.1, which is reproduced from the CAP.

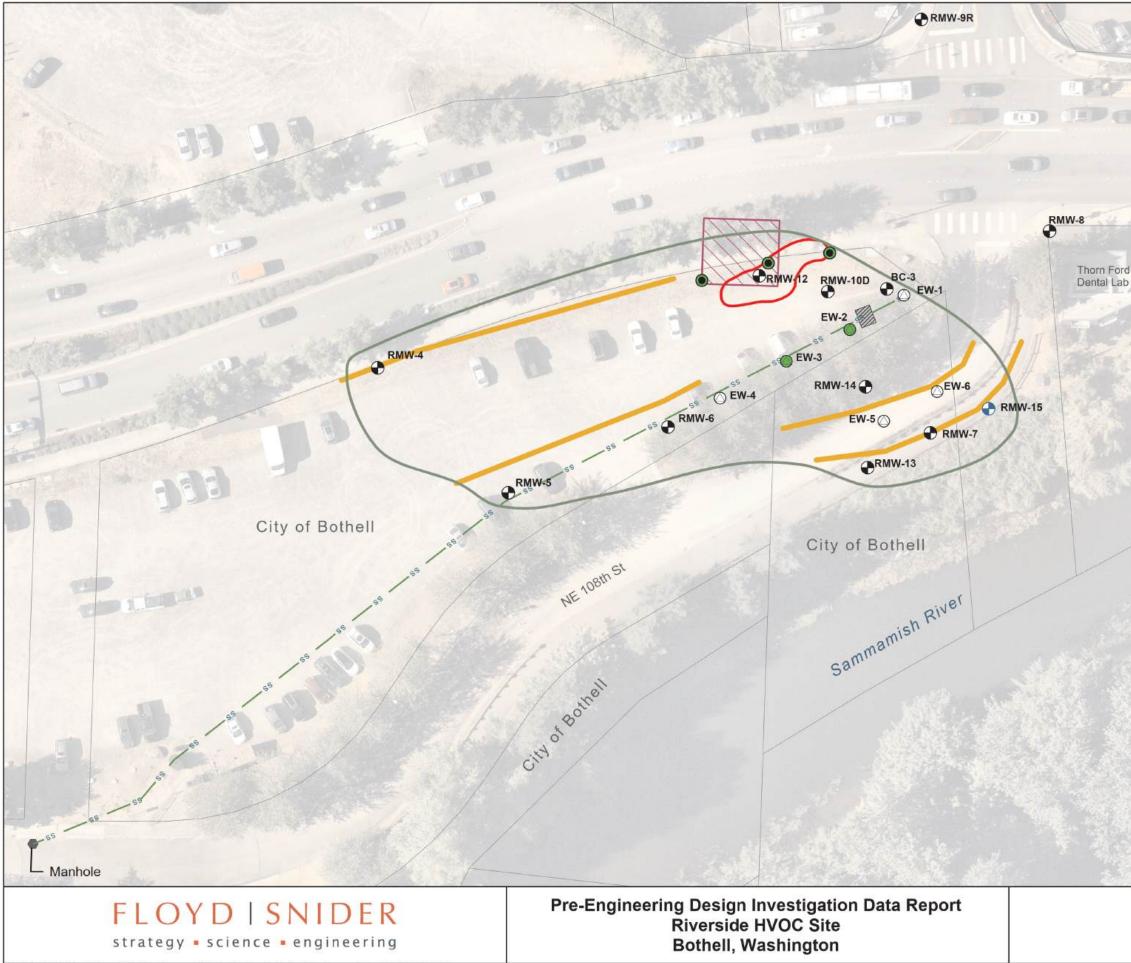
Figure 4.2 Revised Alternative 1

The elements of Alternative 1 are shown on Figure 4.2. This alternative retains groundwater treatment with a soluble organic carbon electron donor, which is expected to be effective in achieving anaerobic biodegradation of HVOCs at the Site, and supplements this alternative with beneficial cultures of bacteria that degrade HVOCs. It additionally addresses potential downgradient vinyl chloride migration by using the alternate technology of passive treatment in the direction of groundwater flow.

Implementation of the cleanup action would include regular O&M including weekly application of soluble organic carbon and periodic changeout of activated carbon vessels used to remove HVOCs from extracted groundwater prior to recirculation. The bio-recirculation system is designed to run for 2 years. The estimated restoration time frame for this cleanup action is 5 years, because the organic carbon added during active recirculation is expected to form biomass that will continue to provide donor electrons to complete the process of anaerobic degradation.

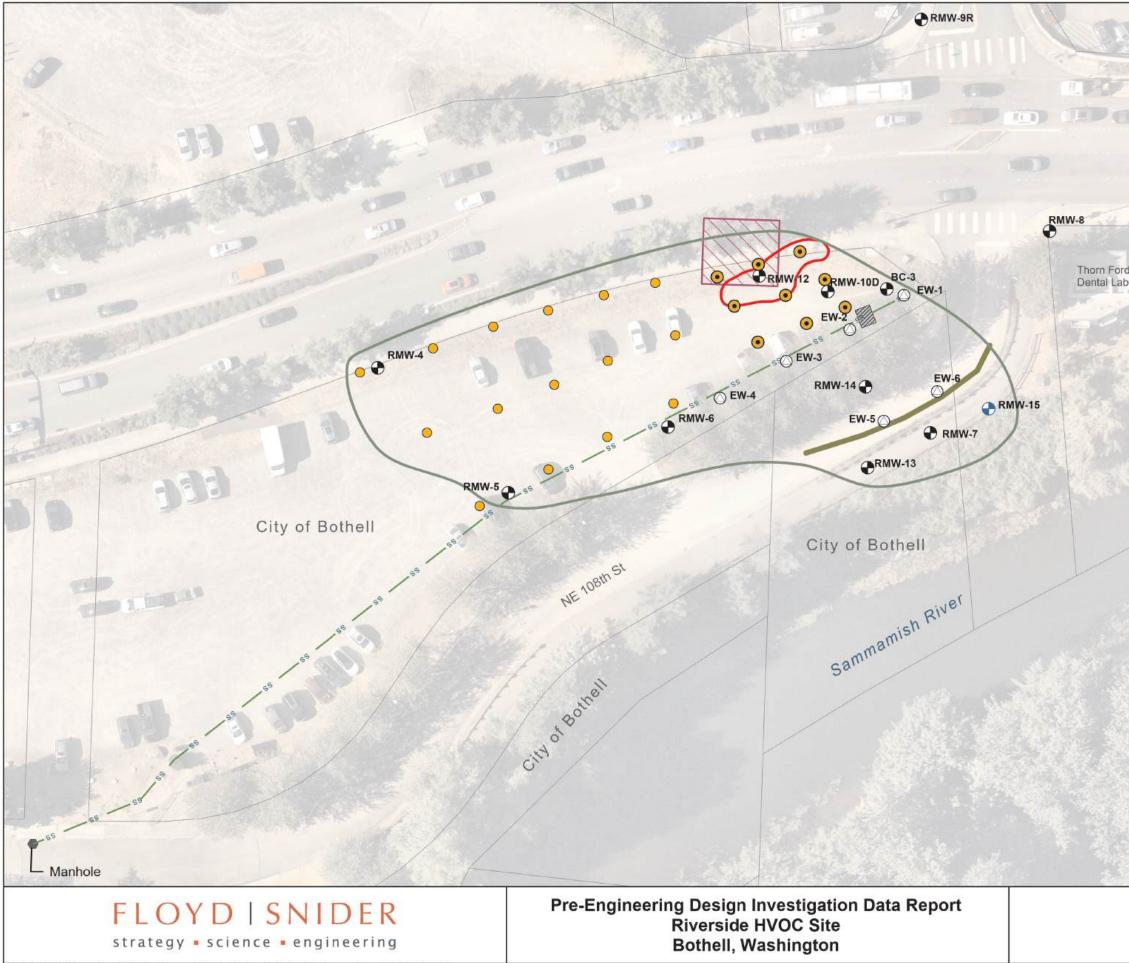
The elements of Alternative 2 are shown on Figure 4.3. This alternative supplements source area treatment with ZVI to achieve prompt abiotic degradation of PCE and TCE and ensure ongoing reducing conditions to promote anaerobic biodegradation. The addition of ZVI, combined with a controlled-release form of organic carbon, allows for a single direct-push application of the treatment materials in lieu of recirculation to degrade the remaining HVOC mass. The addition of colloidal activated carbon downgradient is designed to adsorb HVOCs and allow longer contact time with the treatment materials, which will allow for more rapid cleanup of downgradient groundwater. A double row of injections is assumed in order to form a highly effective barrier. The estimated restoration time frame for this cleanup action is 3 years.
