# Technical Memorandum

Project No.: M0624.04.024

Re: November 2024 Compliance Monitoring–AOC 1  
Northern State Multi Service Center, Sedro-Woolley, Washington  
Agreed Order No. DE 16309, Cleanup ID: 10048

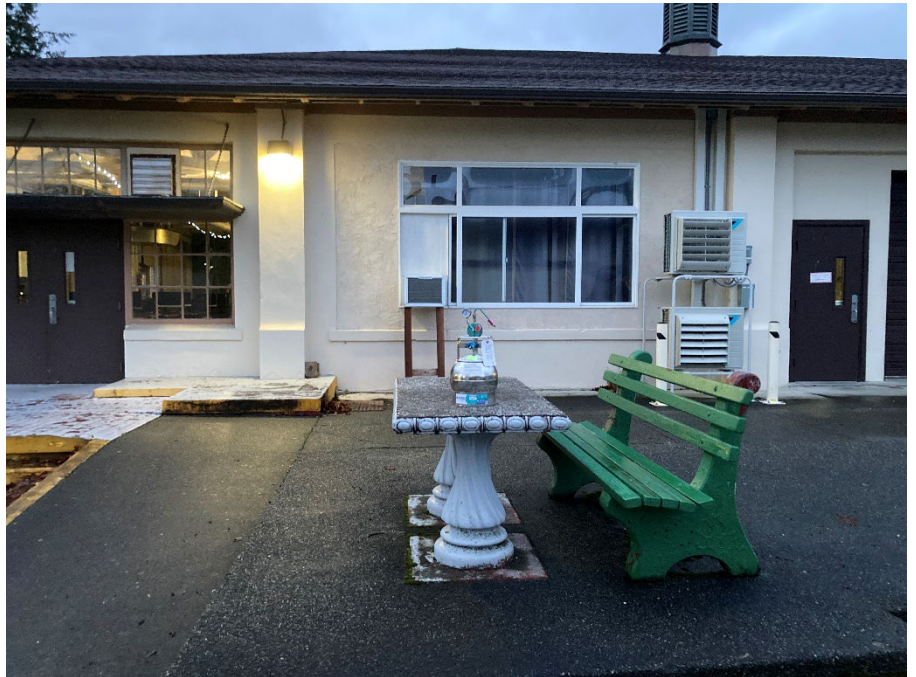
## Photo No. 1.

Outdoor air sample  
OUTAIRO2 on the east  
side of the building,  
collected on November  
19, 2024.

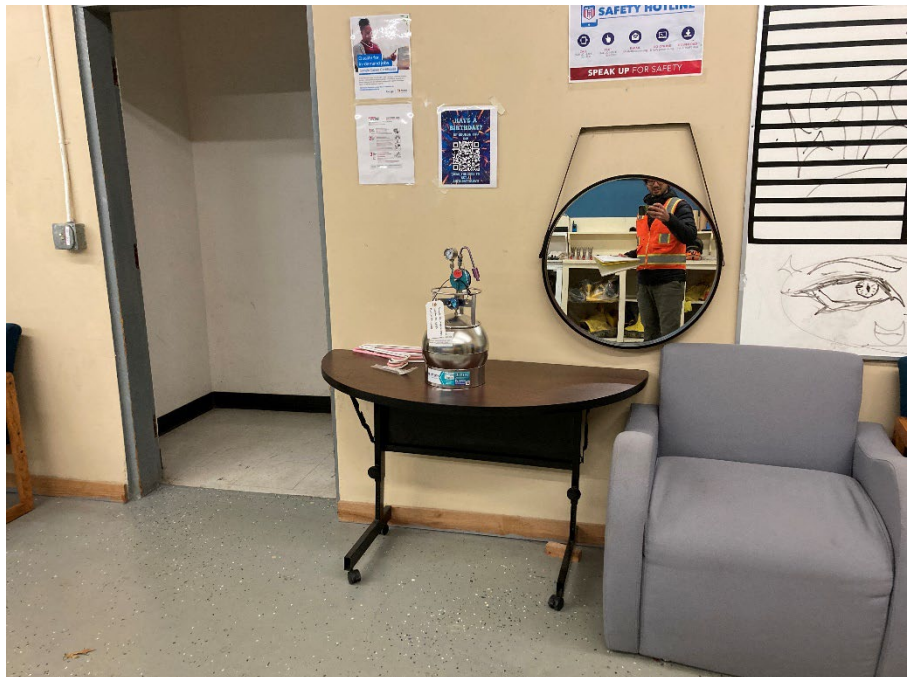
## Photo No. 2.

Indoor air sample  
INAIRO1 in the northern  
portion of the building,  
collected on November  
19, 2024.

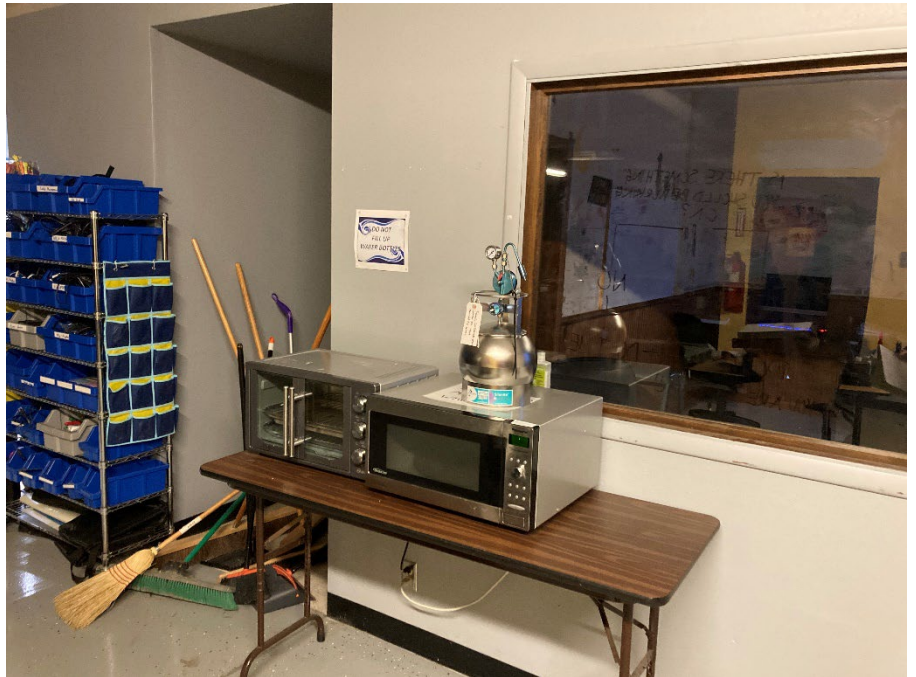
## Photo No. 3.

Indoor air sample  
INAIRO2 in the central  
portion of the building,  
collected on November  
19, 2024.

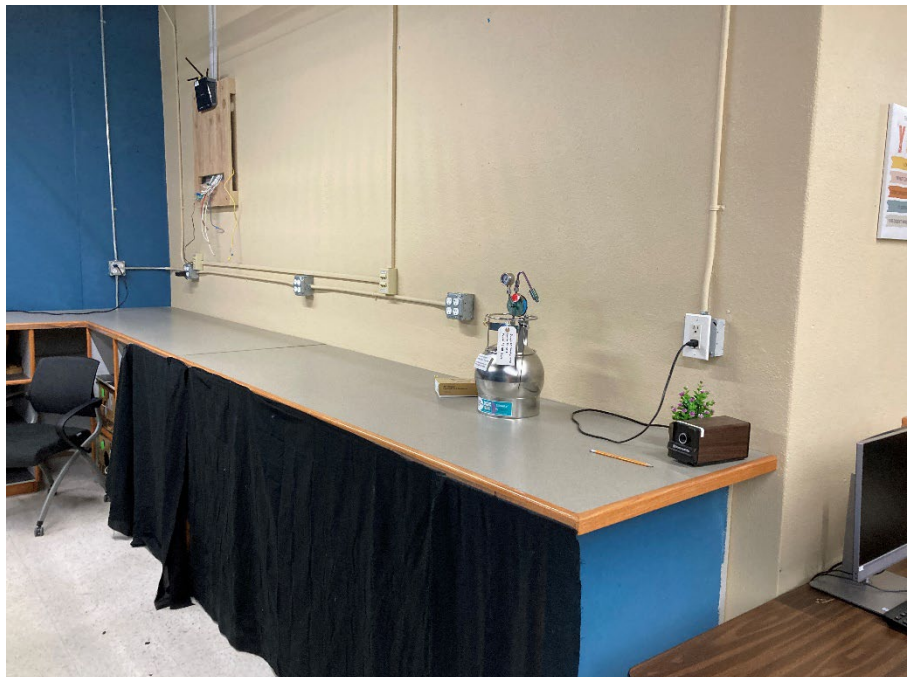
## Photo No. 4.

Indoor air sample  
INAIRO3 in the southern  
portion of the building,  
collected on November  
19, 2024.
