Reference: Port of Everett Interim Action

Port of Everett Interim Action

ExxonMobil ADC
2717/2731 Federal Avenue
Everett, Washington
Ecology Facility Site ID 2728

September 7, 2023

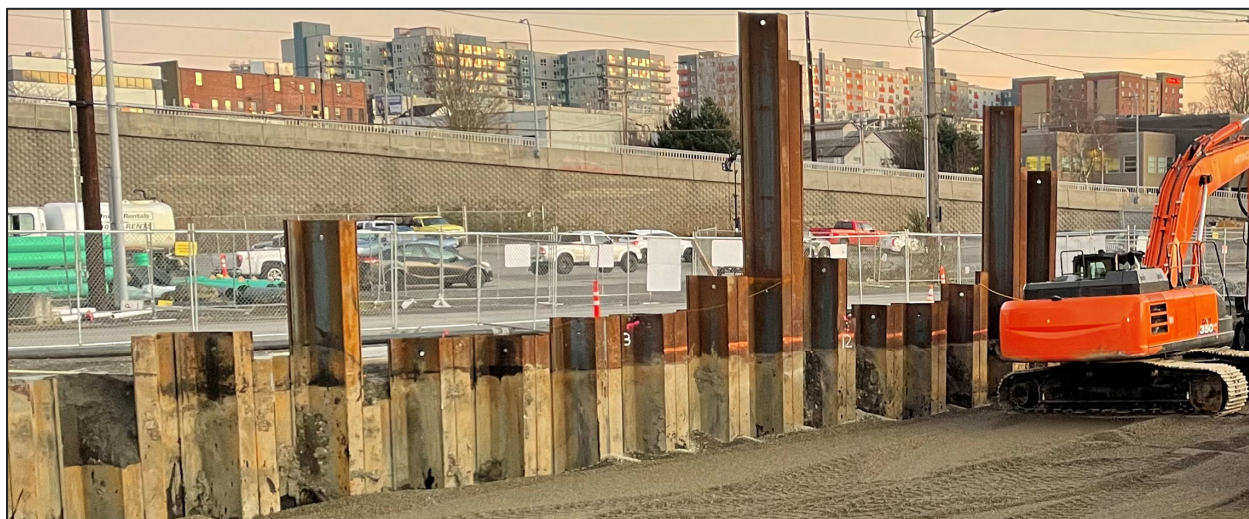
Photograph 4 Permanent Barrier Wall Prior to Hammering Below Grade

Given the relatively flat local hydraulic gradient of 0.02 (Cardno, 2022b), and that the permanent barrier wall does not intersect a lower confining layer, the restricted groundwater flow through the barrier is not expected to cause significant mounding. Based on the historical groundwater sampling data for monitoring wells across the Site, dissolved hydrocarbons are relatively immobile (Cardno, 2022b), and any changes in groundwater flow patterns caused by the barrier wall are not expected to create potential COC transport issues.

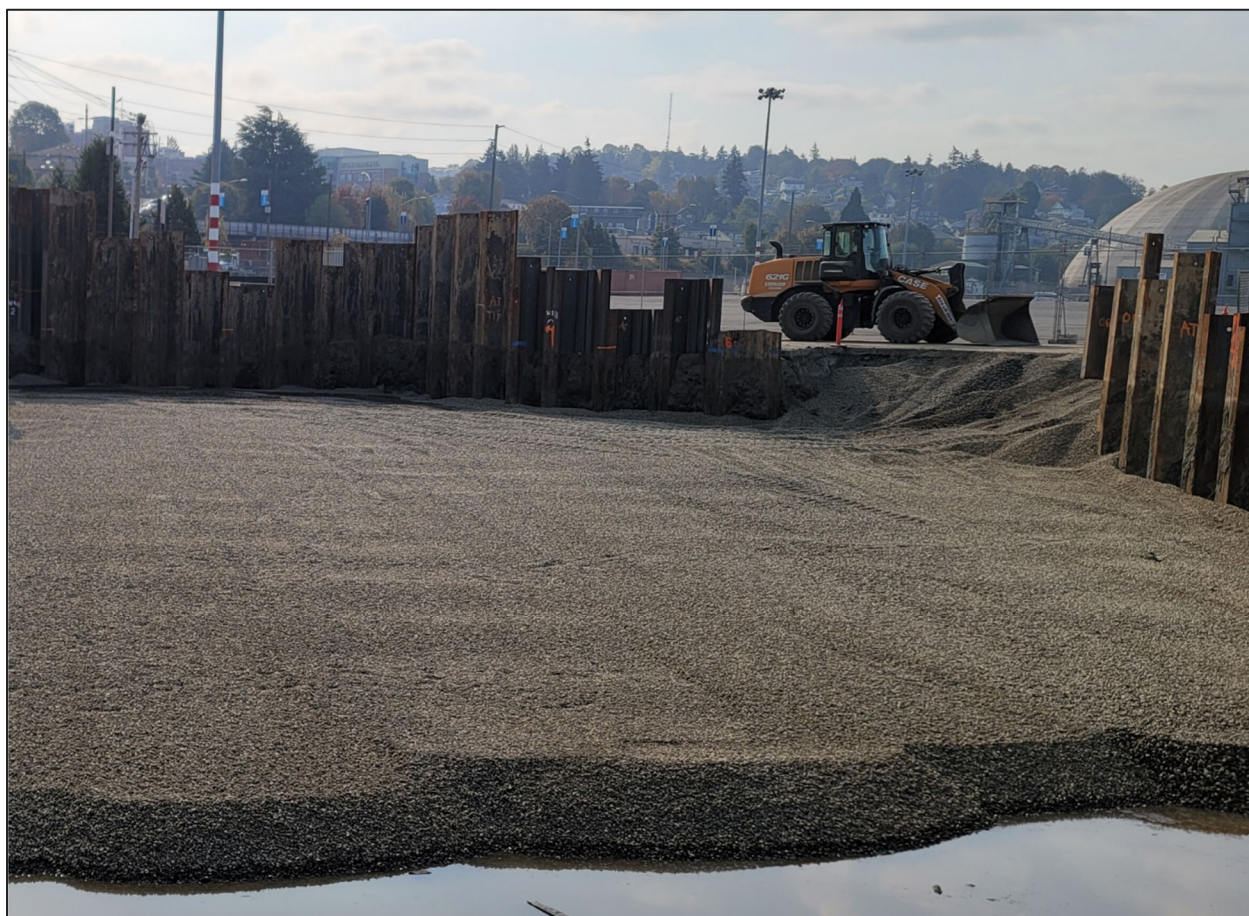
Photograph 11 Backfill Below the Water Table

Backfill material met the gradation specification of Section 9-03.12(4) of the Standard Specifications or AASHTO (American Association of State Highway and Transportation Officials) No. 57. Backfill was placed in conformance with the lines, grades, and dimensions shown on the Plans (Photograph 11; Appendix L). The backfill was deposited, spread evenly, and placed in loose lifts that did not exceed 12 inches in thickness. At the water table surface, the backfill was compacted by mechanical tamping and additional backfill deposited until tamping no longer pushed backfill below the water table.

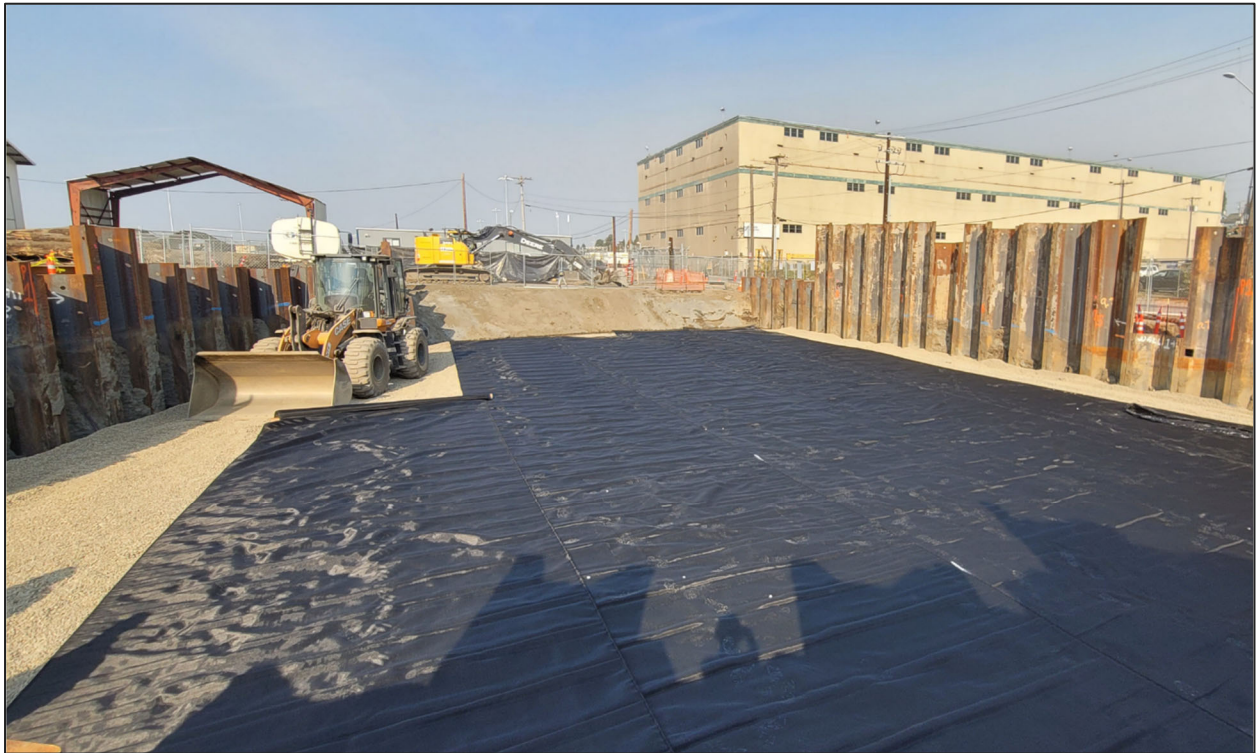
Photograph 12 Geotextile Filter Fabric Installation

The geotextile fabric consisted of a woven material composed of a strong, rot-proof polymeric yarn or fiber orientated into a stable network that retains its relative structure during handling, placement, and long-term service. The fabric has complete resistance to deterioration from ambient temperatures, acid and alkaline conditions, and is indestructible to micro-organisms and insects. During installation, the geotextile fabric was overlapped by at least 2 feet. Dewatering was performed to better facilitate the fabric installation.

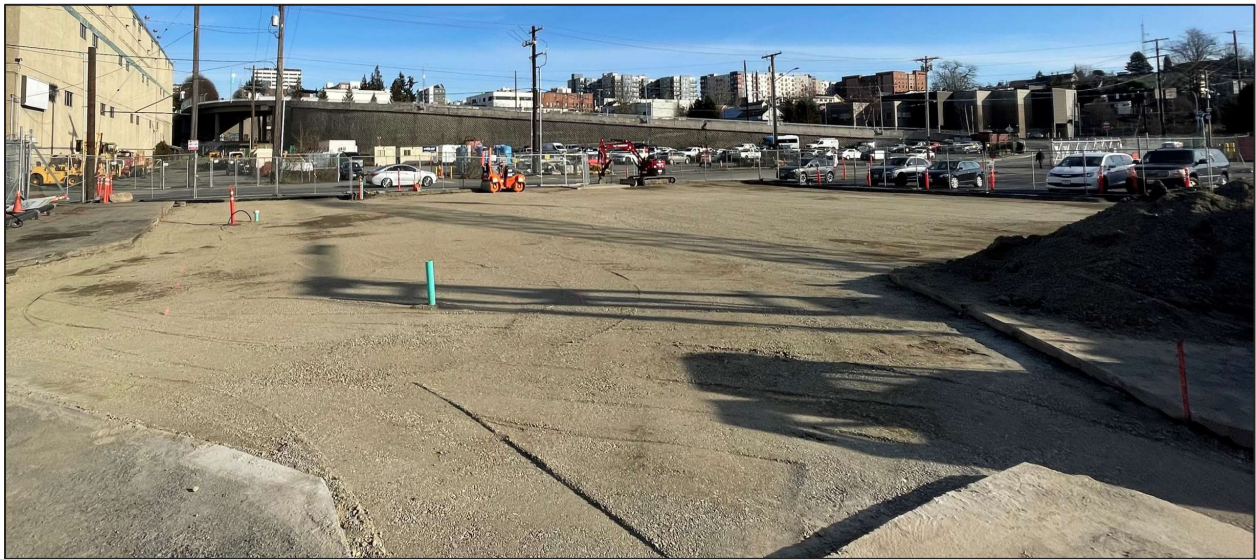
Photograph 13 Backfill Above the Water Table (Subbase)

The subbase backfill met gradation specification of Section 9-03.18 of the Standard Specifications for Foundation Material Class C (Photograph 13). The backfill was placed in conformance with the lines, grades, and dimensions shown on the Plans (i.e., from the water table surface to 24 inches bgs) (Appendix L, Drawing C-3), and in accordance with the applicable provisions of the Standard Specifications.

The subbase backfill was placed in uniform lifts not exceeding 12 inches in uncompacted thickness. Each lift of subbase backfill was compacted to a minimum density of 92 percent of the maximum dry density as determined by WSDOT Standard Operating Procedure 615.

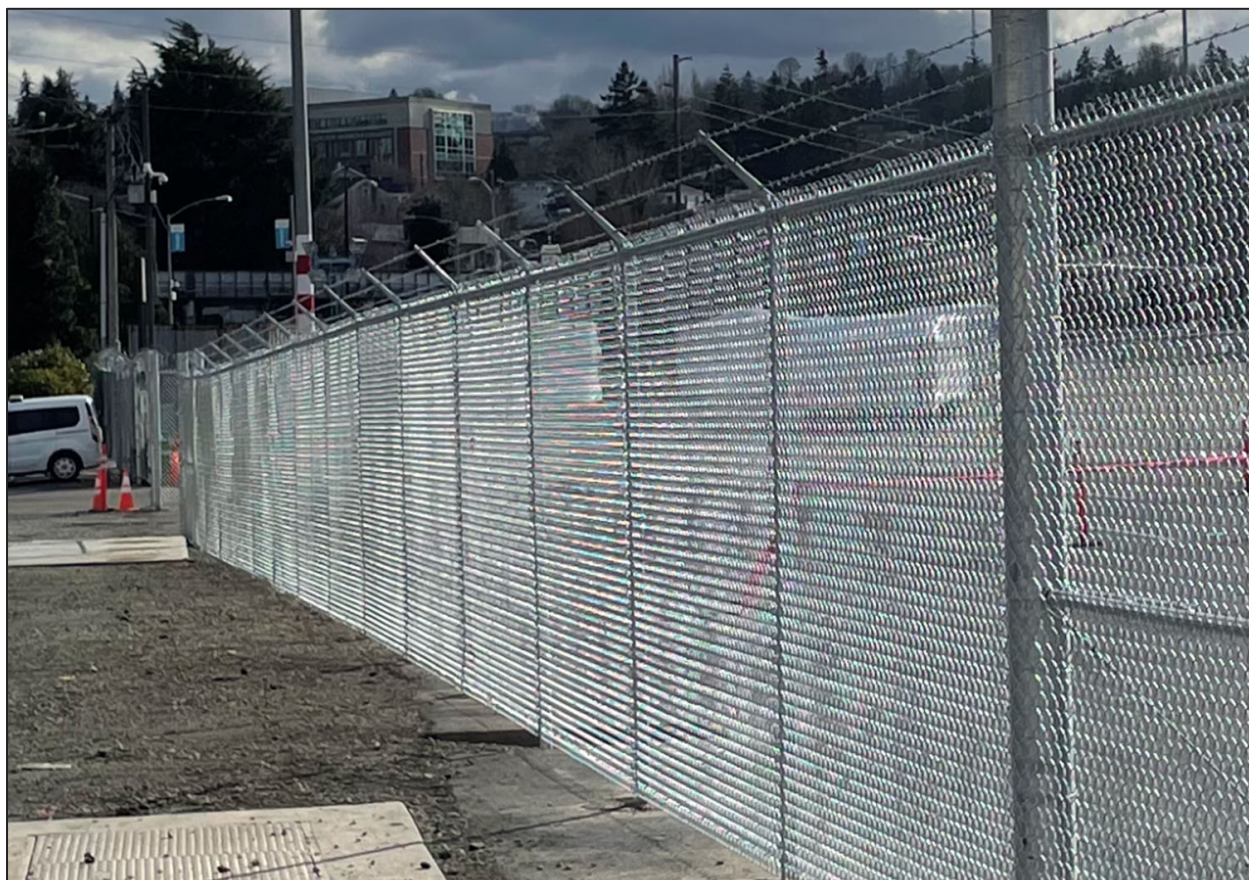
Photograph 16 MARSEC Fencing Reinstallation along Eastern Portion Port of Everett

The fencing at the Site was reinstalled to pre-excavation status. A permanent MARSEC-rated fence was installed along the southern, eastern, and northern sections of the Port property (Photograph 16), conforming to Section 2.3.8 of the United States DOT and United States Coast Guard's *Recommended Security Guidelines for Facilities*, dated August 6, 2004 (USCG, 2004). Additionally, the automatic gates servicing ESR were reinstated to pre-excavation status.

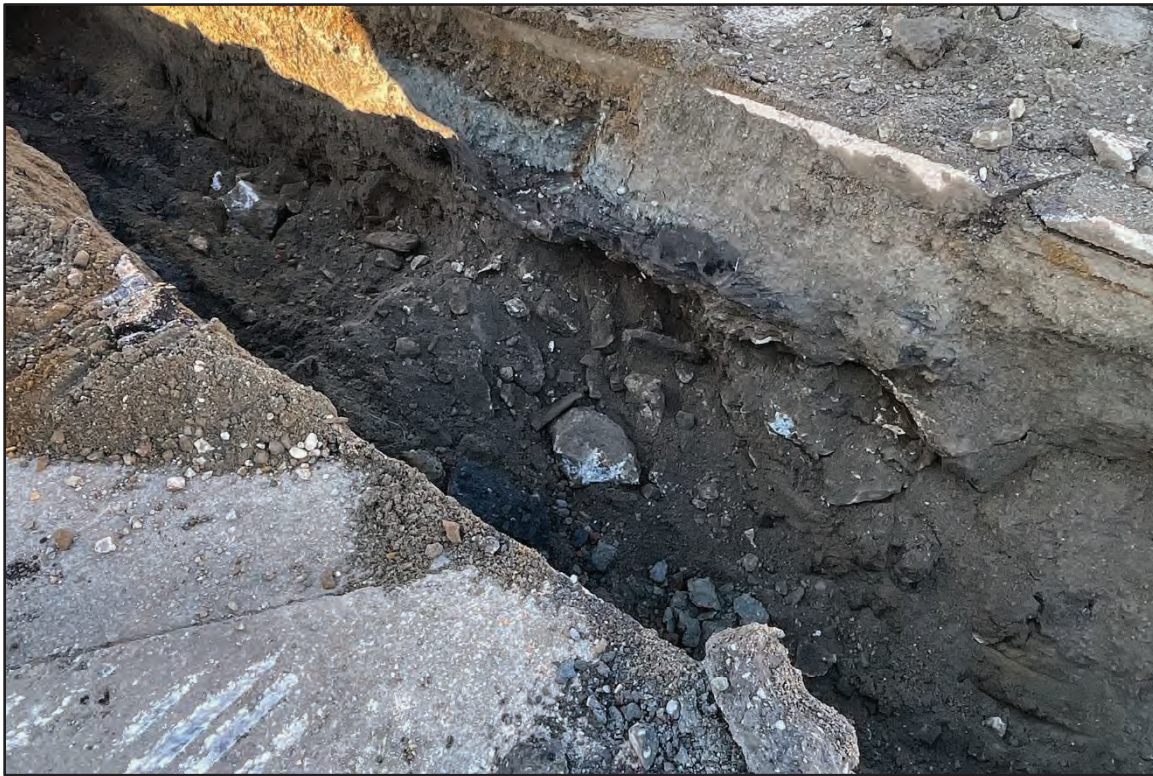
Photo 6. Phase-2 soil removal showing thin debris layer, view to the northeast. Note petroleum contamination of the flooded area.

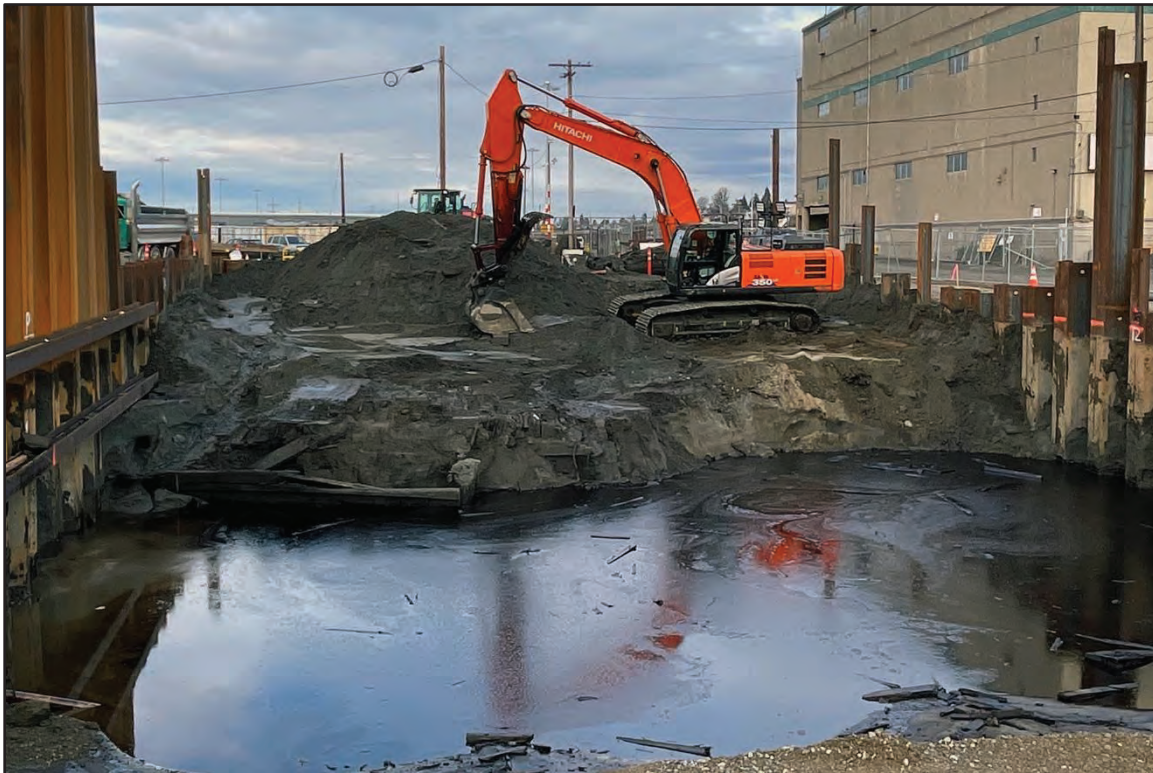
Photo 7. Phase-2 Trenching along the west side showing upper fill incidences and broken concrete.

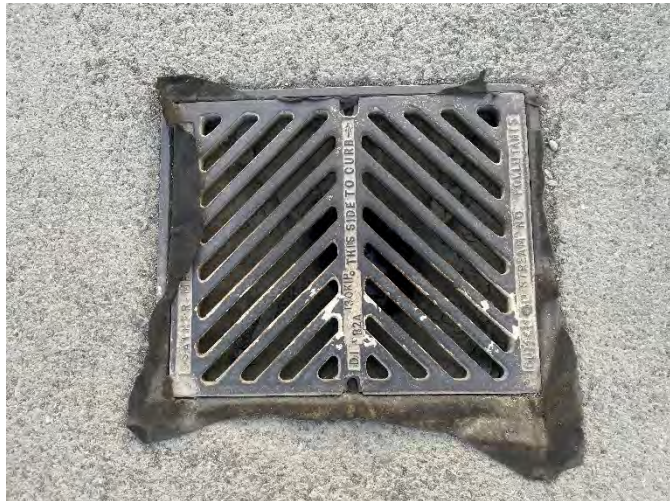
Photo 1. Catch basin with repaired filter.

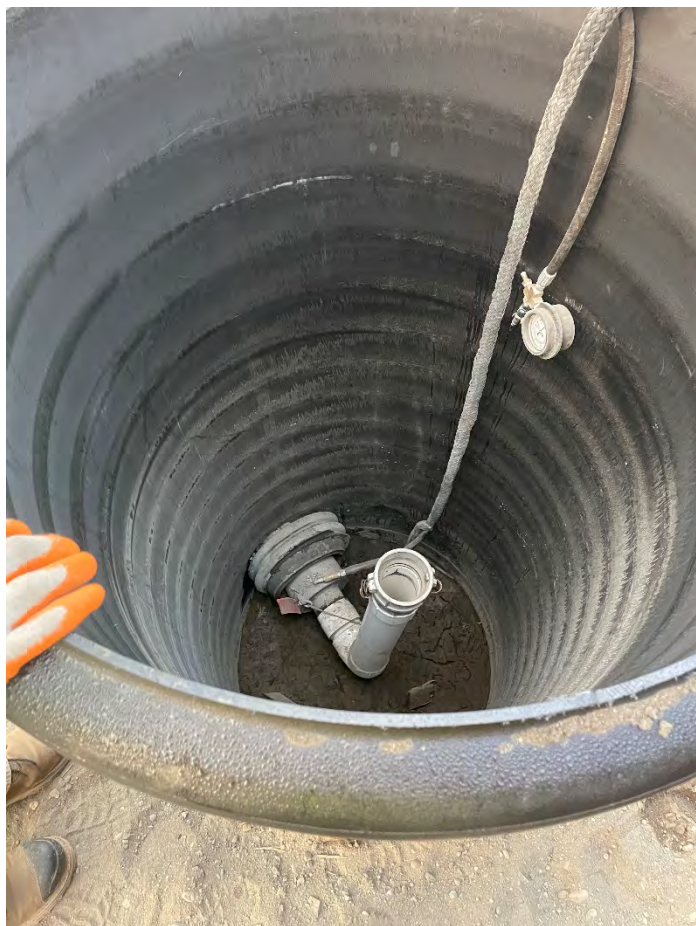
Photo 2. One of three new sump/catch basins currently being installed. Will cut down to grade and have high/low floats with filter to collect and filter groundwater/surface flow.

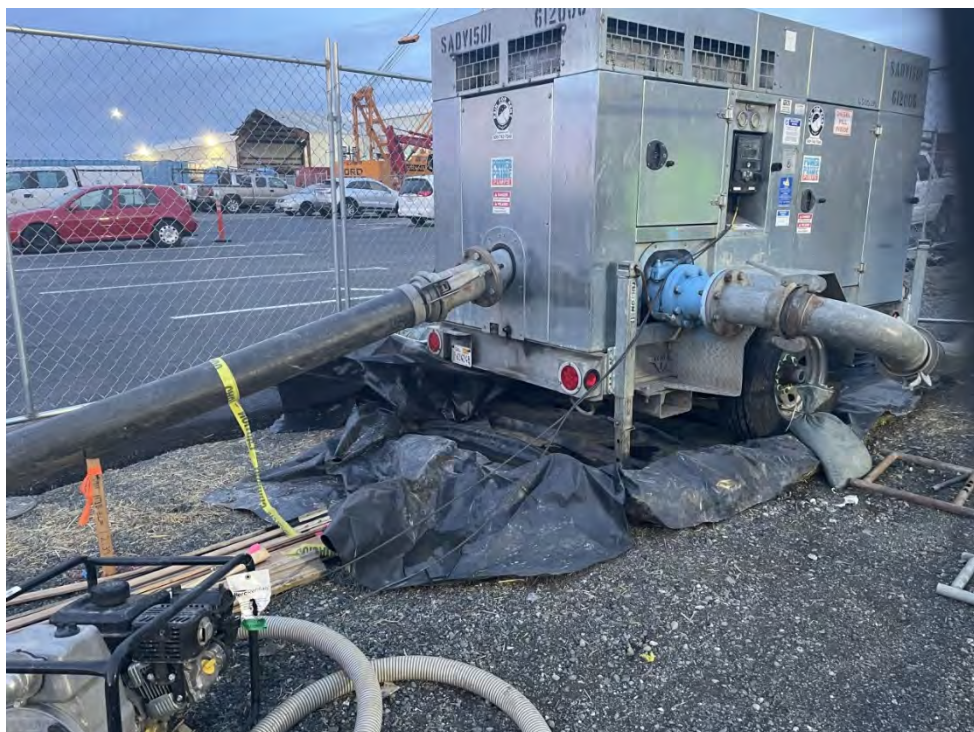
Photo 2. Pump located on southeast corner of site with repaired secondary containment system.

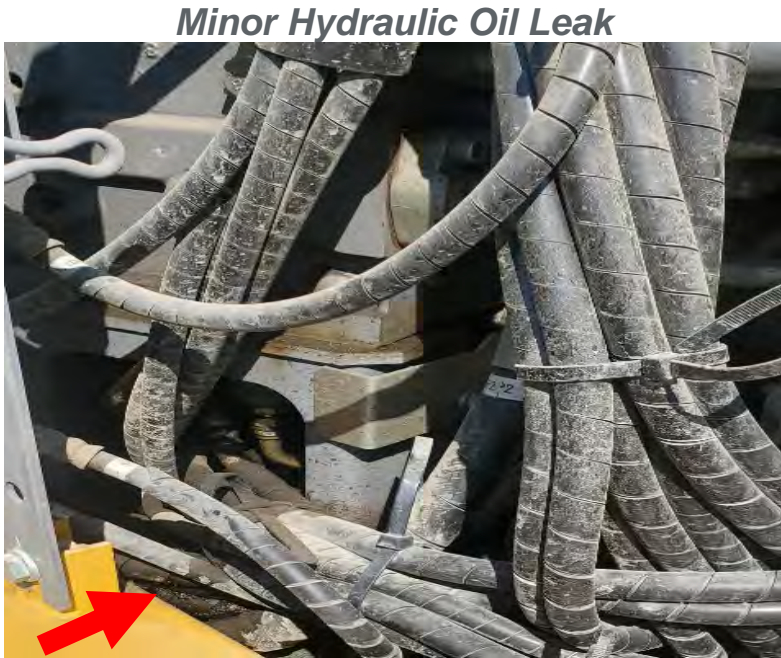
Minor Hydraulic Oil Leak

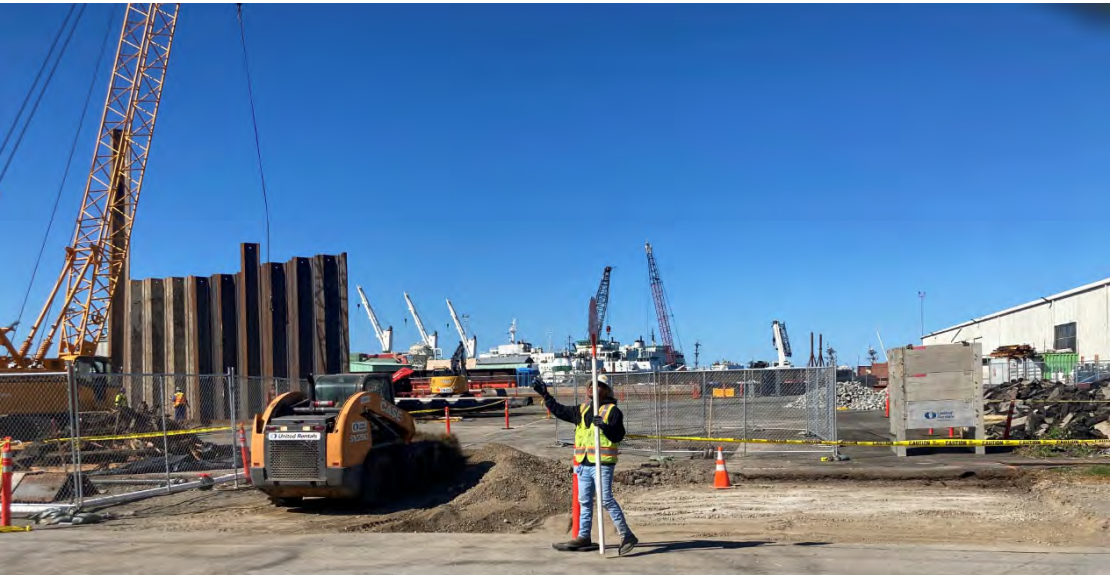
Phase 1 Southern Shoring Wall 09/09/22

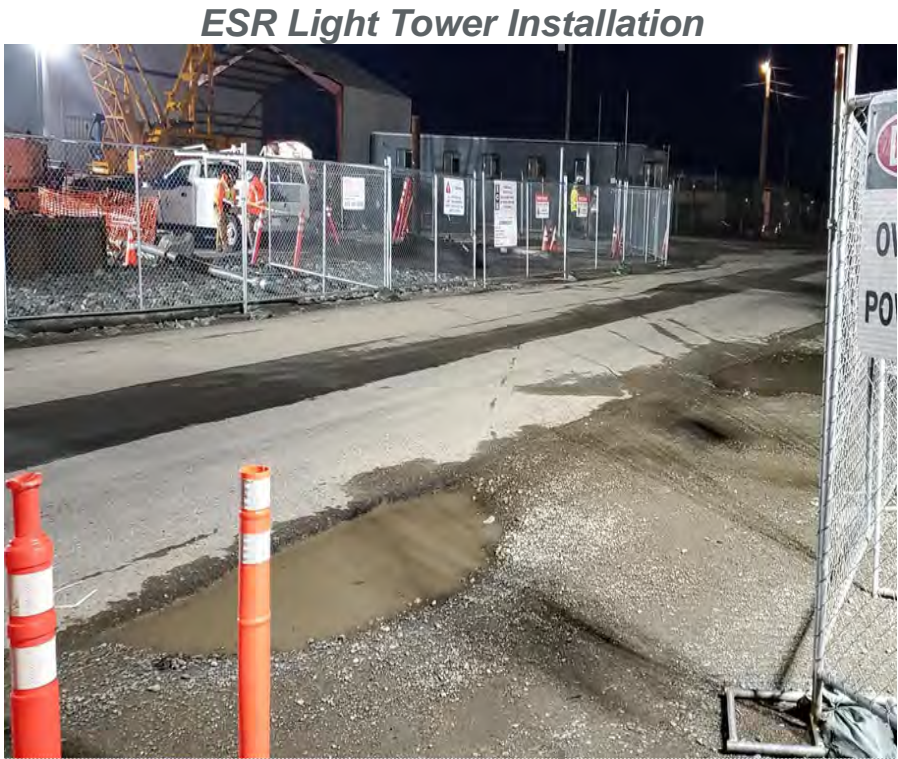
ESR Light Tower Installation
