Re: DTG Yakima – Agreed Order No. DE 21624 – Monthly Progress Letter – January

Re: Monthly Data Assessment Report DTG Yakima Landfill Fire Incident – January 2025

DTG LPL LANDFILL FIRE INVESTIGATIONS AND MITIGATION

Monthly Monitoring Data Review

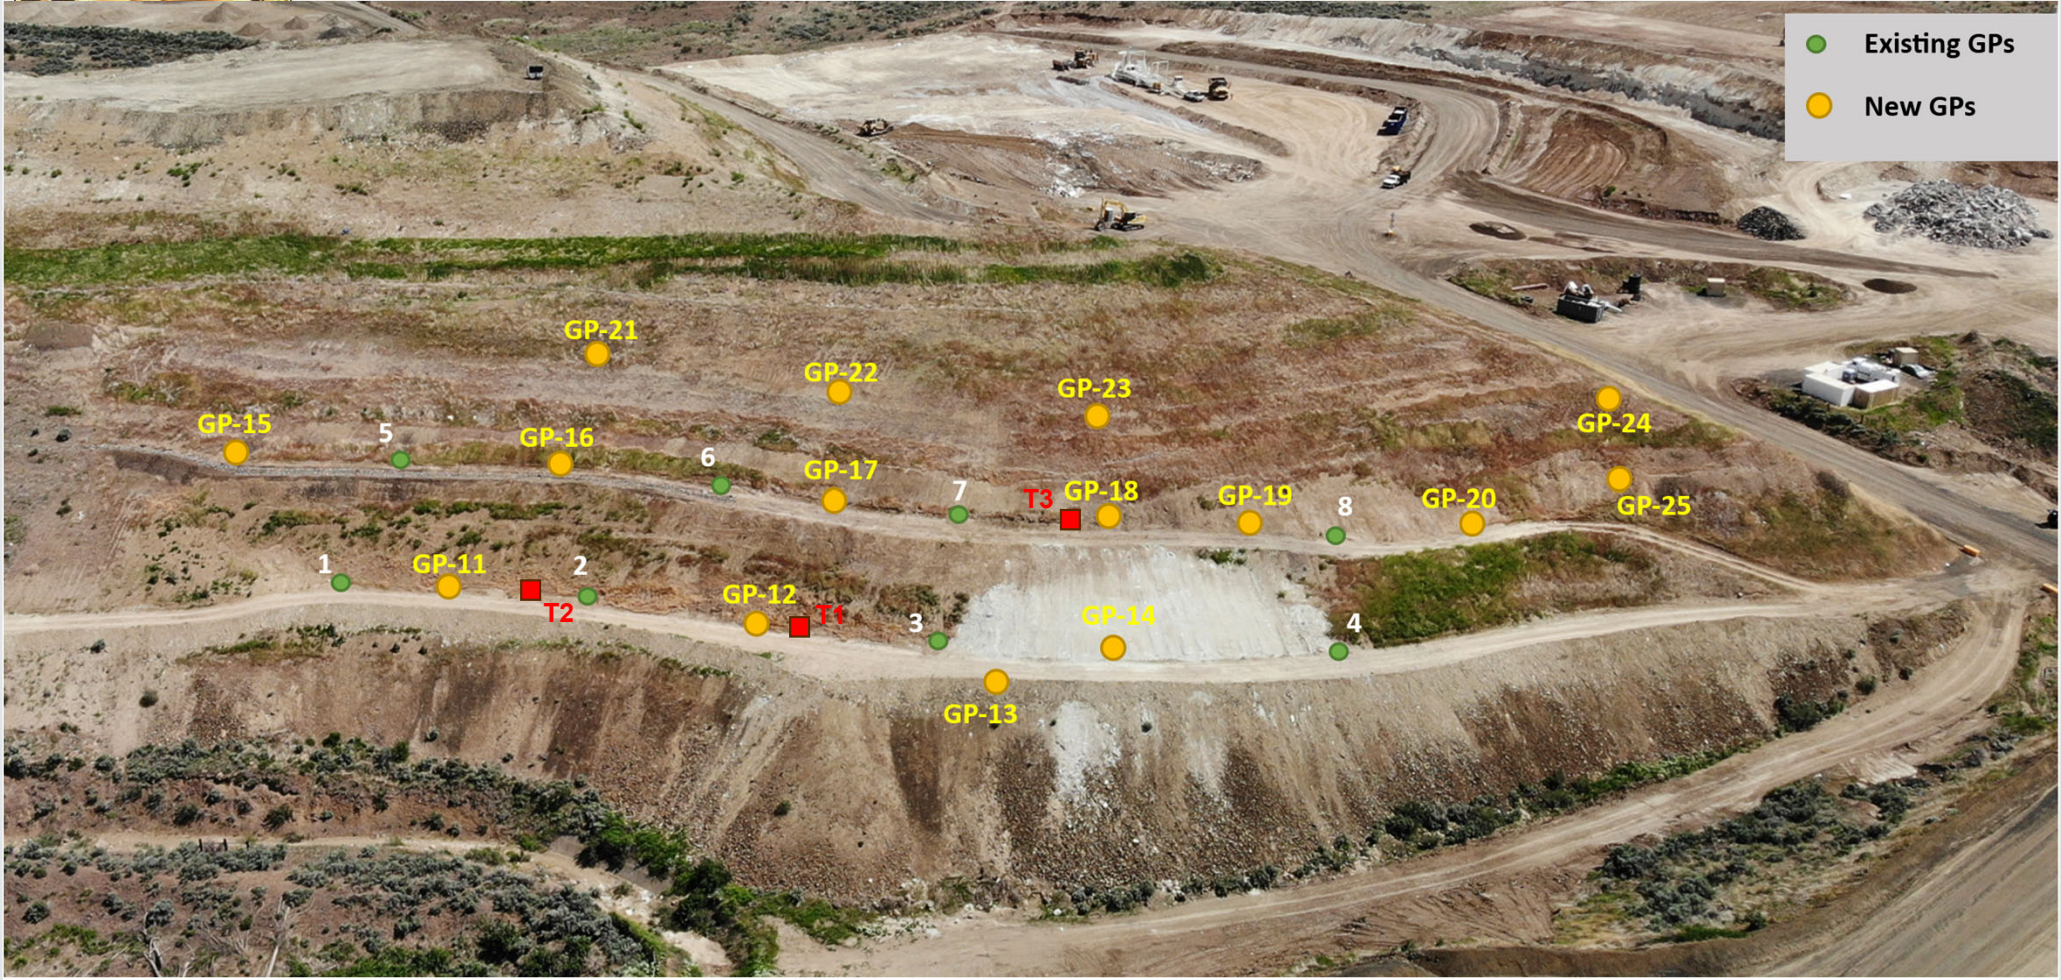
- Existing GPs
- New GPs

Thermistor temperatures mostly stable, with downward trend in T-1 and T-2, and the levelling trend in T-3 continuing. Monitoring of T-1 is recommended to ensure no major changes. Noted that the deeper measurement of 20ft below surface is cooler than measurements at 10ft depth but oscillations indicate there is an issue with the temperature readings at 20 ft. on T-1. Consideration should be given to installing a dedicated thermistor.

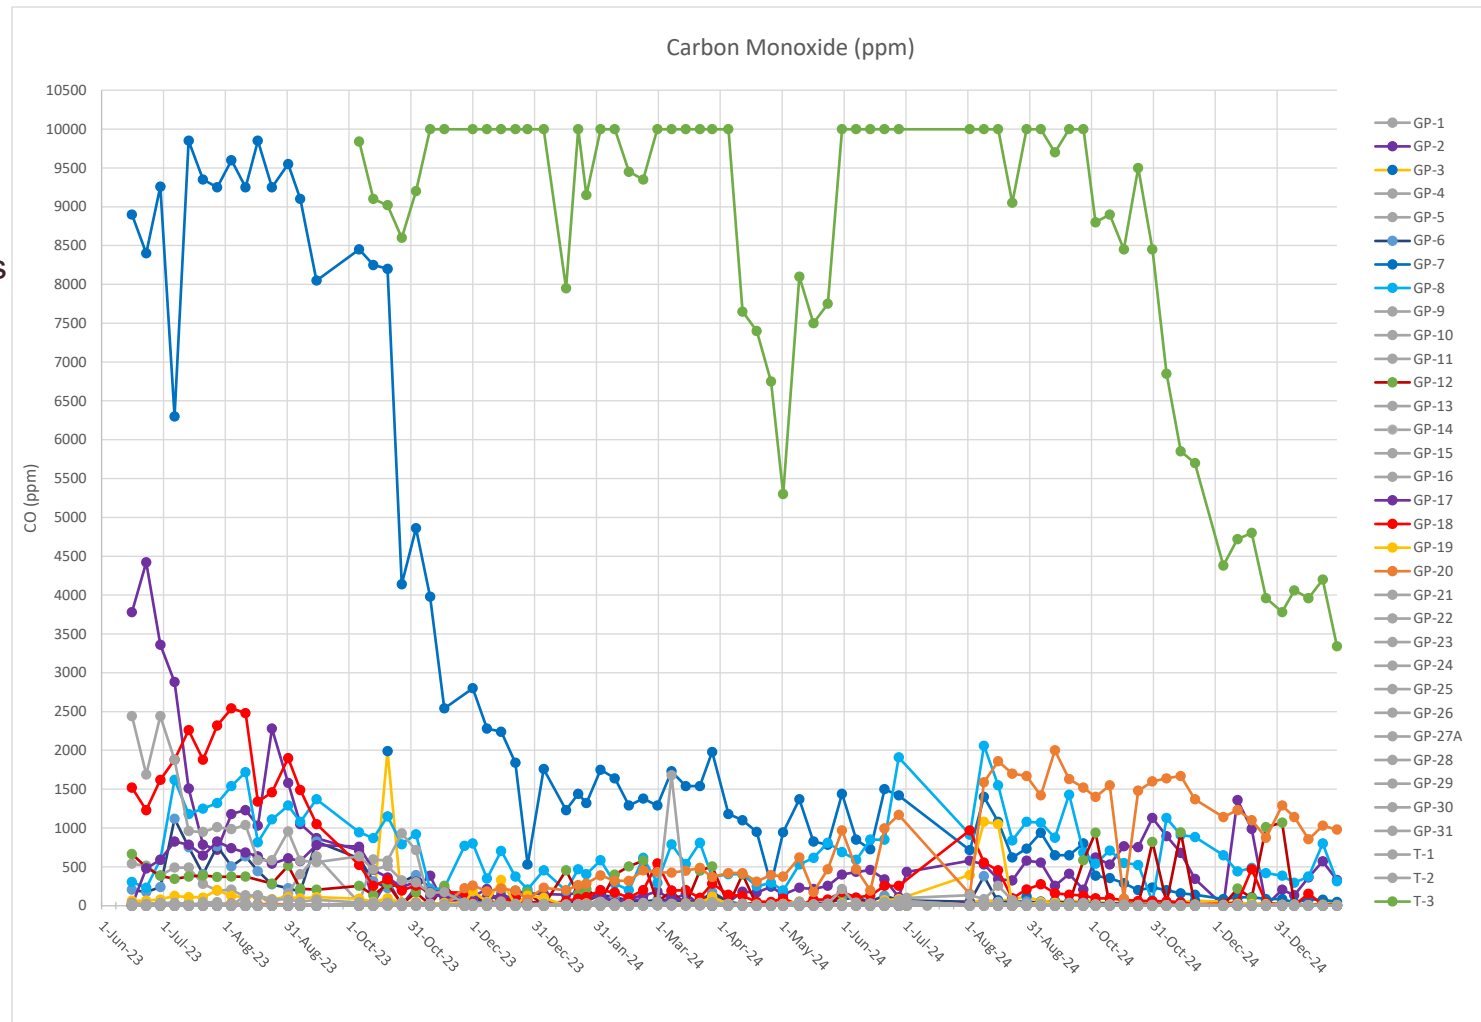
Carbon Monoxide

January has seen large pressure swings, with a large increase at the beginning of the month and a large decrease at the end. This explains the slower trend upwards during the month and the sharp downwards tick at the end of the month.

CO levels are now at an all-time low, with T-3 measuring below 3,500ppm (uncorrected)

CO levels in GP-12 have decreased, following the increase that was noted in December.

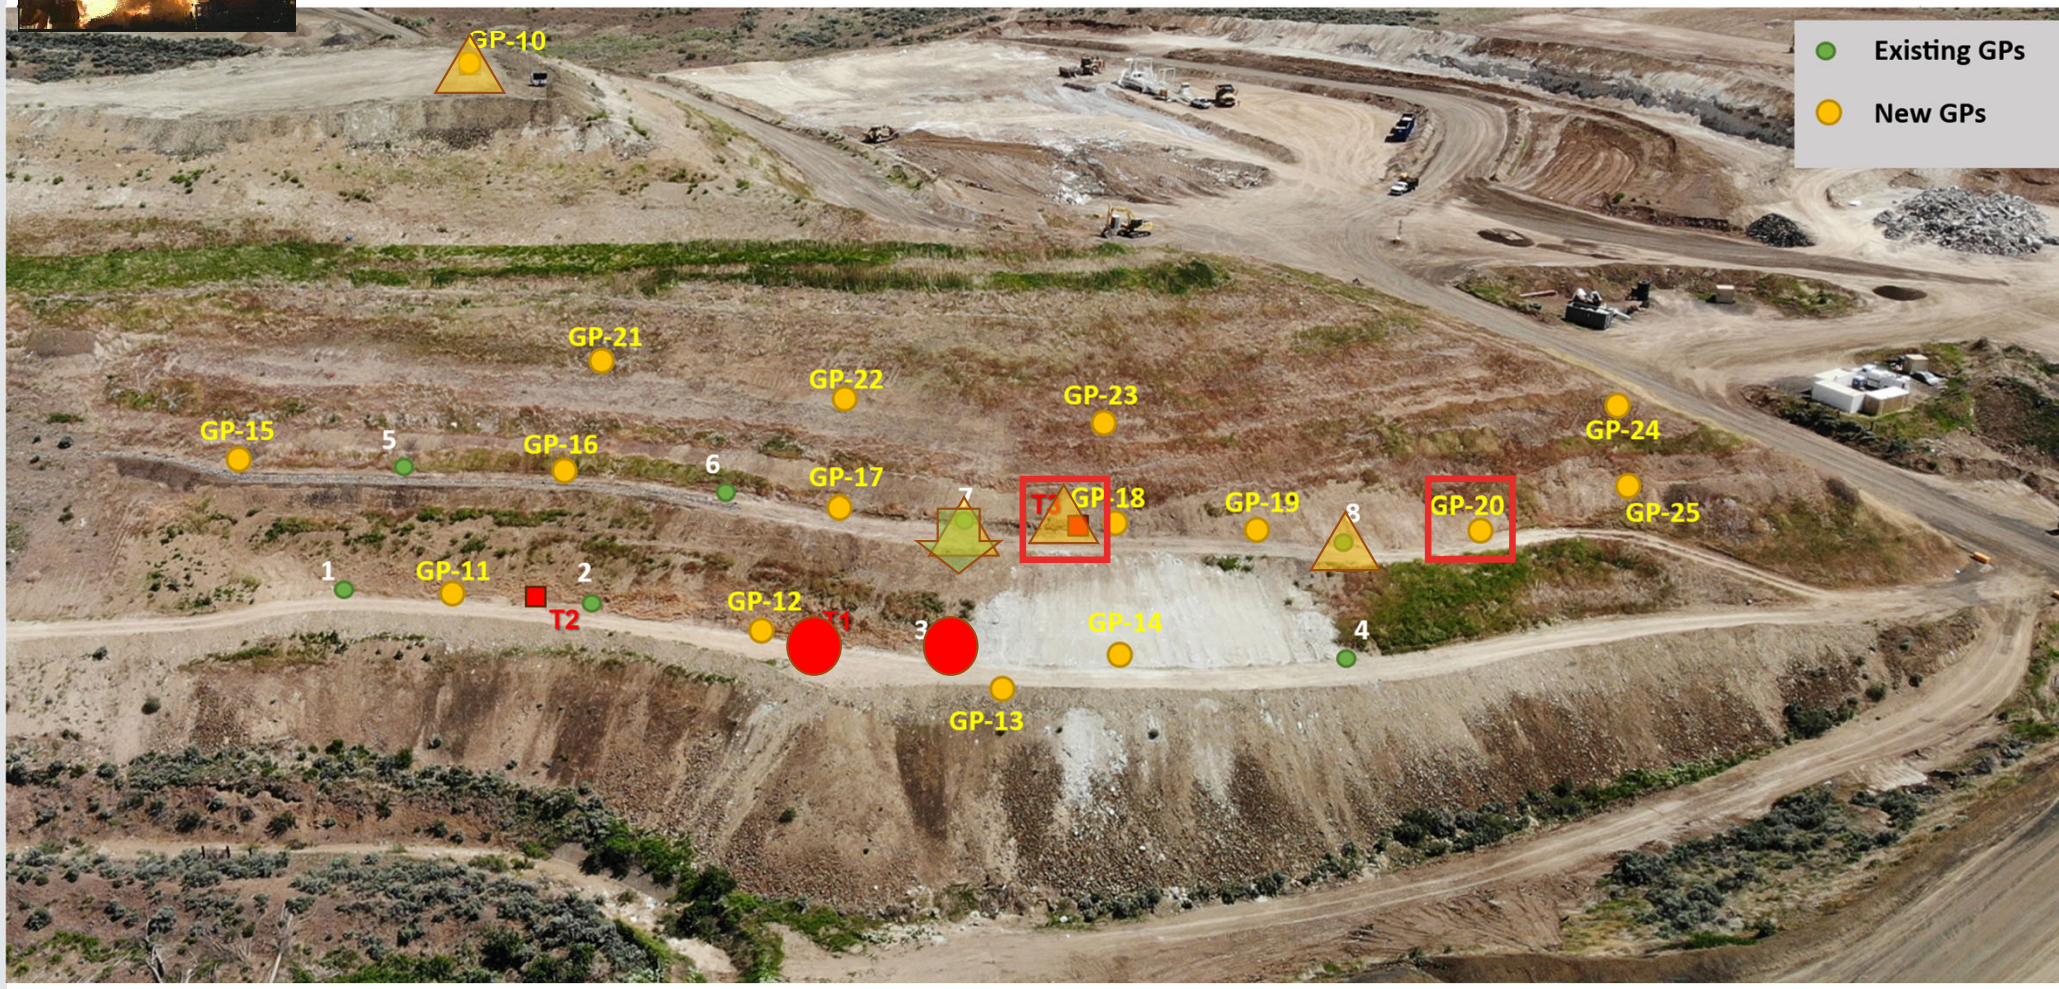
Fire Path

- Existing GPs
- New GPs
