# INITIAL INVESTIGATION FIELD REPORT

# ERTS726990 - National Ave Orphan USTs

SUNBIRDS SHOPPING CENTER

1757 N NATIONAL AVE  
CHEHALIS, WASHINGTON

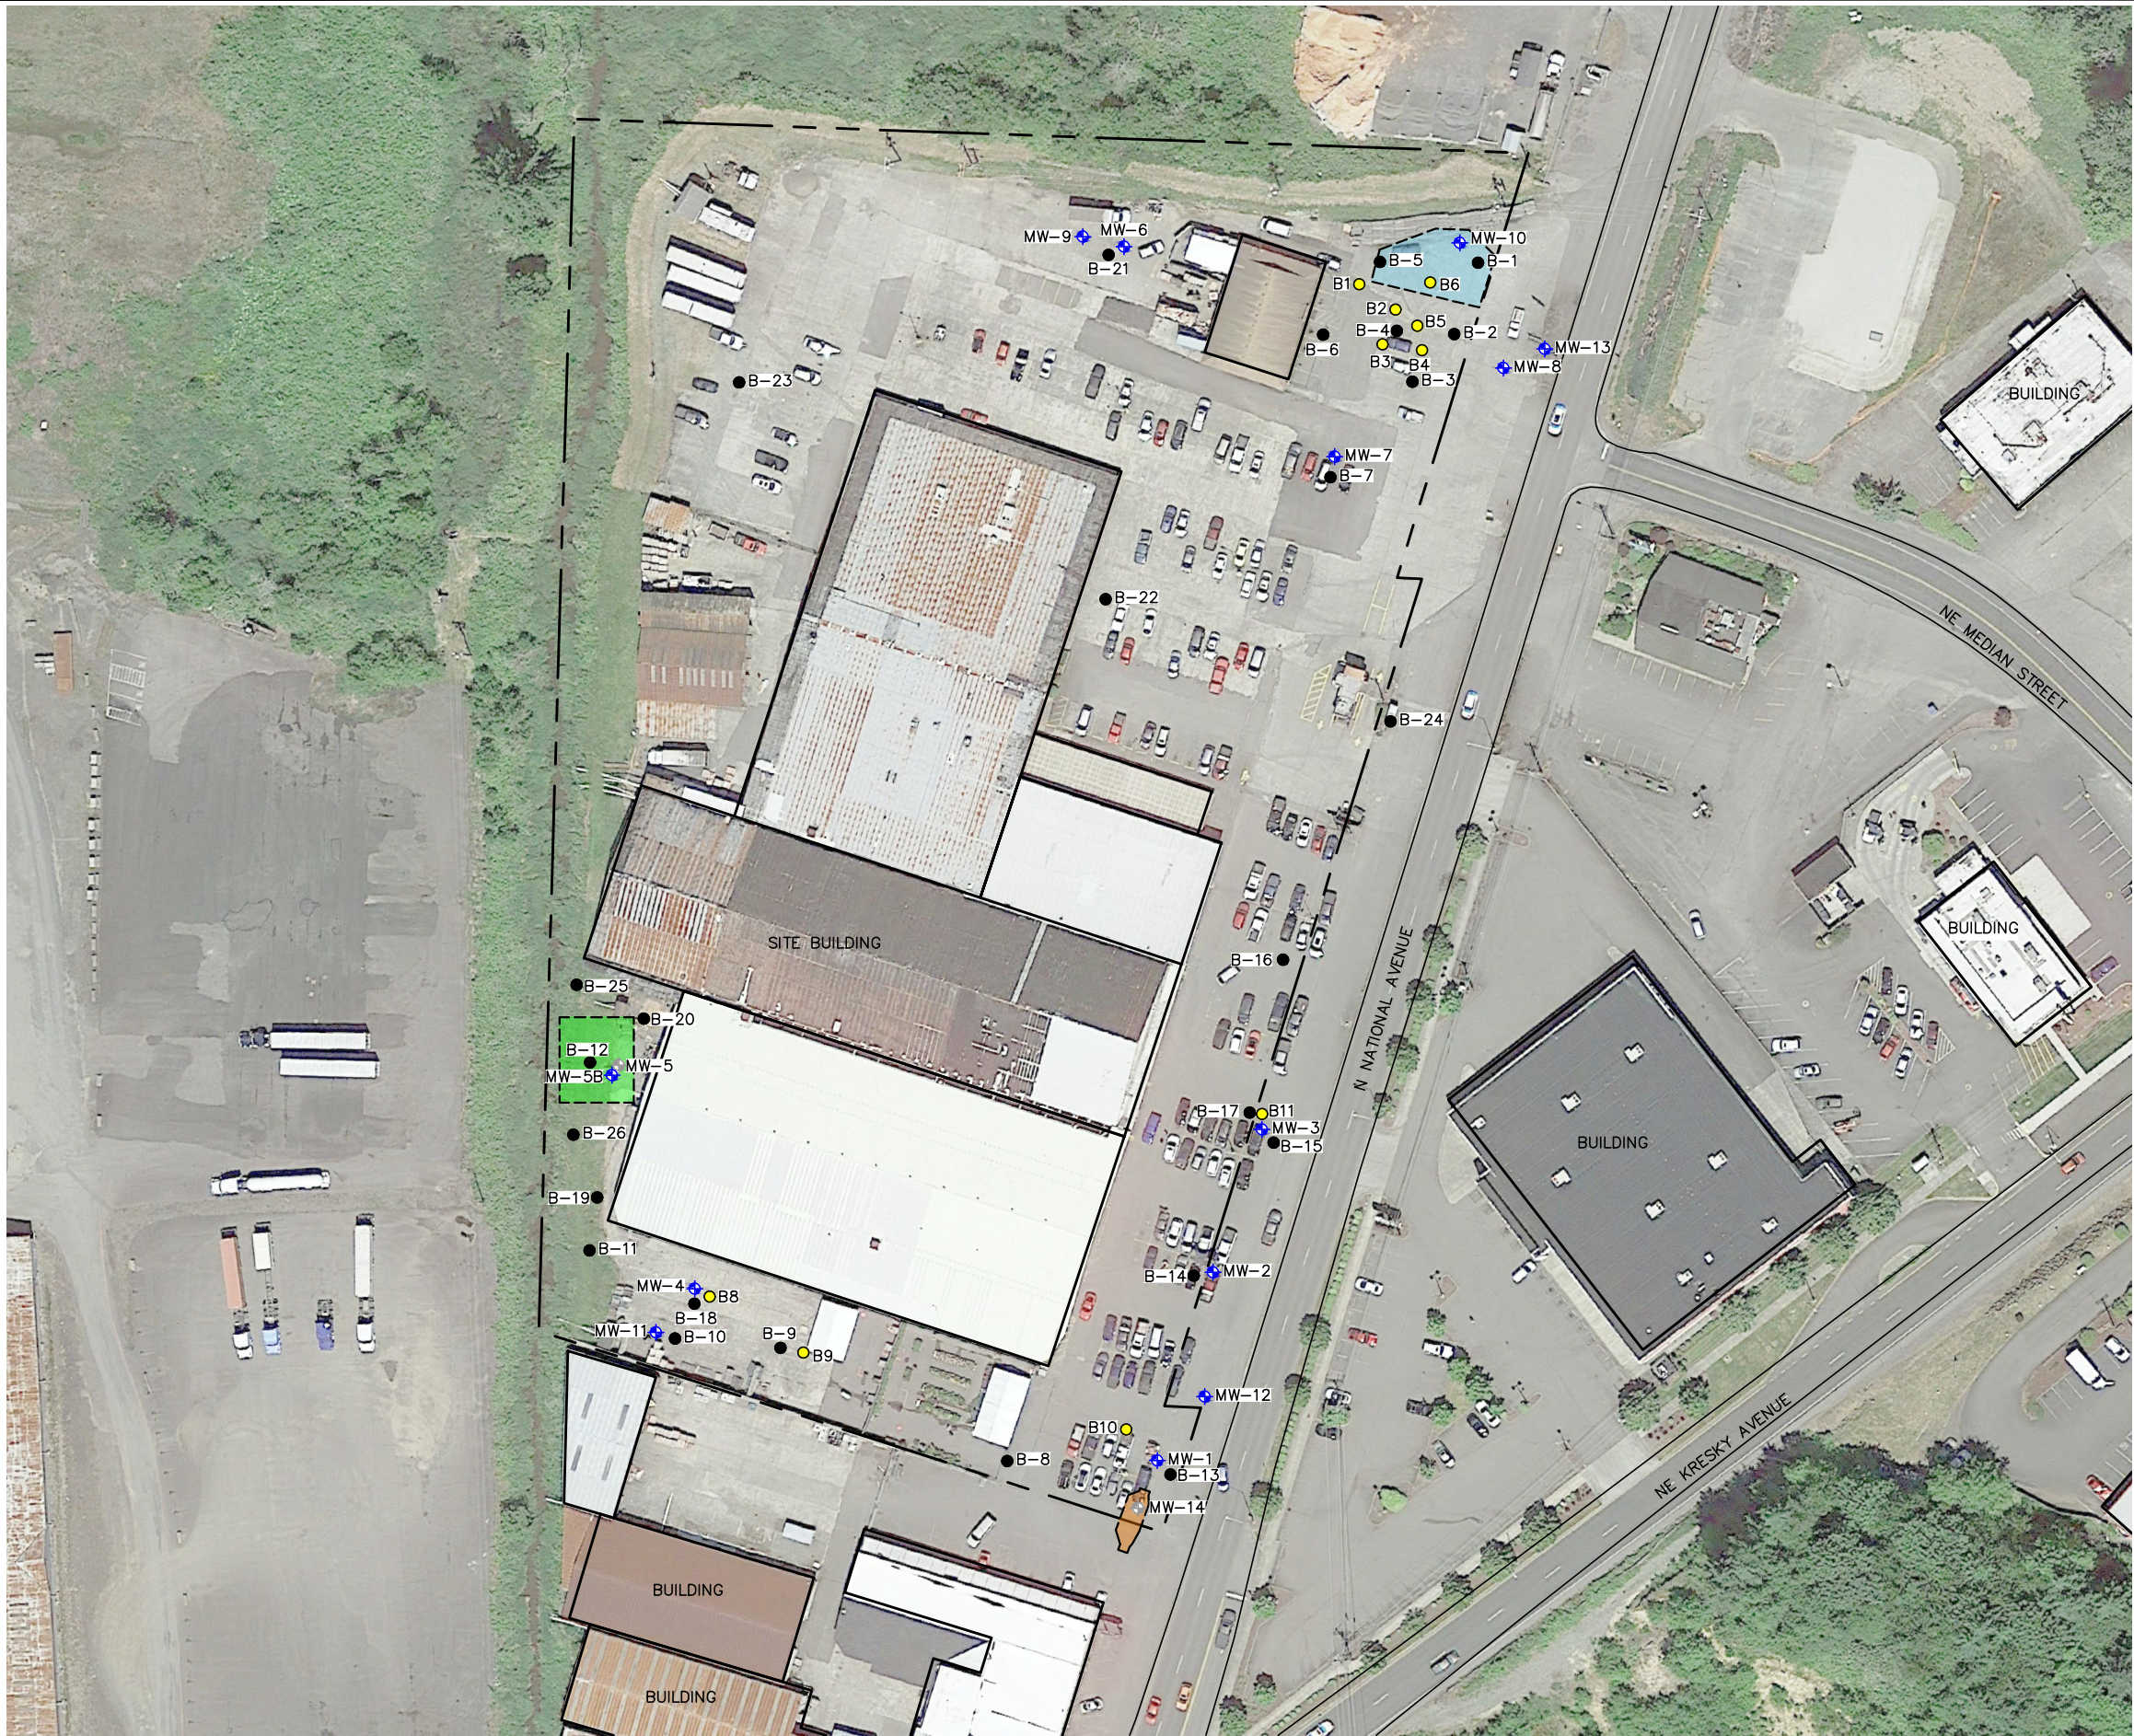
FIGURE 2  
SITE MAP

| LEGEND | |
|---|---|
| B-1 ● | AEG BORING LOCATION |
| B10 ● | ROBINSON NOBLE BORING LOCATION |
| MW-1 ◆ | MONITORING WELL LOCATION |
| ■ | EXCAVATION AREA (MAY 2022) |
| ■ | EXCAVATION AREA (NOVEMBER 2022) |
| ■ | EXCAVATION AREA (OCTOBER 2023) |

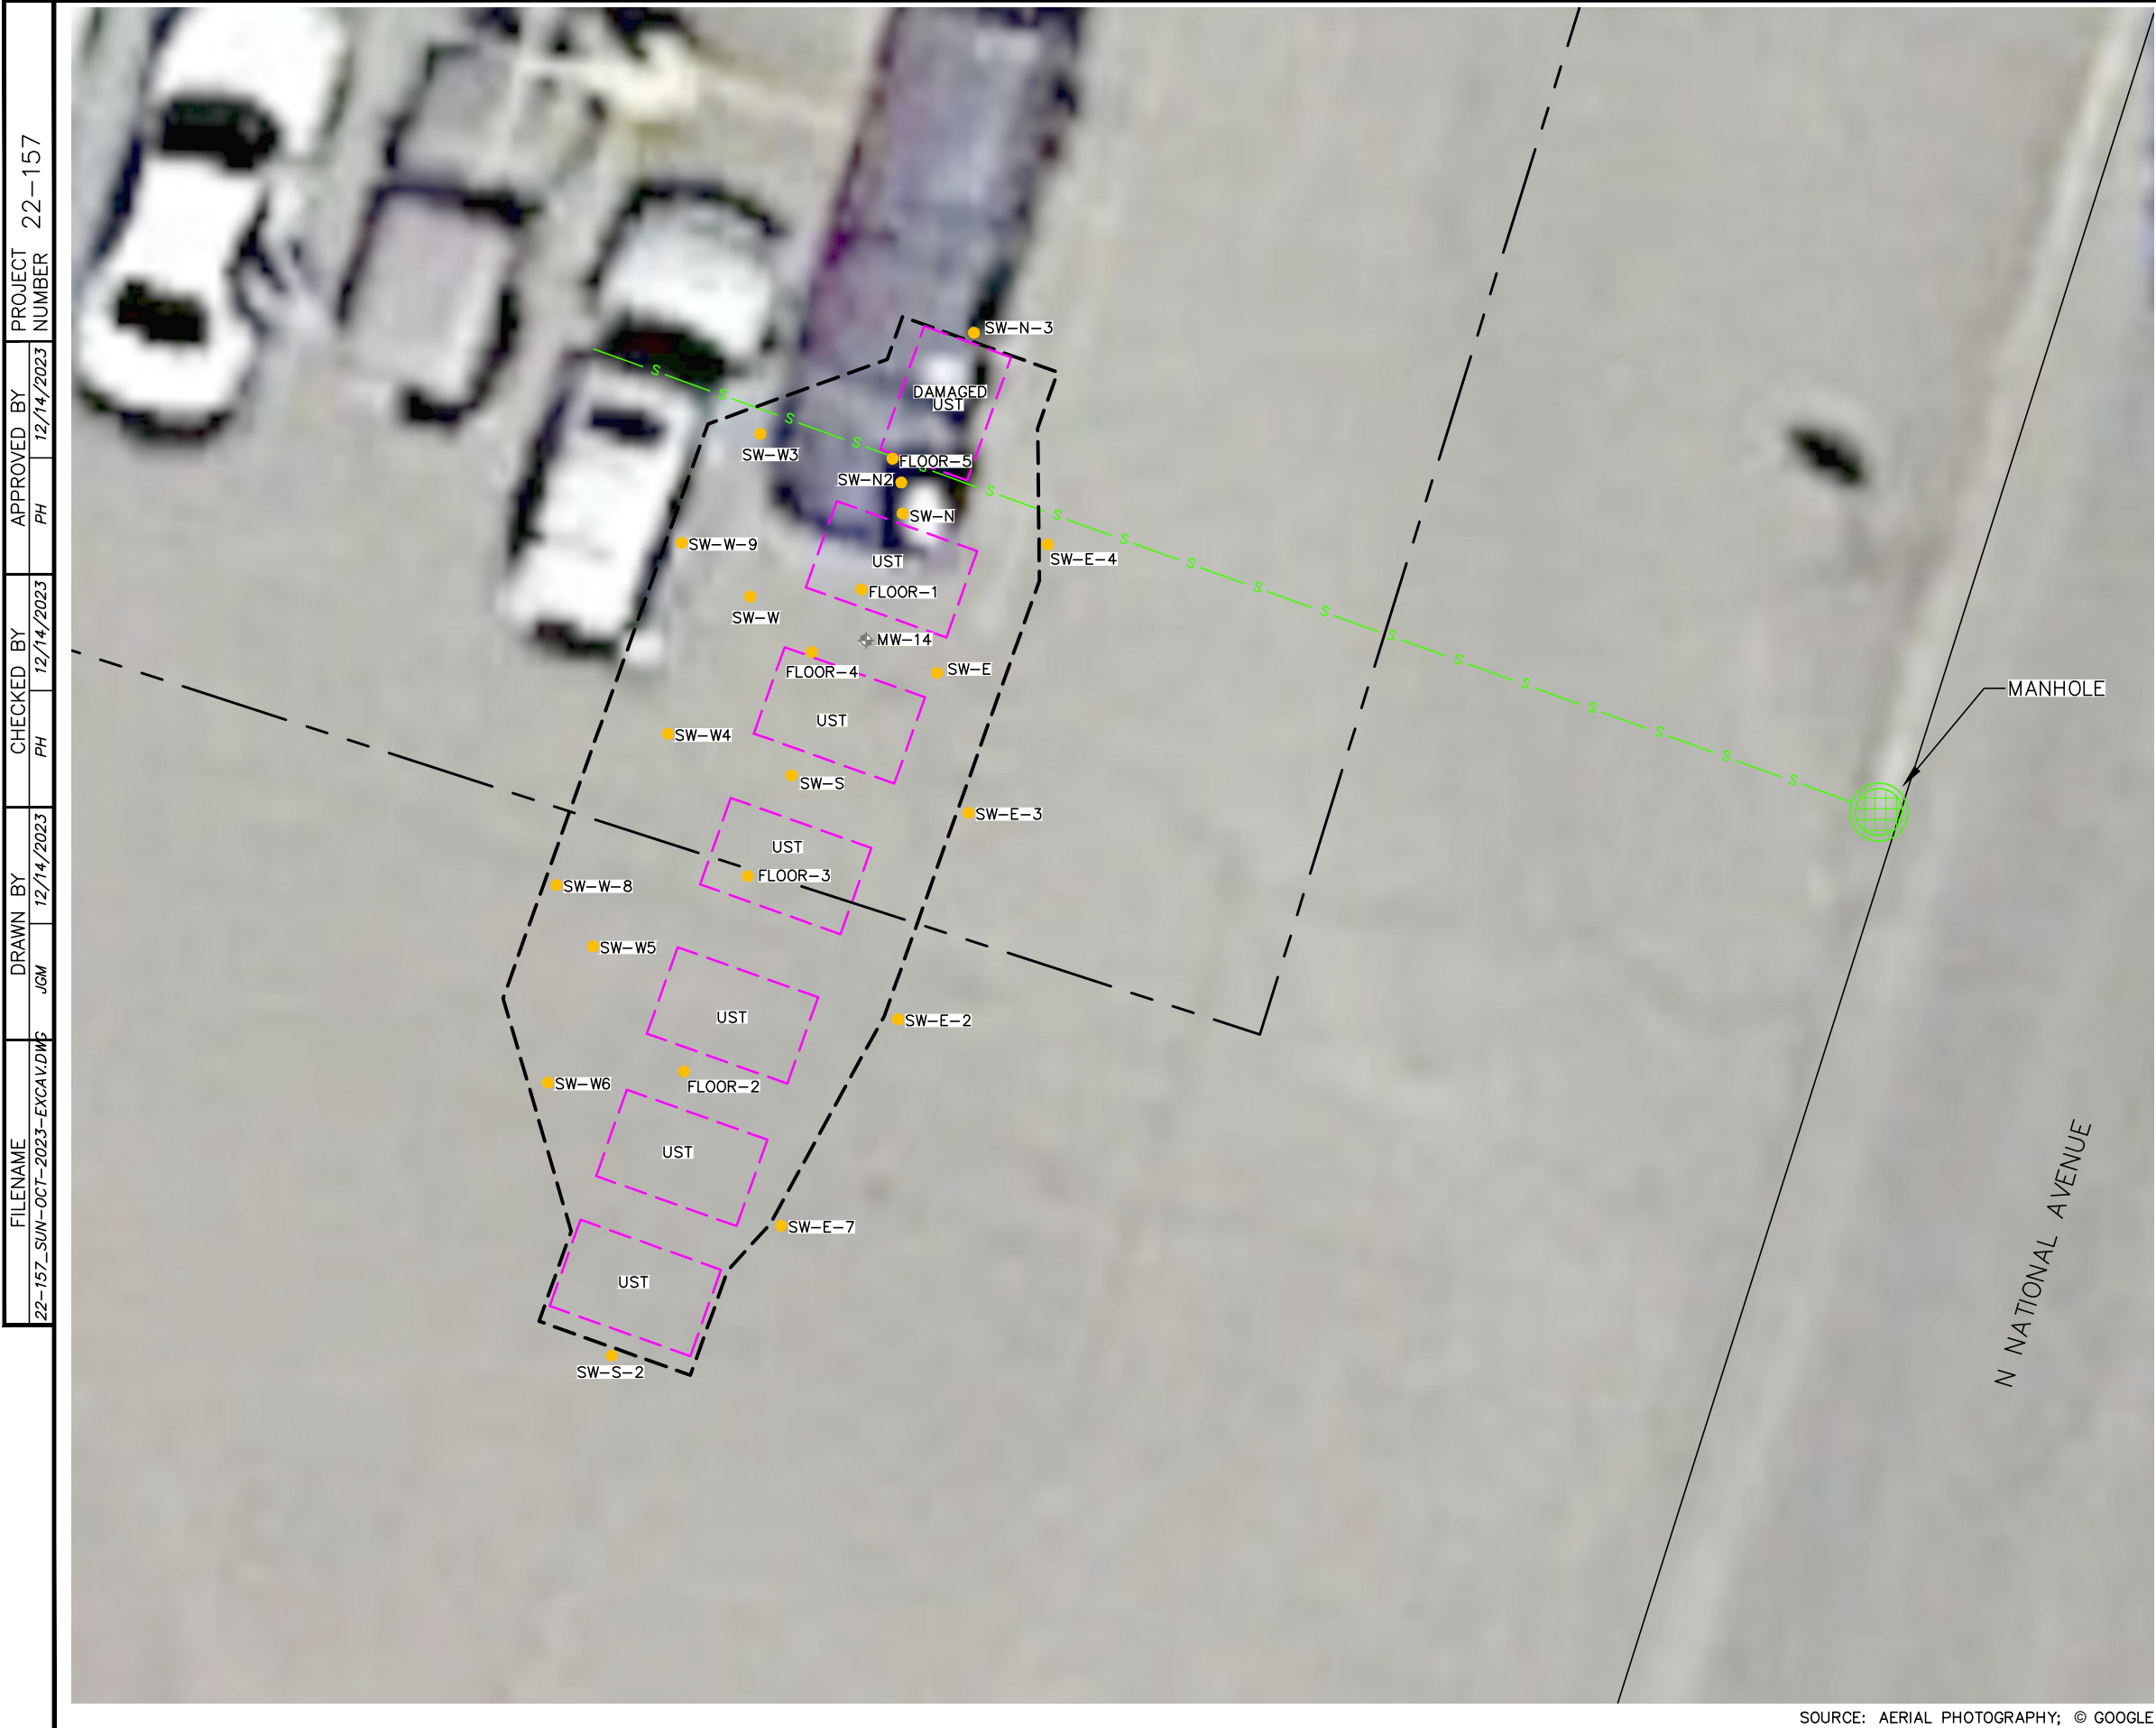
FIGURE 3

| LEGEND | |
|---|---|
| SW-W ● | SOIL SAMPLE LOCATION |
| --- | EXCAVATION (OCTOBER 2023) |

UST EXCAVATION  
OCTOBER 2023

**Table 1 - Summary of Soil Analytical Results**  
Sunbird Shopping Center (22-157)  
Chehalis, Washington
