TERMINAL 30 2023 ANNUAL SITE PERFORMANCE REPORT – YEAR 4

2023 Annual Terminal 30 Site Performance Report

Port of Seattle
Terminal 30 Site

Project number: 60681370

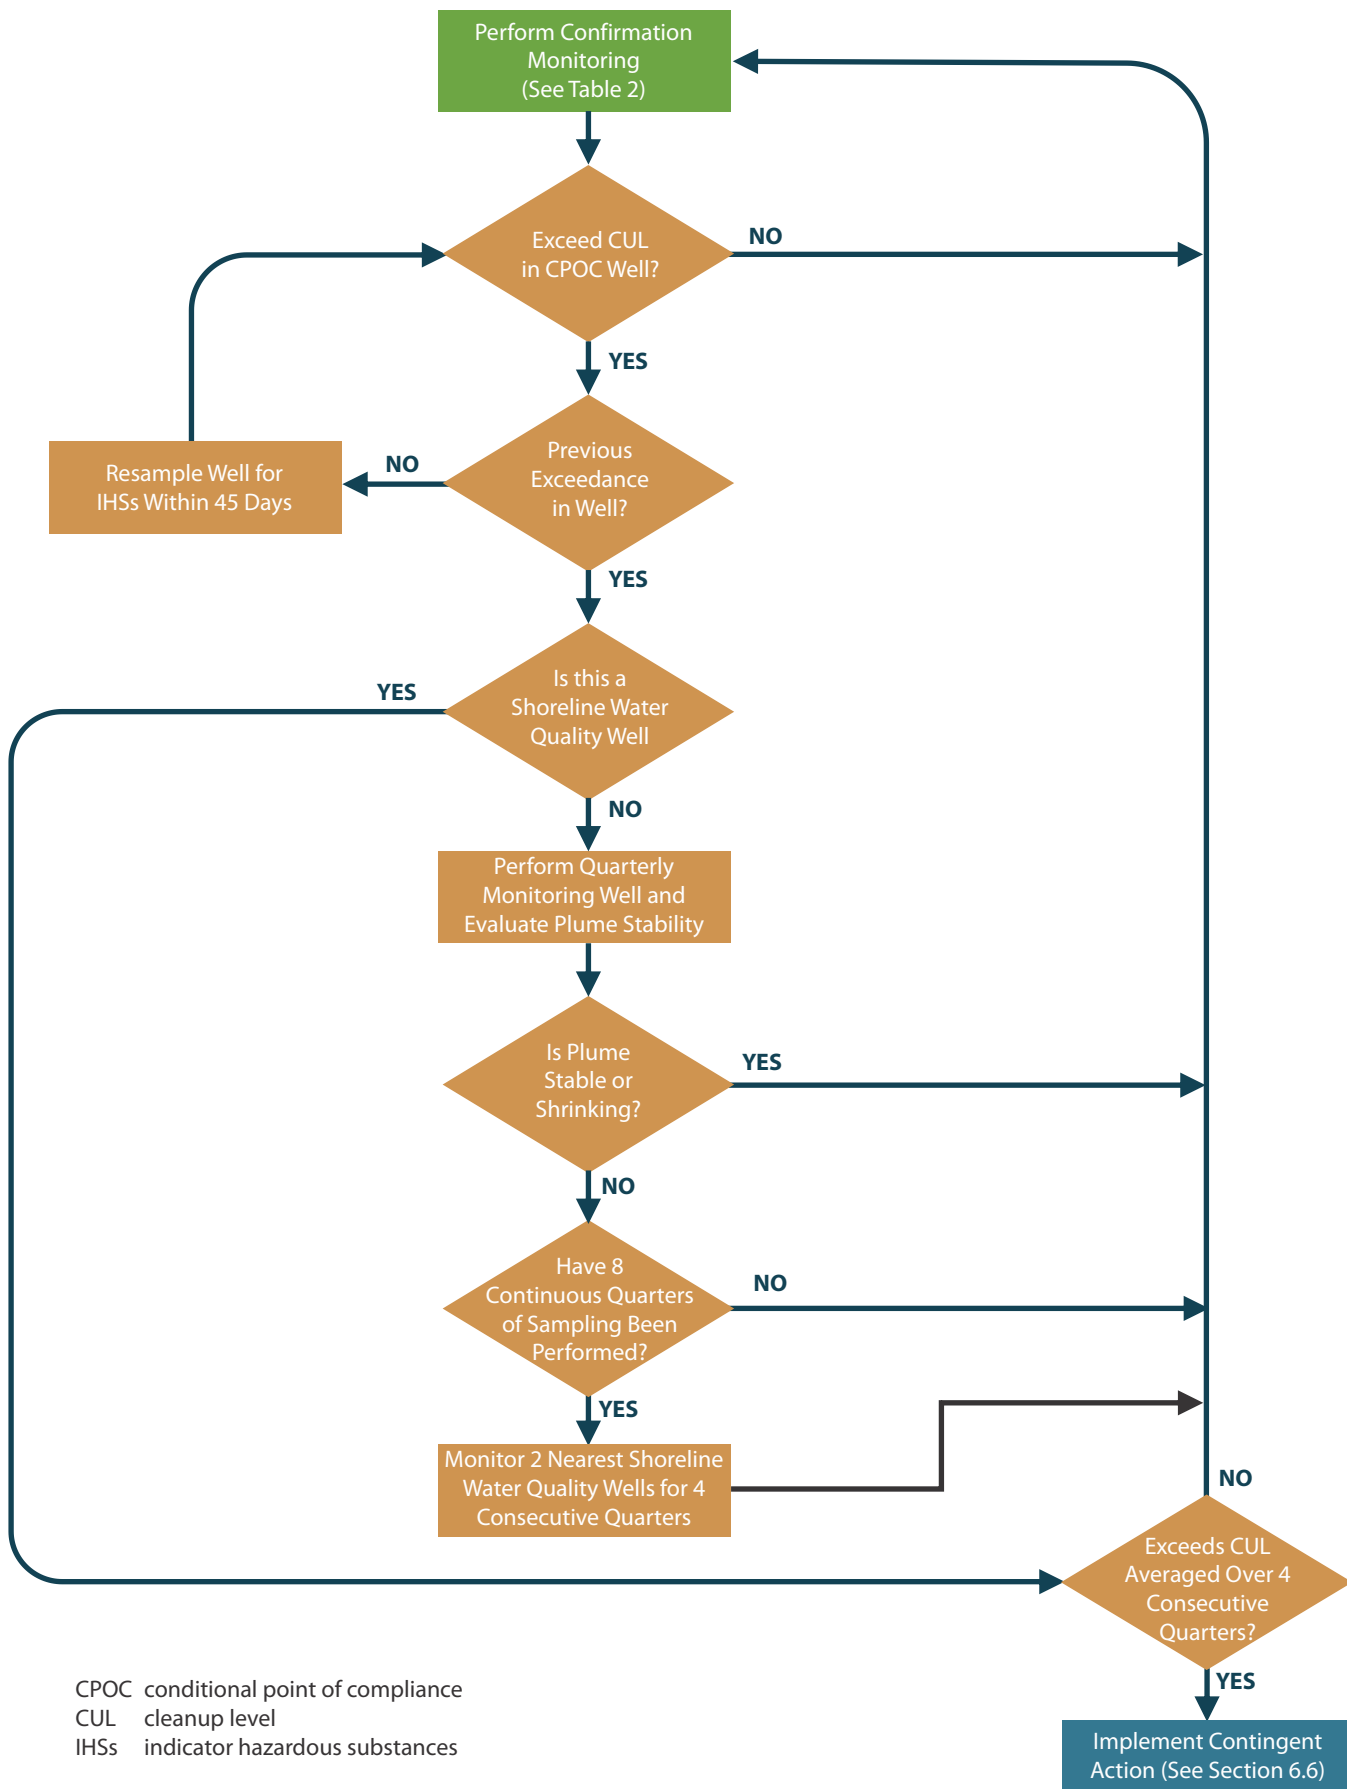
1. Performance Monitoring Wells include: RW-9, RW-11A, MW-42, MW-39A, and MW-36A. MW-59 will become a Performance Monitoring Well once LNAPL has not been present for 4 consecutive quarters.
2. The intent is to initially operate the AS/SVE system for 3 to 5 years even if the data suggest that significant mass is no longer being removed.
3. "Significant mass" has not been defined and will need to be negotiated between the Port and Ecology based on vapor and groundwater data.

Data collected from the performance monitoring wells were evaluated and used to make decisions regarding AS/SVE system operation. The flow chart in Figure 5 of the CMP (included for reference in Appendix I) provides guidance on decision making criteria. There are no planned modifications or recommendations to the CMP.
