RE: TECHNICAL MEMORANDUM – Follow-Up Vapor Assessment Results
Chinook Development
1446 NW 53rd Street
Seattle, Washington 98107
AEG Atlas Project No. 21-101
VCP ID No. NW3324

VAPOR ASSESSMENT

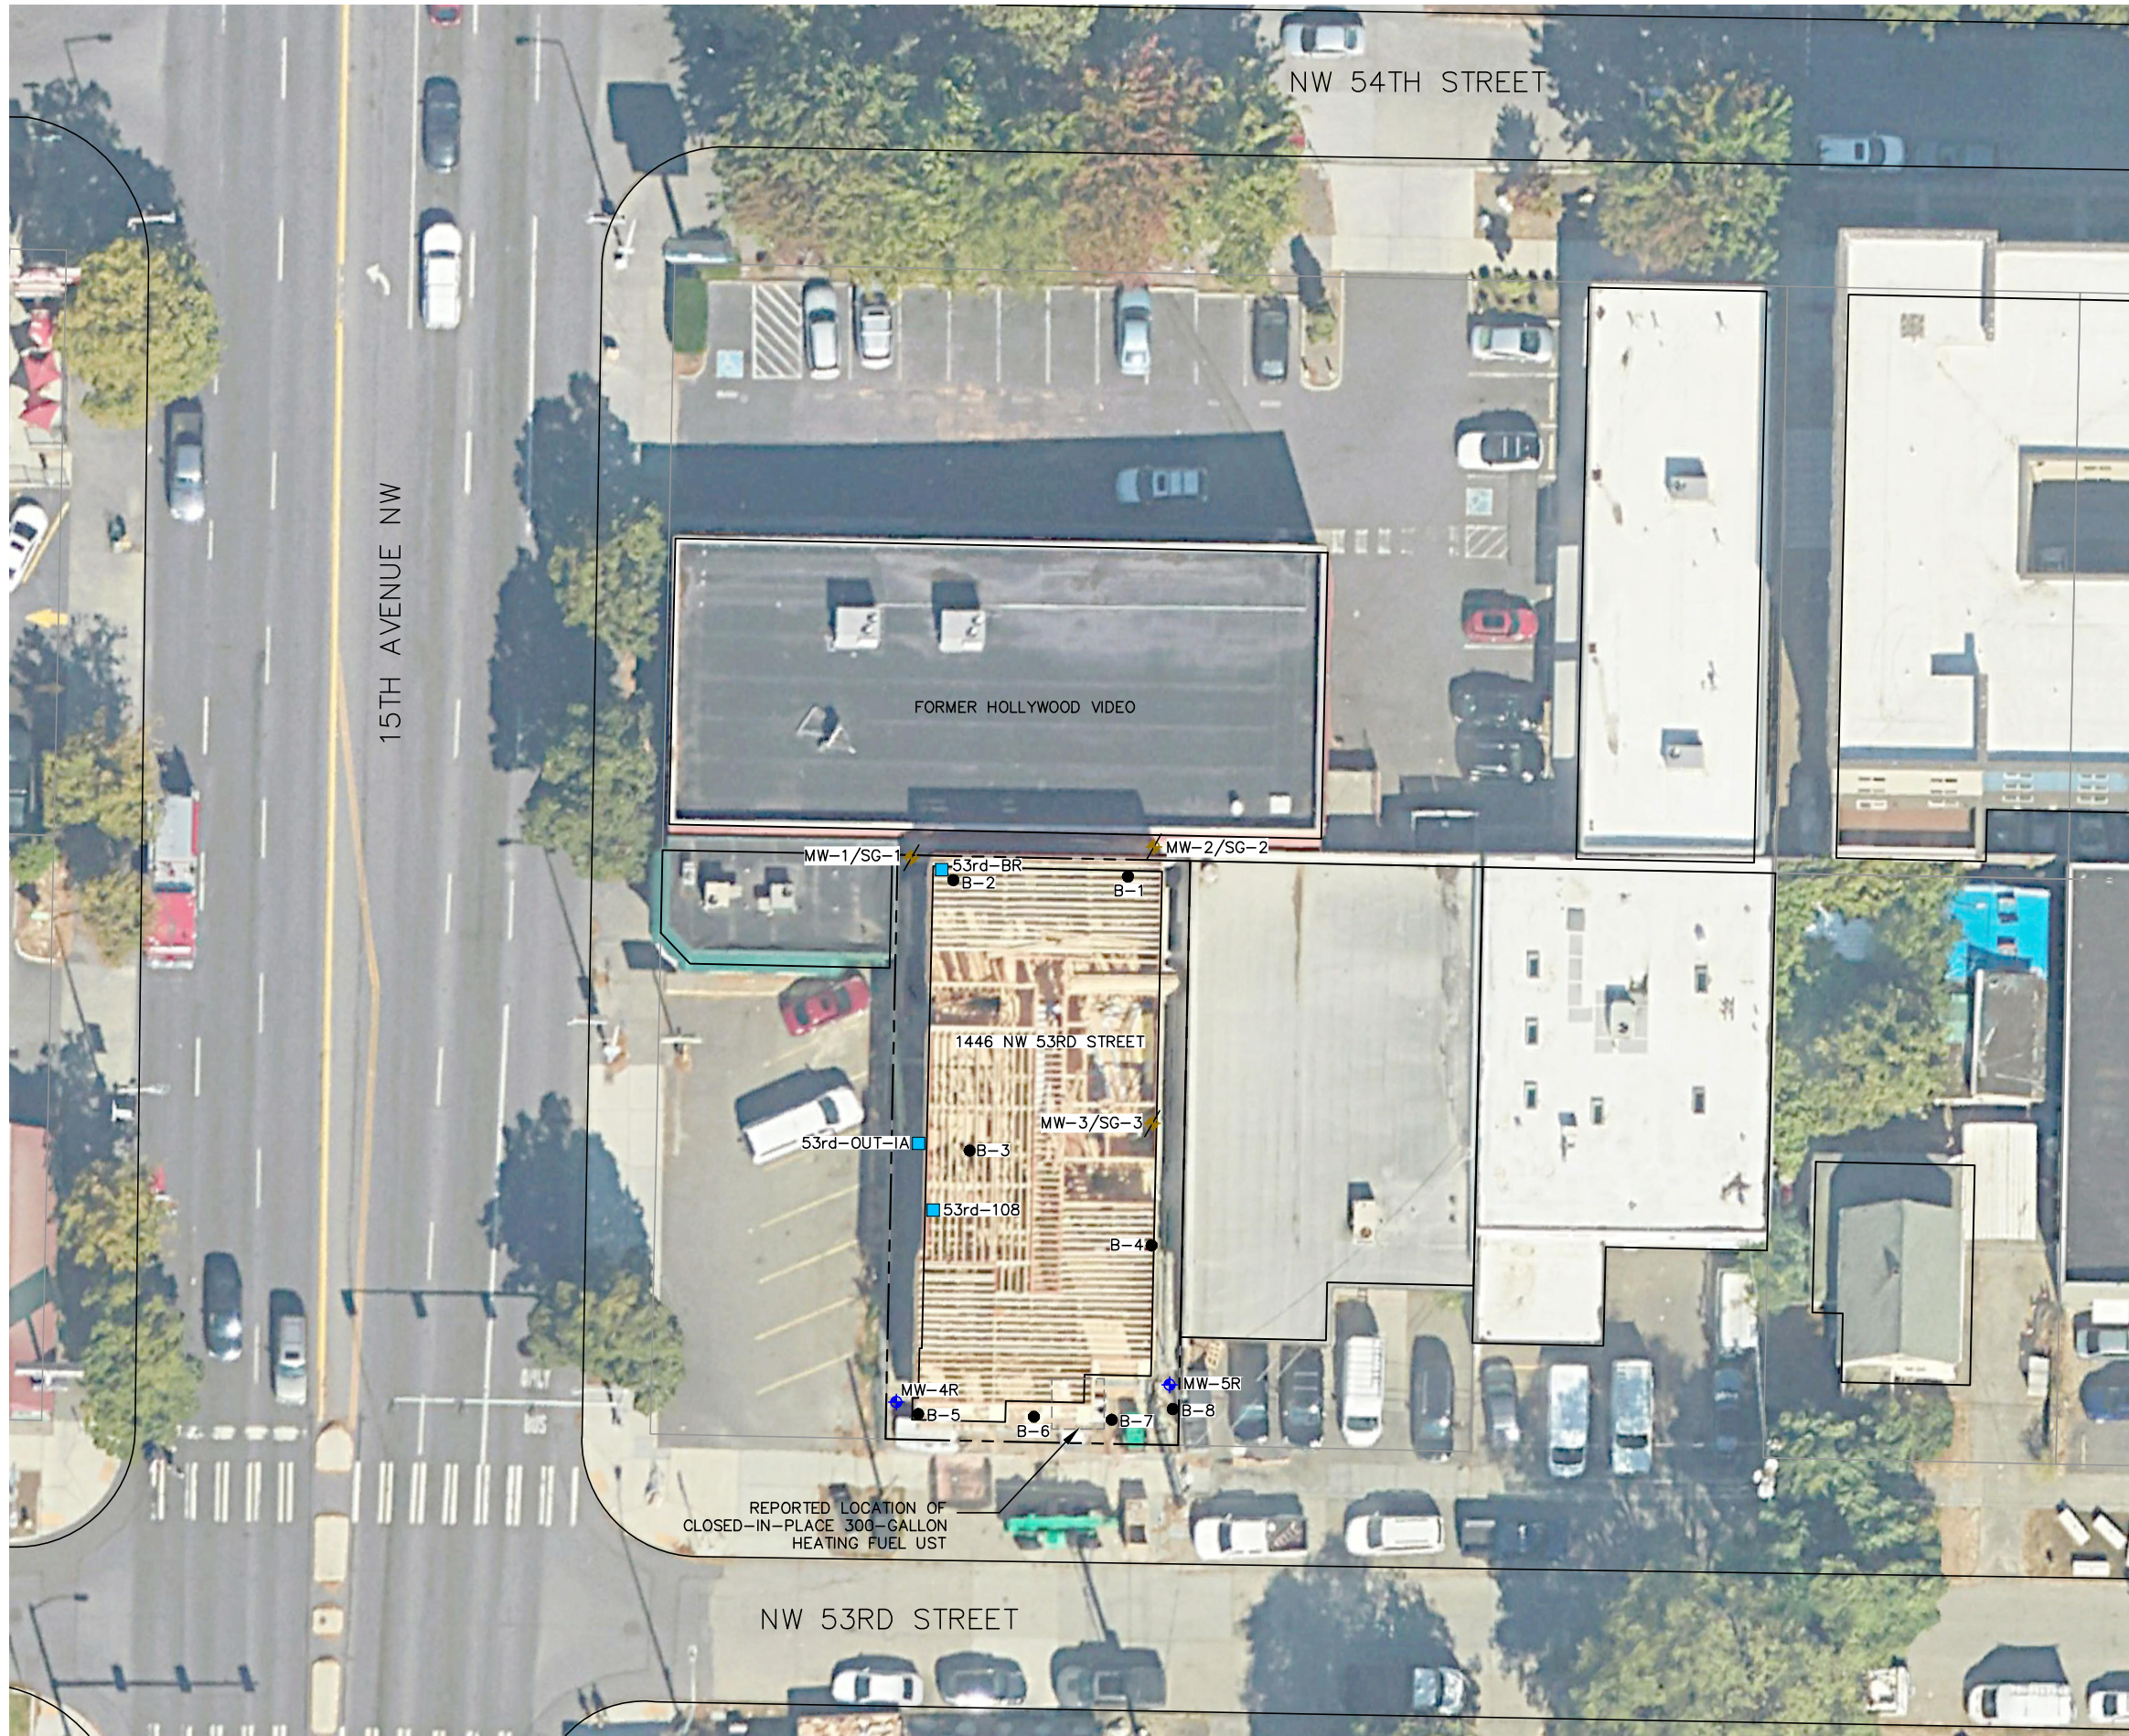
FIGURE 2
SITE MAP

Sample locations are illustrated in Figure 2, *Site Map*, and Figure 4, *Floor Plans – Main Level*. Analytical results are presented in Table 1, *Soil Gas, Sub-Slab Vapor, and Indoor Air Analytical Results*. Laboratory datasheets are provided in Appendix A, Supporting Documents, *Laboratory Datasheets*.
