CRITICAL AREAS REPORT JENSEN MARINE TRADES CENTER – PORT OF FRIDAY HARBOR SAN JUAN ISLAND, WASHINGTON

Essency Environmental, LLC. 2020. Critical Areas Report for Jensen Marine Trades Center – Port of Friday Harbor. San Juan Island, WA. Prepared for Leon Environmental, LLC. November 10.

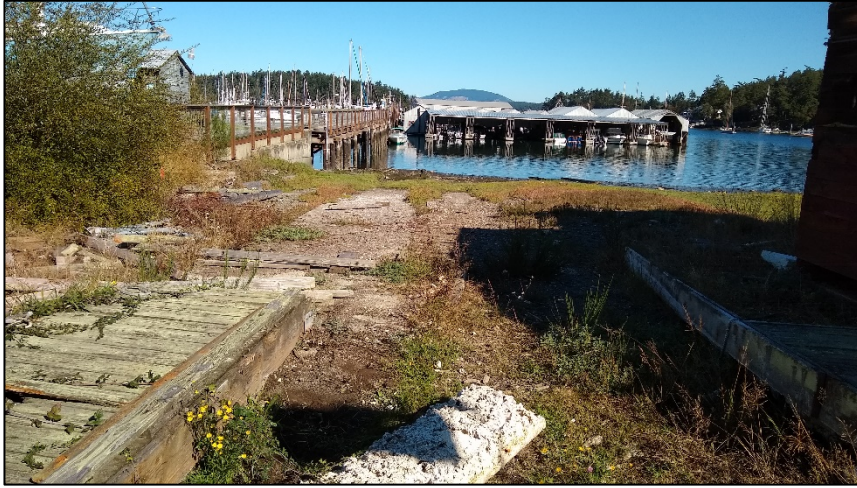
Photo 1. Concrete boat ramp at northwest portion of study area, facing north.

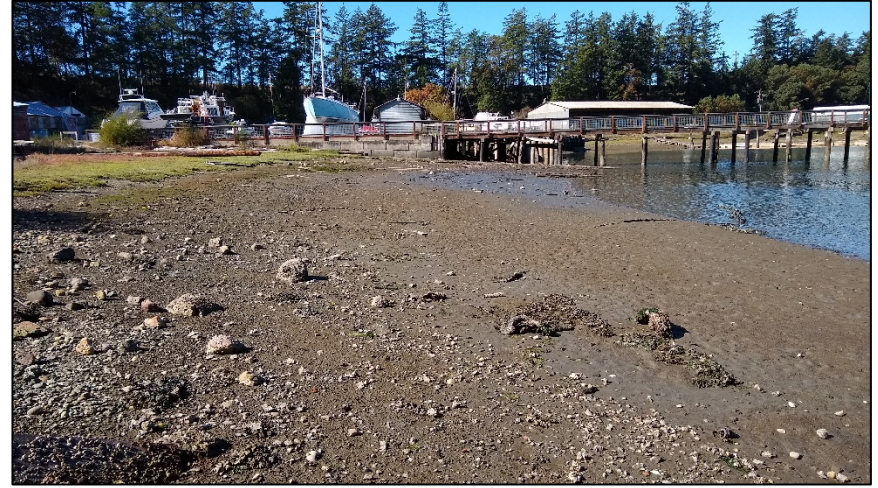
Photo 2. Shoreline at northwest portion of study area, facing west.

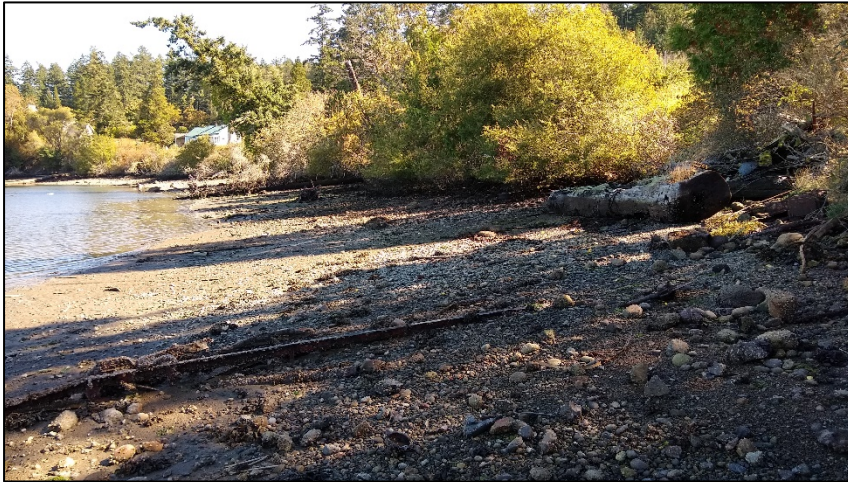
Photo 3. Shoreline at the northeast portion of study area, facing northeast.

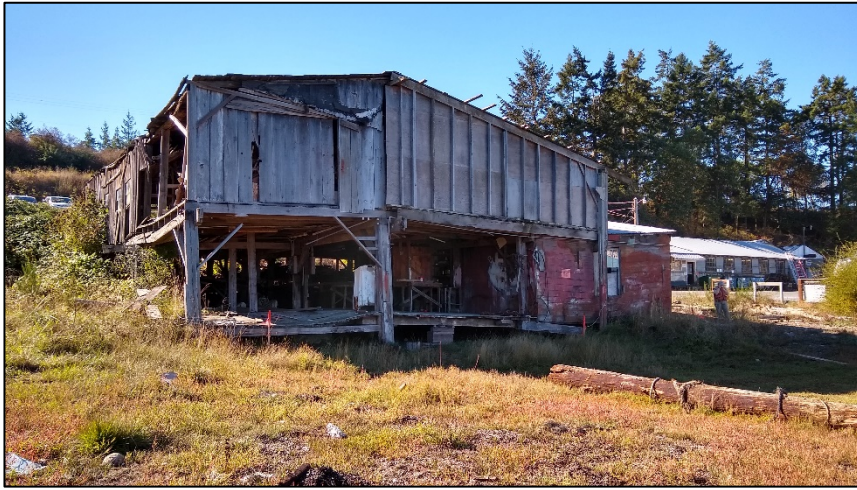
Photo 5. Boat building and upper intertidal area, facing south.

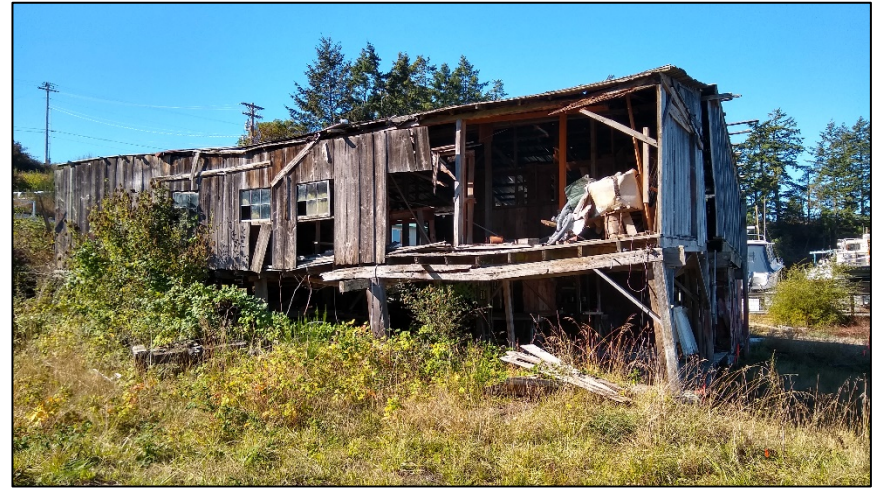
Photo 6. Boat building, facing west-southwest.

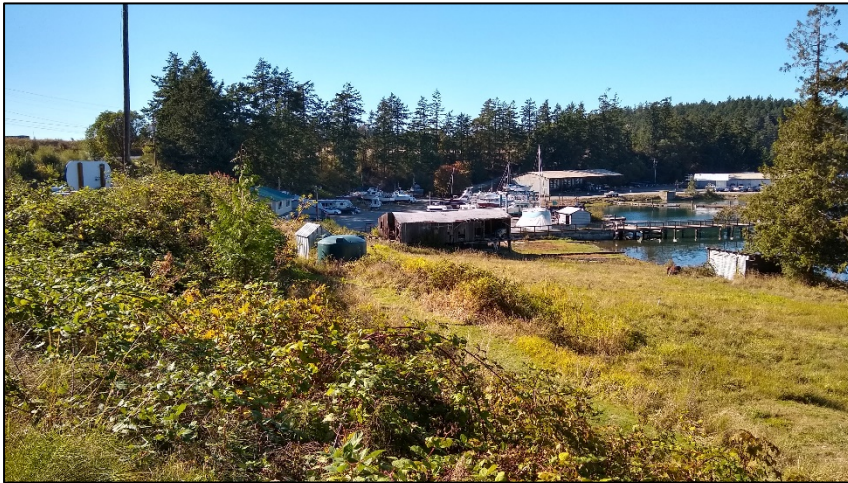
Photo 7. From southeast corner of Parcel 351341005000, facing west. An excavated trench or remains of a former farm pond is located under the blackberries at the center of photo.

What appears to be a remnant portion of a farm pond, perhaps an irrigation pond, is present in the southcentral portion of site (Figure 2). This pond is visible on a 2008 aerial but was largely filled in by 2011. Aerials from 2008 and prior show several buildings in the vicinity, and active agricultural activities including greenhouses, tilled beds, and partitioned growing structures. A pump house and water tank are still present on the property to the southwest of the old pond (Figure 2 and Survey Drawing in Appendix B). This pond may have been lined to hold water which explains why cattails (*Typha sp.*) are present in an area of surrounding upland soils and no obvious natural water source. This artificial water feature is not regulated by San Juan County code per the definition of “Wetland” in the code which clearly excludes irrigation and drainage ditches, and farm ponds. From SJCC 18.20.230 - *“Wetland” means an area that is inundated or saturated by surface water or groundwater at a frequency and duration sufficient to support, and that under normal circumstances does support, a prevalence of vegetation typically adapted for life in saturated soil conditions. Wetlands generally include swamps, marshes, bogs, and similar areas. Wetlands do not include those artificial wetlands intentionally created from nonwetland sites, including, but not limited to, irrigation and drainage ditches, grass-lined swales, canals, detention facilities, wastewater treatment facilities, farm ponds, and landscape amenities, or those wetlands created after July 1, 1990, that were unintentionally created as a result of the construction of a road, street, or highway. Wetlands may include those artificial wetlands intentionally created from nonwetland areas created to mitigate conversion of wetlands.*

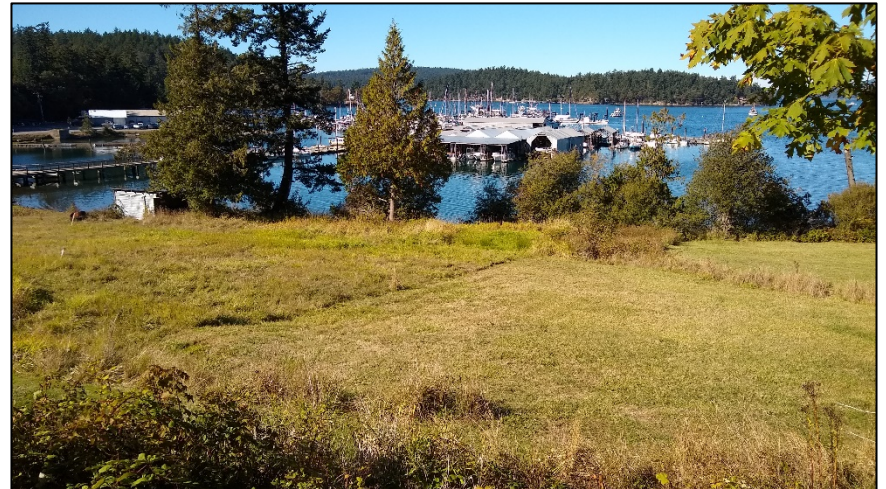
Photo 8. From southeast of Parcel 351341005000, facing northwest. Recently mown portion is on the adjacent parcel to the east of the project site.

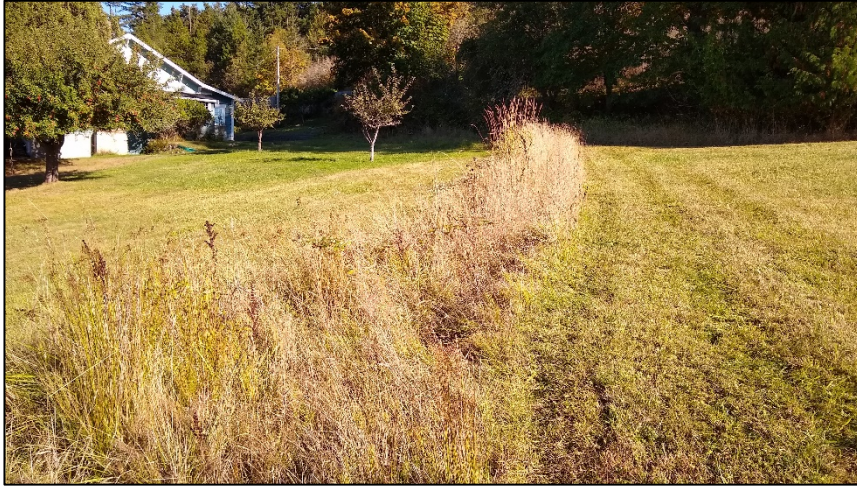
Photo 9. Excavated ditch on adjacent parcel to the east, facing southeast.

An excavated ditch is present on the adjacent parcel to the east. The ditch carries water downslope from roadside ditches via a culvert under Turn Point Road. A vertical cut slope is present on the upslope side of Turn Point Road and there is no channel or other upslope source of water that would indicate a wetland or a stream was historically present in this area. This ditch is not readily visible on 1932 aerial image, although the quality of the image is not clear enough to see this level of detail. The oldest aerial on which the ditch is clearly visible is from 2008. Water from this culvert under the road sheet flows down the slope into the excavated ditch.

The ditch is trapezoidal, ranges from 3-6 feet wide, and is about 1-foot deep. It ends abruptly at both the upslope and downslope ends. A perched, 6-in corrugated plastic pipe (CPP) discharges into the ditch near the upslope end that appears to carry water from a drain system (French drain?) on the adjacent parcel to the east. There was a steady trickle coming out of the pipe on 9/28/20. The water immediately infiltrated into the bottom of the ditch. There was no surface flow further downslope. There is a triangular shaped area dominated by reed canarygrass (*Phalaris arundinacea* – FACW), soft rush (*Juncus effusus* – FACW), and field horsetail (*Equisetum arvense* – FAC), downslope of the ditch. A shallow swale is present in this area that appears to carry surface flows to the edge of bluff during wet periods when surface water overflows from the downslope end of the ditch. The soils on either side of the ditch are upland soils and did not have hydric soil indicators. The soils in the triangular area are also upland and did not have hydric soil indicators. No indicators of either hydric soil or wetland hydrology were present in the sample plots in this area (P4 and P6). Observed soil characteristics match those of the mapped series, Mitchellbay-Rock Outcrop-Killebrew Complex, 3 to 15 percent slopes. This ditch is not a regulated feature under San Juan County Code.

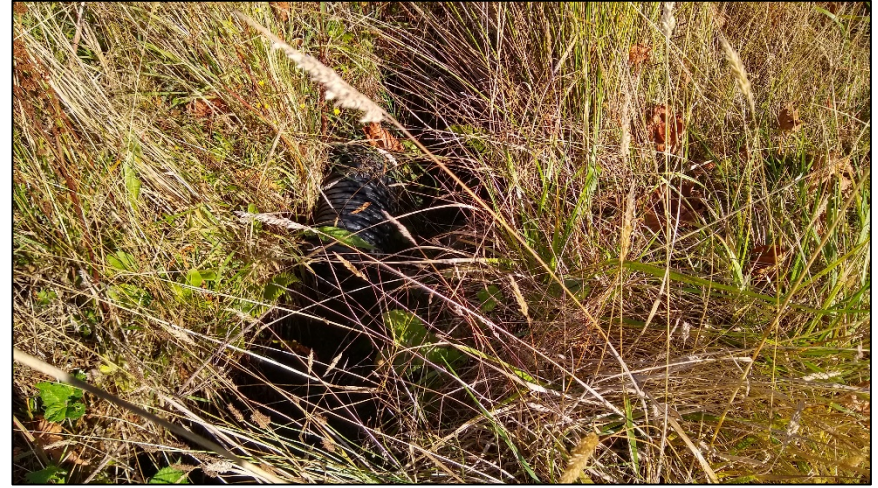
Photo 10. A corrugated plastic pipe drains to the upper end of the ditch on the adjacent property. The pipe may drain from the base of the retaining wall upslope of the residence on that property.

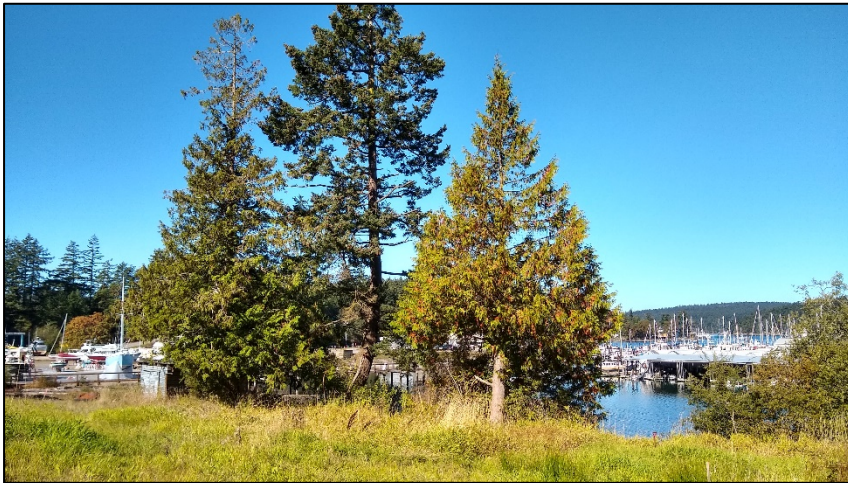
Photo 11. Trees mapped along the shoreline of Parcel 351341005000, facing northwest.

A row of trees, including some mature conifers, is currently present on the low bluff along the marine shoreline between the existing shed and east project boundary. Trees inventoried included western red cedar (*Thuja plicata*), Douglas fir (*Pseudotsuga menziesii*), and Scouler's willow (*Salix scouleriana*). Individual tree species and diameters are shown on a table on Figure 2. The shoreline bluff is slightly undercut causing some of the trees to hang out over the high

tide line. Two of the cedar trees (T7 and T9 on Figure 2) are horizontal at the base and seem likely to fall into the cove in the near future.

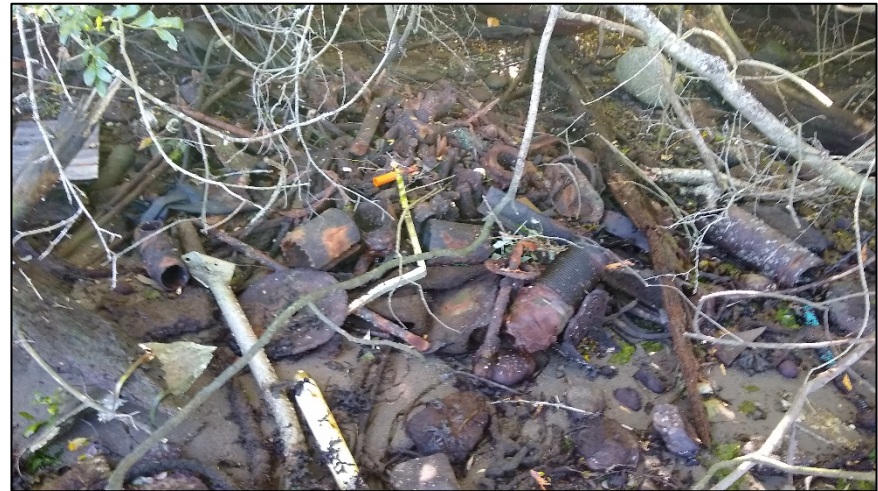
Photo 12. Vessel debris in the upper intertidal zone along the shoreline.

Over the years, a variety of shipbuilding debris was disposed of in the upper intertidal zone within Shipyard Cove and buried in the shoreline bank. Rusted metal, tires, pieces of boats, and other miscellaneous debris are visible along the shore, both in the water and embedded in the shoreline bluff within the project boundaries. The former boat building located in the southwestern portion of the project site is also filled with old equipment and boat building materials. According to information provided by Leon Environmental, LLC, areas of both marine and upland sediment contamination are present within the study area, on the Port of Friday Harbor lands to the west, and in adjacent marine areas within Friday Harbor/Shipyard Cove.

The intertidal area on the project parcel waterward of the bluff between the existing shed to the east project boundary is cobble-dominated beach habitat. Sparse macroalgae (*Fucus sp.*) grows attached to cobbles in this area. Several large logs are present on the beach. Over the years, a variety of shipbuilding debris was disposed of in the upper intertidal zone within Shipyard Cove and buried in the shoreline bank. Rusted metal, tires, pieces of boats, and other miscellaneous debris are visible along the shore, both in the water and embedded in the banks within the project boundaries. The former boat building located in southwestern portion of the project site is also filled with old equipment and shipbuilding materials. According to information provided by Leon Environmental, LLC, known areas of both marine and upland sediment contamination are present within the study area boundaries, on the Port of Friday Harbor lands to the west, and in adjacent marine areas within Friday Harbor/Shipyard Cove. Gravel and sand areas north of the bluff within the 5 to 7-ft elevation range could provide substrate for surf smelt spawning. However, Washington State maps of forage fish spawning areas do not show forage fish spawning sites in the project vicinity (Washington State 2020). Vessel debris may make this substrate suboptimal for forage fish spawning.
