February 2025  
Anacortes Former Water Treatment Plant Demolition

# Construction Completion Report

Ecology Consent Decree No. 20761

Prepared for the Washington State Department of Ecology

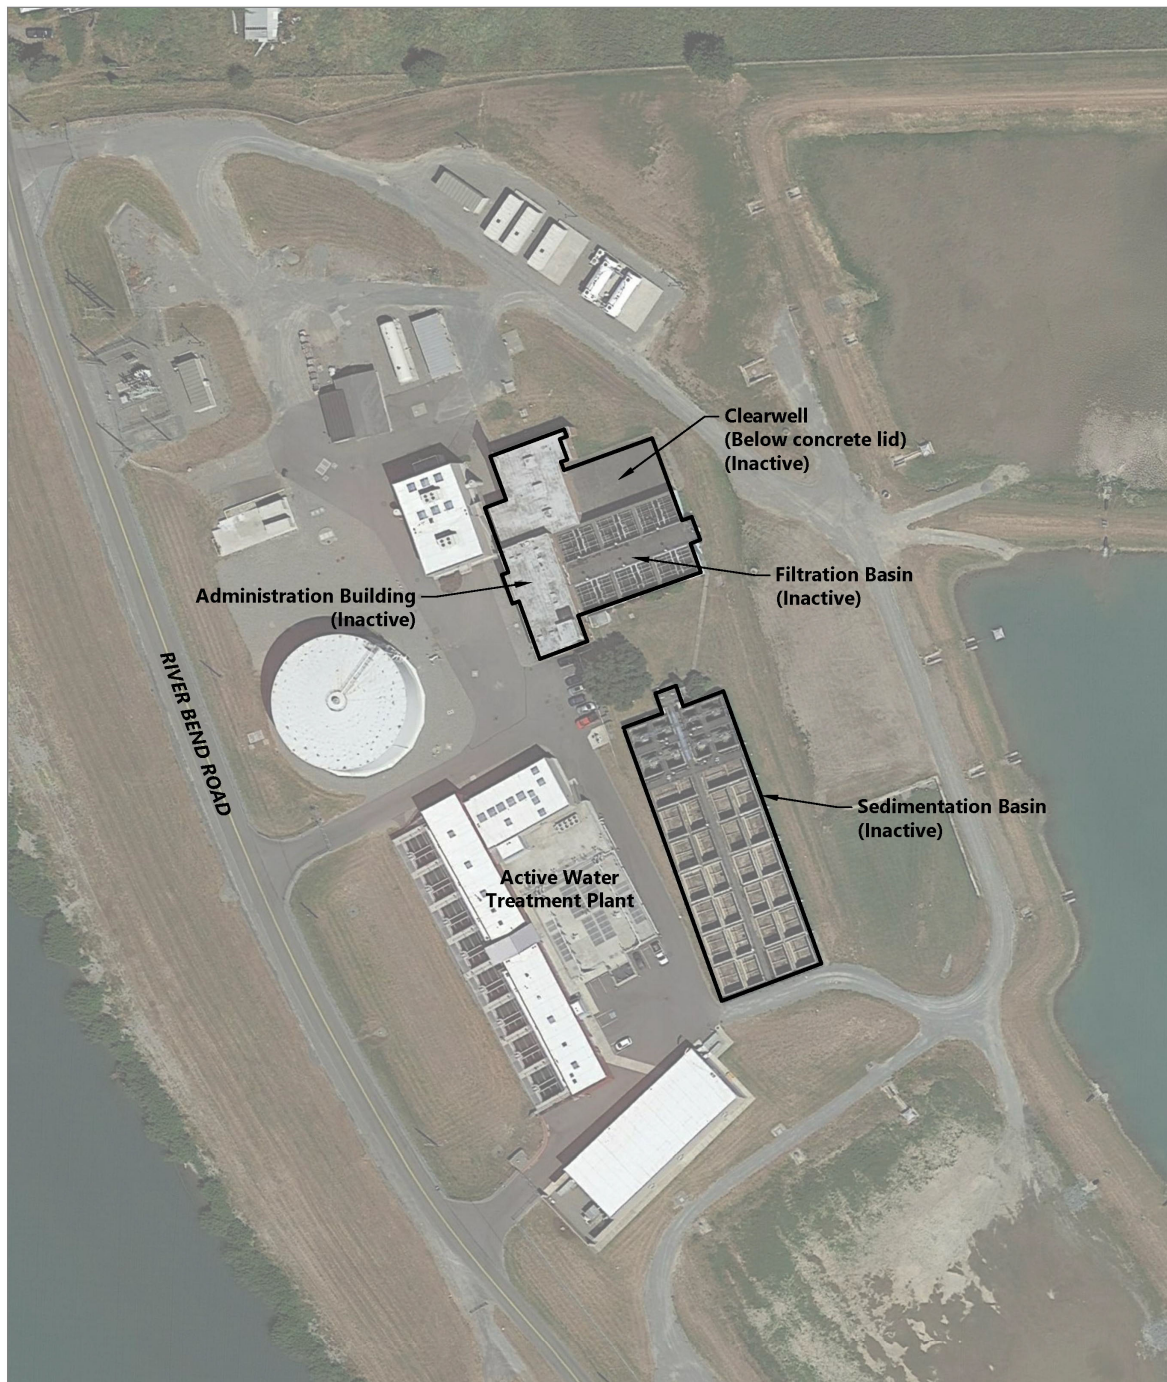
**Figure 1-2  
Site Overview**

The City operates a municipal water treatment plant at the Site. The current facilities, which became operational in 2013, replaced the FWTP that was constructed in 1969 and 1970. The FWTP facilities included an Administration Building, a Sedimentation Basin, a Filtration Basin, and a Clearwell (Figure 1-2).

During decommissioning activities performed in 2015, contaminants of potential concern were found in decommissioned FWTP building materials and in shallow soils immediately adjacent to the FWTP structures. In 2016, a Remedial Investigation (RI) was performed in accordance with the Model Toxics Control Act (MTCA), Revised Code of Washington Chapter 70.105D, and Washington Administrative Code (WAC) Chapter 173-340 to characterize the nature and extent of contaminants in Site environmental media (i.e., soil and groundwater). The results of the RI (Stantec 2019) confirmed that exterior coatings containing PCBs on the Sedimentation Basin and Filtration Basin of the FWTP were the source of PCBs in soil. PCB concentrations in soil above 1 milligram per kilogram (mg/kg) (i.e., the MTCA Method A: Unrestricted Land Use cleanup level) were limited to the upper 1 foot of soil immediately adjacent to the exterior of the Sedimentation and Filtration basins. No impacts to groundwater were identified. The Site consists of the Sedimentation and Filtration basins and the shallow soils immediately surrounding them, in which PCBs have been detected (Figure 1-2).

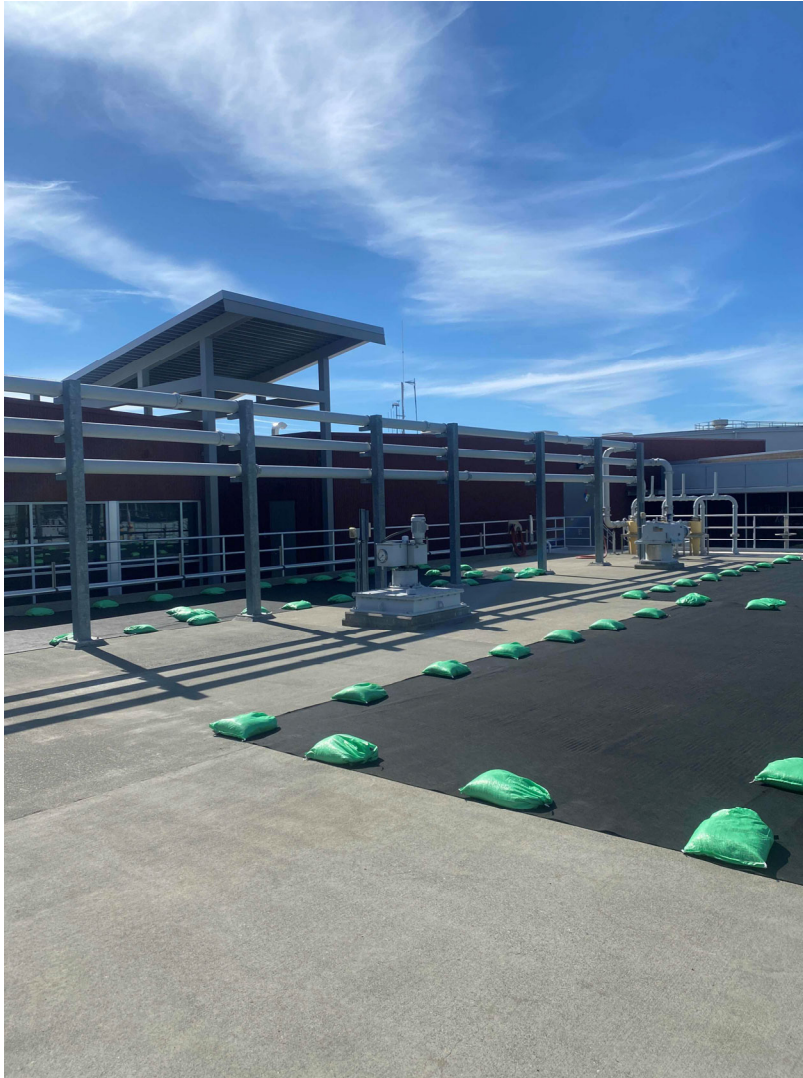
**Photograph 3**  
**Dust Protections Installed on the Active Sedimentation Basin**

- Installed dust protections (e.g., geotextile fabrics) on the active water treatment plant; Sedimentation Basin; Clearwell roof structures; and the heating, ventilation, and air conditioning (HVAC) intake units (Photographs 3 and 4)

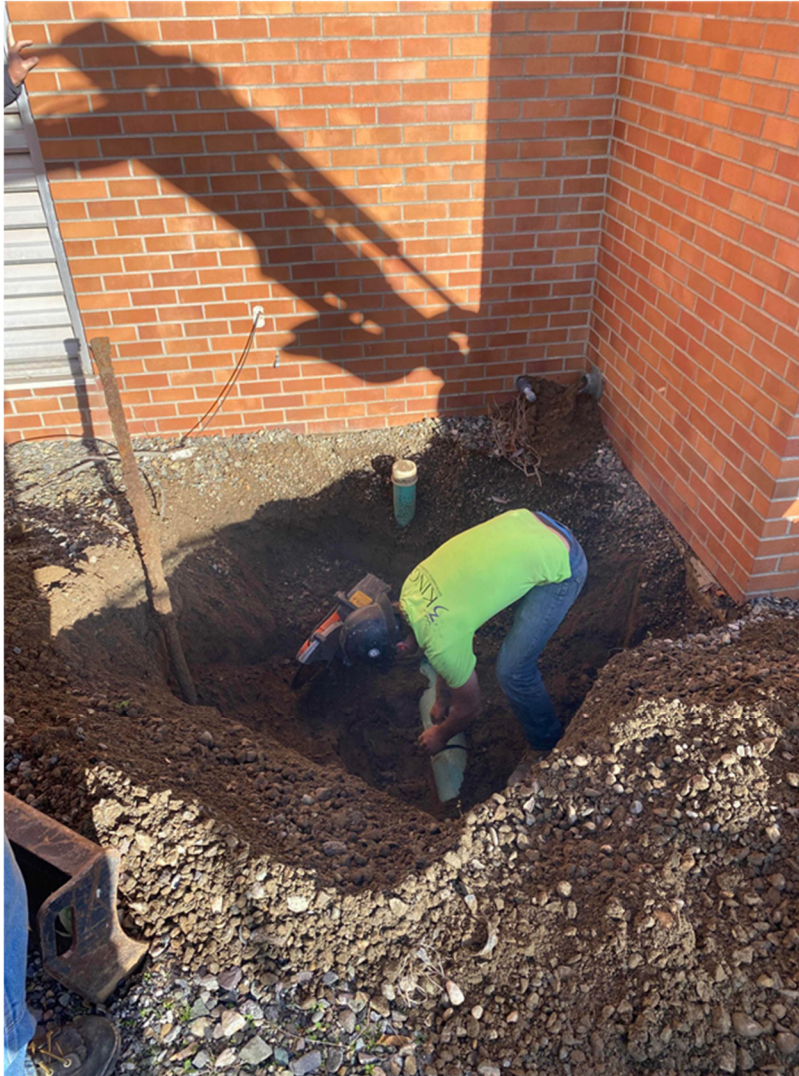
**Photograph 6**  
**3 Kings Disconnecting the Sanitary Sewer Line**

On October 18, 2023, 3 Kings cut and capped the sanitary sewer connection on the west side of the Administration Building. There was no sanitary sewer connection associated with the Sedimentation Basin.

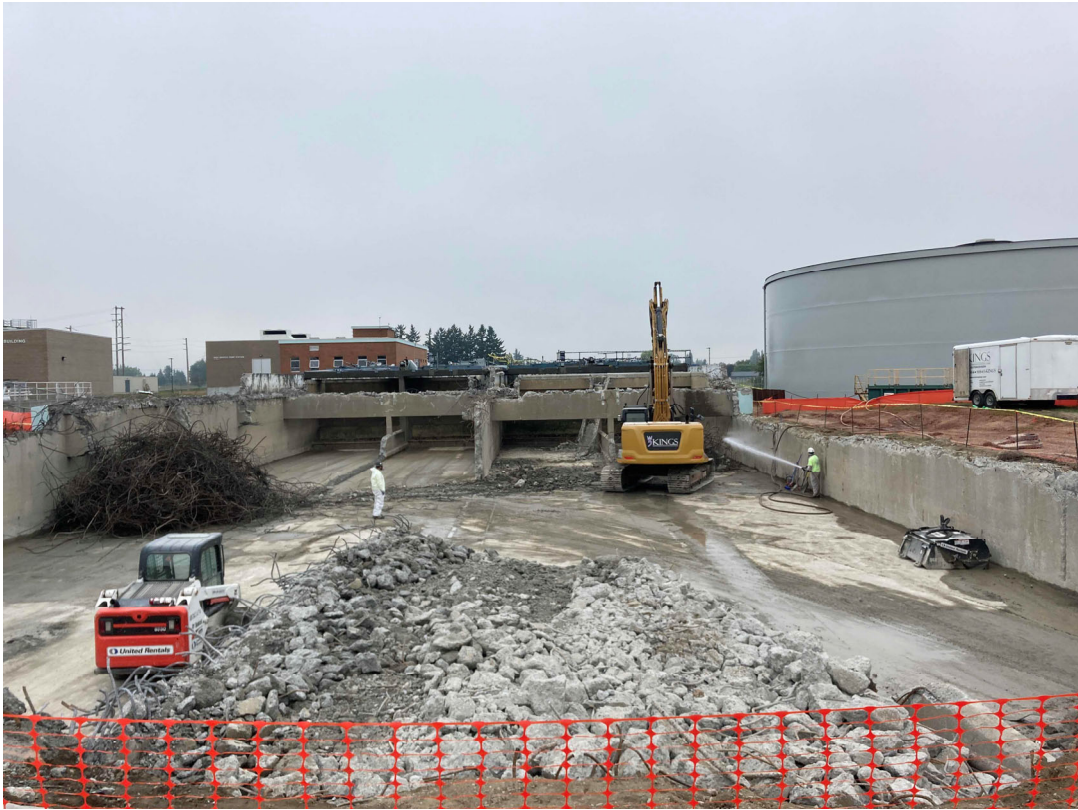
**Photograph 10**  
**Sedimentation Basin Demolition**

3 Kings initiated demolition of the Sedimentation Basin on August 16, 2023. 3 Kings demolished the structure using CAT 349 and CAT 336 excavators with concrete processing attachments. The demolition of the east half of the basin progressed from south to north. Then the demolition of the west side of the basin progressed both north and south from the center.

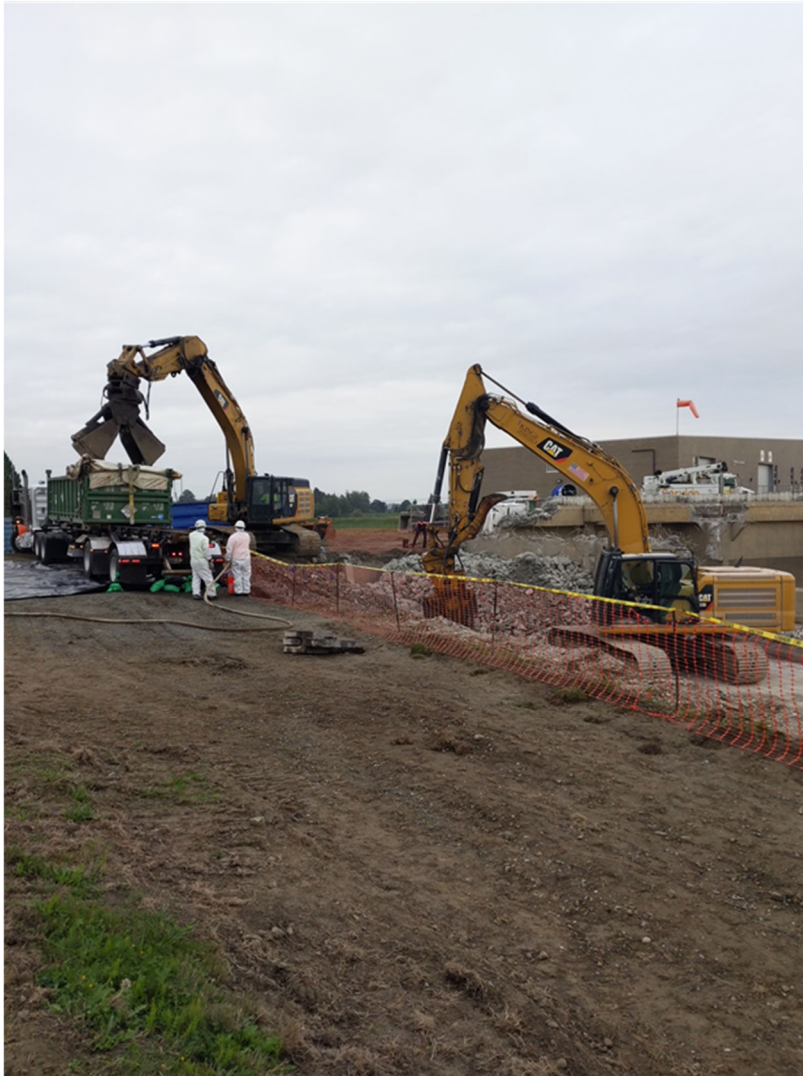
**Photograph 11**  
**PCB BPW Demolition Debris Loadout**

Waste loadout commenced on August 21, 2023, and occurred concurrently with the building demolition. Demolition debris was loaded into intermodal waste containers and transported via trucks to Waste Management's rail facility. At the rail facility, the intermodals were placed on railcars and transported to Chemical Waste Management in Arlington, Oregon. Unpainted scrap metal, including concrete reinforcing bars, was segregated, washed of any incidental demolition dust, and placed in roll-off containers for shipment to Metro Metals in Tacoma, Washington, for recycling. The demolition and loadout of the Sedimentation Basin was completed on November 6, 2023, following the basin cleaning, confirmation sampling, and removal of the expansion joint discussed in the following sections.

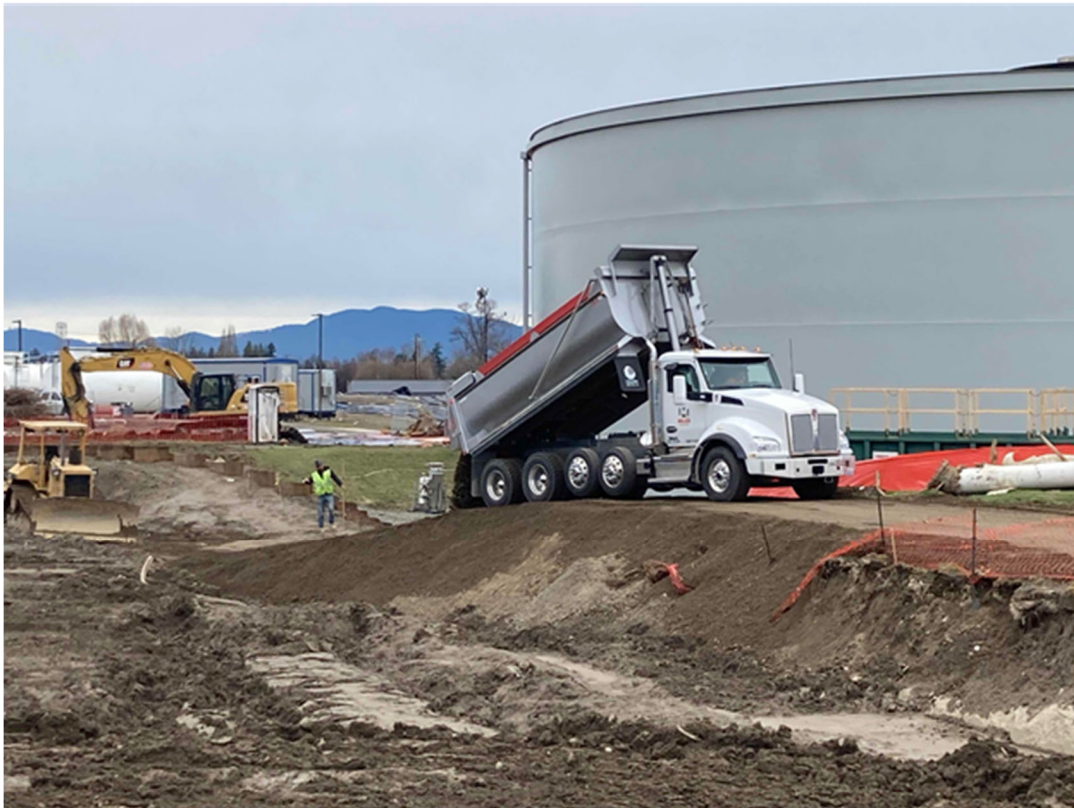
**Photograph 12**  
**Backfill of the Sedimentation Basin**

Prior to placement of backfill in the Sedimentation Basin, 3 Kings fractured the full depth of the slab at approximately 2-foot intervals to promote drainage. The first layer of backfill placed in the Sedimentation Basin was the processed uncontaminated concrete (i.e., PCB concentrations less than 1 mg/kg). 3 Kings placed this material in an approximately 8-inch thick layer across of the basin. On November 20, 2023, 3 Kings began placing the lagoon soils in the basin that the treatment plant had removed from their on-Site sediment lagoons as part of their ongoing Site maintenance. The lagoon soils had been stockpiled for use as backfill. Following the placement of the initial lagoon soil layer, Materials Testing and Consulting tested the material and determined there was too much moisture in the material to achieve the required compaction.

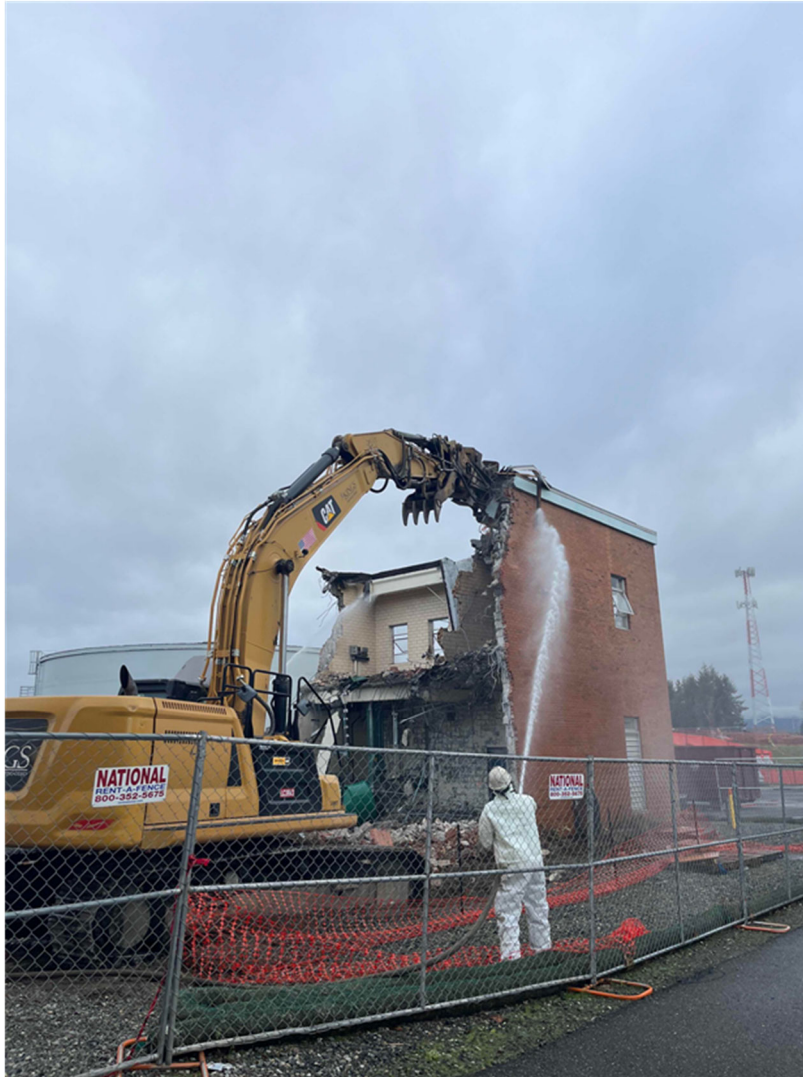
**Photograph 13**  
**Demolition of the Administration Building**

3 Kings demolished the Administration Building from the center and worked out toward the edges, pulling the debris inward to avoid potentially contaminating the surrounding area or causing any damage to the active facility. Additional protective measures included a designed scaffolding erected by BrandSafway between the active HSP Building and the Administration Building to prevent demolition debris from impacting the active HSP Building. In addition, steel plates and wooden pallets were placed over the active vaults and manholes on the east side of the building as a protection measure.

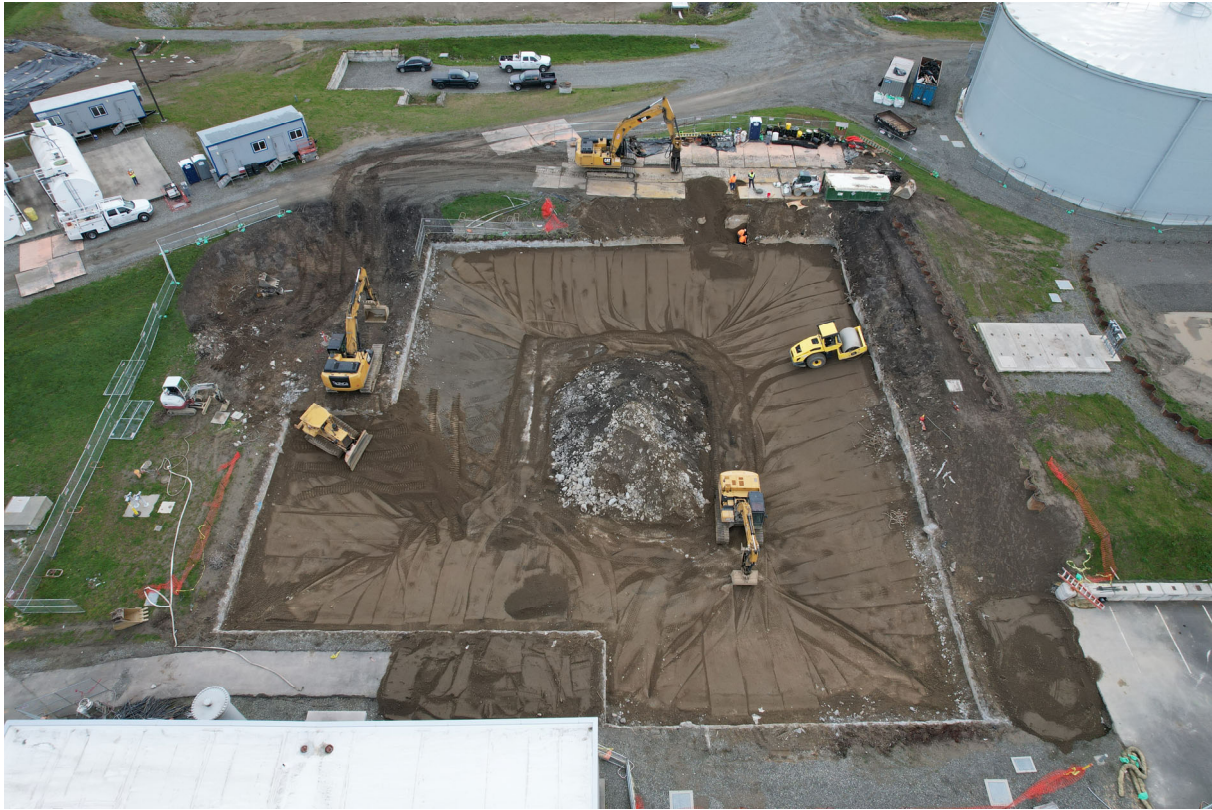
**Photograph 16**  
**Backfilling of the Filtration Basin and Administration Building**

Prior to placement of backfill in the Filtration Basin and Administration Building, 3 Kings fractured the slab at approximately 2-foot intervals to promote drainage. On March 25, 2024, 3 Kings began backfilling and grading. The stockpiled lagoon soils were still not suitable due to elevated moisture content, and Anchor QEA provided 3 Kings with interim measures to be performed. Revisions to the backfill guidance included placing the contractor-generated fill materials (Filtration Basin media, processed concrete designated for reuse, and excavated soil removed during the demolition of the perimeter walls) in the deeper portion of the Clearwell under the former Pump Room and Pipe Gallery.

To provide stability for the remaining walls until the basin could be backfilled to the proposed final grade, gravel borrow import was specified for placement at a 3:1 slope around the perimeter of the basin. Remaining contractor-generated fill materials were placed in the center of the basin and compacted. Additional backfill with the lagoon soil to the grades outlined in the original design and grading plan was deferred to the City to complete as a separate project when the material was drier and more suitable to compact.

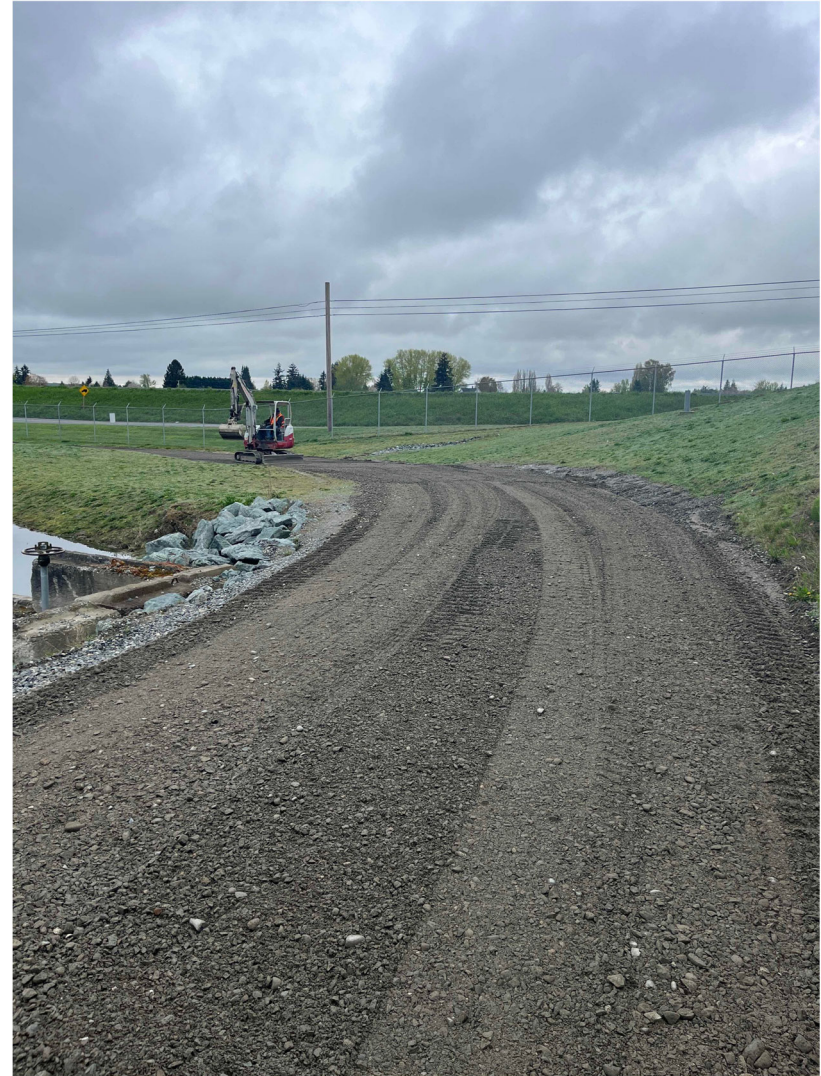
**Photograph 18**  
**Resurfacing the Gravel Roadway**

Beginning on April 11, 2024, 3 Kings received deliveries of 1.25-inch-minus crushed rock (i.e., crushed rock with the maximum of 1.25-inch diameter in any direction) for resurfacing the main gravel road from the south gate, around the new Clearwell, to the north gate. The south portion of the work area where trucks, equipment, and disposal boxes were staged was also resurfaced with the crushed rock.

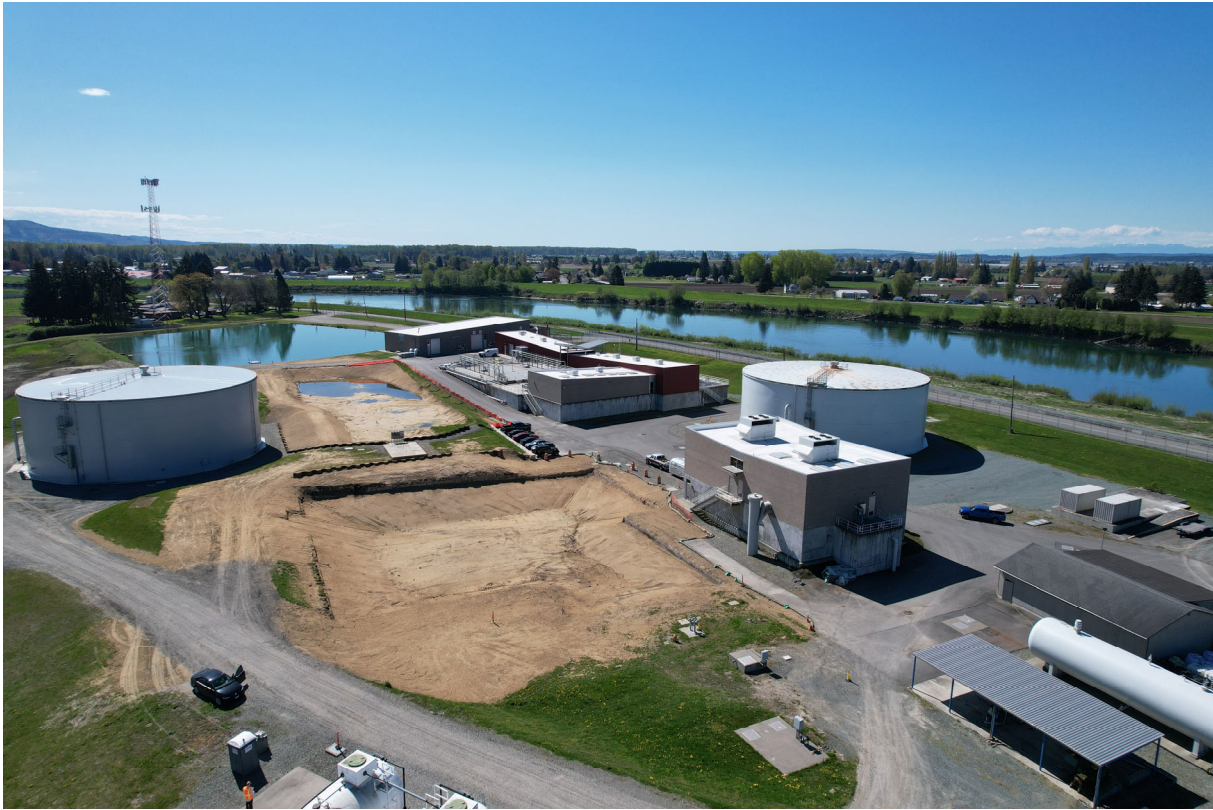
**Photograph 19**  
**Final Site Conditions at 3 Kings Demobilization on April 18, 2024**

During the week of April 15, 2024, 3 Kings demobilized the remaining equipment from the Site. United Rental demobilized the water management system components and baker tanks. The two job trailers were also disconnected from the Site-provided internet and electrical and demobilized from the Site. On April 18, 2024, 3 Kings were completed with the demobilization and Anchor QEA documented the Site conditions with drone images.

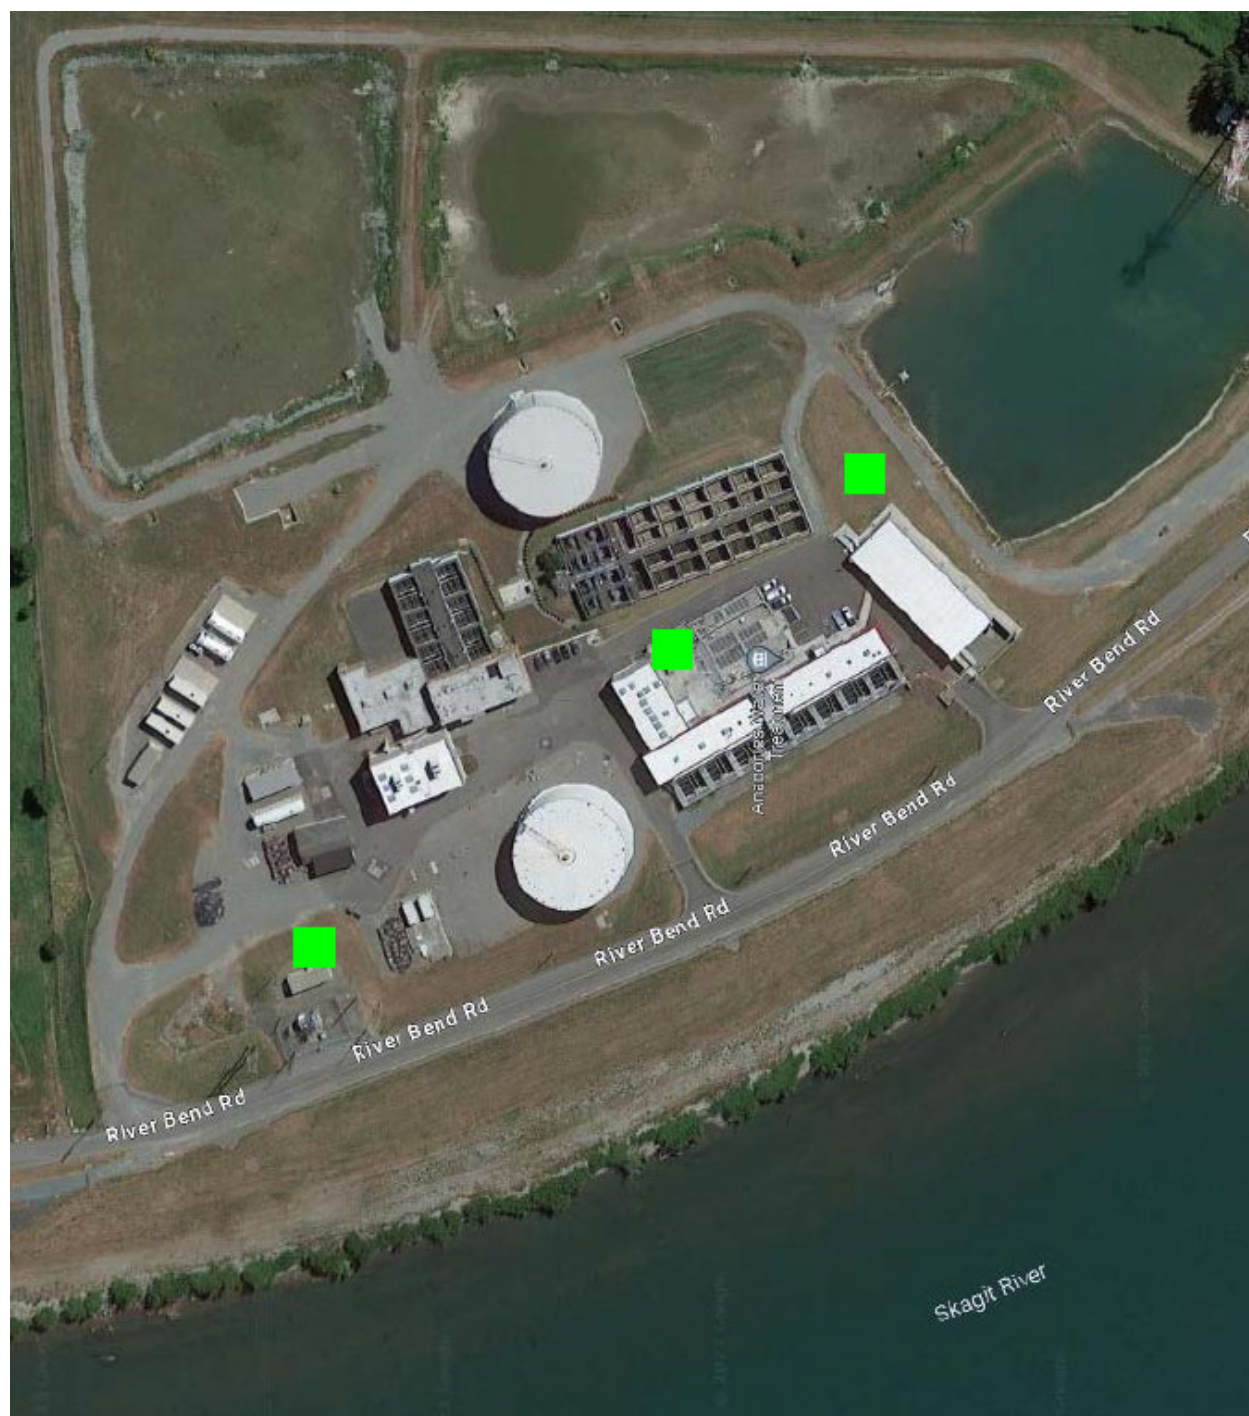
**Figure 8-1**  
**Baseline Air Monitoring Locations**

Baseline PM<sub>10</sub> monitoring data were collected by Anchor QEA over a period of 8 workdays leading up to the demolition between August 1 and 15, 2023. Air monitoring data was averaged every 15 minutes and over the 8-hour workday. Baseline PM<sub>10</sub> air monitoring data was collected using a TSI DustTrak II 8530 real-time monitor. Readings were collected at three Site perimeter air monitoring station locations identified in the AMP and as shown in Figure 8-1.
