SPILL RESPONSE: REMEDIAL ACTION REPORT

Nissen Property
16006 75th Place West
Edmonds, Washington 98026

Re: Spill Response - Remedial Action Report

Nissen Property
16006 75th Place West
Edmonds, Washington 98026
United Financial Casualty Company Claim 24-375701102

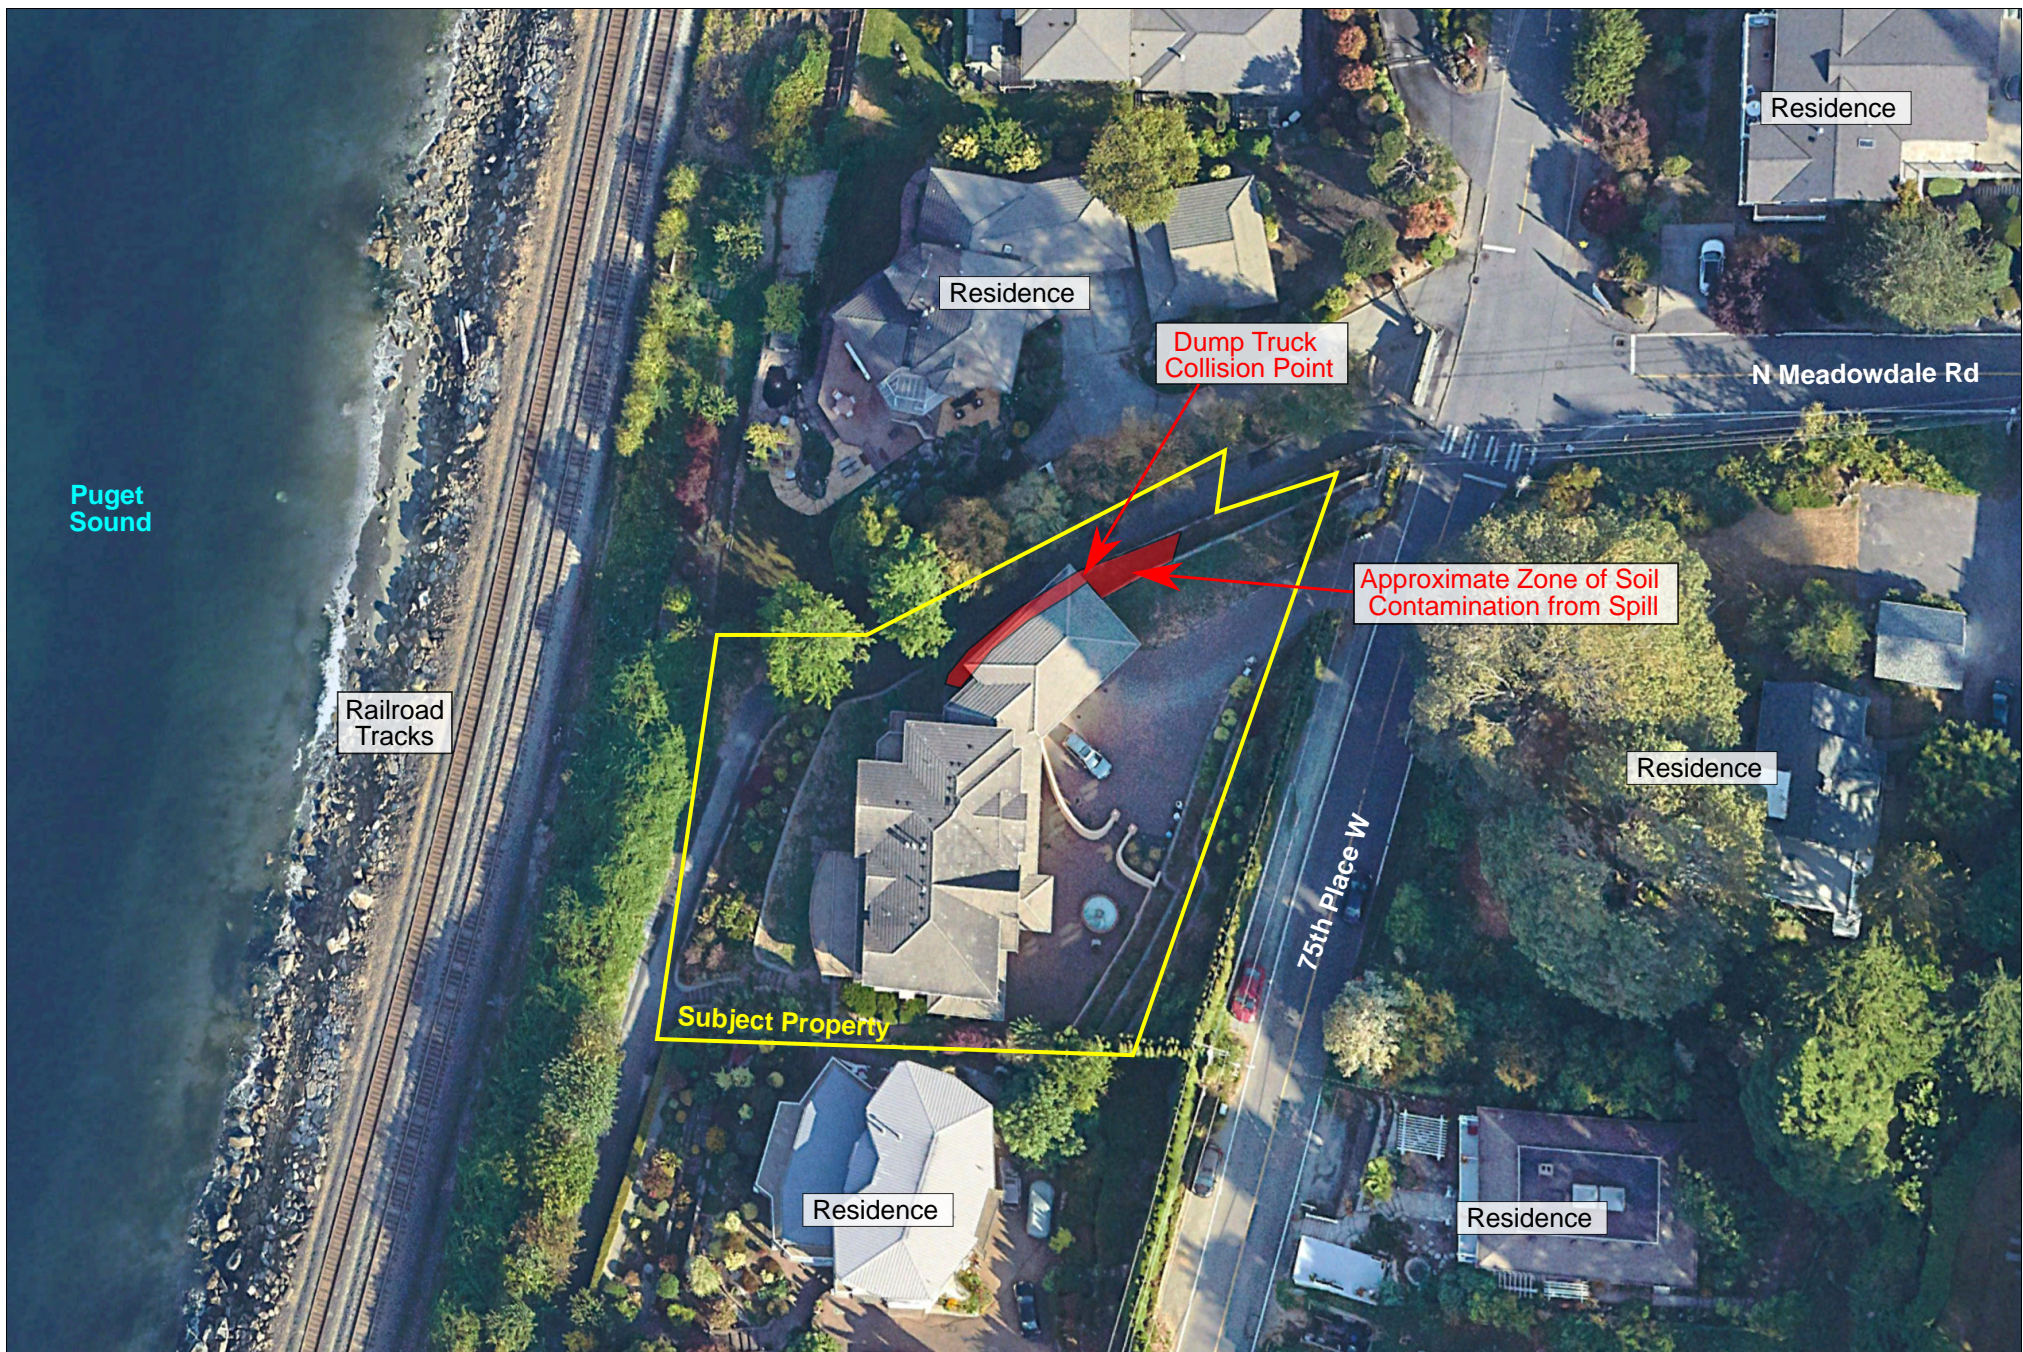
Figure 2

Annotated Aerial Photo of Site & Vicinity

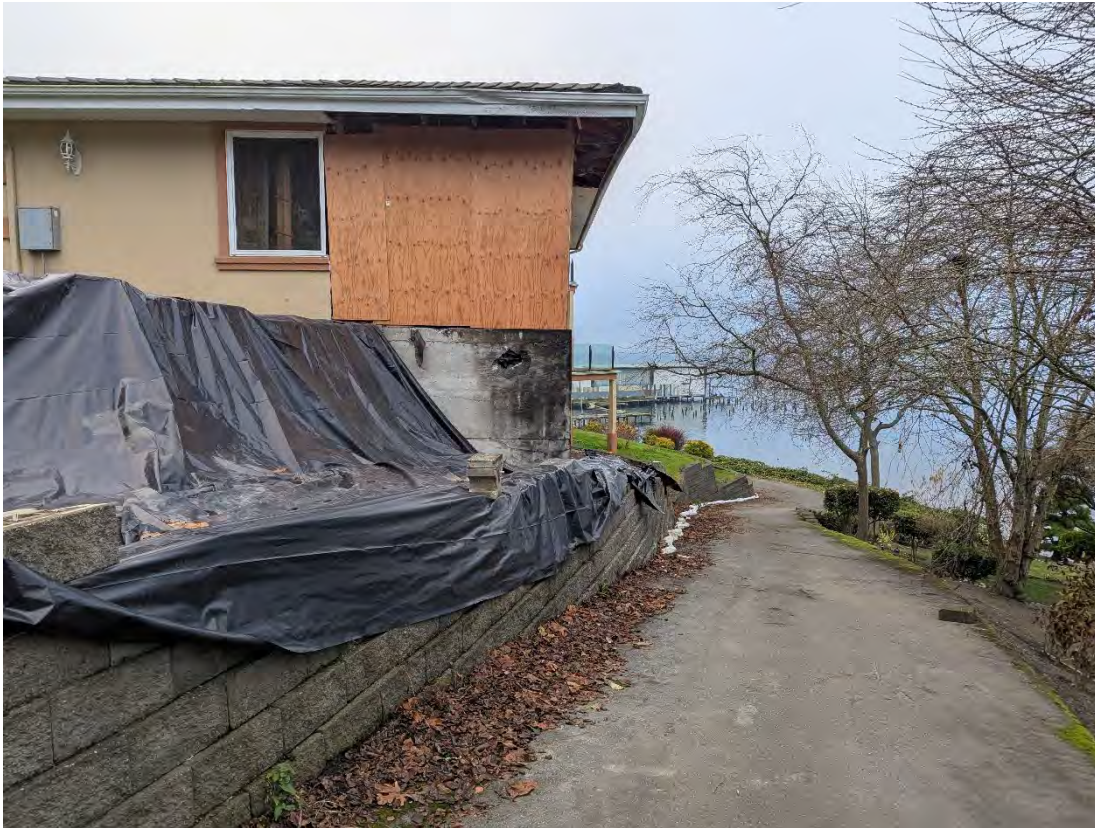
View of the site on December 3, 2024.

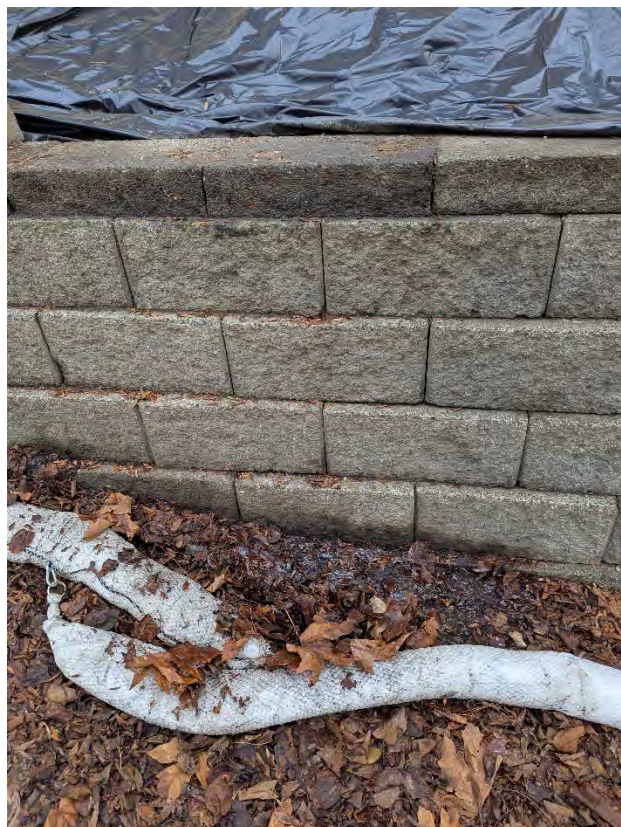
View of oily leaves and dark stained retaining wall blocks beneath the spill area on December 3, 2024.

Ultra Northwest was onsite on January 7, 2025, prior to the clean up work, to remove approximately 60 linear feet of a stone retaining wall located northwest and west of the residential garage and home. The retaining wall had been approximately 4 feet high. Some petroleum was noted on the faces of the stone walls and were sprayed with Biosolve to enhance

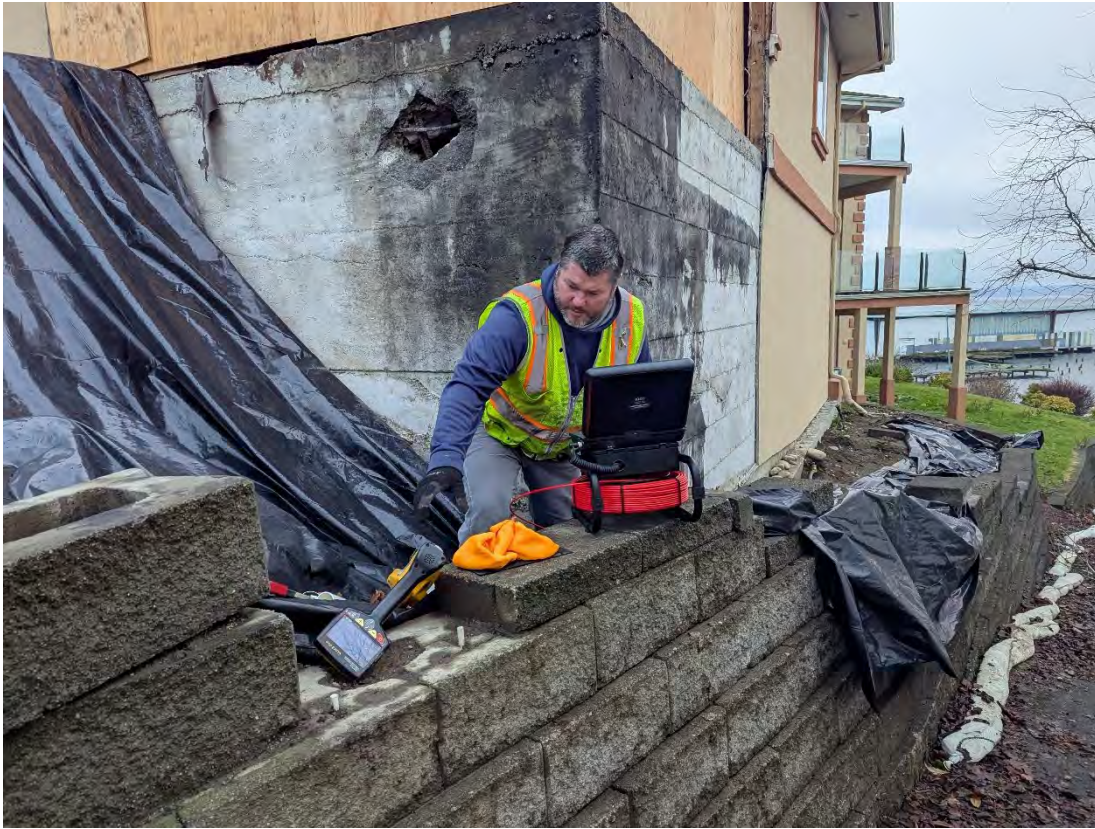
View of the camera and red cable being prepared to evaluate the footing drain system by CNI Locates on January 7, 2025.

The upper feet of exposed pipe was filled with soil, so a camera was placed in the adjacent roof drain that connects to the same footing drain further to the south along the home's western exterior wall. The camera confirmed that the footing drain is non-perforated. The cable connected to the camera can be tracked using the locate equipment to determine the drain's pathway. Due to bends in the drainage pipe, the camera was not able to follow the full route of the pipe; however, the pipe was found to follow the base of the retaining wall for the garage and house. To verify its discharge point, a hose was placed into one of roof drain entrances into the footing drain. The drain was found to ultimately discharge into a catch basin located within one of the terraces to the west of the main residence. No sign of petroleum was noted on the camera or cable when removed from the drain and no sign of petroleum was noted in the hose water discharged into the catch basin during the test. The footing drain was determined not to be a pathway for contamination from the initial release.

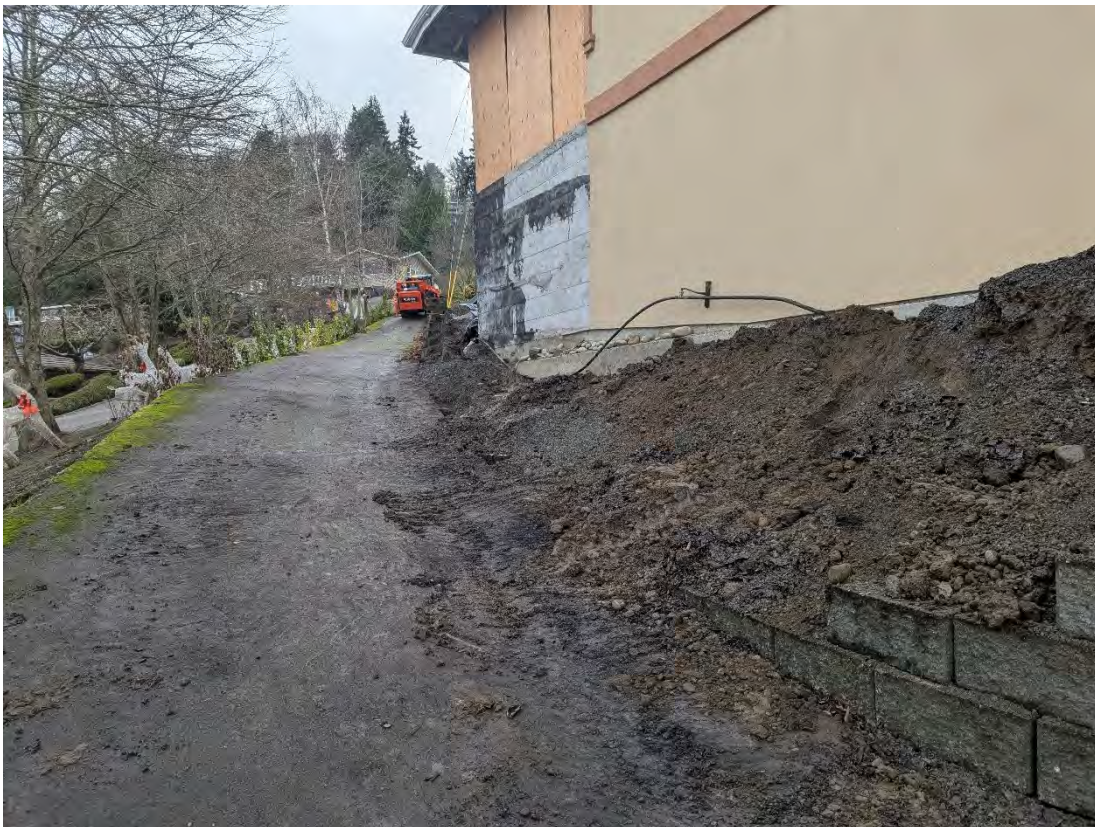
View of the site on January 8, 2025, following removal of the retaining wall.

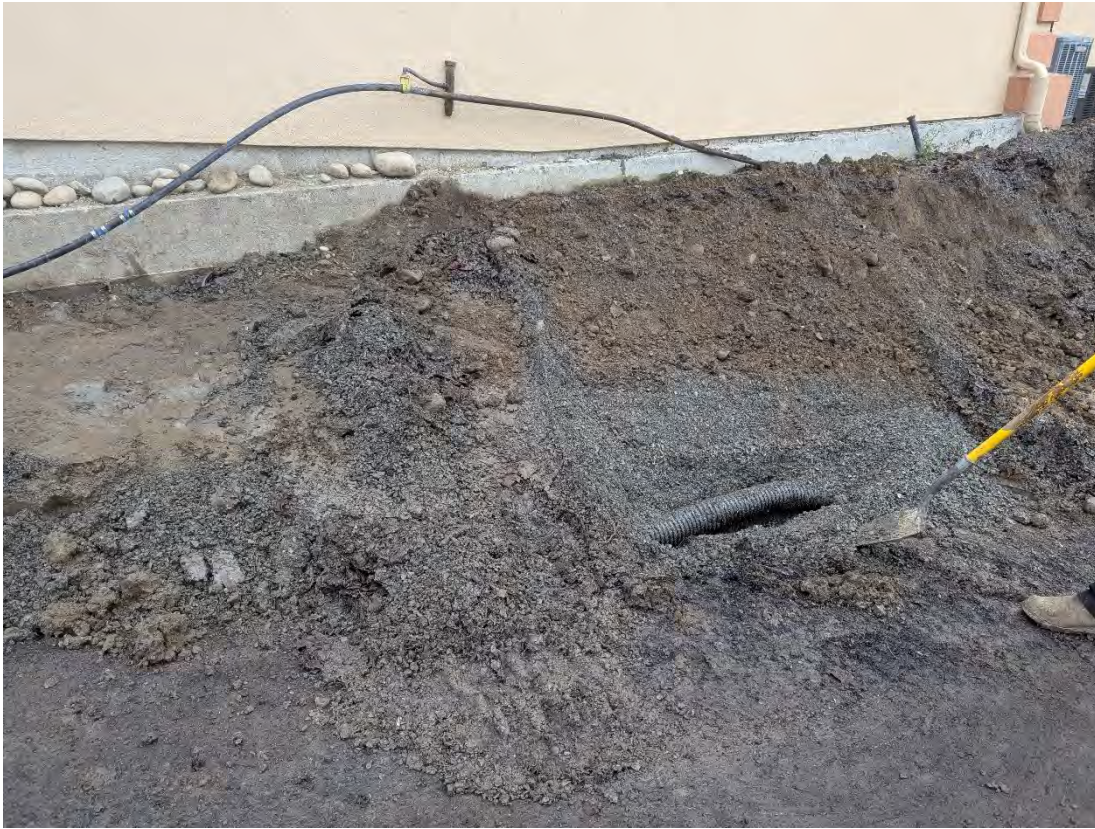
Initial discovery of a black 4" perforated pipe beneath the former retaining wall.

A perforated pipe was uncovered beneath the retaining wall during excavation. The perforated pipe ran the length of the retaining wall with an elbow at the lowest point of elevation and continued to the west. The perforated pipe was an obvious pathway for the diesel released during the spill; however further excavation around the elbow found that the pipe ended approximately one foot or so west of the elbow. The deepest portion of the excavation was beneath the retaining wall, which was one to 1.5 feet below the adjacent paved pathway elevation, and approximately 3 feet depth near where the perforated pipe ended. The diesel fuel is suspected to have backed up at the point where the piping ended to create a larger impacted area.

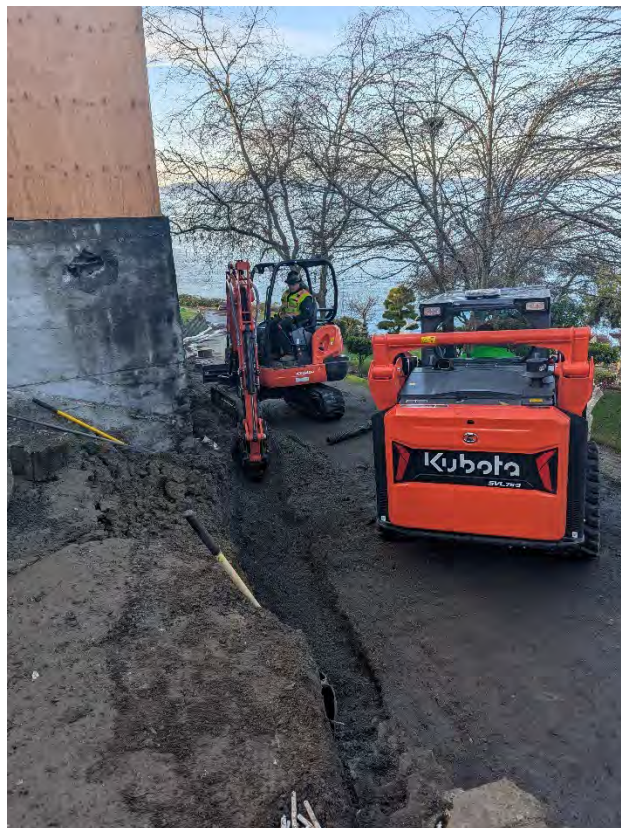
View of the excavation taking place on January 8, 2024. Material was excavated with the mini excavator and then placed in the skid-steer for transport to the dump truck parked along 75th Place W.

Soil was removed with a small excavator and/or by hand by Ultra Northwest personnel and placed in a Kubota SVL 75-3 skid-steer for transport into dump trucks. Excavation took place around the northwest corner of the garage foundation and along the soil adjacent to and beneath the former retaining wall. The retaining wall excavation was relatively narrow (3 feet wide).

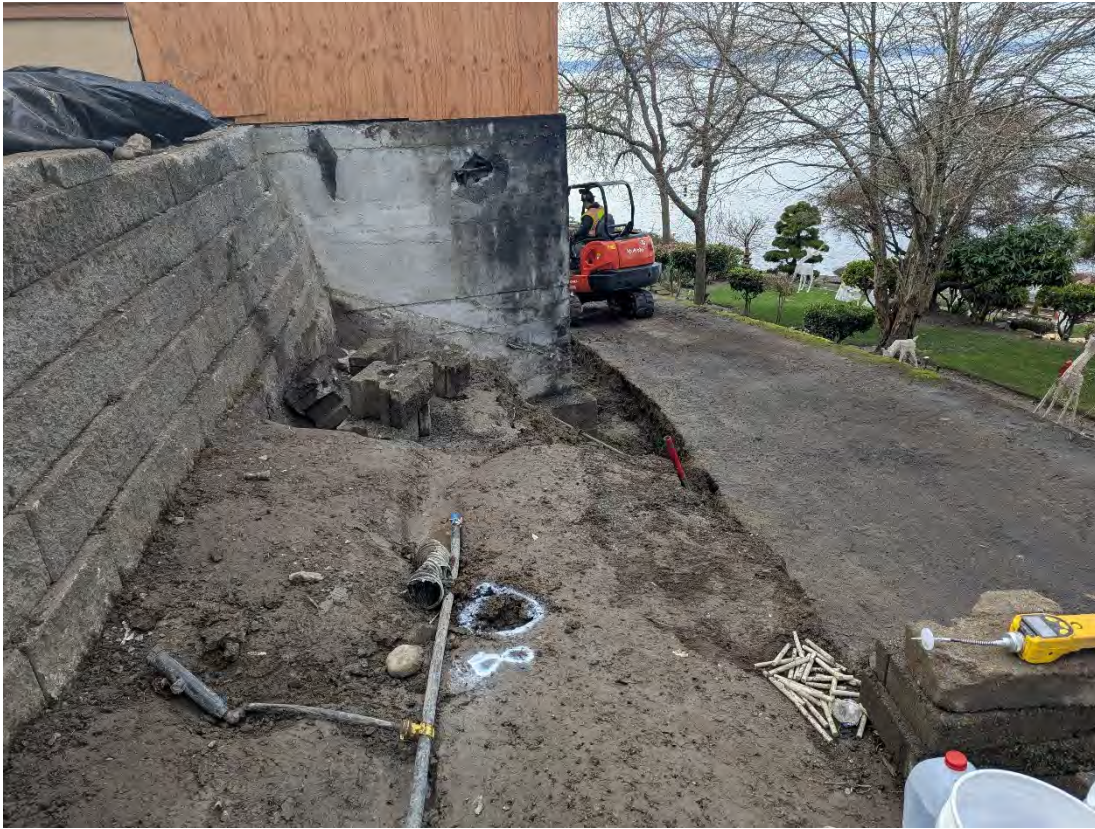
View of the north end of the excavation, looking south. Sample 8 was collected to evaluate soil conditions in an area that was previously excavated by GrayMar.

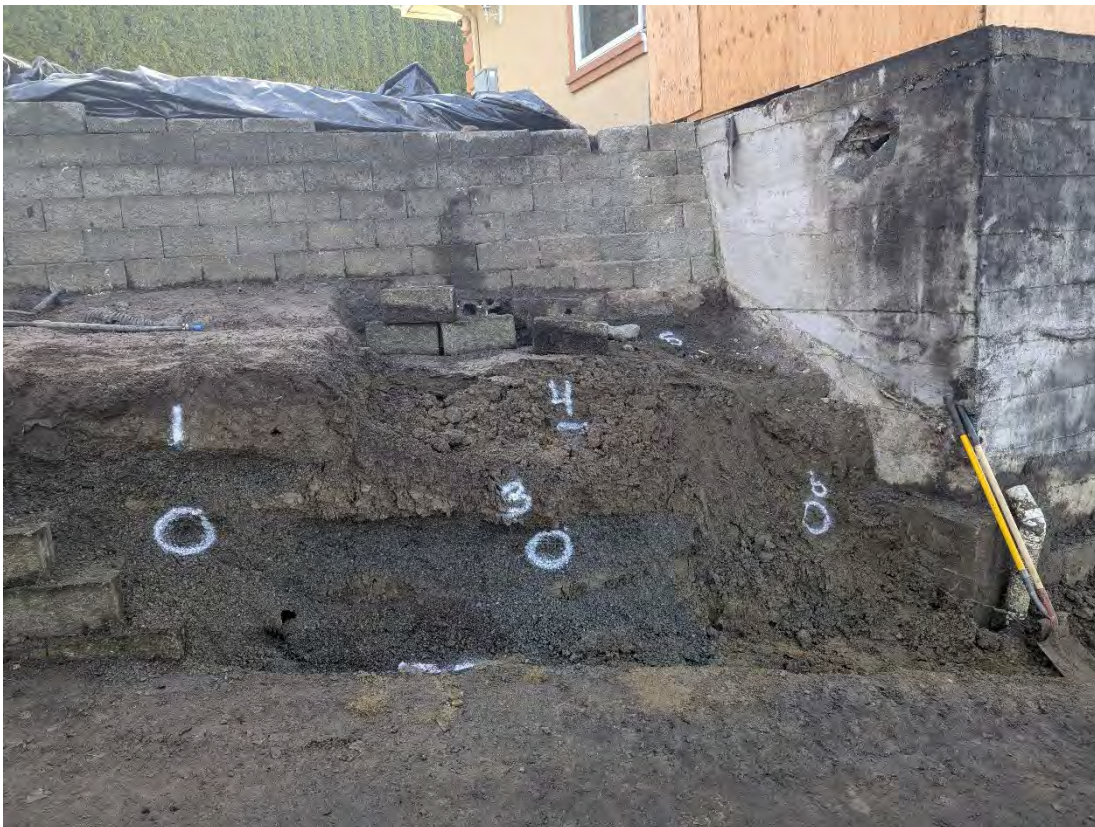
View of the sample locations collected north of the garage building, looking east. The shovels are propped against the northwest corner of the garage building.

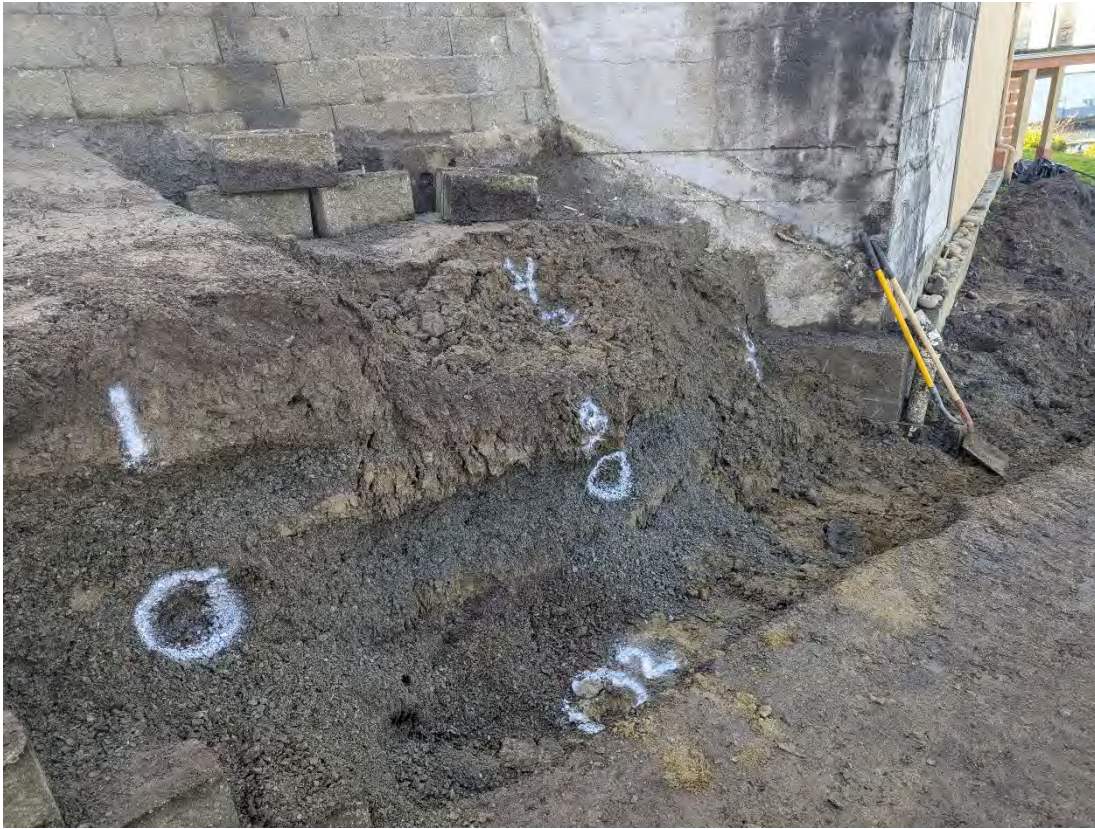
Different view of the northern end of the excavation and sample locations.

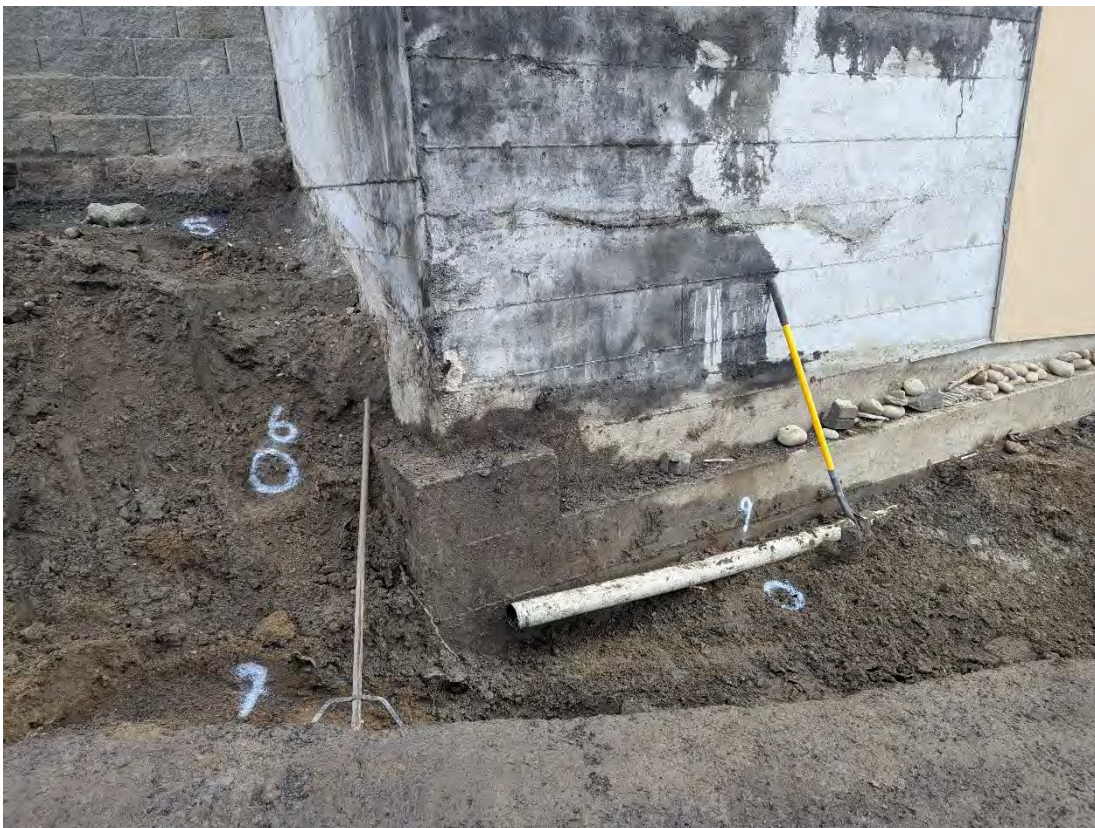
View of sample locations 5, 6, 7, and 9 near the northwest corner of the garage foundation and footing, following excavation.

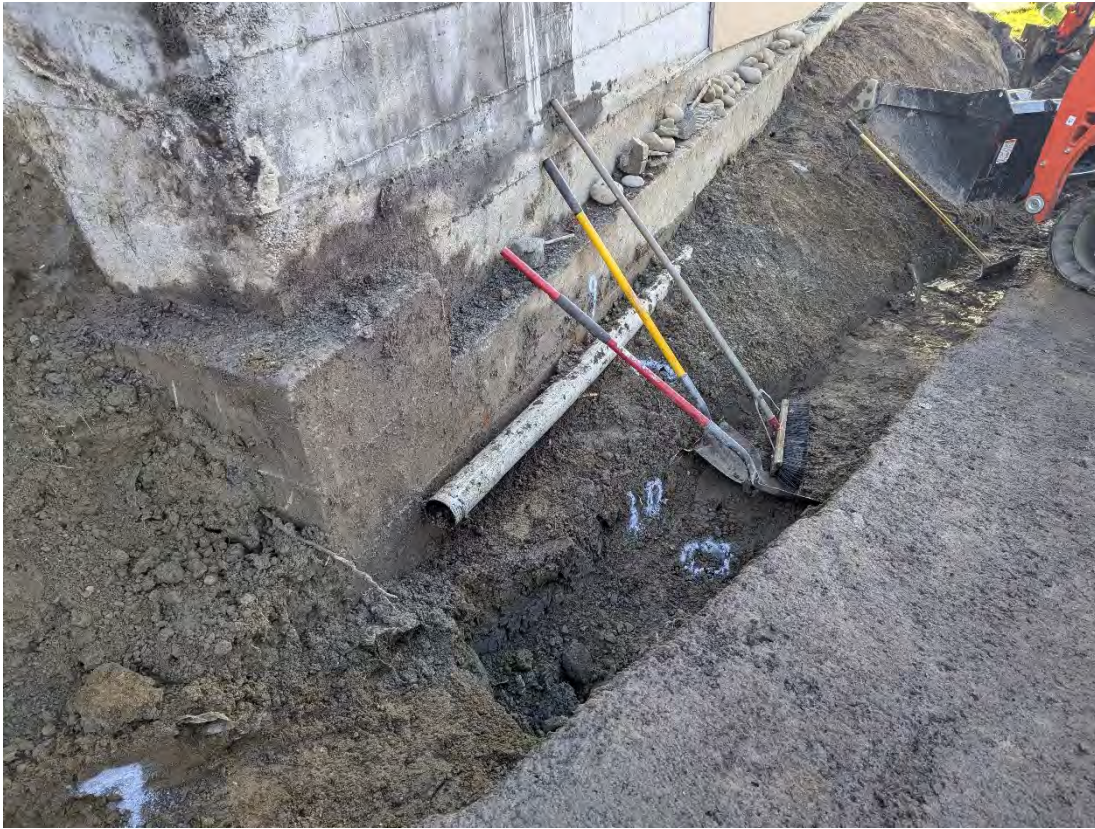
View of location of sample 10, at the base of the excavation near the building corner.

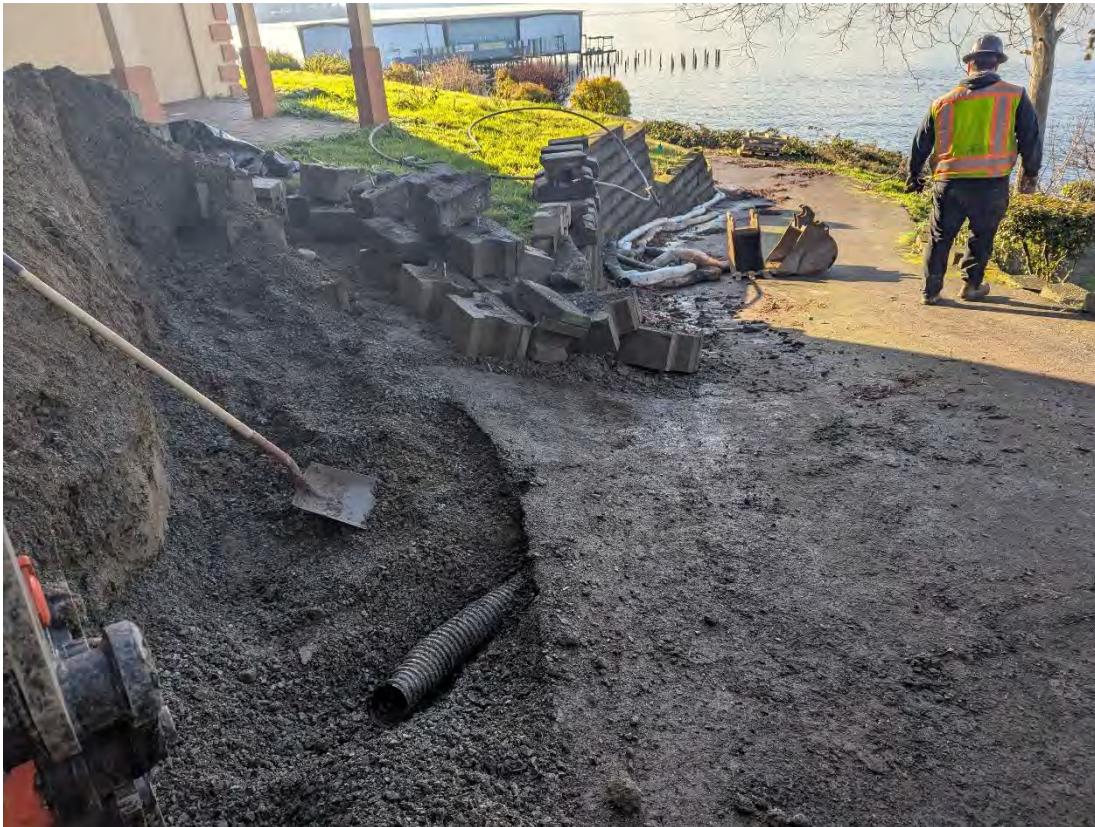
View of perforated pipe extending beneath the asphalt near southern end of the excavation (January 8, 2025).

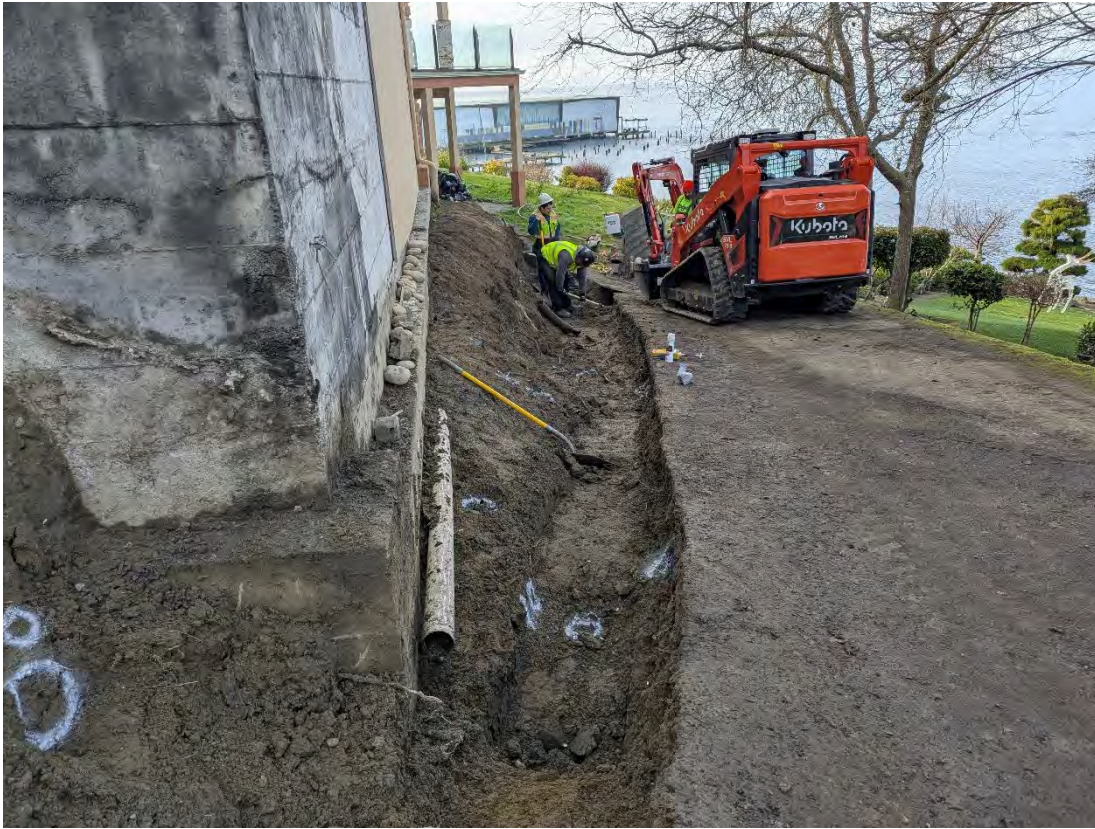
Excavation continued on January 9, 2025.

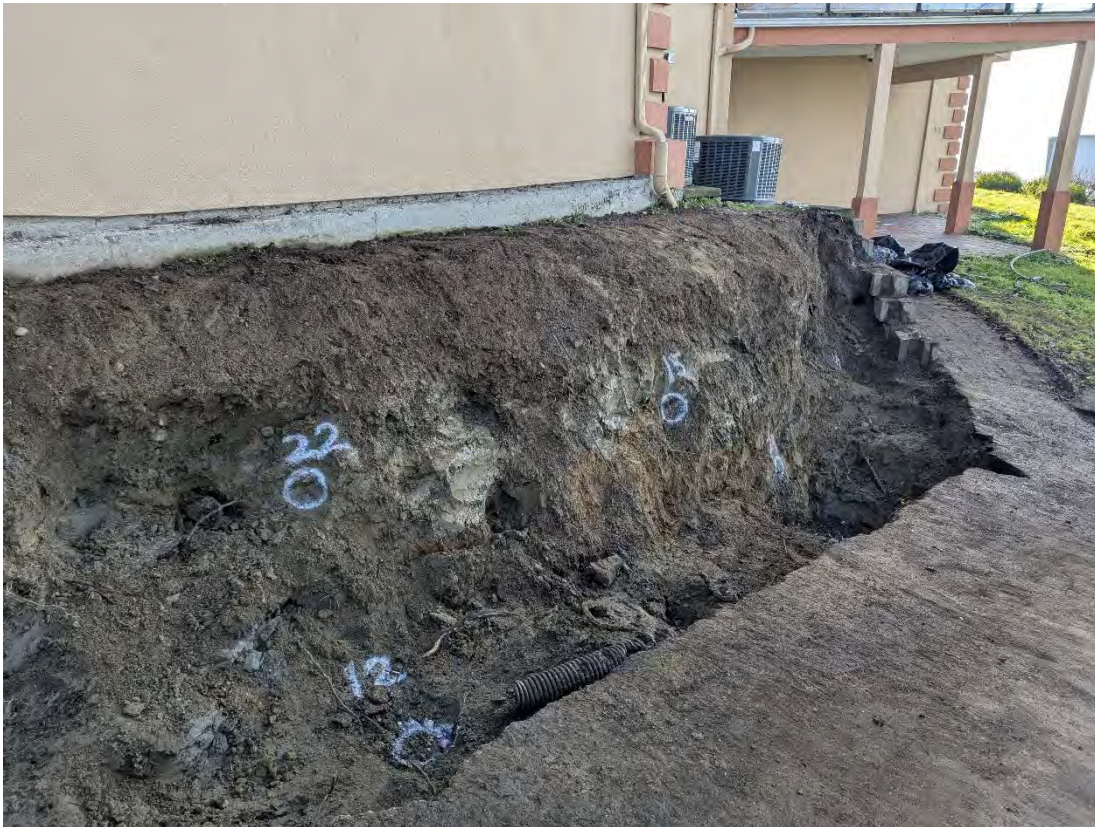
View of excavation and sample locations on January 9, 2025.

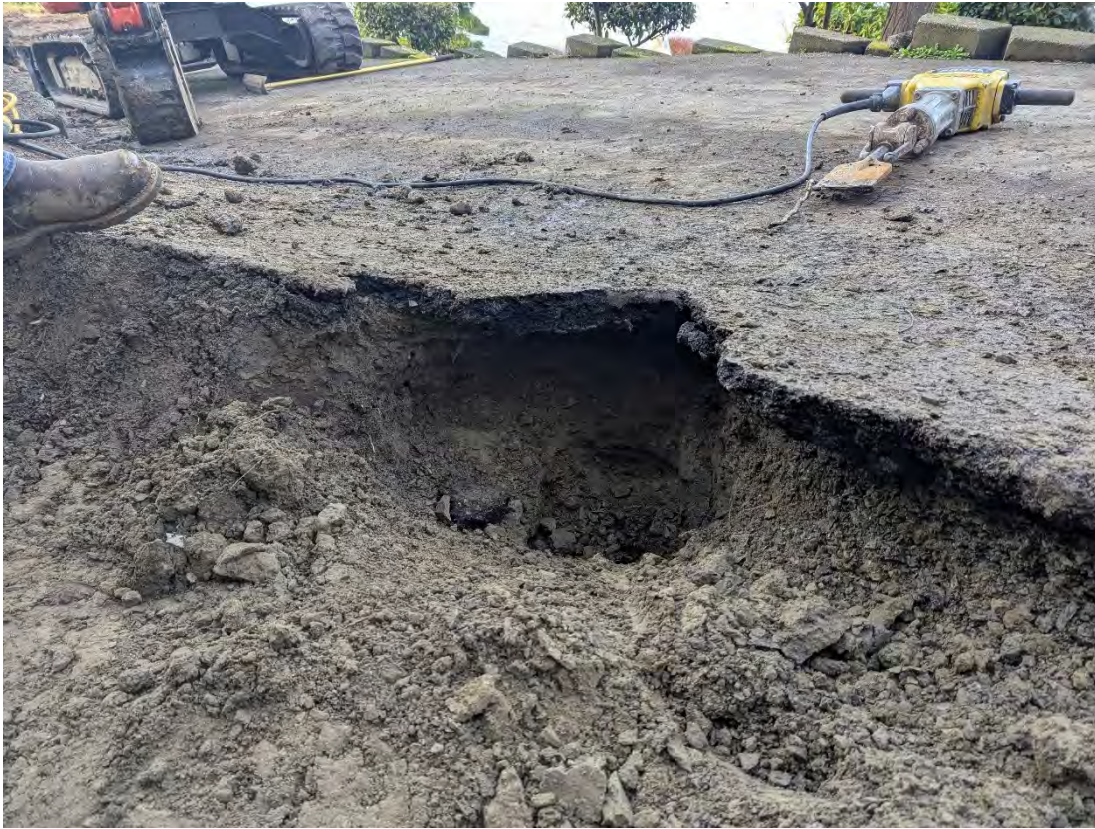
View of location where perforated pipe ended, approximately one to 1.5 feet west of retaining wall beneath the asphalt.

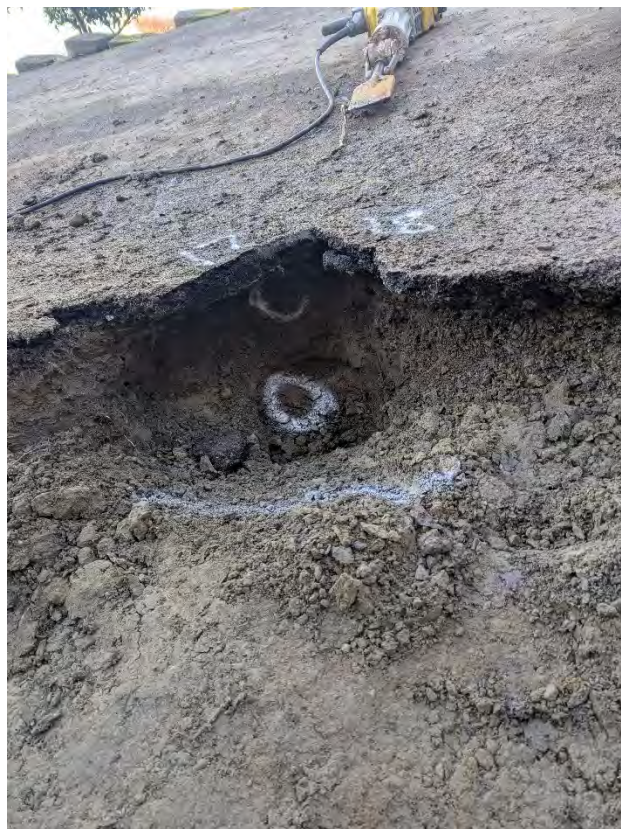
View of sample locations collected in sandy gravel fill beneath asphalt (sample 17) and below perforated pipe (sample 18).

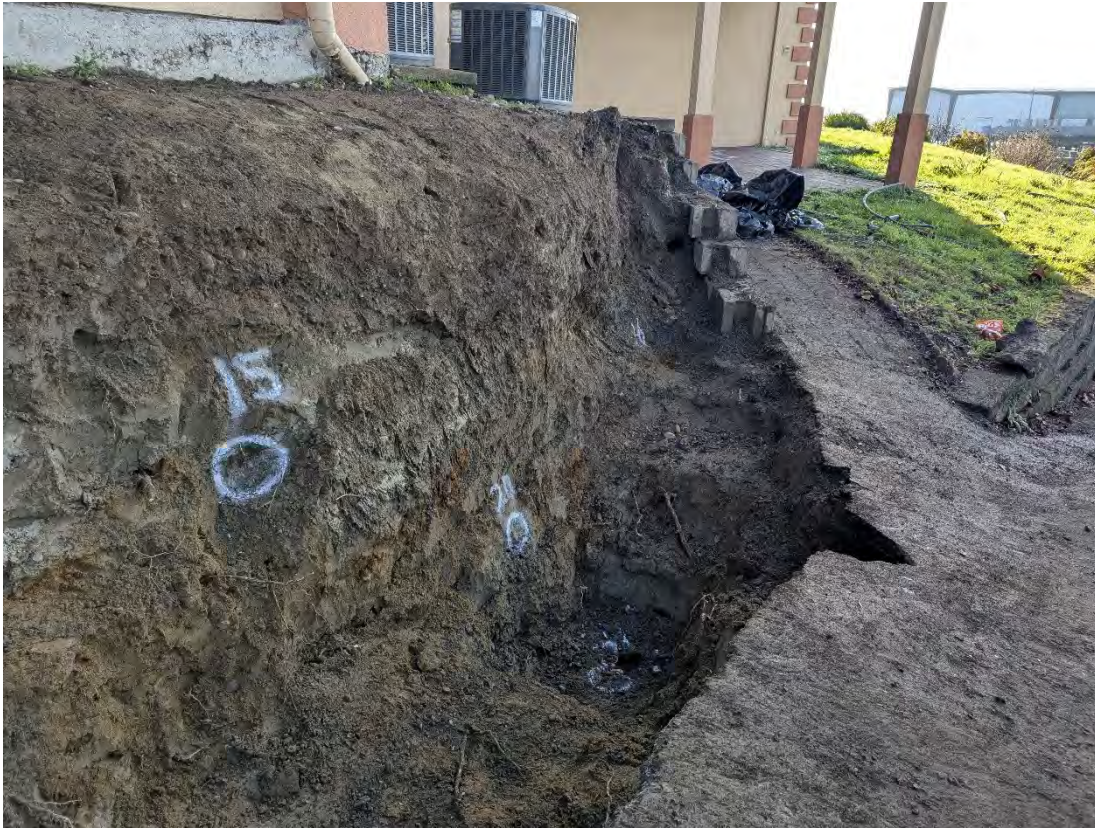
View of the final excavation and sample locations near where the perforated pipe ended.

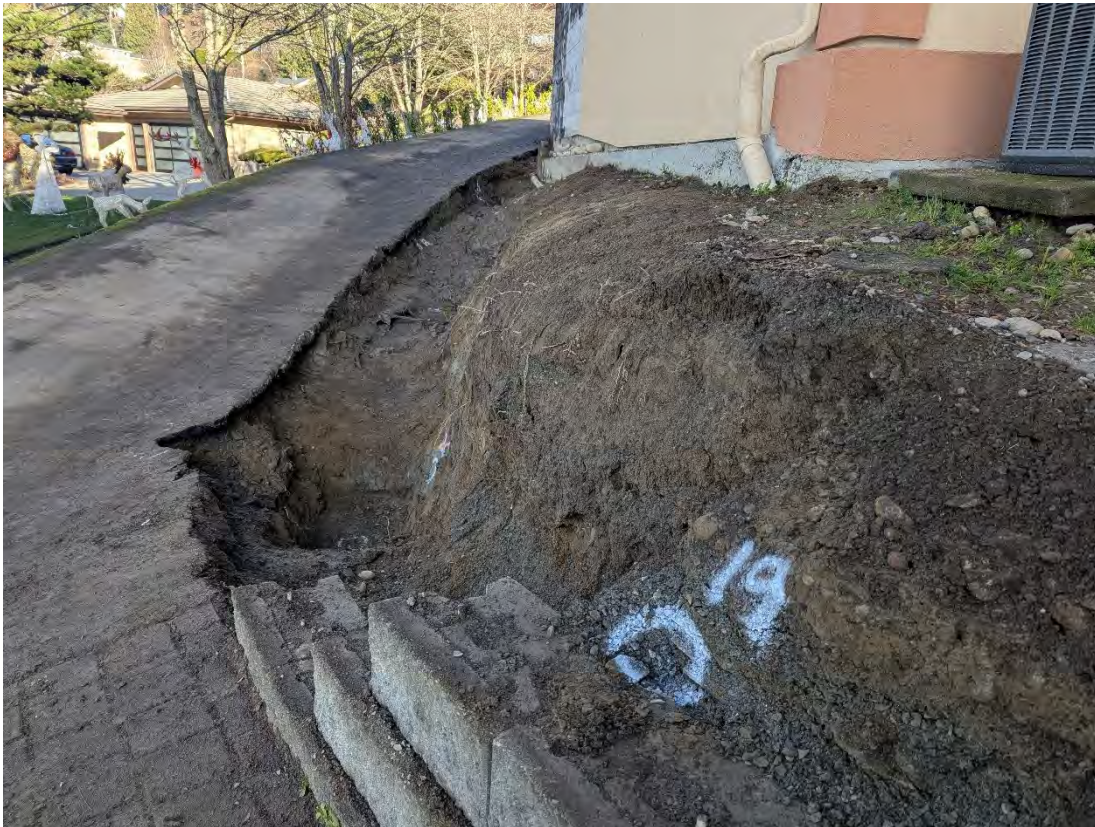
View of southernmost sample (sample 19) collected in approximately the same location as the southernmost sample collected by Stratum Group on December 3, 2024.

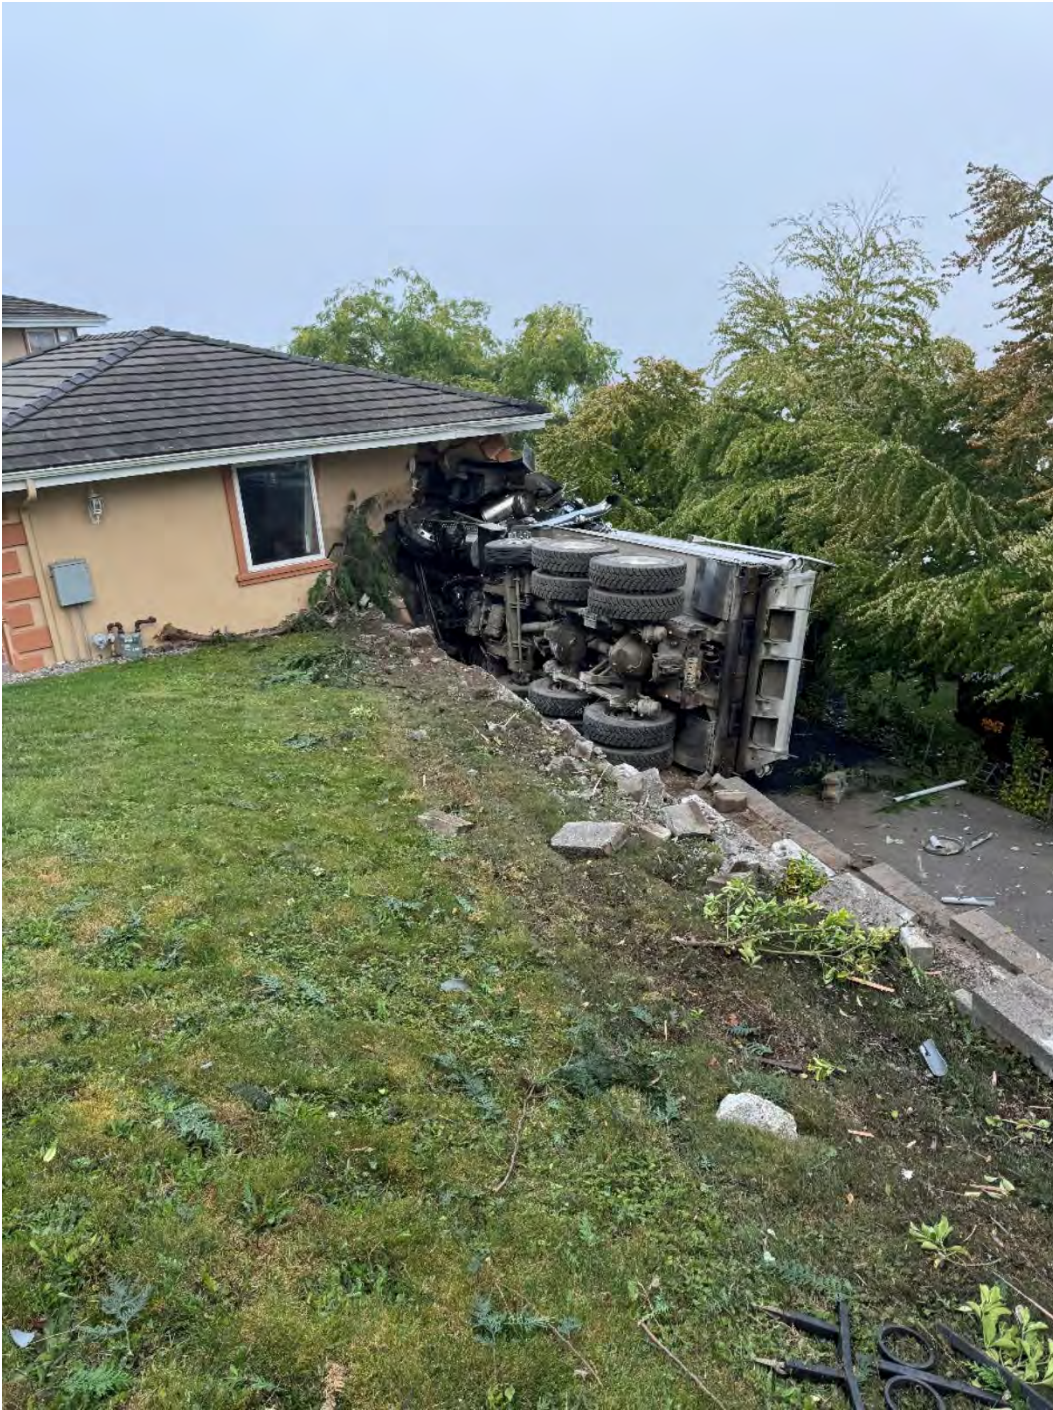
View of dump truck in contact with NW corner of the residential garage. Dump truck is balanced on terrace above asphalt pathway on September 4, 2024. Photo provided by Rick Nissen, property owner.

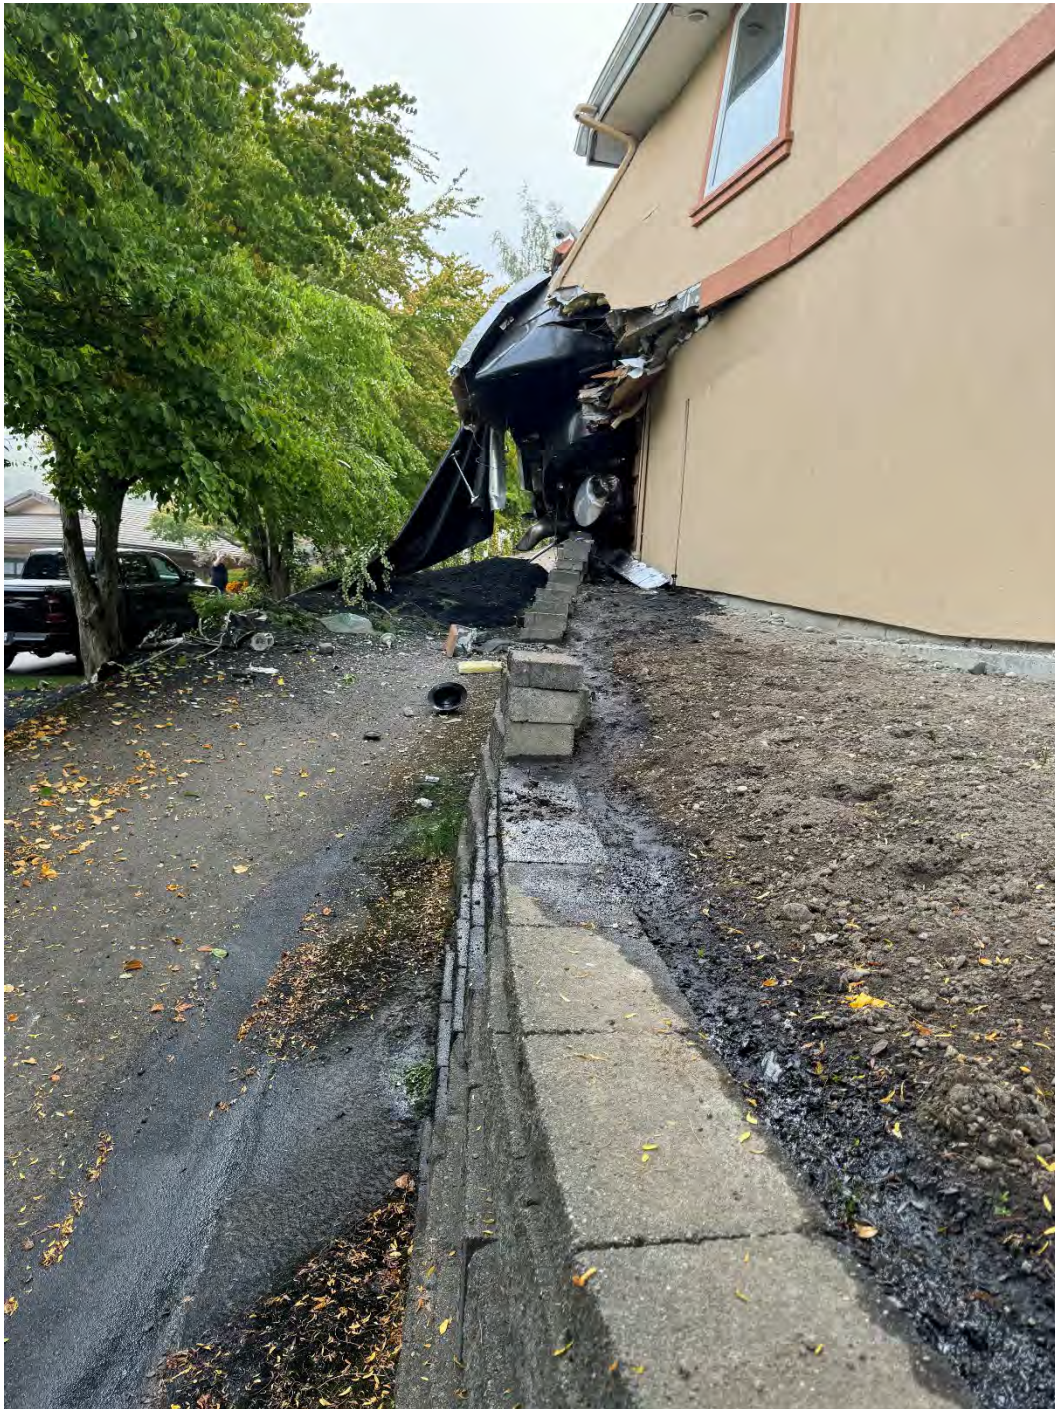
View of diesel spill with notable presence of diesel at northwest corner of the building, along soil edge of retaining wall, and along the base of the retaining wall on the asphalt pathway on September 4, 2024. Photo provided by Rick Nissen, property owner.
