Subj: 2017 Annual MMR Report: Former Josephine Mill No. 1

Stimson employee Ted Carlson (Area Woodlands Manager) completed an annual spring site inspection on June 15, 2017 pursuant to the Post Removal Site Control Plan (PRSCP) found in Appendix E to the Final Removal Action Report (RAR) dated February 10, 2012. The PRSCP outlines the long-term maintenance and monitoring obligations to ensure the continuous protection, integrity and stability of the mine waste repository constructed at the former Josephine Mill No. 1 in Pend Oreille County, Washington. This letter serves as the 2017 annual spring Monitoring Maintenance and Repairs (MMR) report.

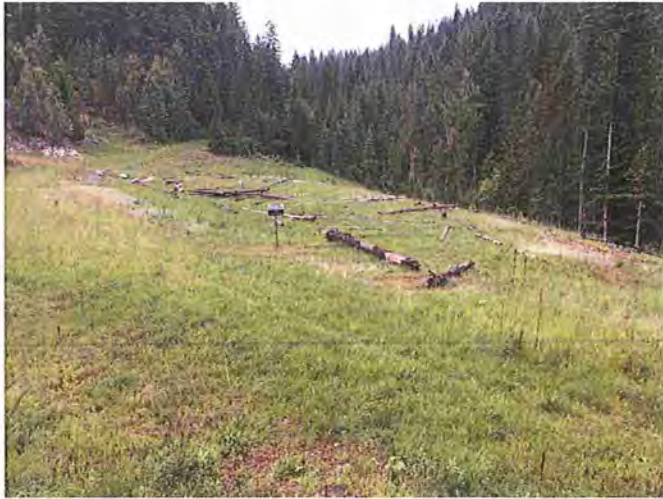
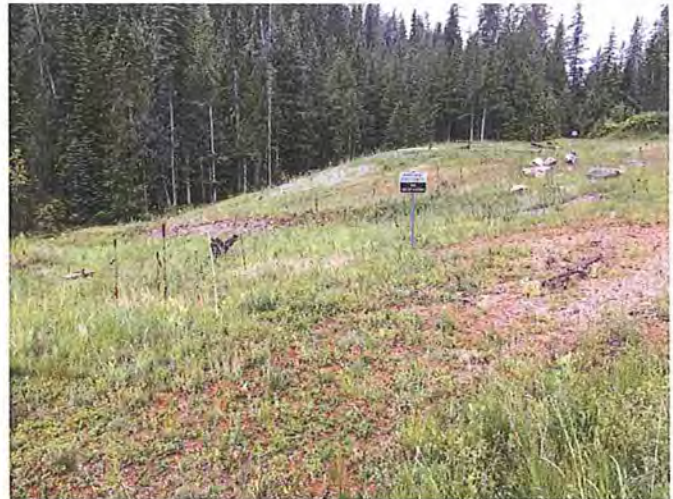
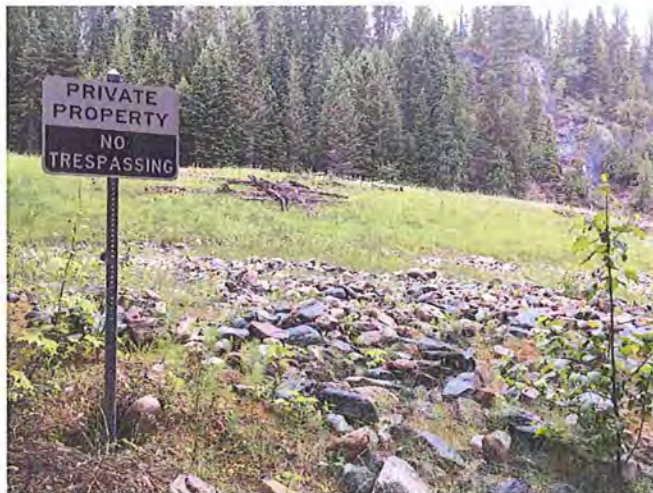
Confirm presence and condition of warning signage

- All 3 warning signs remain upright and in place, were undamaged, and are readily visible.

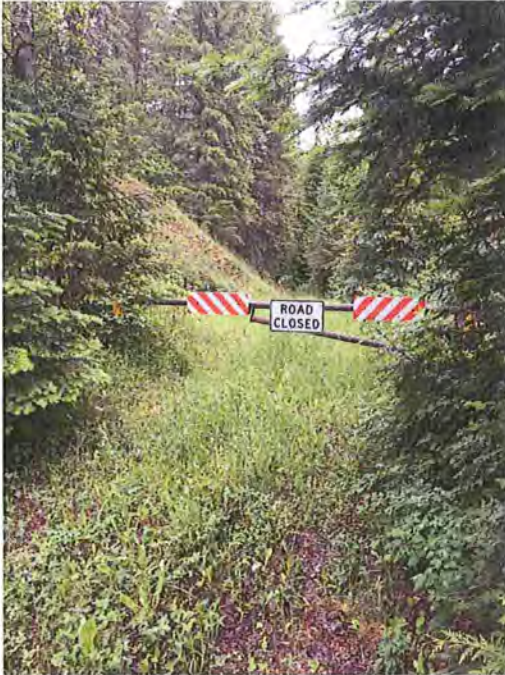
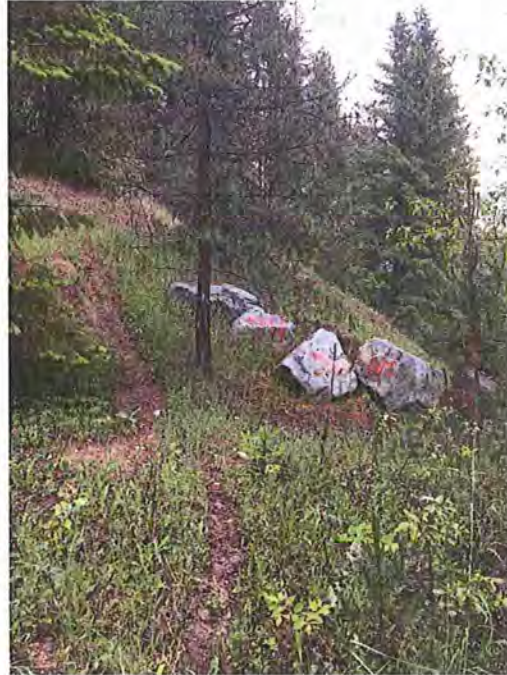
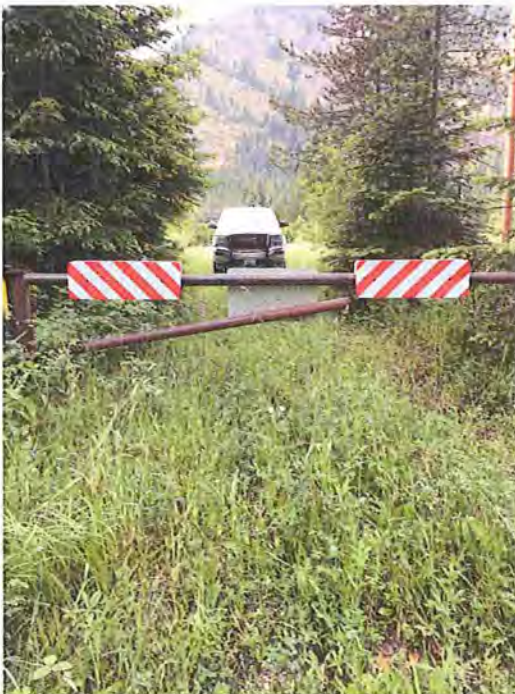
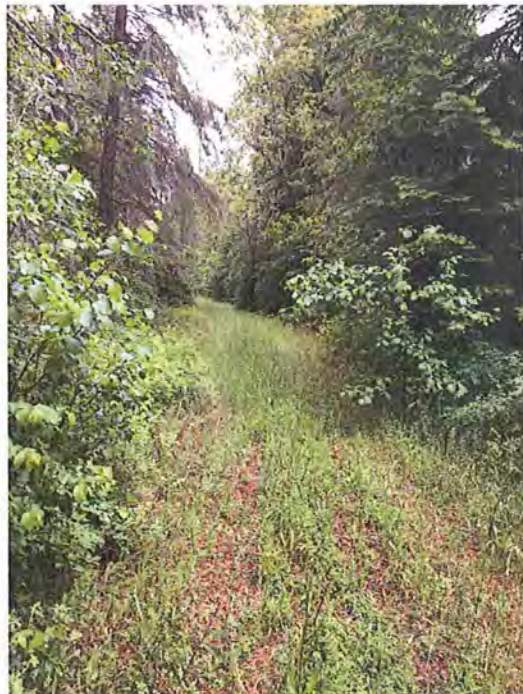
Confirm presence and operation of site controls including access gates

- *The gate was closed and in good working order with an intact lock. Boulders and other structures designed to restrict vehicular entry remain in place and were undamaged. Fresh paint was added to the inscriptions. There was evidence of some breaching by ATV traffic which gained access by going above the line of boulders, but occurrence appears to be sporadic and travel is confined to the access road as no signs of entry onto the repository cap were seen.*

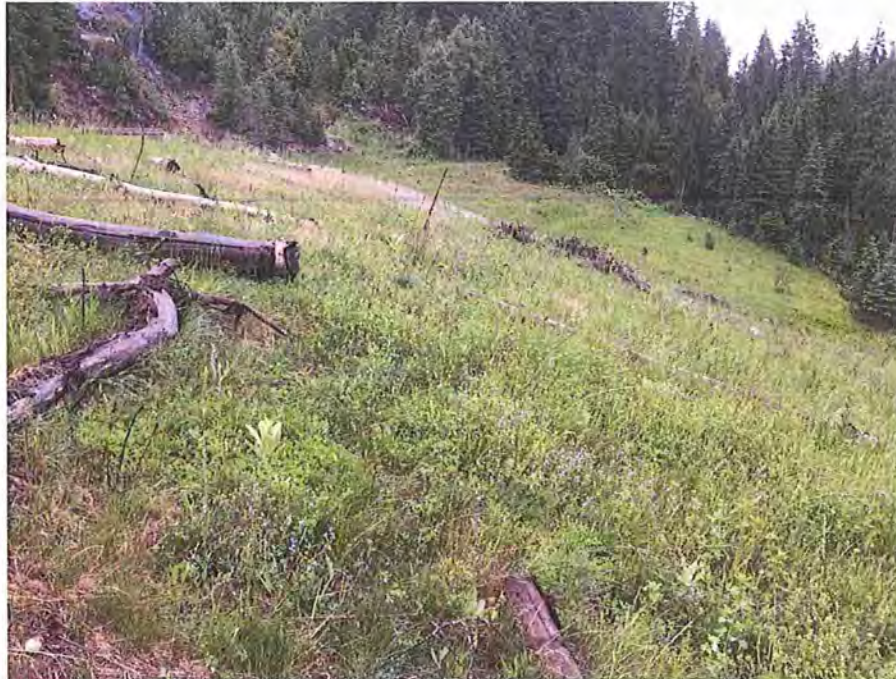
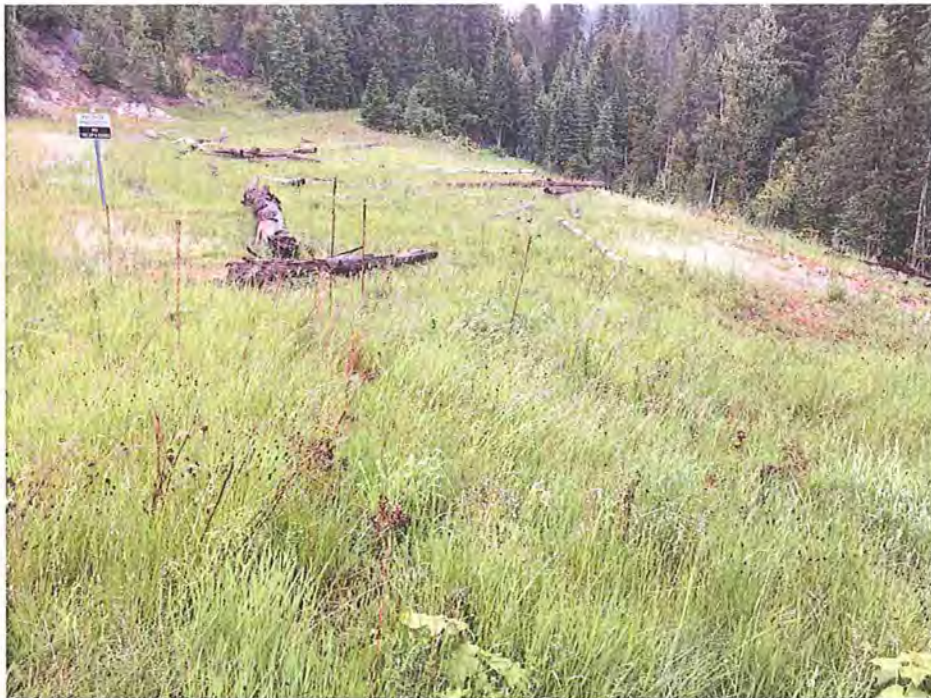
Observe the condition of the repository cover and identifying areas of movement, erosion or exposed liner

- *The repository cap appears stable and has a good vegetative cover dominated by grasses. The logs distributed on the cap to discourage entry are in good physical condition. No erosion or areas with exposed liner were visible, and there was no evidence of mass movement.*

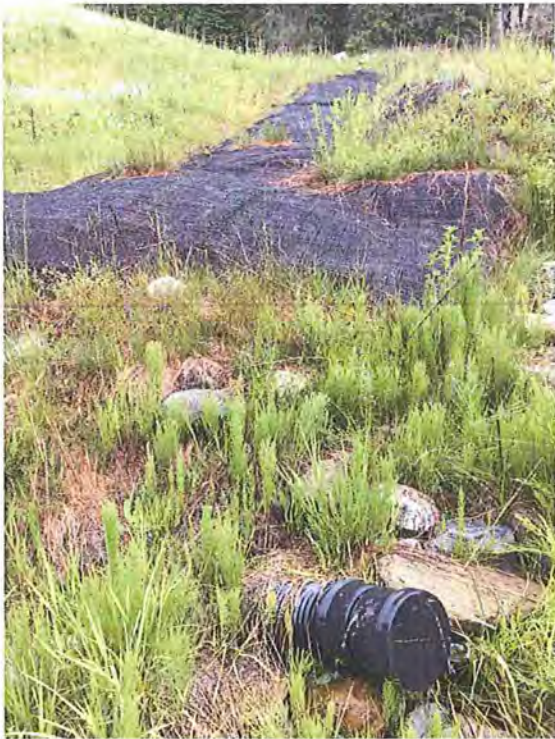
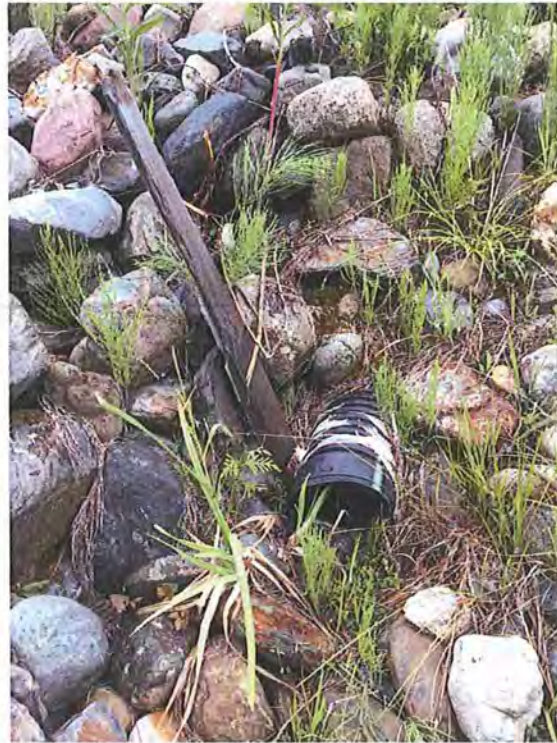
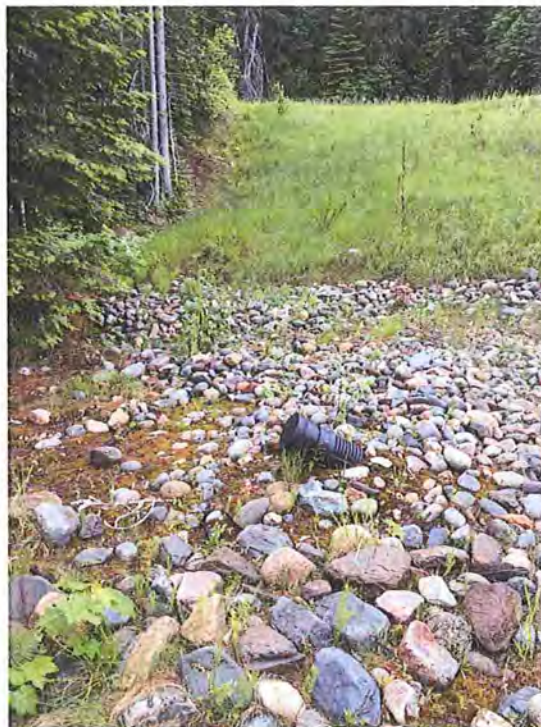
Observe operation of the underdrain system and cleanout as necessary

- *The underdrain system appeared to be functioning as engineered, and all cleanouts were clear of debris.*

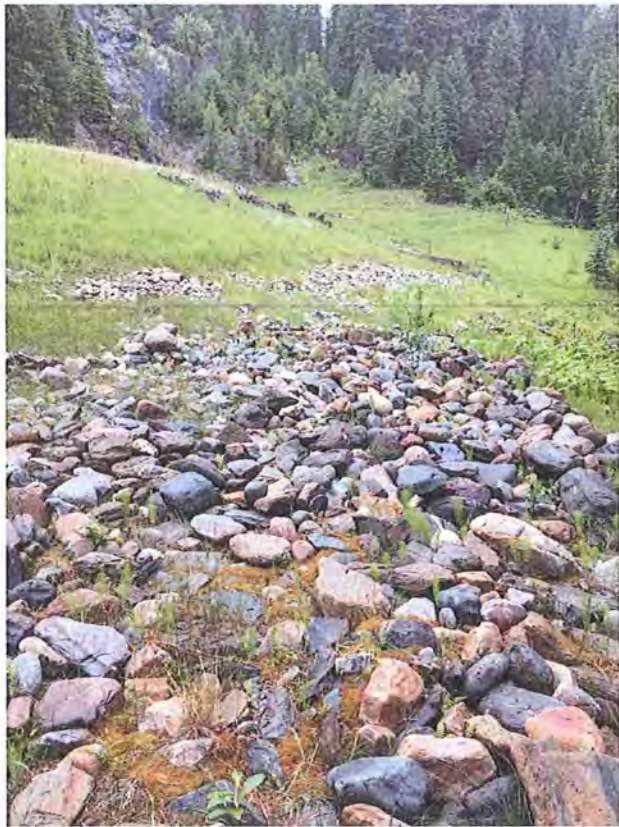
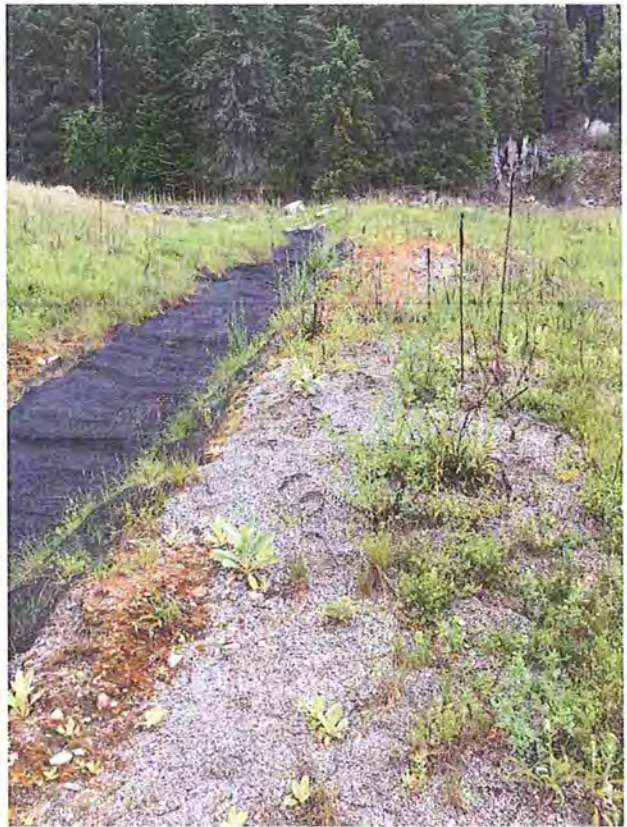
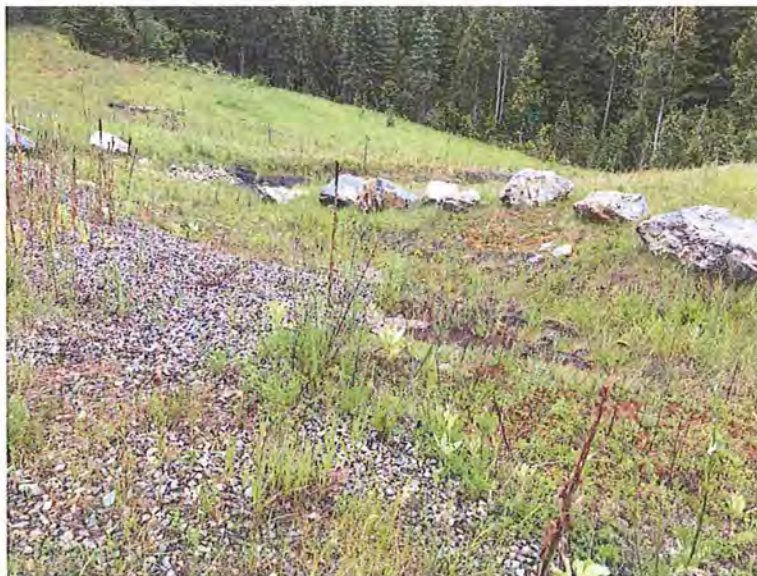
Observe the condition of stormwater management structures
- *No visual damage to the system was evident.*
