**SITE REMEDIATION, CHARACTERIZATION  
and GROUNDWATER MONITORING REPORT**

**Cameo Boutique**

**6871 East State Route 106**

**Simpson Geosciences Project Number SG2024-107**

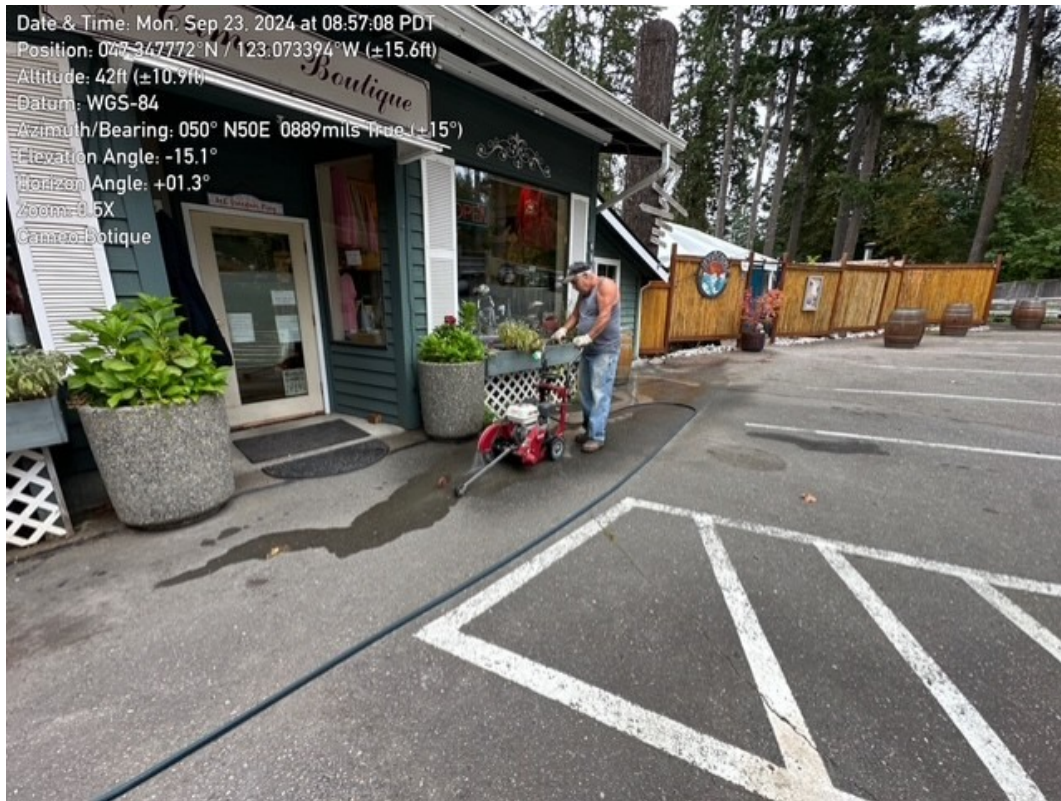
Photograph 4.1 View looking east of the project area. The asphalt was saw cut to prevent cracking.

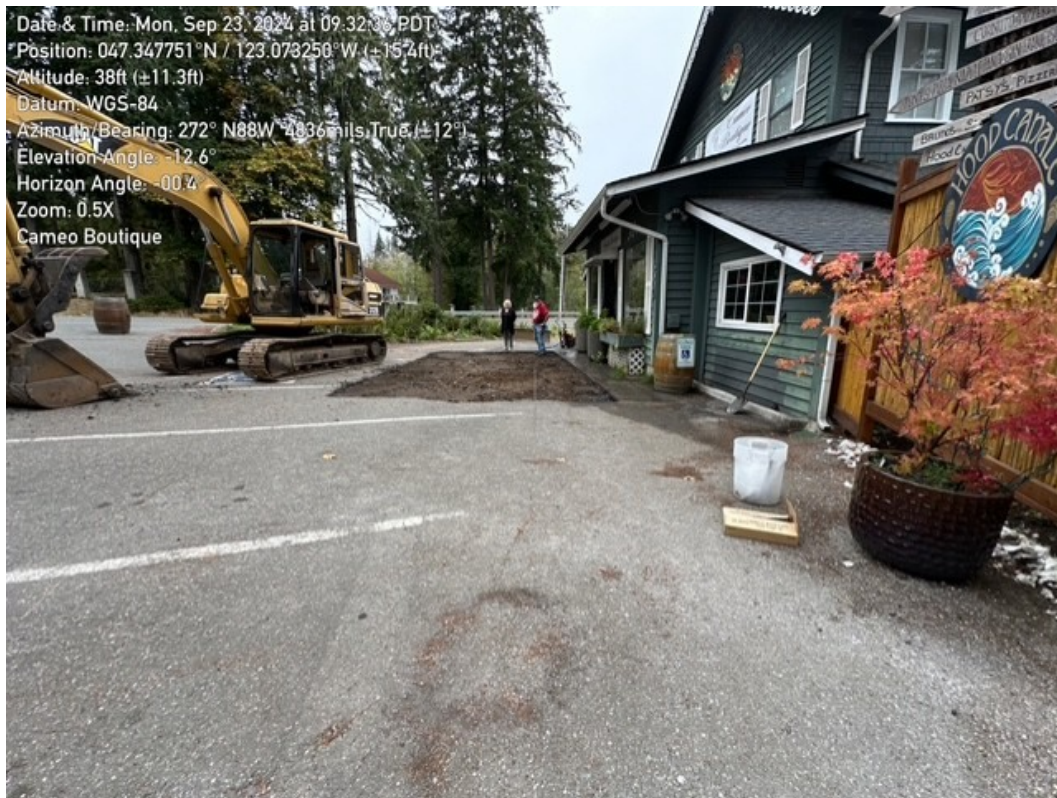
Photograph 4.2 The asphalt cover was removed from the project area.

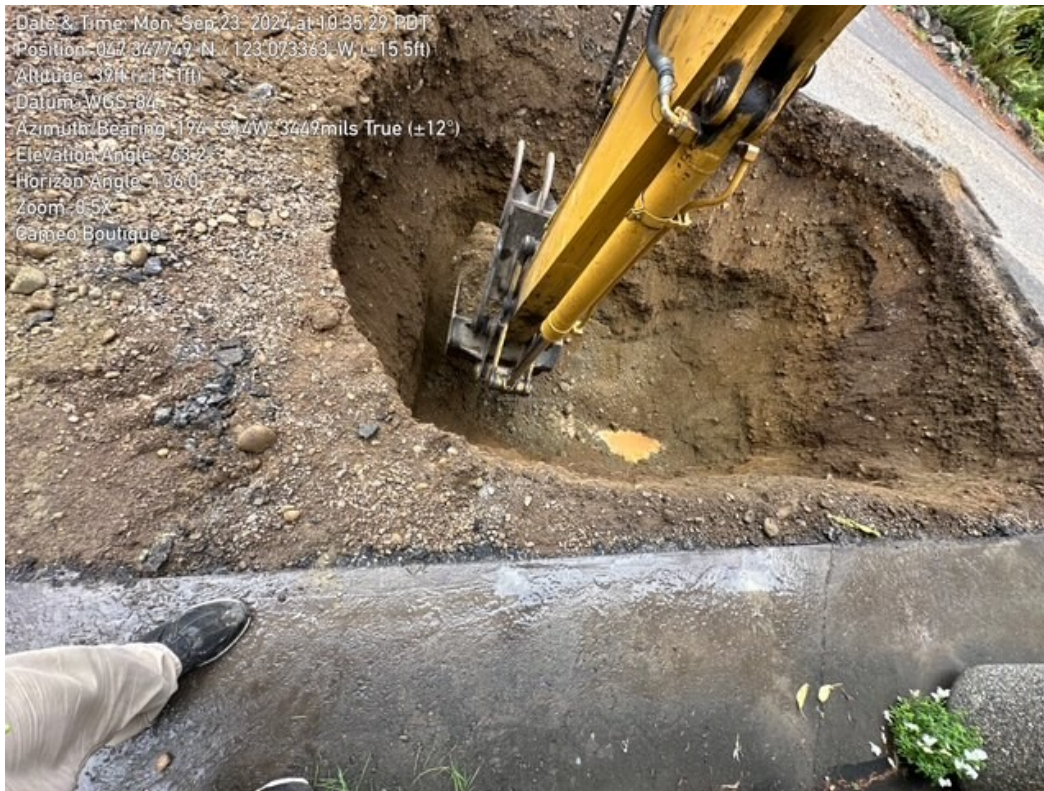
Photograph 4.3 The remedial excavation proceeded until a thin lens of GRO impacted soil was removed directly above the static water level.

Simpson Geosciences mobilized to the Subject Property on September 23, 2024 to observe remedial excavation of suspected GRO impacted soil in the vicinity of the former USTs. Soil impacted with gasoline range organics (GROs) was excavated near the south side of the building in the former location of underground storage tanks removed previously by Cascade Environmental in the 1990's. The GRO impacted soil encountered during excavation was confined to a narrow 2-inch thick seam of sandy gravel directly above the water table. Approximately 2-3 cubic yards of moderately impacted soil was removed and transported offsite for disposal. Documentation of the soil disposal at the landfill is pending.

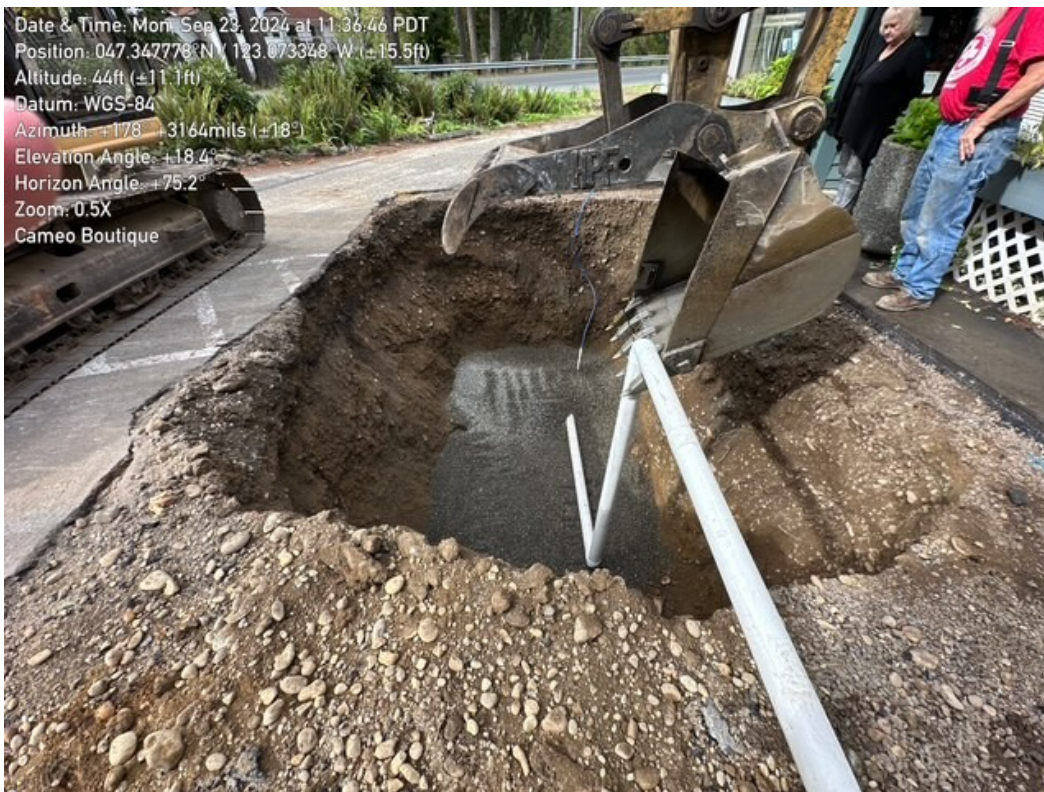
Photograph 4.4 View of the air sparging line being placed in a bed of pea gravel.

Following removal of the soil, a one-inch diameter slotted PVC pipe was laid horizontally below the water saturated zone at a depth of approximately 9 fbg with 4-inch diameter passive air return pipe. The sparge line was connected to a one-inch riser which was plumbed into a rotary vane air compressor. A 15-foot long trench was also dug north of Cameo Boutique building in the inferred down gradient location of the tank nest. A second one-inch diameter slotted PVC air sparging line was installed to a depth of approximately 6 fbg with 4-inch passive air return pipe. Both sparge circuits are shown in Figure 3.

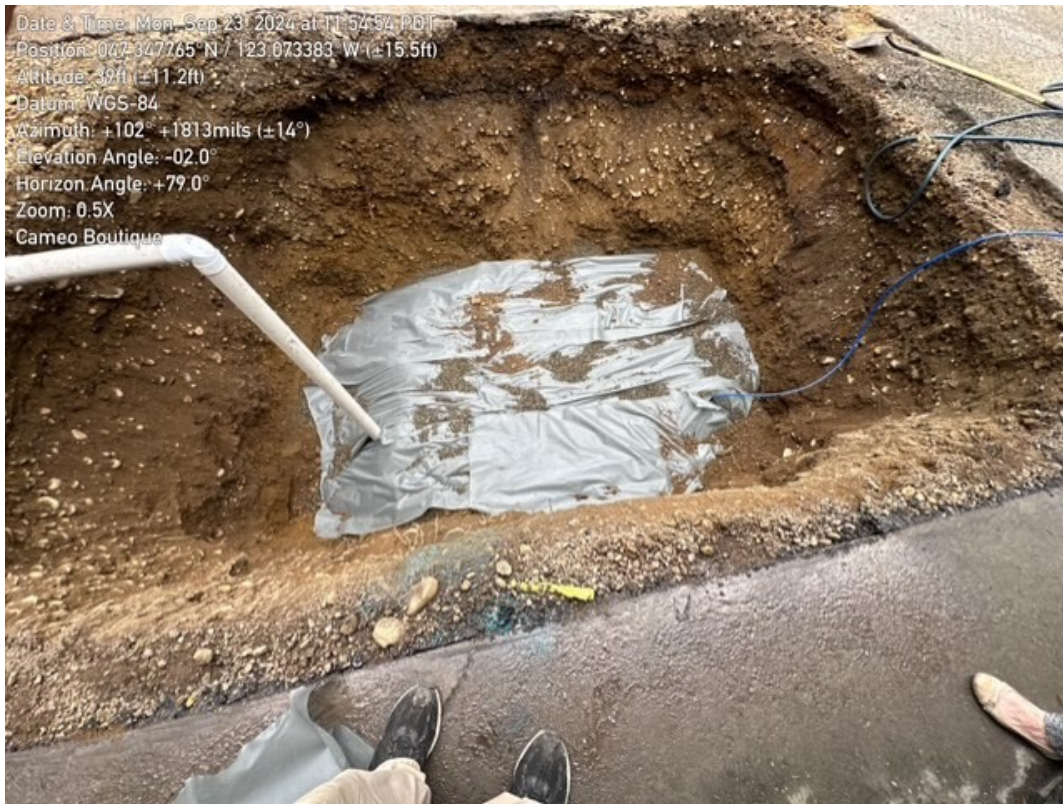
Photograph 4.5 The pea gravel was filled up above the water level, then a 4-inch diameter passive air return was installed, and covered with filter fabric.

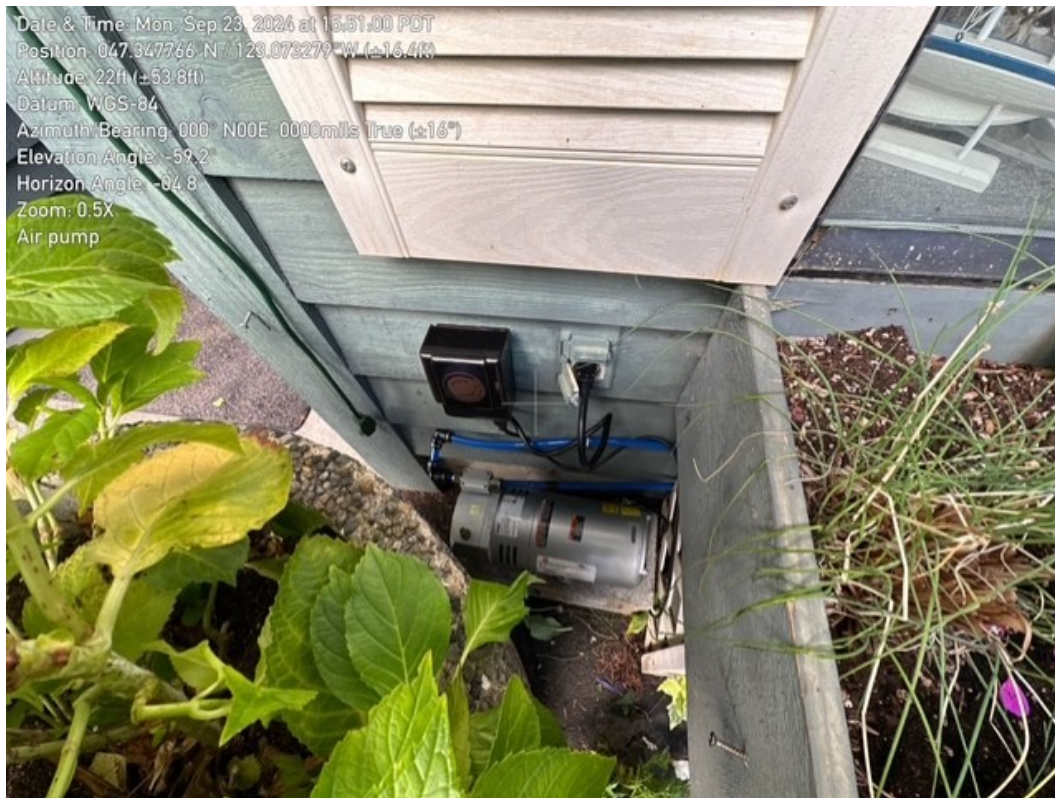
Photograph 4.6. View of the rotary vane compressor used to pump air into the groundwater. The compressor was on a timer for nighttime operation.

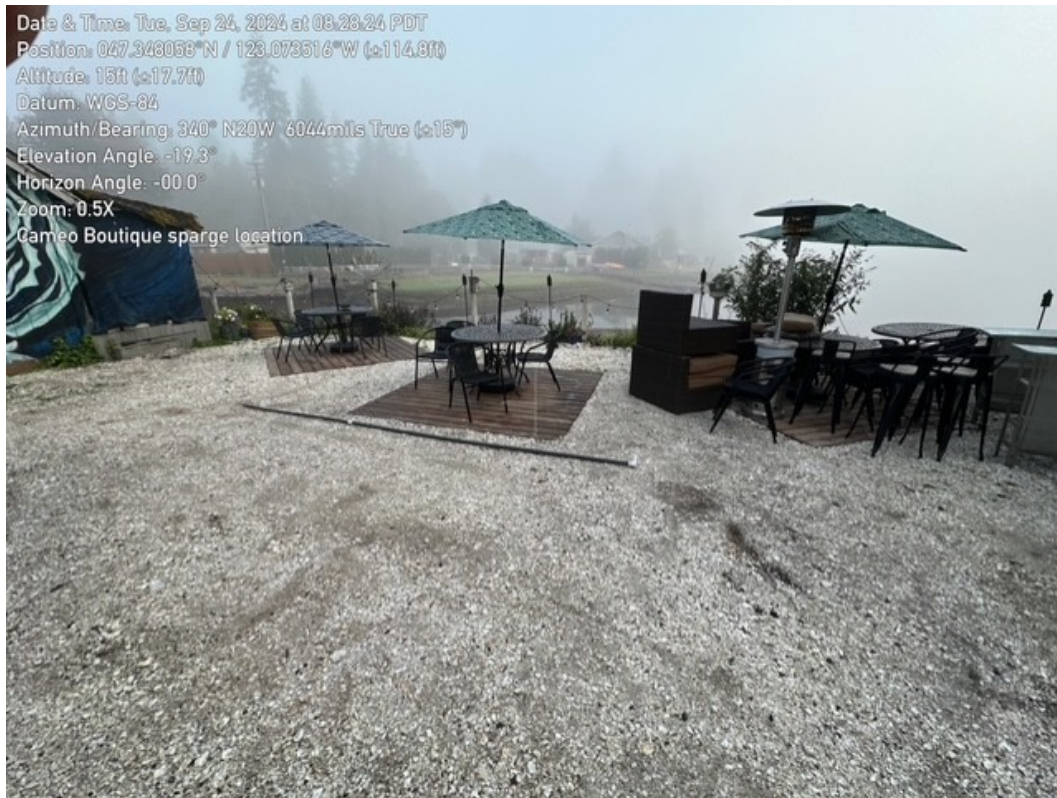
Photograph 4.7. View of the northern air sparging line laid out prior to the excavation of the sparging trench.

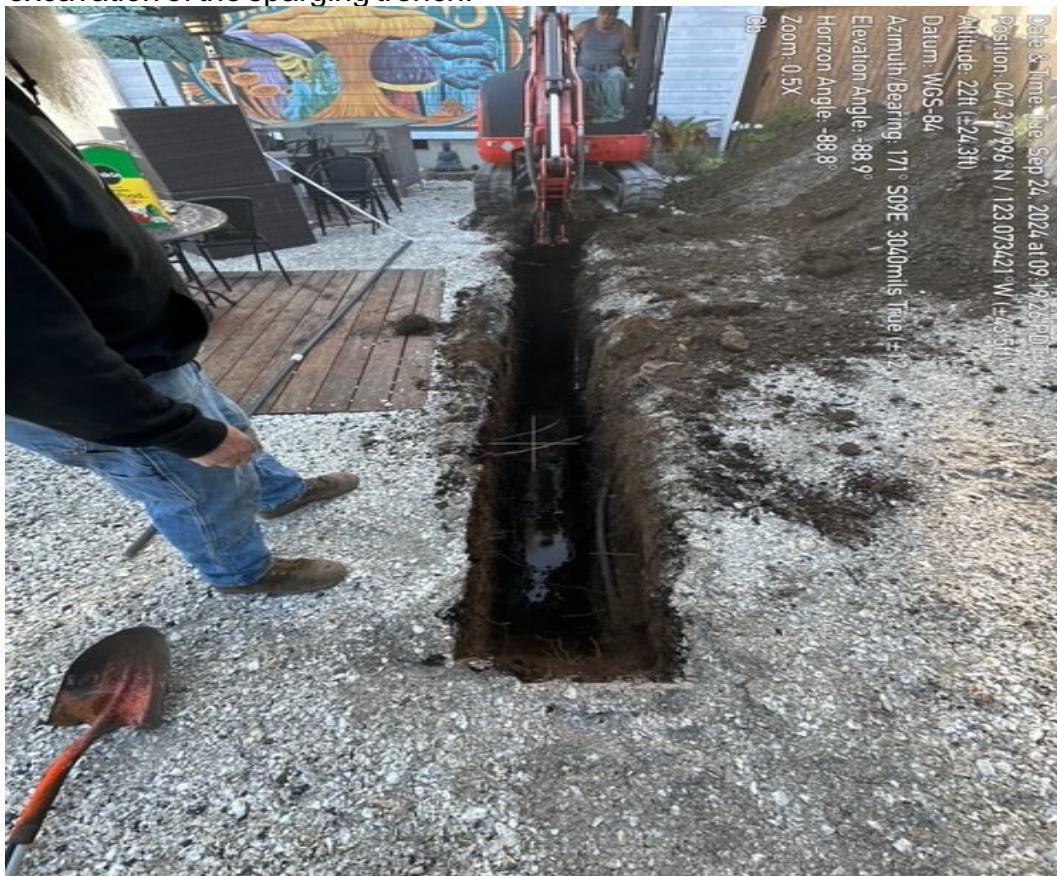
Photograph 4.8. View of trench excavated to install the northern sparge line.

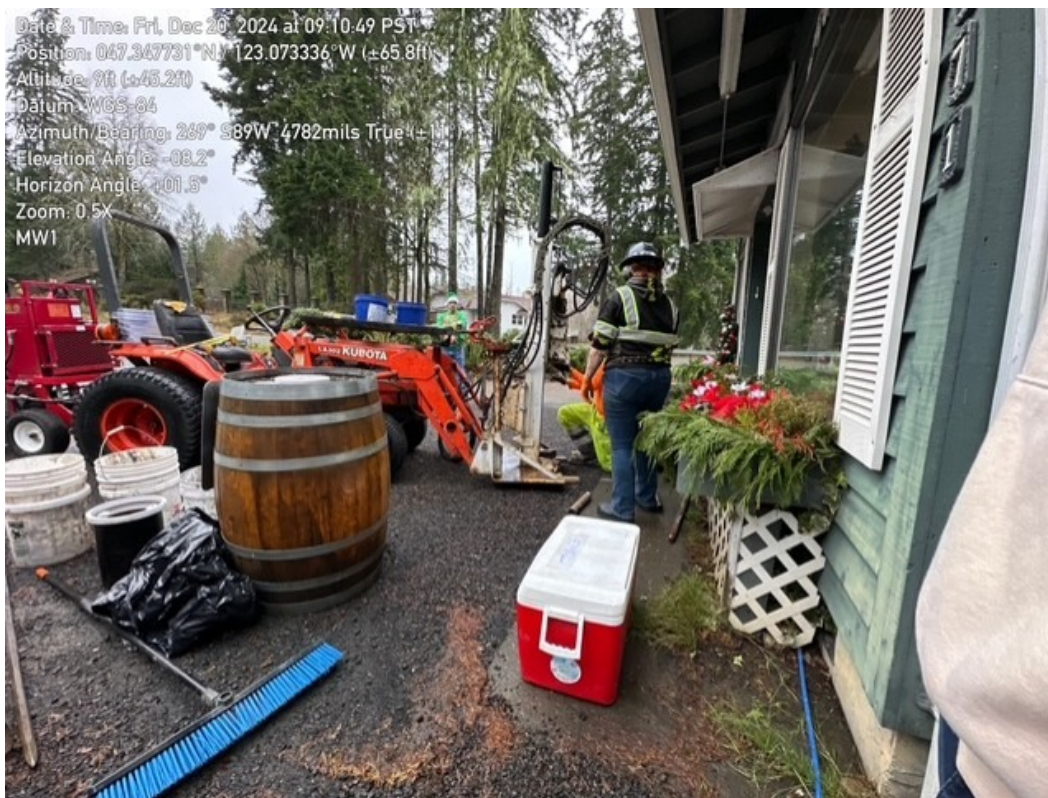
Photograph 4.9. View of Monitoring Well MW1 being installed.

Simpson Geosciences remobilized to the Subject Property on December 20, 2024 to install groundwater monitoring wells. Four groundwater monitoring wells were installed by a licensed driller, Holocene, on the Cameo Boutique property. Two soil borings were advanced to 15 feet below grade (fbg) south of the building in the vicinity of the former USTs. Groundwater monitoring well MW1 was advanced into the remedial excavation south of and adjacent to the building. MW2 was installed in the inferred upgradient location of the former tank basin.

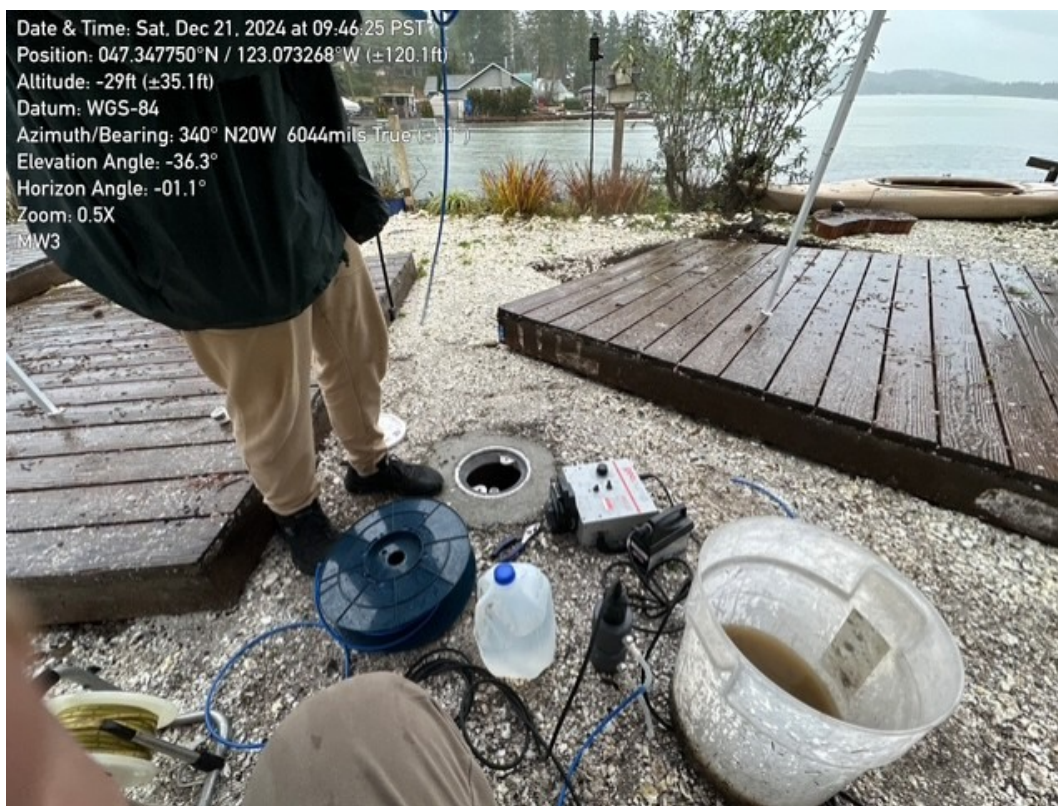
Photograph 4.10. View of typical groundwater sampling setup showing a peristaltic pump, discharge bucket, distilled rinse water and water chemistry meter.

The groundwater wells were sampled the day after installation on December 21, 2024 to allow groundwater conditions to stabilize. The water quality parameters were monitored for temperature, dissolved oxygen, conductivity, salinity, pH, total dissolved solids and oxygen reduction potential during purging of the wells. Once the parameters stabilized to within 10% of two consecutive readings, the water samples were decanted into specialized VOA (volatile organic analysis) containers using a low flow peristaltic pump, checking to be sure no air bubbles were present when capped. The samples were labeled, logged in on the chain of custody, chilled with ice in an insulated cooler and transferred directly to the Washington State accredited environmental laboratory (Friedman and Bruya, Inc.) in Seattle following chain of custody procedures by the site assessor.
