# Cameo Shop a.k.a Cameo Boutique

SHARP Report — Part 1 of 2

Location and land use info	
6871 E State Route 106, Union, Mason County, 98592	
Primary parcel	322335000002
Land use	commercial
Responsible unit	SWRO

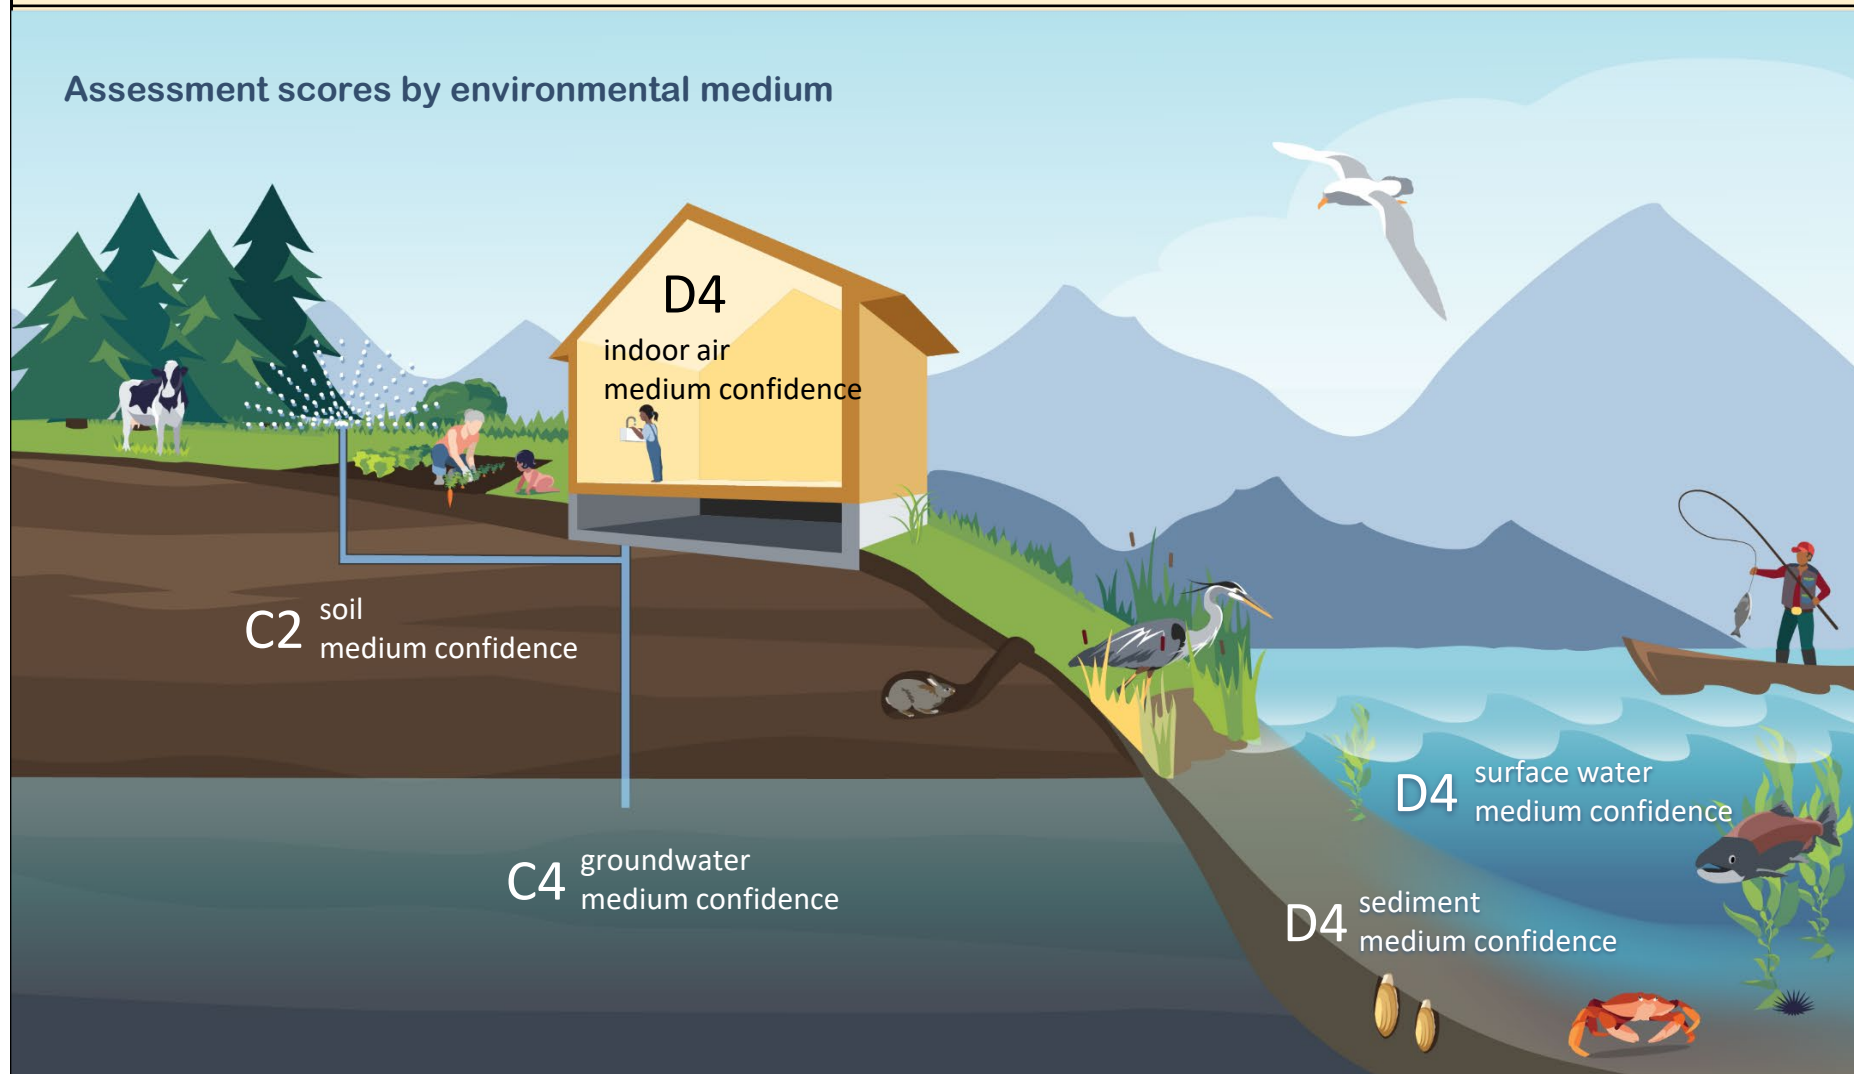
Conceptual site model

Source/source area description
Release of gasoline to soil from removed underground storage tanks.

### Assessment scores by environmental medium
