714440
I5 SB, MP 25.5
Cowlitz
100003555
17210
N/A

Two trucks crashed onto the bank of the Columbia River at about MP 25.5 on southbound I-5.

The release from Truck #1 has been cleaned up, as confirmed by analytical results. NFA List Truck #1 release to the CSCSL.

ICBC CLAIM # BZ75056-6
SPADY TRANSPORT LTD. DIESEL RELEASE
I-5 MILE 26.1, NEAR WOODLAND, WASHINGTON

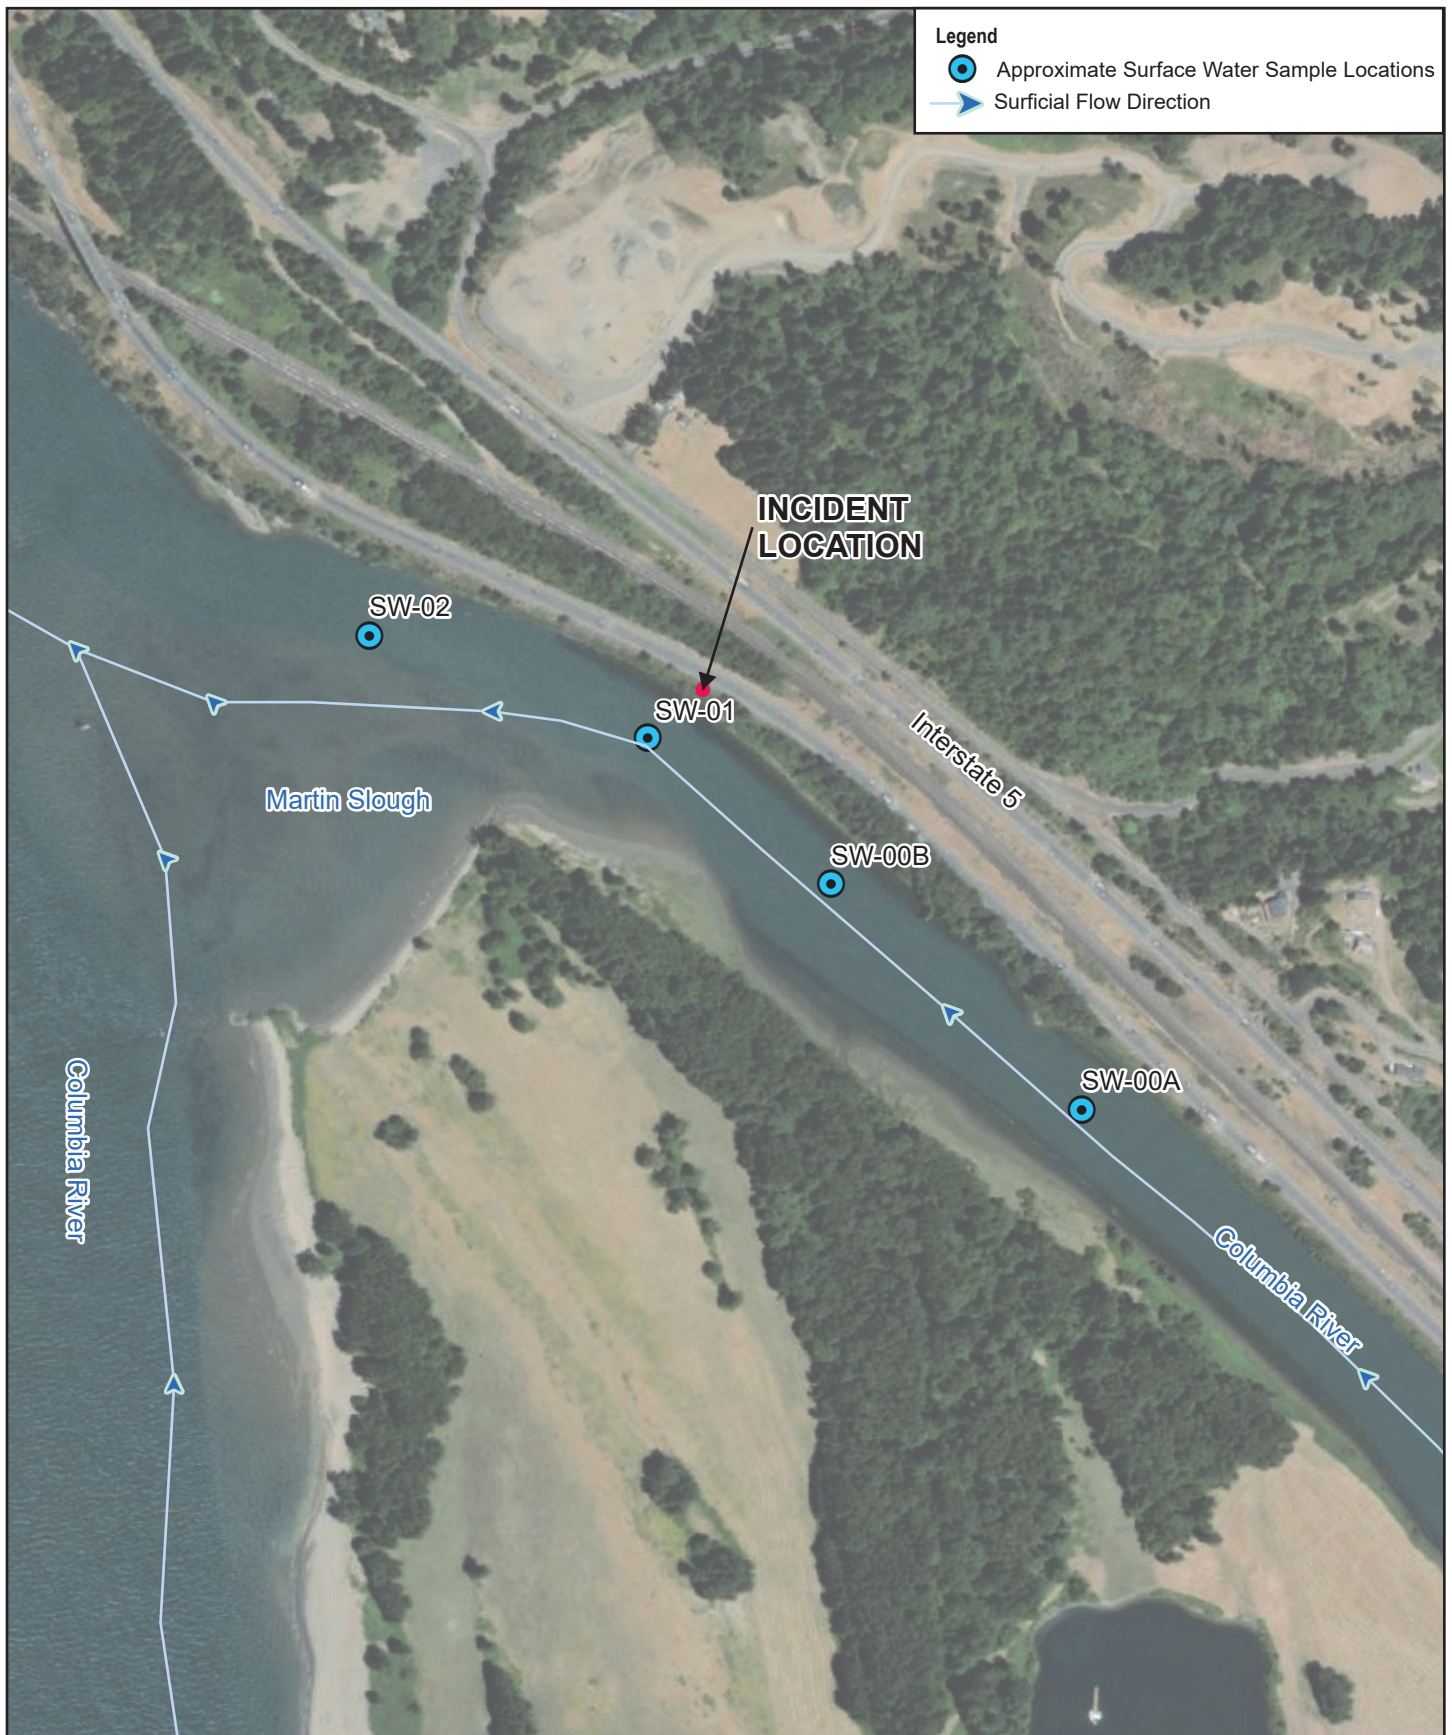
FIGURE 2

A release of diesel from at least one saddle tank occurred during a crash. Diesel release was into soil, surface water (Columbia River) and potentially sediment. A boom contained the surface water release from the time of emergency response until it was removed in January 2023. Surface water sheen removed by absorbent materials (see report photos from May 3, 2022). Surface water results from May 3, 2022 showed that petroleum concentrations were not detected. The laboratory reporting limit was less than the applicable cleanup level for unweathered diesel at 150 micrograms per liter (ug/L) from TCP Implementation Memorandum No. 23.

SURFACE WATER SAMPLING LOCATIONS

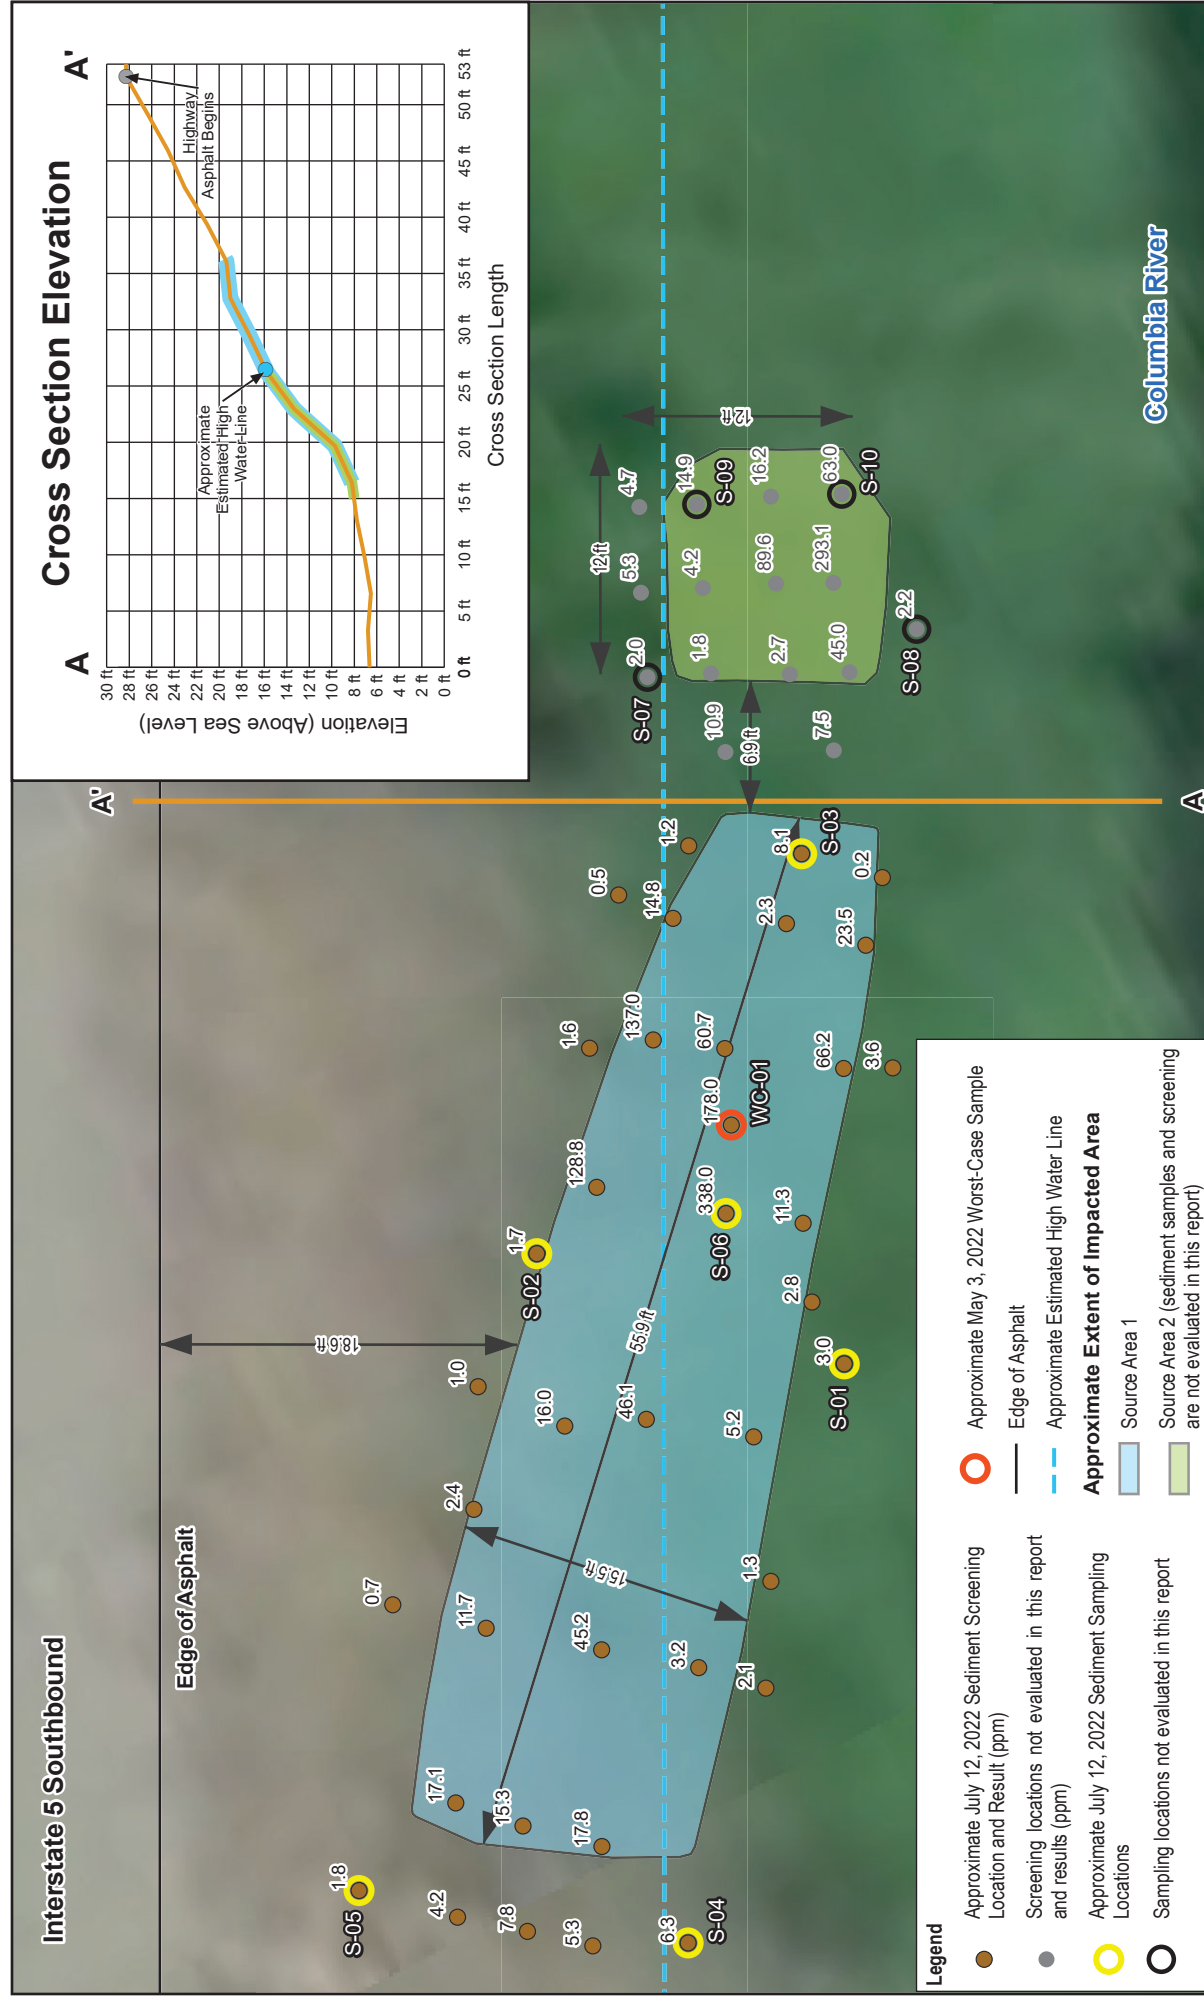
FIGURE 3

Ecology concurred that the analytical results showed that a sediment station cluster of potential concern was not present. Based on the average of three sediment sampling stations compared to the diesel sediment cleanup objective (SCO) of 340 mg/kg. Ecology requested additional soil sampling at three locations with above average PIDs.

Notes
Sediment sample and screening results are in parts per million (ppm). All Site features are approximate.

SEDIMENT SAMPLE LOCATIONS
