Huntingdon Project No. 194-2088
Document No. HND0042R.ENV

**UNDERGROUND STORAGE TANK SITE ASSESSMENT
U S WEST COMMUNICATIONS FACILITY
102 EAST ALDER STREET
WALLA WALLA, WASHINGTON
WDOE SITE ID#: 010033**

November 18, 1994

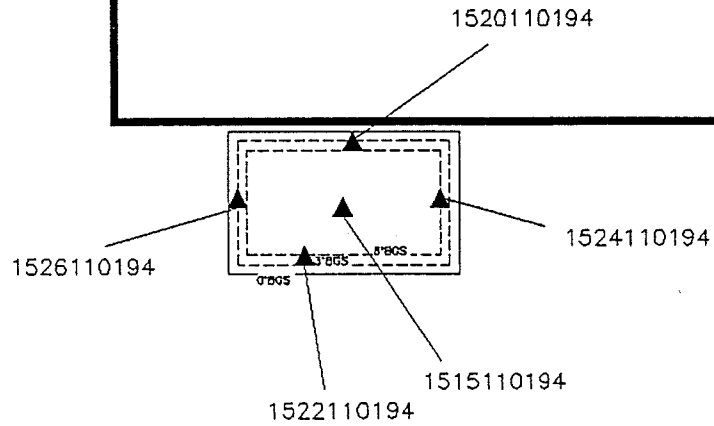
initiated to remove the observed PCS, however, these activities were restricted by the building foundation and confined work space. Sampling and headspace testing of soil from the tank excavation indicated volatile organic vapors were present. PID readings ranged from 32.4 parts per million (ppm) for the base to 45.3 ppm for the east sidewall. PID readings for the stockpiled material ranged between 43.5 ppm and 211 ppm. For more details on field observations, please refer to the Tank Closure Field Forms in Appendix 4. The final dimensions of the excavation are depicted in the Detailed Site Plan (Appendix 1, Figure 4).

Representative soil samples were obtained from the boundaries of the tank excavation. These samples were received and analyzed by Analytical Technologies (ATI) Laboratory in Portland, Oregon. Analytical results are summarized in Table 2 while the laboratory reports are contained in Appendix 5. Sample locations are shown on Figure 3 (Appendix 1).

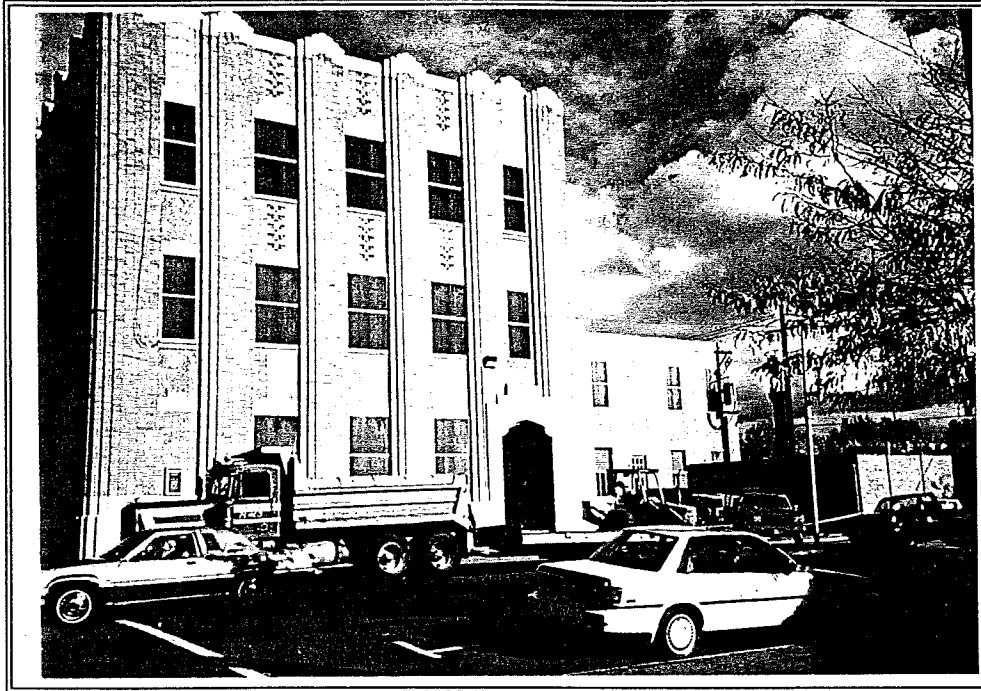
VIEW: Subject Site

DIRECTION: Looking East

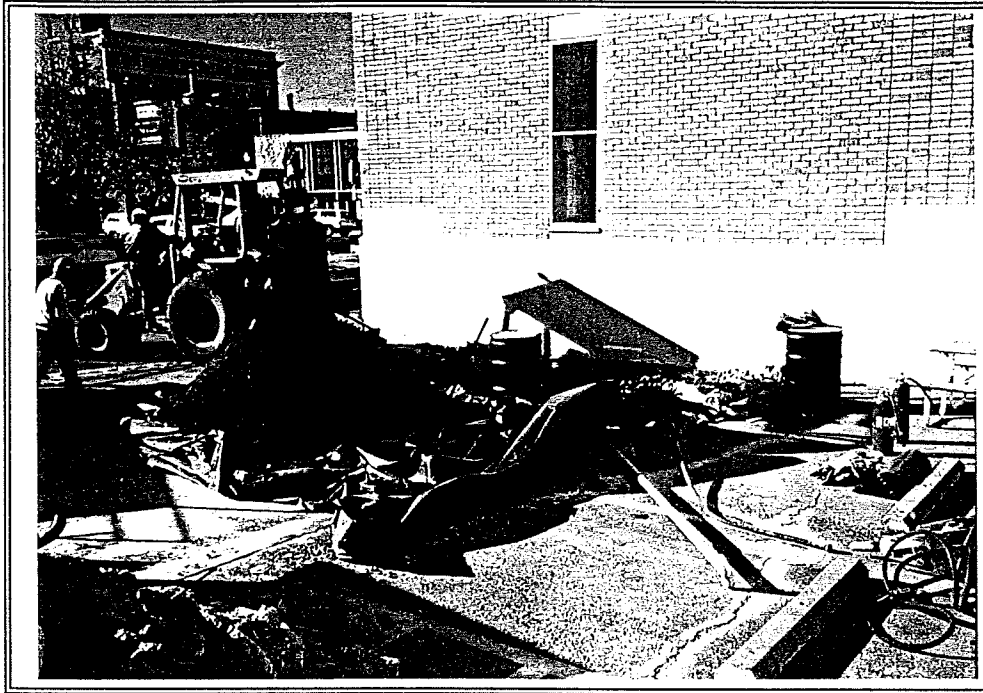
VIEW: Tank Excavation Site

DIRECTION: Looking Northwest
