DEPARTMENT OF
ECOLOGY
State of Washington

<u>Site Name (Name over door):</u> 3 Rivers Resort	<u>Site Address (including City, State, and Zip):</u> 7764 La Push Rd, Forks, WA 98311	<u>Phone</u> Click to enter text. <u>Email</u> Click to enter text.
<u>Site Contact, Title, Business:</u> Jason Annis	<u>Site Contact Address (including City, State, and Zip):</u> 7764 La Push Rd, Forks, WA 98311	<u>Phone</u> 360-640-5195 <u>Email</u> threeriversresort@gmail.com
<u>Site Owner, Title Business:</u> Olympic Resorts Inc	<u>Site Owner Address (including City, State, and Zip):</u> 7764 La Push Rd, Forks, WA 98311	<u>Phone</u> Click to enter text. <u>Email</u> Click to enter text.
<u>Site Owner Contact, Title, Business:</u> Eric Marhofer (consultant)	<u>Site Owner Contact Address (Including City, State, and Zip):</u> Aspect Consulting, Seattle, WA	<u>Phone</u> Click to enter text. <u>Email</u> emarhofer@aspectconsulting.com
<u>Previous Site Owner(s):</u> Click to enter text.	<u>Additional Info (for any Site Information Item):</u> The site does not have any previous or existing LUST or VCP listing.

INSPECTION INFORMATION

Site Plan
3 Rivers Resort
Cleanup Summary Report
Forks, Washington

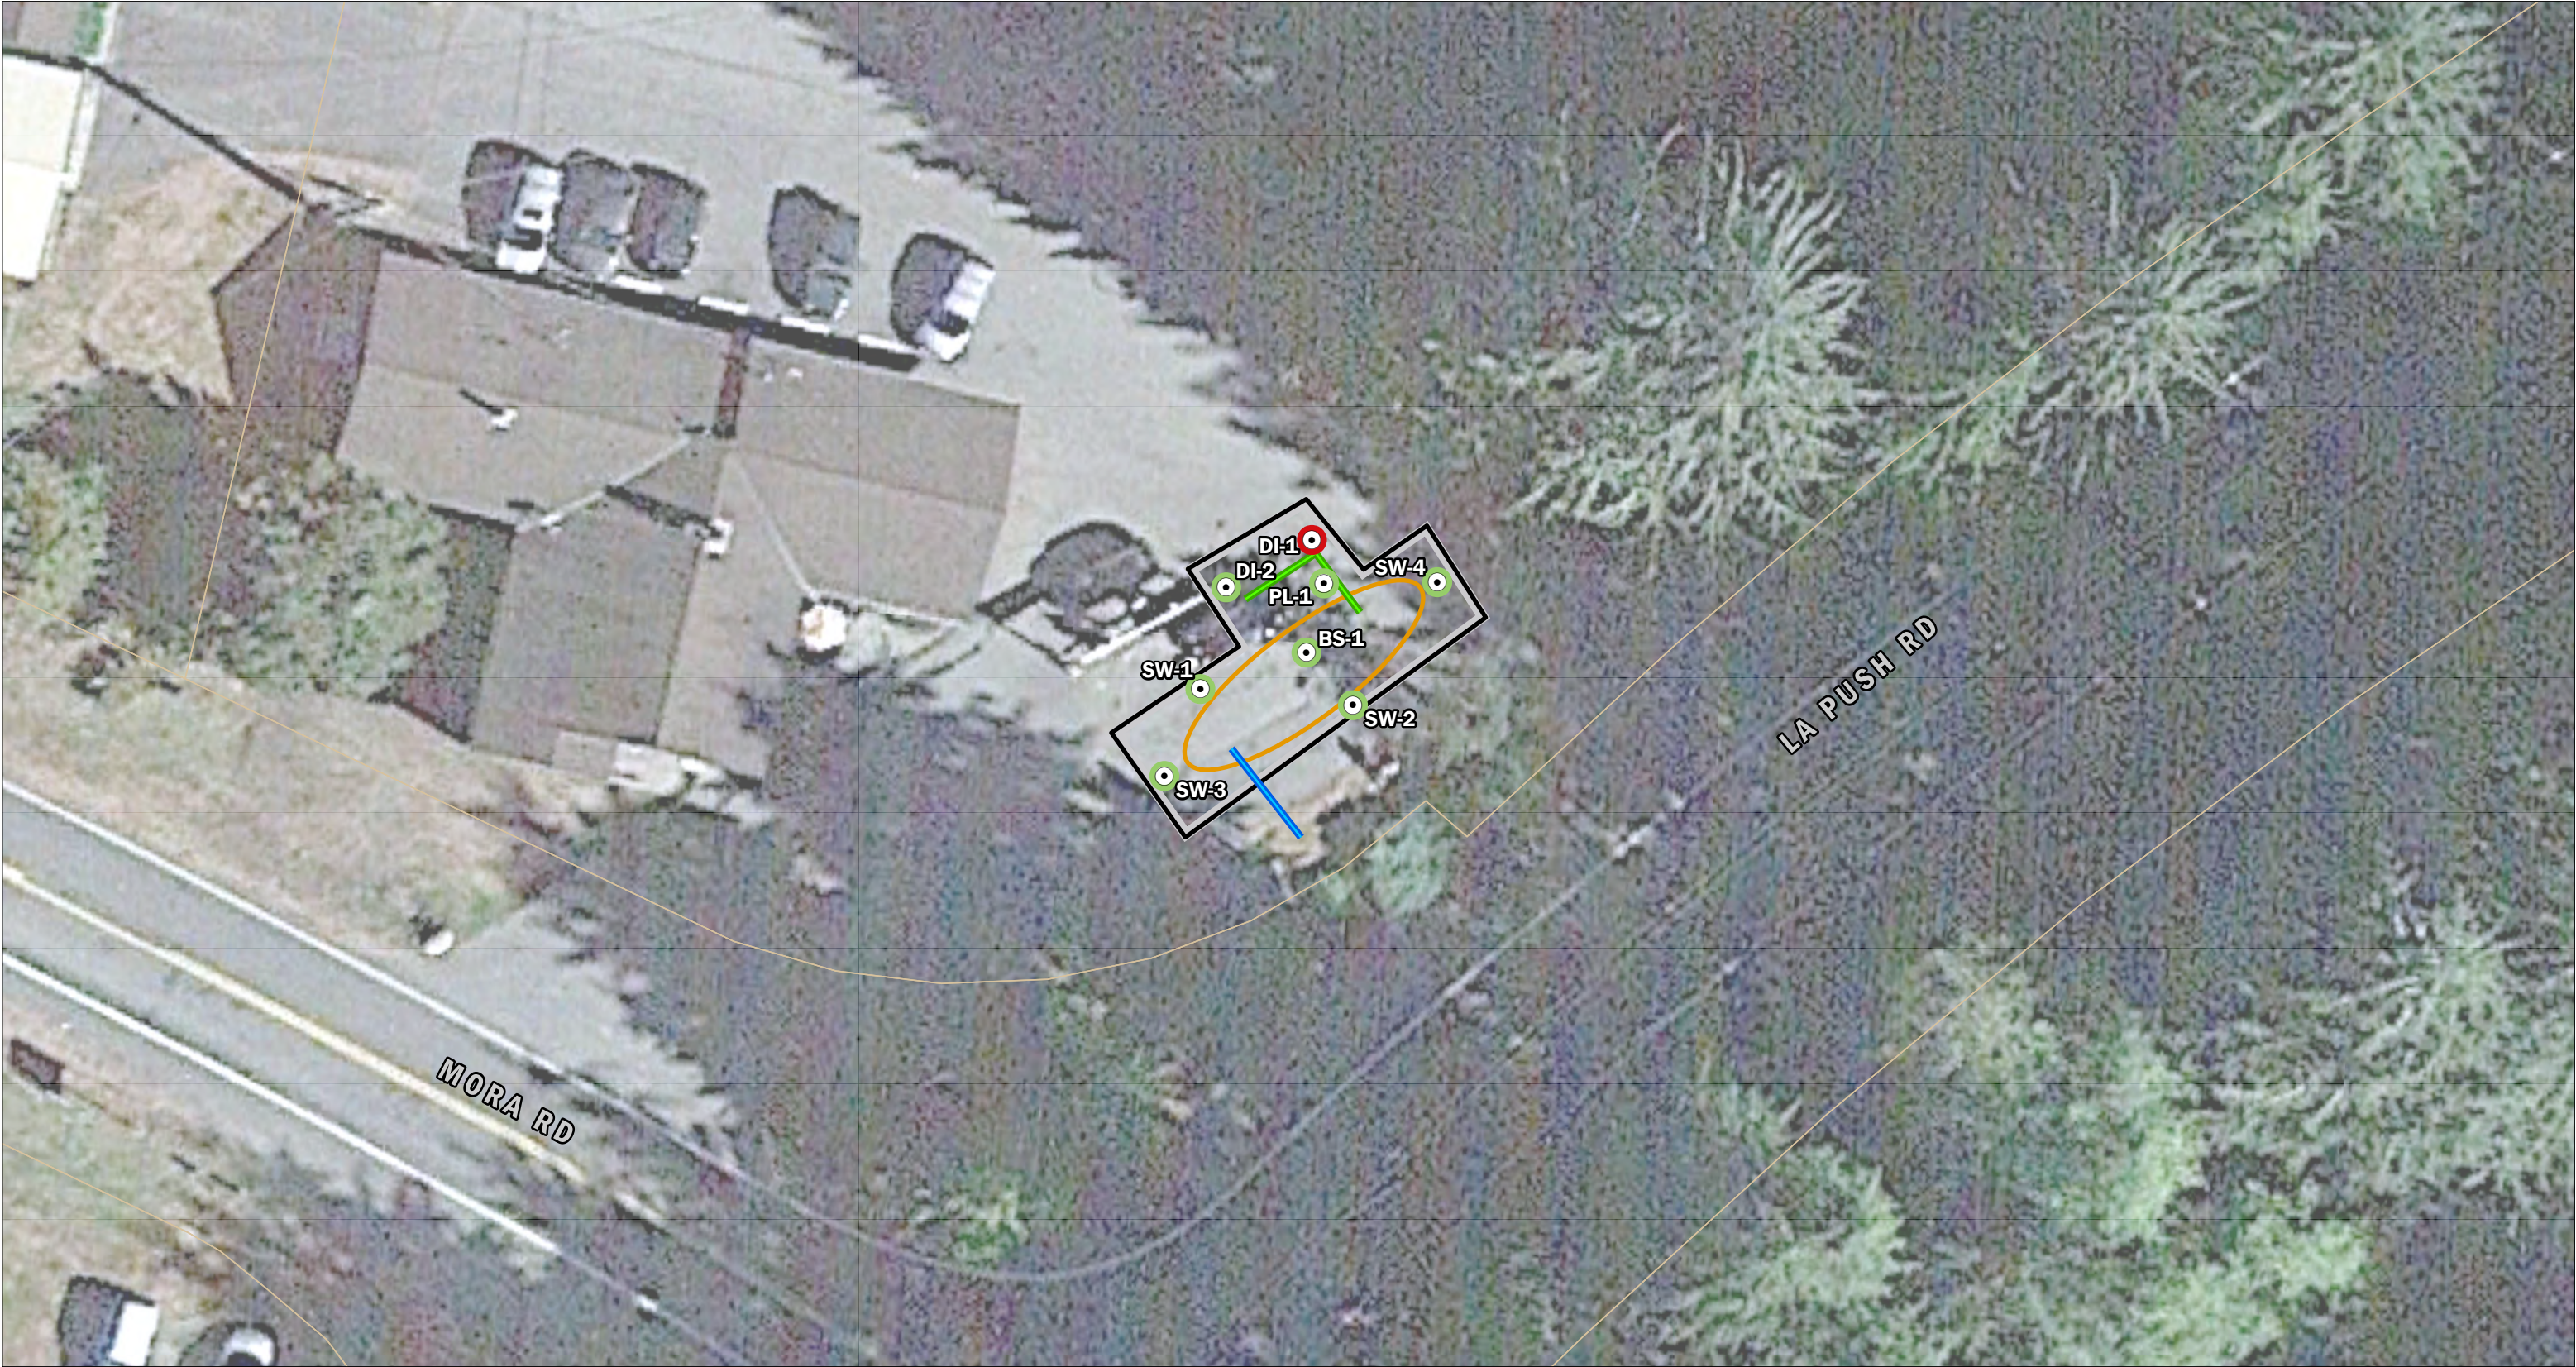
MAY-2022	BY: RLD / NLK	FIGURE NO. 2
	PROJECT NO. 220038	REVISED BY: CEB

The Site Assessment Report indicated that contamination was not identified in the main UST excavation but was present beneath a dispenser island located north of the UST. Eight soil samples were collected from the excavation after the tank, piping, and dispensers were removed, and two from the soil stockpile. Soil samples were analyzed for TPH-G, TPH-Dx, and BTEX. TPH-G (130 mg/kg), TPH-D (3,600 mg/kg), benzene (2.4 mg/kg), and toluene (19 mg/kg) were detected in one soil sample (DI-1; 2.5 feet bgs) at concentrations above MTCA Method A soil cleanup levels for unrestricted land uses. Contaminants were not detected in any other soil sample at concentrations above the laboratory reporting limits, including excavation and stockpile samples.

- Soil Sampling Location
- One or more analytes detected above MTCA Method A cleanup level
- One or more analytes detected below MTCA Method A cleanup level
- No detections
- Product Line
- Vent Line
- ▭

Previous UST System Excavation Area
- ▭

Decommissioned Underground Storage Tank
- ▭
