2024 Operations, Maintenance, and Monitoring Annual Report

South Park Landfill

**Seattle
Public
Utilities**

March 2025

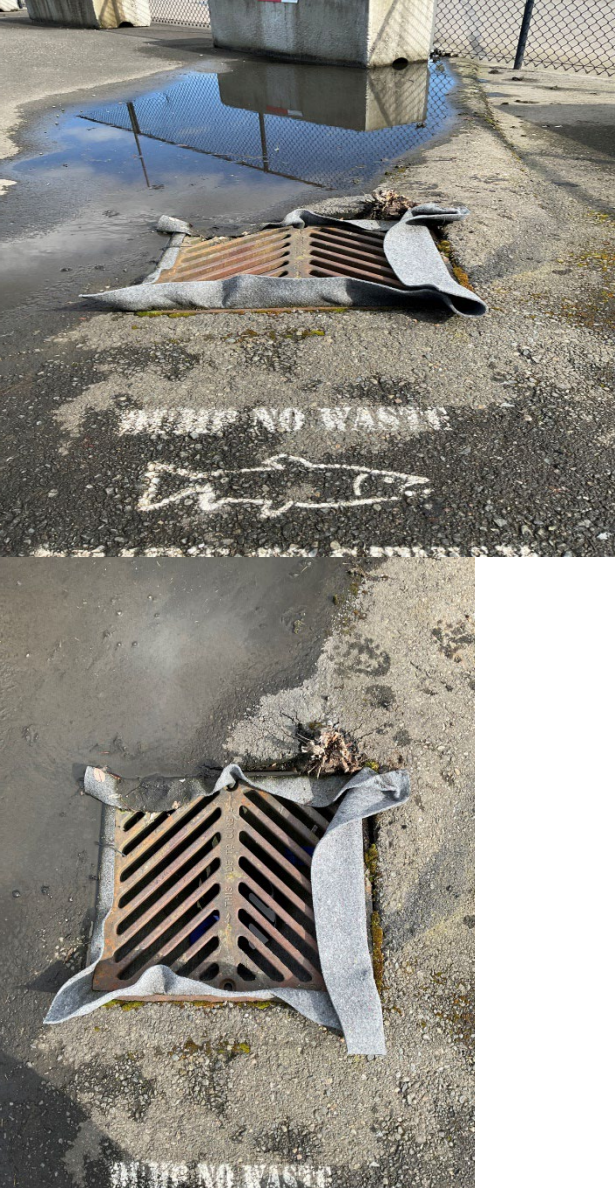
CPSP Location	Description	October 2023 Inspection		Condition Status	March 2024 Inspection		Photographs	
		Conditions Observed and Recommended Action	Action Taken		Conditions Observed and Recommended Action	Timeline for Repair and/or Reinspection		Recommended Action Assignment
AC-23	Invasive plant growth	6ft tall plant next to the storm drain. Remove the plants and seal the cap penetration.	Plant was cut back	Improvement	Most of the plant has been removed but the roots are still there, and the cap penetration was not sealed. Plant roots had pushed up the pavement. Repair and seal pavement.	60 days	CenterPoint

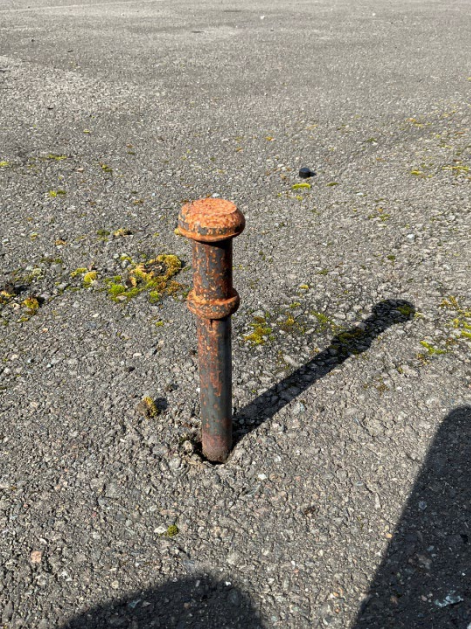
CPSP Location	Description	October 2023 Inspection		Condition Status	March 2024 Inspection			Photographs
		Conditions Observed and Recommended Action	Action Taken		Conditions Observed and Recommended Action	Timeline for Repair and/or Reinspection	Recommended Action Assignment	
AC-29	Metal stakes penetrating the cap			New Point	Four (4) Metal stakes penetrating the cap. Cap needs to either be sealed around the stakes or the stakes removed and the pavement repaired.	60 days	CenterPoint

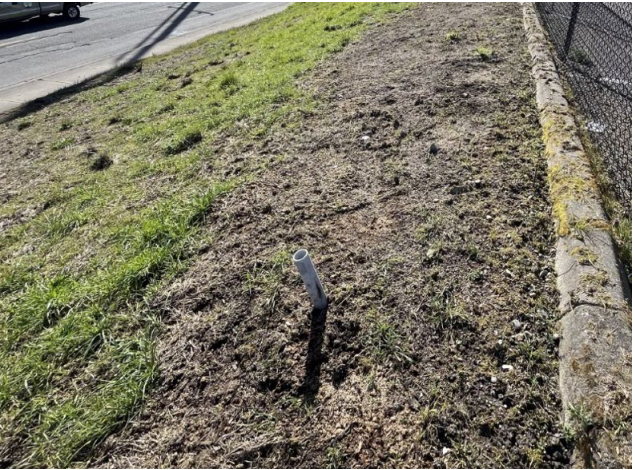
CPSP Location	Description	October 2023 Inspection		March 2024 Inspection				Photographs
		Conditions Observed and Recommended Action	Action Taken	Condition Status	Conditions Observed and Recommended Action	Timeline for Repair and/or Reinspection	Recommended Action Assignment	
Low-Permeability Geomembrane								
G-1	An open pipe present	Need investigation of this open pipe and action should be taken to cap it, if it does not have any purpose.	Action Not Yet Completed	No significant changes observed	Previous recommendations remain	60 days	CenterPoint

On December 10, 2024, Catchment Solutions, on behalf of CPSP completed maintenance at location G-1, capping two open pipes in the landscaping slope. This repair will be inspected during the 2025 Annual Cap Inspection.

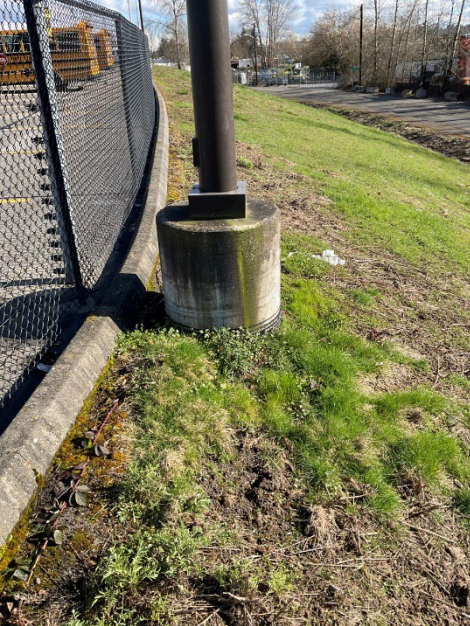
CPSP Location	Description	October 2023 Inspection		Condition Status	March 2024 Inspection			Photographs
		Conditions Observed and Recommended Action	Action Taken		Conditions Observed and Recommended Action	Timeline for Repair and/or Reinspection	Recommended Action Assignment	
G-4	Blackberry shrubs growth in the area and poor vegetation.	Improved growth of grass and growth of blackberry shrubs around the region. Remove the blackberry shrubs before the roots spread and re-seed the grass.	Blackberries removed and evidence of seeding. No maintenance form was submitted for this point.	Improved	Blackberries have mostly been removed, no new grass is growing, but there is evidence of an attempt to reseed (small holes in the ground). Re-establish appropriate vegetation. Submit maintenance form.	No later than end of calendar year	CenterPoint

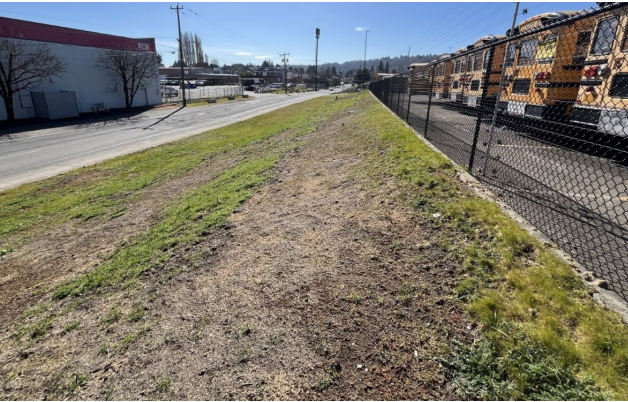
CPSP Location	Description	October 2023 Inspection		March 2024 Inspection				Photographs
		Conditions Observed and Recommended Action	Action Taken	Condition Status	Conditions Observed and Recommended Action	Timeline for Repair and/or Reinspection	Recommended Action Assignment	
G-8	Exposed geomembrane around utility access hole	Work with Site Coordinator to prepare a plan to re-establish cover over the geomembrane. The geomembrane should be carefully exposed so as to not damage the geomembrane and inspected to determine if it is excess material or part of the cover. Make repairs as necessary and install adequate cover soil in accordance with the IAWP.	No documentation of actions taken	Site not observed during inspection.	Previous recommendations remain	60 days	CenterPoint will work in coordination with Site Coordinator to establish a solution	Location was not observed during inspection
G-12	Poor vegetative cover	Dirt appears to be tilled and the area may have been seeded. No maintenance report received. Submit maintenance report if the tilling was intentional otherwise repair vegetation.	No documentation of actions taken.	Worse	No vegetation established.	No later than end of calendar year	CenterPoint

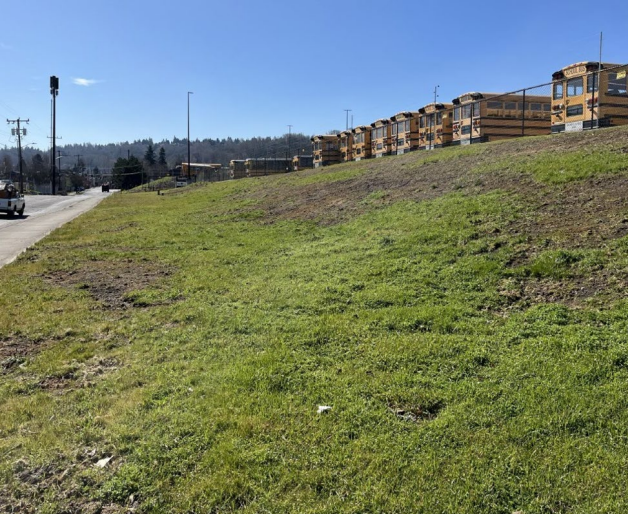
G-14	Invasive Plants	Invasive large plant growth. Remove the large plant due to risk of roots compromising the cover system.	Plants removed. No maintenance form was submitted for this point.	Improved	Large plants were removed. Stump was not found to determine if the roots had damaged the cap. Recommend inspecting the cap to determine if it was damaged. Submit maintenance form.	No later than end of calendar year	CenterPoint

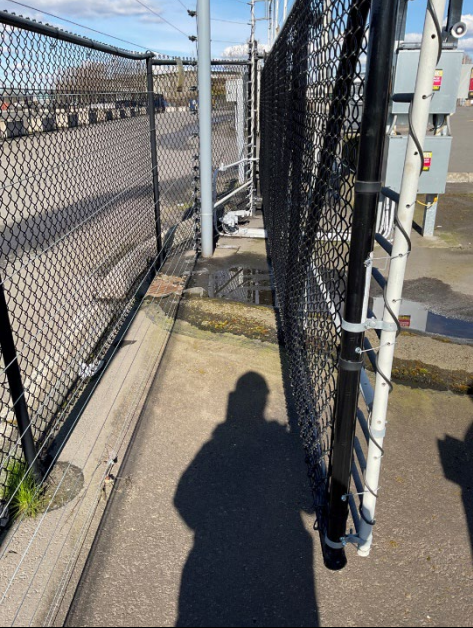
CPSP Location	Description	October 2023 Inspection		Condition Status	March 2024 Inspection			Photographs
		Conditions Observed and Recommended Action	Action Taken		Conditions Observed and Recommended Action	Timeline for Repair and/or Reinspection	Recommended Action Assignment	
SW-4	Catch basin clogged	Catch basin inlet obstructed with sediment buildup and plant growth. Remove the obstruction and vegetation.		No significant changes observed	Catch basin inlet obstructed with sediment buildup and plant growth. Remove the obstruction and vegetation.	No later than end of calendar year	CenterPoint

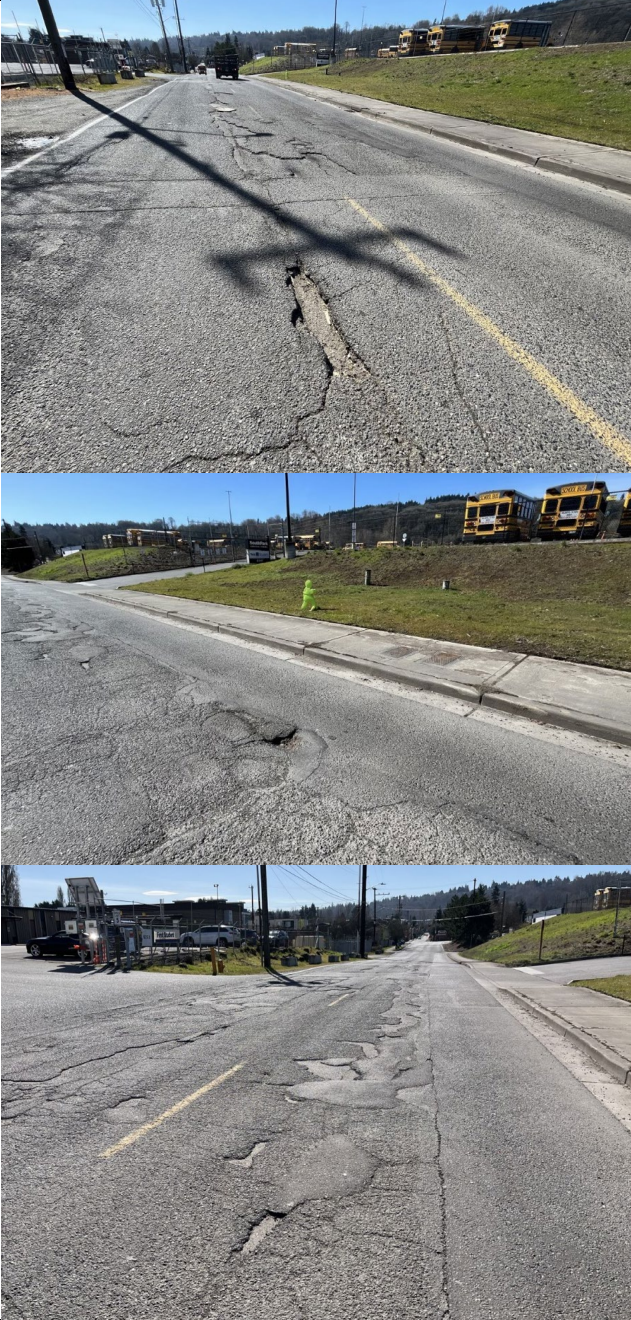
ROW Location	Description	October 2023 Inspection		March 2024 Inspection			Photographs	
		Conditions Observed and Recommended Action	Action Taken	Condition Status	Conditions Observed and Recommended Action	Timeline for Repair and/or Reinspection		Recommended Action Assignment
AC-2	Asphalt open cracking	Cracks got extended. Repatching should be coordinated with SDOT	No action taken	Worse	Cracks got extended and holes are deeper. Some of the holes are close to penetrating the cap. Previous recommendation remains	No later than end of calendar year	SPU to coordinate with SDOT

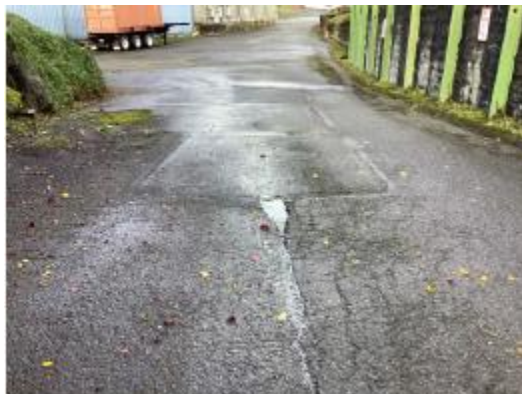
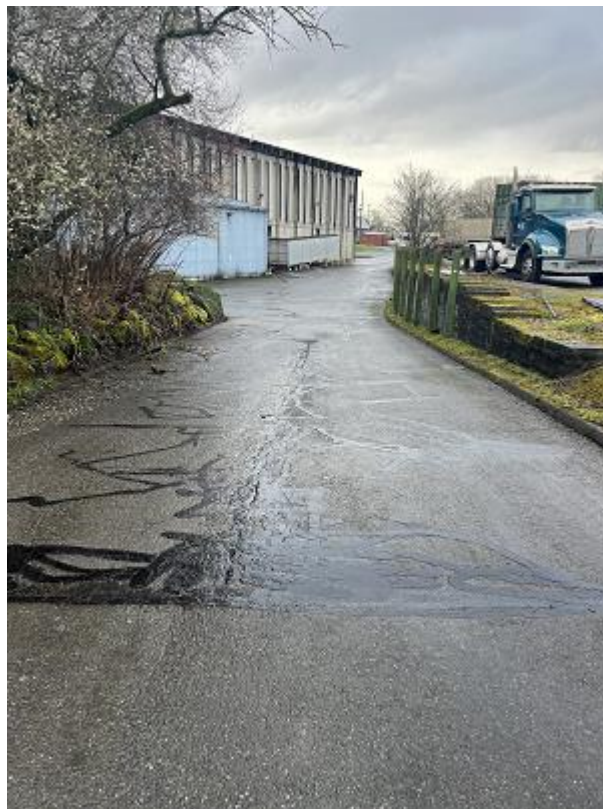
AC-13

Before

After

In February 2024, cracks were repaired at locations SRDS AC-13, AC-14, and AC-20 with hot mix asphalt and sealant. The Site Coordinator observed the repairs and determined the repair activities were complete.

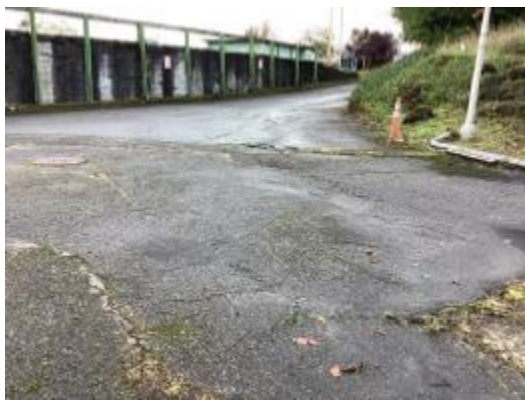
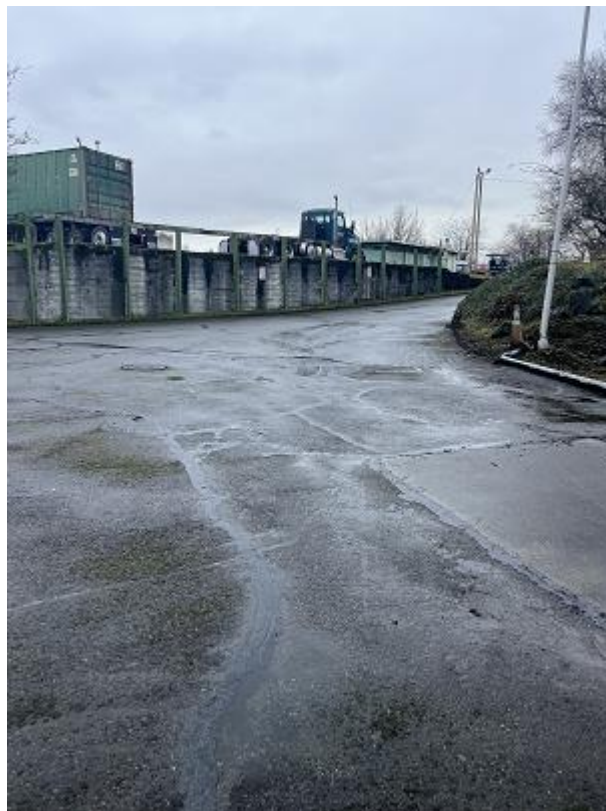
Describe Maintenance Location (attach sketch and photos):
AC-14

Before

After

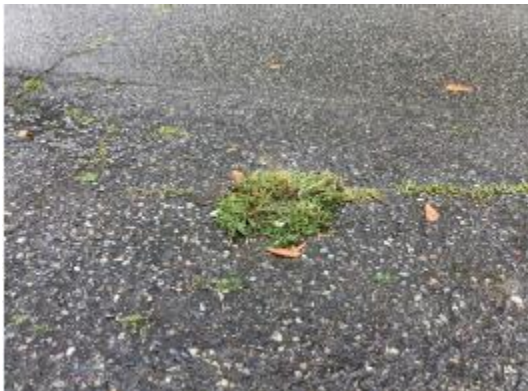
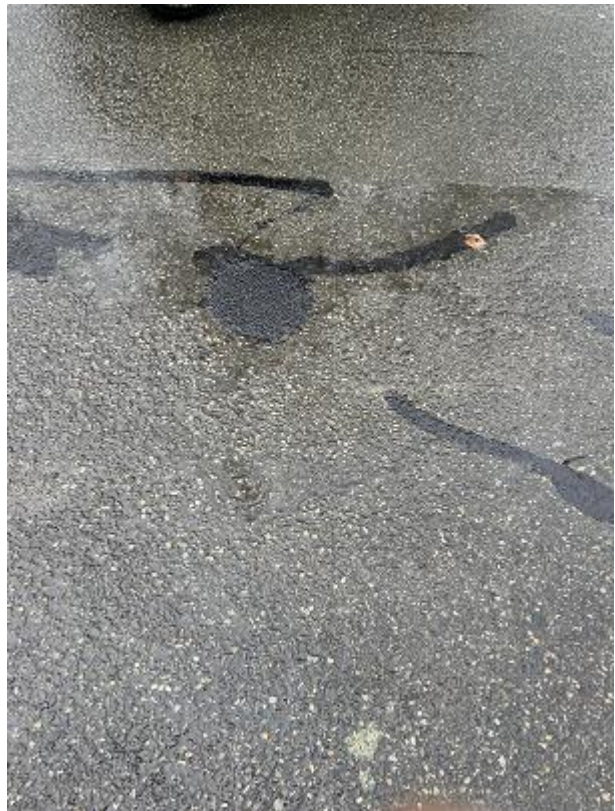
Describe Maintenance Location (attach sketch and photos):
AC-20

Before

After

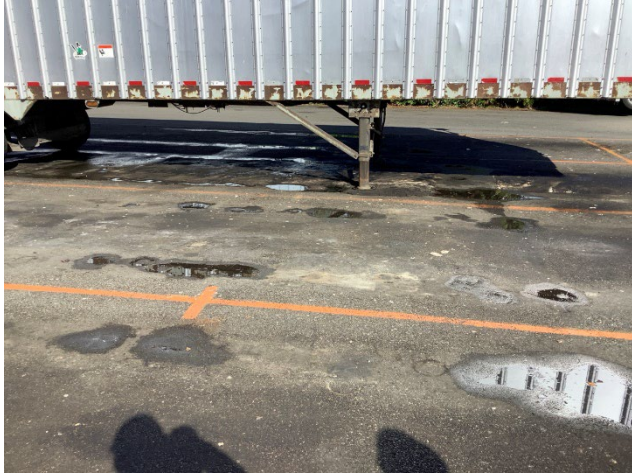
SRDS	Description	March 2024 Inspection		October 2024 Inspection				Photographs
		Conditions Observed and Recommended Action	Action Taken	Condition Status	Conditions Observed and Recommended Action	Timeline for Repair and/or Reinspection	Recommended Action Assignment	
Asphalt Concrete								
AC-5	Cracking, divots and ponding	New location	No actions taken or required	New condition at this location	Area has potholes and divots with ponding.	December 2025	Site Coordinator

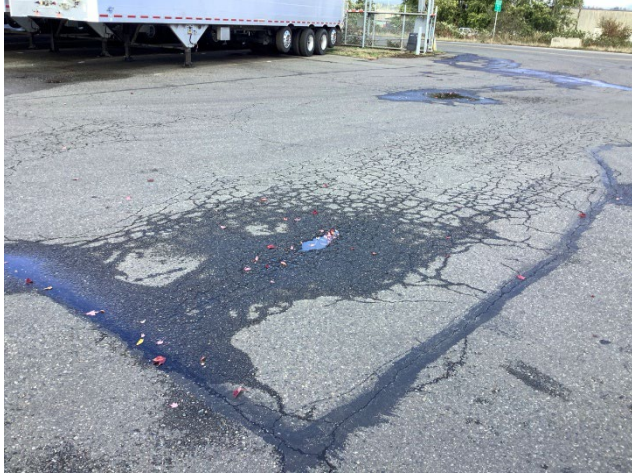
AC-22	Cracking and rut in asphalt	NA	NA	New location	Cracks and ruts in pavement. Patch rut in asphalt and seal to prevent further degradation.	December 2025	SRDS

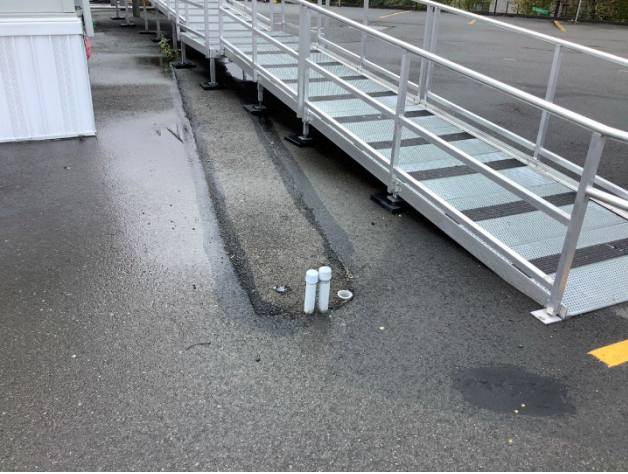
CPSP Location	Description	March 2024 Inspection		October 2024 Inspection				Photographs
		Conditions Observed and Recommended Action	Action Taken	Condition Status	Conditions Observed and Recommended Action	Timeline for Repair and/or Reinspection	Recommended Action Assignment	
Asphalt Concrete								
AC-3	Uncapped pipe	Uncapped pipe protruding from the asphalt needs to be capped or filled and sealed.	Action Not Yet Completed	No significant changes observed	The pipe has not been capped. Previous recommended actions remain.	Past Due	CenterPoint

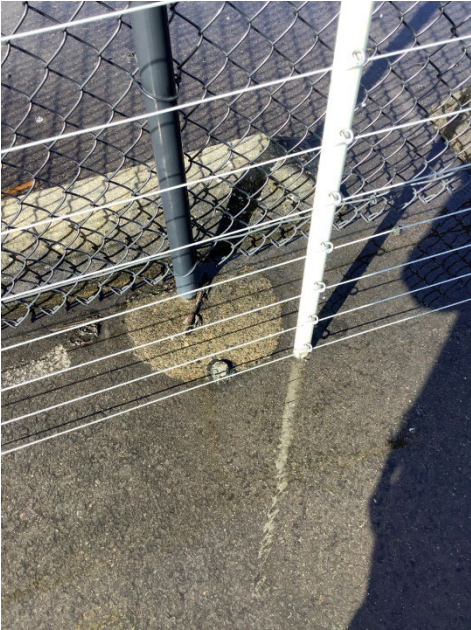
AC-6	Gaps and holes in electric fence post holes	Evidence of continued ponding. Unclear if changes were made.	Action Not Yet Completed	Resolved	Water was flowing during inspection, ponding issue resolved.	NA	NA

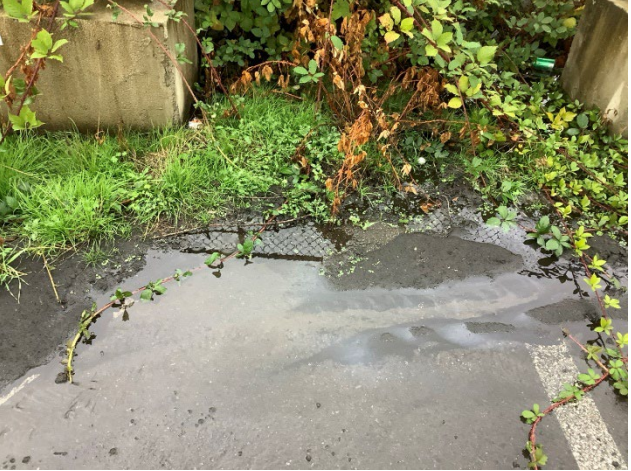
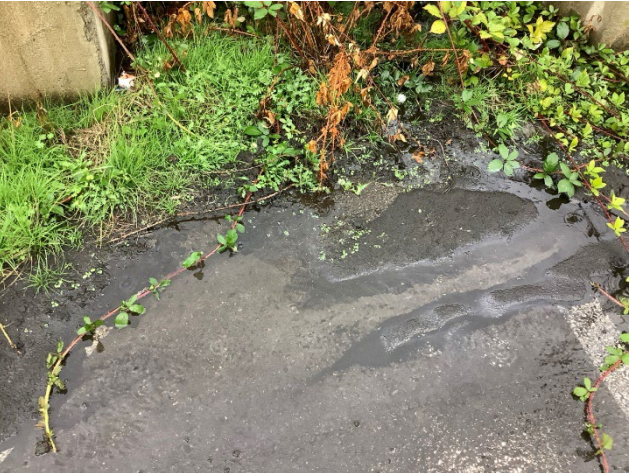
CPSP Location	Description	March 2024 Inspection		October 2024 Inspection				Photographs
		Conditions Observed and Recommended Action	Action Taken	Condition Status	Conditions Observed and Recommended Action	Timeline for Repair and/or Reinspection	Recommended Action Assignment	
AC-13	Blackberry shrubs growth and stagnated water behind the concrete blocks	Blackberries continue to grow. Sediment blocking flow from the swale causing up to 4" of ponding water. Remove blackberry shrubs and clear pathways to allow proper water flow into the storm drains.	Plants were cut back. Maintenance form was submitted.	Worse	Sediment buildup with oil sheen was observed. Blackberries have grown back. Regular maintenance is recommended.	Ongoing	CenterPoint

AC-13: Sediment buildup with oil sheen was observed. Blackberries have grown back. Regular maintenance is recommended.

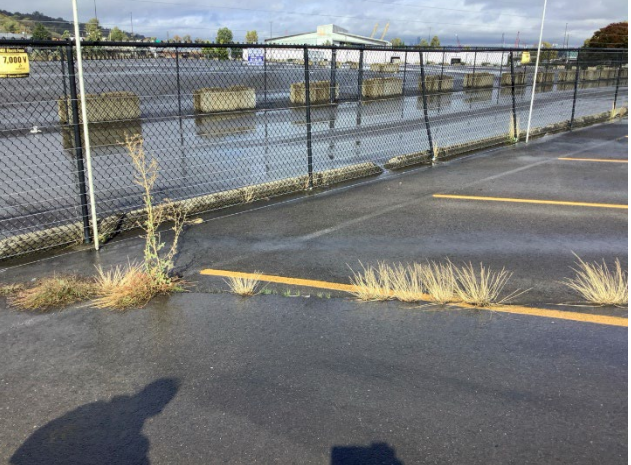
AC-20	Minor cracks	Plant growth in crack Follow-up reinspection	No actions taken or required	Worse	Increased plant growth indicates the cracks have worsened and the asphalt needs to be sealed.	December 2025	CenterPoint

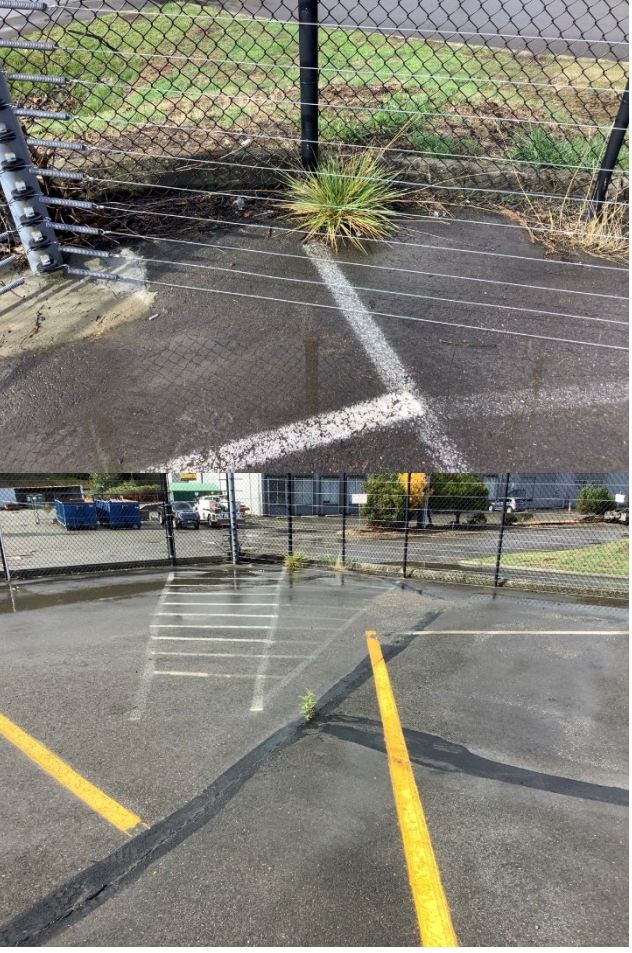
CPSP Location	Description	March 2024 Inspection		October 2024 Inspection				Photographs
		Conditions Observed and Recommended Action	Action Taken	Condition Status	Conditions Observed and Recommended Action	Timeline for Repair and/or Reinspection	Recommended Action Assignment	
AC-21	Holes near fence allowing growth of plants & ponding presence	Plant has been mostly removed. Seal pavement where the plant was growing.	Plant was cut back. Maintenance form was submitted.	No significant changes observed	Previous recommendations remain.	Past Due	CenterPoint

AC-21: Seal pavement where the plants have grown back.

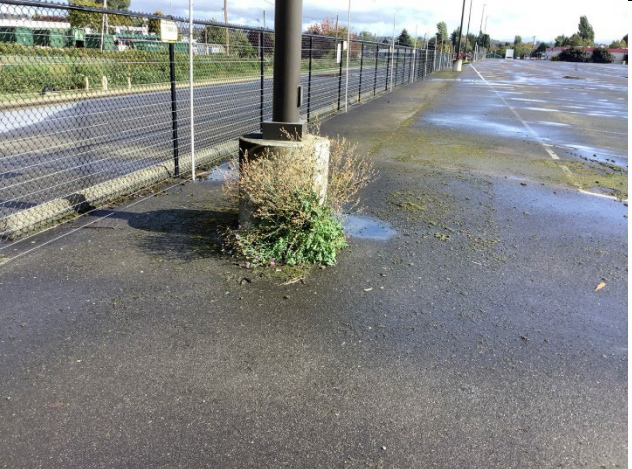
AC-22	Unsealed pavement after plant removal	Part of the plant was removed but has since regrown. Remove the plant and seal the pavement.	No actions taken or maintenance forms received	No significant changes observed	Post is not sealed, as indicated by plant growth. Remove plant and seal pavement.	Past Due	CenterPoint

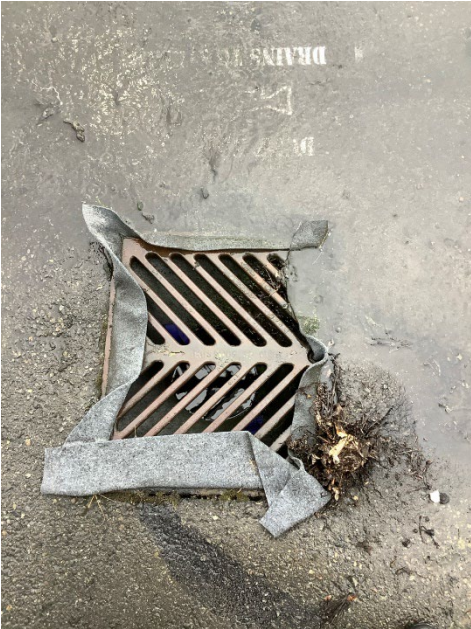
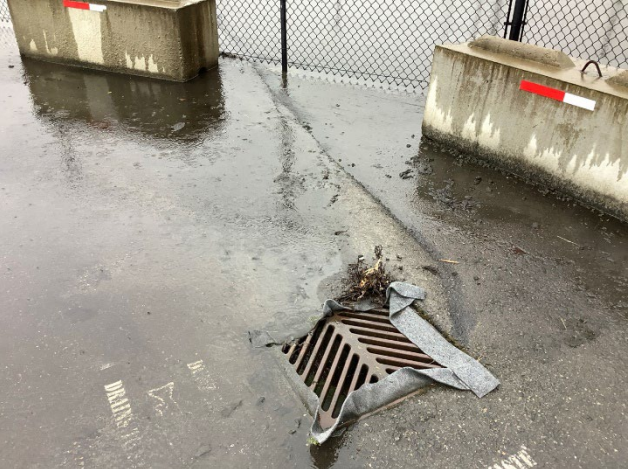
CPSP Location	Description	March 2024 Inspection		October 2024 Inspection				Photographs
		Conditions Observed and Recommended Action	Action Taken	Condition Status	Conditions Observed and Recommended Action	Timeline for Repair and/or Reinspection	Recommended Action Assignment	
AC-23	Separation of pavement from storm drain	Most of the plant next to the storm drain has been removed but the roots are still there, and the cap penetration was not sealed. Plant roots had pushed up the pavement. Repair and seal pavement.	No actions taken	No significant changes observed	Previous recommendations remain.	Past Due	CenterPoint

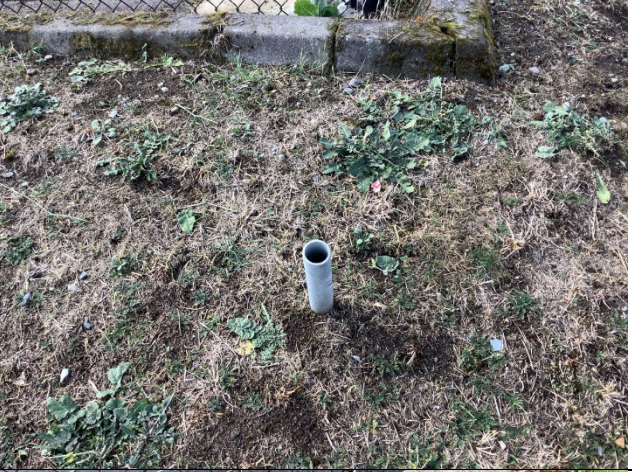
CPSP Location	Description	March 2024 Inspection		October 2024 Inspection				Photographs
		Conditions Observed and Recommended Action	Action Taken	Condition Status	Conditions Observed and Recommended Action	Timeline for Repair and/or Reinspection	Recommended Action Assignment	
Low-Permeability Geomembrane								
G-1	An open pipe present	Need investigation of this open pipe and action should be taken to cap it, if it does not have any purpose.	Action Not Yet Completed	No significant changes observed	Previous recommendations remain.	Past due	CenterPoint

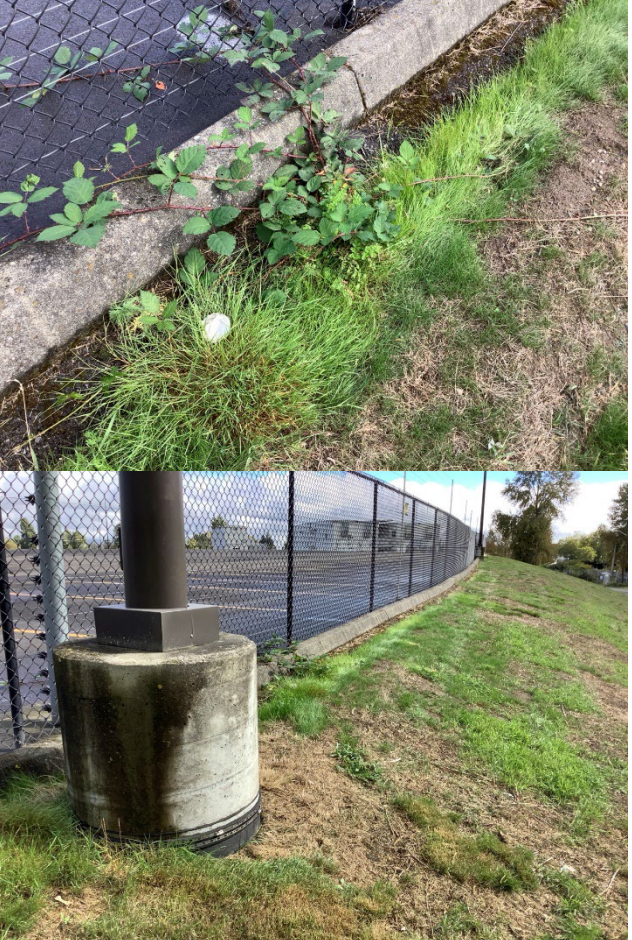
G-4	Blackberry shrubs growth in the area and poor vegetation	Blackberries have mostly been removed, no new grass is growing, but there is evidence of an attempt to reseed (small holes in the ground). Re-establish appropriate vegetation. Submit maintenance form.	Blackberries removed and evidence of seeding.	Improved	Maintenance forms received for clearing blackberries, however blackberries have grown back. Regular maintenance is recommended.	Ongoing	CenterPoint

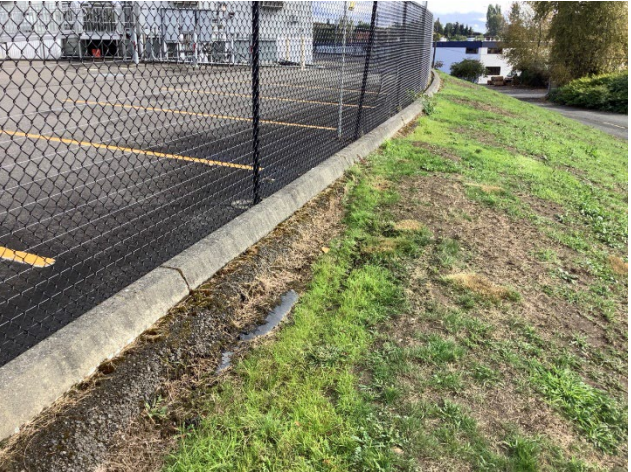
CPSP Location	Description	March 2024 Inspection		October 2024 Inspection				Photographs
		Conditions Observed and Recommended Action	Action Taken	Condition Status	Conditions Observed and Recommended Action	Timeline for Repair and/or Reinspection	Recommended Action Assignment	
G-6	Geomembrane exposed in this area	<p>Geomembrane still exposed.</p> <p>Locations with exposed geomembrane are of the highest concern due to the potential compromise of the landfill cap. The configuration of the geomembrane and cover at the interface of the parking area does not appear to be in accordance with Figure 5 of the Interim Action Work Plan (IAWP). The geomembrane appears to be directly below the asphalt with no drainage layer or surfacing layer in between. Along with Site Coordinator, prepare a plan to reestablish cover over the geomembrane. Most likely, the area should be exposed, and the geomembrane tested for damage before repairs are made. The crest of slope should then be provided cover to the maximum extent possible considering the existing asphalt and curb configuration.</p> <p>Geomembrane still exposed. Previous recommendations remain.</p>	Action Not Yet Completed	No significant changes observed	Geomembrane still exposed. Previous recommendations remain.	Past Due	CenterPoint

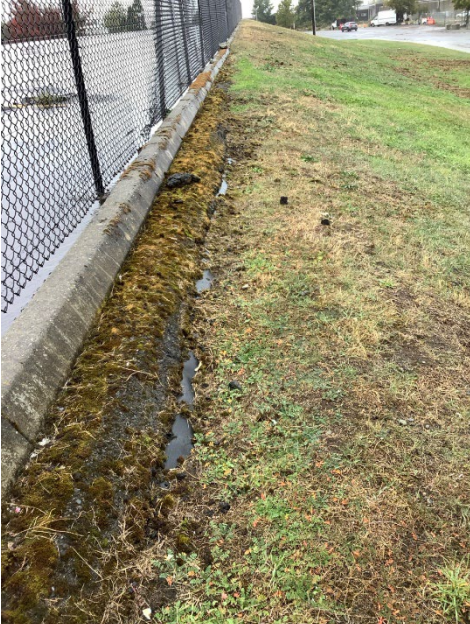
G-7	Exposed and damaged geomembrane at the parking area interface	<p>Maintenance forms were received, however geomembrane still exposed. See G-6 for recommended action.</p>	Action Not Yet Completed	No significant changes observed	Geomembrane still exposed. Previous recommendations remain.	Past Due	CenterPoint

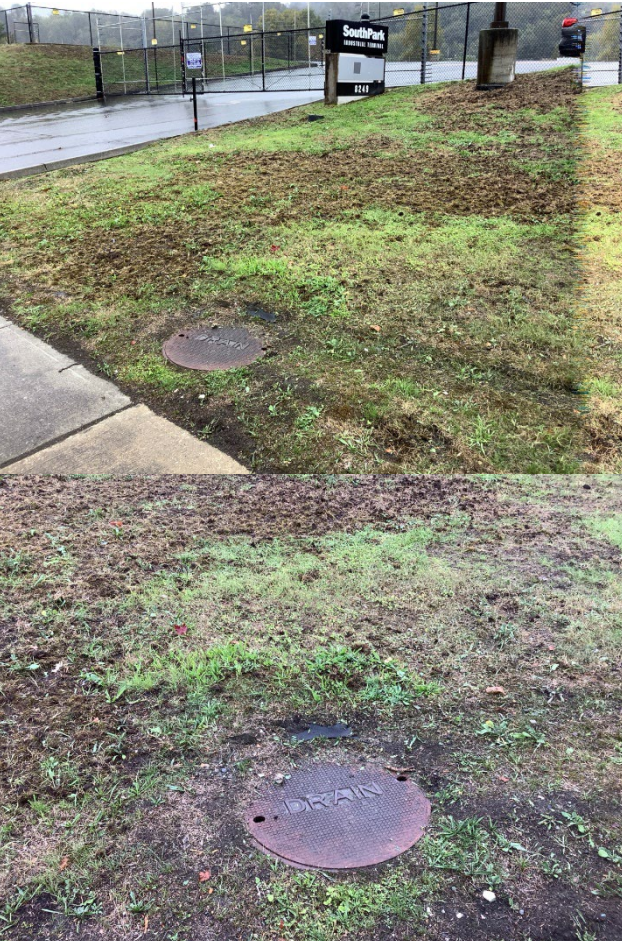
CPSP Location	Description	March 2024 Inspection		October 2024 Inspection				Photographs
		Conditions Observed and Recommended Action	Action Taken	Condition Status	Conditions Observed and Recommended Action	Timeline for Repair and/or Reinspection	Recommended Action Assignment	
G-8	Exposed geomembrane around utility access hole	Work with Site Coordinator to prepare a plan to re-establish cover over the geomembrane. The geomembrane should be carefully exposed so as to not damage the geomembrane and inspected to determine if it is excess material or part of the cover. Make repairs as necessary and install adequate cover soil in accordance with the IAWP.	No documentation of actions taken	No significant changes observed	Geomembrane still exposed. Previous recommendations remain.	Past Due	CenterPoint

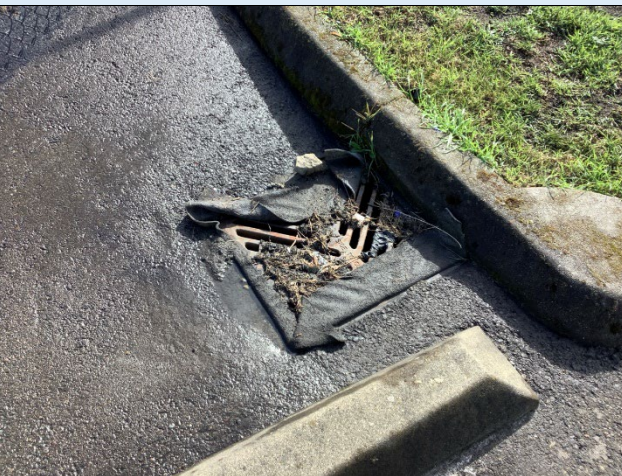
Stormwater Management Facilities								
SW-3	Catch basin clogged	Catch basin inlet partially obstructed. Remove the obstruction.	Some debris was removed. No maintenance form was submitted.	No significant changes observed	Previous recommendations remain. This will likely be an area of continuous maintenance.	Ongoing	CenterPoint

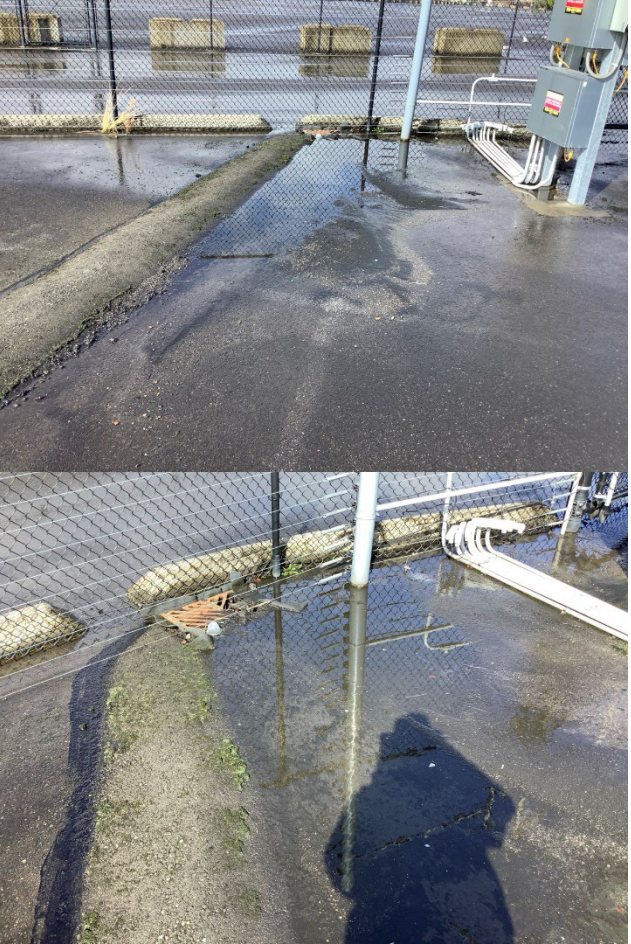
CPSP Location	Description	March 2024 Inspection		October 2024 Inspection				Photographs
		Conditions Observed and Recommended Action	Action Taken	Condition Status	Conditions Observed and Recommended Action	Timeline for Repair and/or Reinspection	Recommended Action Assignment	
SW-4	Catch basin clogged	Catch basin inlet obstructed with sediment buildup and plant growth. Remove the obstruction and vegetation.	Action Not Yet Completed	No significant changes observed	Previous recommendations remain.	Ongoing	CenterPoint

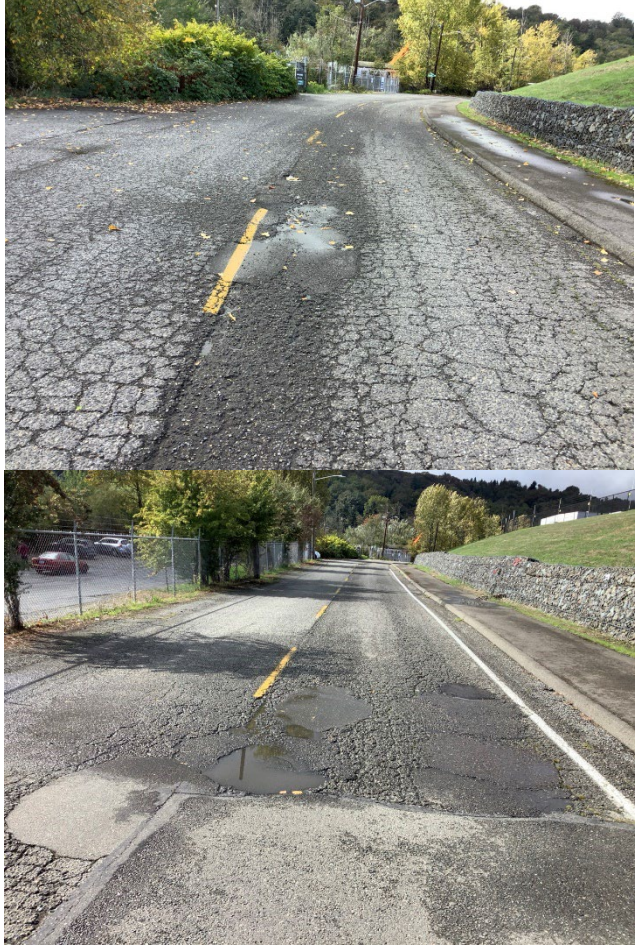
ROW Location	Description	March 2024 Inspection		October 2024 Inspection			Photographs	
		Conditions Observed and Recommended Action	Action Taken	Condition Status	Conditions Observed and Recommended Action	Timeline for Repair and/or Reinspection		Recommended Action Assignment
Asphalt Concrete								
AC-1	Asphalt cracks and ruts	Part of the pothole was repaired but there is still a significant size hole in the asphalt and cracking.	Partial Asphalt Patching.	Improvement	Partial asphalt patching was observed. Repair/repatching should be coordinated with SDOT. Report on the SDOT Find It, Fix It app.	December 2025	SDOT

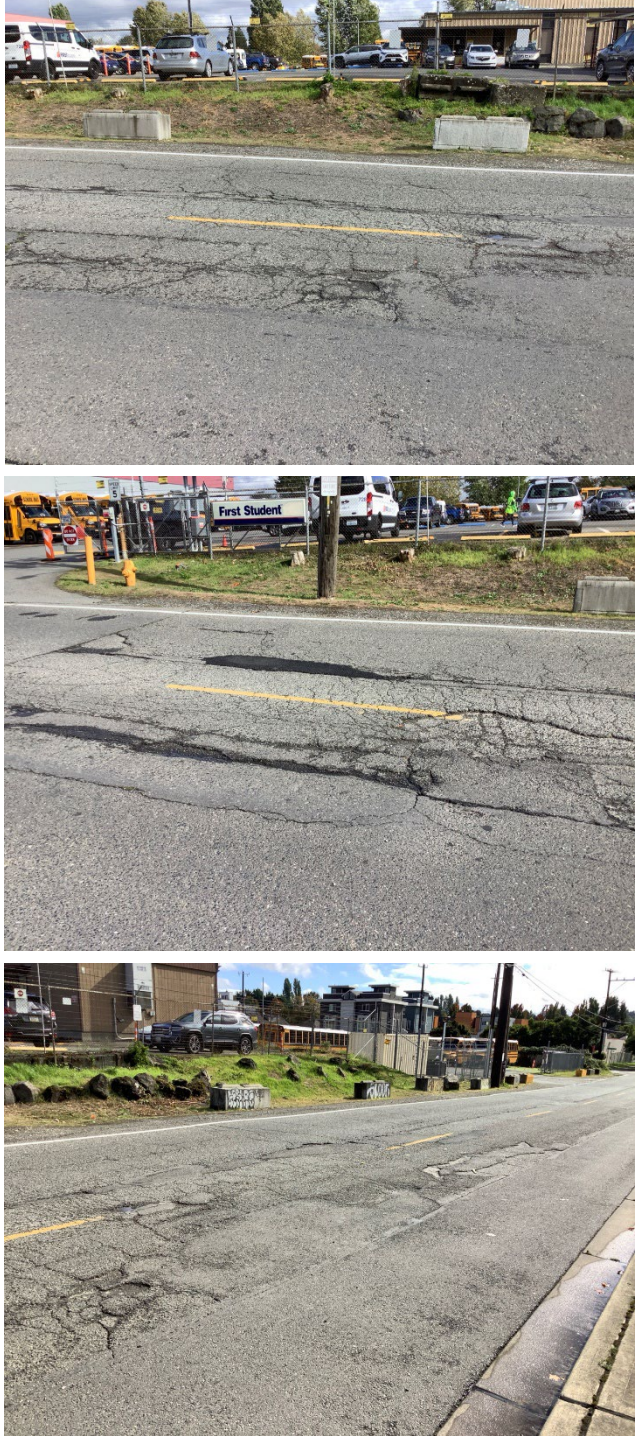
ROW Location	Description	March 2024 Inspection		October 2024 Inspection			Photographs	
		Conditions Observed and Recommended Action	Action Taken	Condition Status	Conditions Observed and Recommended Action	Timeline for Repair and/or Reinspection		Recommended Action Assignment
AC-2	Asphalt open cracking	Cracks got extended and holes are deeper. Some of the holes are close to penetrating the cap. Repatching should be coordinated with SDOT	No action taken	Improved	Previous pothole and some deep cracks were patched; however, several cracks are deeper and need repair. Repair/repatching should be coordinated with SDOT. Report on the SDOT Find It, Fix It app.	December 2025	SDOT

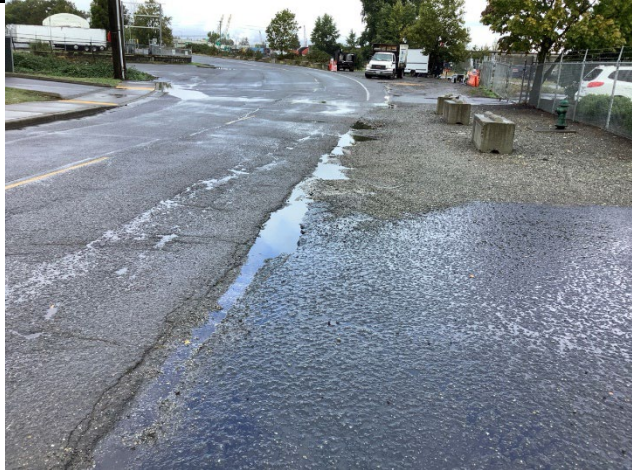
ROW Location	Description	March 2024 Inspection		October 2024 Inspection				Photographs
		Conditions Observed and Recommended Action	Action Taken	Condition Status	Conditions Observed and Recommended Action	Timeline for Repair and/or Reinspection	Recommended Action Assignment	
AC-3	Potholes alongside of street in the gravel	Pothole appears to be getting worse and should be patched to prevent further erosion.	Site Coordinator reported on SDOT Find It, Fix It; repairs were not made	Worse	Previous conditions remain. Repair should be coordinated with SDOT. Report on the SDOT Find It, Fix It app.	December 2025	SDOT

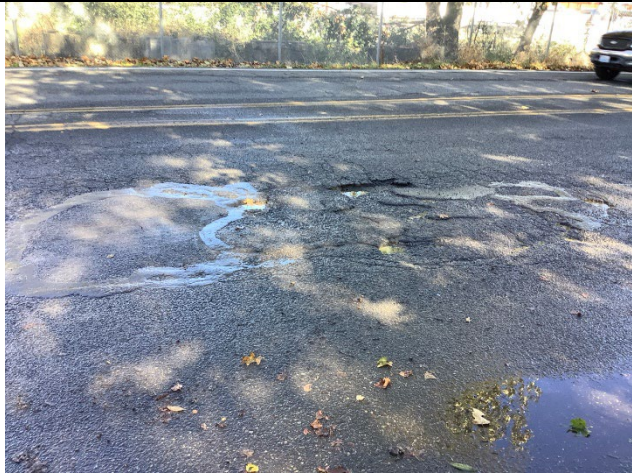
AC-4	Asphalt cracks and ruts in the middle of roadway	Previous pothole had been patched	Repaired	Worse	Previous pothole was repaired; however, several asphalt cracks and ruts have worsened and are in need of repair. Repair/repatching should be coordinated with SDOT. Report on the SDOT Find It, Fix It app.	December 2025	SDOT

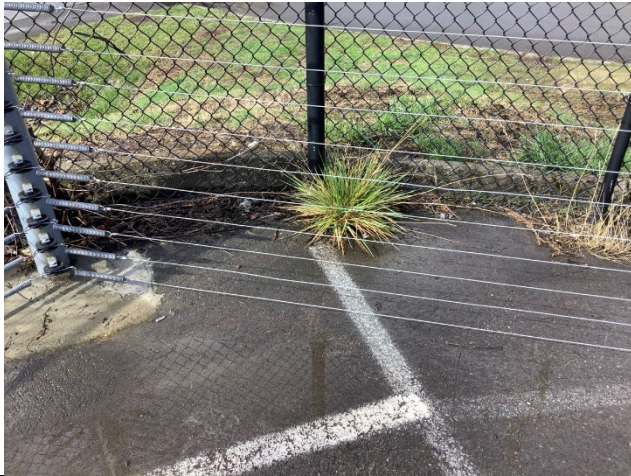
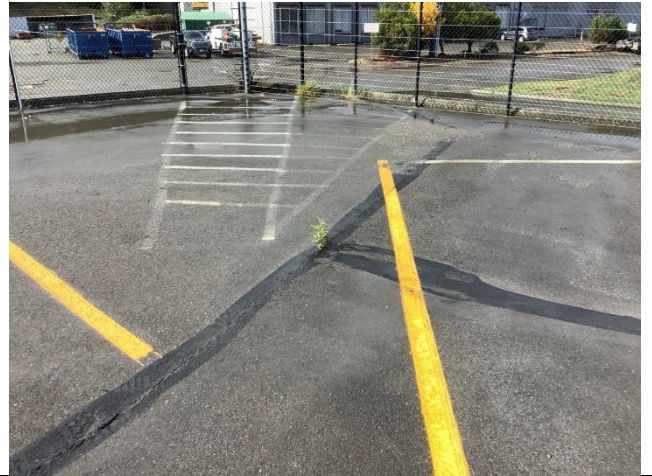
AC-21: Seal pavement where the plants have grown back.

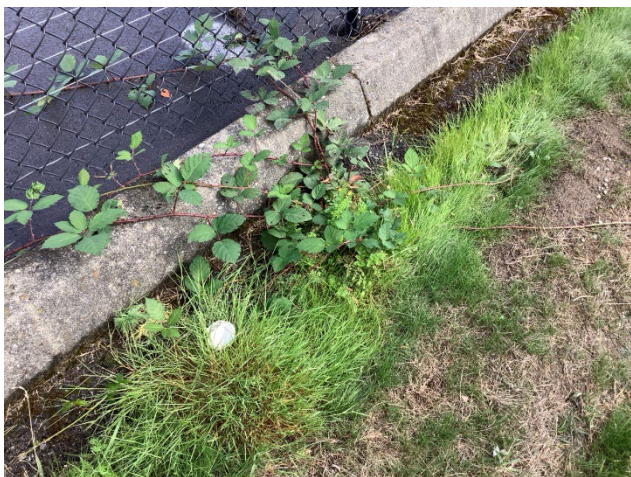
G-4: Blackberries have grown back. Regular maintenance is recommended.

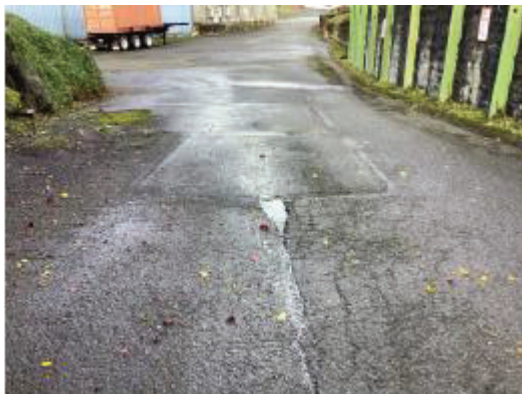
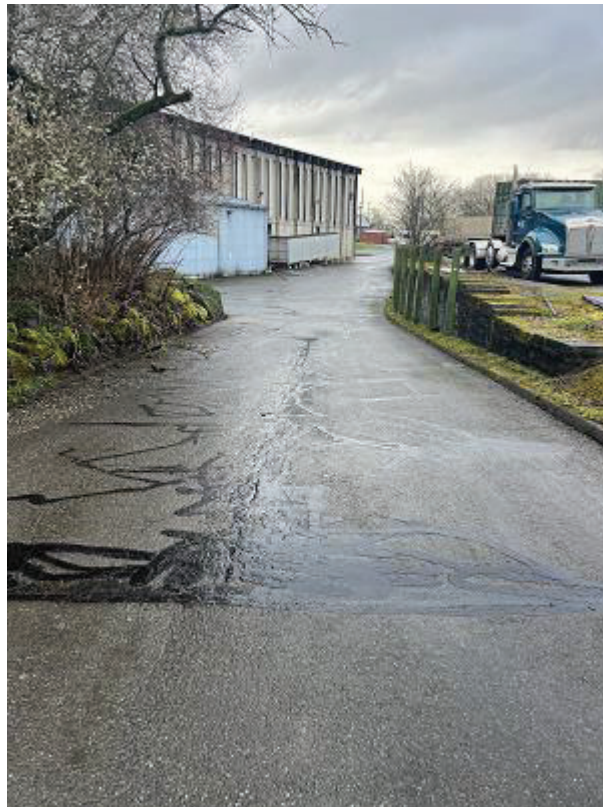
AC-13

Crack Open

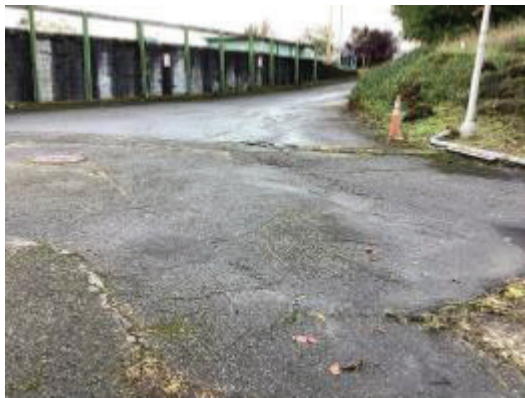
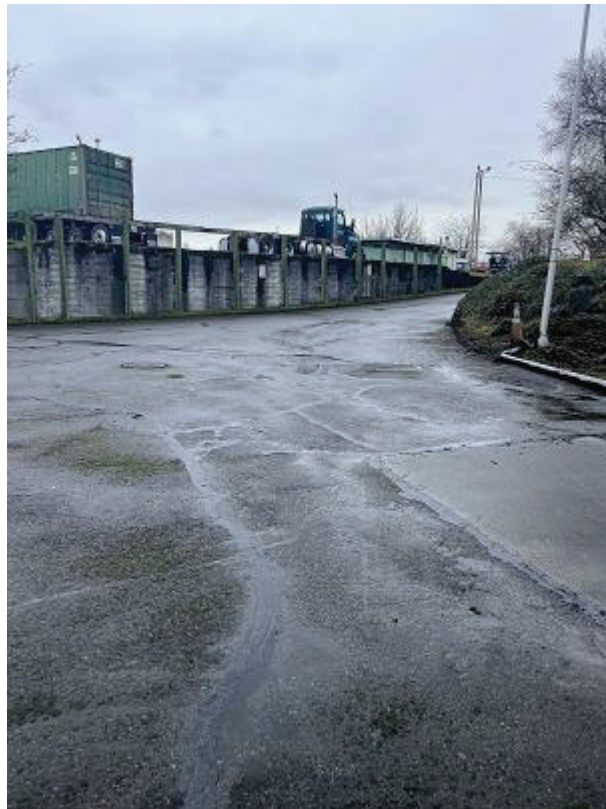
Describe Maintenance Location (attach sketch and photos):
AC-14

Reason for Maintenance:
Crack open

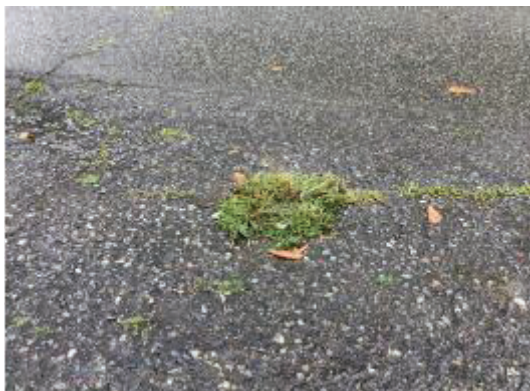
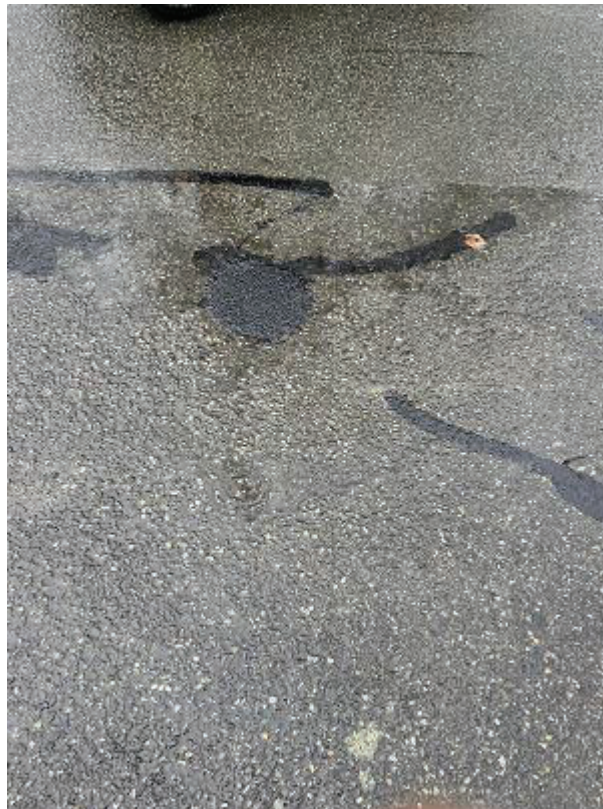
AC-20

Crack open

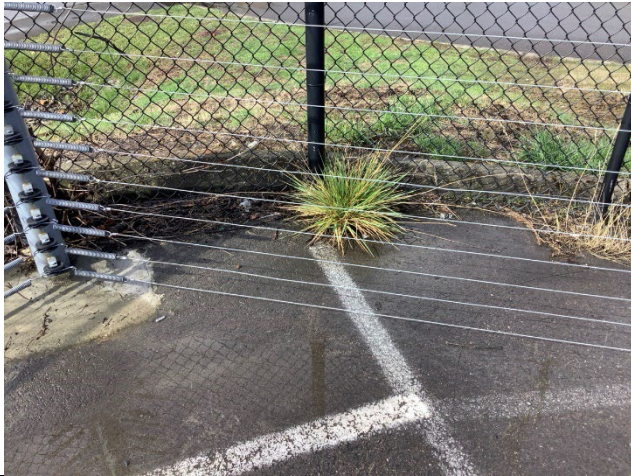
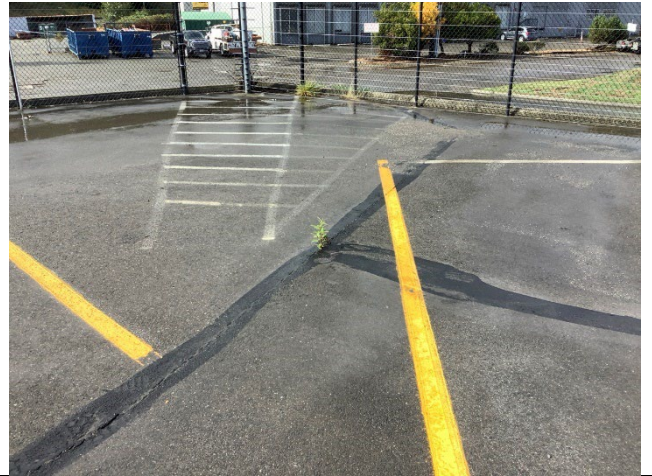
AC-21: Seal pavement where the plants have grown back.

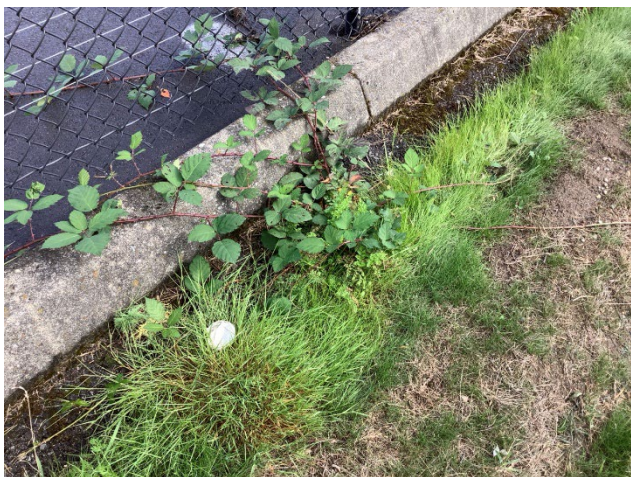
G-4: Blackberries have grown back. Regular maintenance is recommended.
