2024 Operations, Maintenance, and Monitoring Annual Report

South Park Landfill

**Seattle
Public
Utilities**

March 2025

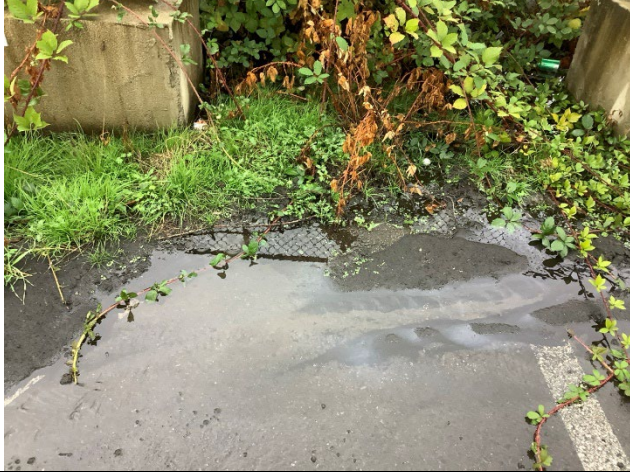
AC-13: Sediment buildup with oil sheen was observed. Blackberries have grown back. Regular maintenance is recommended.

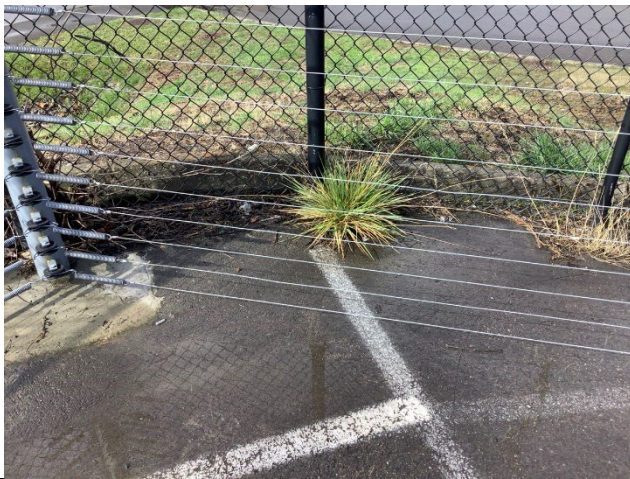
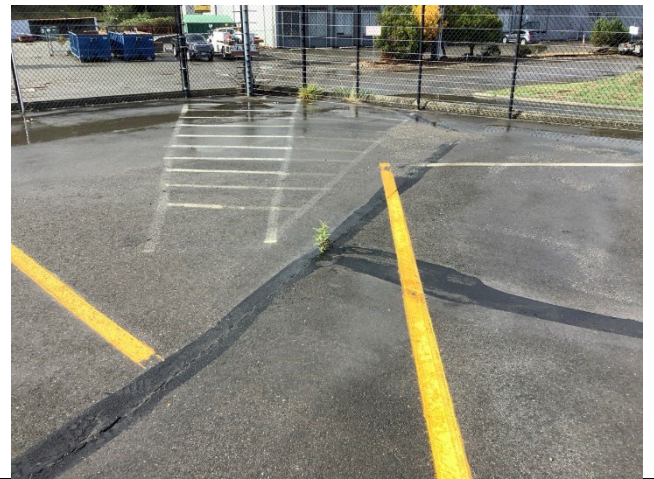
AC-21: Seal pavement where the plants have grown back.

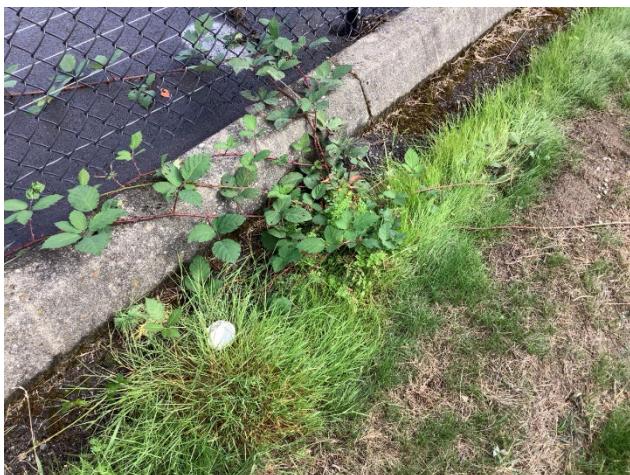
G-4: Blackberries have grown back. Regular maintenance is recommended.
