Re: Supplemental Subsurface Investigation and Disproportionate Cost Analysis Report
Former Brookdale Golf Course
1802 Brookdale Road East
Tacoma, Washington 98445

J.S. Held, LLC (J.S. Held) is pleased to submit this *Supplemental Subsurface Investigation and Disproportionate Cost Analysis Letter Report* (SSI and DCA) for the Former Brookdale Golf Course located at 1802 Brookdale Road East in Tacoma, Washington (subject property, or “Site”). The work detailed herein is being performed on behalf of Ichijo USA Co., Ltd. (Ichijo, or ‘Client’). The subject property was previously operated as a golf course facility and is currently being redeveloped as a residential neighborhood consisting of single-family homes. Ichijo currently owns the subject property. A general vicinity map is included in **Figure 1**.

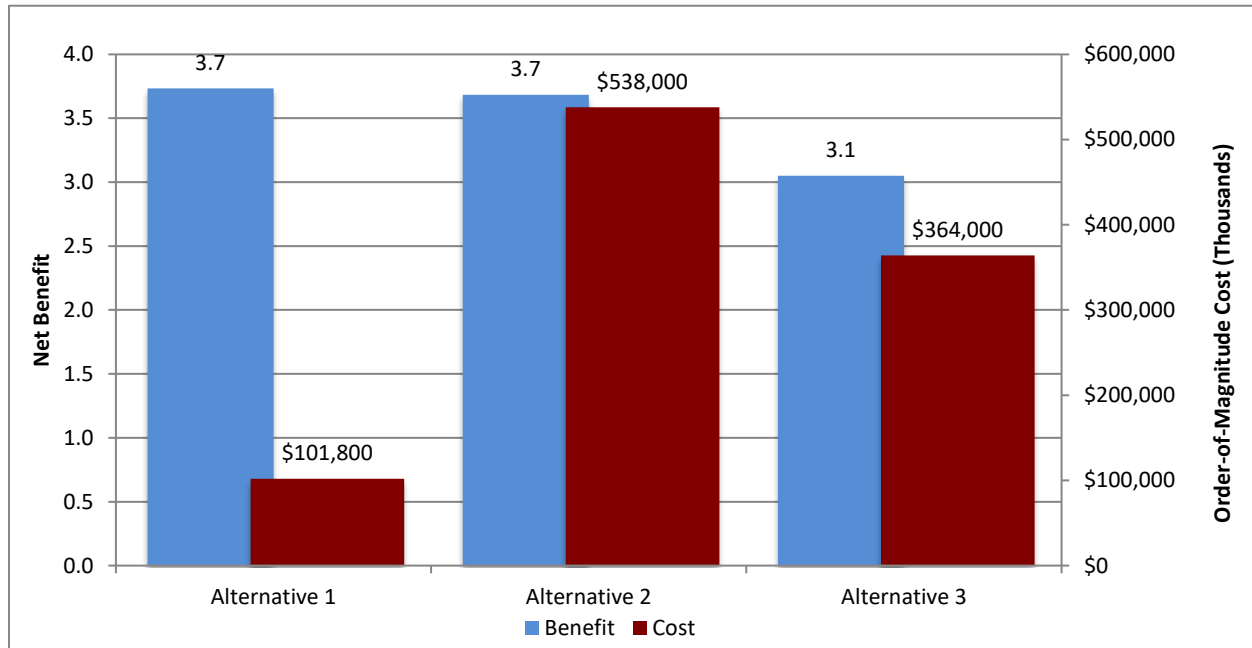
Cost-To Benefit Analysis Chart

As previously discussed, each alternative was assigned a score for each of the criteria. A score of 5 represents the highest overall perceived benefit and a score of 1 represents the lowest overall perceived benefit. The raw scores are summarized below and are weighted for each criterion according to weighting factors established by Ecology. The sum of the individual weighted scores for each alternative represents a value of the overall benefit of the alternative. The chart below present the DCA using the estimated order-of-magnitude costs and net benefit values presented above.

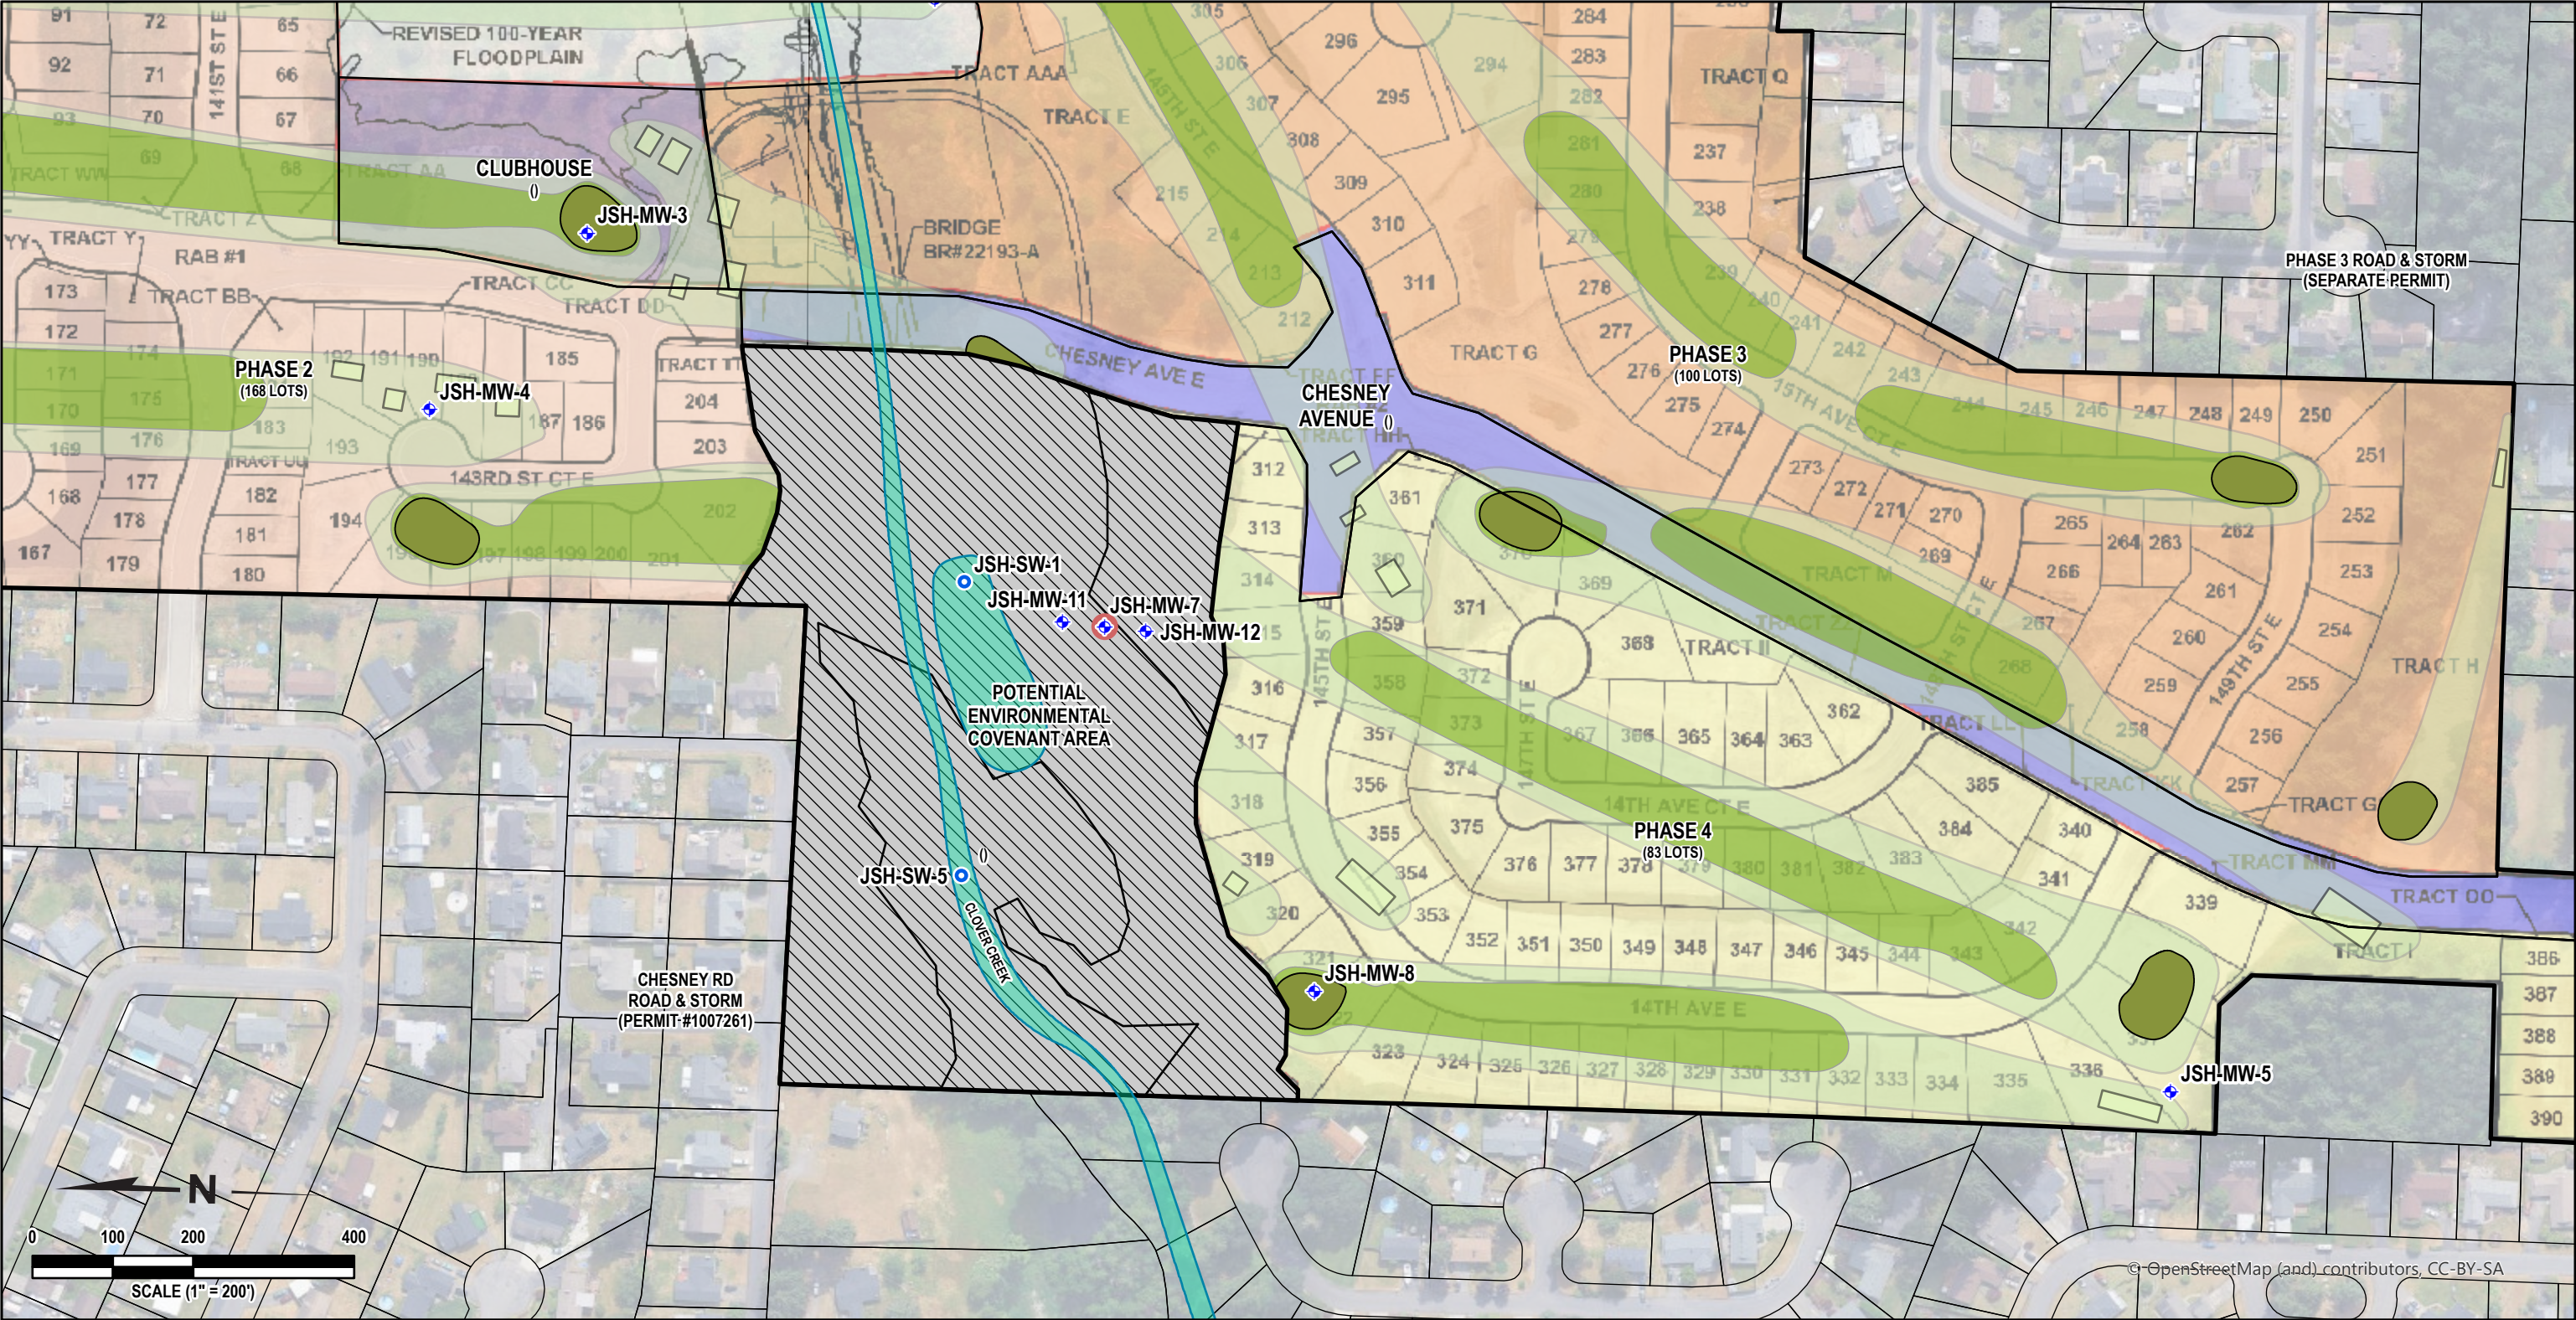
- SURFACE WATER SAMPLE
- MONITORING WELL LOCATION
- INDICATES A DIELDRIN DETECTION EXCEEDING MTCA METHOD B CLEANUP LEVELS IN GROUNDWATER

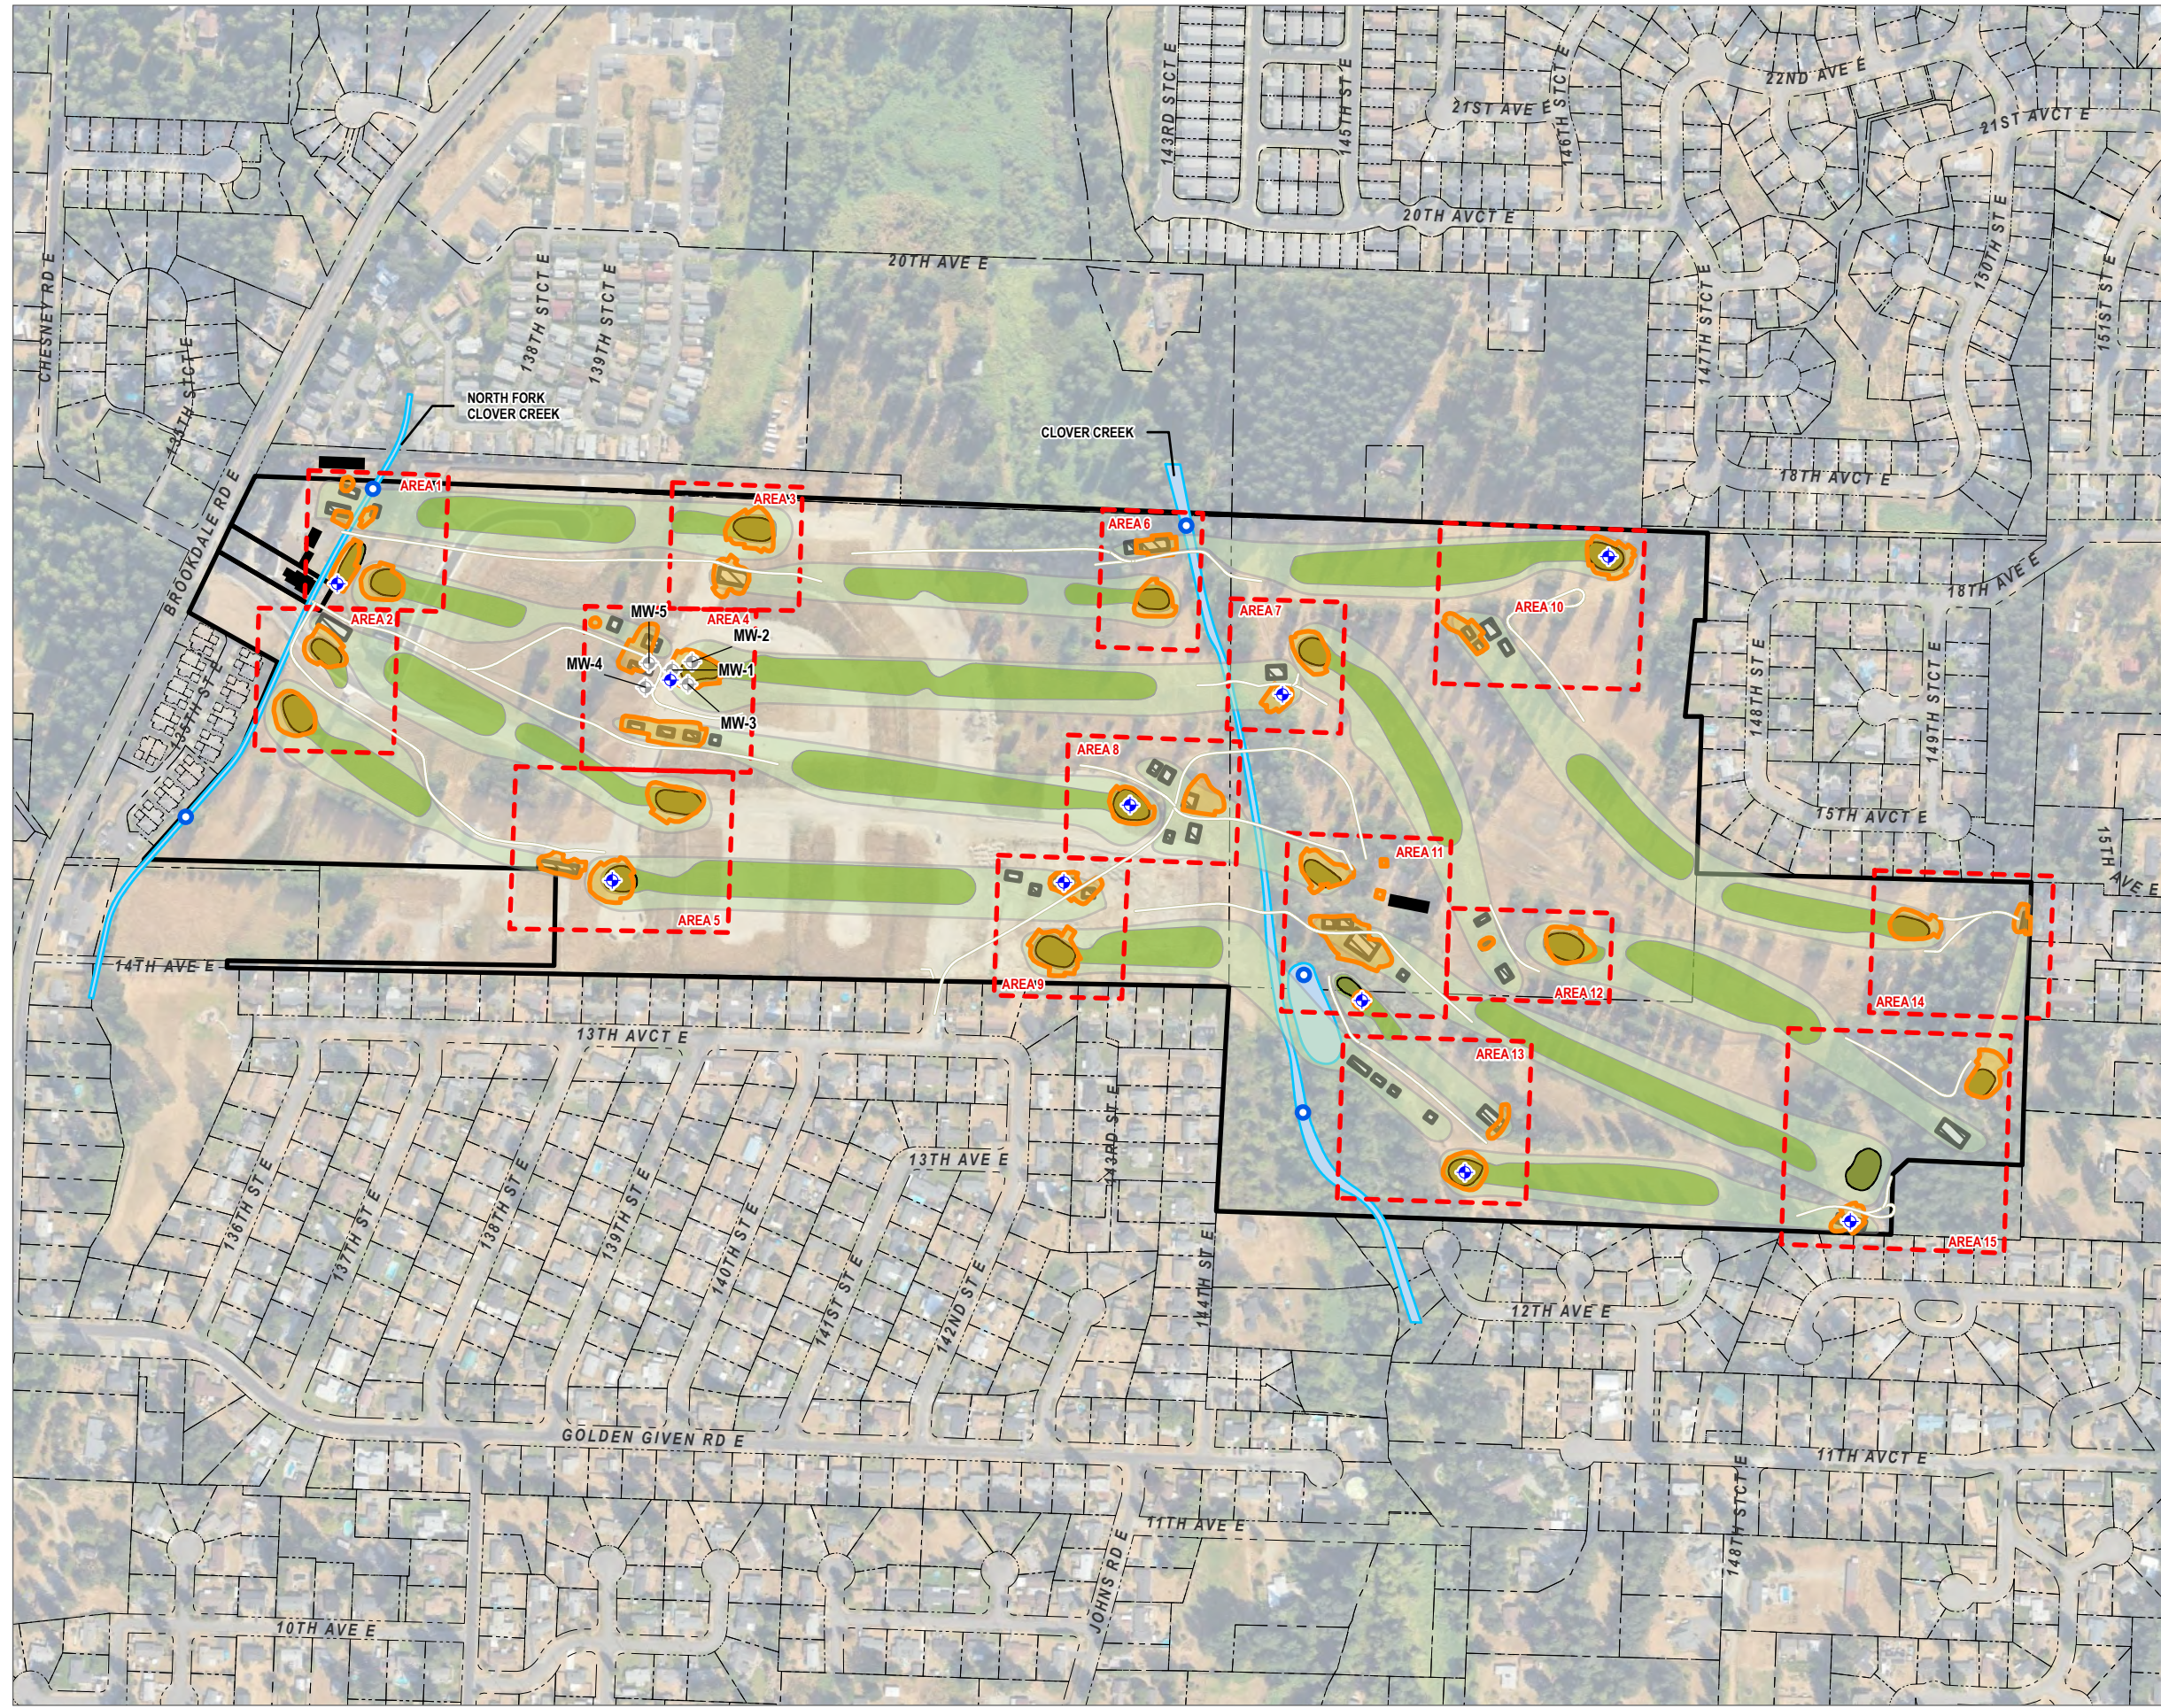
- PROPOSED MONITORING WELL LOCATION
- DECOMMISSIONED MONITORING WELL LOCATION
- PROPOSED SURFACE WATER SAMPLE LOCATION
- GOLF COURSE CART PATH
- APPROXIMATE LIMITS OF REMEDIAL EXCAVATION
- APPROXIMATE SUBJECT PROPERTY BOUNDARY
- BUILDING
- FORMER GOLF COURSE GREEN
- FORMER GOLF COURSE FAIRWAY
- FORMER GOLF COURSE HOLE
- FORMER GOLF COURSE TEE BOX
- PARCEL BOUNDARY
- REMEDIAL AREA
- WATER FEATURE

Surface water conditions will be assessed in Clover Creek and the North Fork Clover Creek tributary for the presence of dieldrin. TRC will collect a total of five surface water samples during the groundwater assessment. Proposed surface water sample locations are depicted on Figure 2.
