SUBJECT: AMENDED VAPOR INTRUSION ASSESSMENT REPORT
East Aloha Street Property
1900, 1902, and 1906 East Aloha Street, Seattle, Washington
Project Number: 1631-001

SOIL GAS SAMPLE ANALYTICAL RESULTS
1900 AND 1902 EAST ALOHA STREET
BUILDINGS

CRAWLSPACE AND INDOOR AIR
SAMPLE ANALYTICAL RESULTS
1900 AND 1906 EAST ALOHA STREET
BUILDINGS

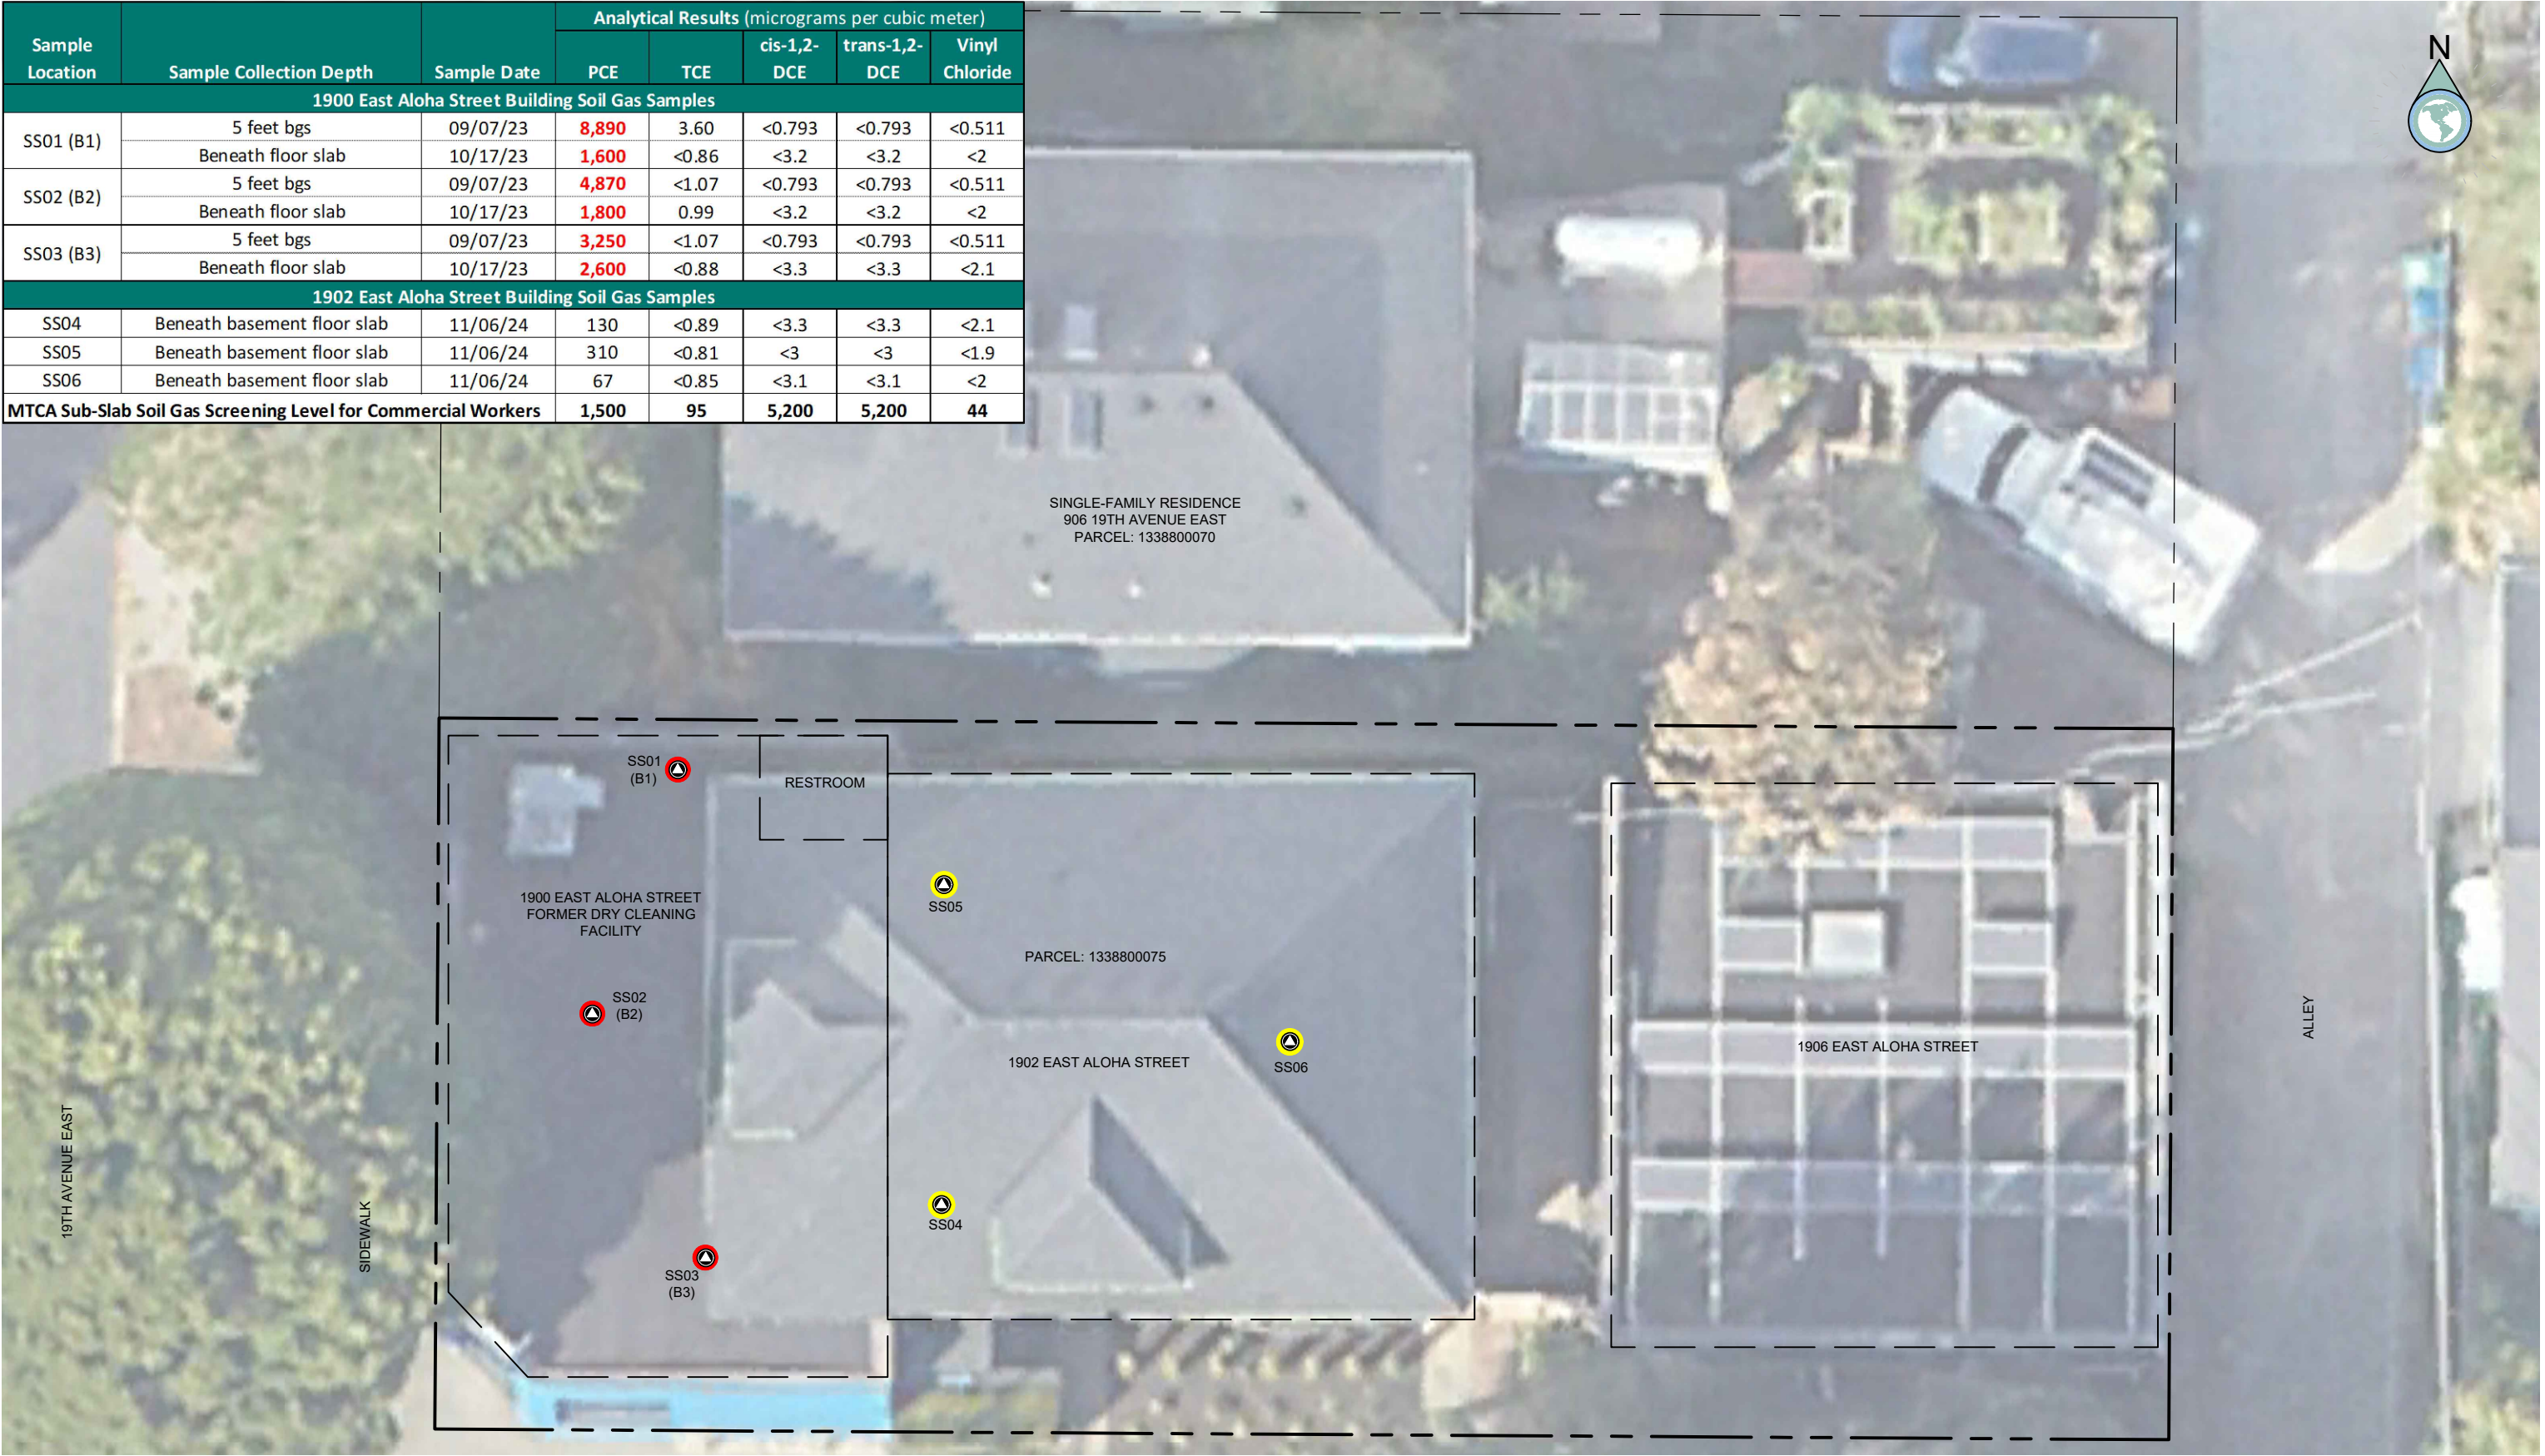
FIGURE 2

- **CVOCs.** PCE was detected at concentrations exceeding the MTCA soil gas screening level for commercial workers of 1,500 $\mu\text{g}/\text{m}^3$ in soil gas samples SS01, SS02, and SS03, located in the northern, central, and southern portions of the 1900 East Aloha Street building, respectively. Detected PCE concentrations ranged from 1,600 $\mu\text{g}/\text{m}^3$ in soil gas sample SS01 to 2,600 $\mu\text{g}/\text{m}^3$ in soil gas sample SS03. TCE was detected at a concentration below the MTCA soil gas screening level for commercial workers in soil gas sample SS02. Other CVOCs were not detected above laboratory reporting limits in any of the analyzed soil gas samples.

- **Helium.** Helium was not detected at concentrations above laboratory reporting limits in soil gas samples submitted for analysis, confirming the integrity of each sample point during soil gas sample collection.

- **CVOCs.** PCE was detected at concentrations below the MTCA soil gas screening level for commercial workers of 1,500 µg/m³ in soil gas samples SS04, SS05, and SS06, located in the southwestern, northwestern, and eastern portions of the 1902 East Aloha Street building basement, respectively. Detected PCE concentrations ranged from 67 µg/m³ in soil gas sample SS06 to 310 µg/m³ in soil gas sample SS05. Other CVOCs were not detected above laboratory reporting limits in any of the analyzed soil gas samples.
- **Helium.** Helium was not detected at concentrations above laboratory reporting limits in soil gas samples submitted for analysis, confirming the integrity of each sample point during soil gas sample collection.

Sample Location	Sample Collection Depth	Sample Date	Analytical Results (micrograms per cubic meter)				
			PCE	TCE	cis-1,2-DCE	trans-1,2-DCE	Vinyl Chloride
1900 East Aloha Street Building Soil Gas Samples							
SS01 (B1)	5 feet bgs	09/07/23	8,890	3.60	<0.793	<0.793	<0.511
	Beneath floor slab	10/17/23	1,600	<0.86	<3.2	<3.2	<2
SS02 (B2)	5 feet bgs	09/07/23	4,870	<1.07	<0.793	<0.793	<0.511
	Beneath floor slab	10/17/23	1,800	0.99	<3.2	<3.2	<2
SS03 (B3)	5 feet bgs	09/07/23	3,250	<1.07	<0.793	<0.793	<0.511
	Beneath floor slab	10/17/23	2,600	<0.88	<3.3	<3.3	<2.1
1902 East Aloha Street Building Soil Gas Samples							
SS04	Beneath basement floor slab	11/06/24	130	<0.89	<3.3	<3.3	<2.1
SS05	Beneath basement floor slab	11/06/24	310	<0.81	<3	<3	<1.9
SS06	Beneath basement floor slab	11/06/24	67	<0.85	<3.1	<3.1	<2
MTCA Sub-Slab Soil Gas Screening Level for Commercial Workers			1,500	95	5,200	5,200	44

Given the uncertainty in the initial soil gas sampling results from September 2023 due to a likely breach of the sample train in two of the three soil gas samples, SoundEarth conducted a sub-slab soil gas sampling event on October 17, 2023, to further evaluate soil gas conditions directly beneath the floor slab of the 1900 East Aloha Street building and to assess whether there is a potential vapor intrusion risk to building occupants. The October 2023 sampling event included the collection of three sub-slab soil gas samples in the approximate locations from which the previous soil gas samples were collected in September 2023 (sample locations SS01, SS02, and SS03; Figure 2).

To evaluate soil gas conditions beneath the 1902 East Aloha Street building and assess the potential vapor intrusion exposure risk to future building occupants, SoundEarth conducted a sub-slab soil gas sampling event on November 6, 2024. The November 2024 sampling event included the collection of three sub-slab soil gas samples beneath the southwestern, northwestern, and eastern portions of the building basement at a depth of approximately 6 feet below street grade (sample locations SS04, SS05, and SS06, respectively; Figure 2).

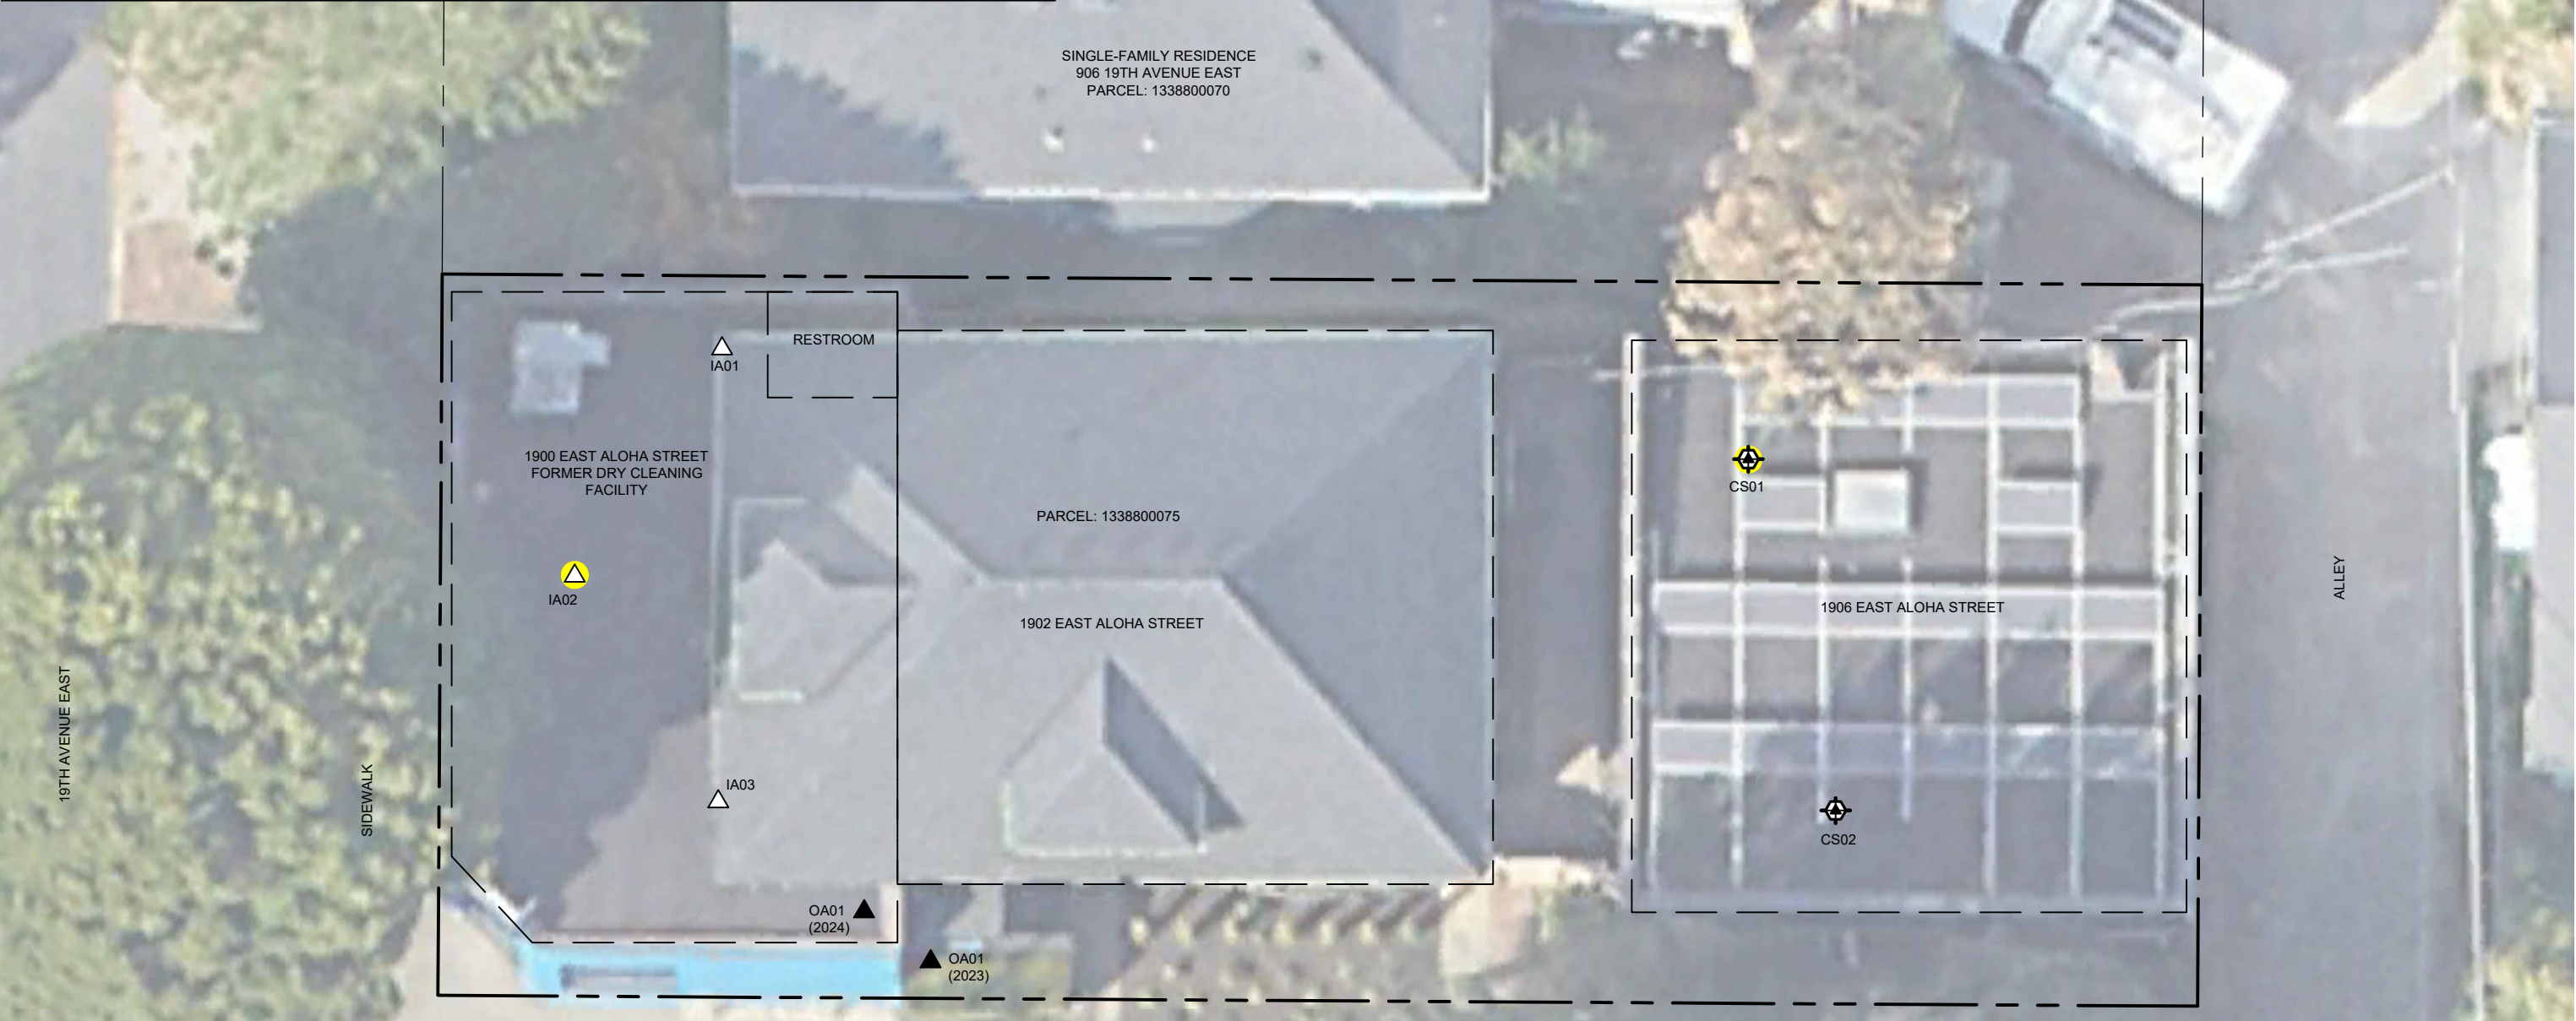
FIGURE 3

- **PCE.** PCE was detected at a concentration of 11 µg/m³ in indoor air sample IA02, collected from the central portion of 1900 East Aloha Street building. This concentration is below the MTCA indoor air screening level for commercial land use. PCE was not detected at concentrations above the laboratory reporting limit in indoor air samples IA01 and IA03 or in outdoor air sample OA01.

- **CVOCs.** PCE was not detected at concentrations above laboratory reporting limits in crawlspace samples CS01 and CS02, located in the northwestern and southwestern portions of the 1906 East Aloha Street building, respectively. TCE was detected at a concentration of 0.13 $\mu\text{g}/\text{m}^3$ in crawlspace sample CS01, which is below the MTCA indoor air screening level for commercial land use of 2.9 $\mu\text{g}/\text{m}^3$. Other CVOCs were not detected above laboratory reporting limits in the analyzed crawlspace samples. No CVOCs were detected above laboratory reporting limits in outdoor ambient air sample OA01.

Sample Location	Location	Sample Date	Analytical Results (micrograms per cubic meter)				
			PCE	TCE	cis-1,2-DCE	trans-1,2-DCE	Vinyl Chloride
1900 East Aloha Street Building Indoor Air Samples							
IA01	Northern portion of building	11/16/23	<6.8	--	--	--	--
IA02	Central portion of building		11	--	--	--	--
IA03	Southern portion of building		<6.8	--	--	--	--
OA01	Exterior - southeastern corner		<6.8	--	--	--	--
1906 East Aloha Street Building Crawlspace Samples							
CS01	Crawlspace - northwestern portion of building	11/06/24	<6.8	0.13	<0.4	<0.4	<0.26
CS02	Crawlspace - southwestern portion of building		<6.8	<0.11	<0.4	<0.4	<0.26
OA01	Roof of 1900 East Aloha Street Building		<6.8	<0.11	<0.4	<0.4	<0.26
MTCA Indoor Air Screening Levels for Commercial Workers			45	2.9	156	156	1.3

The indoor air sampling event included the collection of three indoor air samples (IA01 through IA03) and one outdoor ambient air sample (OA01). Indoor air samples were collected in the approximate locations of sub-slab soil gas samples SS01 through SS03, previously collected by SoundEarth. The outdoor air sample was collected in an upwind location along the southeastern portion of the 1900 East Aloha Street building based on wind direction observed at the time of sampling (Figure 3). Indoor and outdoor air samples were collected using laboratory-provided, 6-liter SUMMA canisters. Each SUMMA canister was placed approximately 4.5 feet above ground surface within the breathing zone of potential building occupants and fitted with a flow controller calibrated by the laboratory for an 8-hour sample collection. Initial and final vacuum readings for each canister were recorded on the Chain of Custody form. After a sample was collected, the SUMMA canister valve was fully closed, and the end cap was replaced and tightened. The SUMMA canisters were submitted to F&B under standard chain-of-custody protocols for analysis of PCE by EPA Method TO-15.

To evaluate the potential risk of vapor intrusion within the 1906 East Aloha Street building, SoundEarth collected two samples of air from the crawlspace beneath the building on November 6, 2024. This method of sampling was conducted instead of soil gas sampling due to the presence of the crawlspace and lack of accessibility for drilling equipment beneath the 1906 East Aloha Street building. Crawlspace sample points CS01 and CS02 were installed in the northwestern and southwestern portions of the building, respectively, by drilling a 3/8-inch-diameter hole through the floor of the building in each sample location (Figure 3). Teflon tubing was inserted into the crawlspace through the holes drilled through the floor and sealed to prevent indoor air from reaching the crawlspace to the extent possible. An outdoor air sample, OA01, was collected simultaneously from the southeastern corner of roof of the 1900 East Aloha Street building to evaluate ambient air conditions.
