# WHITMAN Environmental Sciences

May 3, 2022

Subject: Sub-Slab Soil Vapor Sampling  
1048 State Avenue  
Marysville, Washington

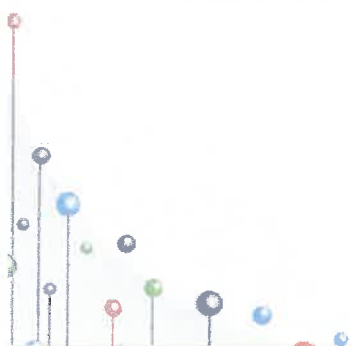
As you have authorized, **Whitman Environmental Sciences, (WES)** has conducted an initial site investigation on the above referenced property to evaluate the potential for vapor intrusion in the site structure. Figure 1 is a Site Map identifying the site and surrounding area. The property is a commercial parcel of about 2.13 acres located in central Marysville, developed with a multi-tenant building of about 27,500 square feet.

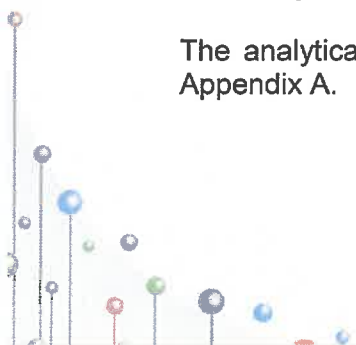
For this evaluation, WES obtained sub-slab vapor samples from four locations inside the building. The sub-slab sample locations are indicated in Figure 2, a Site and Sample Location Plan. The four locations were chosen to be in the estimated area of the former dry cleaning equipment, or at locations that would be downgradient with respect to groundwater migration. Groundwater in this area would be expected to migrate generally to the west or southwest.

The sub-slab vapor sampling found very high concentrations of PCE, TCE and C12DCE, as well as lesser concentrations of other related compounds. The sample Pawn SE was likely located closest to the former location of the dry cleaning equipment and contained 2,100,000 ug/m<sup>3</sup> of PCE compared to an Ecology screening level of 320 ug/m<sup>3</sup>. (The units ug/m<sup>3</sup> are micrograms per cubic meter of air.) The sample also contained 91,000 ug/m<sup>3</sup> of TCE and 5,300 ug/m<sup>3</sup> of trans-1,2, dichloroethene, both at levels greatly exceeding Ecology's sub-slab screening levels for those compounds. Cis-1,2-dichloroethene was detected at 25,000 ug/m<sup>3</sup>, but there is no current published screening level for that compound. It is a common breakdown product of PCE once released into the environment.

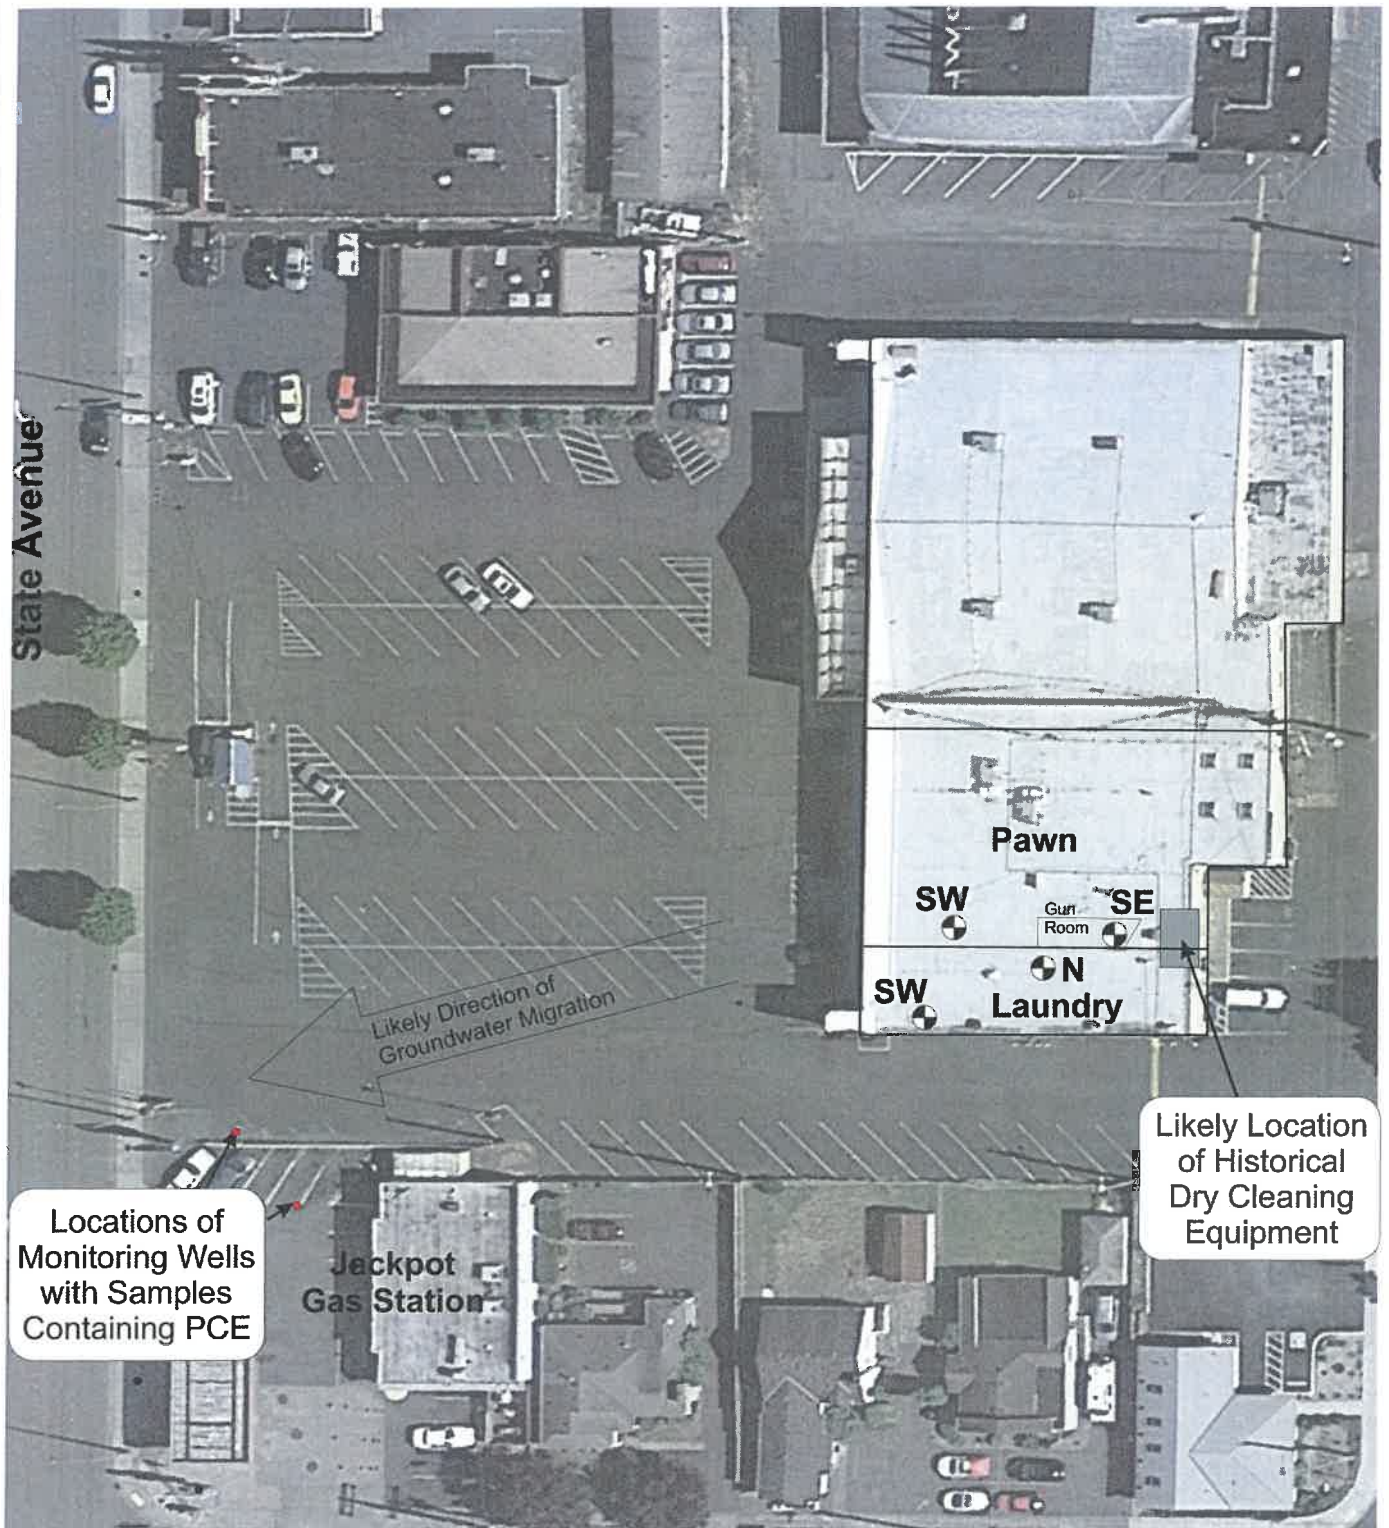
Figure 2 - Site and Sample Location Plan

Likely Location of Historical Dry Cleaning Equipment

Likely Direction of Groundwater Migration

Approximate Location of Sub-Slab Vapor Points

The concentrations reported in the three other samples suggest migration has occurred to the southwest, at levels less than seen in sample Pawn SE, decreasing with distance. However, all of the samples detected PCE and TCE at concentrations up to thousands of times greater than Ecology's sub-slab screening levels. The sample Laundry N was the only sample to contain detectable vinyl chloride, evidence of relatively advanced breakdown of PCE in the environment.

The findings suggest there is a source of PCE and TCE vapors in the vicinity of the tested locations, most likely in the form of contaminated soil or groundwater. The underlying soil is fine sand, which represents a pathway for vapors to migrate into the building. Based on the very high concentrations detected by this testing, it may be appropriate to sample indoor air in the two tenant spaces to evaluate whether or not vapors have impacted air quality in the building. If necessary, actions can be taken to change building ventilation or take active measures to control vapors beneath the floor slab.

The findings also suggest (but do not directly show) that groundwater may be impacted and migrating to the southwest, away from the original source area. Although it is a distance of over 150 feet, this could corroborate the prior suggestions that the PDQ Laundry was the source of PCE found in samples from the Jackpot service station to the southwest. Additional investigation would be needed to determine soil and groundwater conditions on the property.

Based on the findings of this assessment further investigation and/or vapor mitigation action appears warranted.
