DRAFT Periodic Review Sunnydell Dryke Shooting Range

**292 Dryke Road, Sequim, Clallam County, WA 98382
Facility Site ID: 1283666, Cleanup Site ID: 3572**

Toxics Cleanup Program, Southwest Region

May 2025

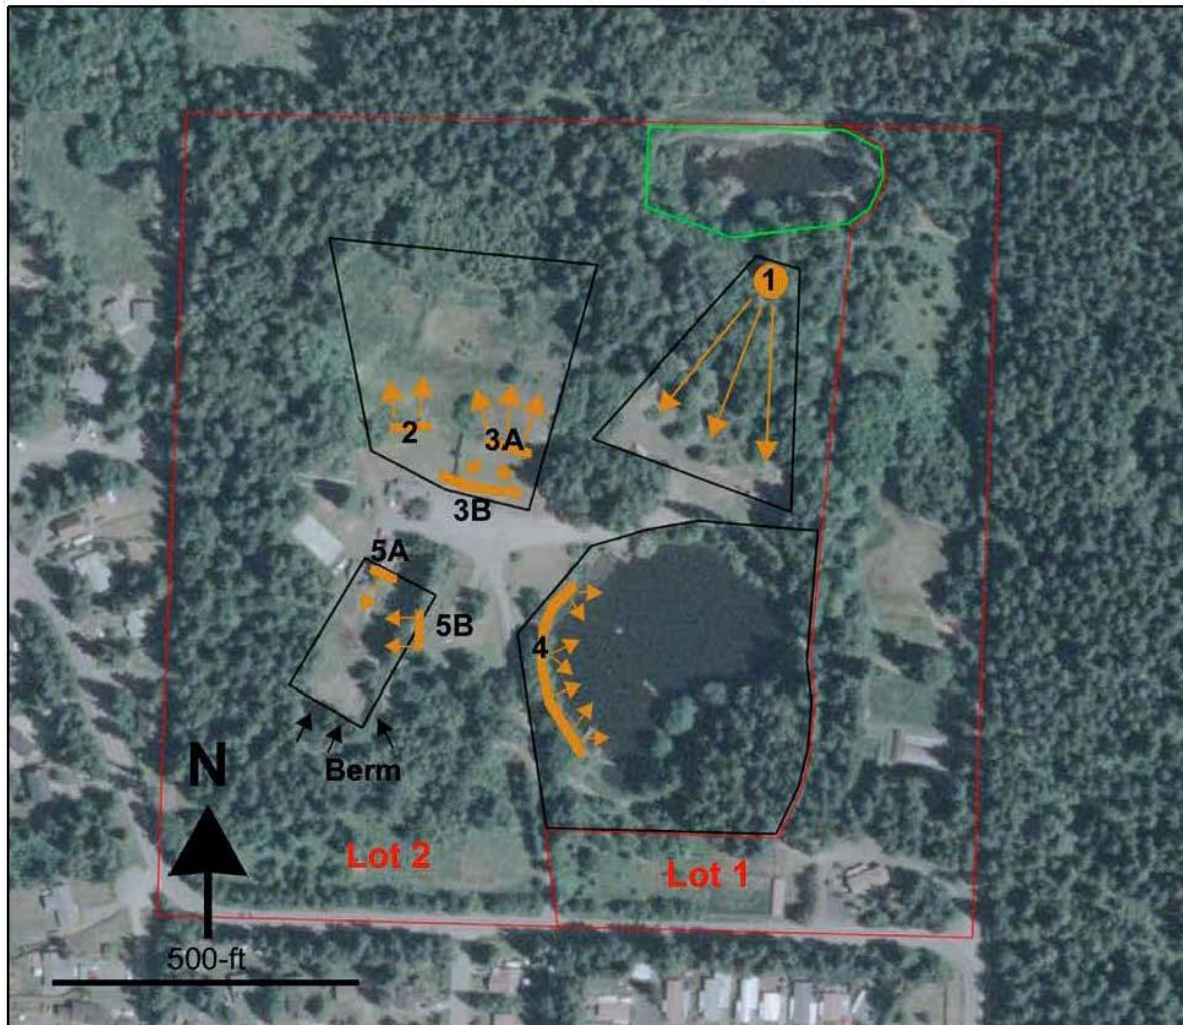
Figure 1: Current Site layout (Washington State Department of Ecology [Ecology] 2013a) showing the Active Shooting Range Management Areas (black polygons); shooting locations (1 [Bus Stop], 2 [Pent House/Bird Box/Weeping Willow], 3A and 3B [Quail], 4 [Upper Pond], 5A and 5B [Rabbit Run]); shooting directions (orange arrows); Lower Pond Management Area (green polygon); and Lots 1 and 2 (red polygons).

The Site consists of a clubhouse, gun repair shop, residence, four active shooting range management areas, and two ponds. The active shooting range management areas and ponds are depicted in Figure 1 in Appendix B. Based on discussions with the property owner during the Site visit on June 11, 2024, the shooting range has an average of 15 shooters per week (60 shooters per month). The active shooting areas include multiple sporting clay shotgun shooting stations. There is also one handgun range which is seldom used.

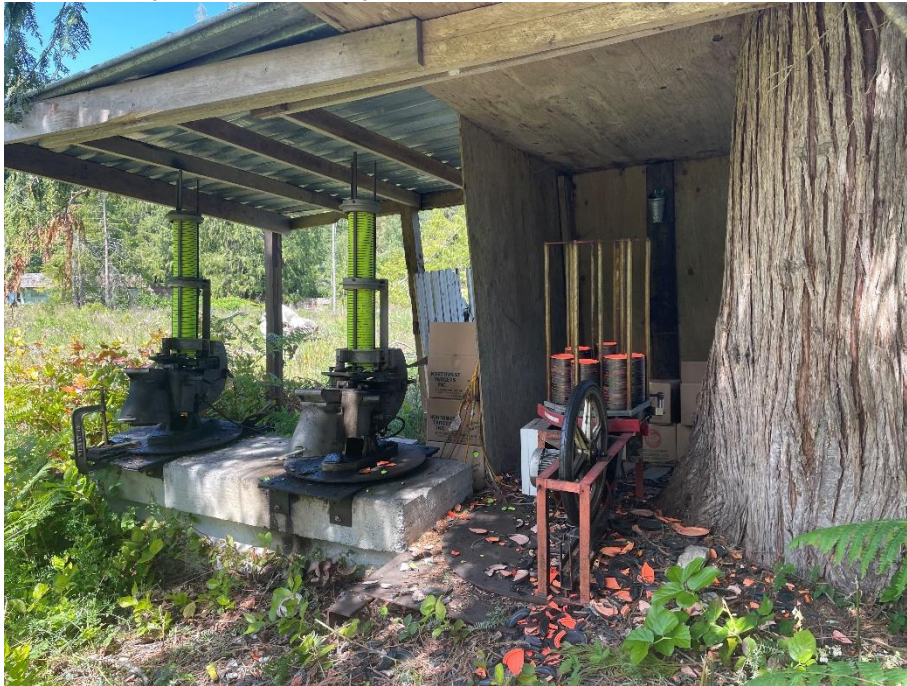
Photo 4 (facing west): Target throwers for shooting locations 5A and 5B (Rabbit Run).

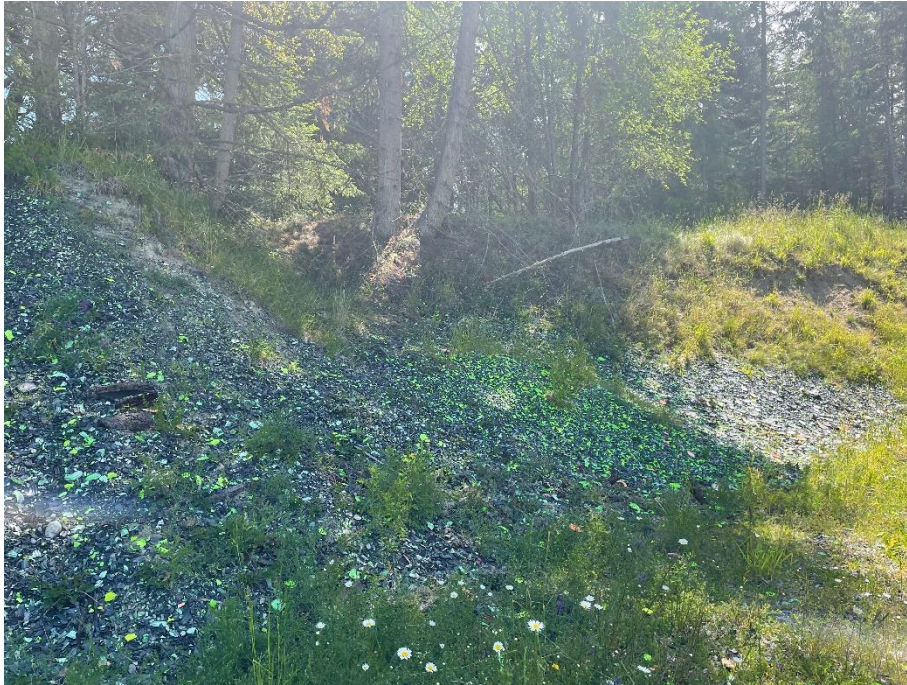
Photo 5 (facing southwest): View of the berm for shooting location 5A and 5B (Rabbit Run) within an Active Shooting Range Management Area.

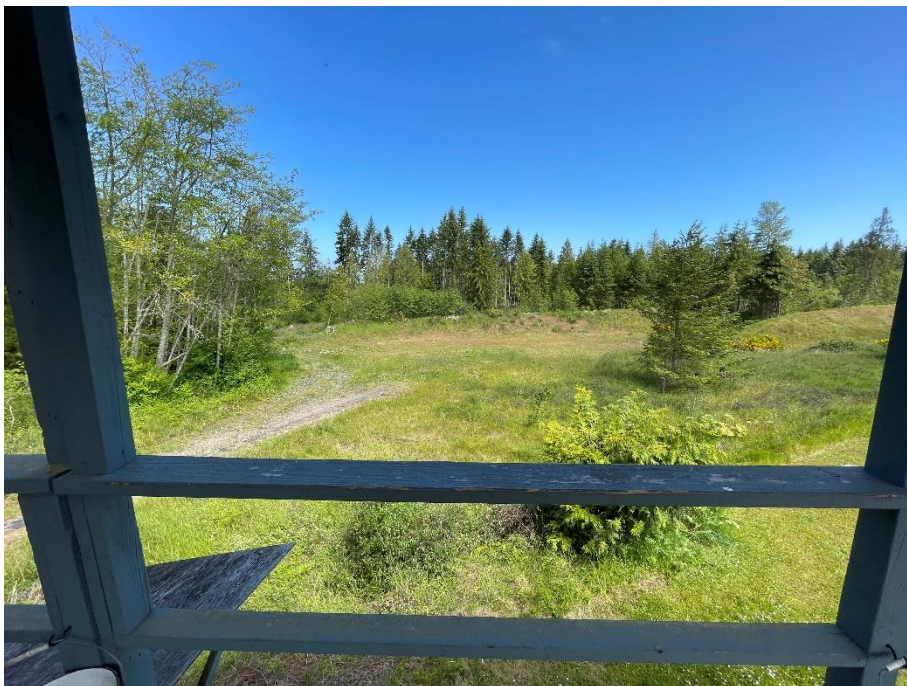
Photo 6 (facing north): Shooting location 2 (Pent House/Bird Box/Weeping Willow) within an Active Shooting Range Management Area.

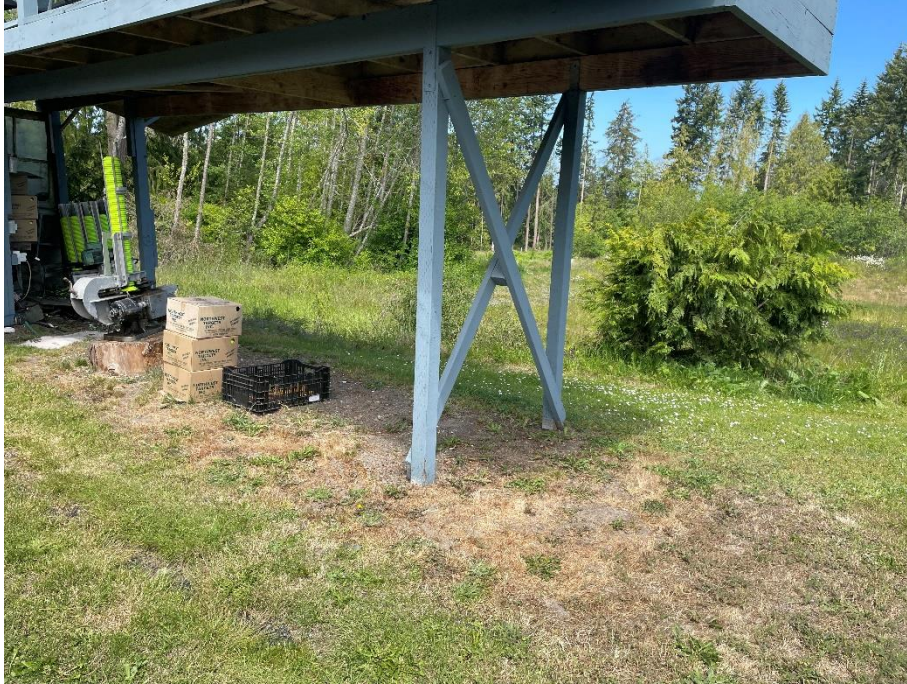
Photo 7 (facing northwest): View of a target thrower for shooting location 2 (Pent House/Bird Box/Weeping Willow).

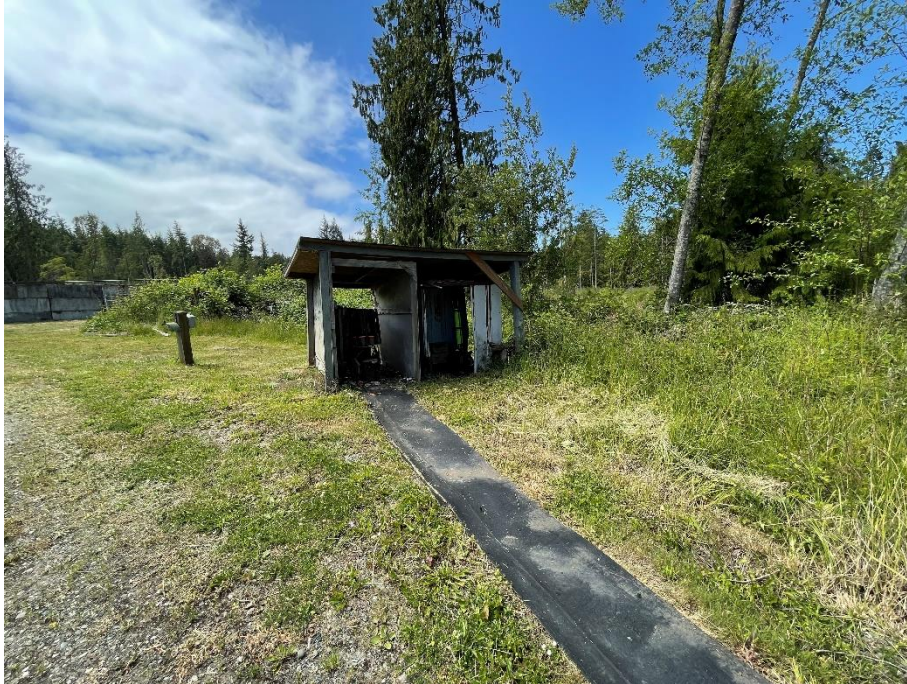
Photo 8 (facing southwest): View of a rabbit target thrower for shooting location 2 (Pent House/Bird Box/Weeping Willow).

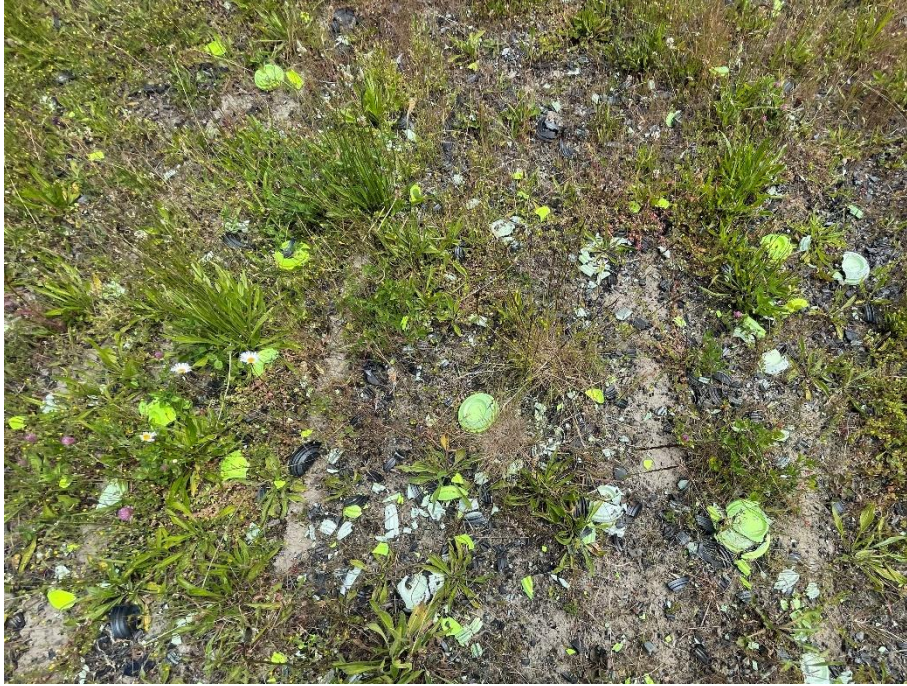
Photo 9 (facing not applicable [NA]): View of broken targets near shooting location 2 (Pent House/Bird Box/Weeping Willow).

- Biodegradable targets are not currently used at the Site, but it is recommended that these be used if economically and practically feasible. If these cannot be used, target fragments should continue to be collected regularly and disposed of off-Site to ensure that they do not contribute additional contamination to the Site. Ecology recommends that the feasibility of biodegradable target use at the Site be re-evaluated every five years as the availability and composition of these types of targets may change over time.
- The Covenant for the property is in place and is effective in protecting human health and the environment from exposure to hazardous substances and the integrity of the cleanup action.

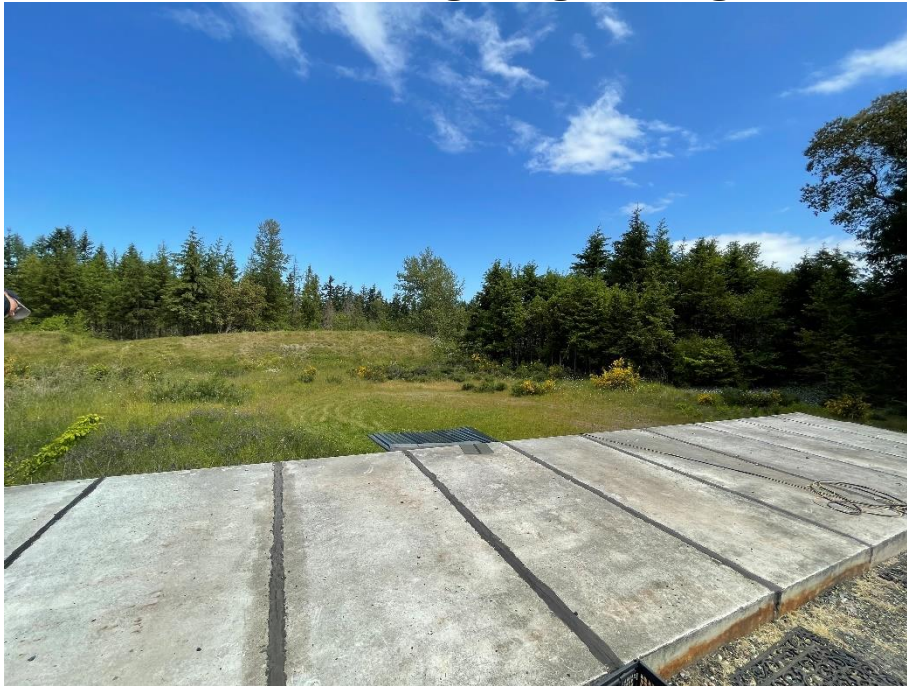
Photo 10 (facing northeast): View from shooting location 3A (Quail) within an Active Shooting Range Management Area.

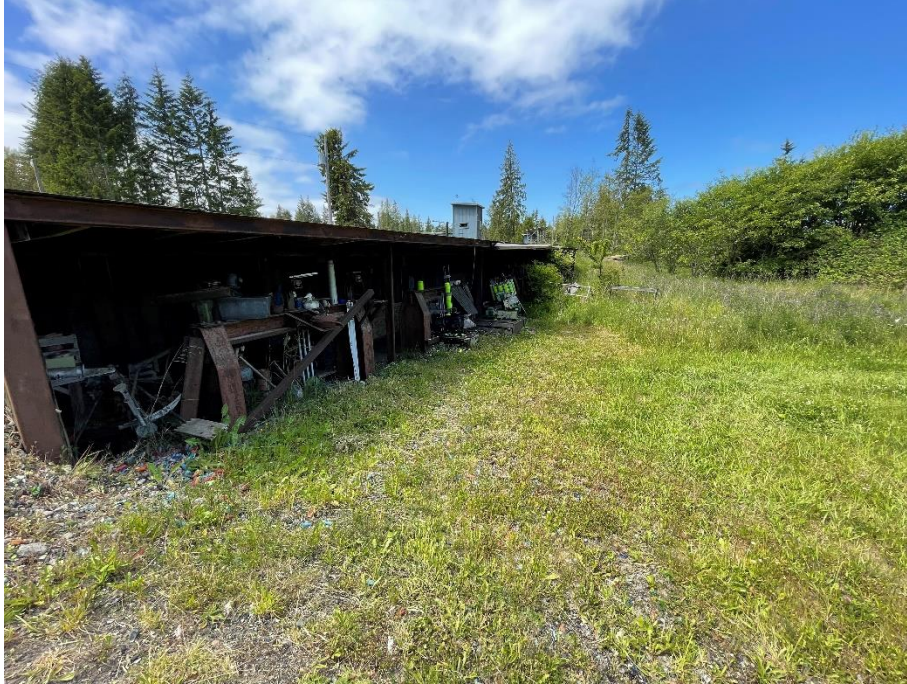
Photo 11 (facing southwest): View of target throwers at shooting location 3A (Quail) within an Active Shooting Range Management.

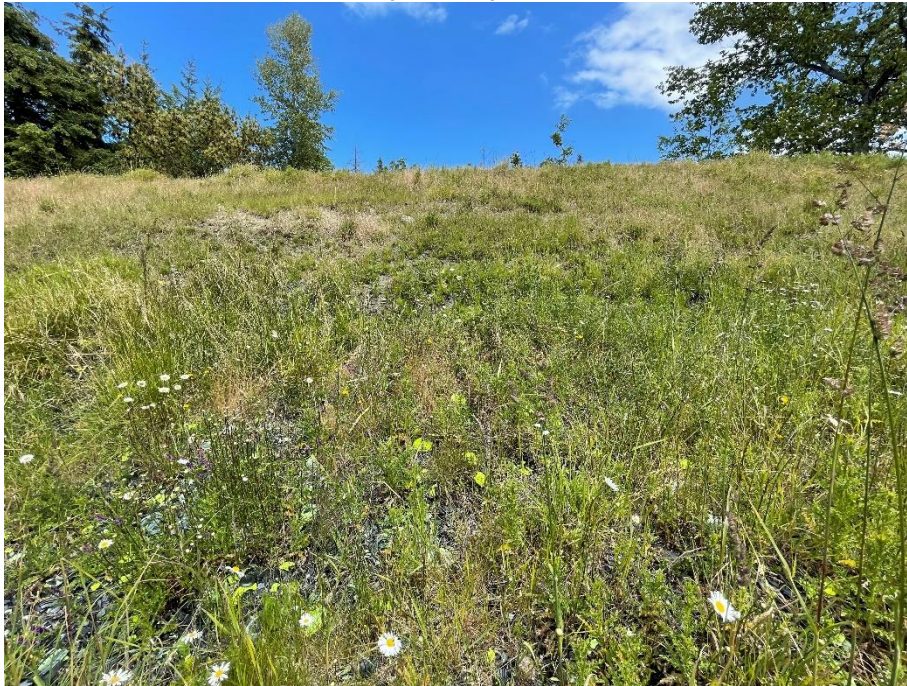
Photo 12 (facing north): View of the berm area for shooting locations 3A and 3B (Quail).

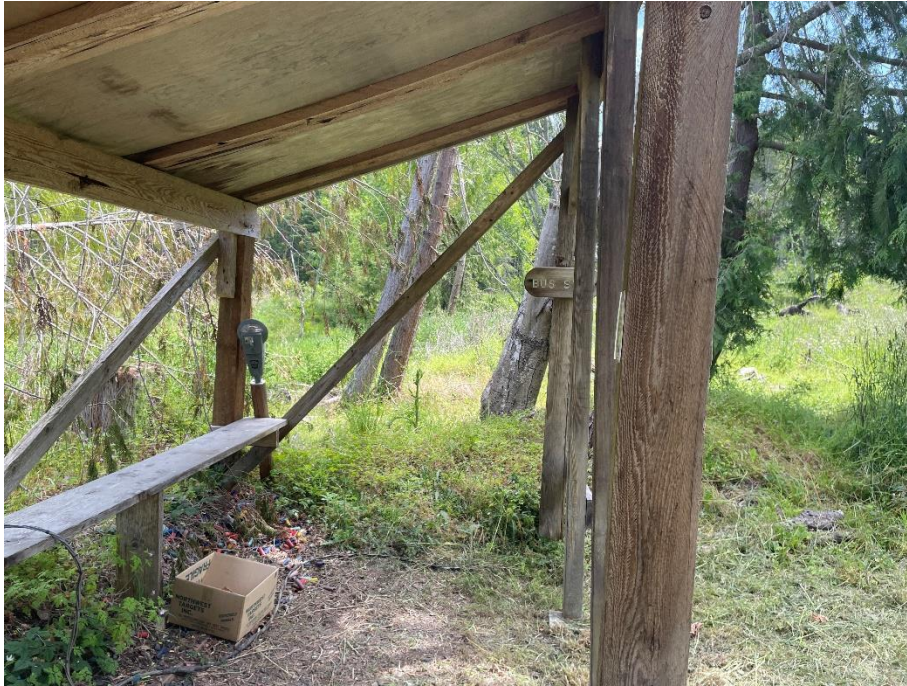
Photo 13 (facing east): View of shooting location 1 (Bus Stop), south of the Lower Pond Area.

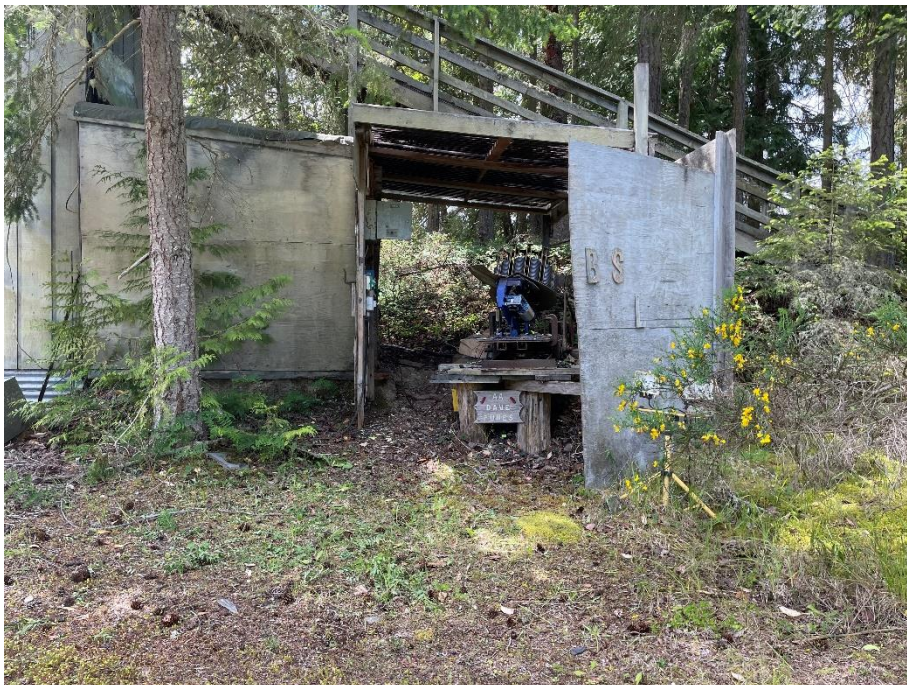
Photo 14 (facing southeast): View of a target thrower for shooting location 1 (Bus Stop) within an Active Shooting Range Management Area.

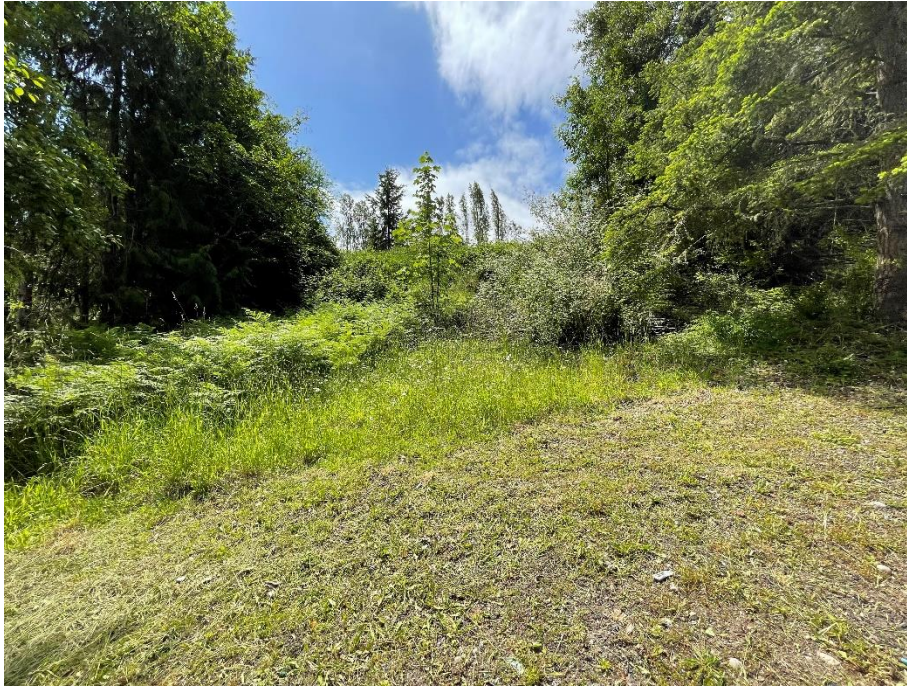
Photo 15 (facing southwest): View of the berm area at shooting location 1 (Bus Stop) within an Active Shooting Range Management.

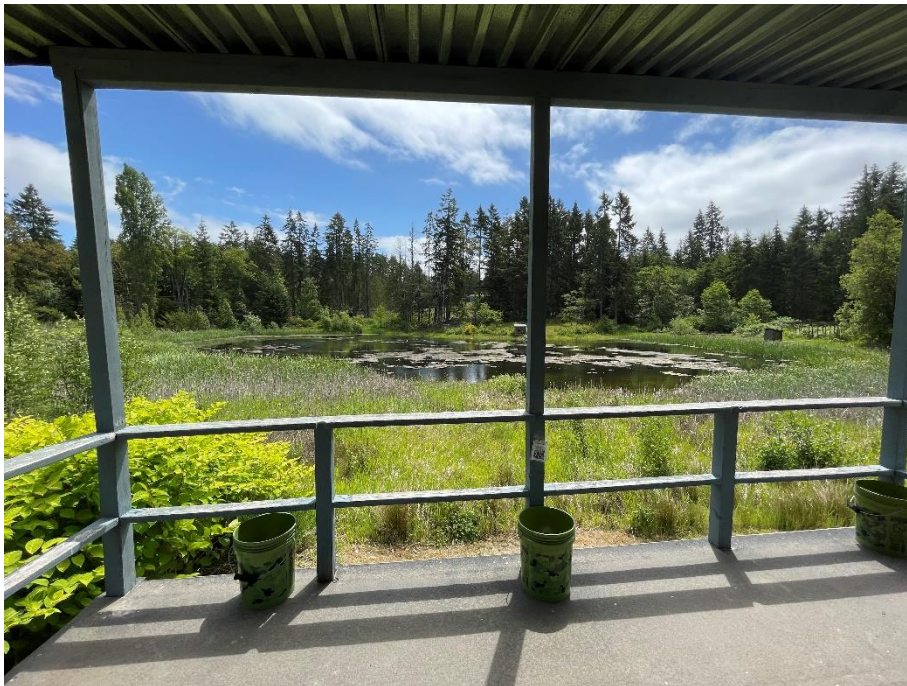
Photo 16 (facing east): View of shooting location 4 over the Upper Pond.

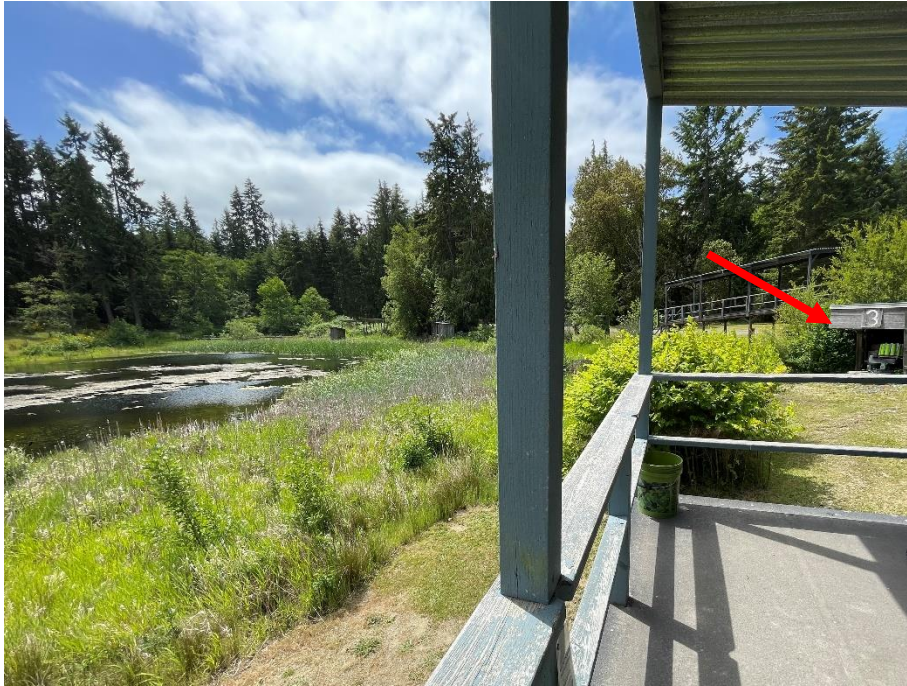
Photo 17 (facing south): View of a target thrower for shooting location 4 over the Upper Pond.

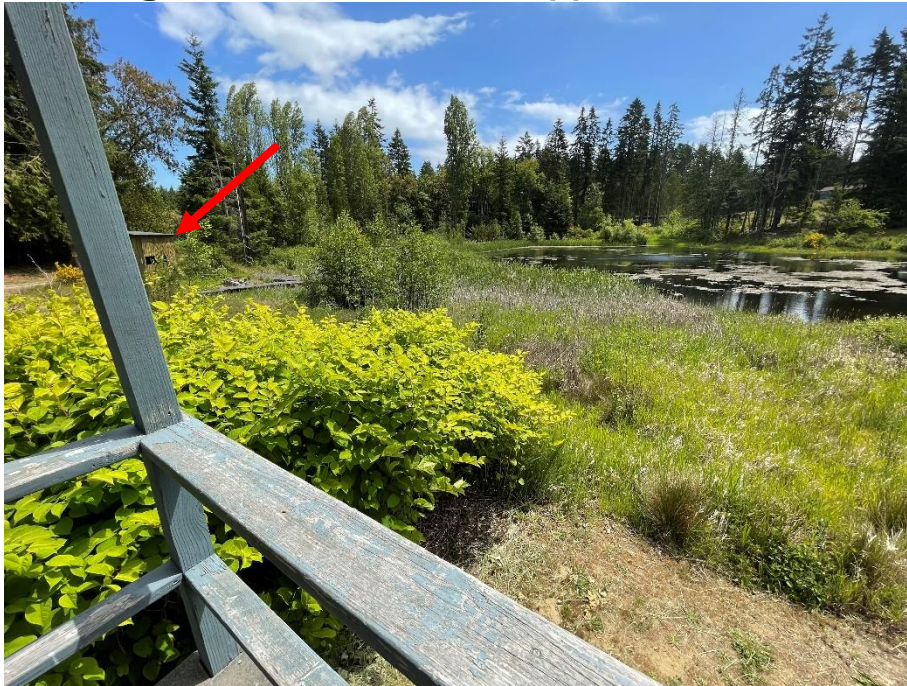
Photo 18 (facing northeast): View of another target thrower for shooting location 4 over the Upper Pond.
