PRE-REMEDIAL DESIGN  
INVESTIGATION 2 DATA REPORT  
Chlor-Alkali RAU, GP West Site, Bellingham,  
Washington

Prepared for: Port of Bellingham

Project No. AS210368-B-06 • February 28, 2024 FINAL

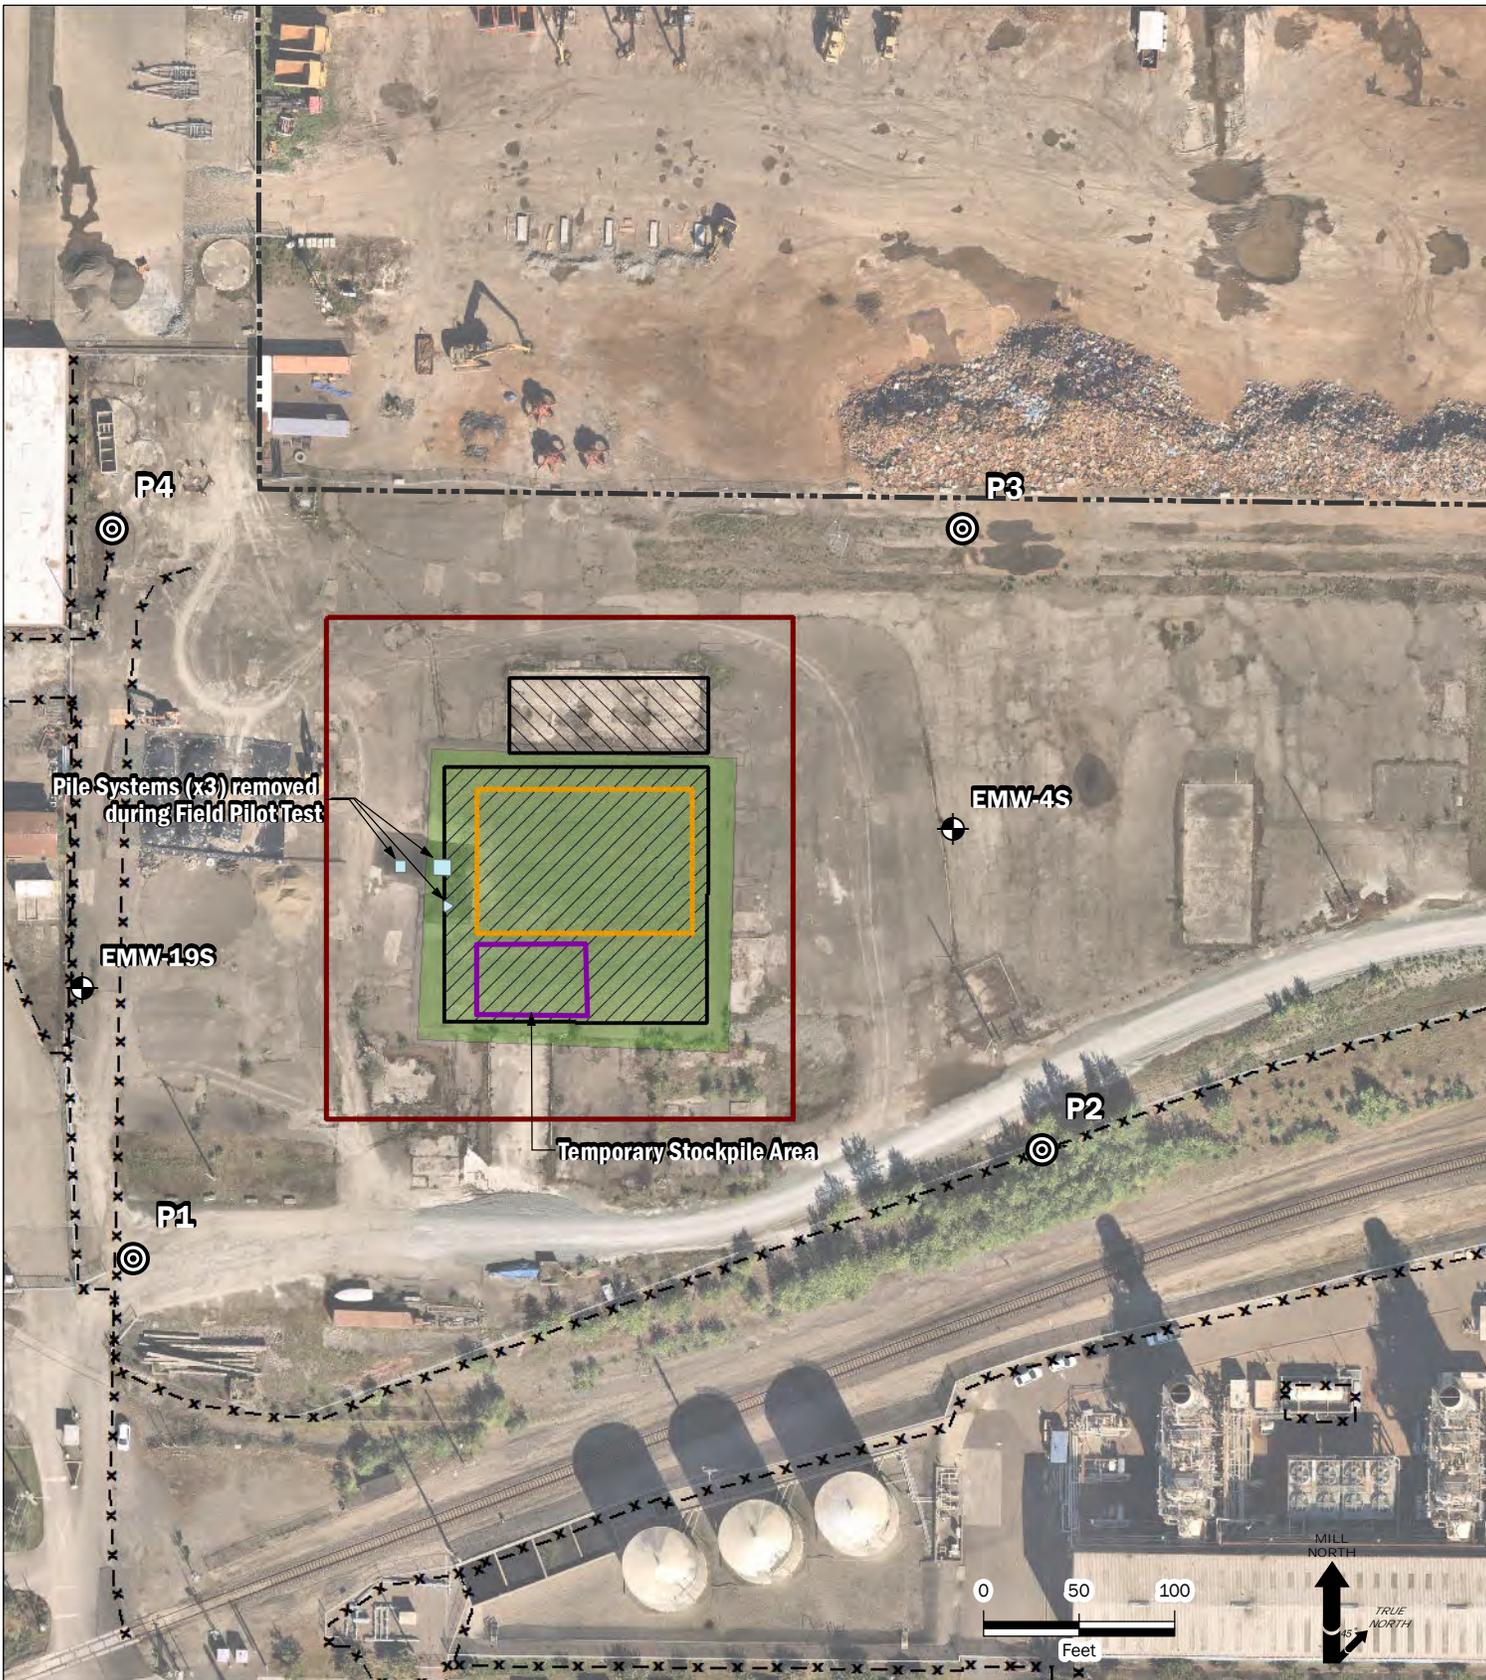
NOV-2023	BY: ACG / HMD	FIGURE NO. <b>3</b>
	PROJECT NO. 210368	REVISED BY: --- / ---

The Pilot Test evaluated means and methods of removal of three concrete pile caps, identified as J5, J4, and L4, and associated concrete grade beams and timber pilings that comprised the foundation for a portion of the Cell Building, as shown on Figure 3. The specific objectives for the Pilot Test were to:

Monitoring Well		Pilot Test Area
	Perimeter Air Monitoring Location		Equipment and Water Management Area
	Pile Caps		Former Cell Building
	Temporary Stockpile Area		Shop Slab
	ABC Recycling Lease Boundary		Paved Area (2017)
	Fence

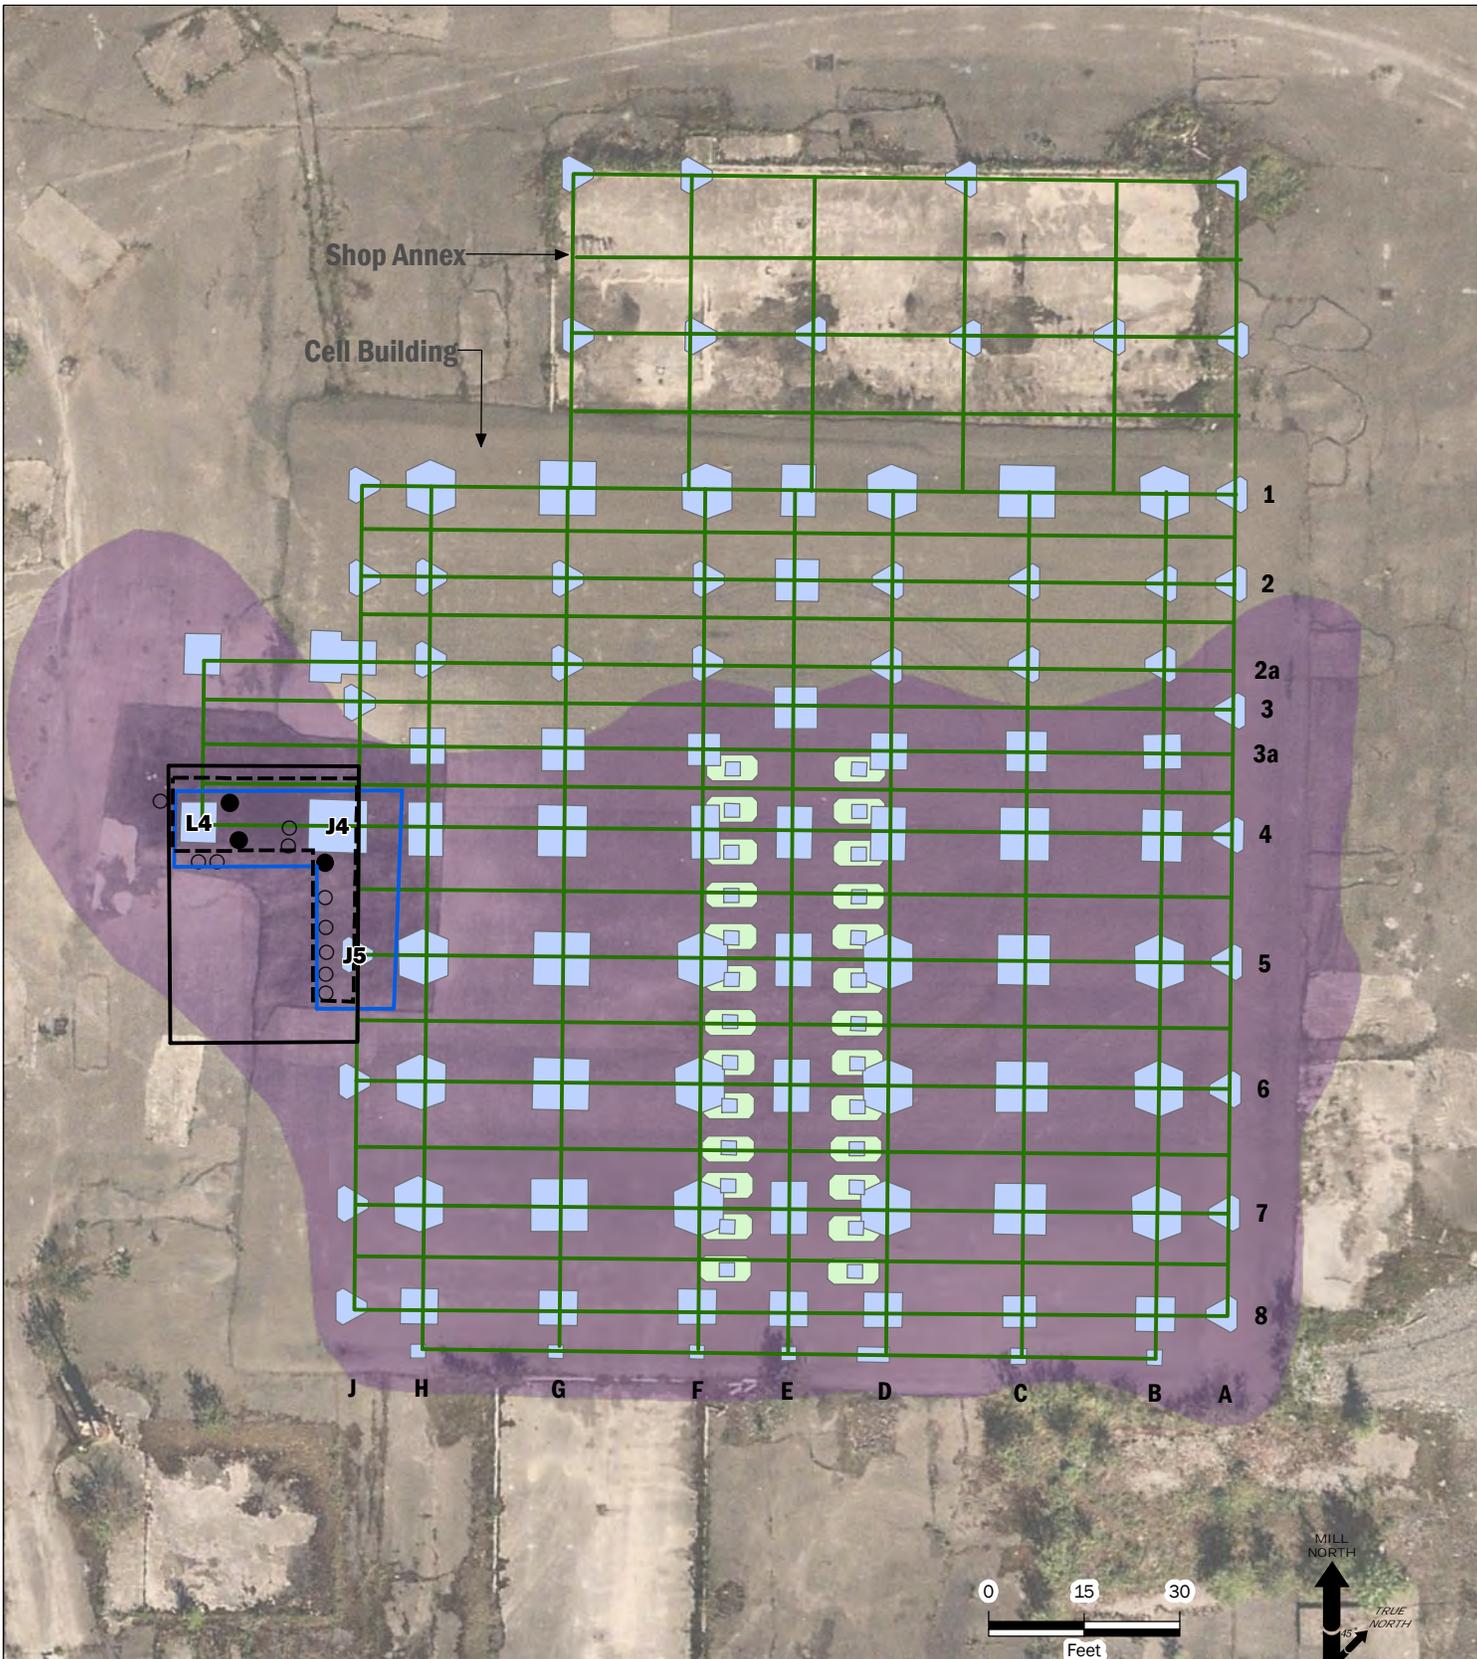
FIGURE NO.  
**4**

At least 10 timber pilings were observed underneath the unanticipated concrete. These timber pilings were not part of the Pilot Test scope and were left undisturbed. The approximate locations of these remaining timber pilings are depicted on Figure 4.

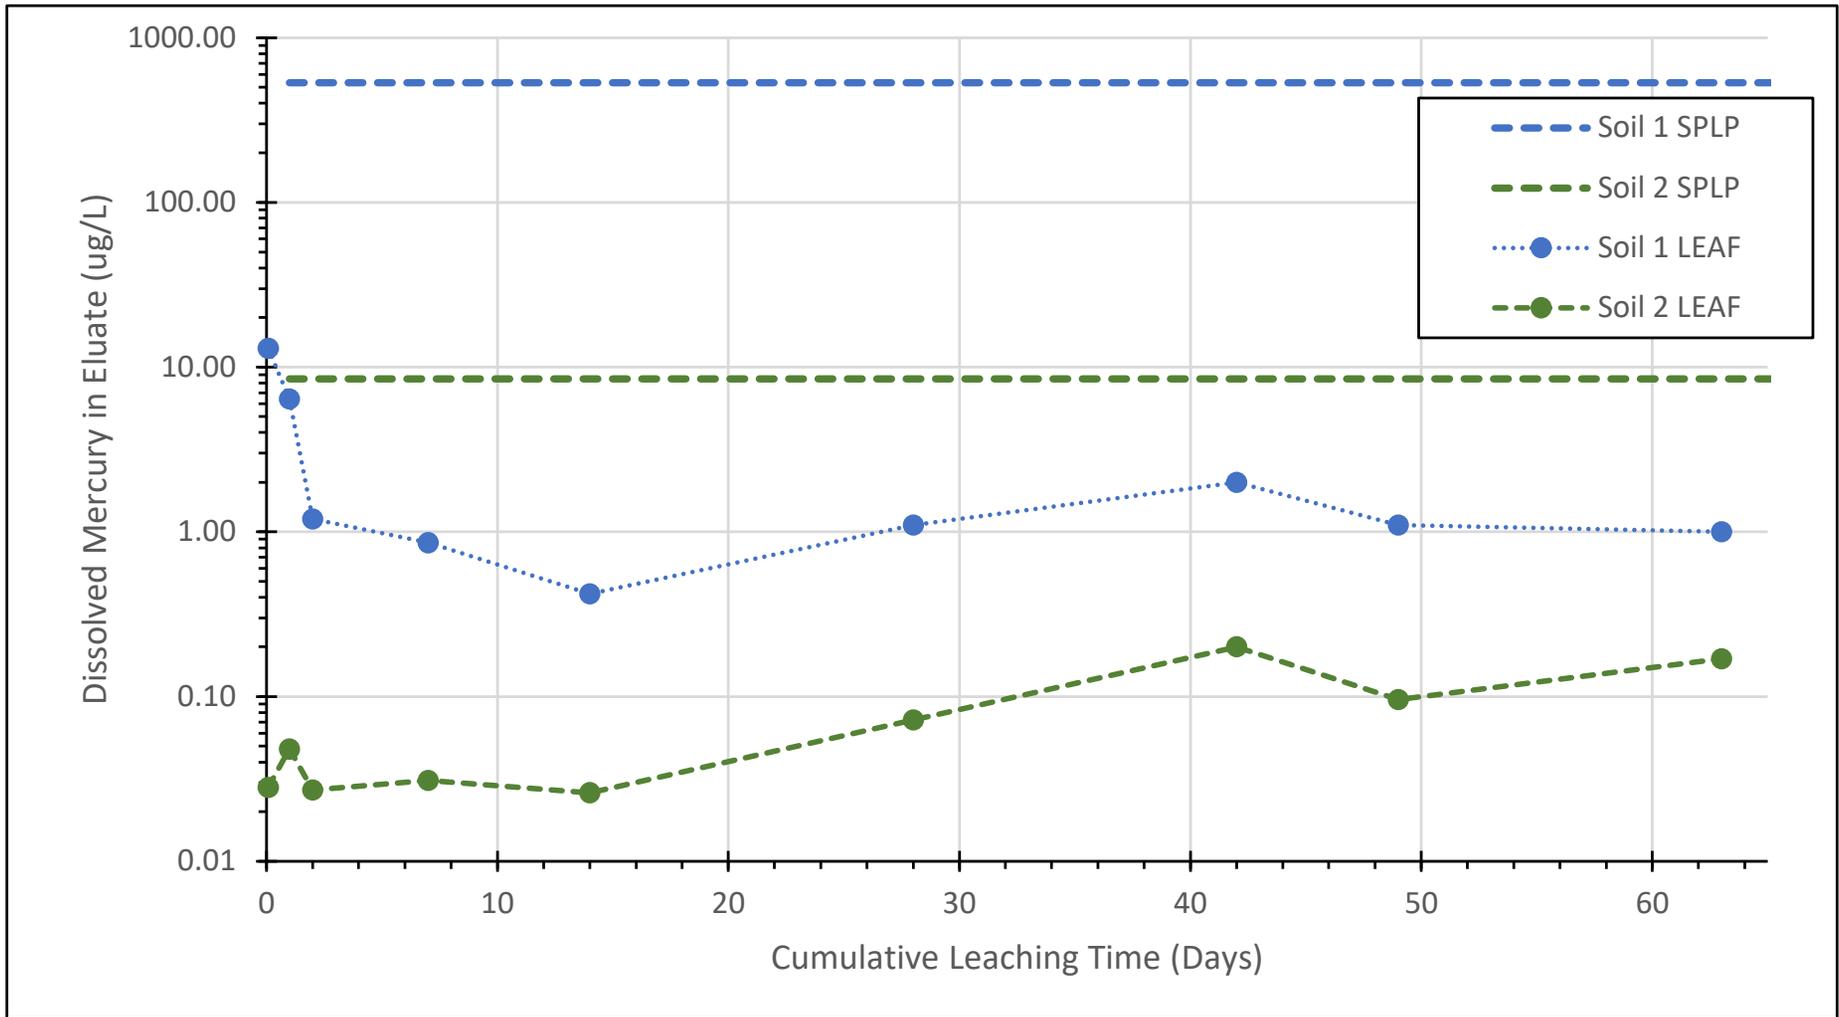
**Figure 5**  
**LEAF Results**

The Treatability Testing evaluated leaching performance of the treated soils by EPA's LEAF methodology (SW-846 Method 1315). The LEAF analysis is included in Appendix H. The leachability performance criteria is to reduce Hg leaching from the treated monolith sufficiently to ensure the groundwater cleanup level for Hg of 0.059  $\mu\text{g/L}$  is achieved at the groundwater conditional points of compliance, which the CAP establishes

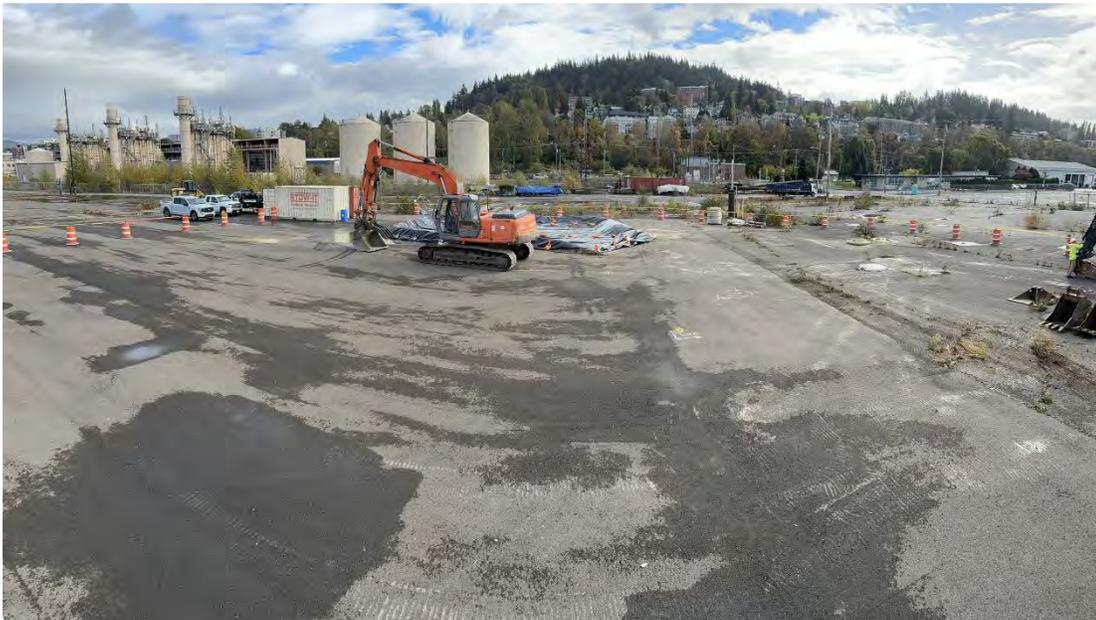
Photograph 1. Site set up with two conex boxes, and prepared stockpile zone.

A temporary stockpile area was constructed adjacent to the Pilot Test area. The temporary stockpile area was prepared by removing debris from the asphalt surface and placing a polyethylene geomembrane underliner with a thickness of 0.010 inches (10 mil) on the asphalt. Adjacent geomembrane sections were continuously overlapped by a minimum of 6 inches. Berms were constructed around the stockpile area to a minimum 9-inch height. Steel plates were placed within the temporary soil stockpile to protect the underliner from damage.

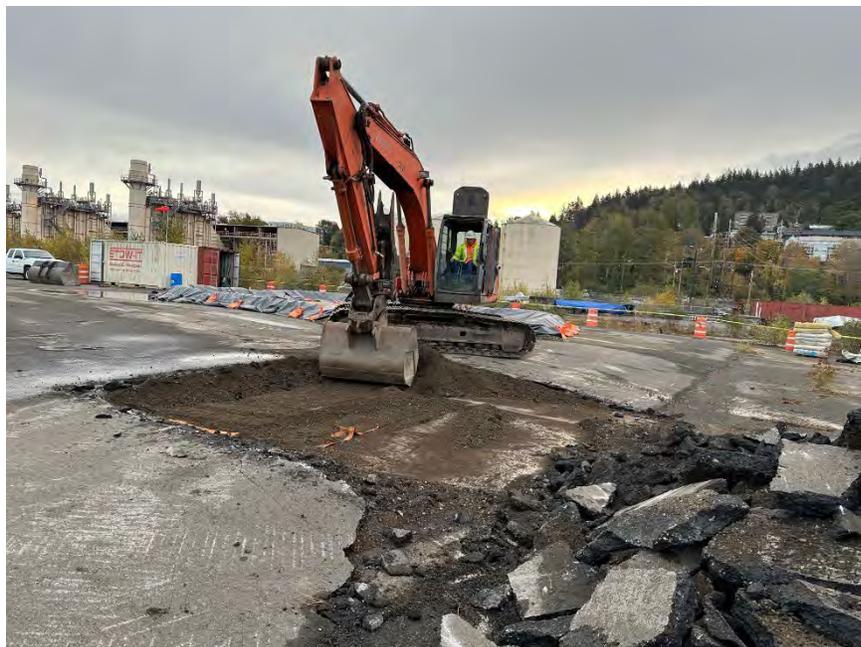
Photograph 2. Pulling up asphalt cap and separation geotextile covering the grade beams and pile caps.

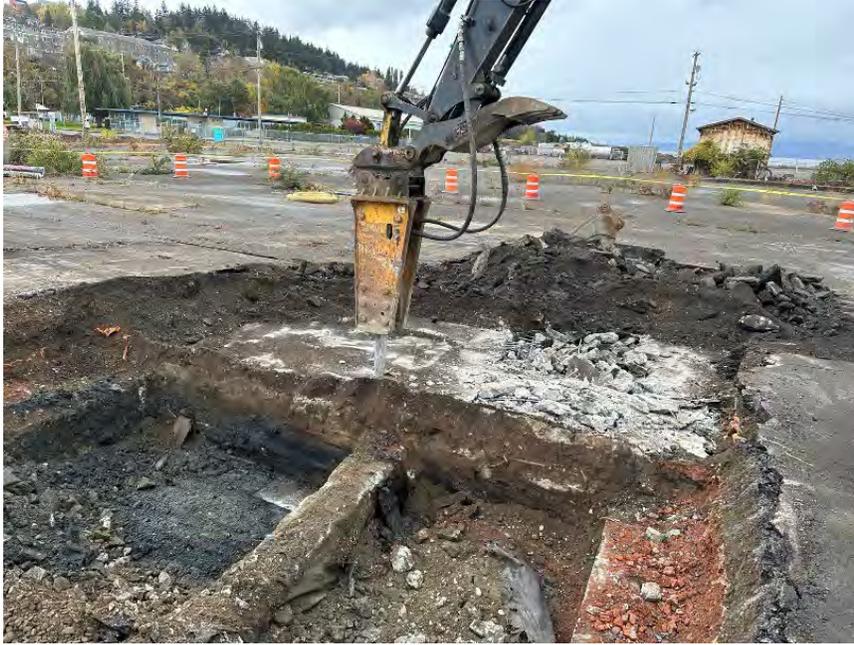
Photograph 3. Demolition of grade beams and unreported concrete slab above L4.

Demolition of the grade beams was conducted using an excavator with a hydraulic cracker. The grade beams were heavily reinforced, with large-diameter rebar. The concrete slab discovered during the Pilot Test was demolished, as needed, to access the pile caps, using the same methods.

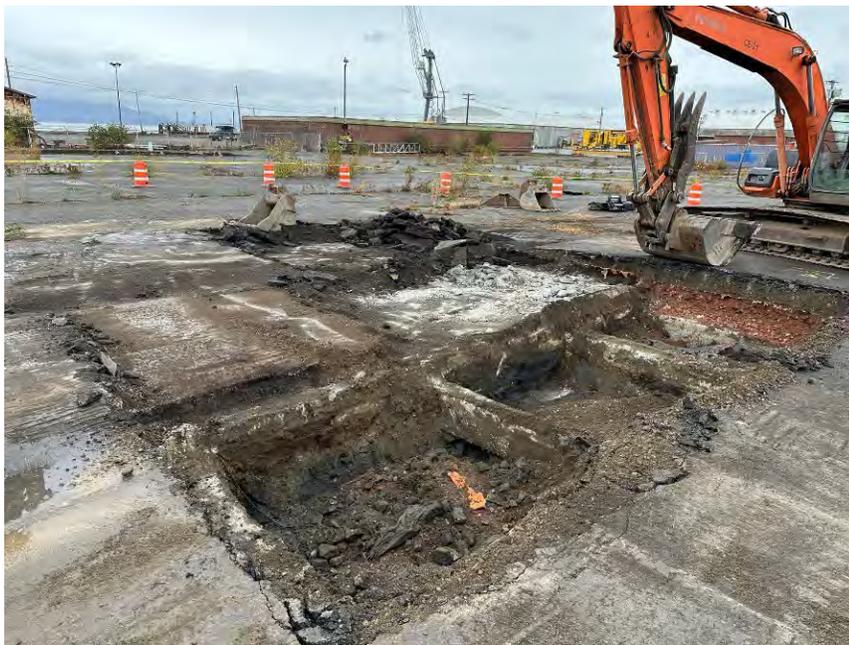
Photograph 4. Exposed grade beams over pile caps J5 and J4.

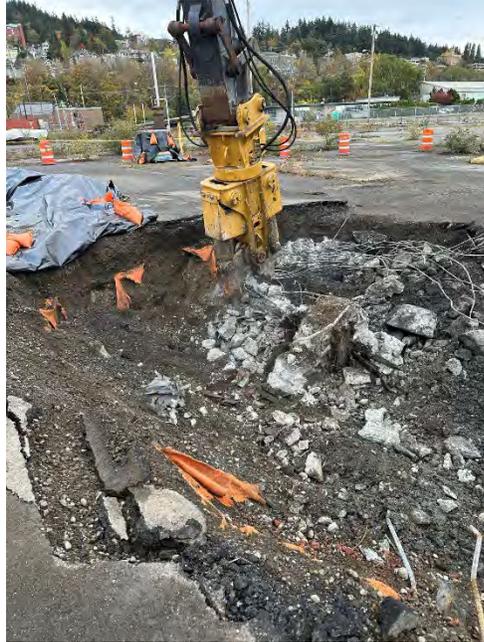
Photograph 5. Demolition of grade beams.

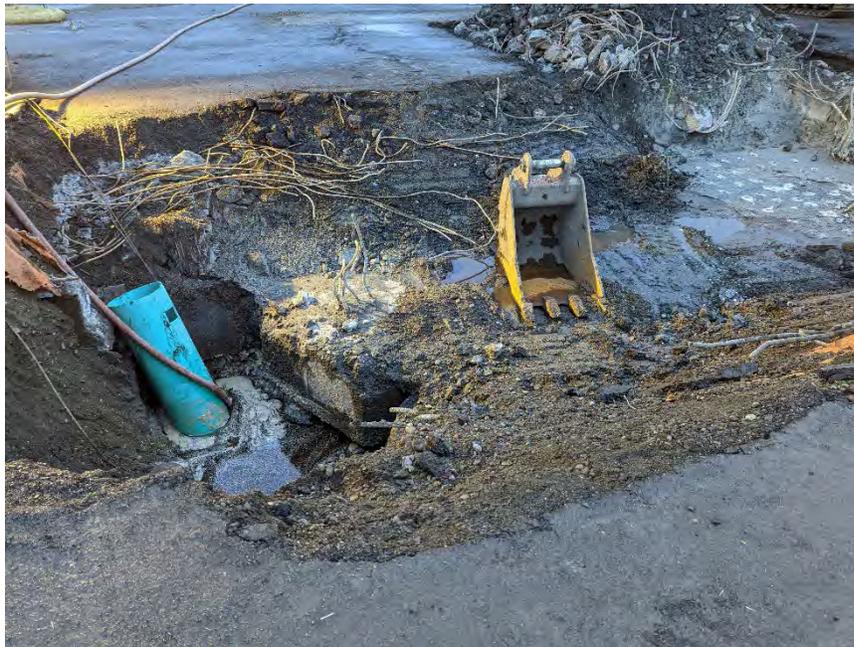
Photograph 6. Constructed groundwater sump and the drilled pile caps for J5 and J4.

Dewatering was conducted using submersible pumps installed in slotted casing pipe surrounded by drain rock (construction sump). Relatively low rates of groundwater inflow were observed throughout the work. Over the course of the Pilot Test, roughly 3,500 gallons Fill Unit groundwater were extracted from the temporary excavations. All water generated from excavation dewatering was conveyed to a 11,000-gallon settling weir tank to remove settleable solids, and then trucked from the weir tank to the Port's pump station (Figure 1) that conveys water to the Aerated Stabilization Basin (ASB) in accordance with the Port's NPDES Permit No. WA-000109-1. Prior to beginning work, Aspect submitted to the Ecology NPDES permit manager a letter requesting authorization to discharge non-routine flows (groundwater) to the ASB per NPDES permit condition S7, which Ecology approved. Copies of those communications and the NPDES permit are included in Appendix A.

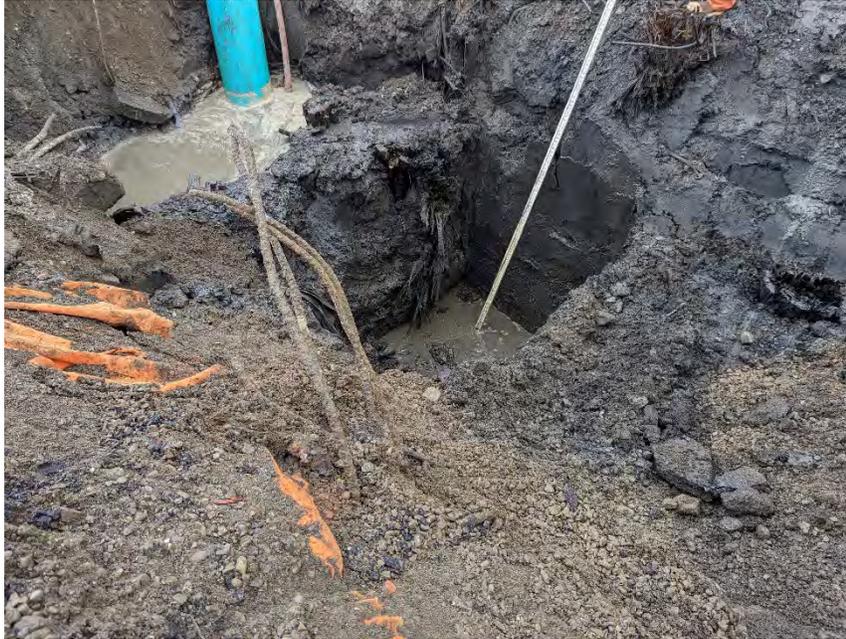
Photograph 7. Excavation to 16 feet below ground surface in preparation to cut timber piles underneath pile cap J5. Additional previously undocumented timber pile is noted in the top right of the image; this and other timber piles not associated with pile caps J5, J4, and L4 were not removed.

The observed aquitard consisted of a very dark grey to brown organic silt underlain by a nonorganic gray silt. When excavating soil underlying pile cap J5, the aquitard was encountered at approximately 14 feet below grade. During the exposure and cutting of timber pilings associated with pile cap J5, slight seepage was observed from the aquitard and the excavation was immediately backfilled with approximately 0.5 feet of soil to reduce the potential of aquitard breaching while obstruction removal continued.

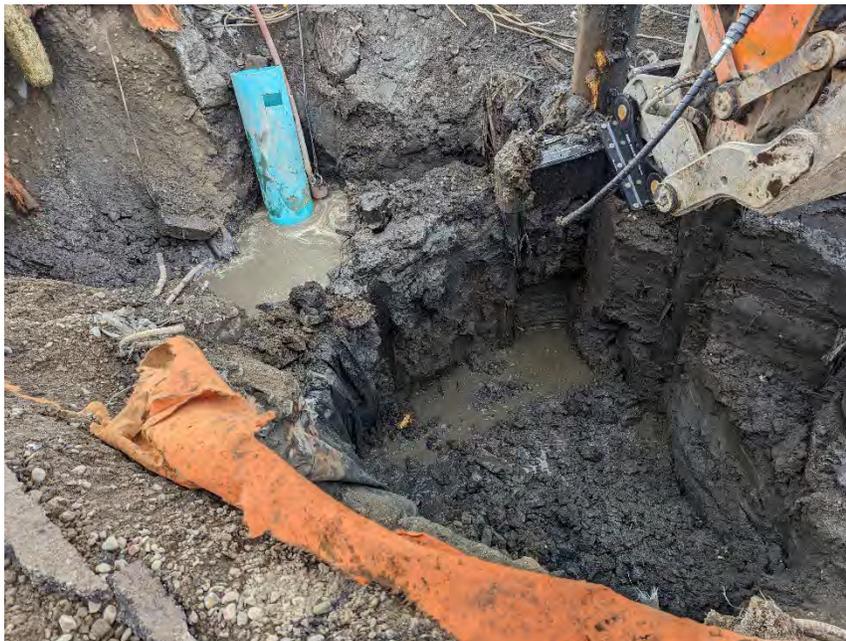
Photograph 8. Cut and extraction of timber pile underneath pile cap J5.

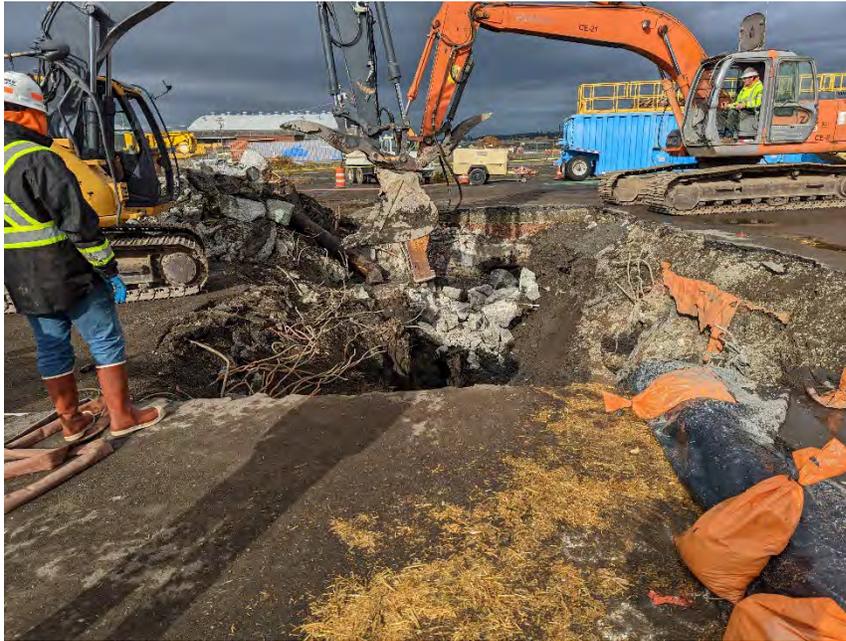
Photograph 9. Filling of excavation beneath the removed J5 pile cap and the removal of pile cap J4.

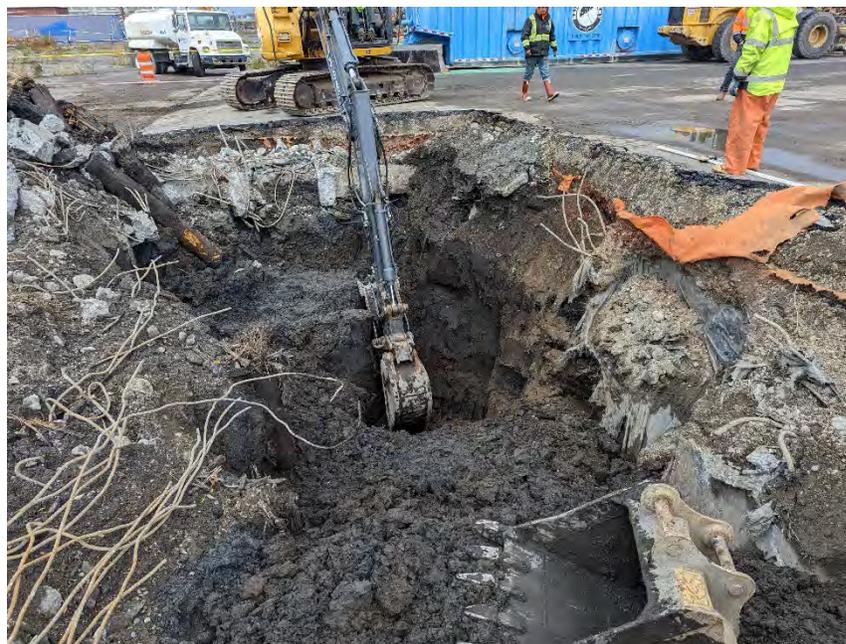
Photograph 10. Excavation to the aquitard beneath pile cap J4 in preparation for timber pilings cutting and removal.

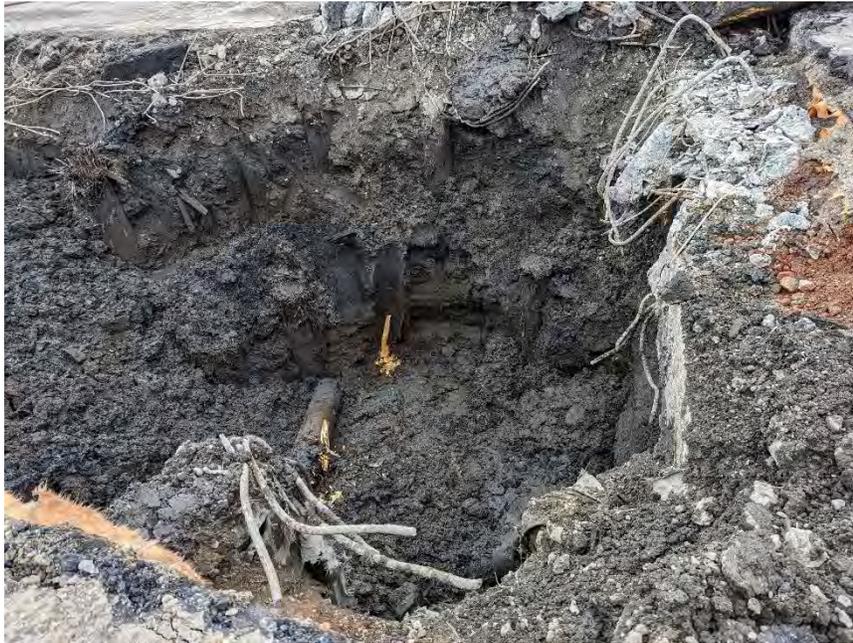
Photograph 11. Image showing a cut timber piling and the first 1.5 feet of the silt aquitard.

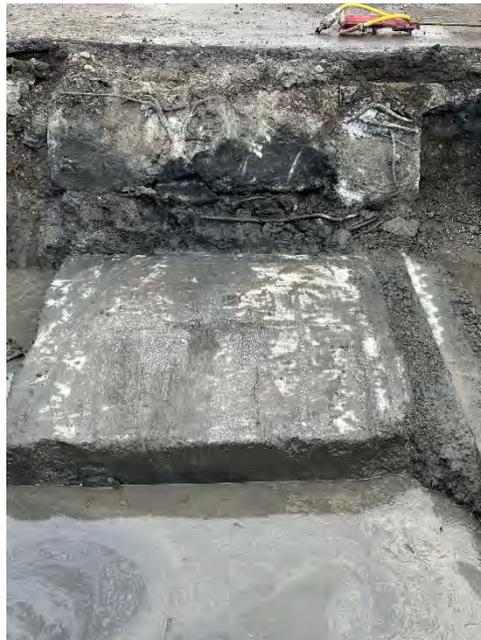
Photograph 12. Exposed pile cap L4.

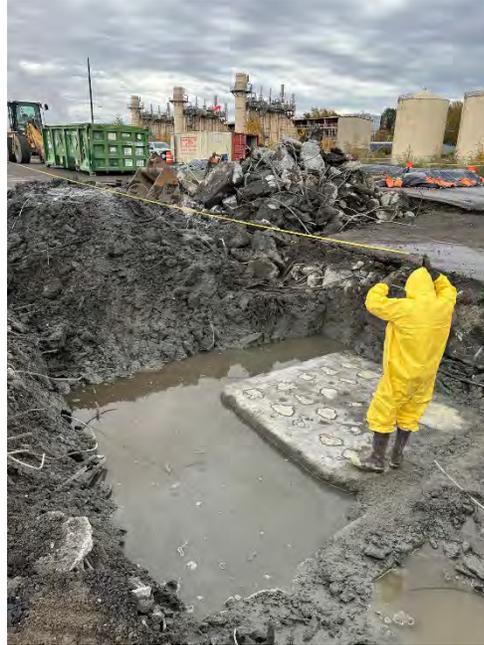
Photograph 13. Pile cap L4 after drilling and filling with Dexpan.

To minimize disturbance of the timber piles on which the pile caps rested, demolition of the pile caps was conducted by drilling holes in a 1-foot grid and filling the holes with expansive demolition grout (Dexpan®) and leaving overnight. This process fractured the pile cap structure with no disturbance of timber piles (Appendix G). The pile caps were

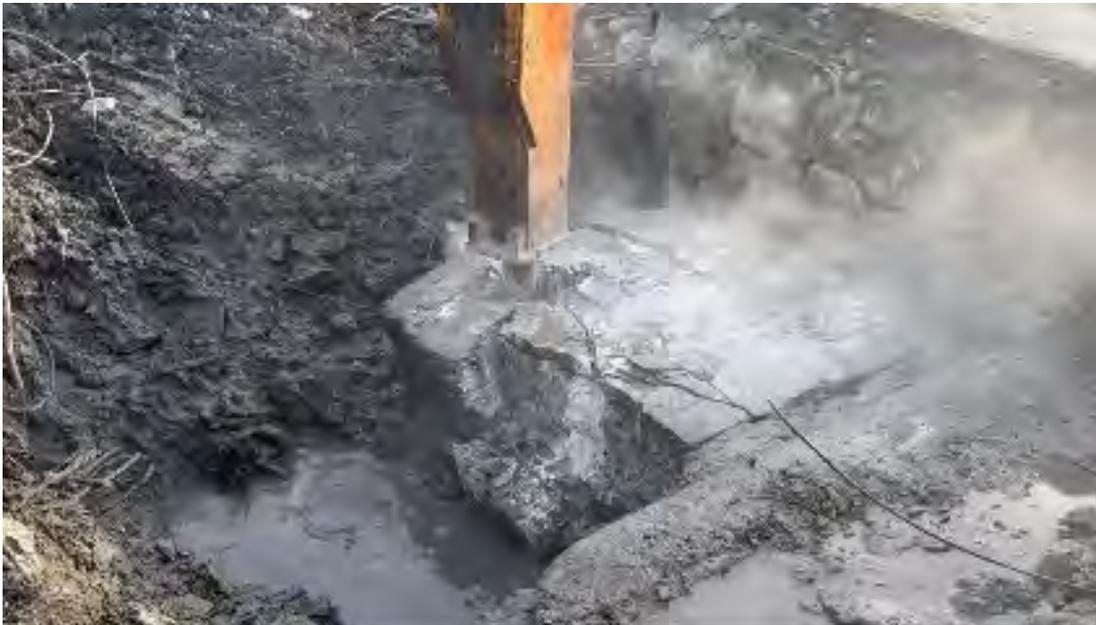
Photograph 14. Using excavator mounted jack hammer to break up pile cap L4. Break up required 1 to 3 hits from the jack hammer to break with minimal vibration.

then demolished using an excavator with a hydraulic breaker. The removal of the soil surrounding the concrete pile caps before the use of demolition grout allowed for expansion resulting in larger fractures, which in turn required less force from the hydraulic breaker, and reduced disturbance of underlying timber pilings.

Pilot Test Result: The use of a hydraulic cracker effectively removed the grade beams, including the steel reinforcement. Removal of all surrounding soils and use of Dexpan® (demolition grout) was effective in fracturing the pile caps, so a hydraulic breaker could demolish the pile caps with minimal disturbance of the underlying timber pilings.

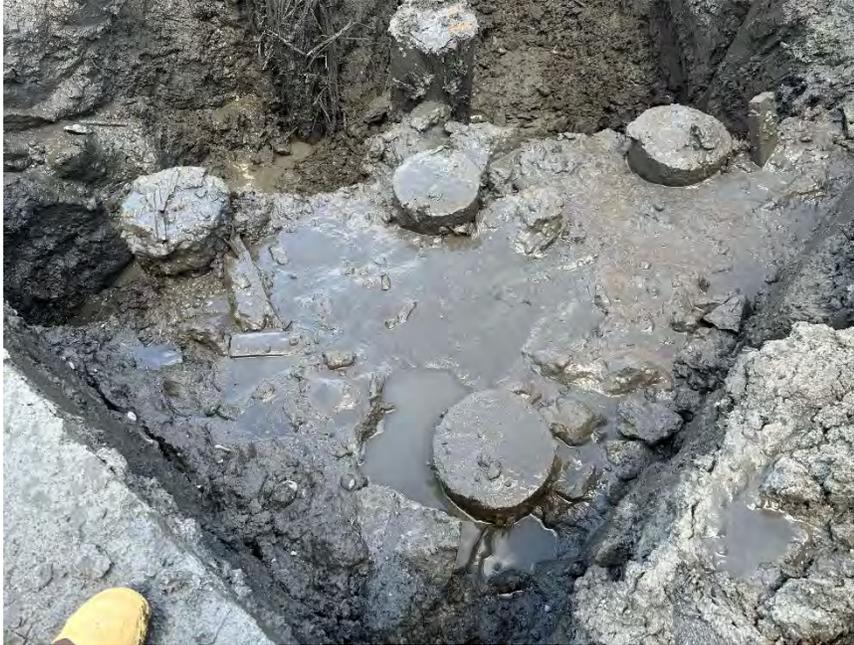
Photograph 15. The tops of exposed timber pilings beneath pile cap L4.

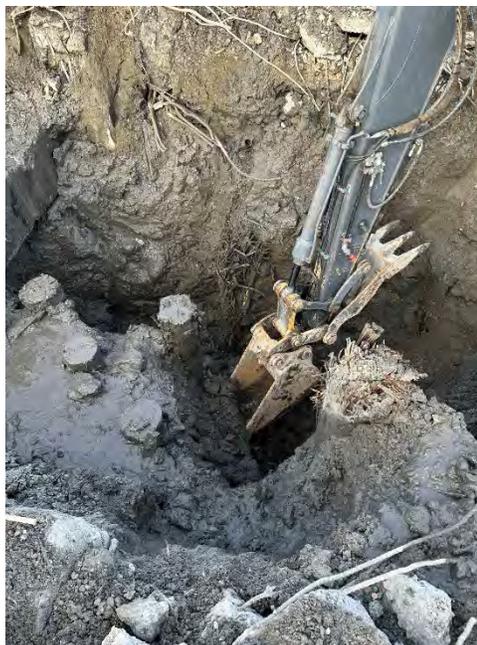
Photograph 16. Excavation in preparation of cutting the timber pilings under pile cap L4.

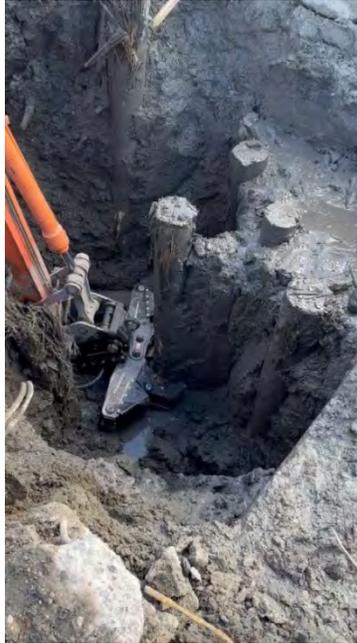
Photograph 17. The use of hydraulic shears to cut one of five timber pilings under pile cap L4. The shears appeared to cause minimal disturbance to piling below the cut.

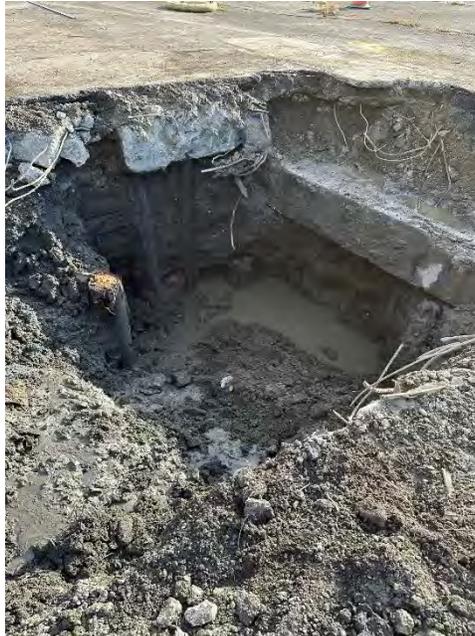
Photograph 18. Completed excavation and removal of pile cap L4 and associated timber pilings. In the upper left of the photo, the undocumented concrete slab is visible and its associated timber pilings that were not removed.

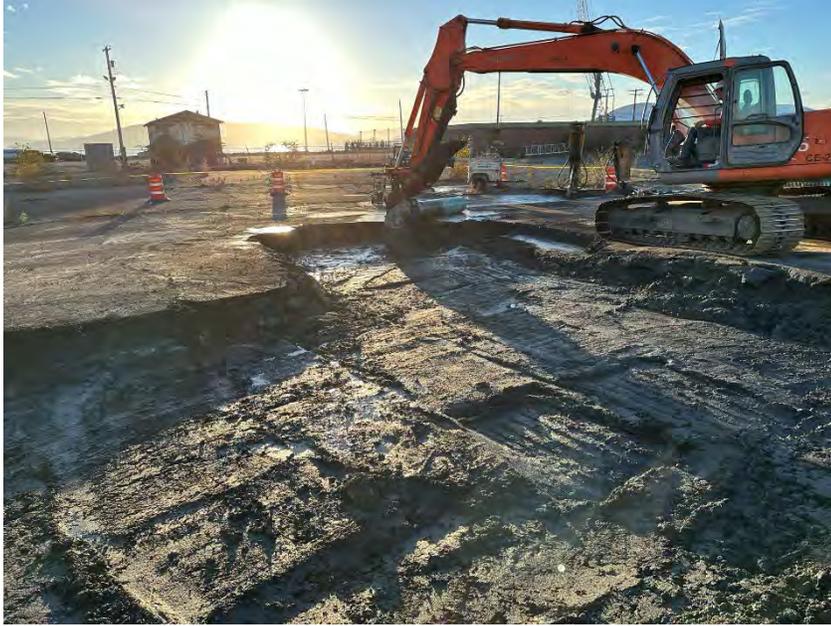
Photograph 19. The backfilled excavation after the completion of the Pilot Test excavation.

All the backfill deeper than 2 feet below final grade were placed in loose lifts no greater than 24 inches and tamped with an excavator bucket. Backfill within 2 feet of final grade was placed in loose lifts no greater than 8 inches thick and compacted with an excavator bucket.

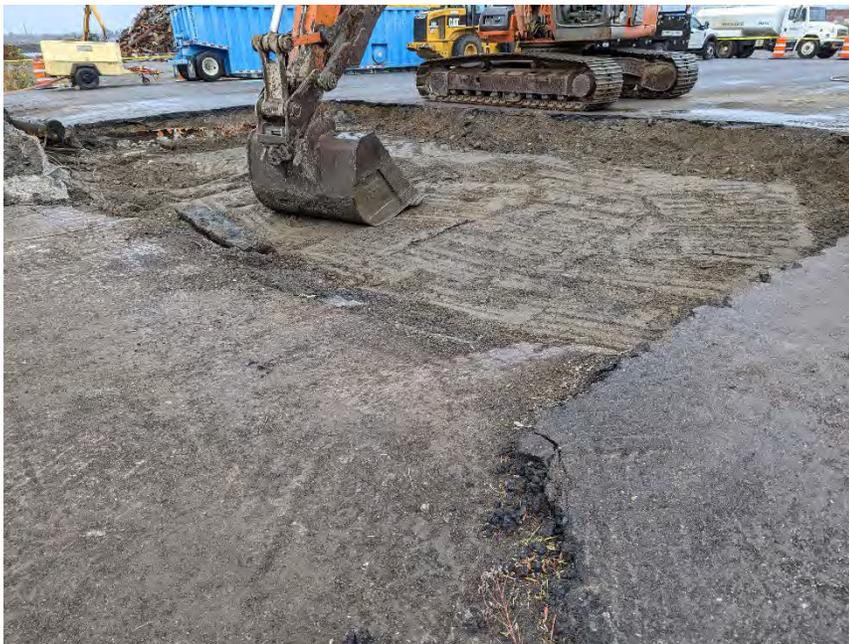
Photograph 20. The backfilled excavation after removal of structure associated with pile caps J4 and J5.

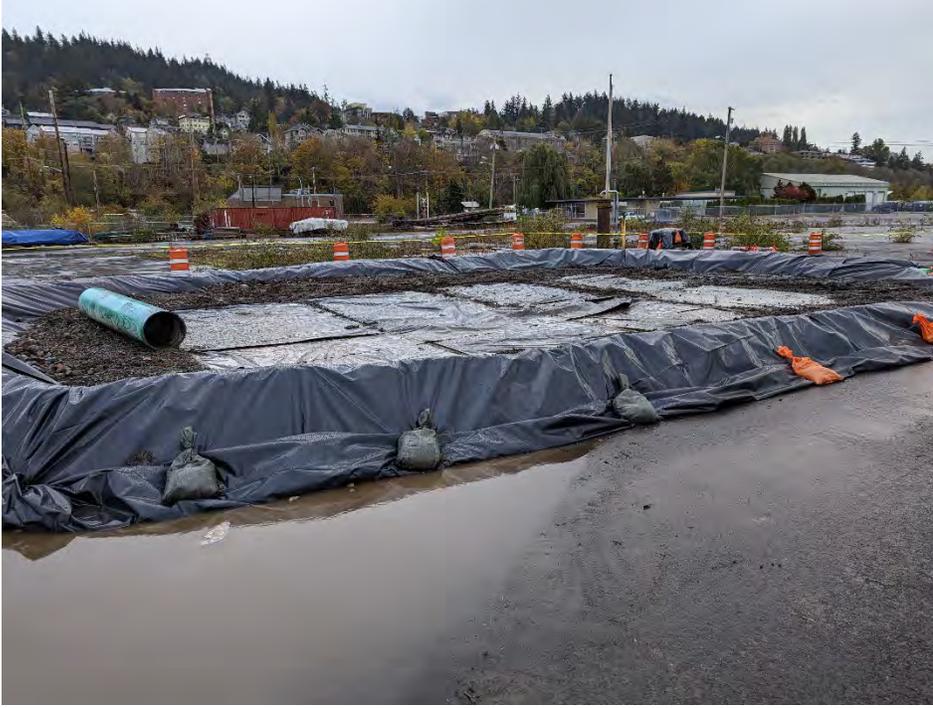
Photograph 21. Stockpile with erosion and sedimentation control best management practices in place, per the TESC Plan.

When not in active use, stockpiles were covered with 10 mil polyethylene geomembrane and anchored, as needed, to prevent disturbance by wind and outside working hours. No tears or discontinuities in the geomembrane underliner or cover were observed. No excavated soils were released or otherwise dispersed outside of the temporary stockpile area.

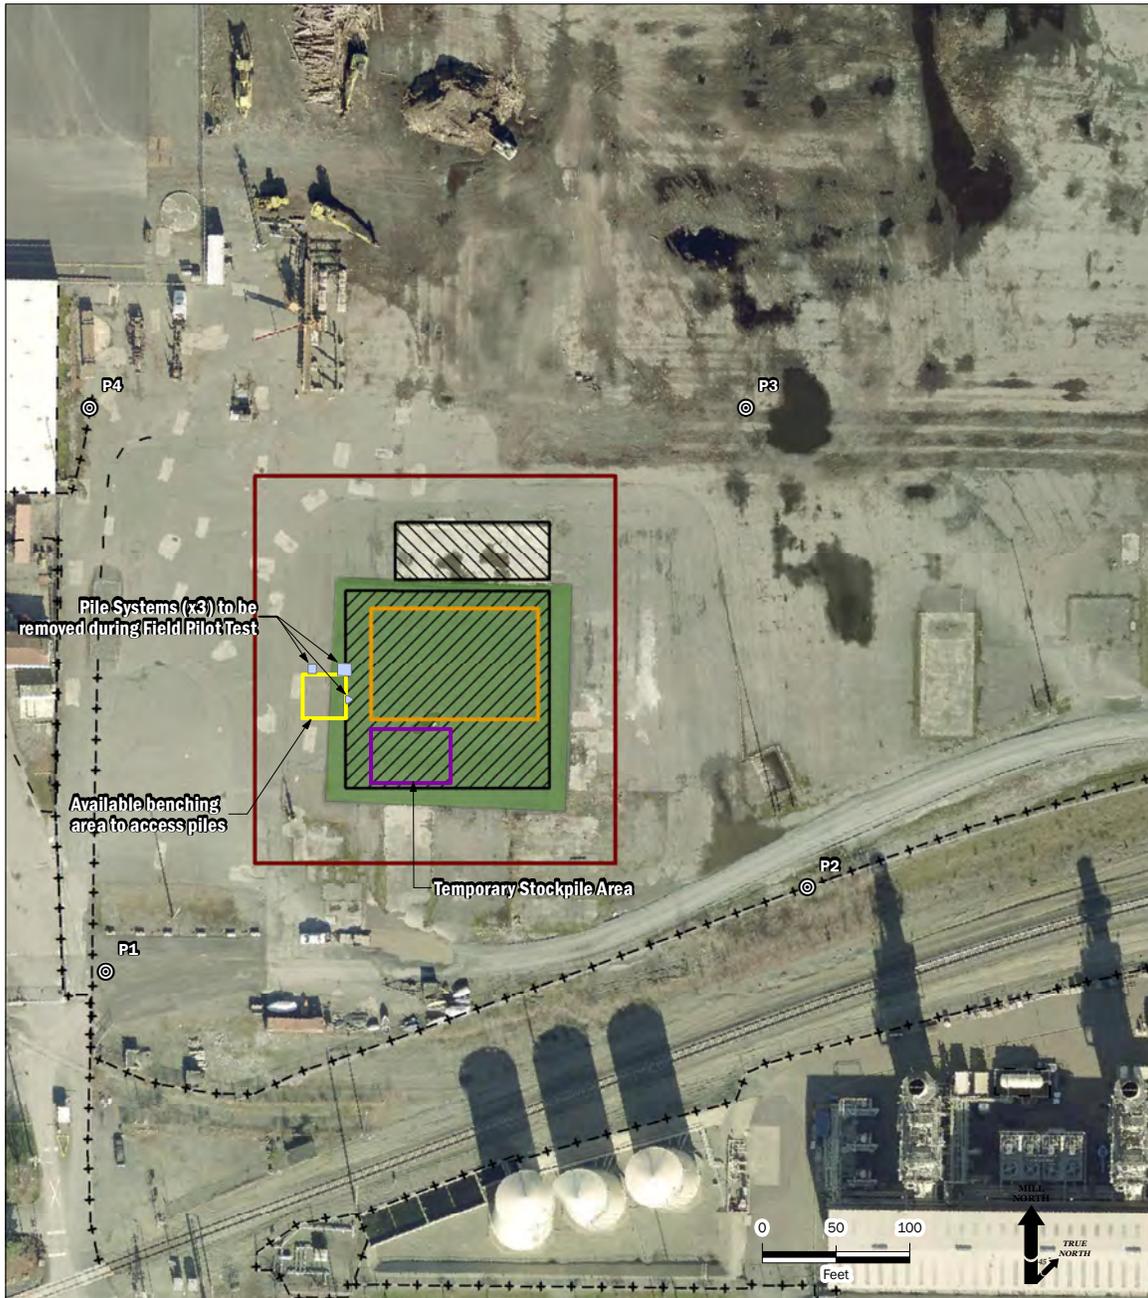
Pile Cap	Pilot Test Area	<h3>Field Pilot Testing - Plan View (1 of 2)</h3> <p>Chlor-Alkali RAU - GP West Site Bellingham, Washington</p>			
Available benching area to access piles	Equipment and Water Management Area				
Temporary Stockpile Area	Former Cell Building		APR-2022	BY: MAV / HRL	FIGURE NO. <b>2</b>
Perimeter Air Monitoring Location	Shop Slab		PROJECT NO. 210368	REVISED BY: DAH / RAP / NLK	
Fence	Paved Area (2017)

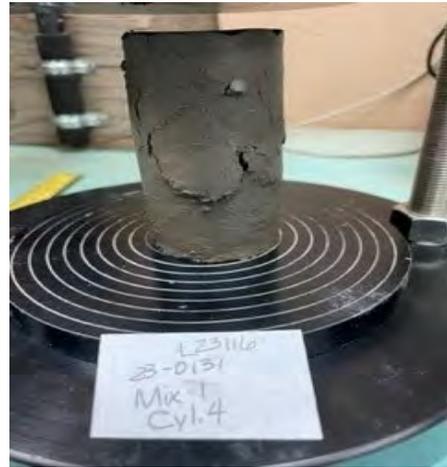
Height to Diameter Ratio: 2.0

Average Rate of Strain: 30%/hour

Deformation Dial Reading (in)	Unit Strain $\epsilon = \Delta L/L_o$	Area CF 1 - $\epsilon$	Corrected Area (ft <sup>2</sup> )	Load on Sample (lbs)	Sample Stress (psf)

0.039	0.010	0.990	0.0222	3.5	158
0.050	0.013	0.987	0.0223	4.2	188
0.060	0.015	0.985	0.0223	4.6	206
0.070	0.018	0.982	0.0224	5.1	228
0.081	0.020	0.980	0.0225	5.8	258

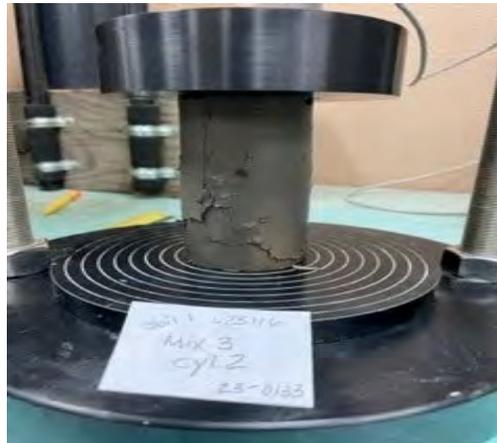
Height to Diameter Ratio: 2.0

Average Rate of Strain: 30%/hour

Deformation Dial Reading (in)	Unit Strain $\epsilon = \Delta L/L_0$	Area CF 1 - $\epsilon$	Corrected Area (ft <sup>2</sup> )	Load on Sample (lbs)	Sample Stress (psf)
0.000	0.000	1.000	0.0230	10.0	435
0.013	0.003	0.997	0.0231	34.7	1504
0.022	0.005	0.995	0.0231	50.0	2162
0.033	0.008	0.992	0.0232	58.8	2536
0.043	0.011	0.989	0.0232	63.8	2744
0.054	0.013	0.987	0.0233	67.3	2887
0.065	0.016	0.984	0.0234	69.8	2986
0.084	0.021	0.979	0.0235	73.0	3108
0.104	0.026	0.974	0.0236	74.1	3139
0.127	0.031	0.969	0.0237	71.6	3015
0.146	0.036	0.964	0.0239	67.5	2829
0.166	0.041	0.959	0.0240	63.1	2631

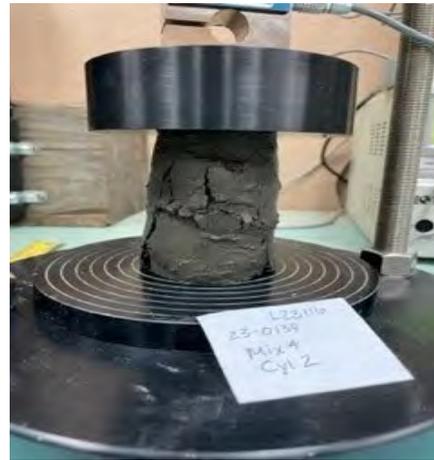
**Unconfined Compression Test Results**

**Laboratory Number:** 23-0134      Tested by: TB/KC  
**Sample ID:** Mix 4 Cylinder 2      Test Date: 2/16/23  
 Soil Description: Soil Mix 1  
 Diameter of Sample: 2.017 inches  
 Area of Sample (Ao): 0.022 ft<sup>2</sup>  
 Height of Sample (Lo): 3.900 inches  
 Water Content: 82.3%  
 Dry Density: 52.6 lb/ft<sup>3</sup>  
 Height to Diameter Ratio: 1.9  
 Average Rate of Strain: 30%/hour

Deformation Dial Reading (in)	Unit Strain $\epsilon = \Delta L/L_0$	Area CF 1 - $\epsilon$	Corrected Area (ft <sup>2</sup> )	Load on Sample (lbs)	Sample Stress (psf)

0.000	0.000	1.000	0.0220	0.0	0
0.004	0.001	0.999	0.0220	2.9	132
0.013	0.003	0.997	0.0221	3.0	136
0.023	0.006	0.994	0.0221	3.0	136
0.033	0.008	0.992	0.0222	3.1	140

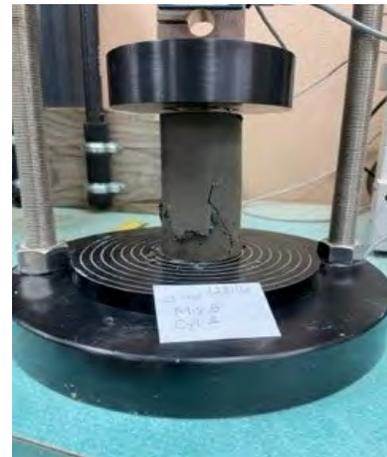
**Unconfined Compression Test Results**

**Laboratory Number:** 23-0135      Tested by: TB/KC  
**Sample ID:** Mix 5 Cylinder 2      Test Date: 2/16/23  
 Soil Description: Soil Mix 1  
 Diameter of Sample: 2.030 inches  
 Area of Sample (A<sub>o</sub>): 0.023 ft<sup>2</sup>  
 Height of Sample (L<sub>o</sub>): 4.017 inches  
 Water Content: 78.1%  
 Dry Density: 51.9 lb/ft<sup>3</sup>  
 Height to Diameter Ratio: 2.0  
 Average Rate of Strain: 30%/hour

Deformation Dial Reading (in)	Unit Strain $\epsilon = \Delta L/L_o$	Area CF 1 - $\epsilon$	Corrected Area (ft <sup>2</sup> )	Load on Sample (lbs)	Sample Stress (psf)
0.013	0.003	0.997	0.0231	13.0	563
0.022	0.005	0.995	0.0231	19.5	843
0.033	0.008	0.992	0.0232	27.9	1203
0.045	0.011	0.989	0.0233	35.1	1509
0.053	0.013	0.987	0.0233	37.8	1622
0.062	0.015	0.985	0.0234	39.8	1704
0.073	0.018	0.982	0.0234	41.0	1750
0.092	0.023	0.977	0.0235	42.9	1822
0.114	0.028	0.972	0.0237	43.5	1838
0.134	0.033	0.967	0.0238	43.5	1828
0.153	0.038	0.962	0.0239	42.7	1786
0.174	0.043	0.957	0.0240	41.0	1705
0.193	0.048	0.952	0.0242	39.1	1618

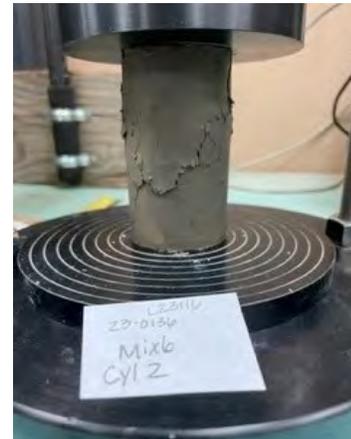
**Unconfined Compression Test Results**

**Laboratory Number:** 23-0136      Tested by: TB/KC  
**Sample ID:** Mix 6 Cylinder 2      Test Date: 2/16/23  
 Soil Description: Soil Mix 1  
 Diameter of Sample: 2.033 inches  
 Area of Sample (Ao): 0.023 ft<sup>2</sup>  
 Height of Sample (Lo): 4.030 inches  
 Water Content: 78.9%  
 Dry Density: 51.9 lb/ft<sup>3</sup>  
 Height to Diameter Ratio: 2.0  
 Average Rate of Strain: 30%/hour

Deformation Dial Reading (in)	Unit Strain $\epsilon = \Delta L/L_0$	Area CF $1 - \epsilon$	Corrected Area (ft <sup>2</sup> )	Load on Sample (lbs)	Sample Stress (psf)
0.012	0.003	0.997	0.0231	20.0	867
0.022	0.005	0.995	0.0231	41.7	1803
0.031	0.008	0.992	0.0232	62.9	2714
0.041	0.010	0.990	0.0232	76.2	3279
0.051	0.013	0.987	0.0233	84.6	3632
0.062	0.015	0.985	0.0234	89.8	3845
0.072	0.018	0.982	0.0234	93.1	3976
0.092	0.023	0.977	0.0235	97.7	4151
0.114	0.028	0.972	0.0237	100.7	4255
0.133	0.033	0.967	0.0238	99.9	4200
0.154	0.038	0.962	0.0239	92.1	3852
0.174	0.043	0.957	0.0240	83.6	3478
