PRE-REMEDIAL DESIGN  
INVESTIGATION 2 DATA REPORT  
Chlor-Alkali RAU, GP West Site, Bellingham,  
Washington

Prepared for: Port of Bellingham

Project No. AS210368-B-06 • February 28, 2024 FINAL

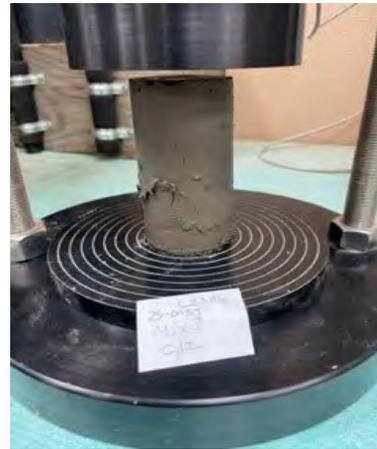
**Unconfined Compression Test Results**

**Laboratory Number:** 23-0137      Tested by: TB/KC  
**Sample ID:** Mix 7 Cylinder 2      Test Date: 2/16/23  
 Soil Description: Soil Mix 1  
 Diameter of Sample: 2.023 inches  
 Area of Sample (Ao): 0.022 ft<sup>2</sup>  
 Height of Sample (Lo): 4.017 inches  
 Water Content: 81.1%  
 Dry Density: 52.3 lb/ft<sup>3</sup>  
 Height to Diameter Ratio: 2.0  
 Average Rate of Strain: 30%/hour

Deformation Dial Reading (in)	Unit Strain $\epsilon = \Delta L/L_0$	Area CF 1 - $\epsilon$	Corrected Area (ft <sup>2</sup> )	Load on Sample (lbs)	Sample Stress (psf)
0.012	0.003	0.997	0.0221	12.0	544
0.021	0.005	0.995	0.0221	24.2	1094
0.032	0.008	0.992	0.0222	36.4	1642
0.042	0.010	0.990	0.0222	43.1	1939
0.052	0.013	0.987	0.0223	47.8	2145
0.062	0.015	0.985	0.0223	50.5	2260
0.072	0.018	0.982	0.0224	52.7	2352
0.093	0.023	0.977	0.0225	55.5	2465
0.113	0.028	0.972	0.0226	57.0	2518
0.133	0.033	0.967	0.0228	56.2	2470
0.153	0.038	0.962	0.0229	53.8	2352
0.174	0.043	0.957	0.0230	50.0	2175

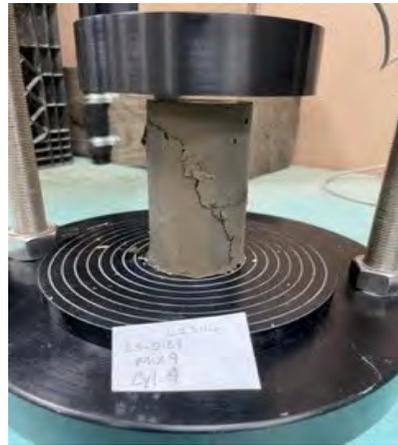
**Unconfined Compression Test Results**

**Laboratory Number:** 23-0139      Tested by: TB/KC  
**Sample ID:** Mix 9 Cylinder 4      Test Date: 2/16/23  
 Soil Description: Soil Mix 1  
 Diameter of Sample: 2.037 inches  
 Area of Sample (Ao): 0.023 ft<sup>2</sup>  
 Height of Sample (Lo): 4.047 inches  
 Water Content: 67.8%  
 Dry Density: 57.3 lb/ft<sup>3</sup>  
 Height to Diameter Ratio: 2.0  
 Average Rate of Strain: 30%/hour

Deformation Dial Reading (in)	Unit Strain $\epsilon = \Delta L/L_0$	Area CF 1 - $\epsilon$	Corrected Area (ft <sup>2</sup> )	Load on Sample (lbs)	Sample Stress (psf)
0.010	0.003	0.997	0.0231	43.0	1865
0.020	0.005	0.995	0.0231	139.7	6044
0.030	0.007	0.993	0.0232	179.2	7733
0.041	0.010	0.990	0.0232	204.5	8801
0.050	0.012	0.988	0.0233	218.1	9365
0.060	0.015	0.985	0.0233	224.3	9607
0.072	0.018	0.982	0.0234	218.3	9322
0.081	0.020	0.980	0.0235	195.0	8309
0.091	0.023	0.977	0.0235	158.1	6719
0.102	0.025	0.975	0.0236	142.2	6026
0.113	0.028	0.972	0.0237	136.3	5761

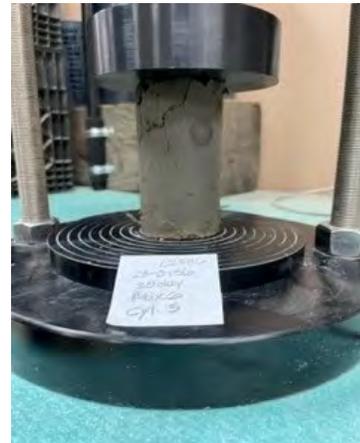
Height to Diameter Ratio: 2.0

Average Rate of Strain: 30%/hour

Deformation Dial Reading (in)	Unit Strain $\epsilon = \Delta L/L_o$	Area CF 1 - $\epsilon$	Corrected Area (in <sup>2</sup> )	Load on Sample (lbs)	Sample Stress (psi)
0.210	0.052	0.948	3.4414	8.6	2
0.218	0.054	0.946	3.4495	50.6	15
0.226	0.056	0.944	3.4568	72.4	21
0.238	0.059	0.941	3.4672	96.8	28
0.248	0.062	0.938	3.4761	112.5	32
0.257	0.064	0.936	3.4844	123.3	35
0.267	0.066	0.934	3.4942	130.3	37
0.277	0.069	0.931	3.5033	135.1	39
0.296	0.074	0.926	3.5217	140.5	40
0.318	0.079	0.921	3.5419	141.1	40
0.337	0.084	0.916	3.5610	131.8	37
0.357	0.089	0.911	3.5802	116.3	32

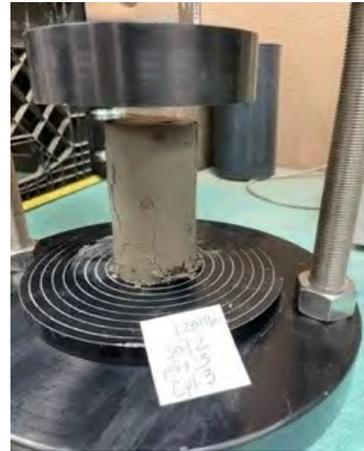
**Unconfined Compression Test Results**

**Laboratory Number:** 23-0201      Tested by: TB/KC  
**Sample ID:** Mix 3 Cylinder 3      Test Date: 3/16/23  
 Soil Description: Soil Mix 2  
 Diameter of Sample: 1.989 inches  
 Area of Sample (Ao): 3.107 in<sup>2</sup>  
 Height of Sample (Lo): 3.970 inches  
 Water Content: 79.3 %  
 Dry Density: 50.9 lb/ft<sup>3</sup>  
 Height to Diameter Ratio: 2.0  
 Average Rate of Strain: 30%/hour

Deformation Dial Reading (in)	Unit Strain $\epsilon = \Delta L/L_0$	Area CF 1 - $\epsilon$	Corrected Area (in <sup>2</sup> )	Load on Sample (lbs)	Sample Stress (psi)
0.059	0.015	0.985	3.1539	54.7	17
0.067	0.017	0.983	3.1601	62.8	20
0.077	0.019	0.981	3.1684	66.8	21
0.087	0.022	0.978	3.1762	68.9	22
0.096	0.024	0.976	3.1842	69.6	22
0.107	0.027	0.973	3.1926	69.1	22
0.116	0.029	0.971	3.2007	66.0	21
0.126	0.032	0.968	3.2089	61.6	19
0.136	0.034	0.966	3.2175	57.1	18
0.147	0.037	0.963	3.2266	52.0	16
0.157	0.039	0.961	3.2346	46.3	14

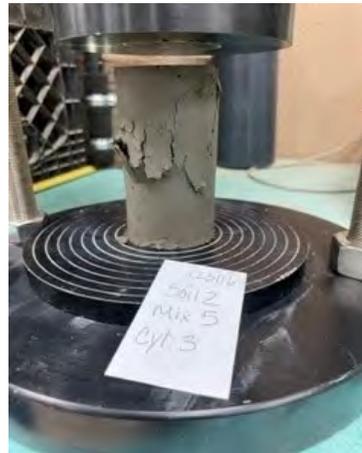
**Unconfined Compression Test Results**

**Laboratory Number:** 23-0203      Tested by: TB/KC  
**Sample ID:** Mix 5 Cylinder 3      Test Date: 3/16/23  
 Soil Description: Soil Mix 2  
 Diameter of Sample: 1.997 inches  
 Area of Sample (Ao): 3.132 in<sup>2</sup>  
 Height of Sample (Lo): 3.930 inches  
 Water Content: 73.6 %  
 Dry Density: 54.6 lb/ft<sup>3</sup>  
 Height to Diameter Ratio: 2.0  
 Average Rate of Strain: 30%/hour

Deformation Dial Reading (in)	Unit Strain $\epsilon = \Delta L/L_0$	Area CF $1 - \epsilon$	Corrected Area (in <sup>2</sup> )	Load on Sample (lbs)	Sample Stress (psi)
0.063	0.016	0.984	3.1827	54.4	17
0.073	0.019	0.981	3.1914	74.3	23
0.082	0.021	0.979	3.1990	96.3	30
0.093	0.024	0.976	3.2077	111.0	35
0.102	0.026	0.974	3.2153	116.7	36
0.111	0.028	0.972	3.2230	119.9	37
0.122	0.031	0.969	3.2320	120.6	37
0.141	0.036	0.964	3.2489	114.3	35
0.161	0.041	0.959	3.2659	101.7	31
0.181	0.046	0.954	3.2829	94.3	29
0.208	0.053	0.947	3.3068	85.7	26

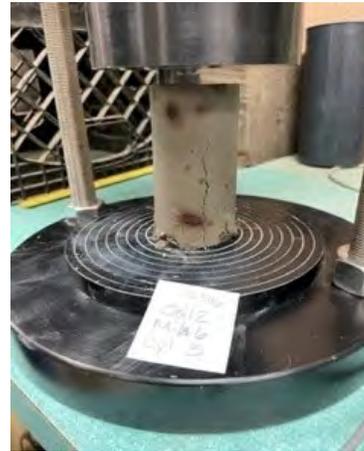
**Unconfined Compression Test Results**

**Laboratory Number:** 23-0204      Tested by: TB/KC  
**Sample ID:** Mix 6 Cylinder 3      Test Date: 3/16/23  
 Soil Description: Soil Mix 2  
 Diameter of Sample: 1.996 inches  
 Area of Sample (Ao): 3.129 in<sup>2</sup>  
 Height of Sample (Lo): 3.954 inches  
 Water Content: 77.7 %  
 Dry Density: 52.5 lb/ft<sup>3</sup>  
 Height to Diameter Ratio: 2.0  
 Average Rate of Strain: 30%/hour

Deformation Dial Reading (in)	Unit Strain $\epsilon = \Delta L/L_0$	Area CF 1 - $\epsilon$	Corrected Area (in <sup>2</sup> )	Load on Sample (lbs)	Sample Stress (psi)
0.033	0.008	0.992	3.1553	25.2	8
0.042	0.011	0.989	3.1624	37.2	12
0.052	0.013	0.987	3.1704	48.8	15
0.062	0.016	0.984	3.1787	58.3	18
0.071	0.018	0.982	3.1862	65.5	21
0.081	0.021	0.979	3.1945	71.8	22
0.091	0.023	0.977	3.2028	76.2	24
0.110	0.028	0.972	3.2185	81.9	25
0.130	0.033	0.967	3.2355	84.4	26
0.150	0.038	0.962	3.2520	81.4	25
0.170	0.043	0.957	3.2696	70.8	22

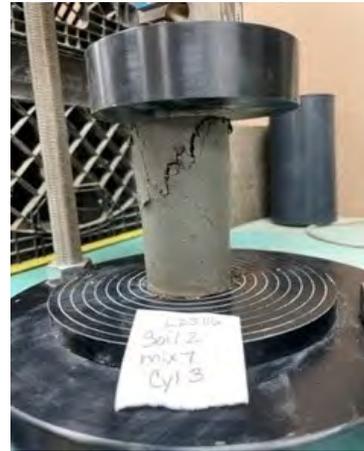
**Unconfined Compression Test Results**

**Laboratory Number:** 23-0205      Tested by: TB/KC  
**Sample ID:** Mix 7 Cylinder 3      Test Date: 3/16/23  
 Soil Description: Soil Mix 2  
 Diameter of Sample: 1.974 inches  
 Area of Sample (Ao): 3.060 in<sup>2</sup>  
 Height of Sample (Lo): 3.971 inches  
 Water Content: 95.4 %  
 Dry Density: 46.1 lb/ft<sup>3</sup>  
 Height to Diameter Ratio: 2.0  
 Average Rate of Strain: 30%/hour

Deformation Dial Reading (in)	Unit Strain $\epsilon = \Delta L/L_0$	Area CF $1 - \epsilon$	Corrected Area (in <sup>2</sup> )	Load on Sample (lbs)	Sample Stress (psi)
0.017	0.004	0.996	3.0730	21.1	7
0.027	0.007	0.993	3.0811	30.3	10
0.037	0.009	0.991	3.0886	36.9	12
0.046	0.012	0.988	3.0957	44.2	14
0.056	0.014	0.986	3.1040	50.0	16
0.066	0.017	0.983	3.1120	53.7	17
0.075	0.019	0.981	3.1190	55.8	18
0.095	0.024	0.976	3.1351	57.3	18
0.115	0.029	0.971	3.1514	56.2	18
0.136	0.034	0.966	3.1681	53.0	17
0.155	0.039	0.961	3.1843	48.4	15

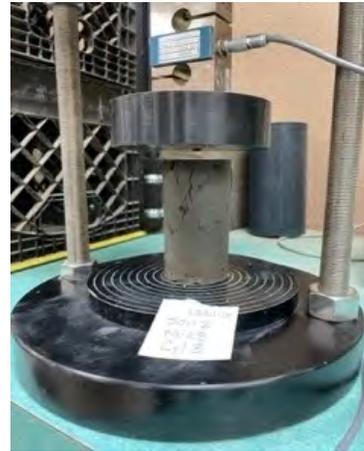
**Unconfined Compression Test Results**

**Laboratory Number:** 23-0206      Tested by: TB/KC  
**Sample ID:** Mix 8 Cylinder 3      Test Date: 3/16/23  
 Soil Description: Soil Mix 2  
 Diameter of Sample: 1.995 inches  
 Area of Sample (Ao): 3.125 in<sup>2</sup>  
 Height of Sample (Lo): 3.965 inches  
 Water Content: 94.5 %  
 Dry Density: 45.6 lb/ft<sup>3</sup>  
 Height to Diameter Ratio: 2.0  
 Average Rate of Strain: 30%/hour

Deformation Dial Reading (in)	Unit Strain $\epsilon = \Delta L/L_0$	Area CF 1 - $\epsilon$	Corrected Area (in <sup>2</sup> )	Load on Sample (lbs)	Sample Stress (psi)
0.021	0.005	0.995	3.1414	15.9	5
0.031	0.008	0.992	3.1494	41.4	13
0.040	0.010	0.990	3.1564	73.3	23
0.049	0.012	0.988	3.1637	91.4	29
0.059	0.015	0.985	3.1724	100.4	32
0.069	0.017	0.983	3.1801	104.3	33
0.079	0.020	0.980	3.1884	104.7	33
0.099	0.025	0.975	3.2047	102.2	32
0.117	0.030	0.970	3.2203	97.2	30
0.138	0.035	0.965	3.2379	86.9	27
0.159	0.040	0.960	3.2551	76.2	23

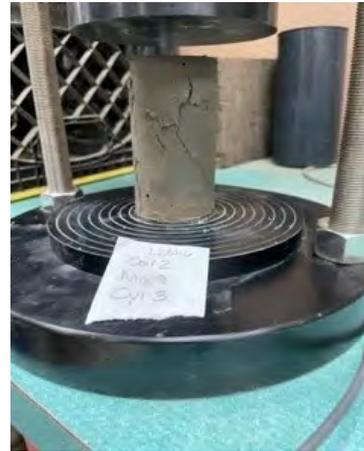
**Unconfined Compression Test Results**

**Laboratory Number:** 23-0207      Tested by: TB/KC  
**Sample ID:** Mix 9 Cylinder 3      Test Date: 3/16/23  
 Soil Description: Soil Mix 2  
 Diameter of Sample: 1.991 inches  
 Area of Sample (Ao): 3.113 in<sup>2</sup>  
 Height of Sample (Lo): 3.971 inches  
 Water Content: 85.1 %  
 Dry Density: 49.2 lb/ft<sup>3</sup>  
 Height to Diameter Ratio: 2.0  
 Average Rate of Strain: 30%/hour

Deformation Dial Reading (in)	Unit Strain $\epsilon = \Delta L/L_0$	Area CF 1 - $\epsilon$	Corrected Area (in <sup>2</sup> )	Load on Sample (lbs)	Sample Stress (psi)
0.029	0.007	0.993	3.1357	41.9	13
0.038	0.010	0.990	3.1432	61.9	20
0.047	0.012	0.988	3.1503	79.5	25
0.058	0.015	0.985	3.1591	92.4	29
0.067	0.017	0.983	3.1667	100.5	32
0.080	0.020	0.980	3.1766	107.1	34
0.087	0.022	0.978	3.1826	110.3	35
0.107	0.027	0.973	3.1990	110.5	35
0.127	0.032	0.968	3.2156	101.1	31
0.147	0.037	0.963	3.2322	85.5	26
0.168	0.042	0.958	3.2501	65.7	20

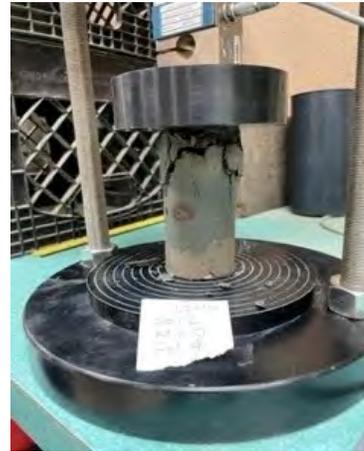
**Unconfined Compression Test Results**

**Laboratory Number:** 23-0208      Tested by: TB/KC  
**Sample ID:** Mix 10 Cylinder 4      Test Date: 3/16/23  
 Soil Description: Soil Mix 2  
 Diameter of Sample: 2.000 inches  
 Area of Sample (Ao): 3.142 in<sup>2</sup>  
 Height of Sample (Lo): 3.932 inches  
 Water Content: 85.5%  
 Dry Density: 48.8 lb/ft<sup>3</sup>  
 Height to Diameter Ratio: 2.0  
 Average Rate of Strain: 30%/hour

Deformation Dial Reading (in)	Unit Strain $\epsilon = \Delta L/L_0$	Area CF 1 - $\epsilon$	Corrected Area (in <sup>2</sup> )	Load on Sample (lbs)	Sample Stress (psi)
0.054	0.014	0.986	3.1858	29.7	9
0.065	0.016	0.984	3.1946	36.2	11
0.074	0.019	0.981	3.2025	46.0	14
0.083	0.021	0.979	3.2098	54.8	17
0.094	0.024	0.976	3.2185	60.1	19
0.103	0.026	0.974	3.2263	63.9	20
0.112	0.029	0.971	3.2345	66.2	20
0.123	0.031	0.969	3.2432	67.3	21
0.133	0.034	0.966	3.2519	67.9	21
0.151	0.038	0.962	3.2676	70.7	22
0.172	0.044	0.956	3.2856	75.4	23
0.191	0.049	0.951	3.3028	78.8	24
0.211	0.054	0.946	3.3201	81.7	25
0.233	0.059	0.941	3.3395	79.9	24
0.252	0.064	0.936	3.3572	70.3	21

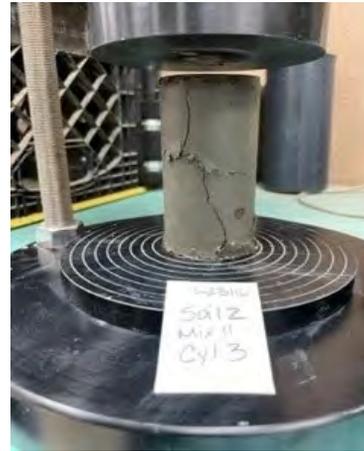
Height to Diameter Ratio: 2.0

Average Rate of Strain: 30%/hour

Deformation Dial Reading (in)	Unit Strain $\epsilon = \Delta L/L_o$	Area CF 1 - $\epsilon$	Corrected Area (in <sup>2</sup> )	Load on Sample (lbs)	Sample Stress (psi)
0.038	0.010	0.990	3.1594	20.9	7
0.046	0.012	0.988	3.1664	37.7	12
0.056	0.014	0.986	3.1744	56.7	18
0.066	0.017	0.983	3.1825	76.6	24
0.075	0.019	0.981	3.1900	97.2	30
0.085	0.022	0.978	3.1980	111.1	35
0.095	0.024	0.976	3.2065	126.6	39
0.114	0.029	0.971	3.2227	147.1	46
0.134	0.034	0.966	3.2397	158.2	49
0.154	0.039	0.961	3.2564	147.2	45
0.174	0.044	0.956	3.2736	108.9	33

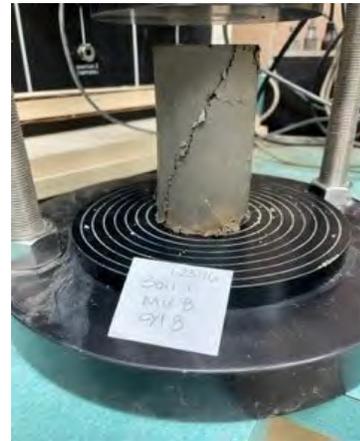
**Unconfined Compression Test Results**

**Laboratory Number:** 23-0138      Tested by: TB/KC  
**Sample ID:** Mix 8 Cylinder 8      Test Date: 3/29/23  
 Soil Description: Soil Mix 1      56 day break  
 Diameter of Sample: 2.036 inches  
 Area of Sample (Ao): 3.256 in<sup>2</sup>  
 Height of Sample (Lo): 4.036 inches  
 Water Content: 64.4%  
 Dry Density: 58.3 lb/ft<sup>3</sup>  
 Height to Diameter Ratio: 2.0  
 Average Rate of Strain: 30%/hour

Deformation Dial Reading (in)	Unit Strain $\epsilon = \Delta L/L_0$	Area CF 1 - $\epsilon$	Corrected Area (in <sup>2</sup> )	Load on Sample (lbs)	Sample Stress (psi)
0.011	0.003	0.997	3.2650	22.5	7
0.020	0.005	0.995	3.2724	47.0	14
0.031	0.008	0.992	3.2809	136.7	42
0.040	0.010	0.990	3.2888	194.1	59
0.050	0.012	0.988	3.2967	259.4	79
0.060	0.015	0.985	3.3052	305.9	93
0.070	0.017	0.983	3.3131	331.5	100
0.089	0.022	0.978	3.3297	331.5	100
0.111	0.027	0.973	3.3477	263.8	79
0.130	0.032	0.968	3.3644	167.0	50
0.151	0.037	0.963	3.3828	142.3	42

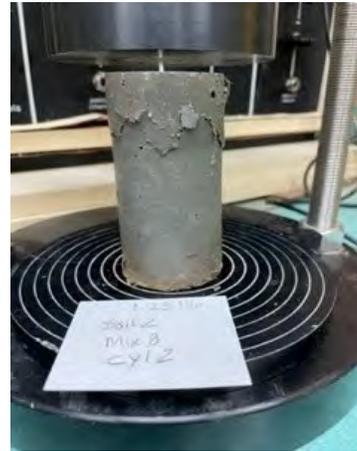
**Unconfined Compression Test Results**

**Laboratory Number:** 23-0206      Tested by: TB/KC  
**Sample ID:** Mix 8 Cylinder 2      Test Date: 4/27/23  
 Soil Description: Soil Mix 2      56 day break  
 Diameter of Sample: 1.985 inches  
 Area of Sample (Ao): 3.095 in<sup>2</sup>  
 Height of Sample (Lo): 3.979 inches  
 Water Content: 89.6%  
 Dry Density: 47.6 lb/ft<sup>3</sup>  
 Height to Diameter Ratio: 2.0  
 Average Rate of Strain: 30%/hour

Deformation Dial Reading (in)	Unit Strain $\epsilon = \Delta L/L_0$	Area CF $1 - \epsilon$	Corrected Area (in <sup>2</sup> )	Load on Sample (lbs)	Sample Stress (psi)
0.215	0.054	0.946	3.2714	22.1	7
0.224	0.056	0.944	3.2799	36.7	11
0.234	0.059	0.941	3.2884	57.0	17
0.244	0.061	0.939	3.2972	83.9	25
0.254	0.064	0.936	3.3059	111.9	34
0.264	0.066	0.934	3.3145	140.1	42
0.273	0.069	0.931	3.3233	161.4	49
0.284	0.071	0.929	3.3324	173.8	52
0.293	0.074	0.926	3.3409	180.9	54
0.313	0.079	0.921	3.3590	191.0	57
0.333	0.084	0.916	3.3776	192.6	57
0.353	0.089	0.911	3.3960	161.1	47

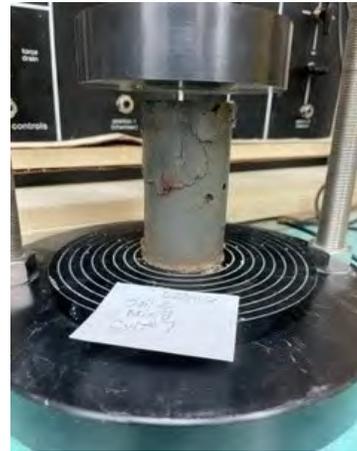
**Unconfined Compression Test Results**

**Laboratory Number:** 23-0206      Tested by: TB/KC  
**Sample ID:** Mix 8 Cylinder 7      Test Date: 4/27/23  
 Soil Description: Soil Mix 2      56 day break  
 Diameter of Sample: 1.998 inches  
 Area of Sample (Ao): 3.135 in<sup>2</sup>  
 Height of Sample (Lo): 3.947 inches  
 Water Content: 93.2%  
 Dry Density: 45.9 lb/ft<sup>3</sup>  
 Height to Diameter Ratio: 2.0  
 Average Rate of Strain: 30%/hour

Deformation Dial Reading (in)	Unit Strain $\epsilon = \Delta L/L_0$	Area CF 1 - $\epsilon$	Corrected Area (in <sup>2</sup> )	Load on Sample (lbs)	Sample Stress (psi)
0.224	0.057	0.943	3.3233	23.3	7
0.233	0.059	0.941	3.3312	44.0	13
0.243	0.062	0.938	3.3407	62.8	19
0.253	0.064	0.936	3.3493	86.7	26
0.262	0.066	0.934	3.3580	115.5	34
0.272	0.069	0.931	3.3669	139.4	41
0.282	0.071	0.929	3.3760	154.7	46
0.301	0.076	0.924	3.3941	159.4	47
0.321	0.081	0.919	3.4128	176.7	52
0.340	0.086	0.914	3.4305	188.8	55
0.361	0.091	0.909	3.4502	153.5	44

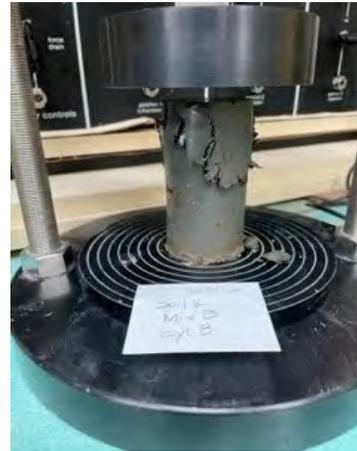
**Unconfined Compression Test Results**

**Laboratory Number:** 23-0206      Tested by: TB/KC  
**Sample ID:** Mix 8 Cylinder 8      Test Date: 4/27/23  
 Soil Description: Soil Mix 2      56 day break  
 Diameter of Sample: 1.998 inches  
 Area of Sample (Ao): 3.135 in<sup>2</sup>  
 Height of Sample (Lo): 3.983 inches  
 Water Content: 81.0%  
 Dry Density: 48.4 lb/ft<sup>3</sup>  
 Height to Diameter Ratio: 2.0  
 Average Rate of Strain: 30%/hour

Deformation Dial Reading (in)	Unit Strain $\epsilon = \Delta L/L_0$	Area CF 1 - $\epsilon$	Corrected Area (in <sup>2</sup> )	Load on Sample (lbs)	Sample Stress (psi)
0.163	0.041	0.959	3.2684	18.3	6
0.172	0.043	0.957	3.2763	31.2	10
0.182	0.046	0.954	3.2850	44.7	14
0.192	0.048	0.952	3.2937	58.0	18
0.201	0.051	0.949	3.3018	70.6	21
0.211	0.053	0.947	3.3103	81.4	25
0.221	0.055	0.945	3.3189	86.2	26
0.231	0.058	0.942	3.3279	88.7	27
0.241	0.060	0.940	3.3368	90.3	27
0.260	0.065	0.935	3.3543	85.5	25
0.281	0.071	0.929	3.3730	84.2	25
0.300	0.075	0.925	3.3906	88.1	26
0.321	0.080	0.920	3.4093	90.9	27
0.340	0.085	0.915	3.4279	92.2	27
0.360	0.090	0.910	3.4464	91.5	27
0.381	0.096	0.904	3.4662	89.8	26
0.400	0.100	0.900	3.4851	82.6	24
