**CONSTRUCTION REPORT
HIDDEN VALLEY LANDFILL
NORTH AREA CLOSURE**

**HIDDEN VALLEY LANDFILL
PIERCE COUNTY, WASHINGTON**

Project No. T02-01.28

CONSTRUCTION REPORT

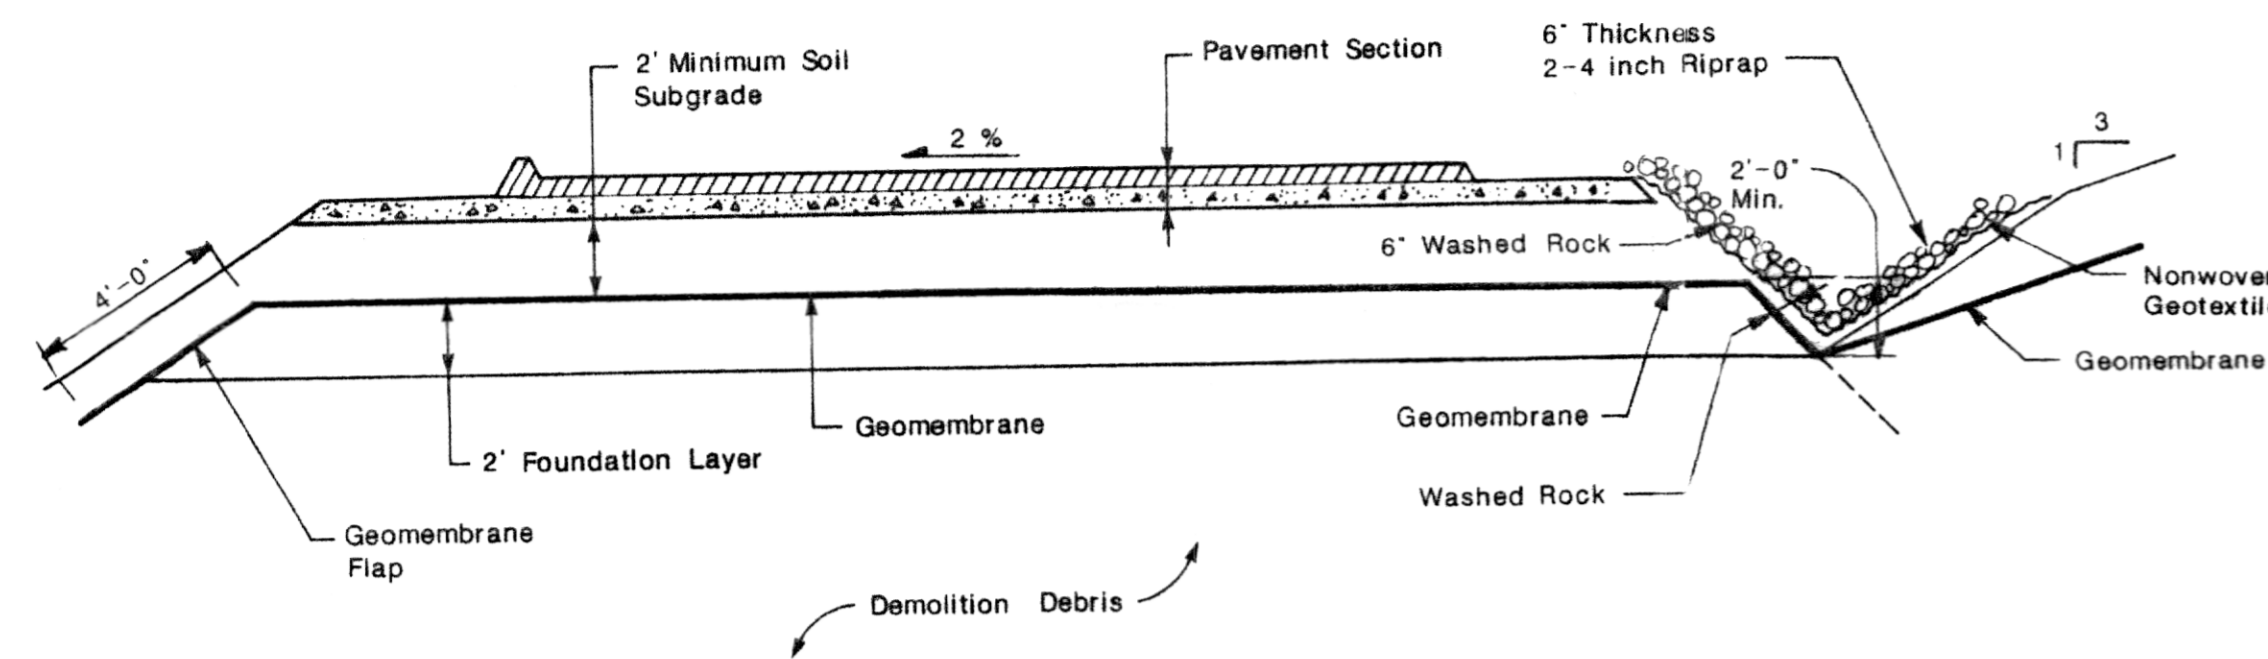
ENTRANCE ROAD SECTION A/2
NTS

NOTE: Geomembrane seams should be oriented perpendicular to the road alignment.

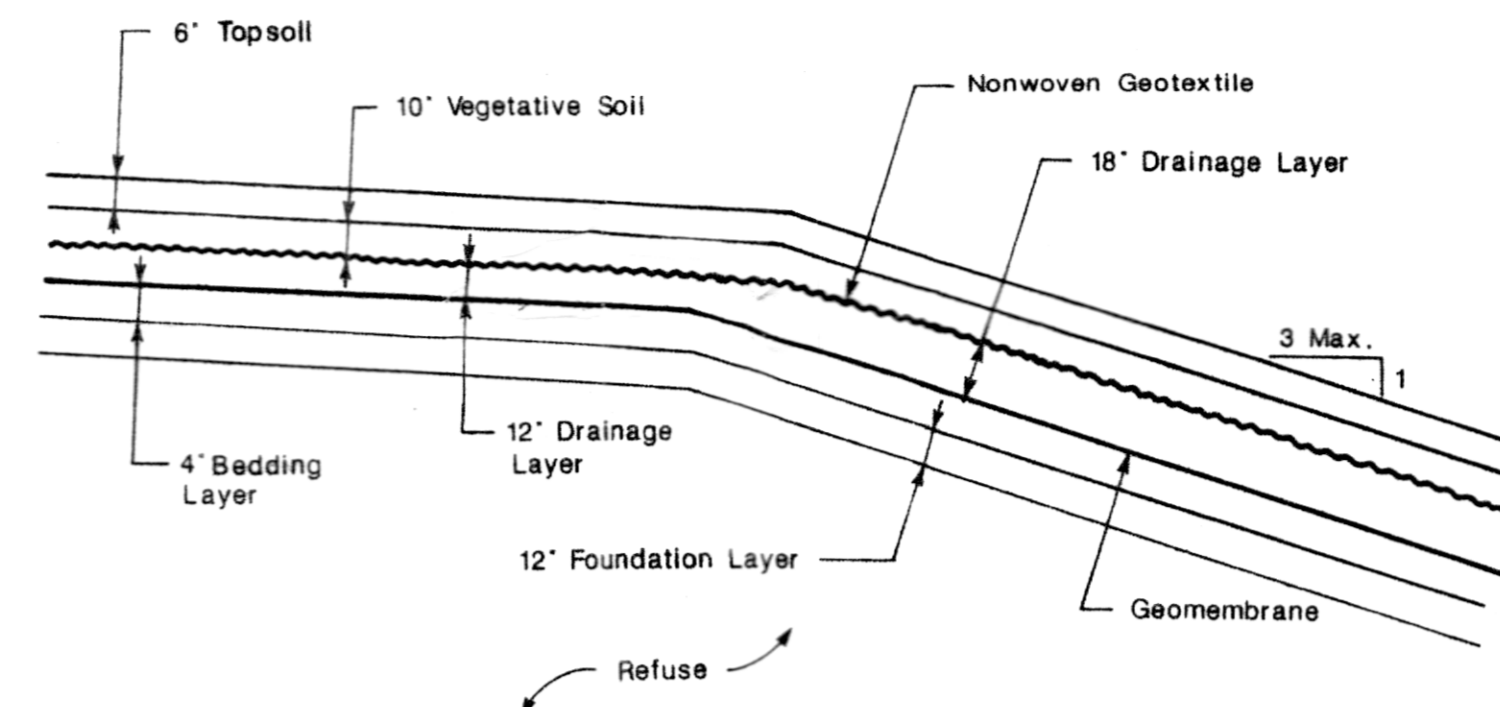
FINAL COVER DETAIL 1
NTS

An "As-Built" cross-section of the final cover is shown on Drawing No. 4, Detail I of the Record Drawings, Appendix A. The geomembrane layer prohibits infiltration of rainfall into the refuse while also blocking gas venting and leachate seep discharges. Erosion of the final cover is controlled by drainage of the water infiltrating through the soils, drainage ditches to divert surface water and vegetation rooted in the topsoil.

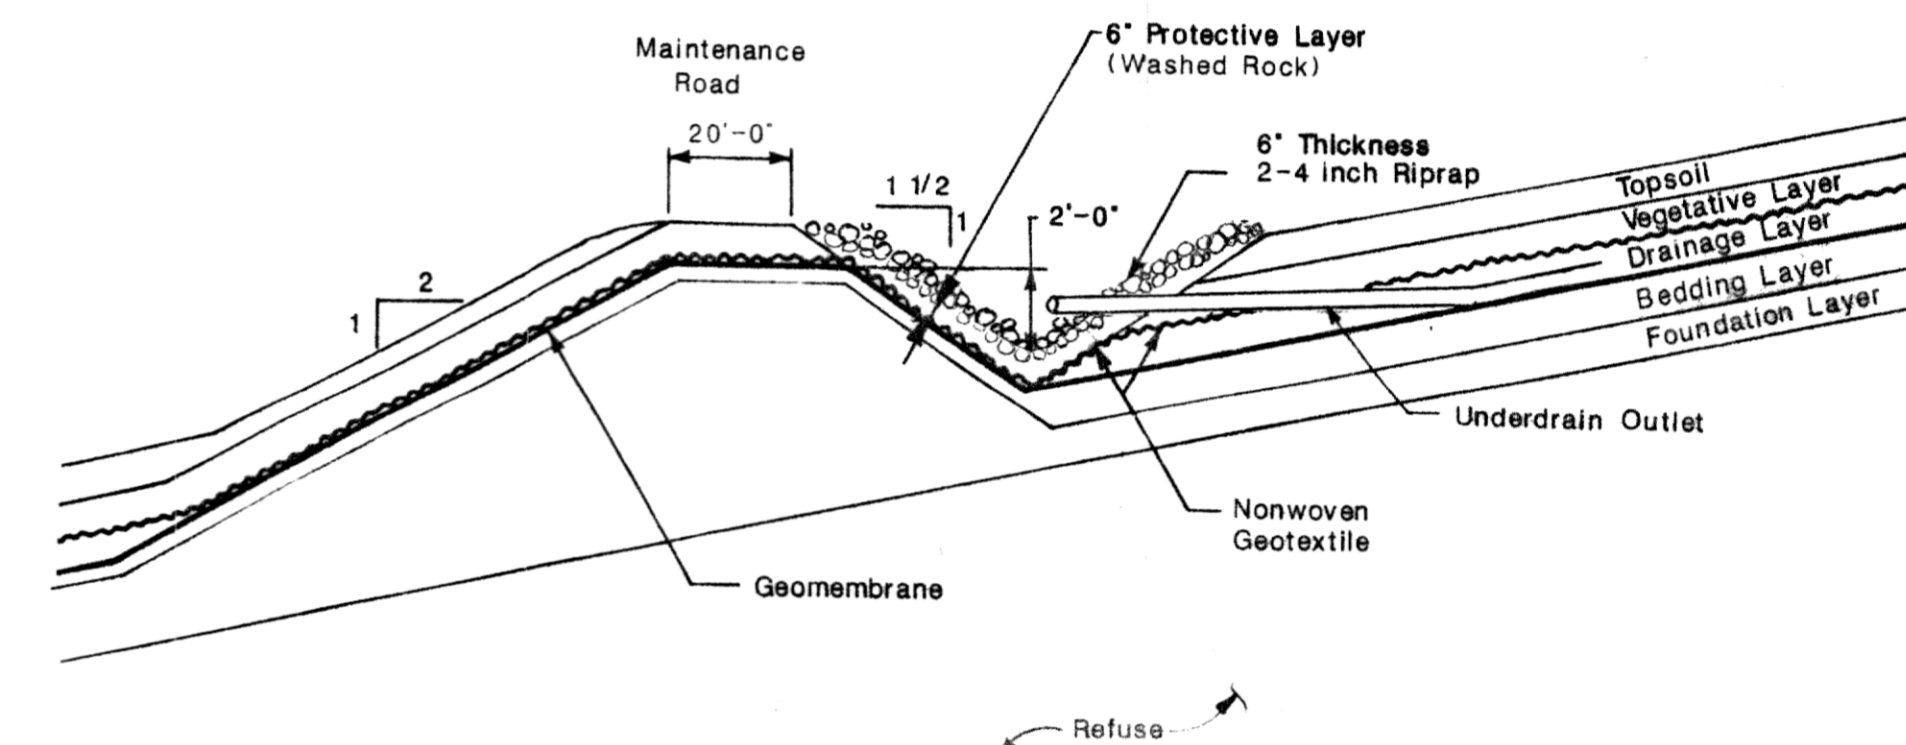
TYPICAL SIDESLOPE DITCH SECTION D/2
NTS

Originally, the design of the slope on the northeast side included two sideslope ditches with foot paths transversing the slope to intercept surface water runoff. However, during construction of the soil buttress in Area 2, these foot paths were widened to full width access roads to allow for equipment access across the face of the slope as shown on Drawing 1. These access road still incorporated drainage ditches on their uphill sides to control surface water as originally designed.

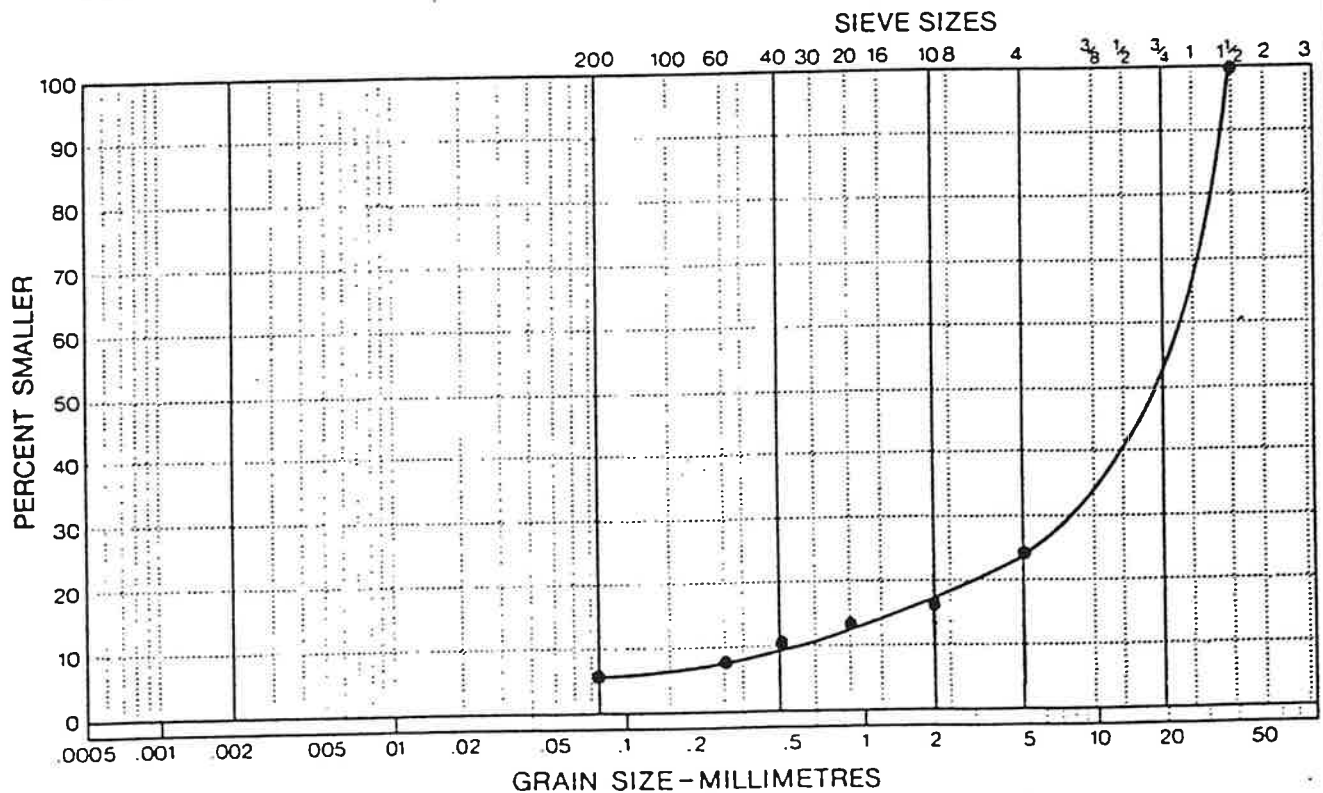
Project: Hidden Valley Landfill Test Hole Number: 2B
 Depth: _____
 Project Number: T-0024 Sample Description _____
 Date Tested: 6-20-89 Gravel: 76.6
 Remarks: Brown, sandy GRAVEL Sand: 17.6
with trace to some silt Silt: 5.8
(Drainage layer). Clay: _____

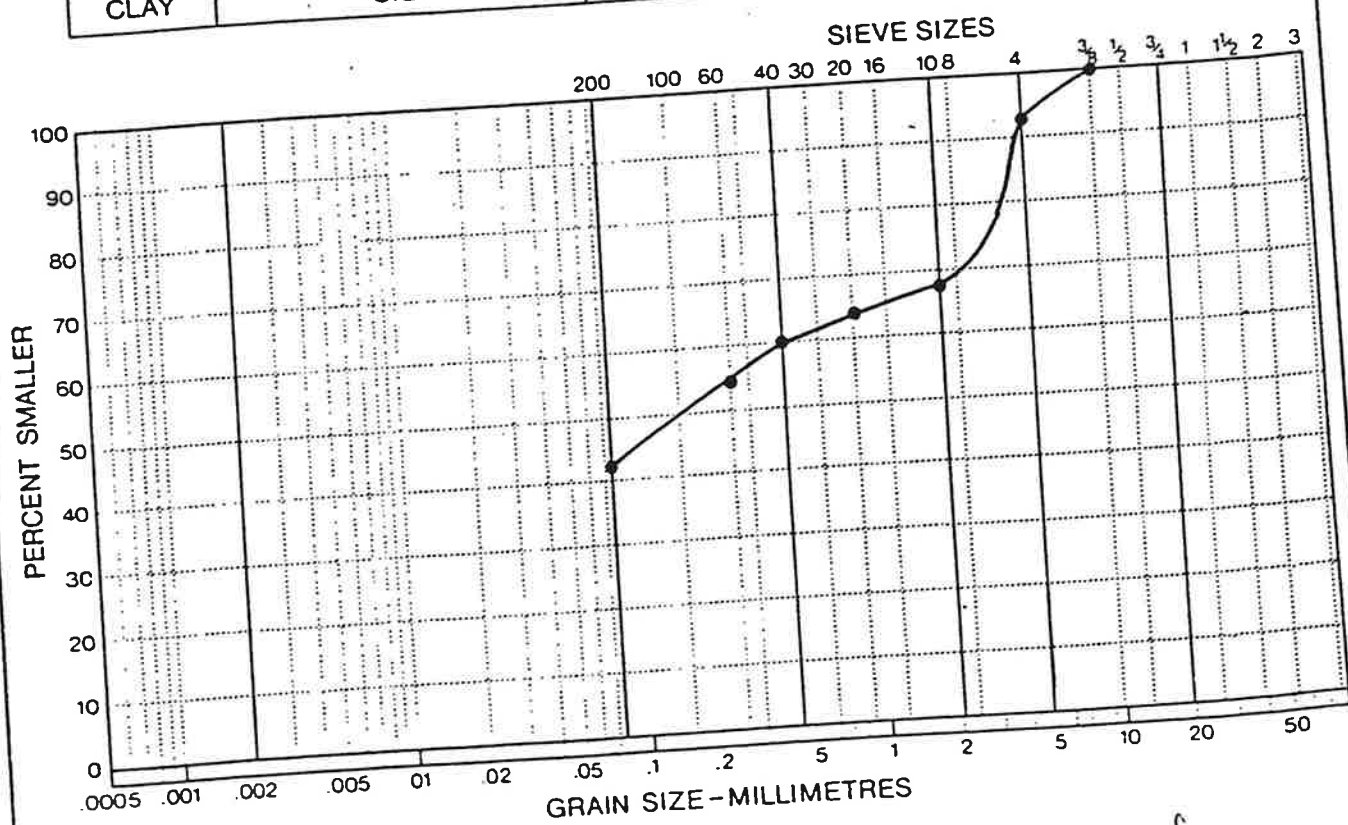
Project: Hidden Valley Landfill Test Hole Number: 3A
 Depth: _____
 Project Number: T-0024 Sample Description
 Date Tested: 6-20-89 Gravel: 7.5
 Remarks: Brown, silty, fine to Sand: 50.5
coarse SAND with some gravel Silt: 42.0
(Foundation layer) Clay: _____

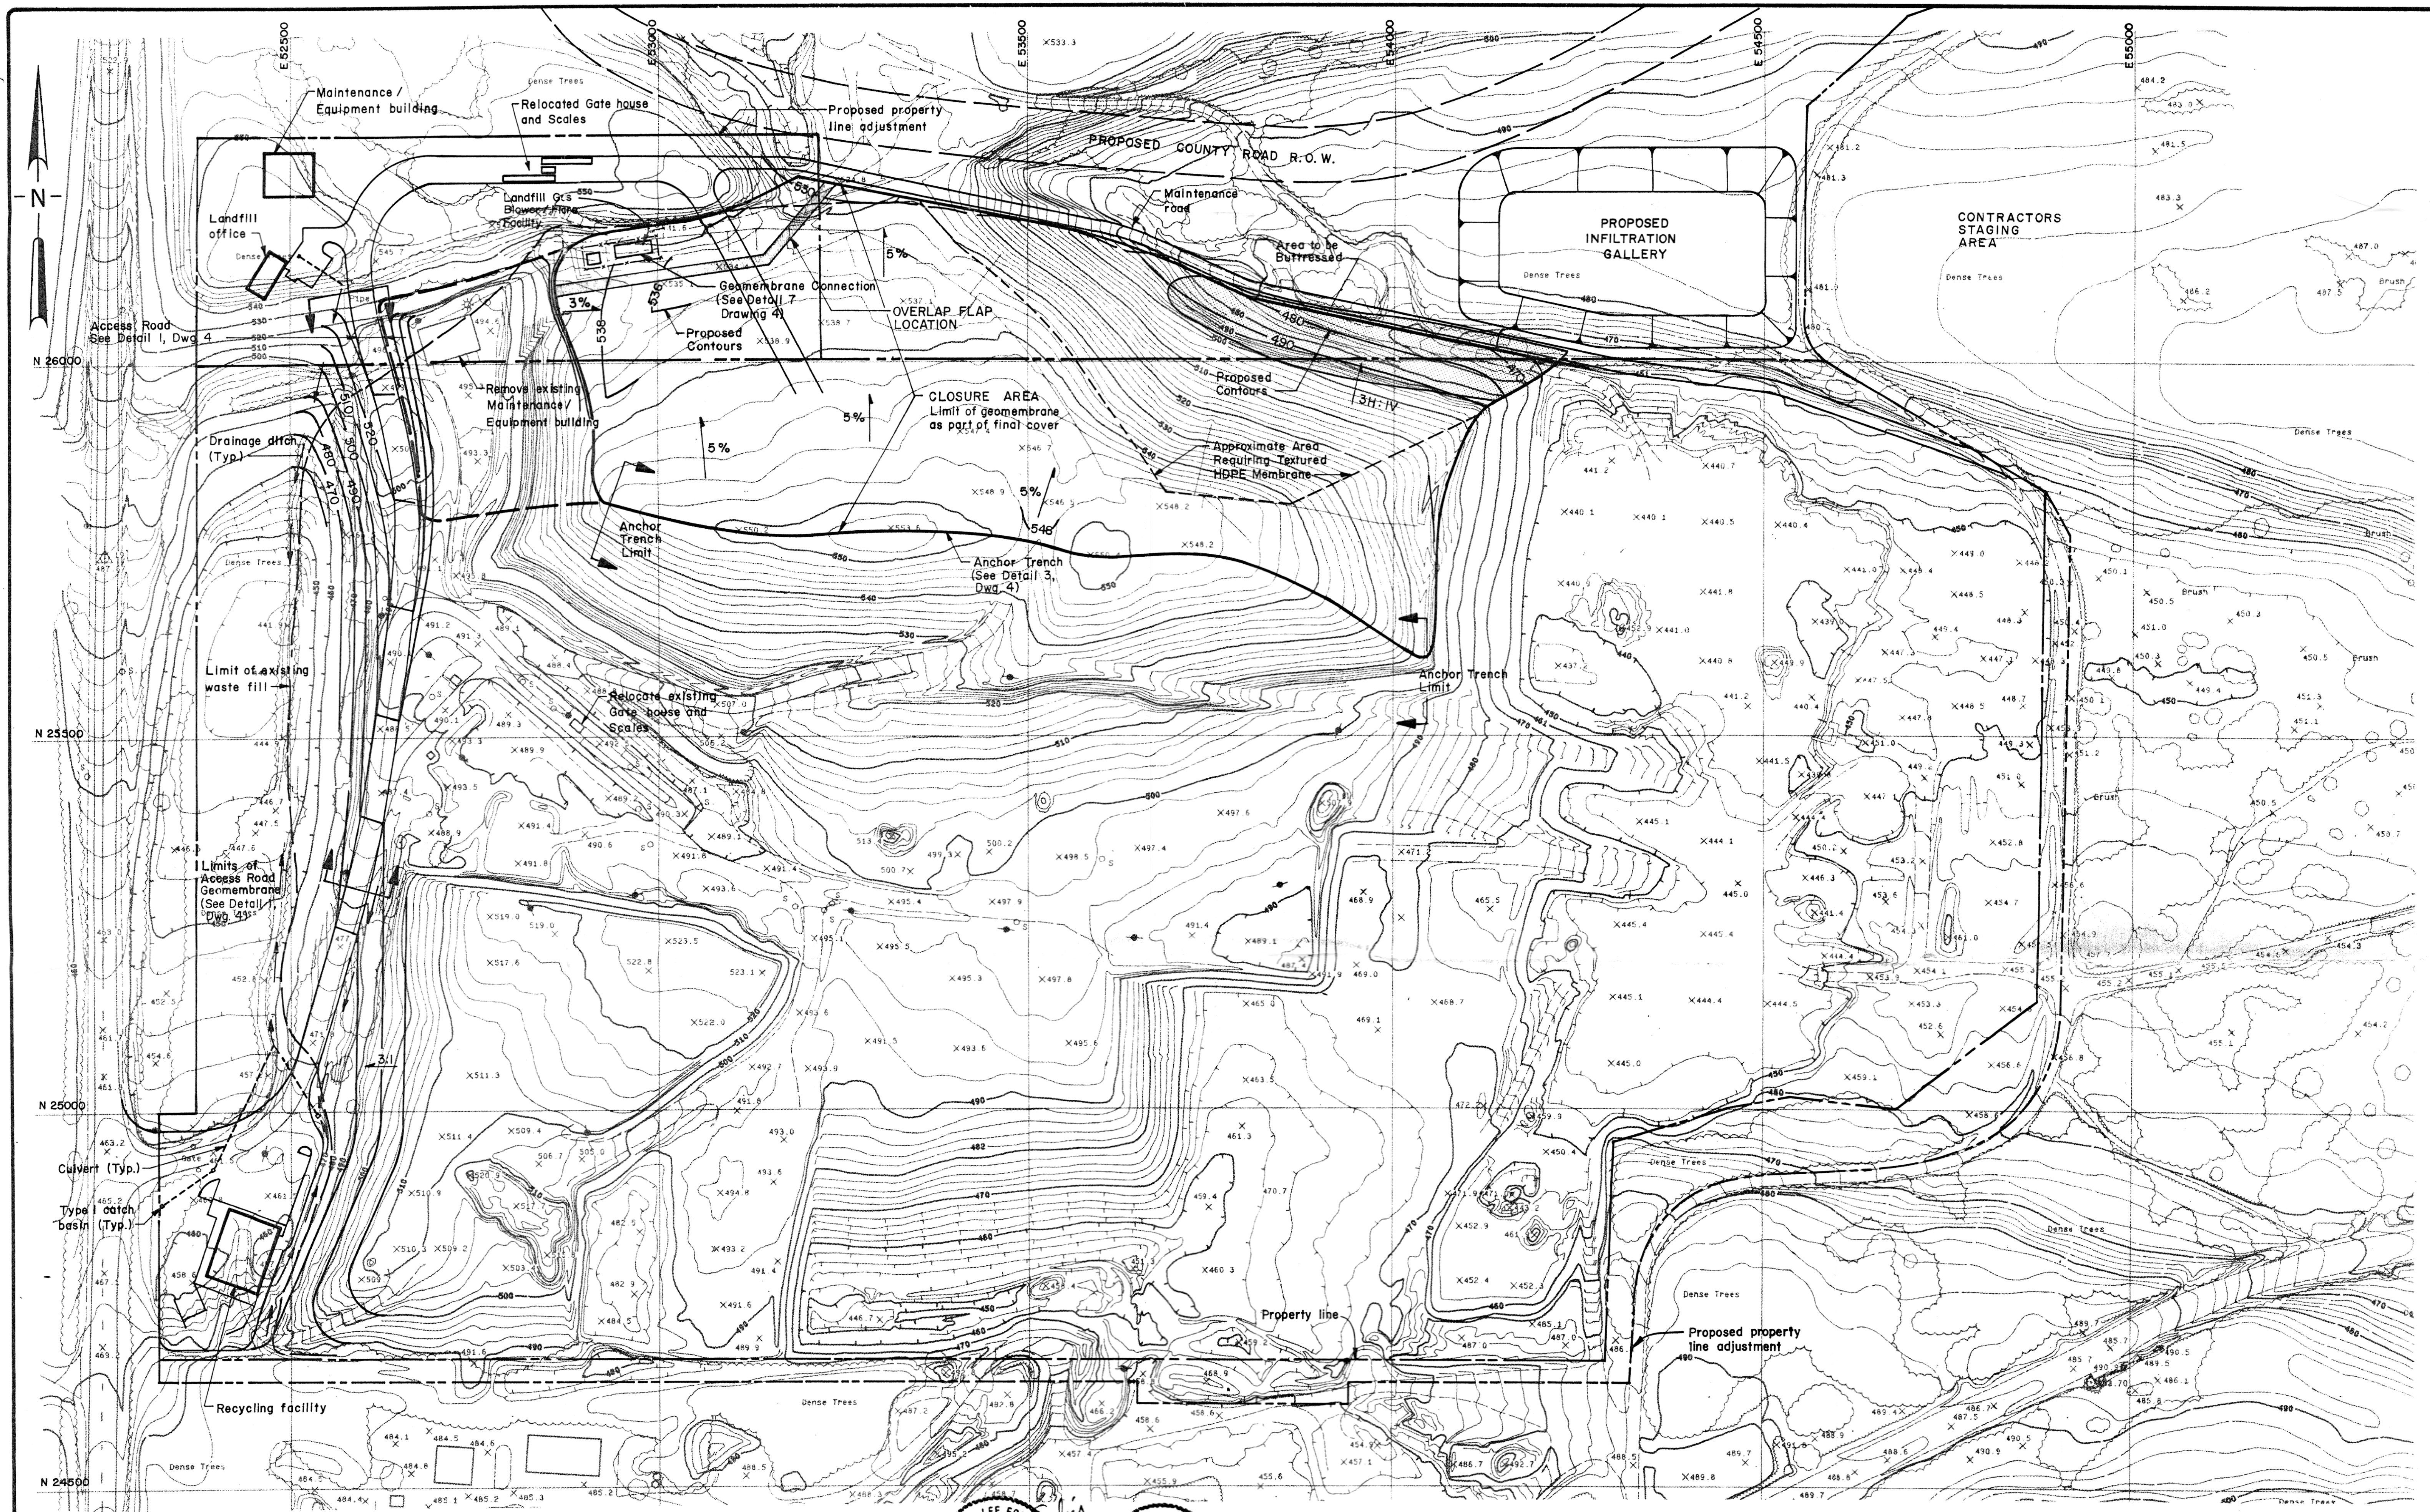
DRAWING NO.
1
PROJECT NO.
T0201.18

Three areas required regrading and/or filling in order to achieve the desired grades and drainage patterns for the closure area as shown on Drawing 1, Appendix A. Area 1 consisted of the central area on the southern margin of the closure. This area was where an old access road transversed the hill up the southern slope and crested the hill through a low point on the ridge. This low point was filled with refuse fill such that the ridge line was more uniform and the surface water drainage was directed to the north. If any surface water was allowed to drain to the south, it would be discharging into future active fill areas.

LAND RECOVERY, INCORPORATED
HIDDEN VALLEY LANDFILL
NORTH AREA CLOSURE
PIERCE COUNTY, WASHINGTON
GRADING PLAN

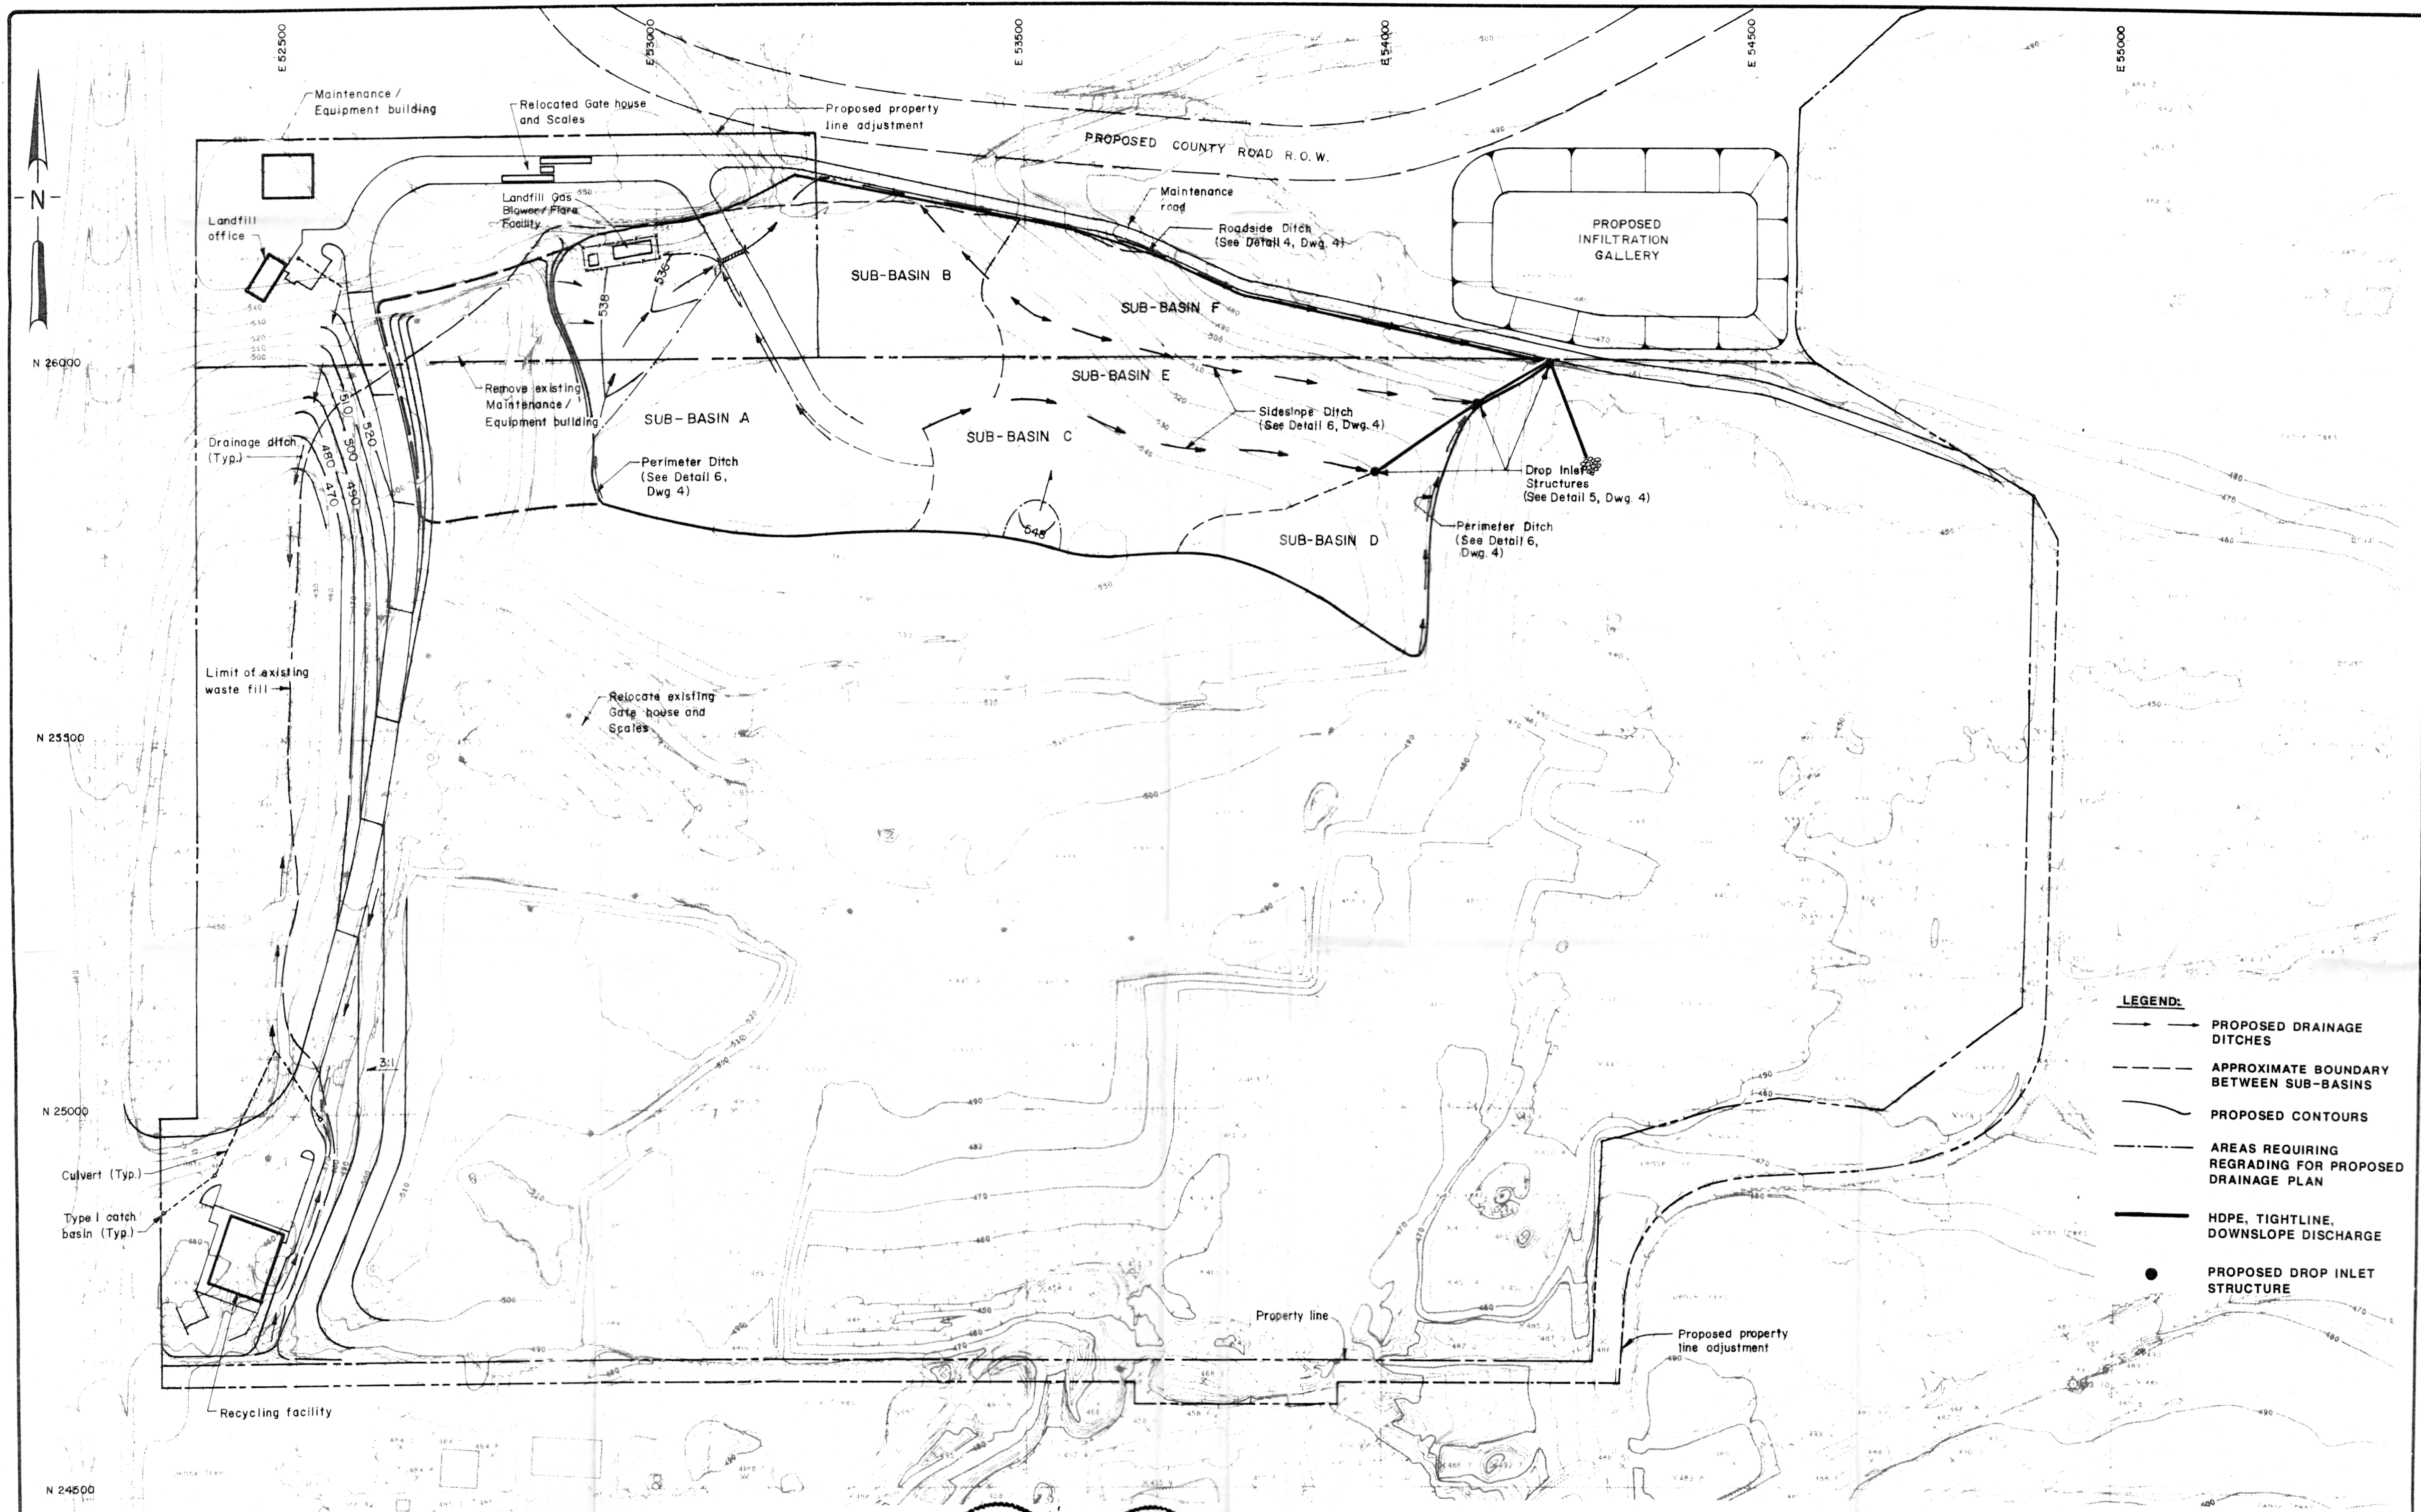
DRAWING NO.
2
PROJECT NO.
T0201.18

Drainage from the site is diverted from five main sub-basins to rock-lined ditches. The ditches for sub-basins A through E, as shown on Drawing 2, Appendix A, direct the runoff to the northeast corner of the closure limits. This runoff drains to the northeast section of the landfill property. Runoff from sub-basin G is diverted to

LAND RECOVERY, INCORPORATED
HIDDEN VALLEY LANDFILL
NORTH AREA CLOSURE
PIERCE COUNTY, WASHINGTON
SURFACE WATER DRAINAGE

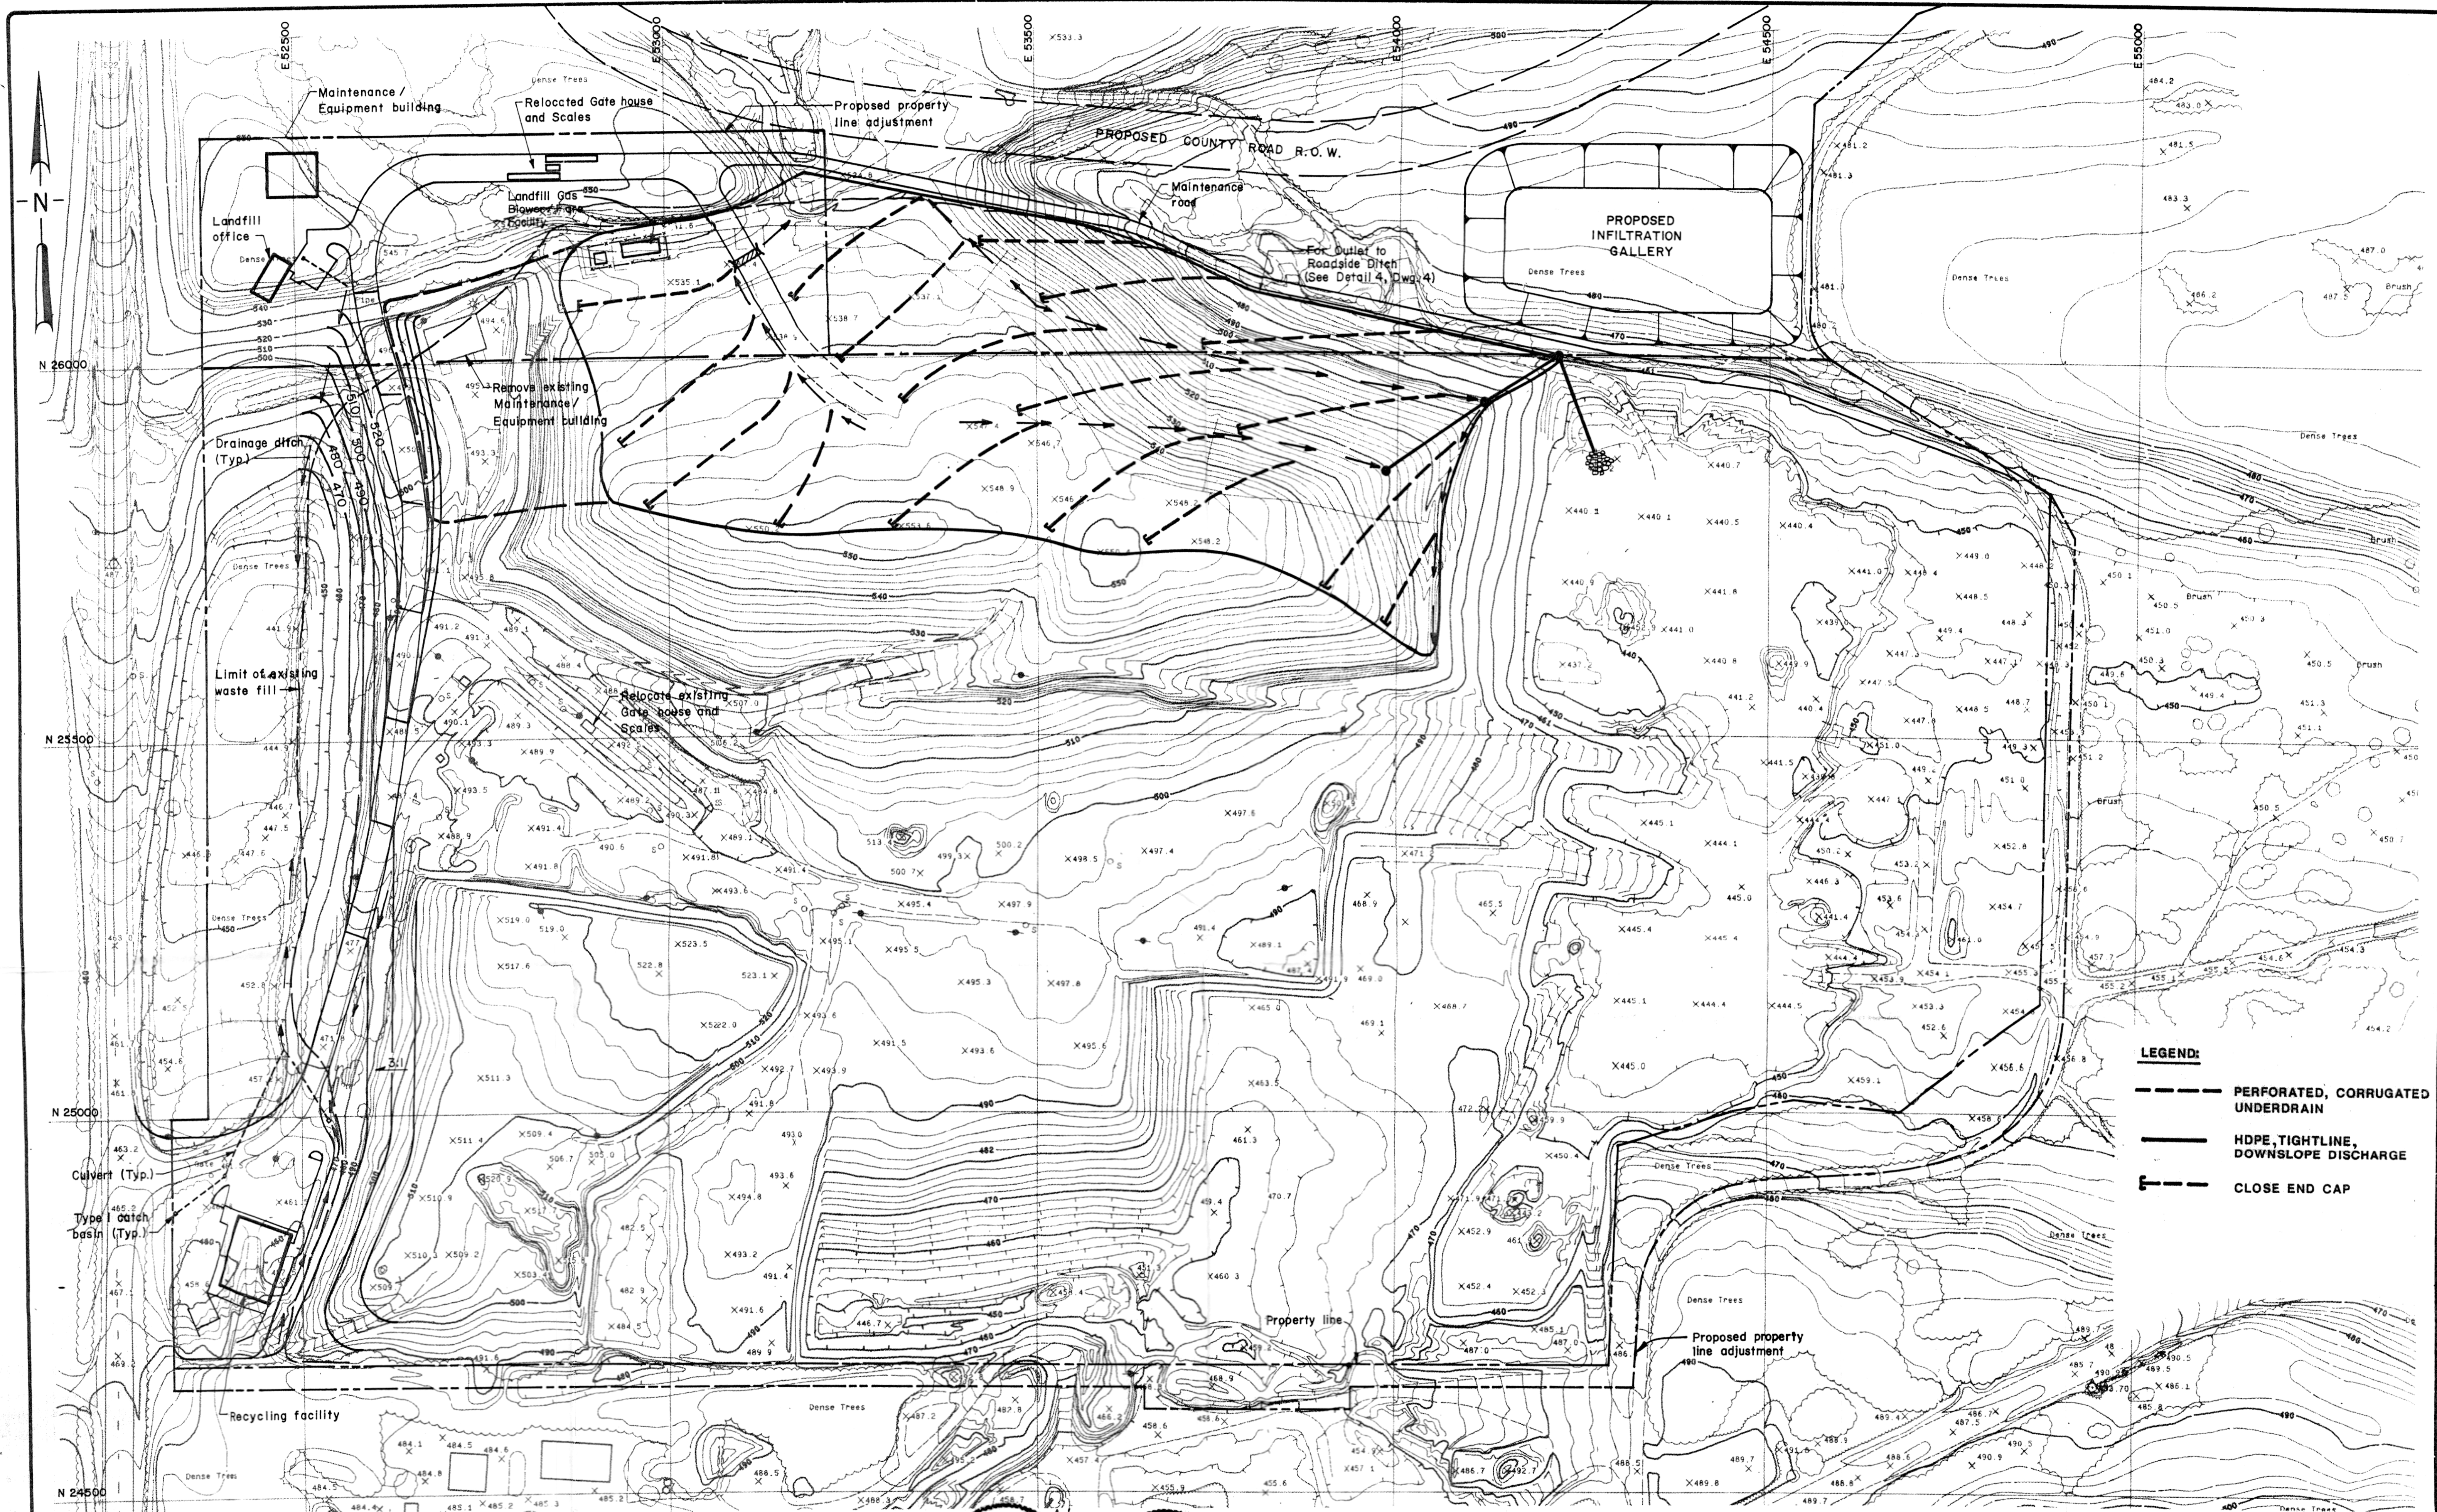
DRAWING NO.
3
PROJECT NO.
T0201.18

In addition to the drainage characteristics of the drainage material, an underdrain system of 3-inch perforated pipe was installed in the drainage layer. The underdrains facilitate the drainage of the cover section at peak flows. Locations of the underdrain piping system can be found in on Drawing 3, Appendix A.

LAND RECOVERY, INCORPORATED
HIDDEN VALLEY LANDFILL
NORTH AREA CLOSURE
PIERCE COUNTY, WASHINGTON
UNDERDRAIN LAYOUT

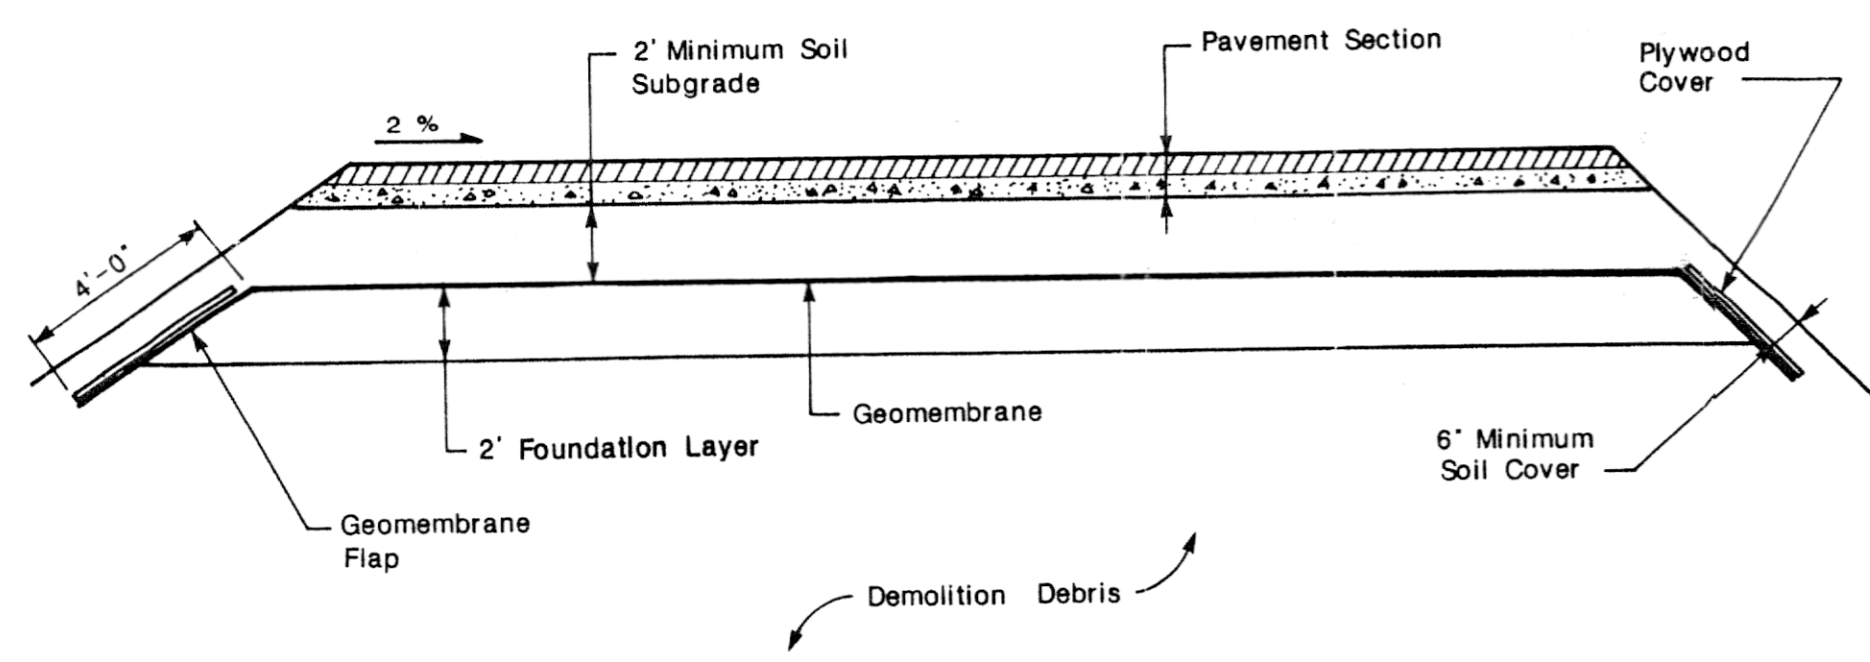
**ENTRANCE ROAD
DETAIL 1**

NOTE: Geomembrane seams should be oriented perpendicular to the road alignment.

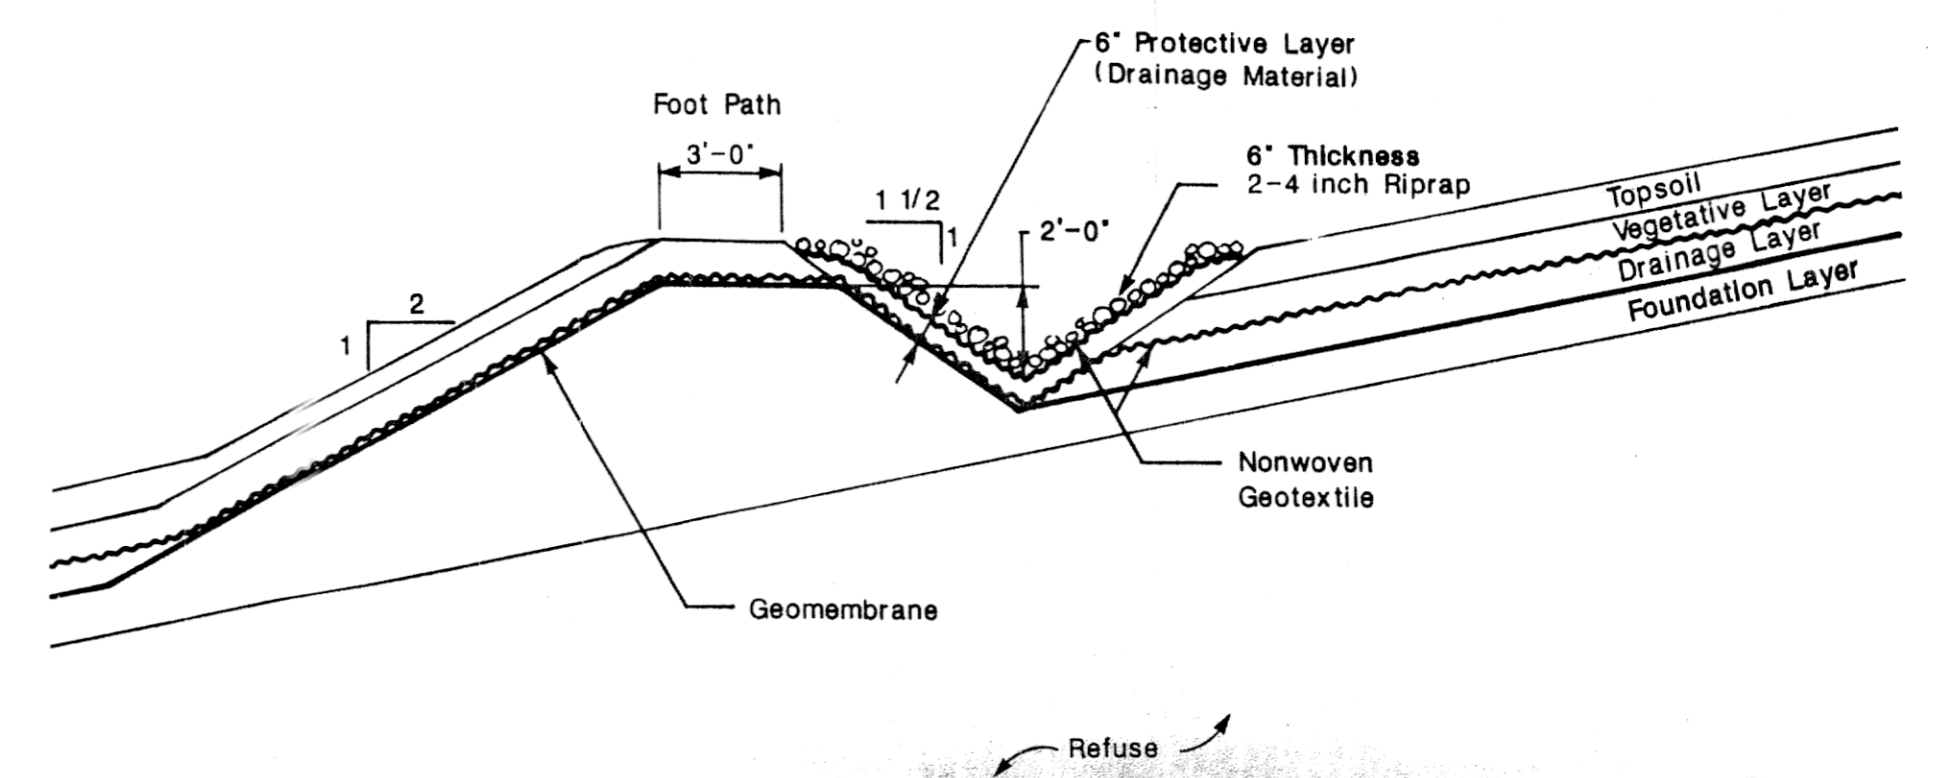
**TYPICAL SIDESLOPE DITCH
DETAIL 6**

NOTE: For perimeter ditch, geomembrane and geotextile is discontinued on downhill side of foot path.
