## **Fifth Five-Year Review**

Sites 302, 303, and 304 and Tank 50

Naval Base Kitsap Manchester,  
Kitsap County, Washington

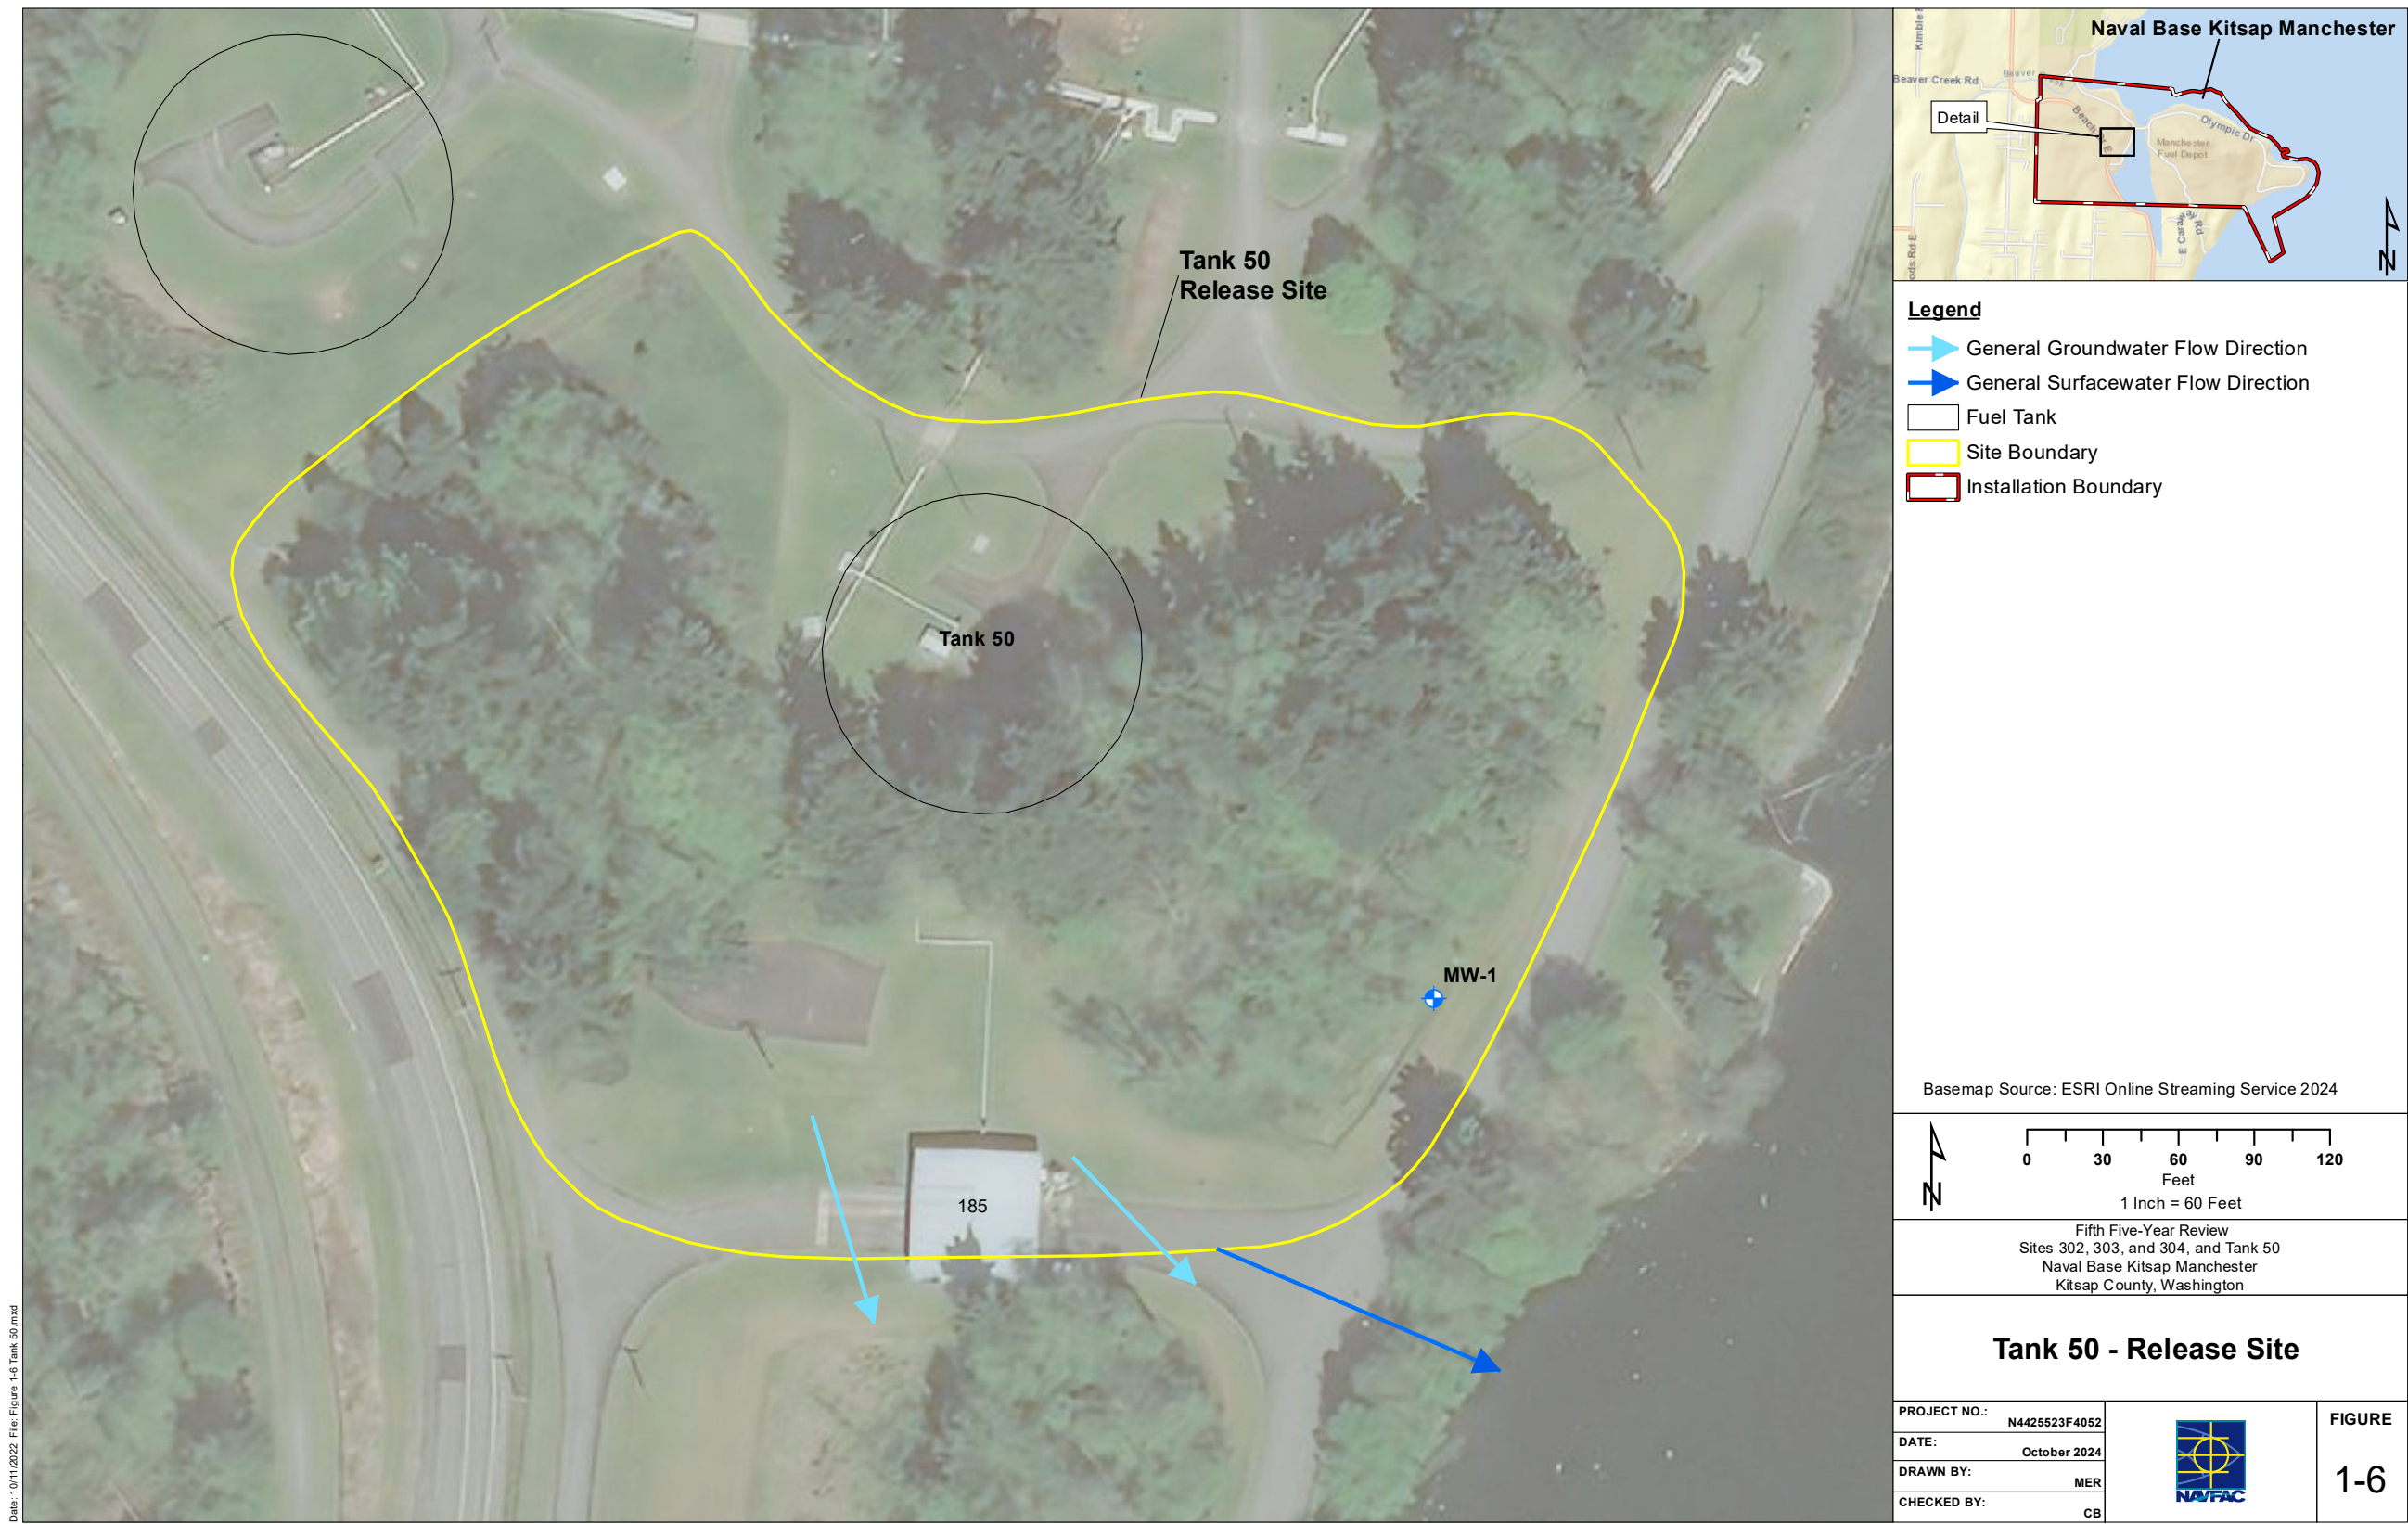
Date: 10/11/2022 File: Figure 1-6 Tank 50.mxd

Tank 50 – UST Release Site (Figure 1-6)	<p>In 1996, discovered a 2-inch diameter hole in the steel wall on the southwest side of tank, 12 feet from the bottom, during cleaning and maintenance activities. A steel patch was welded into the wall of the tank to repair the hole.</p>	<p>Located on the west side of Little Clam Bay.</p> <p>Southernmost tank in a set of four USTs built on the top of a small knoll.</p> <p>Steel cylinder tank approximately 100 feet diameter and 22 feet tall with a capacity of 1.1 Mgal.</p> <p>Field constructed and covered with approximately 4 feet of earthen fill.</p>	<p>Per the NFA letter (Ecology, 1998), petroleum hydrocarbons in soil and groundwater.</p>	<p>Industrial land use/fuel farm.</p> <p>Central portion is open; only piping and housing for tank mechanicals.</p> <p>Periphery slopes steeply to the southeast, south, and southwest and is heavily vegetated with shrubbery and trees.</p> <p>Building 185, a fueling station, is located along the southern boundary.</p>
