# Monthly Progress Report

## **Re: Former Reynolds Metals Remediation – Monthly Progress Report, July 2024**

## Attachment A

### Construction Photographs

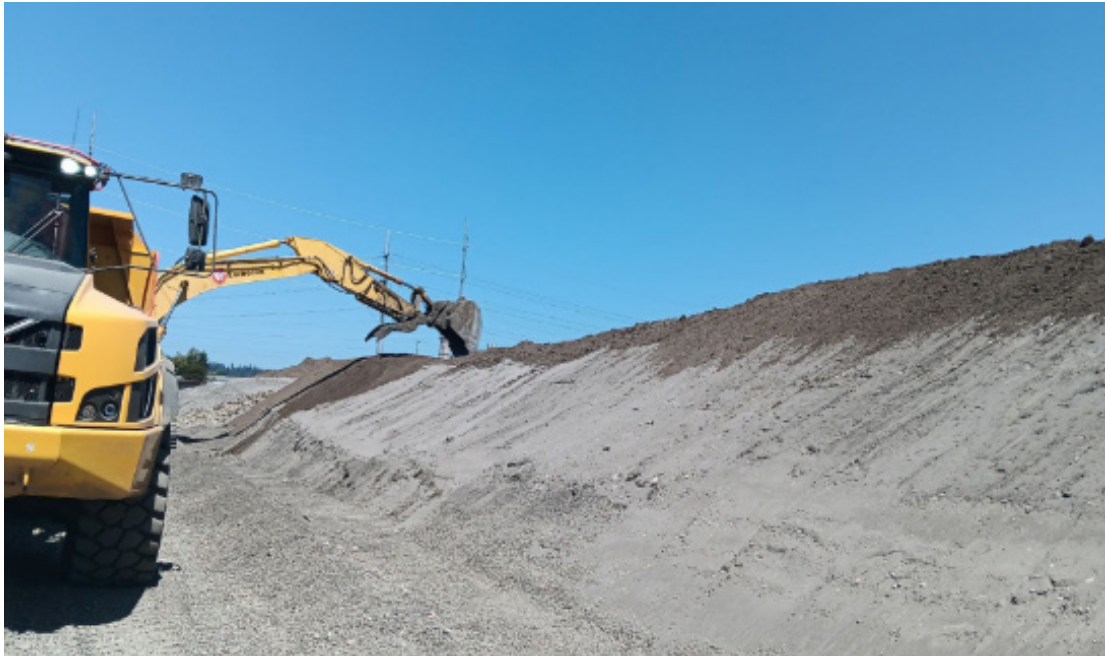
**Photograph 1**  
**East Landfill No. 1**

Topsoil placement along western slope

- A final survey of the seven settlement monuments within East Landfill No. 1 was completed by Envirocon in April 2024.
- Northwest Linings & Geotextile Products, Inc., completed installation of liner and geotextile components of the East Landfill No. 1 in June 2024.
- Envirocon completed topsoil placement of the East Landfill No. 1 low-permeability cap.
- Envirocon continued construction of the East Landfill No. 1 Berth Road perimeter ditch and roadside swale.

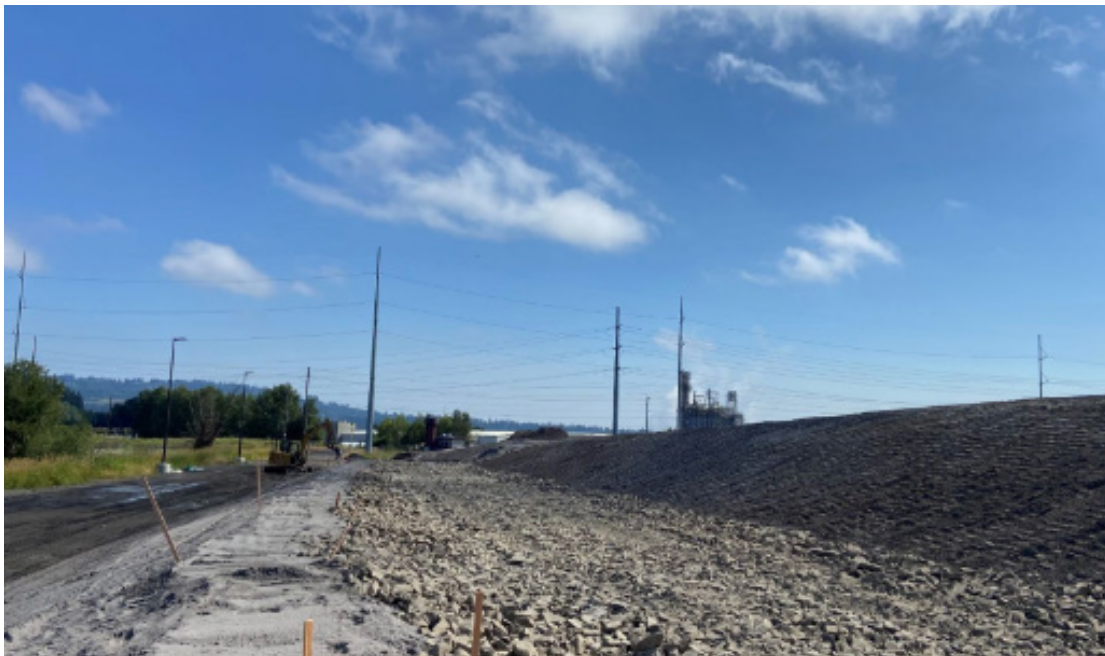
**Photograph 2**  
**East Landfill No. 1**

Perimeter ditch at western corner

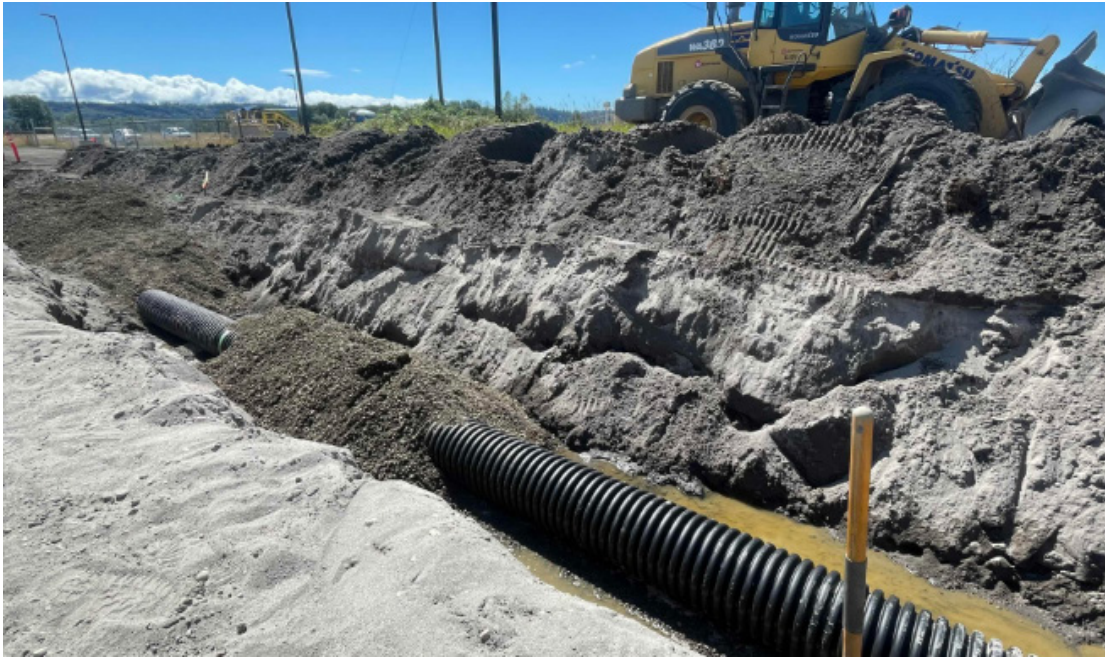
**Photograph 3**  
**East Landfill No. 1**

Installation of 12-inch CPE pipe along Berth Road

- **Stormwater infrastructure**
  - Berth Road stormwater improvements
    - Envirocon installed one Type I catch basin and completed the construction of the 12-inch corrugated polyethylene (CPE) pipe to the existing Pump Station 004 culvert.

- Trenching and backfilling were completed per project specifications. Compaction testing was performed per specifications and the contractor's quality control plan.

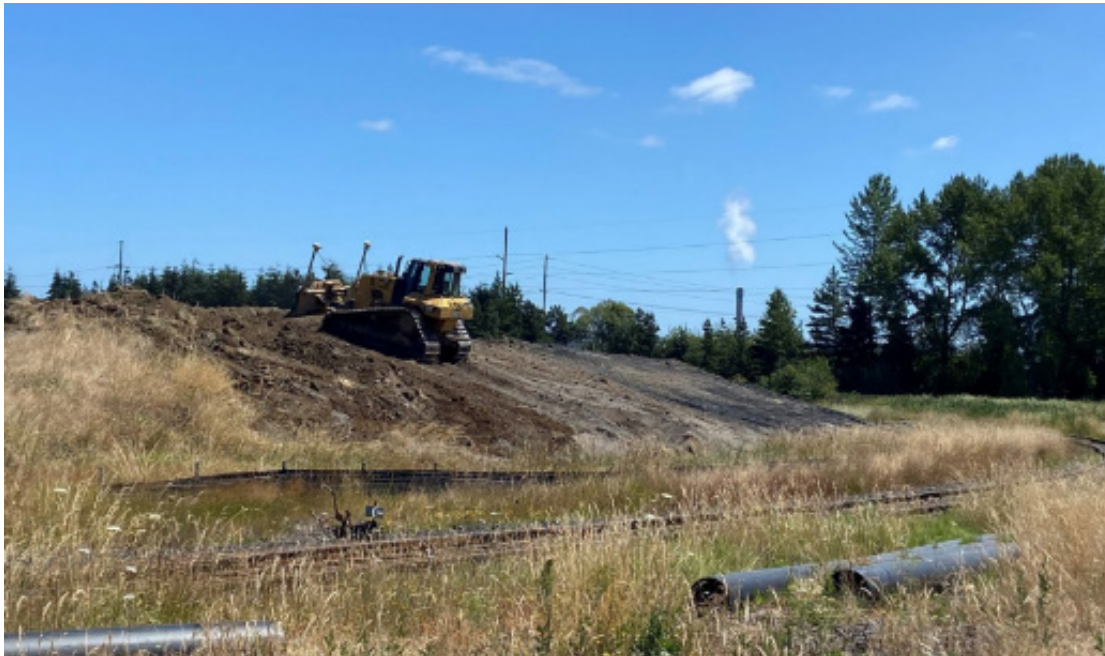
**Photograph 4**  
**East Landfill No. 2**

Regrading southern slope

- SU3
  - Envirocon began preparatory and excavation activities, including the following:
    - Clearing and grubbing of existing ground vegetation and brush
    - Exploratory potholing and excavation to design elevations
- SU4
  - Catwalk and associated infrastructure within easternmost ditch were removed by NWA.
- SU5
  - None this period.
- East Landfill No. 2
  - Envirocon completed grubbing and regrading of slopes and began placement of material excavation from SU3.

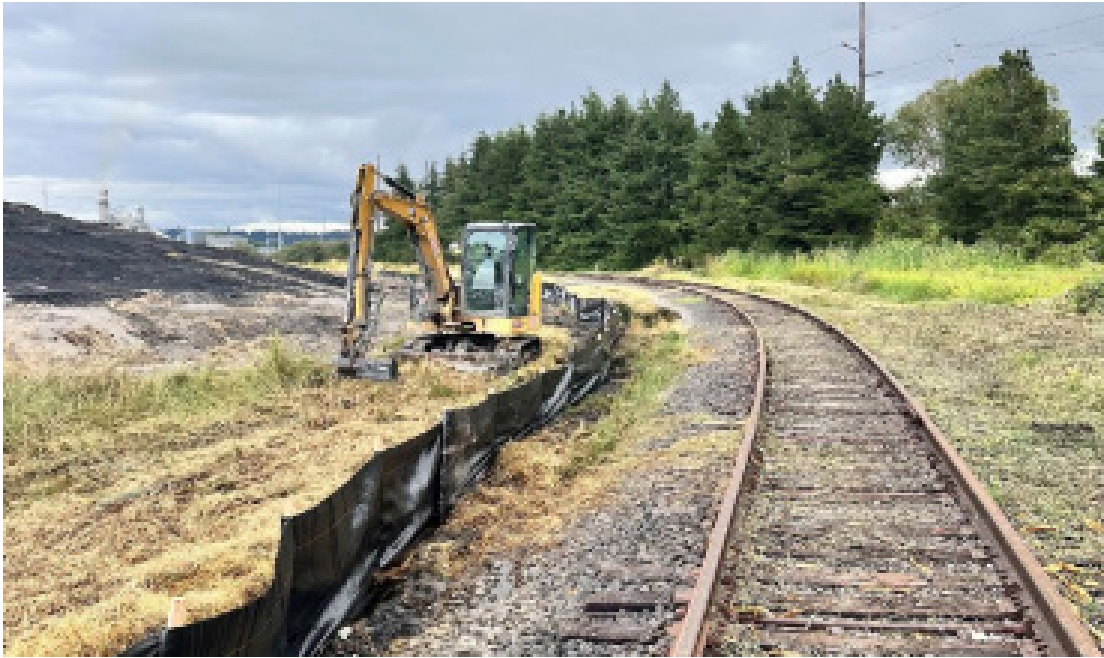
**Photograph 5**  
**East Landfill No. 2**

Silt fence installation along toe of southern slope

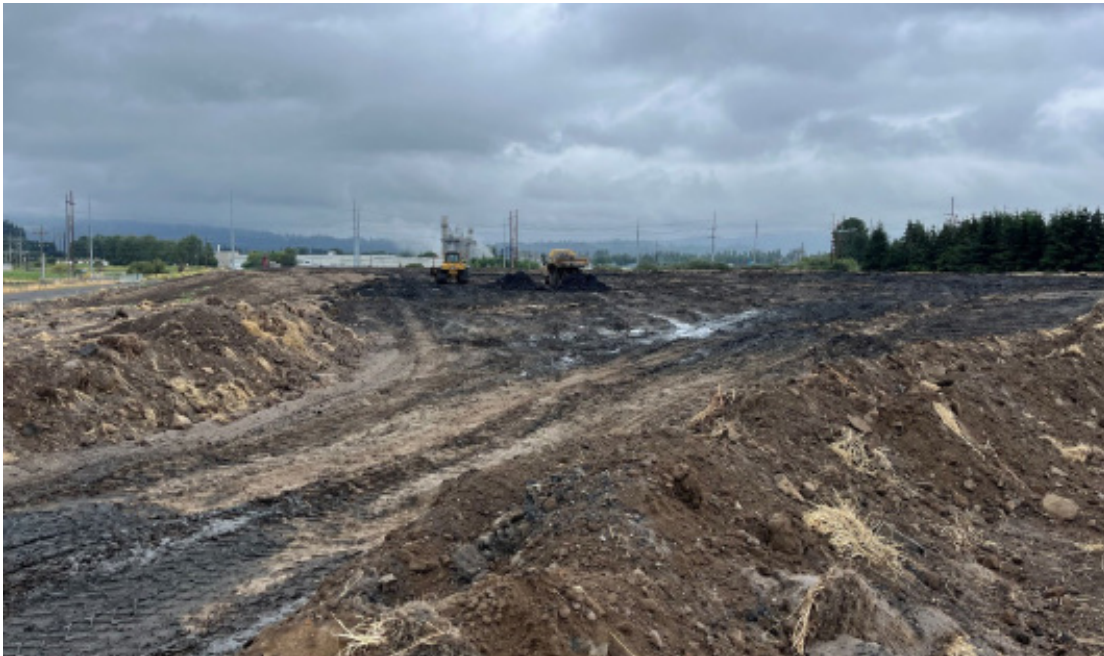
**Photograph 6**  
**East Landfill No. 2**

Grading and consolidation of waste material removed from SU3

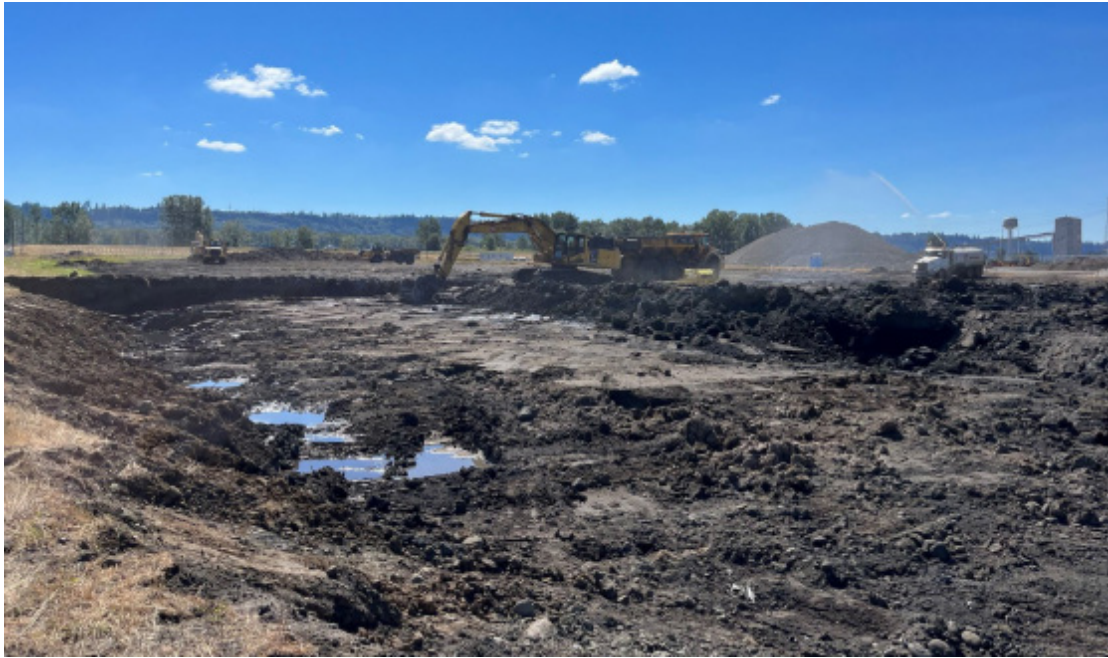
**Photograph 7**  
**Site Unit 3**

Excavation in northeastern quadrant (parallel to Berth Road)

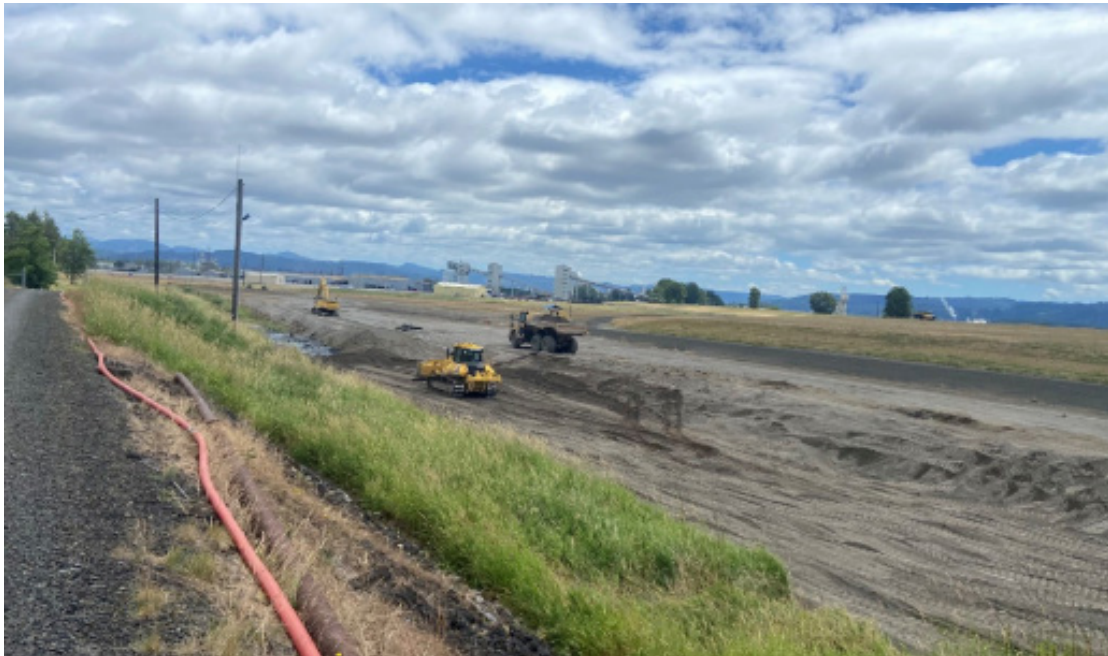
**Photograph 8**  
**U-Ditch**

Placement and grading of general fill

- Work within the West Landfill and SU2 was completed in September 2023.
    - Envirocon completed final regrading of the U-Ditch, including the following:

- Grades below design elevations within the main ditch were backfilled with general fill.
      - Fine grading in the western extents was adjusted to discharge toward the U-Ditch and emulate pre-construction flow patterns.

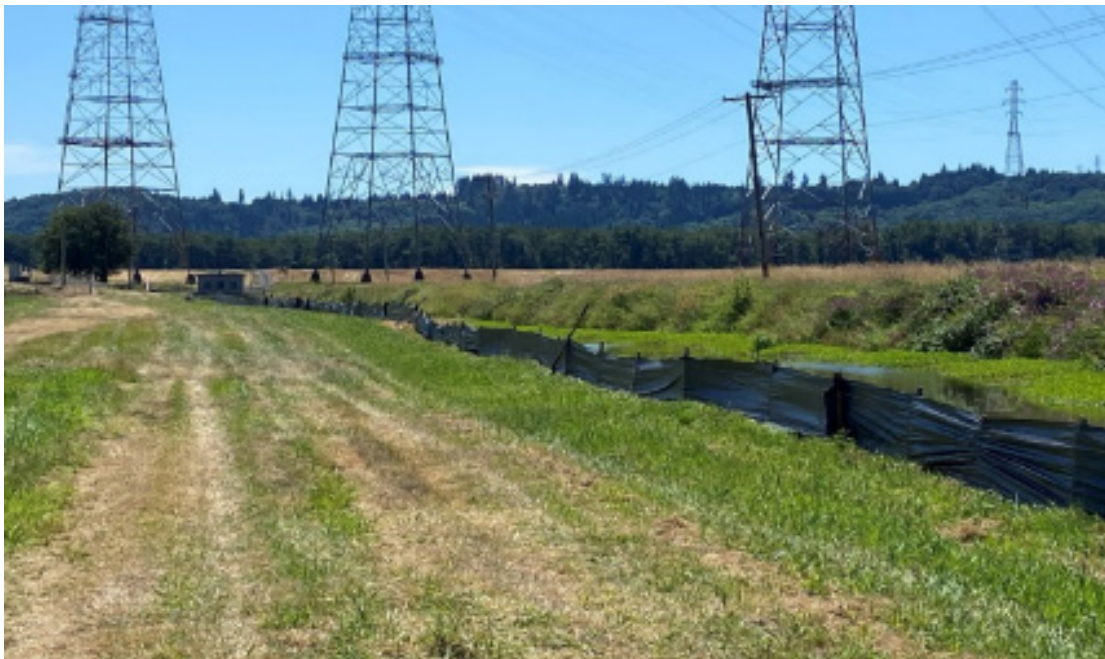
**Photograph 9**  
**Permeable Reactive Barrier**

Silt fence installation along segment 1 (looking south)

- **Installation and maintenance of temporary controls and facilities**
  - Installation and maintenance of temporary erosion and sediment control (TESC) best management practices (BMPs)
    - Envirocon, Inc.,<sup>1</sup> performed site-wide dust suppression control.
    - Envirocon installed silt fence along the PRB alignment and extended the silt fence around the southern slope of East Landfill No. 2.
  - Observations and monitoring of performance for TESC BMPs
    - Envirocon performed daily stormwater inspections, as documented in their construction stormwater site inspection forms, and maintenance on existing TESCOs.
  - Changes or improvements to temporary access and staging facilities
    - Envirocon received, inspected, and stockpiled import pea gravel, coarse sand, and general fill at the West Staging Area and topsoil and general fill at the East Staging Area.

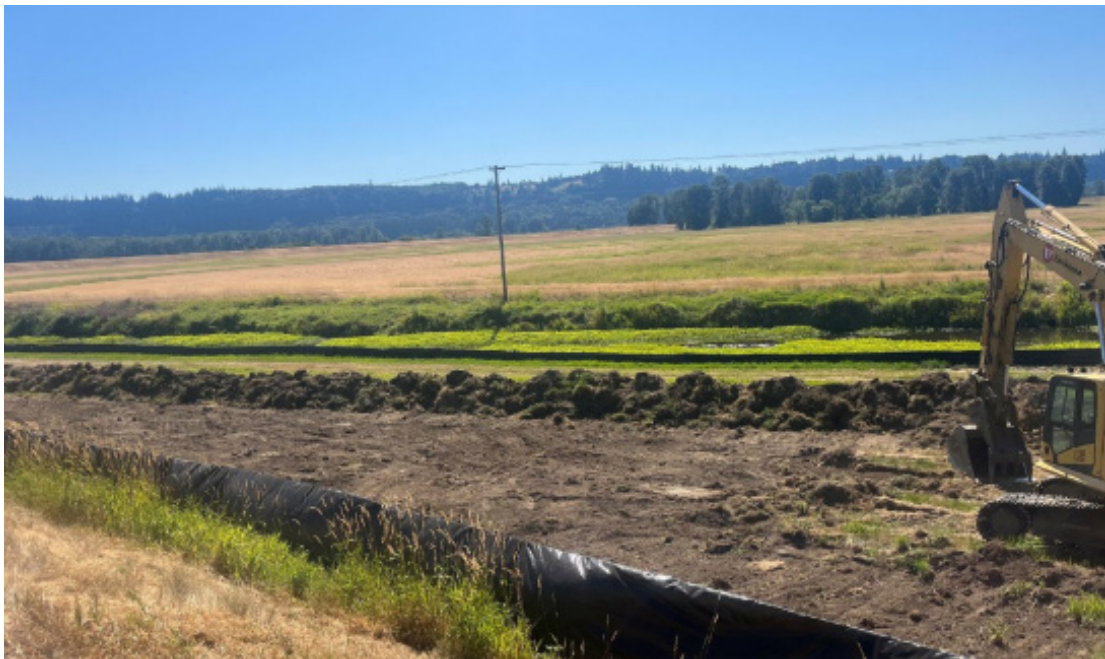
**Photograph 10**  
**Permeable Reactive Barrier**

Preliminary ground leveling along segment 1

- Work was completed in October 2023.
- **Cap placement**
  - Refer to the previous West Landfill and East Landfill discussions.
- **Permeable reactive barrier installation**
  - Envirocon continued preparation work within the limits of the permeable reactive barrier, including the following:
    - Tree removal along Segment 2 alignment
    - Chain-link fence removal along Segment 1 alignment
    - Construction of access road and work pad between segments
    - Preliminary grading and ground leveling

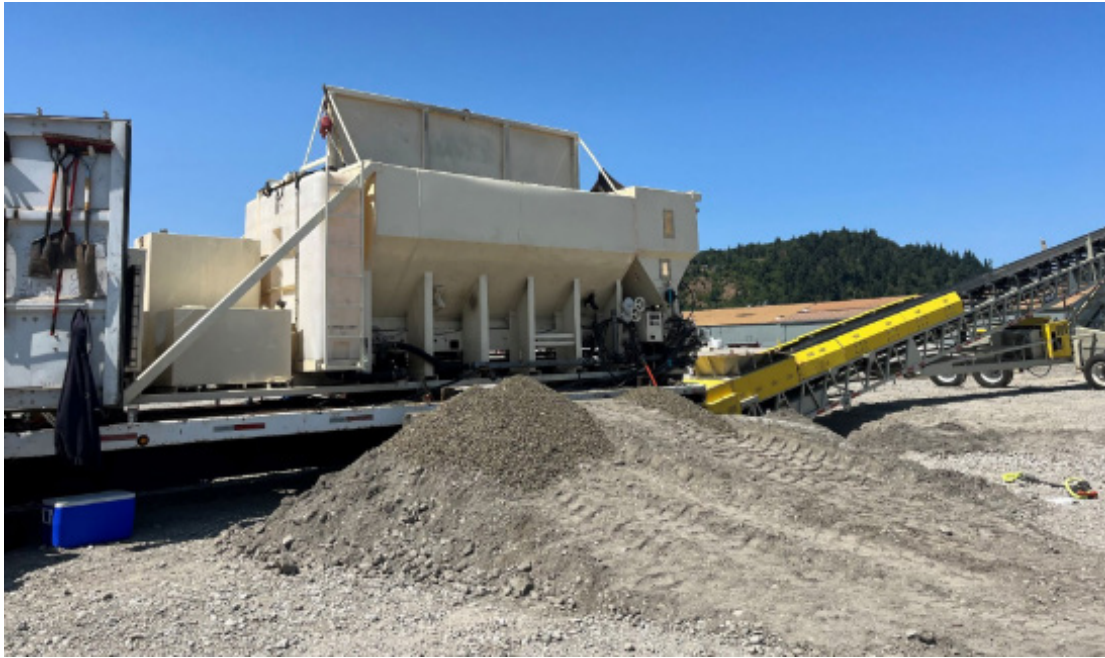
**Photograph 11**  
**East Staging Area**

Mixer and conveyer mobilization and startup

- Reactive backfill mixing equipment was delivered to the East Staging Area.
  - Tsunami Mixing began mixing and stockpiling 3.4% dosage for use in Site Unit (SU) 3.

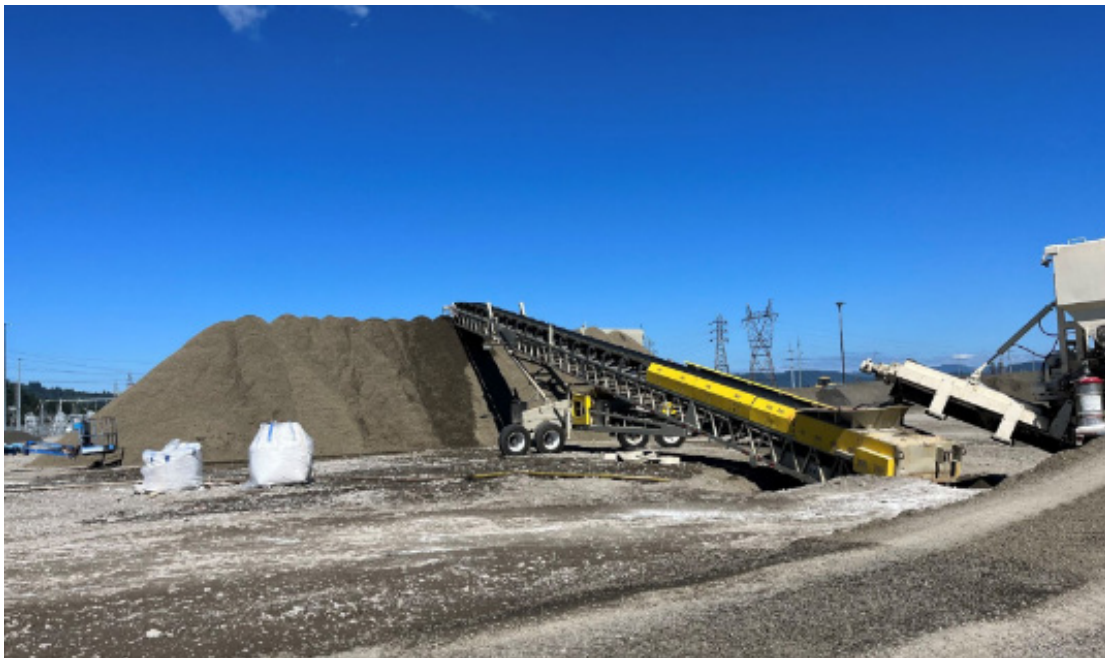
**Photograph 12**  
**East Staging Area**

Mixing 3.4% dosage reactive backfill for use in SU3
