Monthly Progress Report

June 19, 2024

Re: **Former Reynolds Metals Remediation – Monthly Progress Report, May 2024**

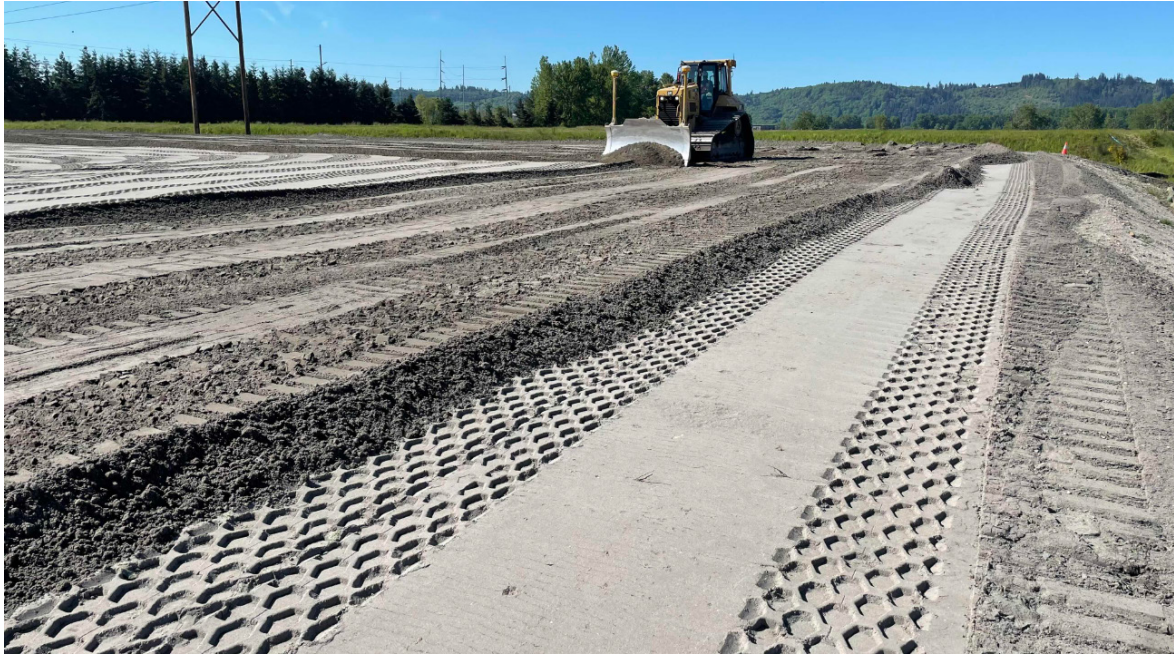
Photograph 1
East Landfill No. 1

Season 2 regrading – general fill

- Envirocon removed the Season 1 drainage channel from East Landfill No. 1 and completed Season 2 regrading of the subgrade. Existing general fill over consolidated waste was regraded, and additional general fill was used to meet elevation and slope requirements. The final surface was proof-rolled with a smooth-drum compactor.

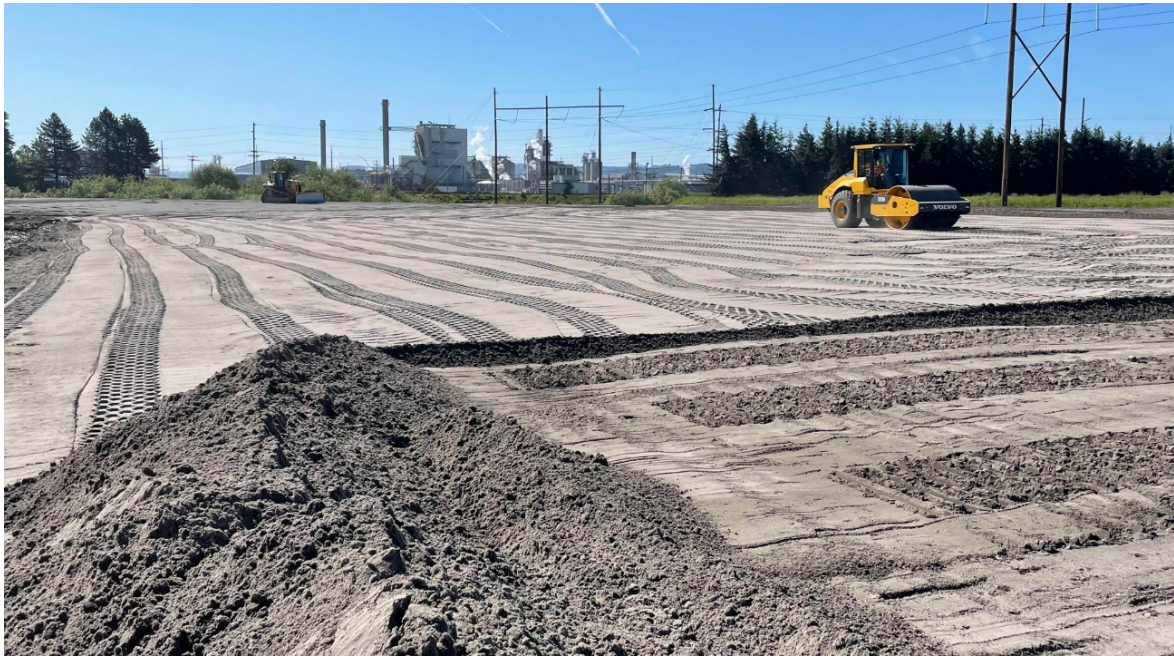
Photograph 2
East Landfill No. 1

Proof-rolling general fill final grade

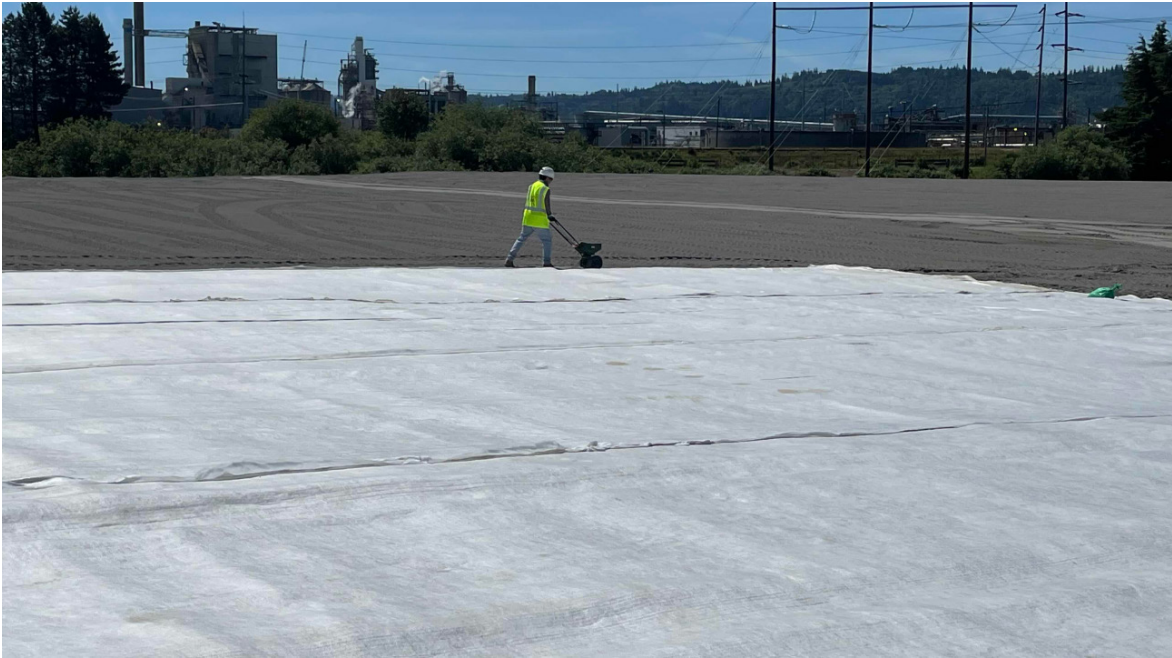
Photograph 3
East Landfill No. 1

Placement of granular bentonite at GCL seams

- Northwest Linings & Geotextile Products, Inc., began deploying the geosynthetic clay layer (GCL) over general fill in East Landfill No. 1. Seams were sealed with granular bentonite at 9-inch overlaps as per project specifications.

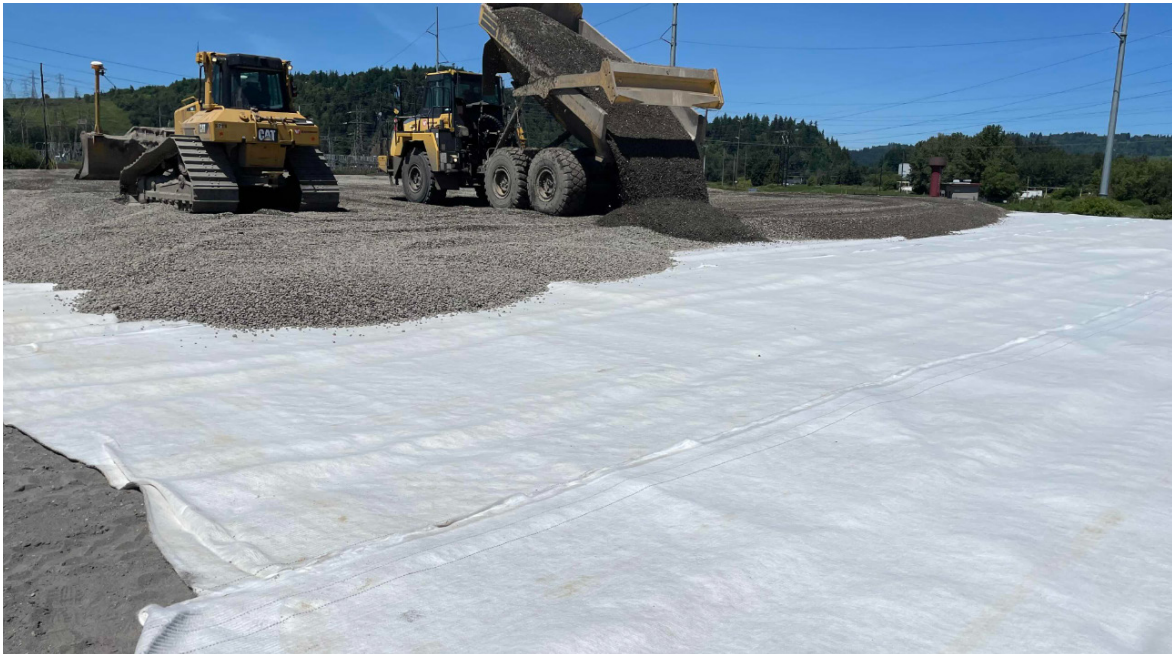
Photograph 4
East Landfill No. 1

Placement and distribution of drainage layer material over GCL

- Envirocon began placing drainage layer material over the GCL membrane.
 - **Site Unit 9, Site Unit 11, and Diesel Aboveground Storage Tank (AST) Area**

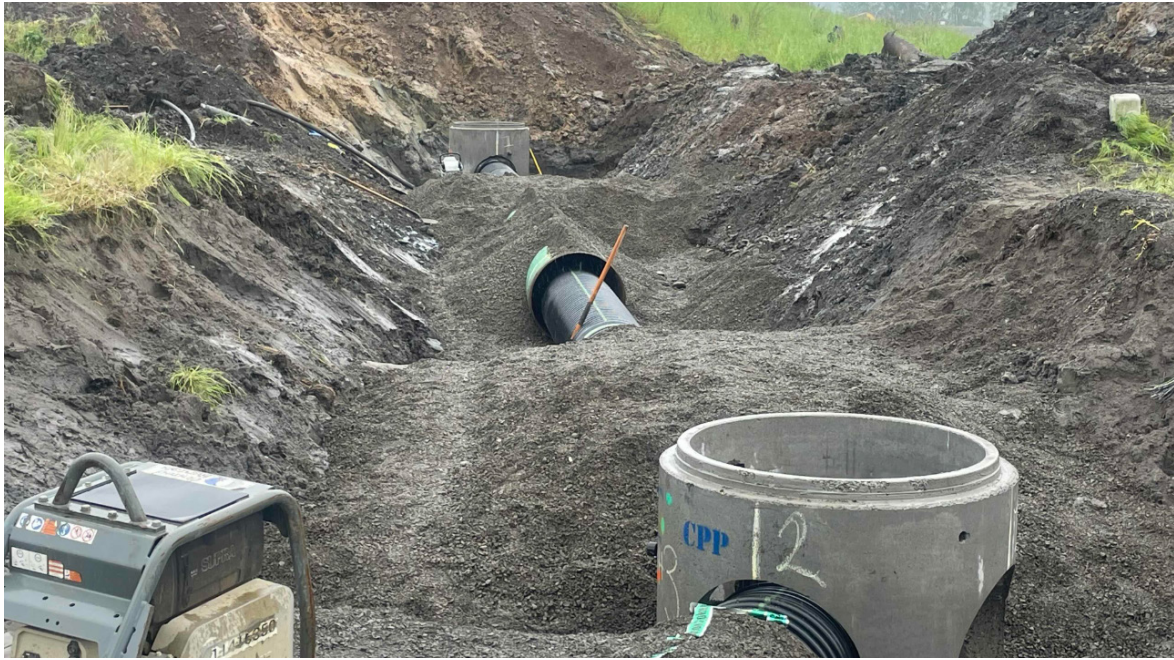
Photograph 5
Berth Road Stormwater Improvements

Installation of 48-inch manholes at Stations D0+05 and C0+12, 24-inch CPE pipe, and 30-inch steel pipe casing

- **Stormwater infrastructure**
 - Berth Road Stormwater Improvements
 - Envirocon installed Season 2 facilities, including the following:
 - 48-inch Type I manholes at stations D0+05, C0+12, and D1+194

- Debris racks on manholes at stations D0+05 and D1+194; grate on manhole at station C0+12
 - 24-inch CPE pipe connections to manholes in East Landfill perimeter ditches

- 30-inch steel pipe casing under railroad between East Landfills
 - 24-inch CPE outlet pipe connection to Season 1 stub
 - Trenching and backfilling were completed per project specifications. Compaction testing was performed per specifications and the contractor's quality control plan.

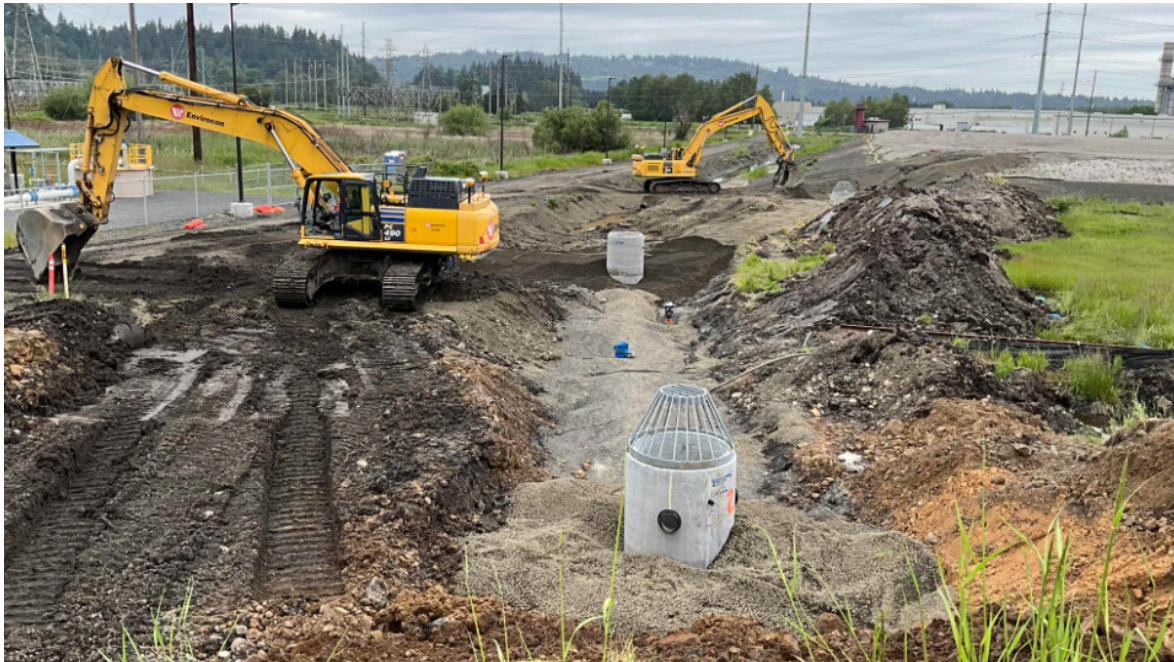
Photograph 6
Berth Road Stormwater Improvements

Placement of select fill over 24-inch CPE pipe

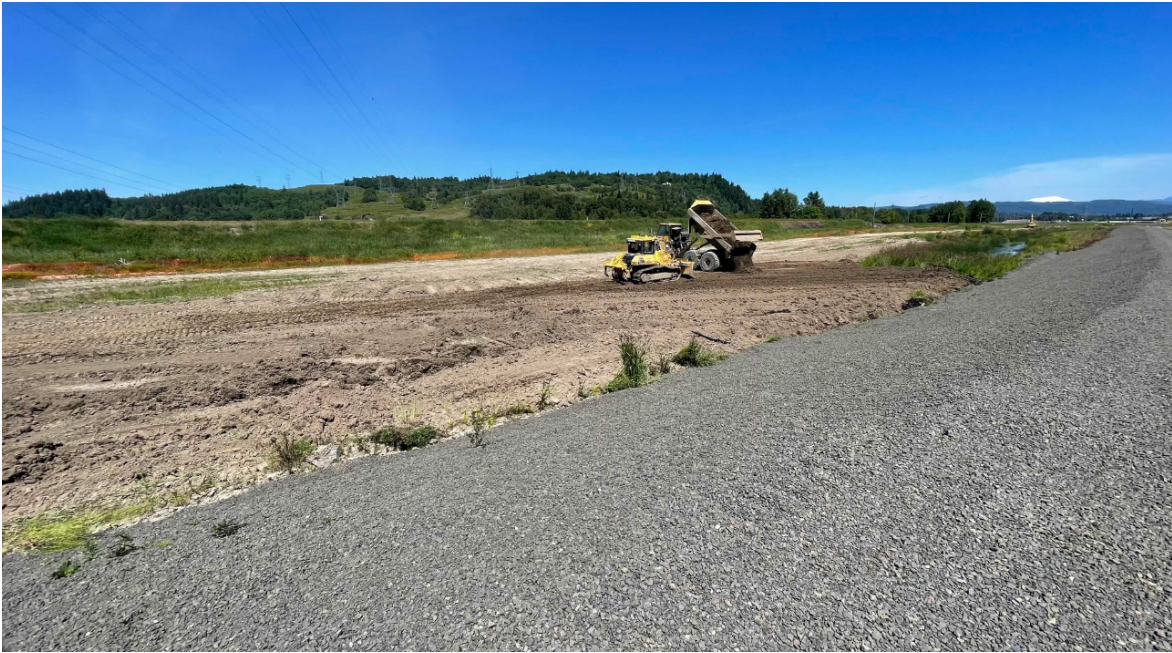
Photograph 7
U-Ditch

Start of final regrading

- Envirocon began final regrading of the U-Ditch.
 - **Site Unit 8, Site Unit 10, and East Landfill No. 1**
 - Work in SU8 and SU10 was completed in September 2023.

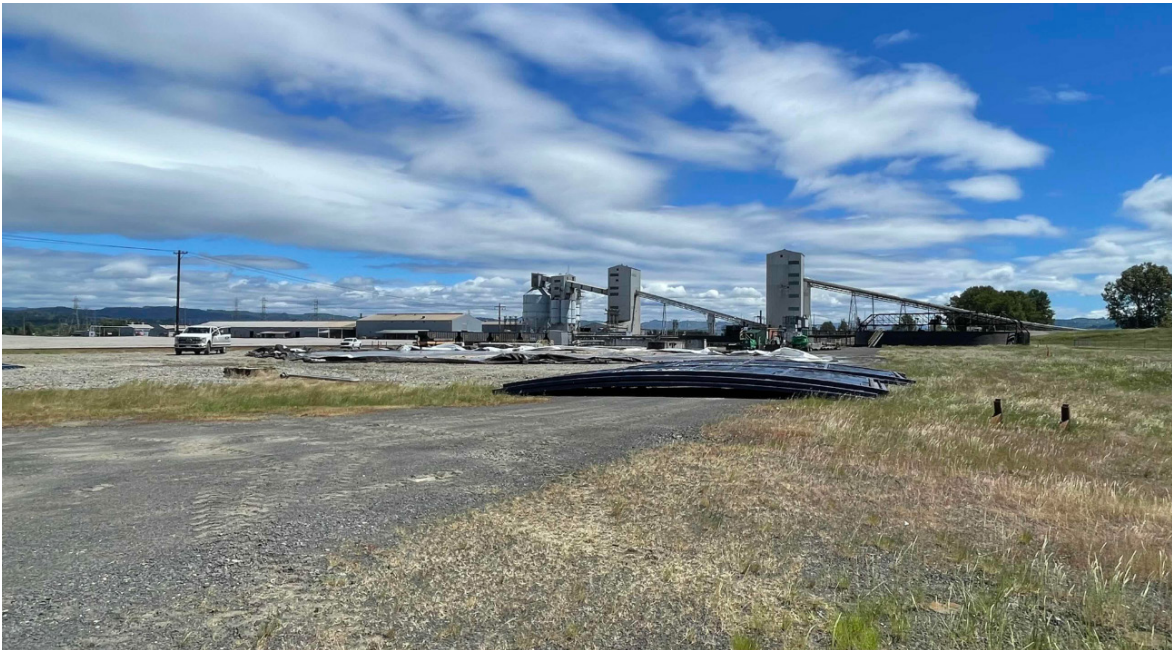
Photograph 8
Facility 77

Deinstallation of 1-million-gallon extension tank

- Denbeste Water Solutions removed the 1-million-gallon Facility 77 temporary water tank extension.
- Envirocon removed the Season 1 temporary manhole and stormwater conveyance ditch for East Landfill No. 1.
