Monthly Progress Report

Re: **Former Reynolds Metals Remediation – Monthly Progress Report, August 2023**

Attachment A

Construction Photographs

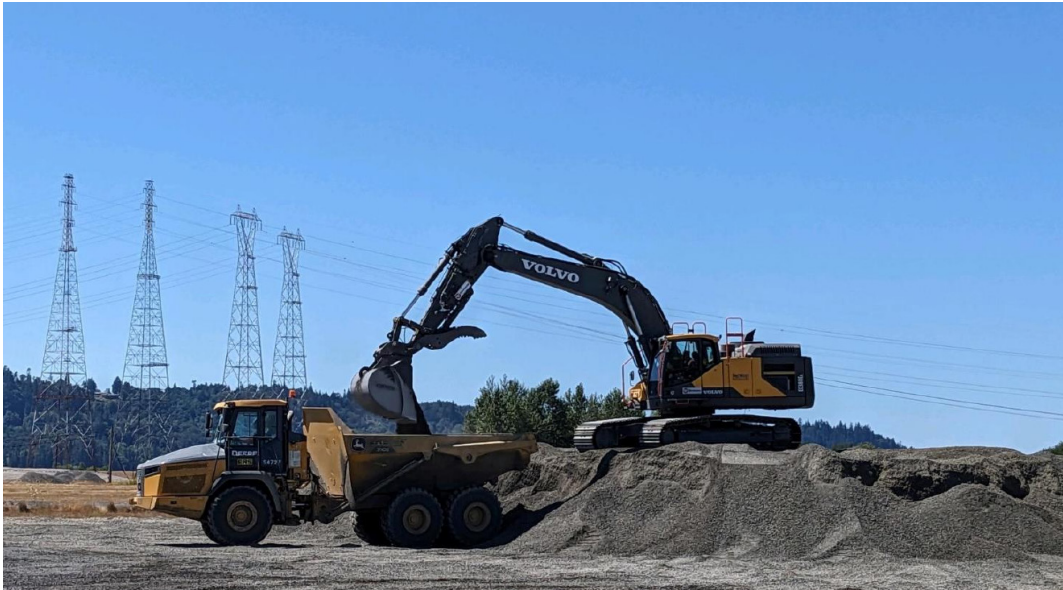
Photograph 1
West Staging Area

Envirocon, Inc., loading select fill at West Staging Area to transport to Site Unit (SU) 2.

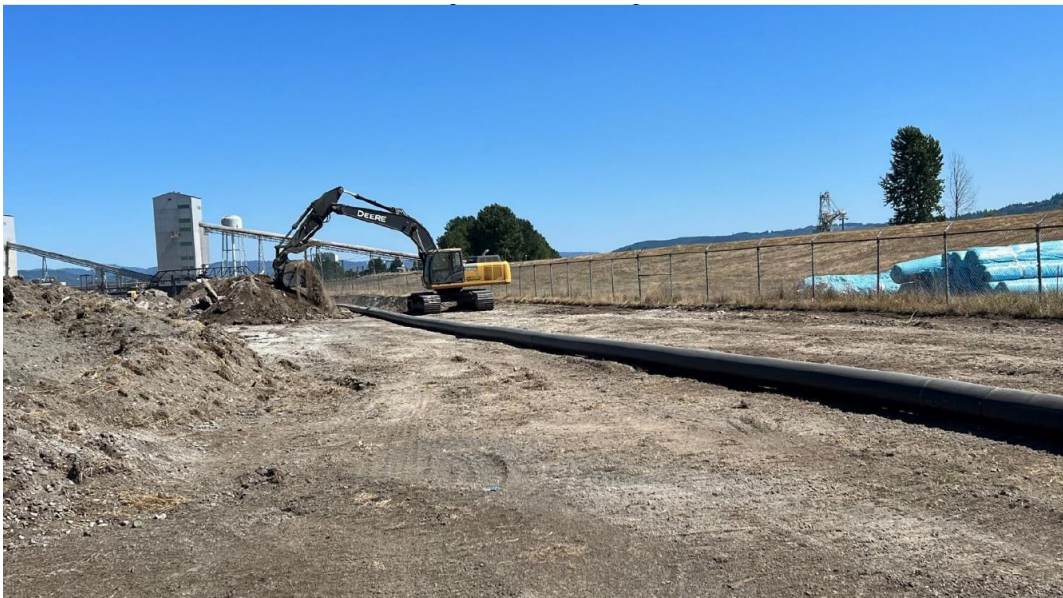
Photograph 2
West Force Main

Catworks trenching along west force main alignment (facing south).

- Work was completed in June 2023.
- **Stormwater infrastructure**
 - Removed surficial concrete for trenching of west force main alignment; performed trenching and installed underground conduit

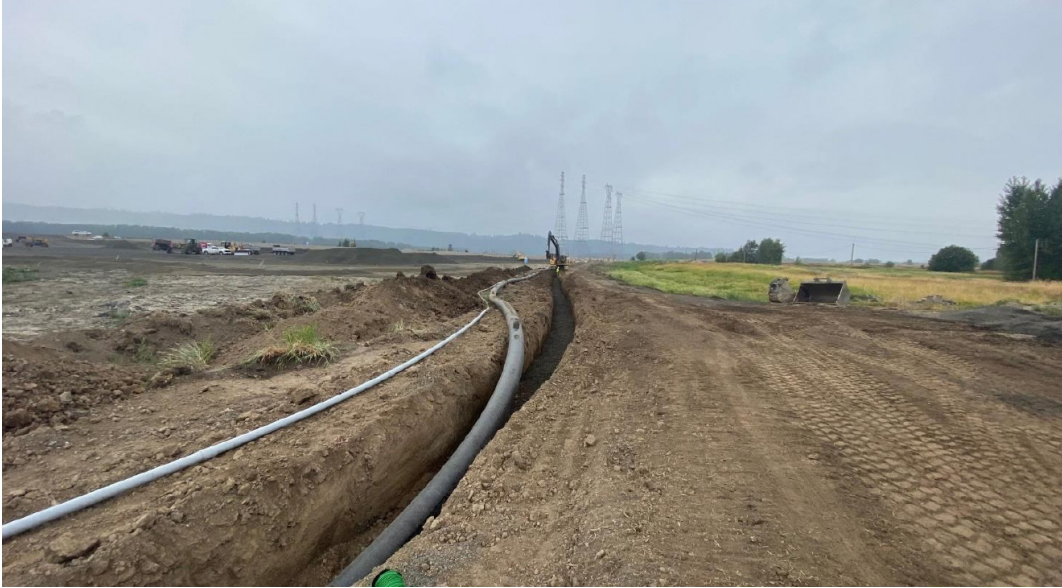
Photograph 3
West Force Main

Installation of 14-inch-diameter high density polyethylene (HDPE) west force main piping (facing west).

- Continued fusing of 14-inch-diameter high density polyethylene (HDPE) west force main piping; installed 14-inch-diameter HDPE piping from Station 123+00 to 100+00

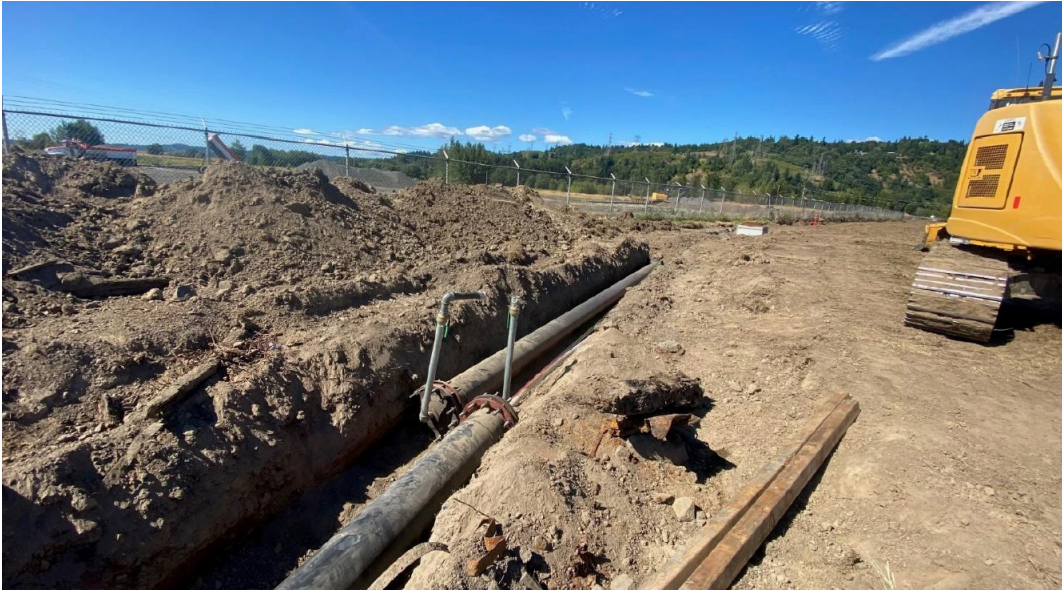
Photograph 4
West Force Main

Installation of 14-inch flange valves in preparation for hydrostatic pressure test.

- Welded 90-degree bends and placed thrust blocks as per project specifications
 - Installed 14-inch-diameter flange valves in preparation for west stormwater force main hydrostatic pressure test

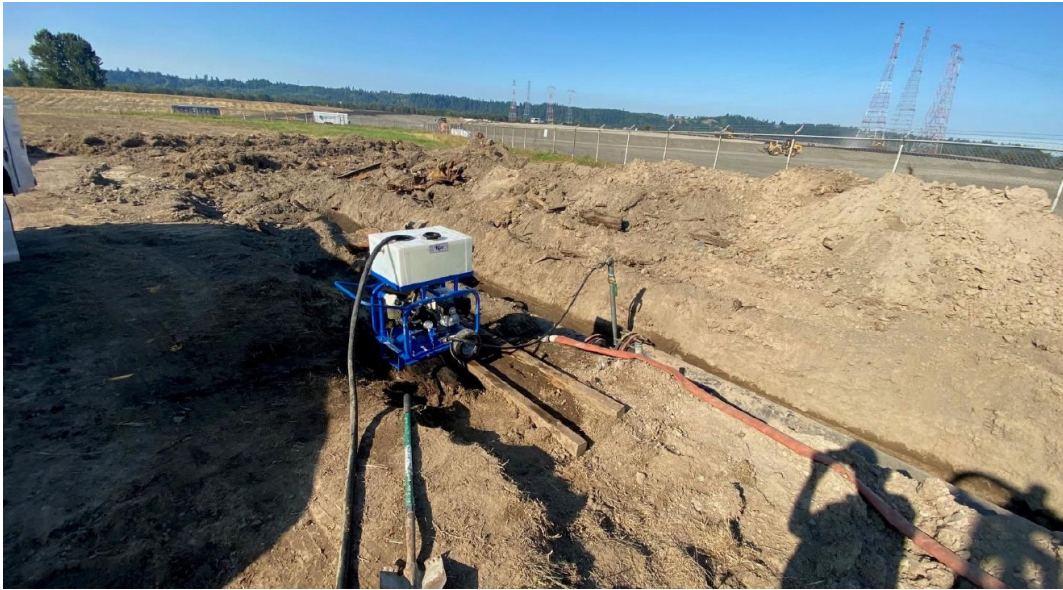
Photograph 5
West Force Main

Hydrostatic pressure test being performed on west force main piping (facing southwest).

- Completed hydrostatic pressure test on approximately 1,450 feet of 14-inch-diameter HDPE stormwater force main pipe
 - Prefabricated conduits for West Pump Station alignment

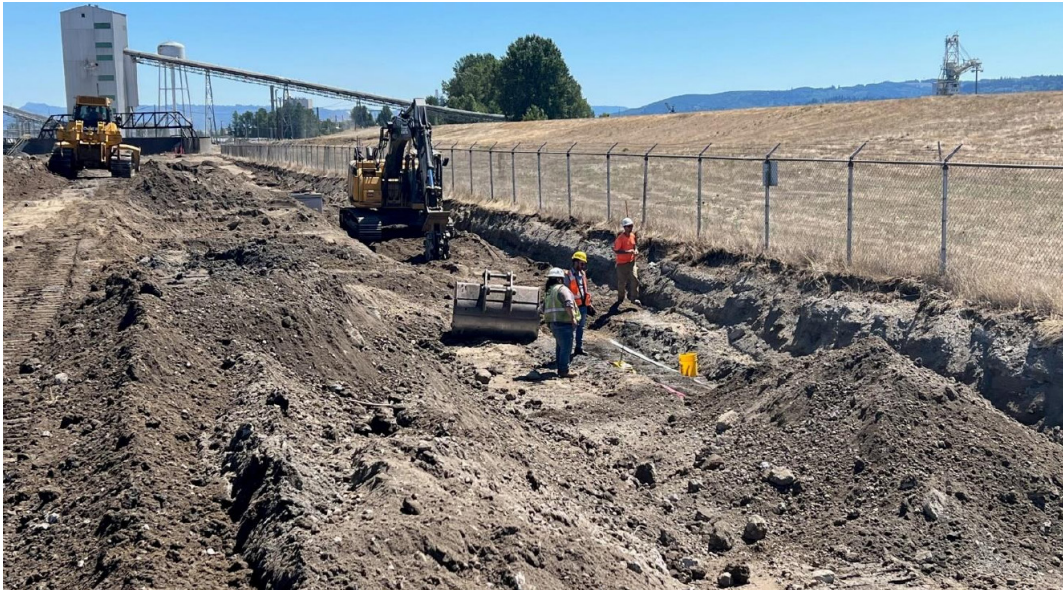
Photograph 6
West Force Main

Compaction testing being performed along west force main backfill material (facing southeast).

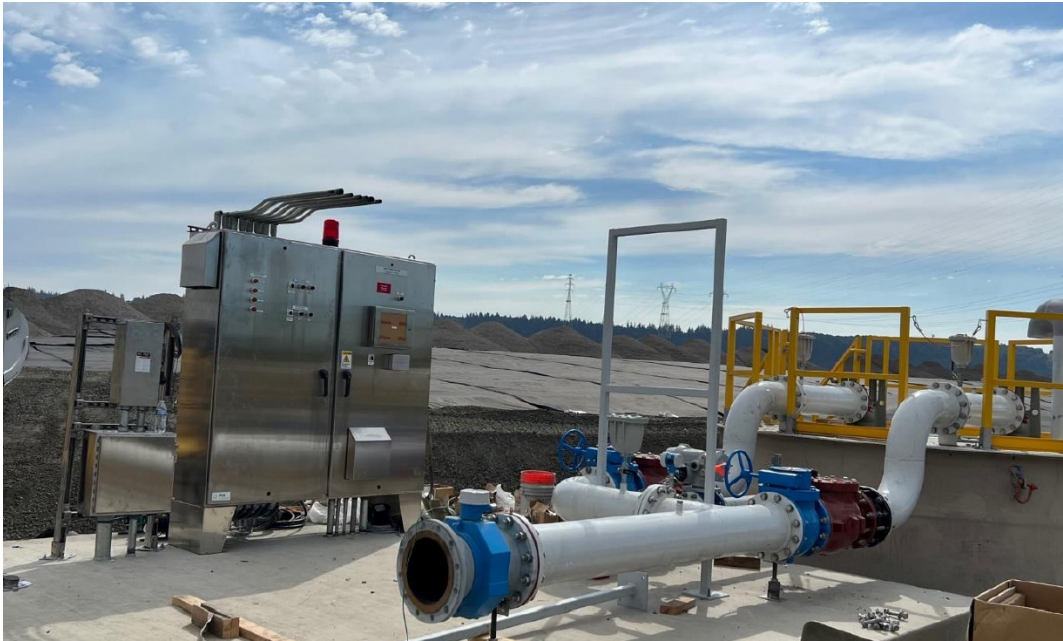
Photograph 7
West Pump Station

Installation of mechanical, electrical, and plumbing at West Pump Station.

- Constructed structural slab for the West Pump Station
 - Installed electrical control panel at the West Pump Station, fittings, and valves
 - Completed mechanical, electrical, and plumbing installation at the West Pump Station

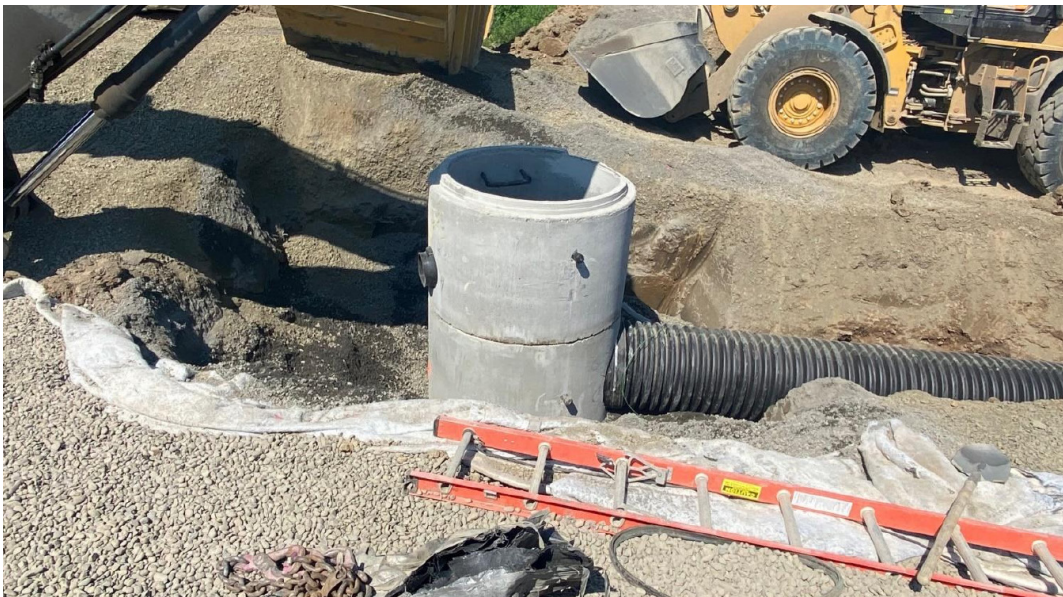
Photograph 8
West Pump Station

Installation of 48-inch-diameter concrete manhole with 24-inch-diameter corrugated polyethylene pipe.

- Installed 74 feet of 24-inch-diameter corrugated polyethylene (CPE) pipe north perimeter ditch of West Landfill; placed a concrete manhole and connected CPE pipe between the manhole and West Pump Station; backfilled around the pipe and manhole and performed compaction testing

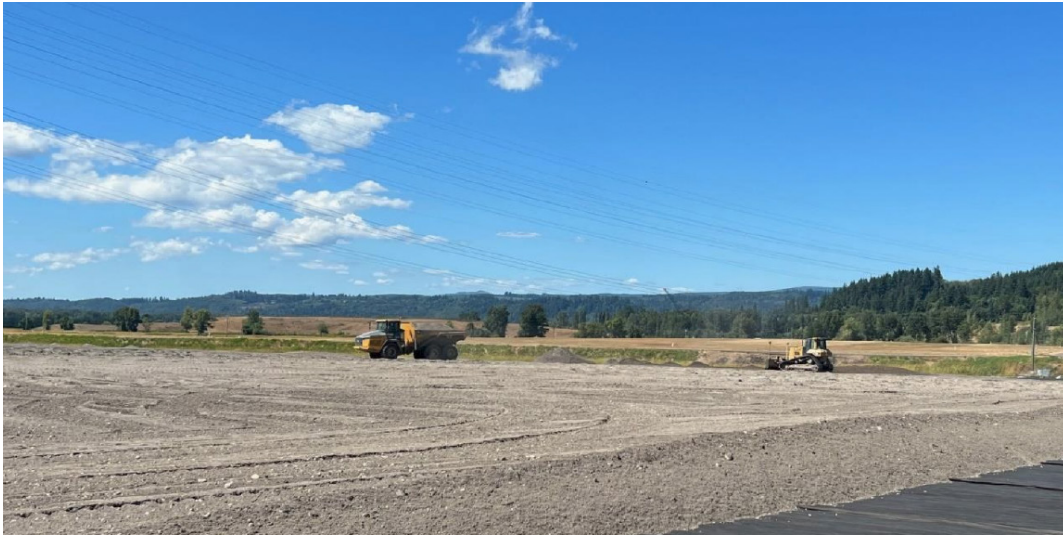
Photograph 9
West Landfill

Envirocon placing general fill above geotextile fabric at West Landfill (facing north).

- Deployed geotextile fabric in West Landfill
 - Finished placing general fill atop geotextile in West Landfill
 - Placed drain rock over geosynthetic clay liner in south and east perimeter ditches of West Landfill

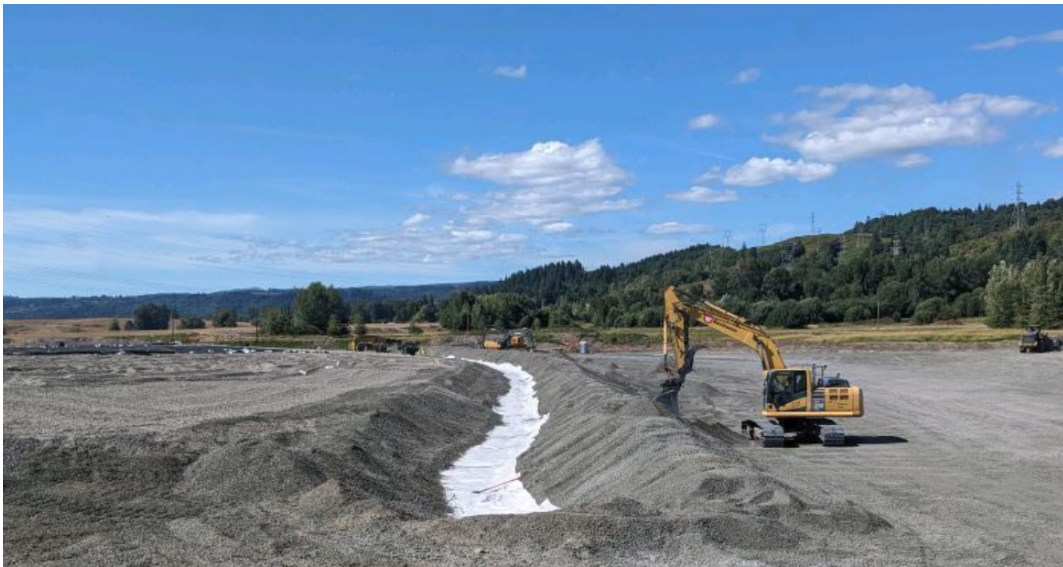
Photograph 10
West Landfill Drainage Ditch

Envirocon constructing berm along the eastern area of the West Landfill. Geosynthetic clay layer was placed in drainage ditch (facing northwest).

- Placed topsoil in West Landfill south perimeter ditch
 - Continued construction of West Landfill east perimeter berm

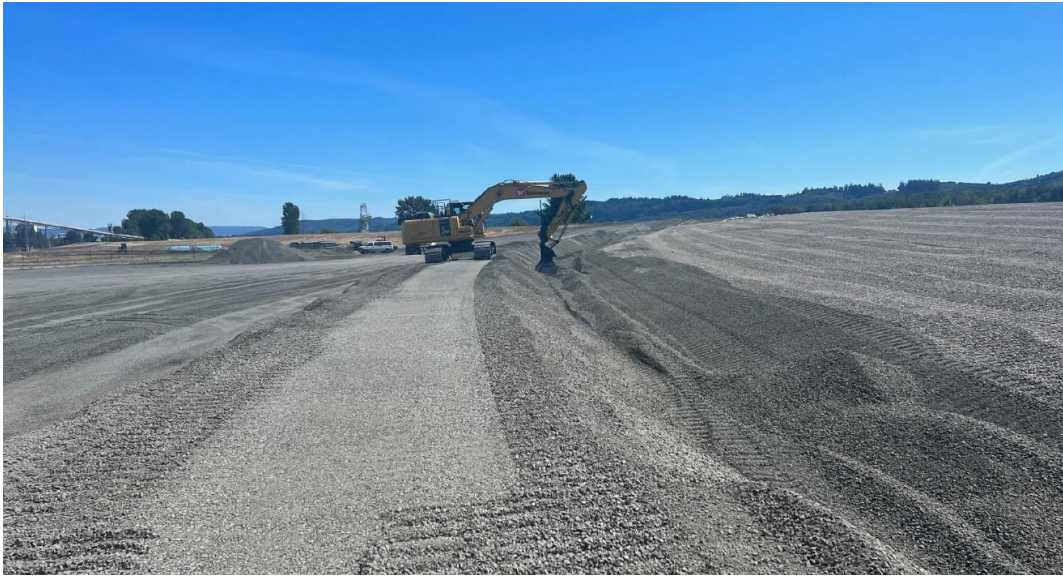
Photograph 11
Site Unit 2

Envirocon performing compaction at SU2 (facing south).

- Mixed and placed activated alumina reactive backfill at eastern area of SU2
- Backfilled SU2 east with select backfill
- Placed topsoil in SU2
- **Site Unit 8 and East Landfill No. 1**
 - Continued SU8 excavation and material placement in East Landfill No.1
 - Staged carbon blocks at perimeter of SU8
 - Completed excavation and topographic survey at SU8
 - Continued grading activities at East Landfill No. 1
- **Site Unit 10**
 - Completed backfilling using select fill, set final grade, and placed topsoil
 - Completed final surveys
- **Cap placement**
 - Refer to the previous West Landfill discussion.
- **Permeable reactive barrier installation**
 - There were no activities this period.

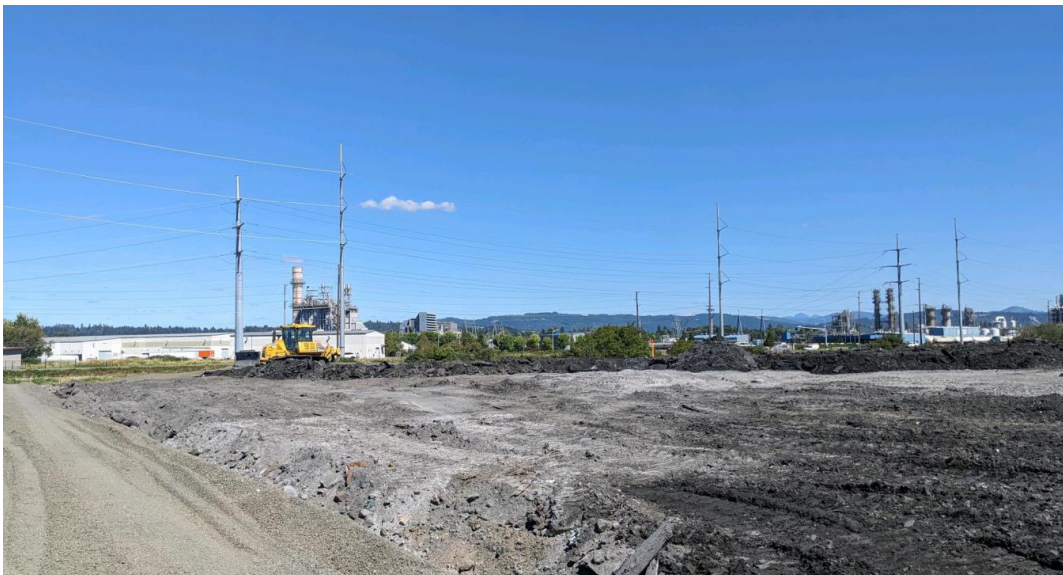
Photograph 12
East Landfill No. 1

Envirocon backfilling at East Landfill No. 1 (facing northeast).

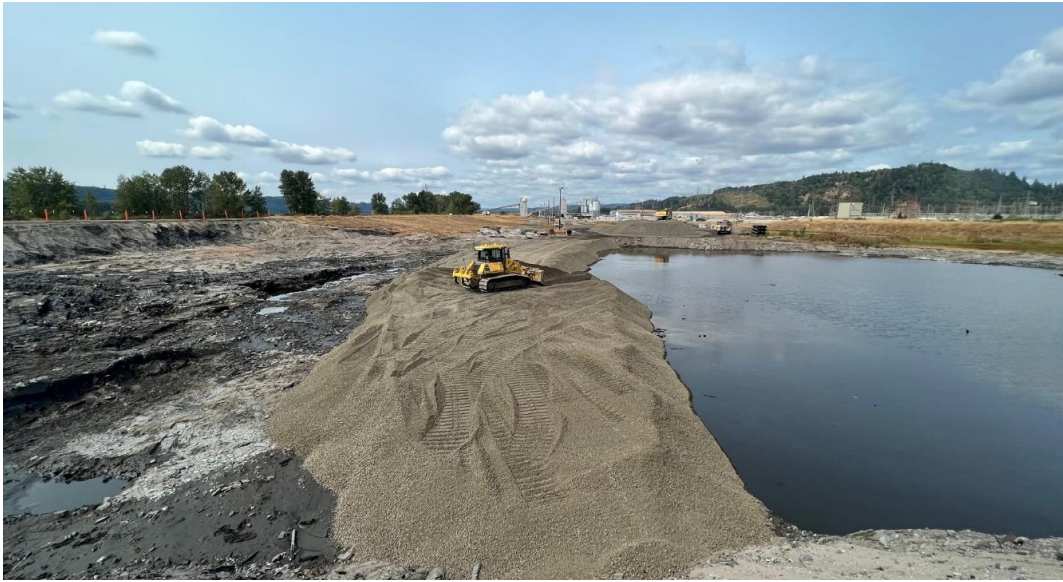
Photograph 13
Site Unit 8

Envirocon backfilling at SU8 (facing northwest).

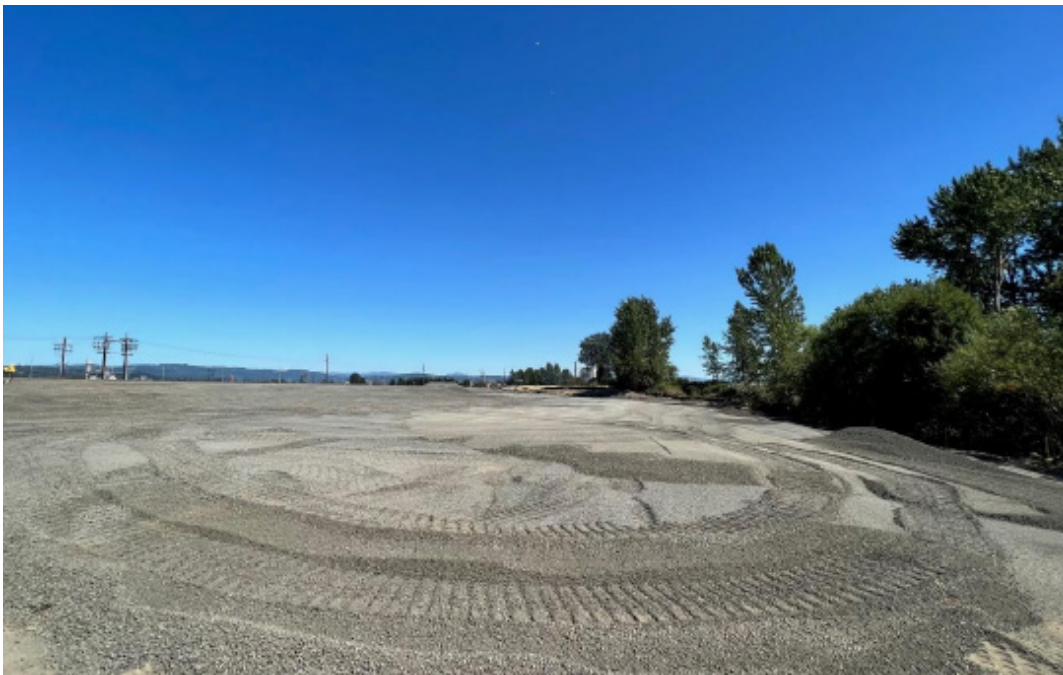
Photograph 14
Site Unit 10

Backfill and compaction completed at SU10 (facing northeast).
