Monthly Progress Report

Re: Former Reynolds Metals Remediation – Monthly Progress Report, September 2024

Attachment A

Construction Photographs

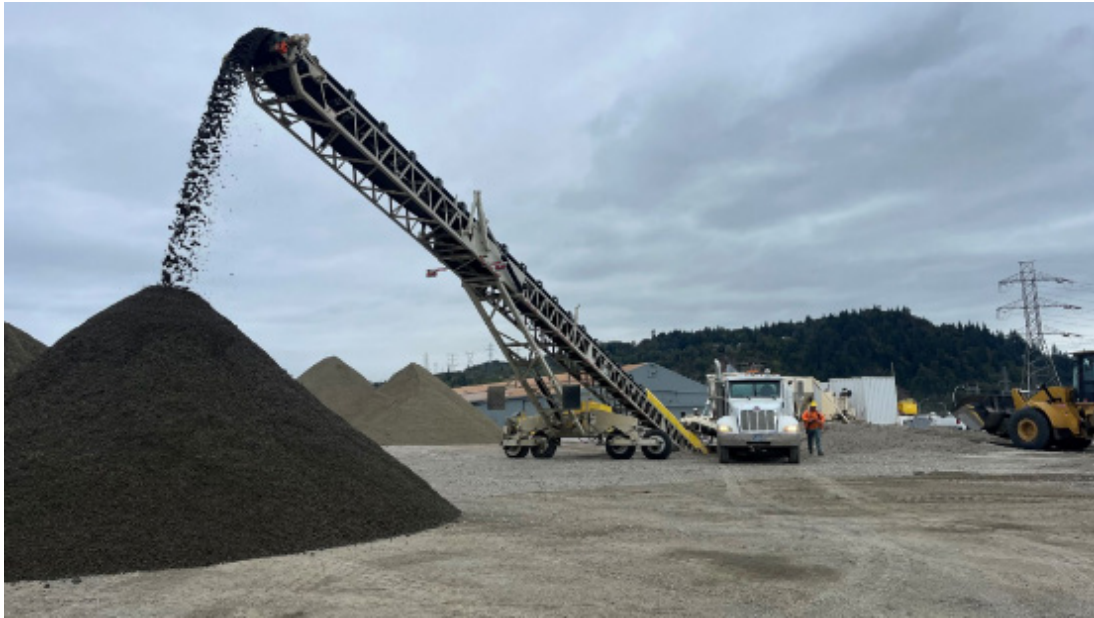
Photograph 1
East Staging Area

Mixing reactive backfill

- A total of 105 super sacks of activated alumina were delivered to the East Staging Area.
 - Tsunami Mixing continued mixing and stockpiling reactive backfill in the East Staging Area for use in Site Unit (SU) 3, SU4, and SU5.

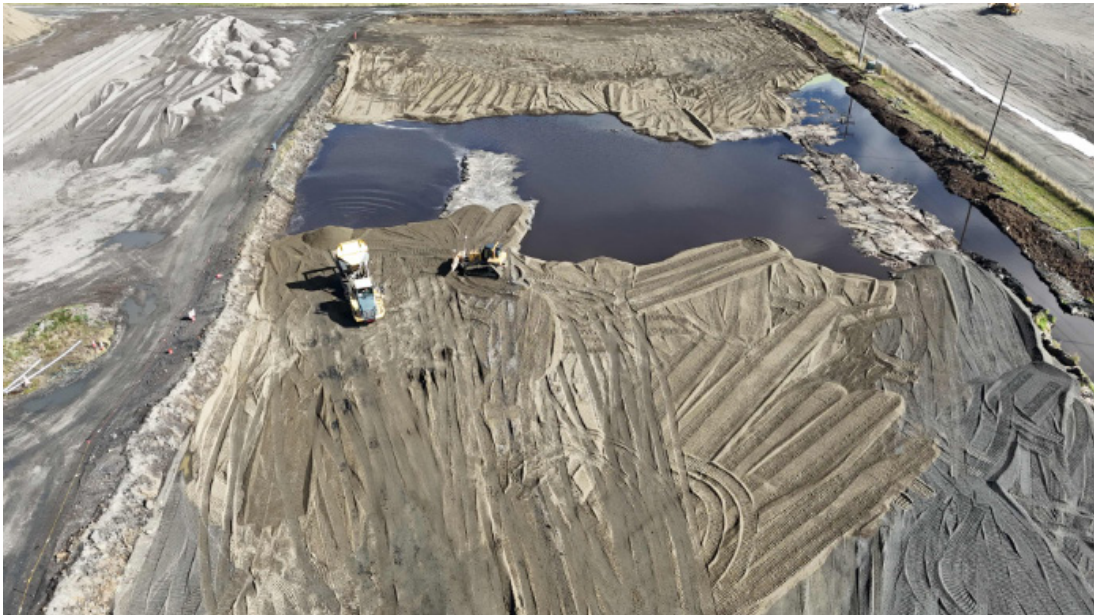
Photograph 2
Site Unit 3

Reactive backfill placement

- Envirocon continued placement of reactive backfill in SU3, began placement of reactive backfill in SU4, and completed placement of reactive backfill in SU5.

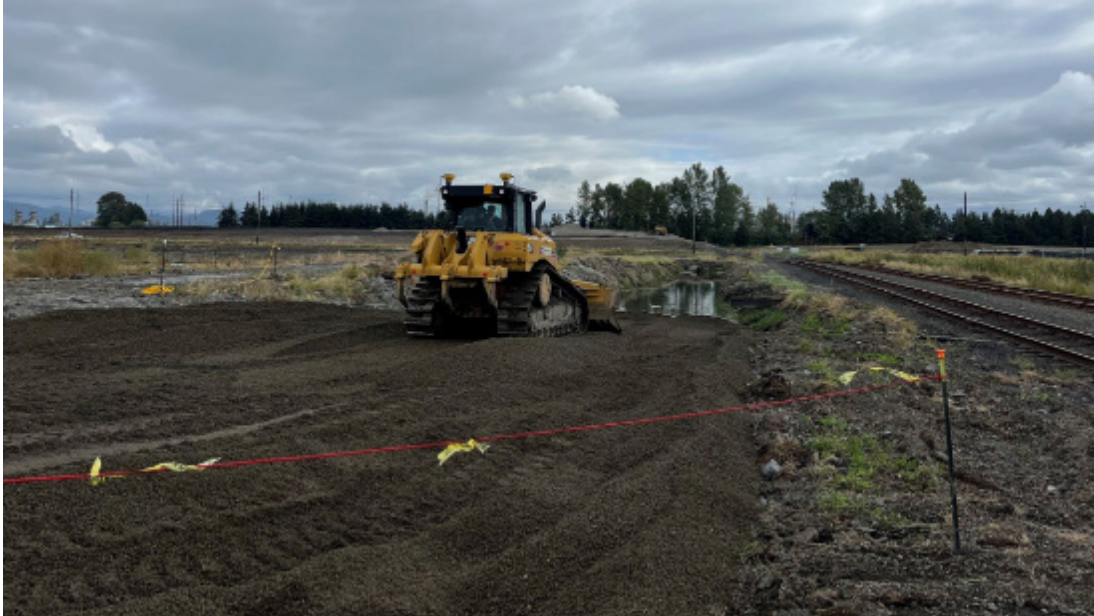
Photograph 3
Site Unit 4

Reactive backfill placement

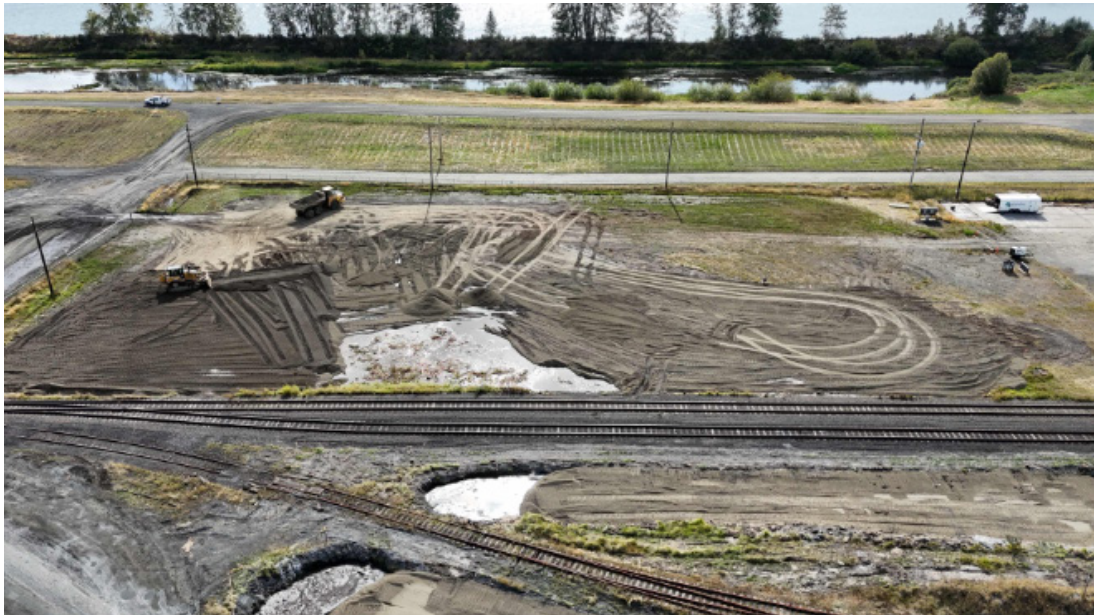
Photograph 4
Site Units 4 and 5

Reactive backfill placement

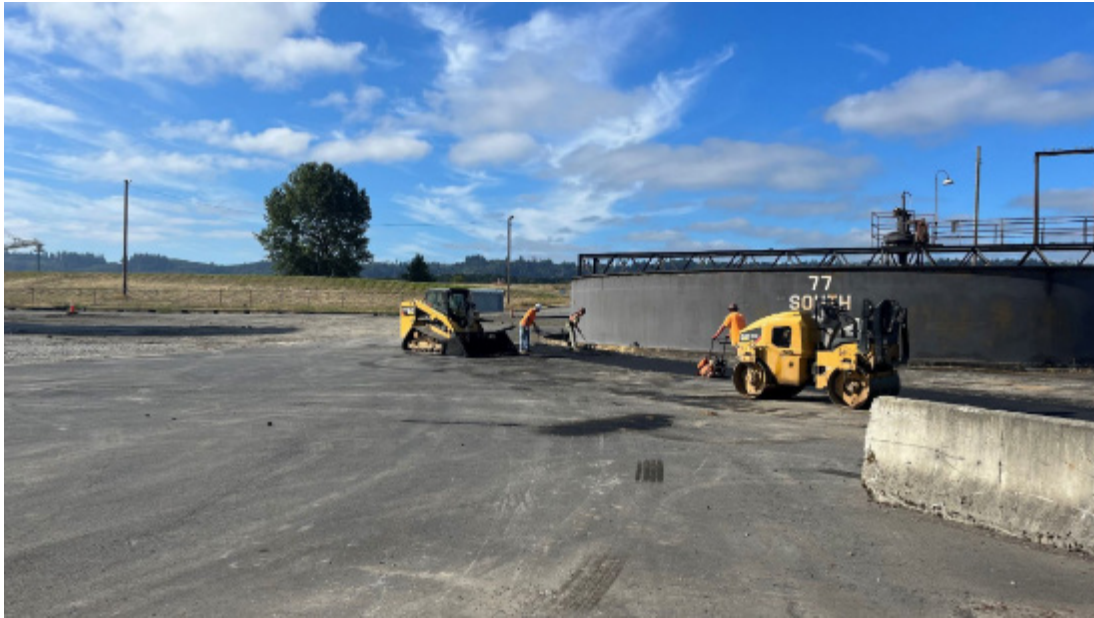
Photograph 5
Facility 77

Asphalt placement over force main alignment

- There were no deviations from project design documents.
- **Ground improvement**
 - Work was completed in June 2023.
- **Stormwater infrastructure**
 - Envirocon completed asphalt placement over the force main at the Facility 77 connection.

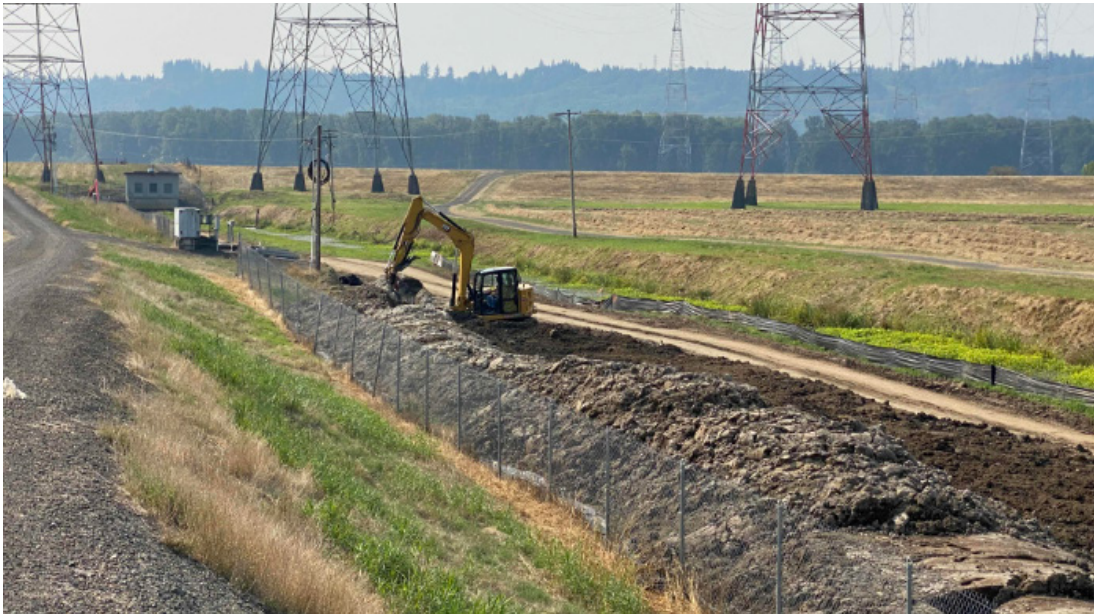
Photograph 6
Permeable Reactive Barrier

Grading and restoration along segment 2 alignment

- Envirocon began housekeeping and restoration work within the limits of the PRB, including final grading and removal of supplemental TESC.

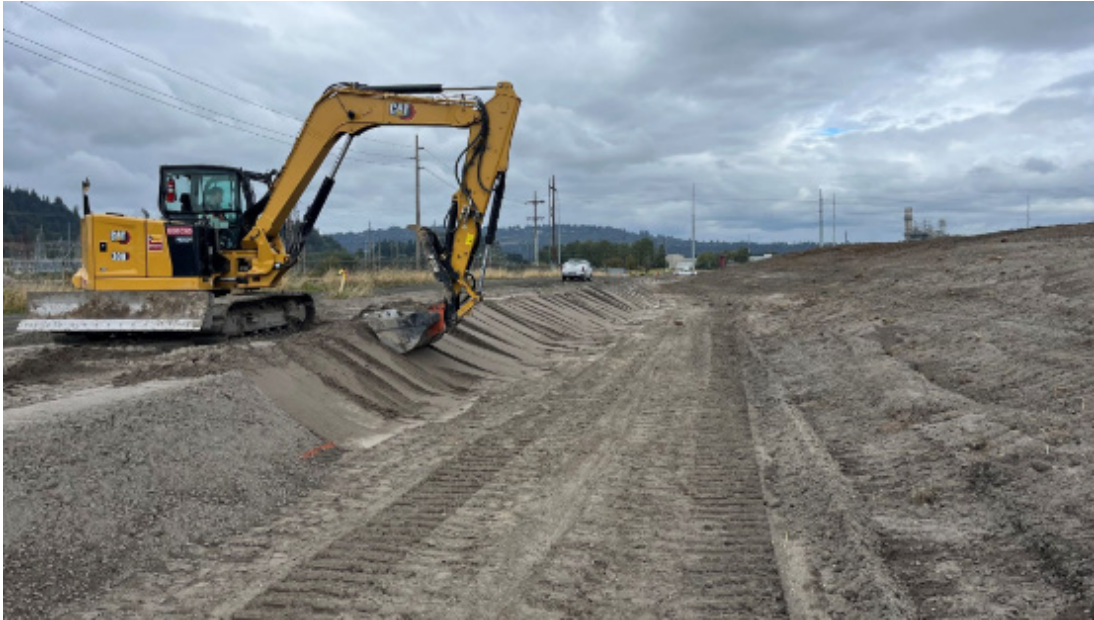
Photograph 7
East Landfill No. 2

Grading west perimeter ditch

- Envirocon began efforts to cap culverts between the SU4 ditches.
 - East Landfill No. 2
 - Envirocon completed final grading of the subgrade and continued grading of the landfill perimeter ditches.

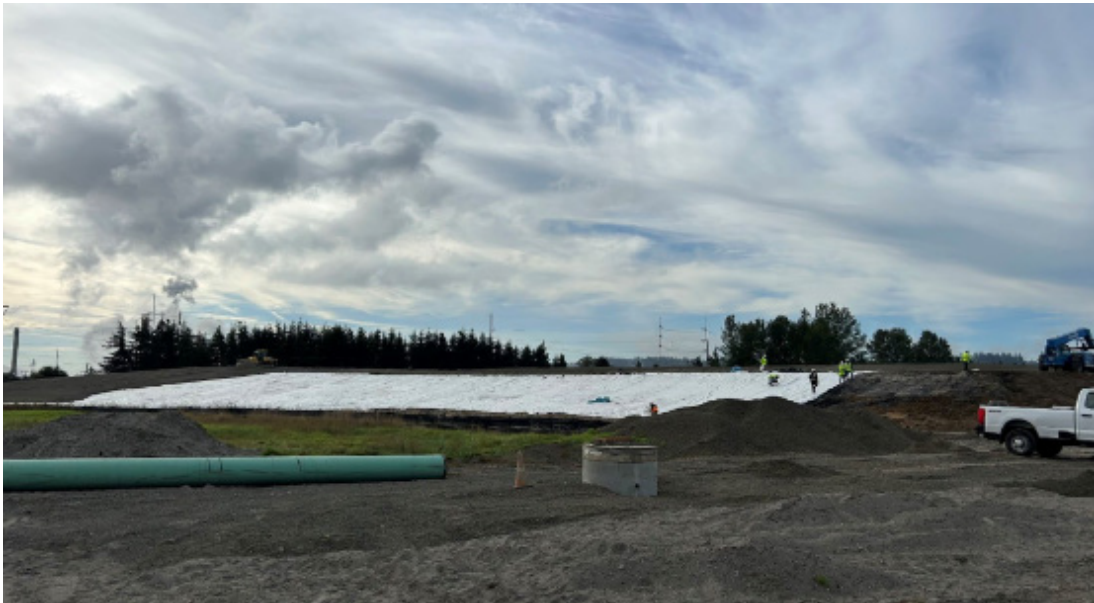
Photograph 8
East Landfill No. 2

GCL deployment along northwestern slope

- Northwest Linings & Geotextile Products began installation of liner and geotextile components of the low-permeability cap, including the following:
 - Completed deployment of the geosynthetic clay layer (GCL) over subgrade. Seams were sealed with granular bentonite at 9-inch overlaps as per project specifications.

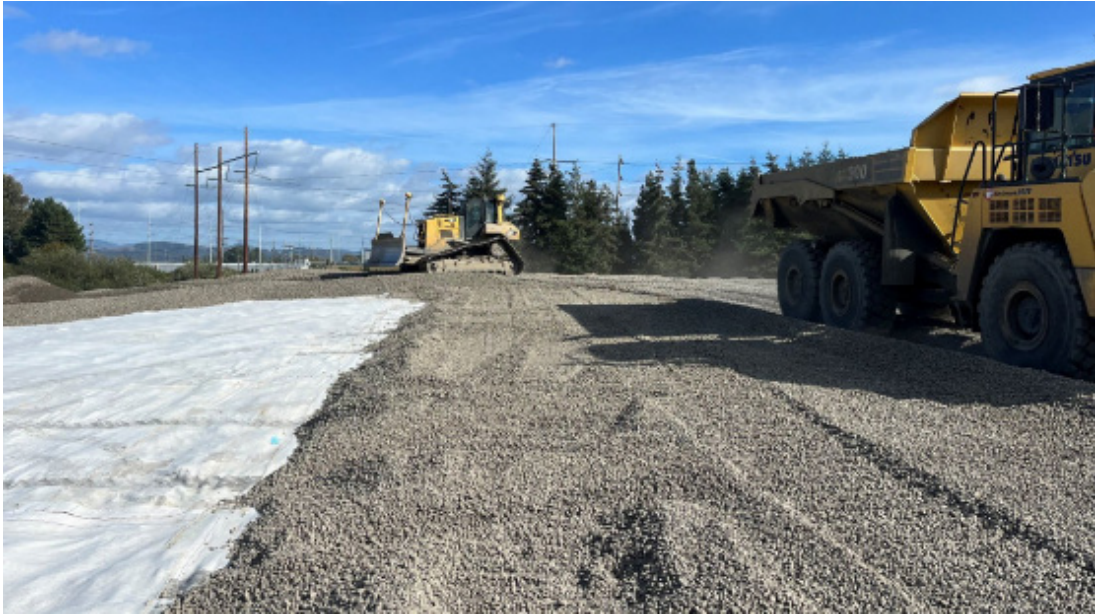
Photograph 9
East Landfill No. 2

Placement of drainage layer material over GCL

- Envirocon began placement of material components of the low-permeability cap, including the following:
 - 12 inches of drainage layer material over the GCL

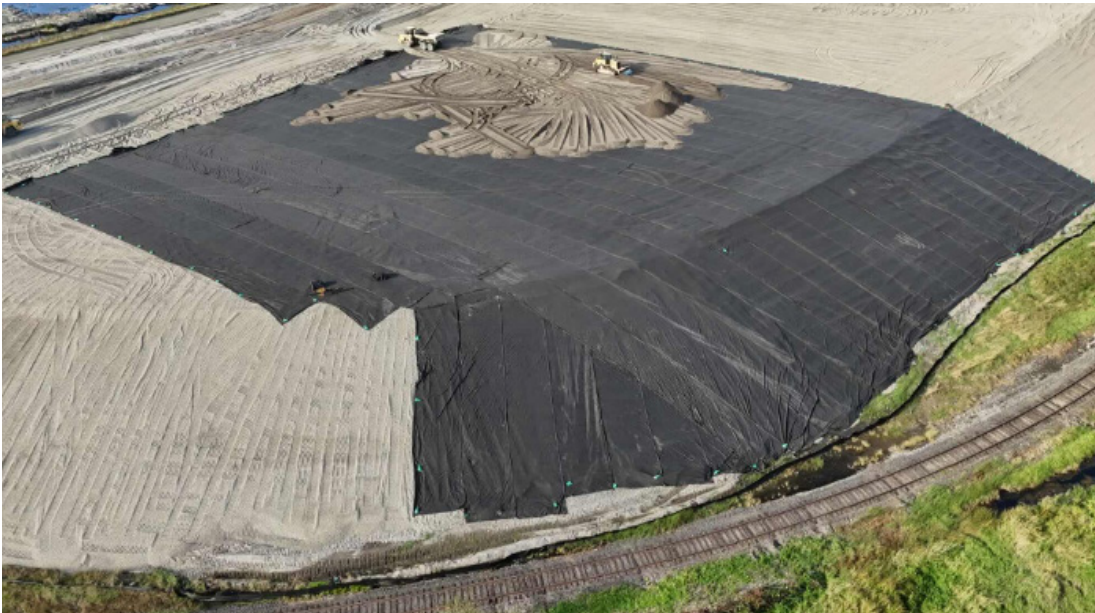
Photograph 10
East Landfill No. 2

Non-woven geotextile deployment and placement of general fill

- Began deployment of the non-woven geotextile over drainage layer material. Seams were sewn with a minimum 3-inch overlap as per project specifications.

- 6 inches of general fill over the non-woven geotextile
 - 6 inches of topsoil over general fill
- **Site Unit 9, Site Unit 11, and Diesel Aboveground Storage Tank (AST) Area**

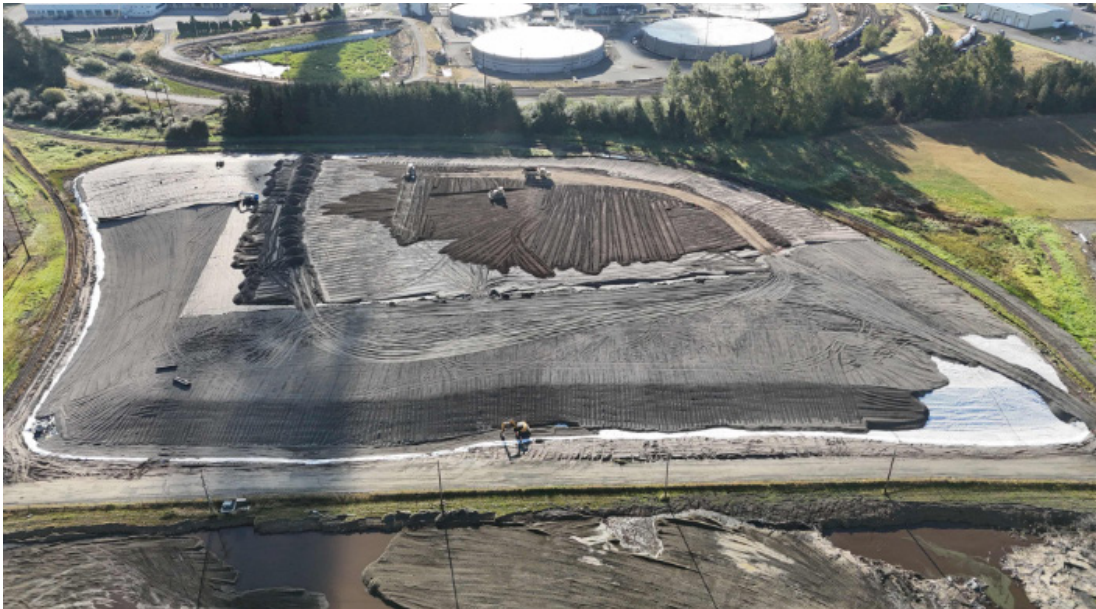
Photograph 11
East Landfill No. 2

Overall progress of all low-permeability cap components (GCL, drainage layer material, geotextile, general fill, and topsoil)

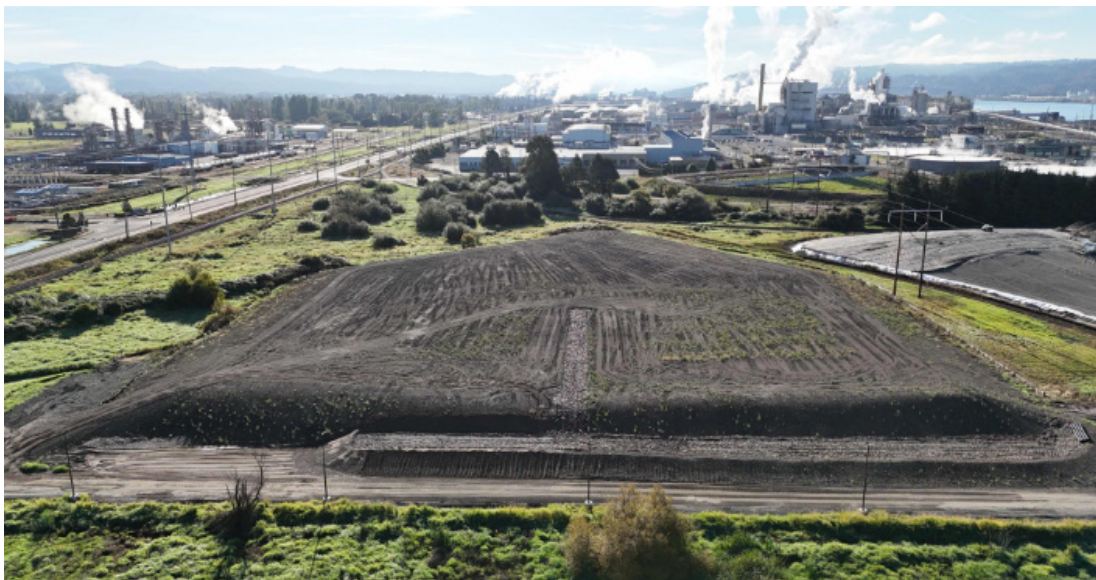
Photograph 12
East Landfill No. 1

Perimeter ditch expansion

- Envirocon completed the East Landfill No. 1 perimeter ditch construction.
 - **Site Units 3 through 5 and East Landfill No. 2**
 - Site Units 3 through 5

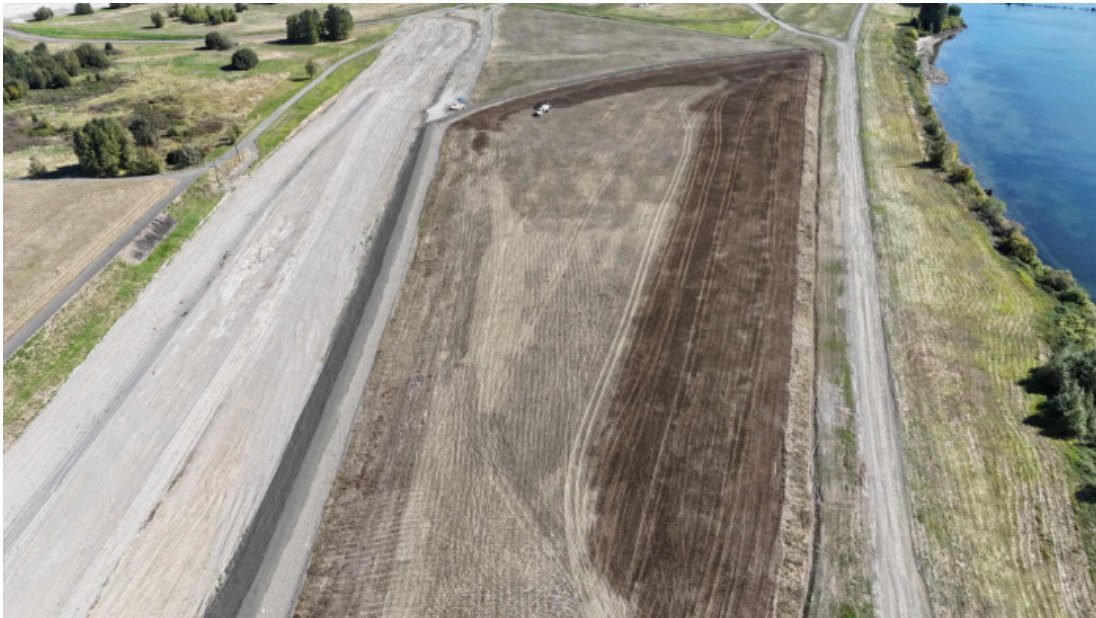
Photograph 13
West Landfill

Hydraulic topsoil application

- Final regrading of the U-Ditch was completed in July 2024.
 - Northwest Hydro-Mulchers completed a hydraulic topsoil application over the West Landfill to support better grass growth and reseeding.
